**HISTORIC BUILDING SURVEY REPORT:  
72 BAILGATE, LINCOLN, LINCOLNSHIRE**

Planning Reference: 2017/0421/LBC  
NGR: SK 9768 7200  
AAL Site Code: LIBA 18  
Museum Accession Number: LCNCC: 2018.110  
OASIS Reference Number: allenarc1-320177

By  
Allen Archaeology Ltd  
Report Number AAL2018104

June 2018

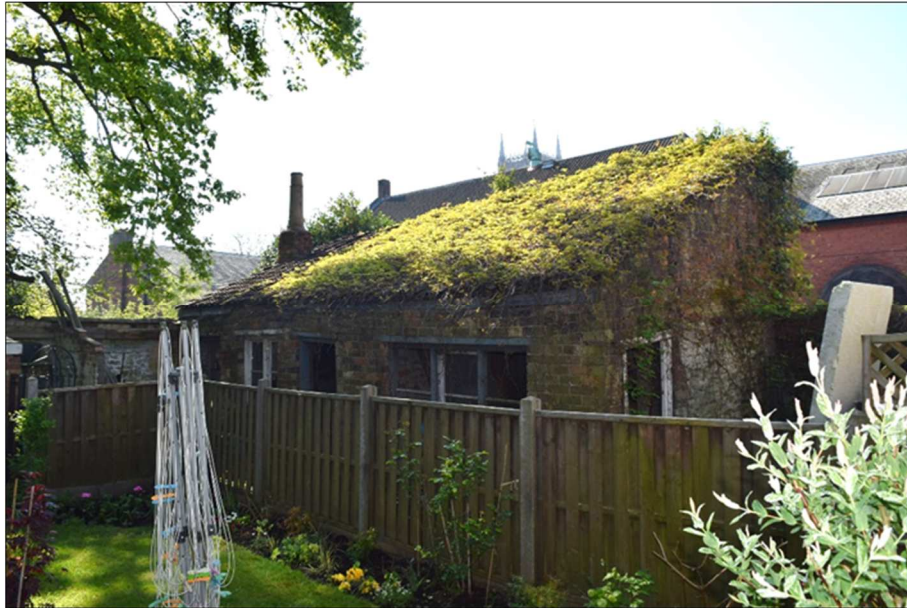
- 6.1 The building comprises a single storey brick outbuilding with attic, built in English Garden Wall Bond, with mono pitched roof of ceramic tiles (Plate 1). It has a single chimney at the east end, with a square stack and tall ceramic pot (Plate 2).
- 6.2 The west elevation has a single doorway towards the north, with plain wooden frame. To the south, a brick boundary wall abuts the elevation (Plate 3). The brickwork is not tied in and the boundary wall appears to be later.

*Plate 1 (Shot 2): General view of the building, looking east-southeast*

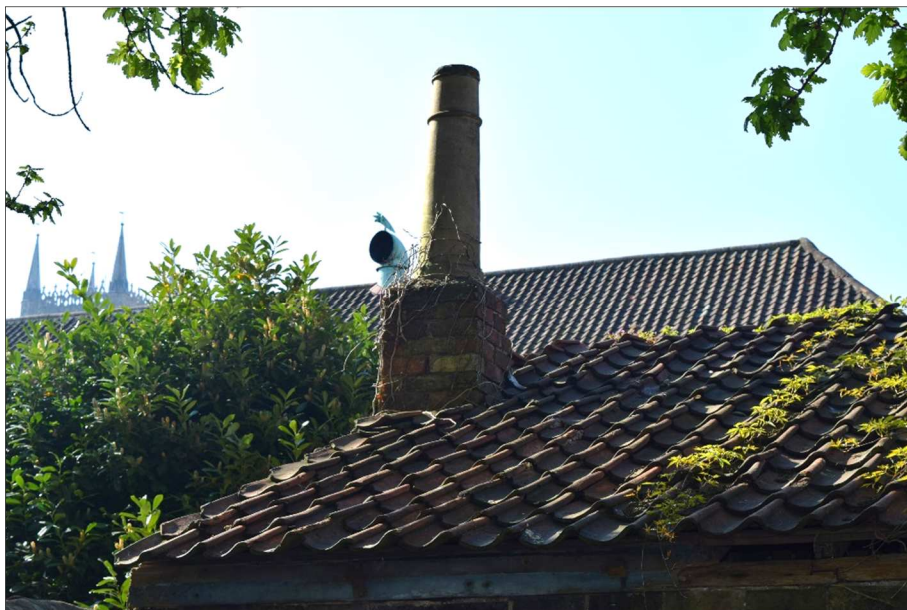
*Plate 2 (Shot 11): Chimney stack at east elevation, looking south-southeast*

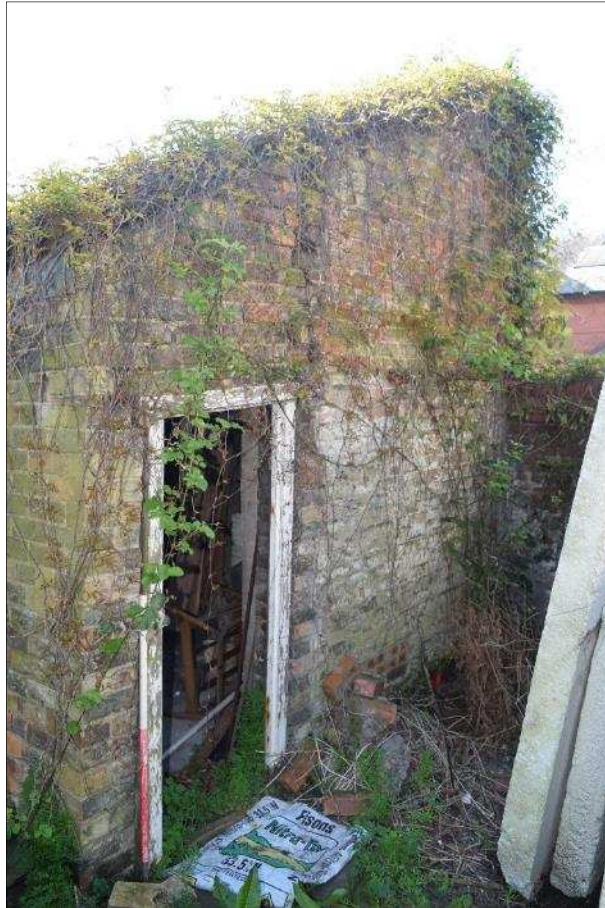
*Plate 3 (Shot 4): West elevation, looking southeast, scale 1m*

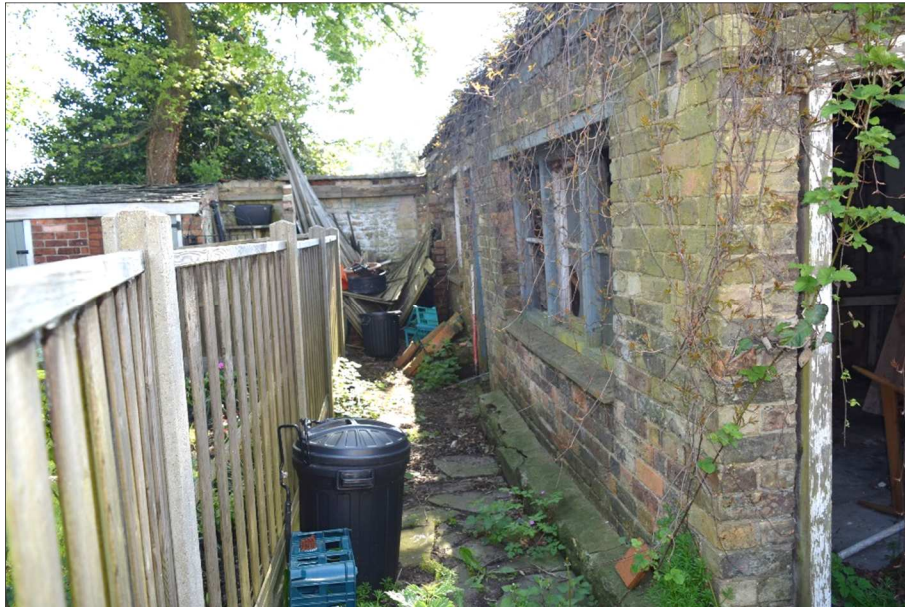
- 6.3 The north elevation has two windows (Plate 4). To the west is a window of three fixed lights with thin wooden glazing bars, to the east is a window of two fixed lights, again with thin wooden glazing bars (Plate 5). Both have a wooden lintel and stone cill.

*Plate 4 (Shot 5): North elevation, looking east-southeast, scale 1m*

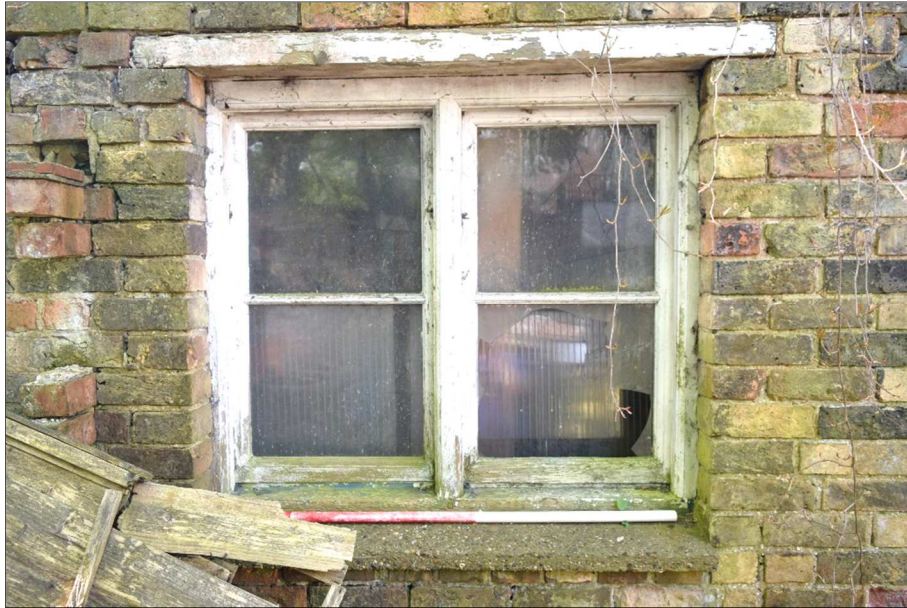
*Plate 5 (Shot 9): Window in north elevation living area, looking south, scale 1m*

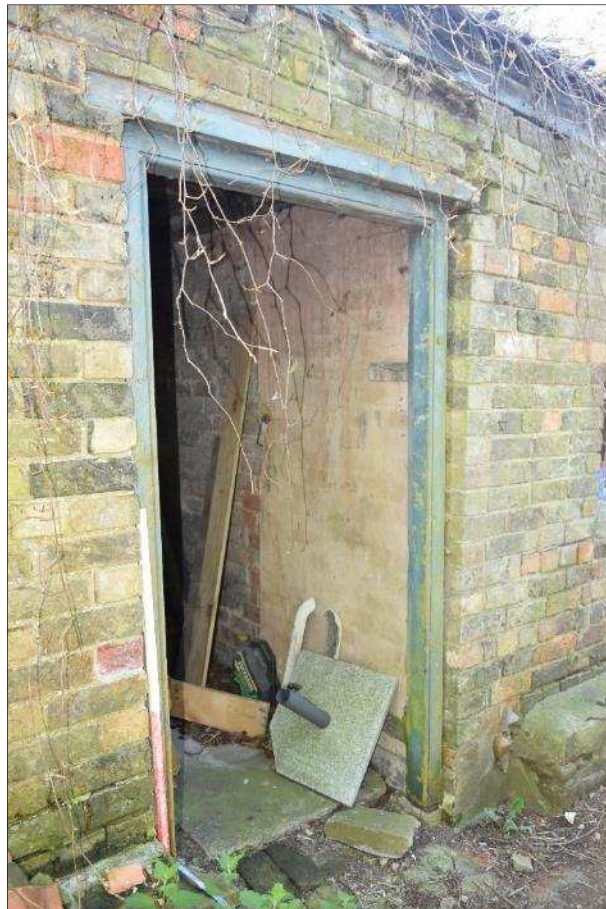
- 6.4 There are two doorways in the north elevation, the door to the west has a moulded wooden frame, whereas the frame is missing from the doorway to the east (Plate 6). Neither have doors. A low brick plinth or buttress, capped with concrete, runs along the north elevation (Plate 7).

*Plate 6 (Shot 7): Door in north elevation living area, looking south-southwest, scale 1m*

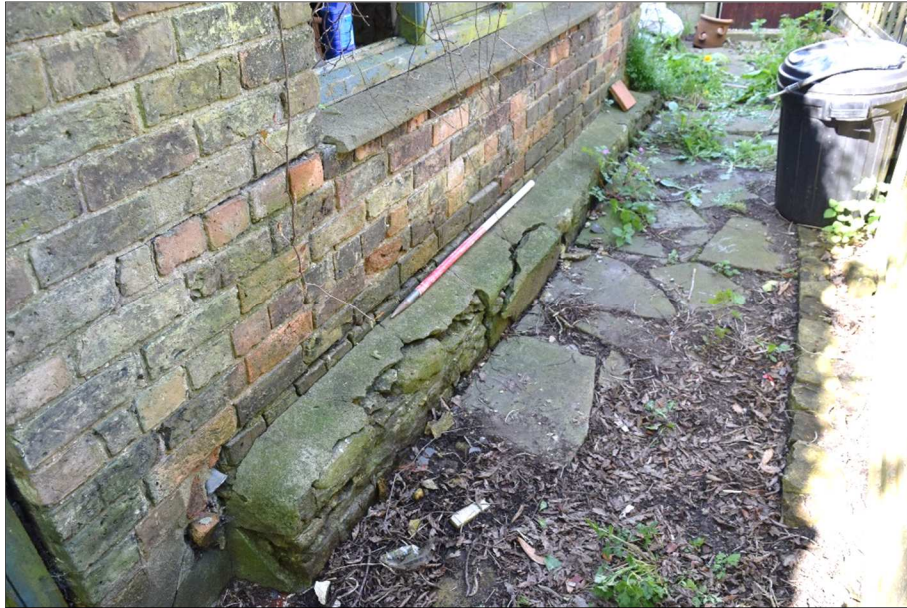
*Plate 7 (Shot 25): Plinth on north elevation, looking southwest, scale 1m*

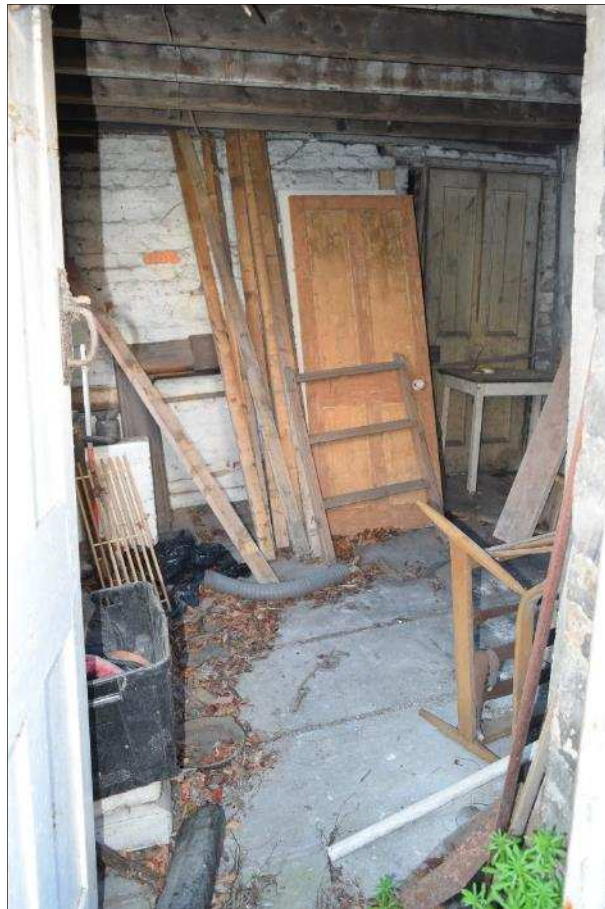
- 6.5 The building is divided into two rooms. The room to the west is the smaller of the two and appears to have served as a washroom or scullery (Plate 8). It has a wooden planked floor and there is a brick stand in the northeast corner, with outlet pipe, likely to have held a wash basin (Plate 9).

*Plate 8 (Shot 13): Scullery interior, looking southeast, scale 1m*

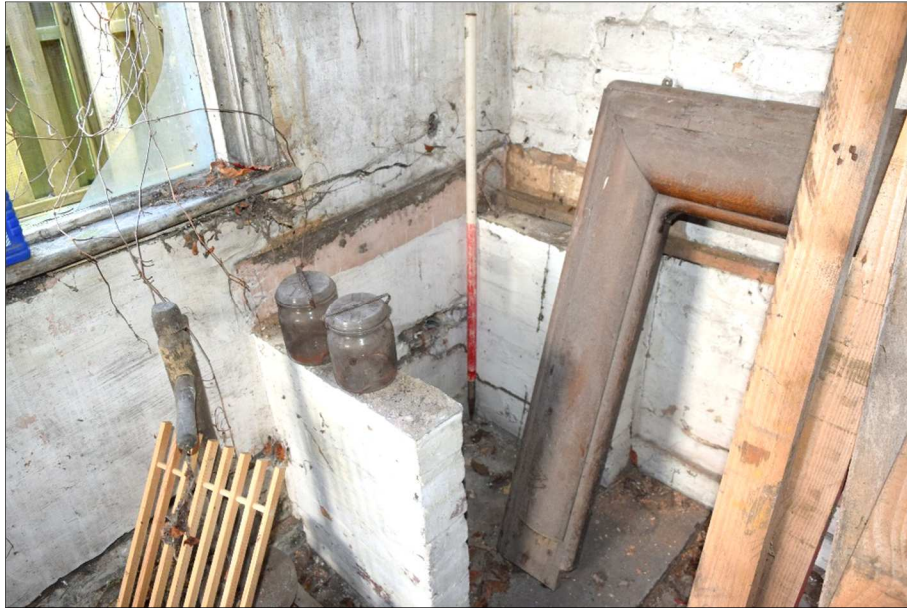
*Plate 9 (Shot 14): Stand for wash basin, looking northeast, scale 1m*

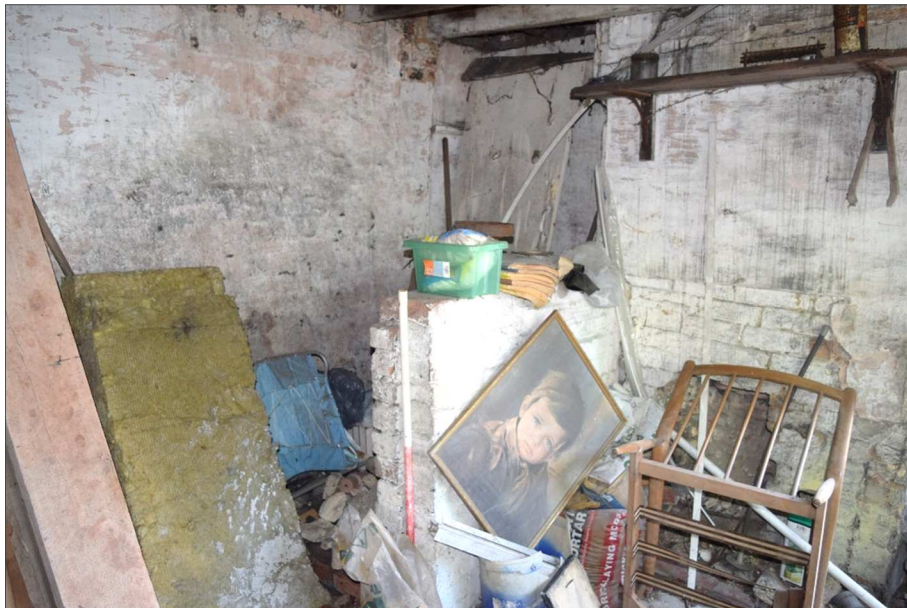
- 6.6 In the southwest corner of the room is a slightly raised area with brick partition, which is of uncertain function (Plate 10). It is situated adjacent to a chimney stack with small fireplace in the centre of the west wall.

*Plate 10 (Shot 16): Brick feature in scullery, looking southwest, scale 1m*

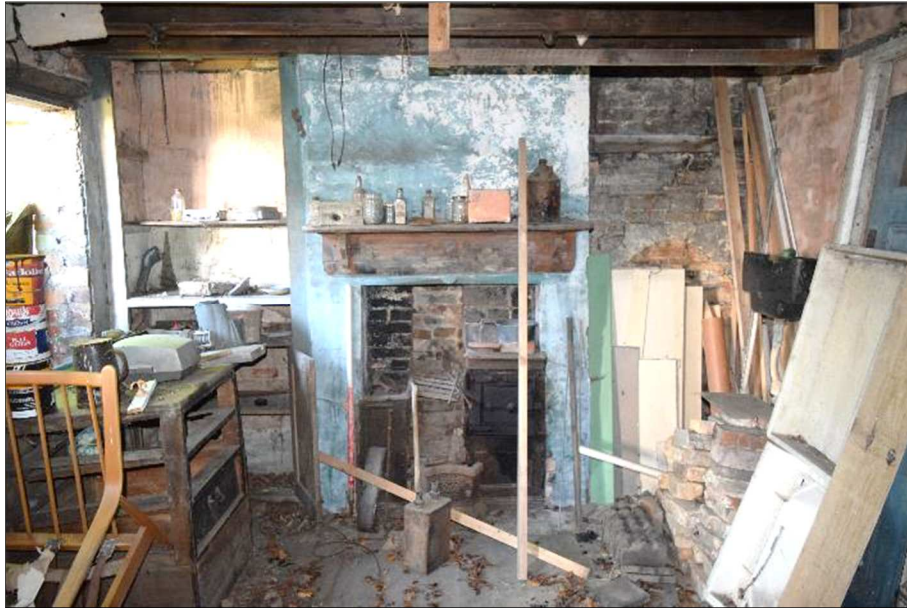
- 6.7 A door leads from the scullery into the adjacent room, which appears to have been a living area. It again has a wooden planked floor, and there is a chimney stack on the east elevation with a small fire grate, a stove and wooden mantelpiece over (Plate 11).

*Plate 11 (Shot 18): Living area interior, looking east, scale 1m*

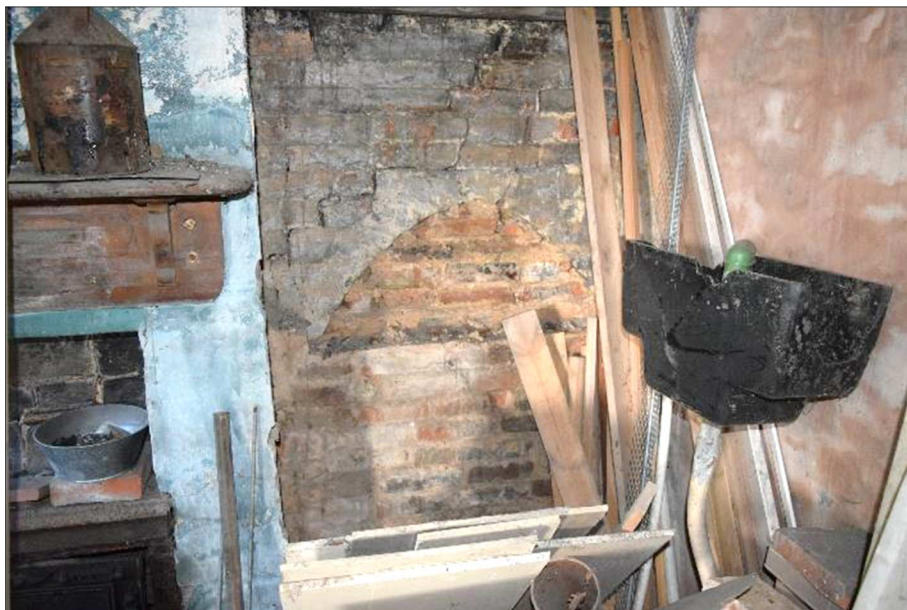
- 6.8 The recess to the north of the fireplace is fitted with cupboards and shelving, the recess to the south has a bricked-up arched recess of uncertain function (Plate 12).

*Plate 12 (Shot 19): Detail of blocked opening in living area, looking east-southeast*

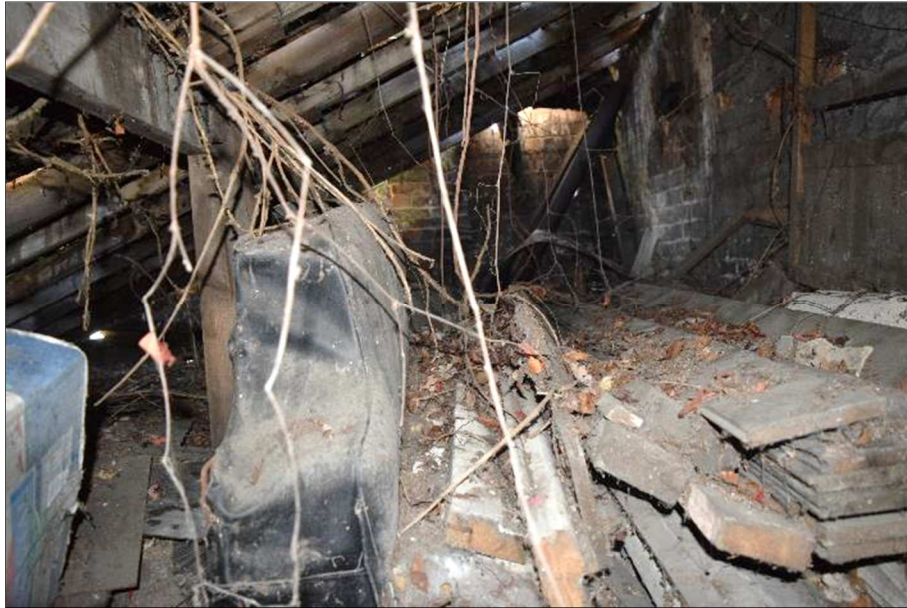
- 6.9 The living area has a ladder access to a loft space running the full length of the building. This was full of assorted stored materials and was not accessible (Plate 13).

*Plate 13 (Shot 21): Loft space, looking east*

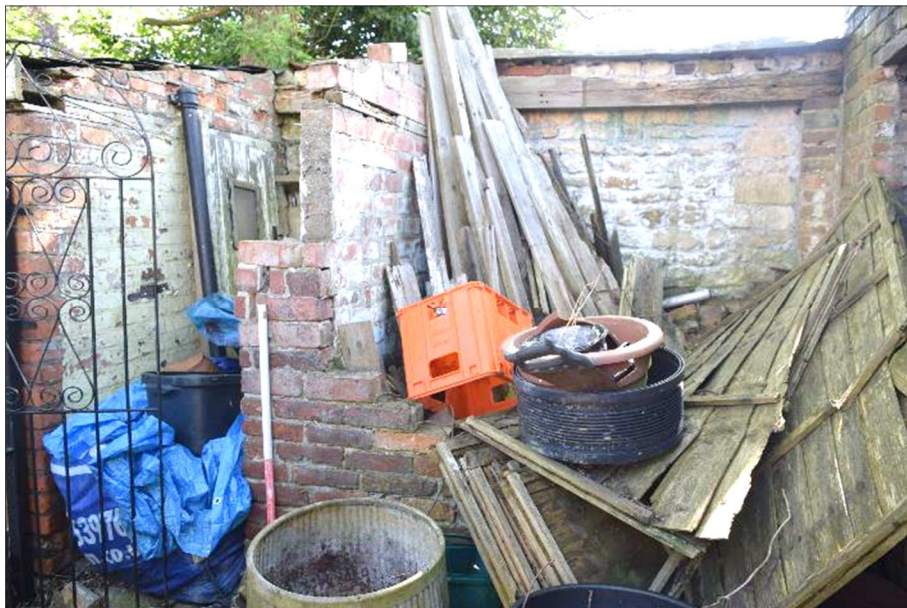
- 6.10 Attached to the north elevation were two derelict outbuildings, comprising a general store and a toilet. These abutted outbuildings for the adjacent property to the north, and a stone boundary wall to the east (Plate 14).

*Plate 14 (Shot 10): Outbuildings, looking northeast, scale 1m*

- 7.2 Derelict outbuildings were attached to the north elevation of the living area of the building, and are later in date, historic mapping indicating that they were built between 1938 and 1966.
