**TREE SURVEY & CONSTRAINTS PLAN
IN ACCORDANCE WITH BS 5837:2012**

Proj. No 7815	Blue Bell Paddock, Gravesend Road, Wrotham, Sevenoaks, Kent, TN15 7JS
Client:	RT Drafting Solutions
Date of Report:	03/12/2019

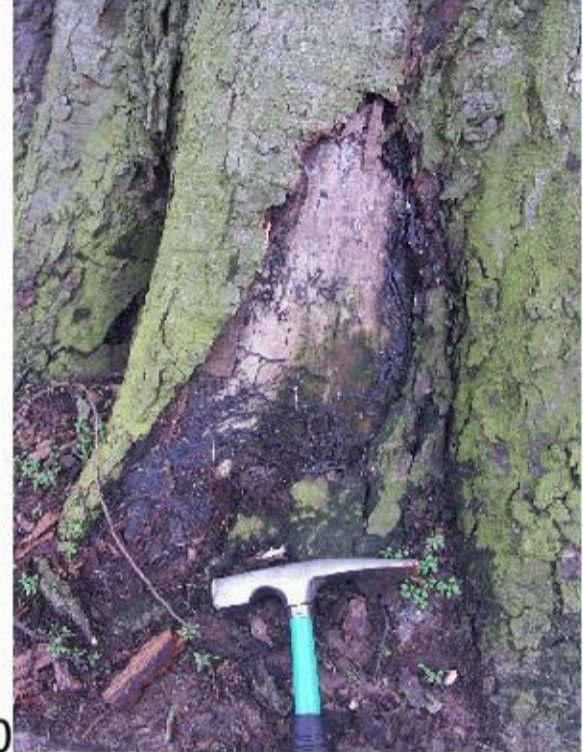
Name: <i>Armillaria mellea</i> (Honey Fungus)	
Symptoms/damage type and cause:	Symptoms of the disease are toadstools which appear between July and December but commonly disappear by October with the autumn frosts. The cap is up to 15cm diameter and yellowish or tawny in colour, the stalk is usually up to 15cm high with a thick whitish to yellow cottony ring and they occur in clusters on stumps, roots, trunk bases and occasionally higher up the stem. Affected wood is initially stained, and then a soft wet brown rot develops which eventually becomes fibrous, stringy and white, often mixed with flaky white material. The rot rarely develops more than 50cm above ground level and sometimes is virtually confined to the roots. There may be dark-zone lines in the wood surrounding the most badly affected parts and often flat white sheets of fungal mycelium growth and sometimes masses of blackish-brown strands develop beneath the bark. Black, rounded bootlace-like strands (rhizomorphs) can often be found among the soil around affected plants. Despite the apparently distinct symptoms, the diagnosis of Honey fungus attack is not always easy. The toadstools are only present in the autumn and do not always occur then, even on badly diseased trees. The bootlace like strands are not always easy to detect in the soil and similar bodies may be formed by other fungi.

Consequence:	This is an extremely serious pathogen recorded on almost all woody plants and several herbaceous species causing decay of the roots and lower stem and eventual death. This renders trees and shrubs liable to windthrow or breakage.
Control:	Treatment of the disease is extremely difficult. Once infected a tree cannot be cured of Honey fungus and the only effective procedure to limit its spread to others is the prompt removal of the diseased individual, together with its entire root system and as much as possible of the surrounding soil. Other methods such as trenches and other barriers together with the application of preparations based on phenolic emulsions can be used, but application must be done on an annual basis and cannot be relied upon at all times in all soil types. Future planting on the site should be of trees regarded to be sufficiently resistant to succeed on infected sites, such as Ash, Beech, Box, Douglas Fir, False Acacia, Hawthorn, Holly, Larch, Laurel, Lime, Silver Firs, Tree of Heaven and Yews. Recently experiments have been undertaken with natural controls including the use of other fungi to remove potential host deadwood from the environment however results are not yet conclusive.

Species affected:	Broadleaved and Coniferous trees
Images:

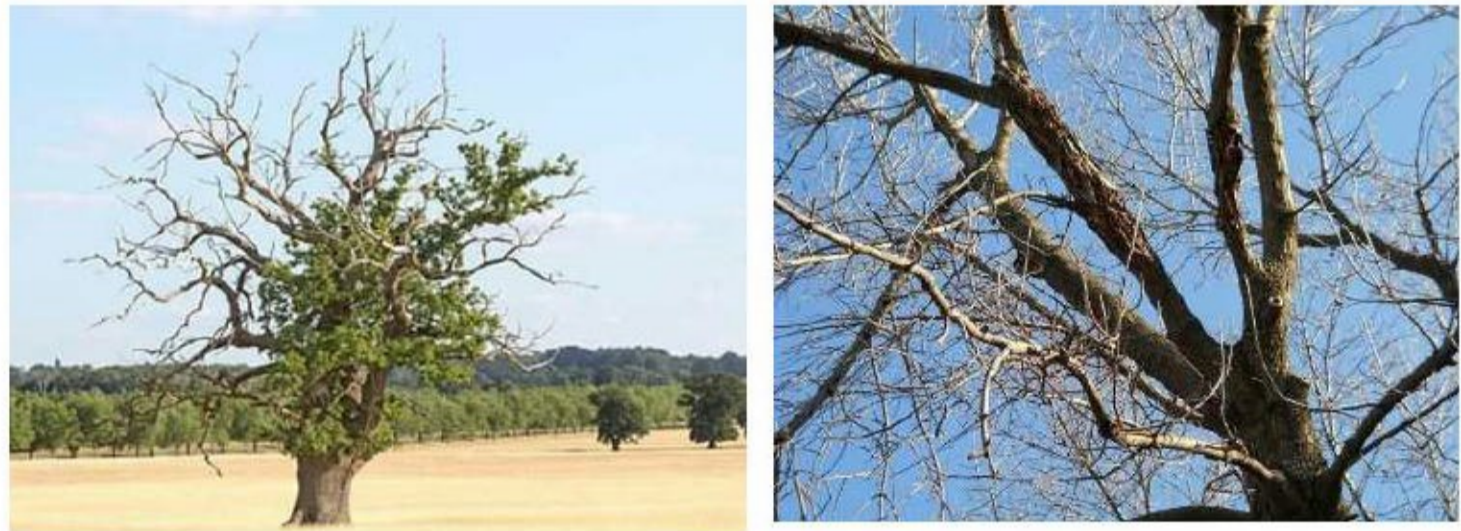
Name: Deadwood	
Symptoms/damage type and cause:	This relates to dead branches in the crown of the tree. In the majority of cases, this is caused by the natural ageing process of the tree or shading due to its close proximity to neighbouring trees. However, in some situations, it may be related to fungal, bacterial or viral infection.
Consequence:	Depending upon the location and mass of dead wood removal of the affected tissue may be necessary to prevent harm to persons or property as the wood will become unstable as it decays and in some circumstances is likely to fall from the tree with little or no warning.
Control:	Detailed monitoring should be undertaken on those trees showing signs of excessive deadwood production to identify the underlying cause.
Species affected:	Most tree species.
Images:

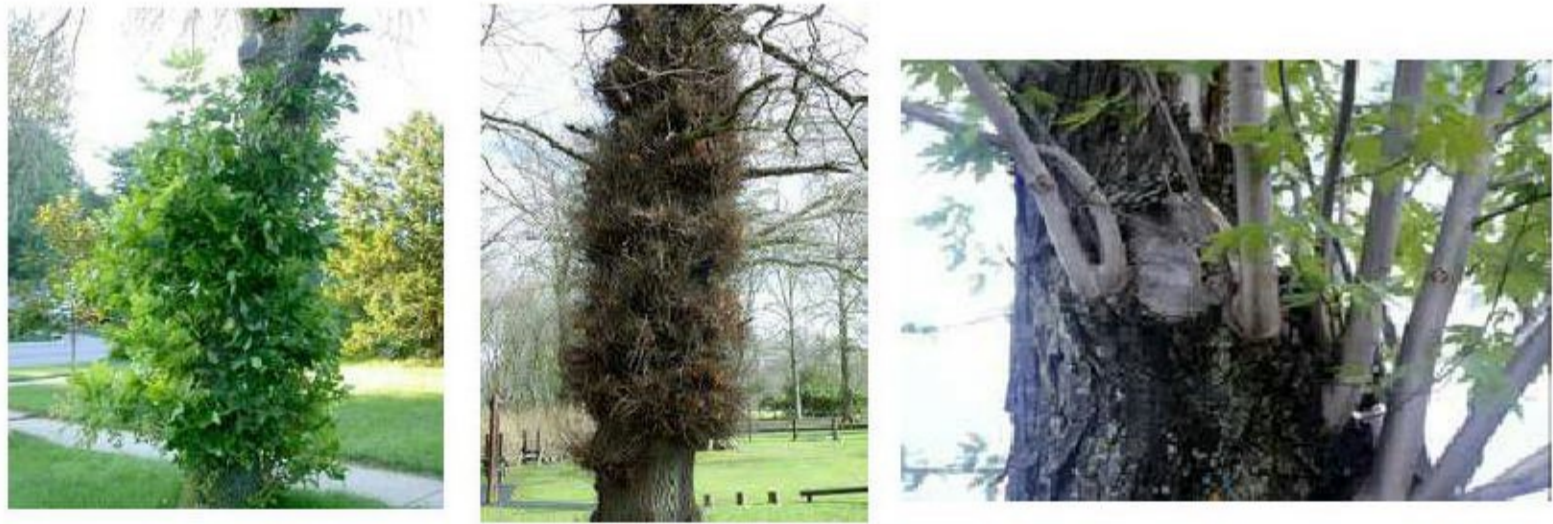
Name: Epicormic growth	
Symptoms/damage type and cause:	This is the production of numerous shoots on the main stem and branches of the tree. They are produced by the bursting into life of otherwise dormant buds. It is commonly associated with elevated levels of stress on the tree.
Consequence:	Whilst epicormic growth is usually symptomatic of an issue elsewhere within the tree, heavy proliferation can cause the trees resources to become depleted or may mask significant structural weaknesses within the framework of the tree.
Control:	Pruning off epicormic growth may be necessary to improve the visual amenity of the tree or prevent the development of a hazard or obstruction. No direct means of prevention are available other than therapeutic measures to alleviate stresses on the tree.
Species affected:	Most tree species, including European Lime, Willow species, Sweet Chestnut, and Silver Maple.
Images:

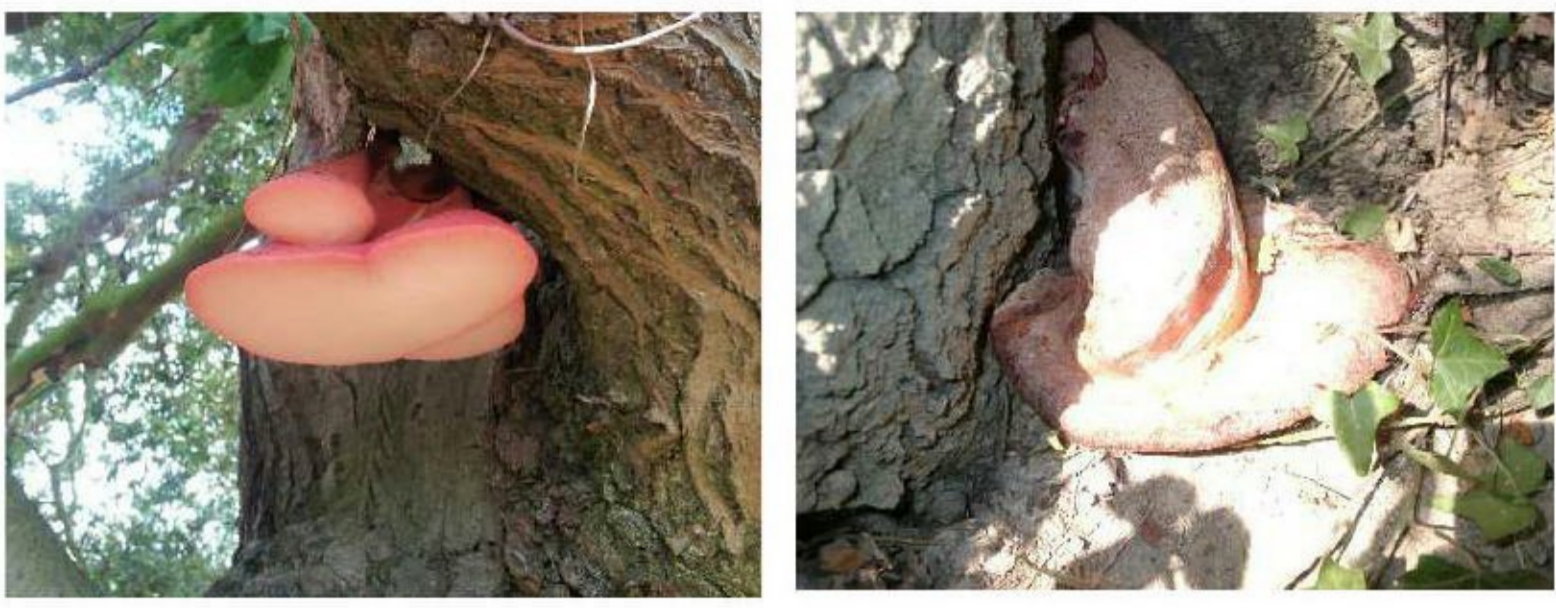
Name: <i>Fistulina hepatica</i> (Beefsteak Fungus)	
Symptoms/damage type and cause:	This common and widespread fungus is most usually found on old Oaks and more rarely on Sweet Chestnuts and other broad-leaved trees. It is a decay fungus attacking the roots and base of the trunk of the infected tree. The presence of the fungal bodies often causes concern. They are tongue-shaped, 30cm or more across, purple-red or dull chocolate above, with an off-white pore surface beneath. The flesh is marbled and reddish, exuding red juice. The fungus may stain the wood.
Consequence:	Generally, a slow acting fungus which can persist for many years. In advanced cases stem breakage can occur. Wood becomes brittle which can result in fracture.

Control:	In advanced cases it may be necessary to fell the host tree to prevent harm to persons or property from falling branches or stems.
Species affected:	<i>Quercus</i> spp, <i>Sativa</i> spp and occasionally other broadleaved species.
Images:

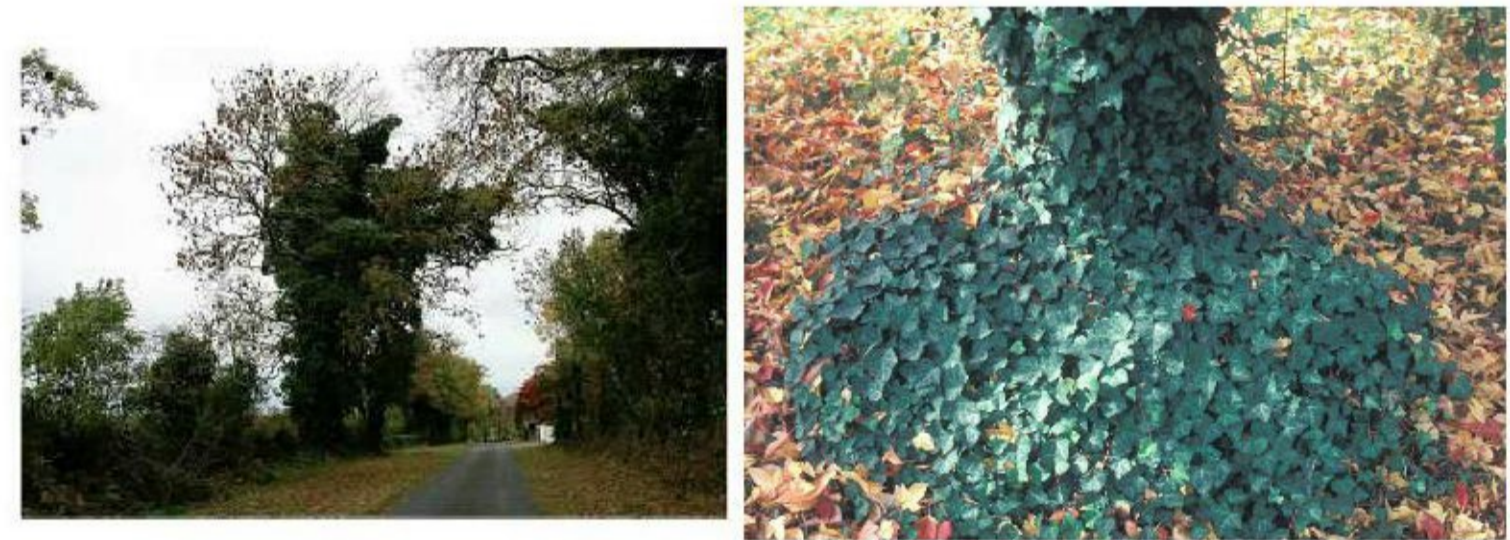
Name: <i>Hedera helix</i> (Ivy)	
Symptoms/damage type and cause:	Ivy may grow to varying degrees on all areas of a tree from the base to the upper crown. It is possible that in doing so it will out-compete the host tree for available light thereby suppressing the host.
Consequence:	This is generally only harmful to the tree on already unhealthy specimens which may be constricted by large ivy stems around the trunk or may have their top growth suppressed by a mass of flowering shoots in the crown. Ivy can also mask potentially dangerous faults on a tree.
Control:	Ivy should only be removed if absolutely necessary because it provides abundant cover to wildlife and then by severing twice close to the ground and removing a length of stem thereby causing the gradual dying away of the aerial parts of the plant providing extended benefit to wildlife whilst relieving the pressure on the tree.
Species affected:	Most trees can be affected.

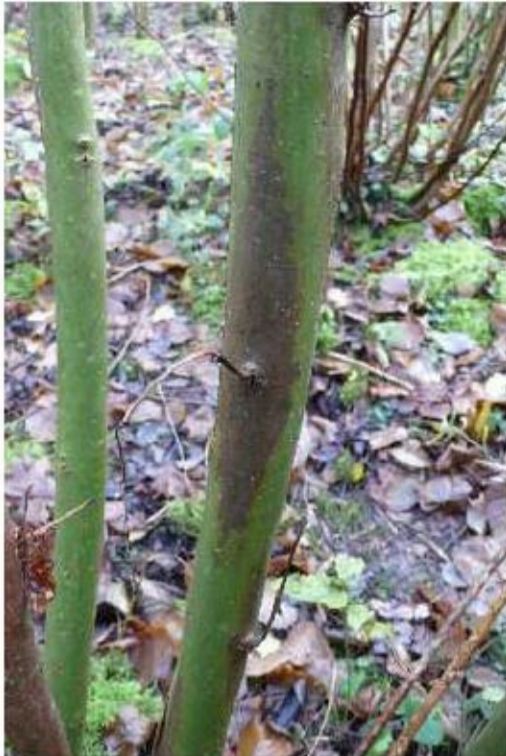
Name: <i>Hymenoscyphus fraxinus</i> (Ash Dieback)	
Notifiable to the Forestry Commission: If you suspect that a tree exhibits this pathogen, you should report it immediately to: Forest Research via the TreeAlert system: https://www.forestryresearch.gov.uk/tools-and-resources/tree-alert/	
Symptoms/damage type and cause:	Symptoms of the disease can be visible on leaves, shoots, stems and branches of affected trees. The primary symptom is leaves and young shoot growth wilting and turning black in the late summer months. The leaves will often drop ahead of the usual period of senescence. As the fungus spreads towards the stem, branches start to show a black diamond that marks the area of infection. The diamond will continue to grow as the fungus progresses until it girdles the branch and kills the vascular tissue. In severe cases, the entire crown shows leaf loss and dieback, which is often associated with the formation of epicormic shoots on branches and the trunk.

Consequence:	The genetic variation within the <i>Fraxinus</i> genus means that individual trees have differing levels of resistance to <i>Hymenoscyphus fraxineus</i> resulting in some trees dying in the year of infection and others displaying minimal symptoms and surviving alongside the presence of the pathogen. Infected trees will fall somewhere on this spectrum.

Control:	You can slow the spread of the Ash dieback disease by locally burning, burying or composting fallen Ash leaves.
Species affected:	<i>Fraxinus excelsior</i>
Images:
