REPORT ON THE STRUCTURAL CONDITION OF
THE ELMS, SPRING HILL, COLSTON BASSETT, NG12 3FR
and VARIOUS OUTBUILDINGS

B u r r H o u s e
CONSULTING STRUCTURAL ENGINEERS
Burr House, Forresters Close
Burbage,
Leicestershire, LE10 2RT
Tel 01455 618645

1.2 This report follows a visual inspection that took place on Monday the 7th September 2020, on instructions received from The Art of Building Ltd.

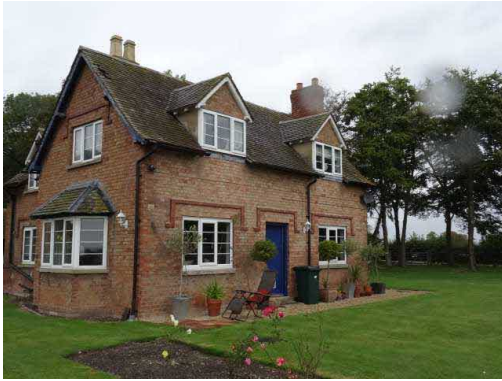
1

1.3 The site is situated on Spring Hill. The report is on the house (Photograph 1) and three outbuildings. One is used as a garage and storage (Photograph 2), the second is empty (Photograph 3) and the third is also empty (Photograph 4).

3.2.1 The walls are reasonably plumb downstairs, but there are several cracks in the brickwork, mainly visible internally and problems with rising damp. Upstairs, the walls lean slightly outwards as a result of the raised collar roof. The external walls need re-pointing generally.

3.2.2 The window and door openings have no lintols over them. The brickwork over is supported on the replacement PVC windows.

3.2.3 The roof is in fair condition, but an area of tiles has been blown off by the wind. The tiles are old and clay tiles become brittle and start to warp. This makes them prone to damage at an exposed site like this. In addition, the fixing nails have probably worked loose. Tiles have been blown off the roof frequently in recent years. The whole roof should be completely removed and replaced, including providing a stiffer structure that does not exert horizontal forces on the external walls.

4.2 The house (Photograph 1) is in need of extensive repairs and renovation, but if this is carried out it would still have external walls built in header bond. This bonding is nowhere near as strong as more traditional bonding such as English bond or Flemish bond. It has less resistance to foundation movement and lateral forces. The foundations are almost certainly one or two courses of brick spreaders at a shallow depth by current standards.

4.4 It is my opinion that the cost of renovating the house would be more than the cost of demolishing it and rebuilding. If renovated the house would still have solid brick walls in header bond, which is weaker than more traditional bonding and be prone to further damp penetration.

4.3 The repairs referred to include replacing the roof including all the tiles and making the roof structure stiffer to prevent future roof spread, installing lintols over all the windows and doors, repointing the walls and providing a complete damp proof course. The foundations should also be investigated, as they are almost certainly brick spreaders and will probably need underpinning. The timber ground floor will probably need to be replaced due to damp in the walls and a lack of ventilation. The ground floor, walls and roof all need thermal insulation.

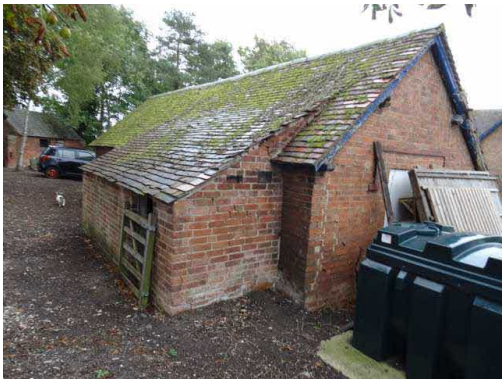
2

2.4 The "garage/storage" building also has a small extension with a lean-to roof also covered in plain clay tiles (Photograph 2).

3.3.1 The brickwork is generally in poor condition. The lean-to section at the back is suffering from subsidence with a severe diagonal crack in the side wall. There is a vertical crack at the rear in the left-hand side wall of the left-hand store that has been repaired and has moved again.

3.3.2 The roof is not tied and sags due to roof spread. It is in poor condition. The lean-to section leaks badly and has plastic sheeting attached to it.

4.1 The outbuildings (Photographs 2,3 & 4) are in such poor condition that they are not fit to be refurbished. In fact, the remote empty building (Photograph 4) is in danger of imminent collapse.

4.5 The outbuildings in Photographs 2,3 & 4 are not structurally safe and should be demolished and rebuilt.

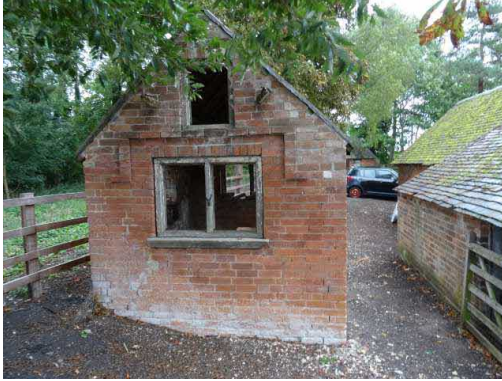
3

3.4.1 The brickwork is in poor condition and has extensive cracking. At the rear, the ground level is some 450mm above inside ground level.

3.4.2 The roof is not tied and is in poor condition.

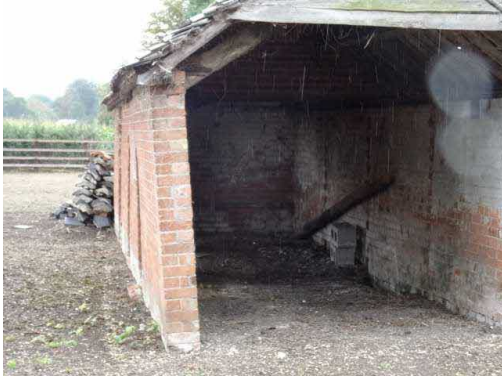
4

3.5.1 The brickwork is in very poor condition and in fact leans outwards dangerously at the front of the left-hand wall. It is at risk of imminent collapse.

3.5.2 The roof is in very poor condition with tiles missing and the roof timbers left exposed to the atmosphere. There are two ties at ceiling level, but they are not fixed well enough to prevent roof spread.

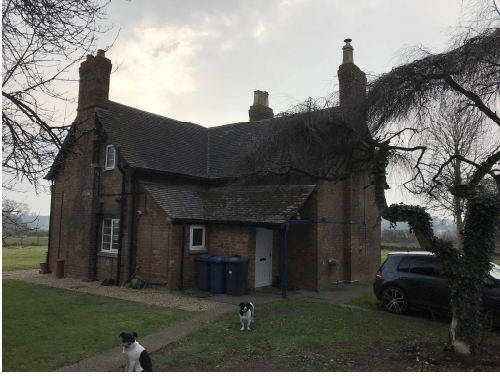
5

2.3 The house has a small extension with a lean-to roof covered in plain clay tiles (Photograph 5).

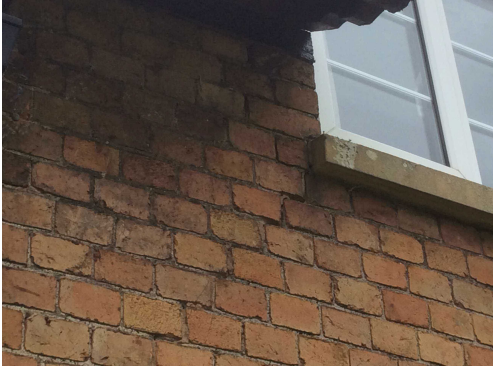
6

2.5 The external walls are solid brick 230mm thick. It was noted that the original house was built in header bond, which is inherently weaker than traditional English bond or Flemish bond (Photograph 6).
