Arboricultural Impact Assessment

Site:	Chantry Car Park Inkersall Road Staveley Chesterfield S43 3LJ
Client:	Mr Terry Damms
Date of Survey:	22 nd April 2021
Weather:	Clear and Bright

Report Author:	S L Farrimond BSc (Hons) MSc Dip Arb Lv. 4
Checked by:	R H Anderson M. Arb. (RFS)

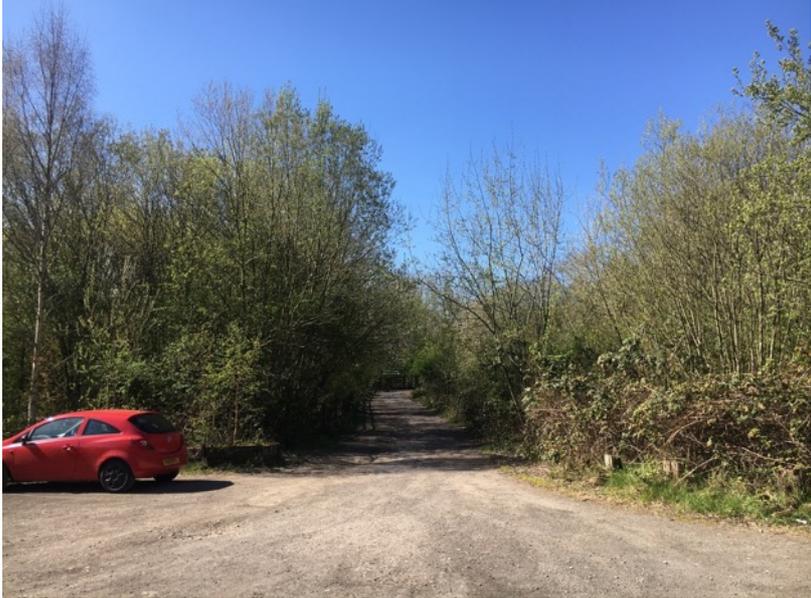
Fig.	Description	Image
3	Photo looking south west from within the car parking area toward the access road.

- 2.2.2 Aside from the overgrown planters, the encroaching vegetation and low overhanging trees around the edges of the parking area and access indicate a degree of neglect of the site. As shown in Figure 3, even on a bright day the access to the site is dark and enclosed. During my visit there was evidence of recent fly-tipping, and it was not surprising in view of the concealed nature of the site.

- 2.2.3 The existing surface consists of an aggregate of fines and coarse chippings which have been compressed by vehicle movement over many years to create a solid, essentially impermeable surface. This type of surface is unfavourable for root development and growth; roots require water percolation and aeration to create a nutrient rich soil environment. This means that the roots of trees around the edge will have preferentially grown elsewhere, not only due to the lack of permeability but also because root penetration pressure is greatly limited in poor, compacted soils (Roberts, J., Jackson, N. & Smith, M., 2006. *Tree Roots in the Built Environment*). The resulting root morphology of the trees at the edges of groups G1, G2 and G3 are highly likely to be biased toward the centre of the groups rather than the outside.

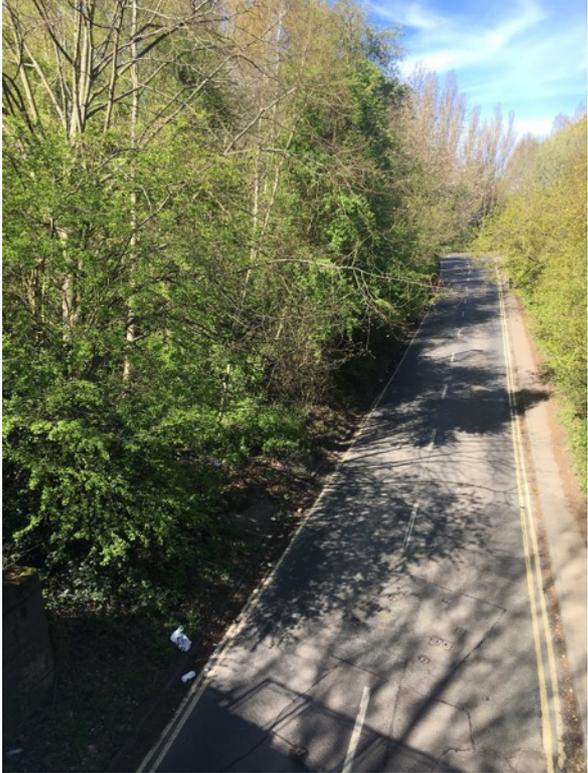
- 2.2.9 The lack of previous management means that trees at the edge of the group, adjacent to targets such as highways, have not been managed for risk mitigation and height clearance. In particular on the boundary with Cemetery Road (fig. 4) there is one dead tree which has failed toward the road and caught in another tree and other trees have been damaged by impacts with high sided commercial vehicles. Frequent safety inspections of trees which are

accessible to the public or have the potential to impact public area should form part of reasonable tree management.

Fig.	Description	Image
4	The northern edge of G1 as viewed from the bridge over Cemetery Road.

- 3.3.3 During the work to facilitate the car park construction, general management work should be carried out on the woodland groups G1 and G2. This should involve selective thinning by the removal of trees with poor forms, those which are suppressing better specimens and those which are dead, dying and diseased. Trees in group G1 which are adjacent to Inkersall Road and Cemetery Road should also be crown lifted to a height of 5.5m to prevent any further impact damage from vehicles.

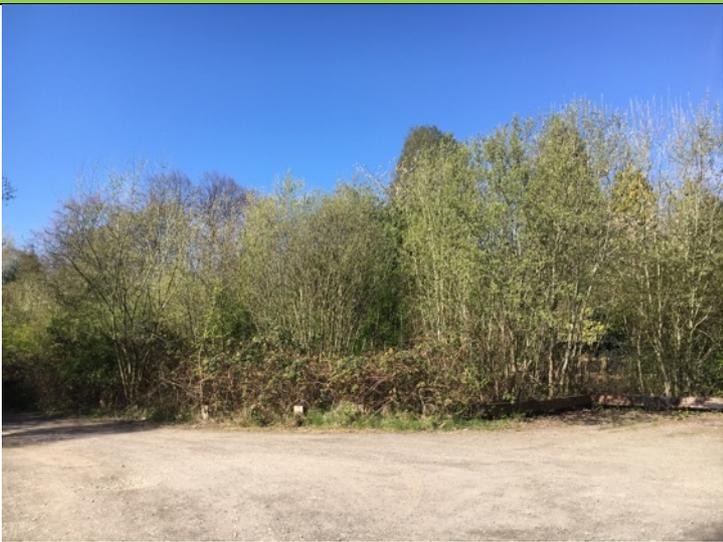
of the access road is best described as an overgrown verge rather than a woodland group. Two early mature trees are present within the group, wild cherry T4 and cherry plum T5, but aside from those the area is populated by young self-seeded and coppice growth hawthorn, ash, goat willow, wild cherry, cherry plum and blackthorn. This creates a dense screen of vegetation between the car park and the road (Fig. 5).

Fig.	Description	Image
5	G3 as viewed from the car park looking west toward Inkersall Road.

3.1.1 The redesigning of the current car park will require the removal of the vegetation west of the access road, this is group G3 which includes the wild cherry T4 and cherry plum T5.

3.1.2 The vegetation in this area is all of low quality and its presence reduces the useability of the car park. Regardless of the proposed redesigning, its removal would be recommended on the grounds of general management for both the car park and the pavement it is

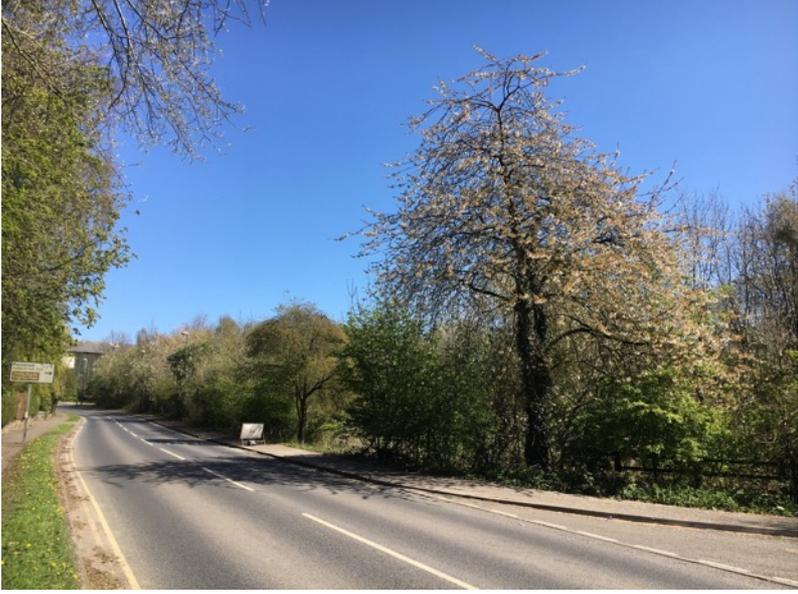
2.2.14 Much like the other groups, there is little evidence of any management of the trees in this area, the vegetation on the western edge is encroaching on the pavement (Fig. 6) and causing damage to the boundary fence. There is also a gap in the group where a tree has failed to the east in recent years, whether this failure was foreseeable is unknown but failure to the west would have impacted the road.

Fig.	Description	Image
6	Looking north along Inkersall road with the G3 on the right of the photo and wild cherry T4 in the foreground.

2.2.15 Wild cherry T4 is the most prominent within the group due to its size and position at the northern corner of the vehicle entrance. Other than its relative size within the group, it is a poor tree which has developed twin stems from ground level with a weak compression union between the primary stems. As the stems increase in diameter they will contact at the union and exert lateral force on each other acting to push the union apart. These unions have a higher likelihood of failure than well-formed tension unions, particularly in strong winds.
