18/05/2021

Inspection of shed to be demolished and assessment of bat roosting potential

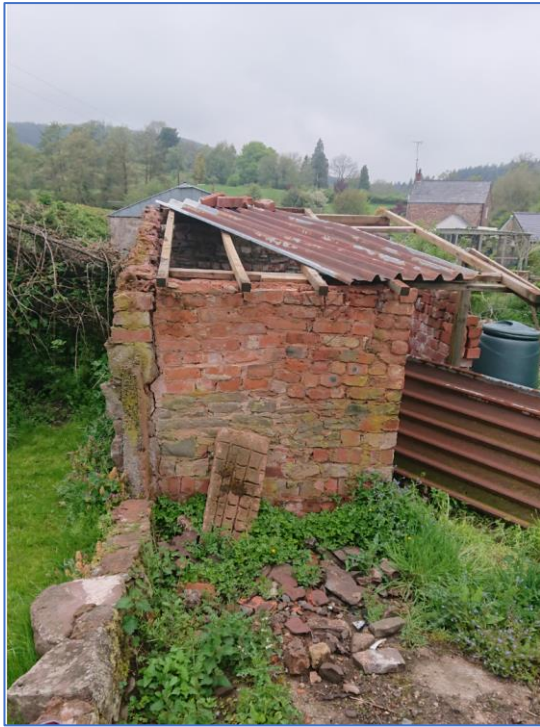
There are small cracks in some of the mortar between courses, and a larger crack where the wall forming the south east elevation abuts the wall forming the southwest elevation. All cracks were inspected visually and were found to be unsuitable to support bat roosting due to being too superficial, too narrow, and conversely, too open and exposed to weather and light.

Photograph 1: South east elevation of shed showing dilapidated roof structure and large crack where two walls abut

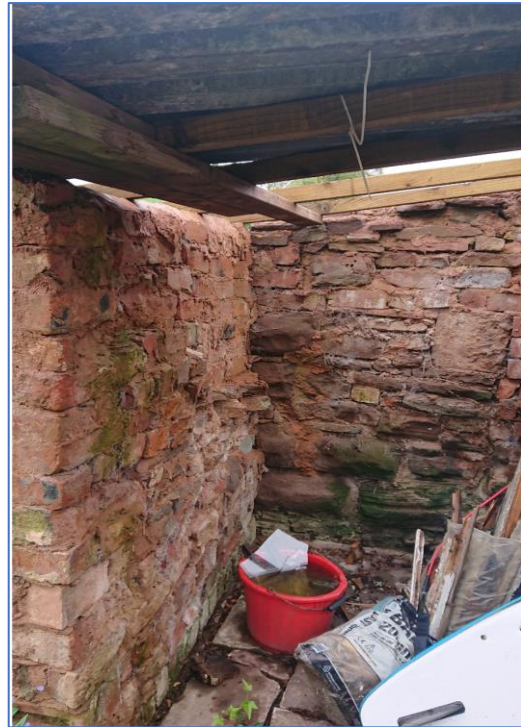
There were no suitable potential roost sites between the timber frame of the roof and the top of the walls, or within the framework itself, and the loose corrugated roof sheet did not provide any suitable potential roost sites beneath it.

The stored items appeared to have been in situ for some time and were visually searched for evidence of bats.

Photograph 2: Interior of shed, showing mortar, internal roof timber structure and stored items
