Structural Report on Proposed Conversion of Existing brick built Farm Outbuilding to Proposed Residential Accommodation at Clapham Holme Farm, Hull Road, Great Hatfield, East Riding of Yorkshire, HU11 4UX

for **Seatswood Architects Ltd**

**Dennis G Mapplebeck,
Linden Associates
25 May 2021**

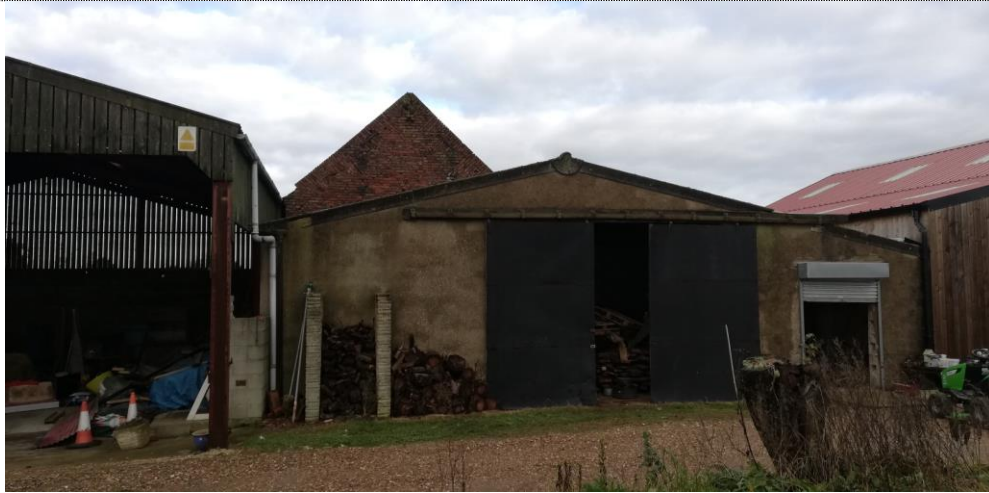
South Elevation

There is a large door opening in the south gable wall, with the brickwork over supported by a substantial steel beam. The beam is in good condition but would benefit from painting with a rust proofing coating.

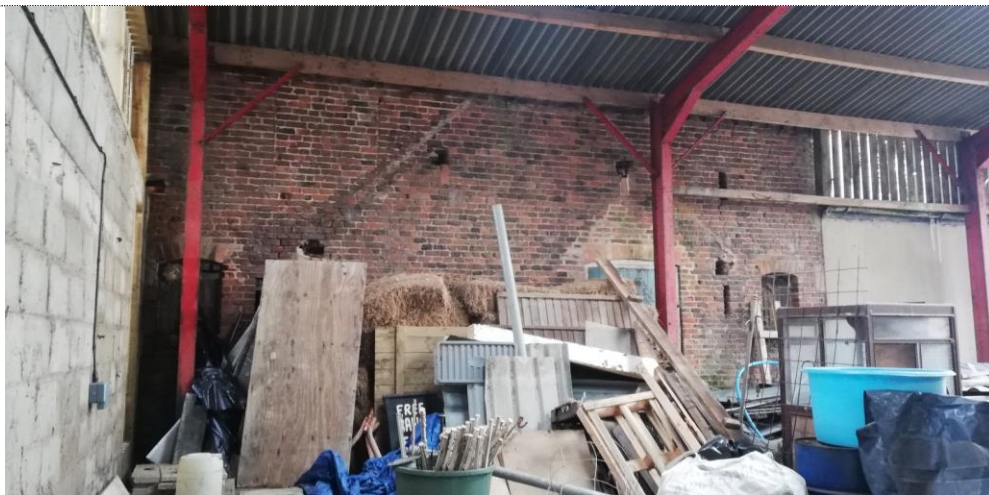
West Elevation (from inside adjacent barn)

There are several window openings and a door opening in the west wall, facing into the adjacent barn, with brick arch detailing over and substantial timber frames. It is suspected that there are no separate lintels to these openings with the timber frames acting as supports to the brick arches. There are no signs of settlement to these openings which are all in good condition.

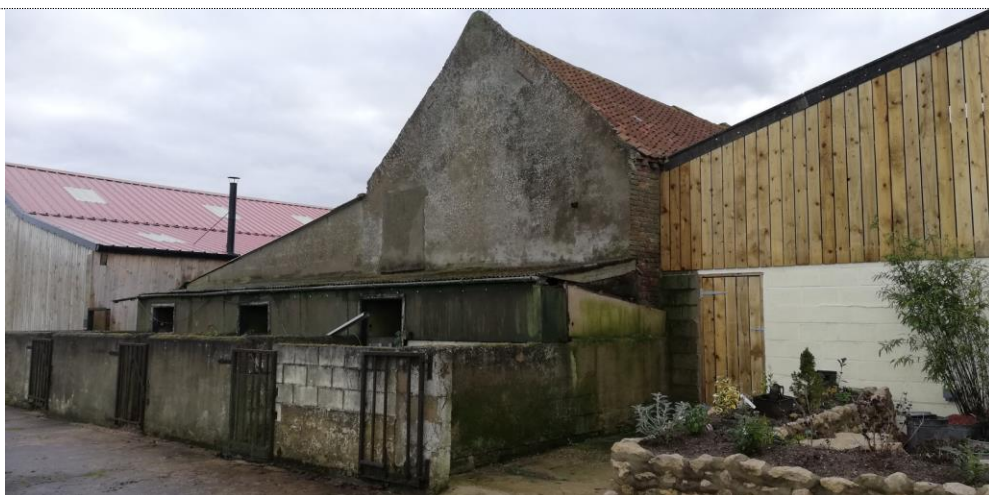
North Elevation

The north gable wall has a cement rendered finish which is in fair condition however some cracks and areas of delamination were noted.

Although the building is 2-storey high there is no existing upper floor. It is suspected that this has been removed at some point in the past. There is evidence in the north gable of a doorway at first floor level which has been bricked up, and some evidence of pockets for floor joists, which have also been bricked up.

4. Re-point brickwork to all walls as required.
5. Renew cement render finish to north gable wall.
6. Install chemical injected DPC to all walls.
7. Break up and remove existing concrete floor slabs and replace with new insulated concrete floors to current insulation standards.
