Job Title
Brunswick Place

Prepared for
Maryland Securities

Report Type
Structural Appraisal

Date
06/05/2021

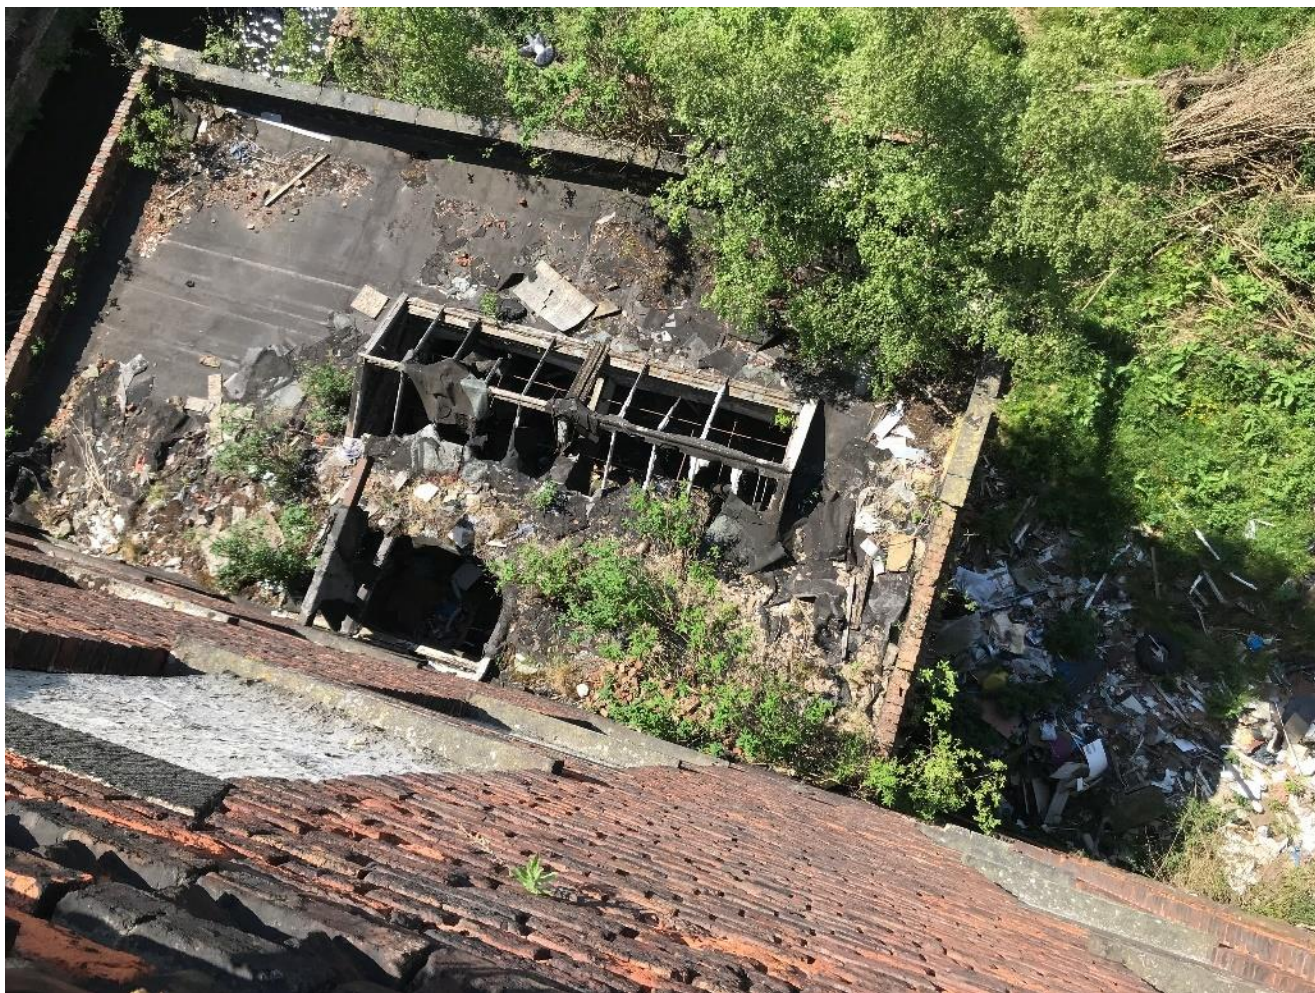
Figure 12: Boiler House Roof Looking Down from Mill Roof

From further observations, looking down from roof of the mill and towpath behind it can be seen the boiler house has sustained significant fire damage at some point in the past and would therefore not be safe to access. Refer to figures 11 and 12.

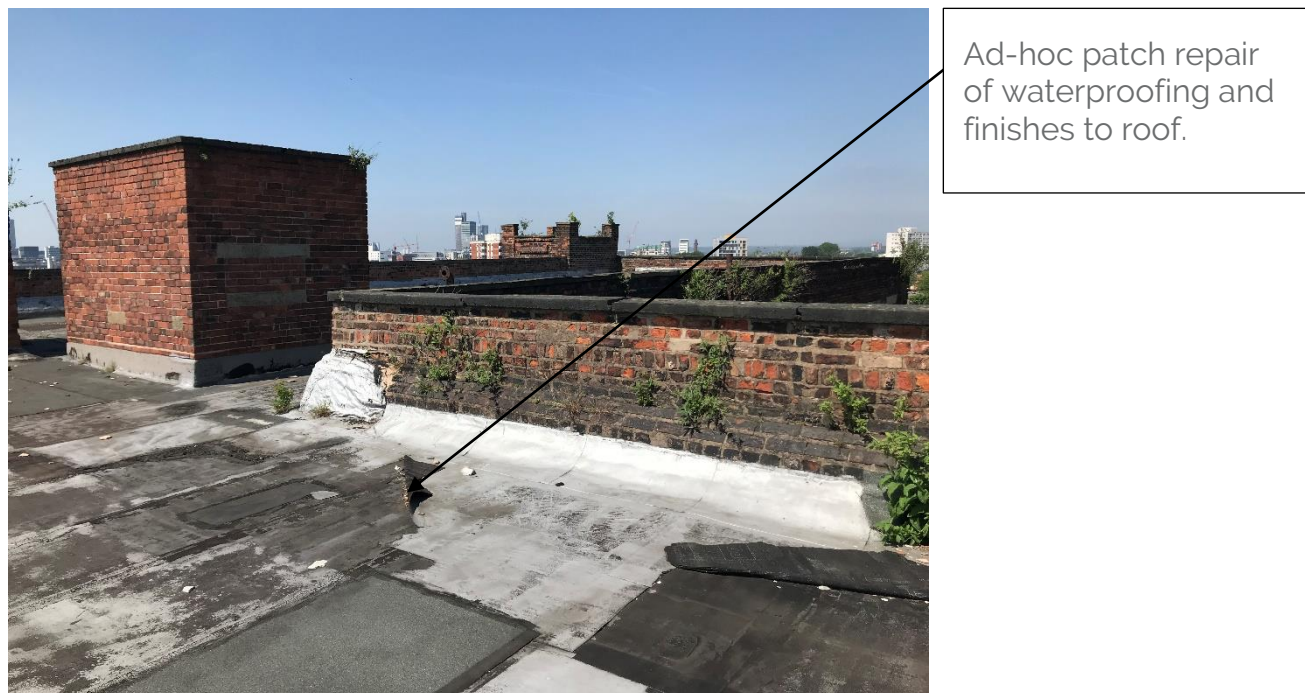
Figure 14: General Roof Observation

Waterproofing of the roof appears to have been addressed multiple times and is generally ad-hoc with no particular falls. The level of the roof undulates due to various patch repairing of the waterproofing and finishing system. Refer to figure 13.

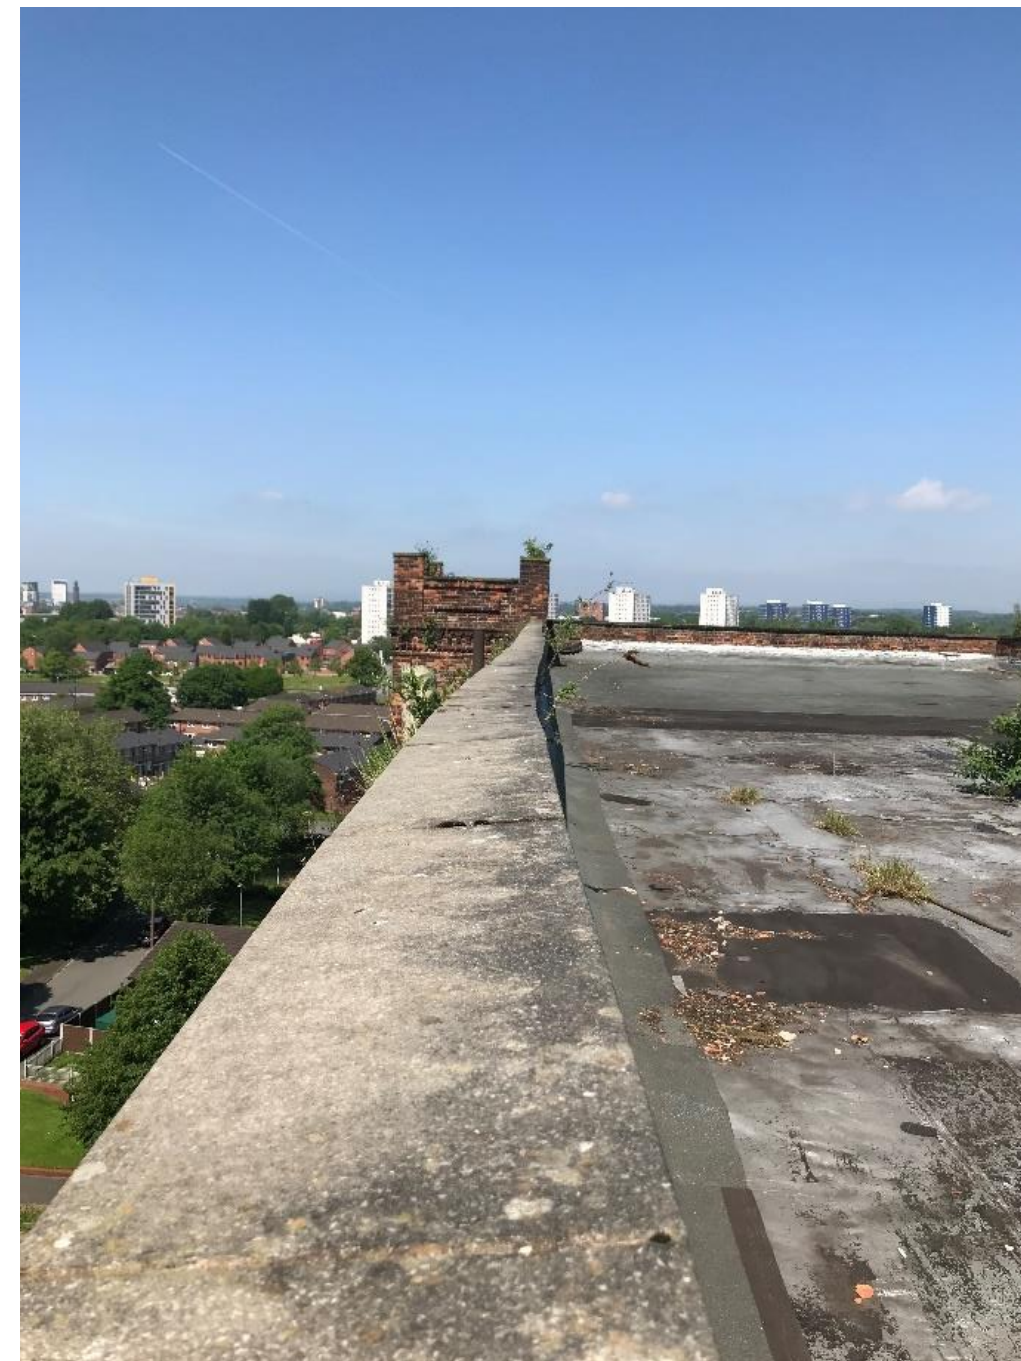
Figure 15: Significant Bowing of Southern Parapet

The interface between southern parapet and original dust chute appears to be leaning outwards towards Bradford Road. Cracking of mortar joints is concurrent with apparent leaning. Refer to figure 15.

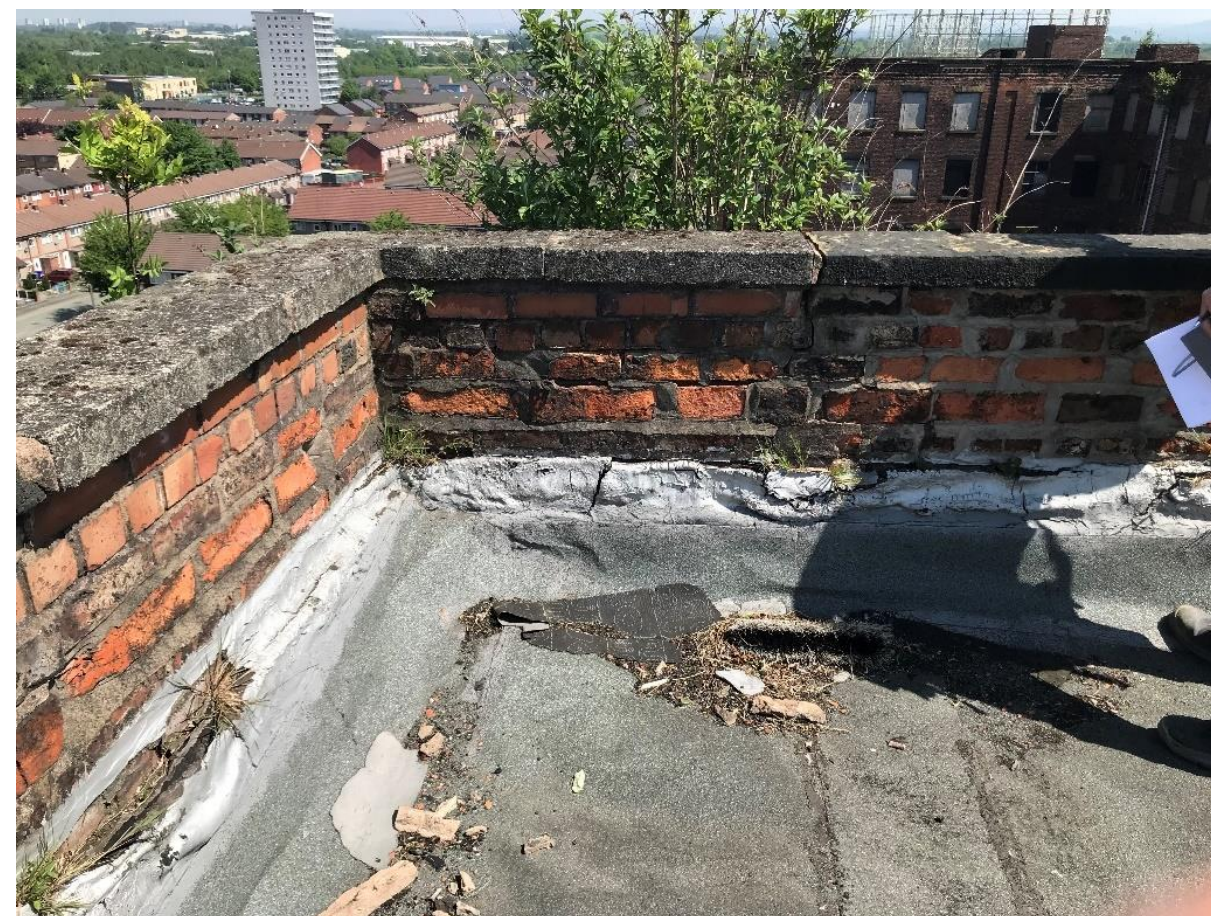
Figure 17: Cracking and Loss of Pointing Generally

There are general areas of loose masonry and loss of pointing. Refer to figure 16.

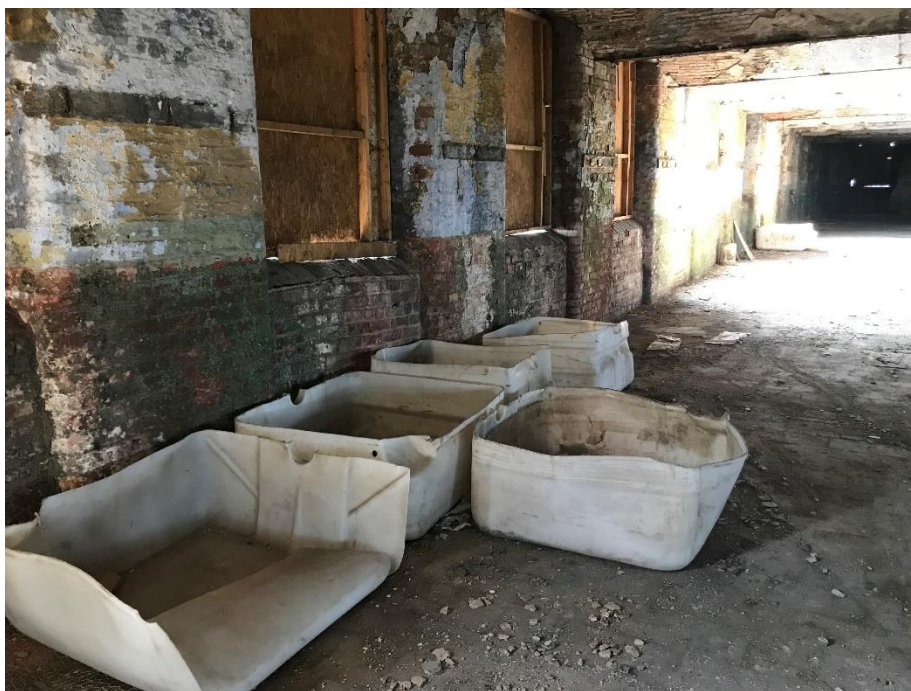
Figure 18: Plastic Buckets to Catch Water from Leaking Roof.

Significant water ingress was evident throughout the jack arches and supporting structure. Civic Engineers are aware of historic roof leaks which is concurrent with the previously described roof waterproofing repairs but also the strategic placement of buckets across the sixth floor. Roof leakage over time has resulted in delamination of the cast iron structure in

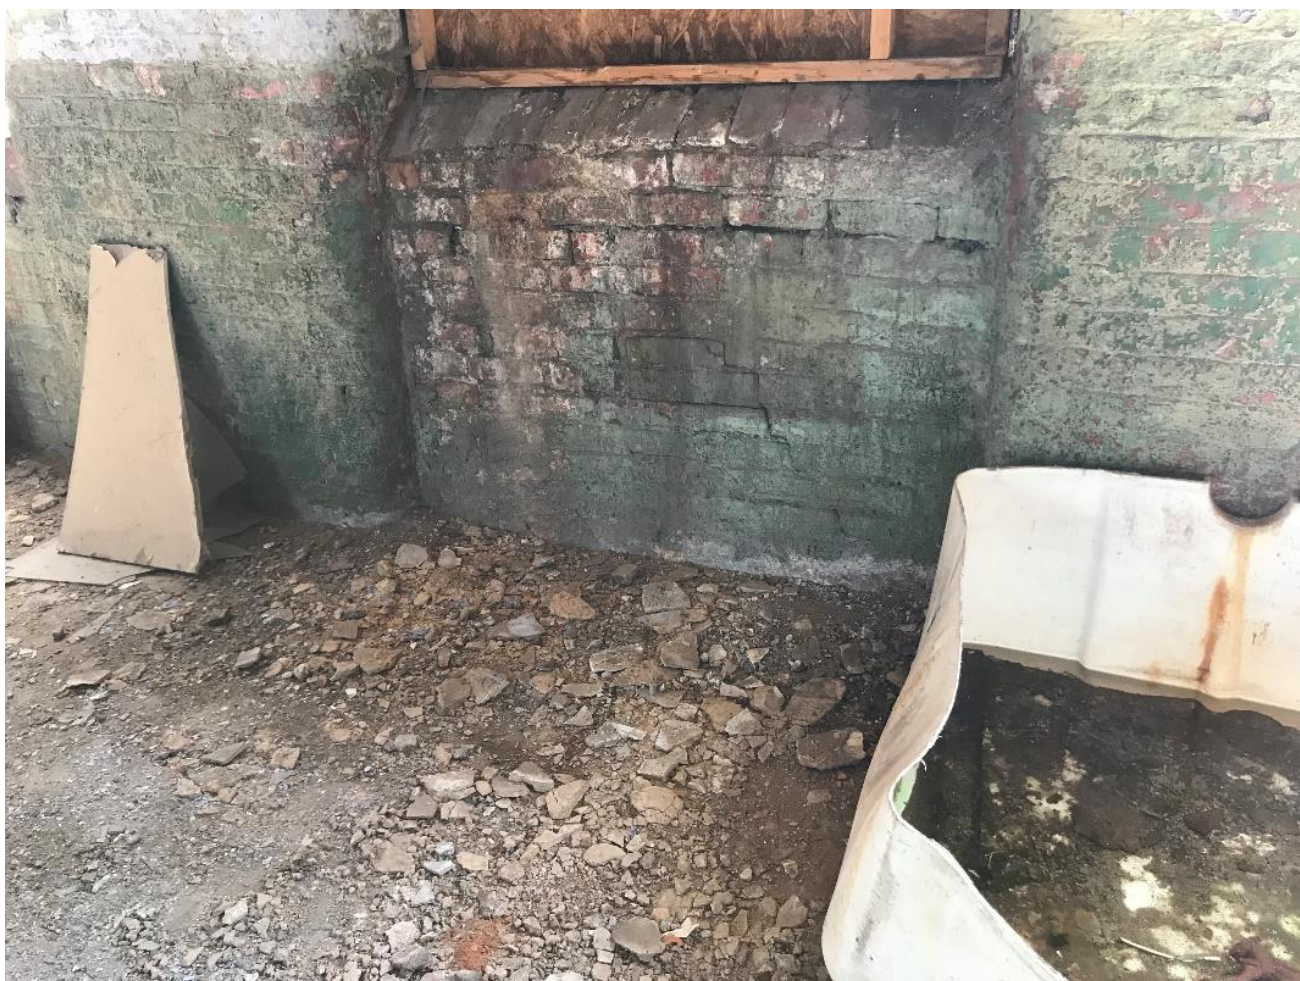
Figure 21: Drop in Cill Level and Associated Cracking to Masonry

In approximately the second quarter of the elevation fronting the Ashton Canal, the masonry wall appears to have settled. This occurs across 4 bays and is evident through visual signs of distress in the structure. There is an obvious drop in cill level across the four bays with associated cracking to adjacent spandrel panels and masonry panels beneath cills. With this there is also an obvious drop and undulation of the floor level. Refer to figure 20.

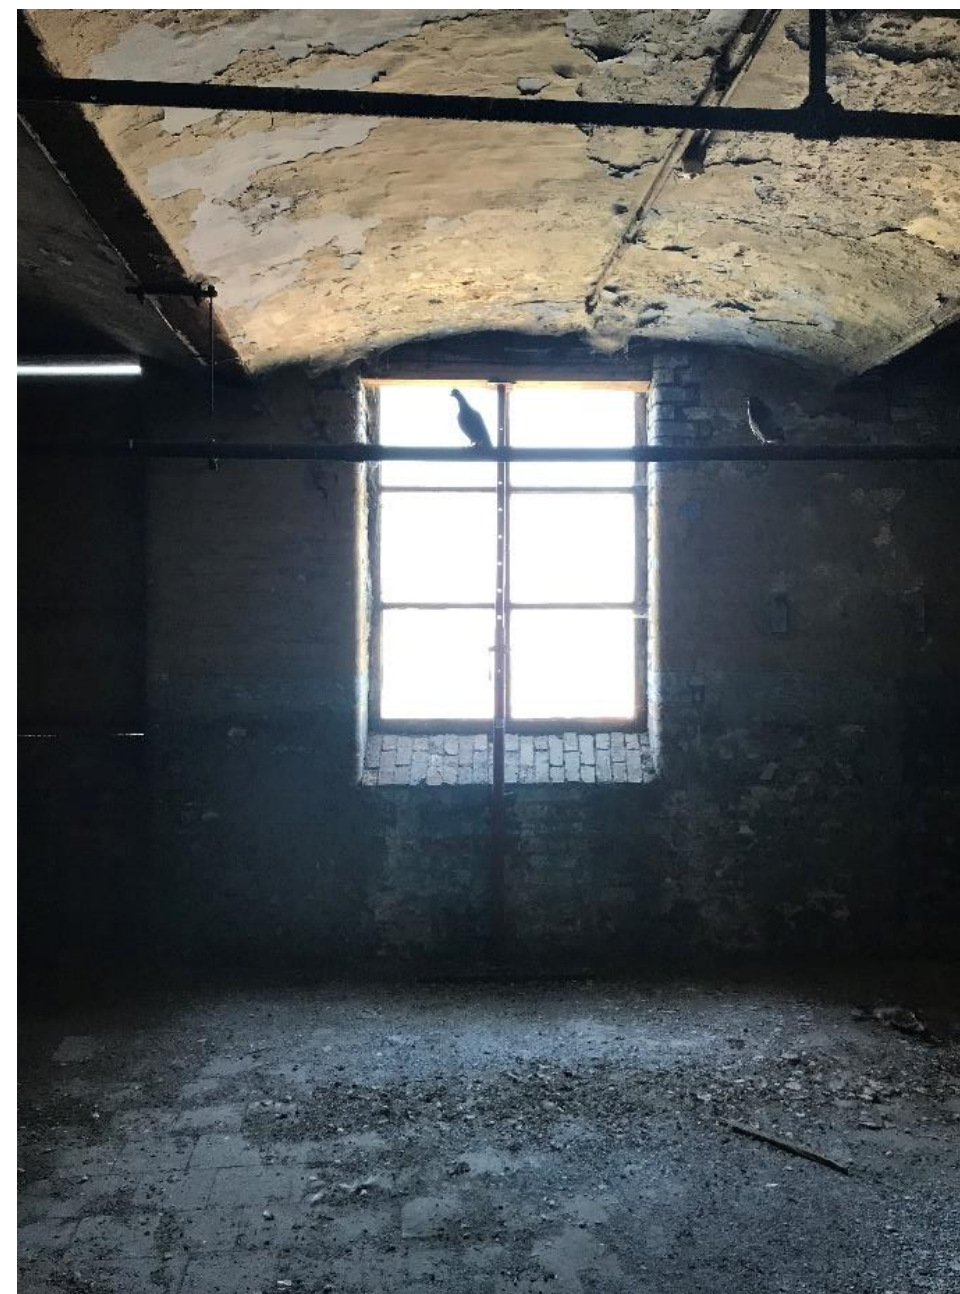
Figure 22: Propped Lintels

To the elevation fronting Bradford Road within the south western wing lintels have been propped presumably to address failure of these units. Refer to figure 21 and also sections discussing observations of elevations.

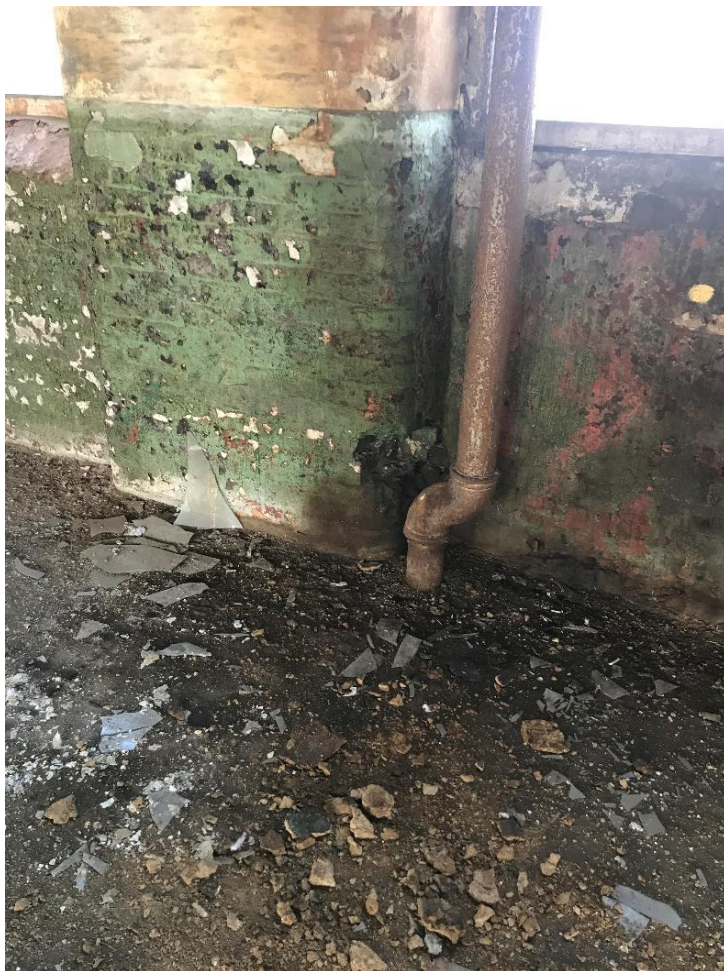
Figure 23: Small Areas of Masonry Loss in Pier

Small areas of localised masonry section loss can be seen within the structural masonry piers. Refer to figure 22.

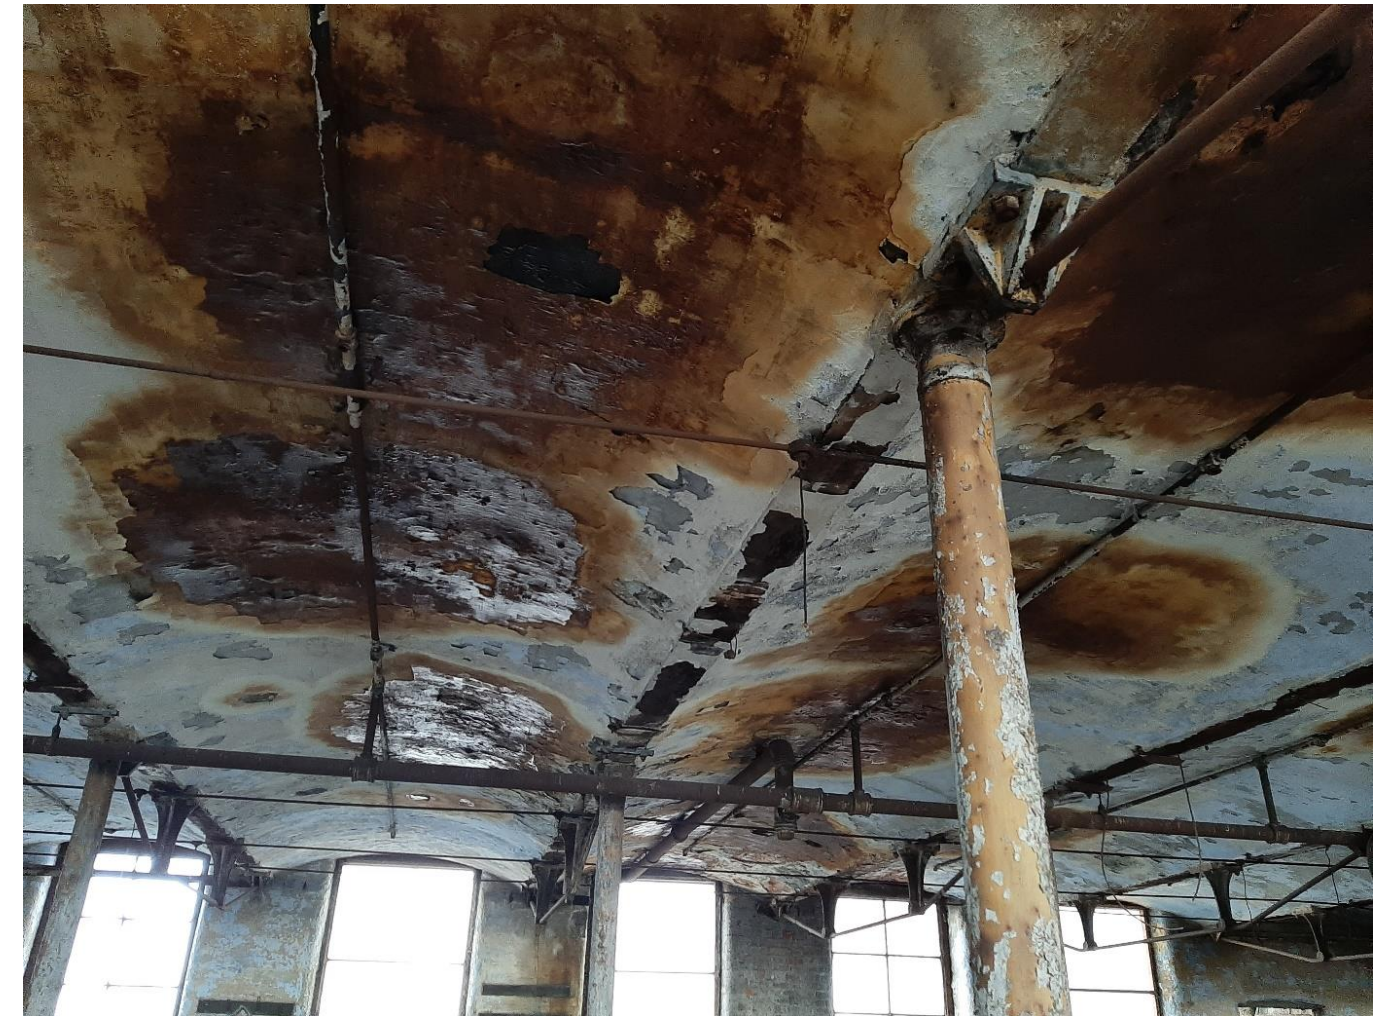
Figure 24: Significant Water Staining to Soffit. Strengthening Observed to Beams

Significant amounts of water staining to the soffits of the south west wing were observed (Figure 23). Unlike other floors the structure at high level fifth floor the south western wing has been strengthened similarly to the main wing with underslung, assumed, steel tie bars. Refer to figure 23 and 24.

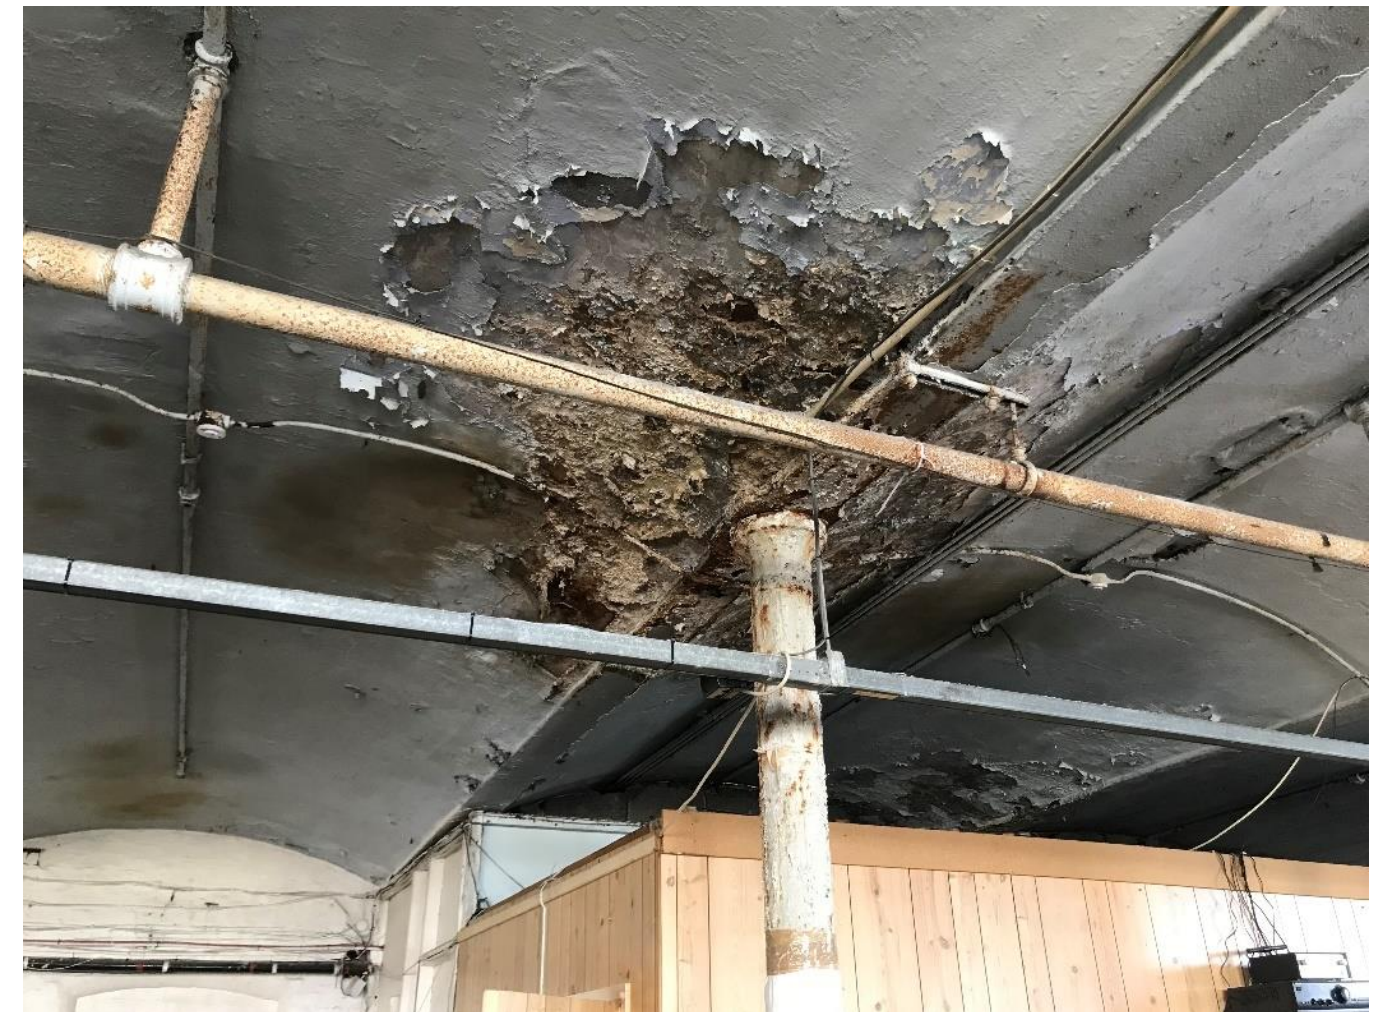
Figure 27: Damage to Masonry Jack Arch and Cast Iron Structure

There is evidence of significant water ingress and associated damage to masonry jack arches and lamination of cast iron structure. Refer to figure 26.

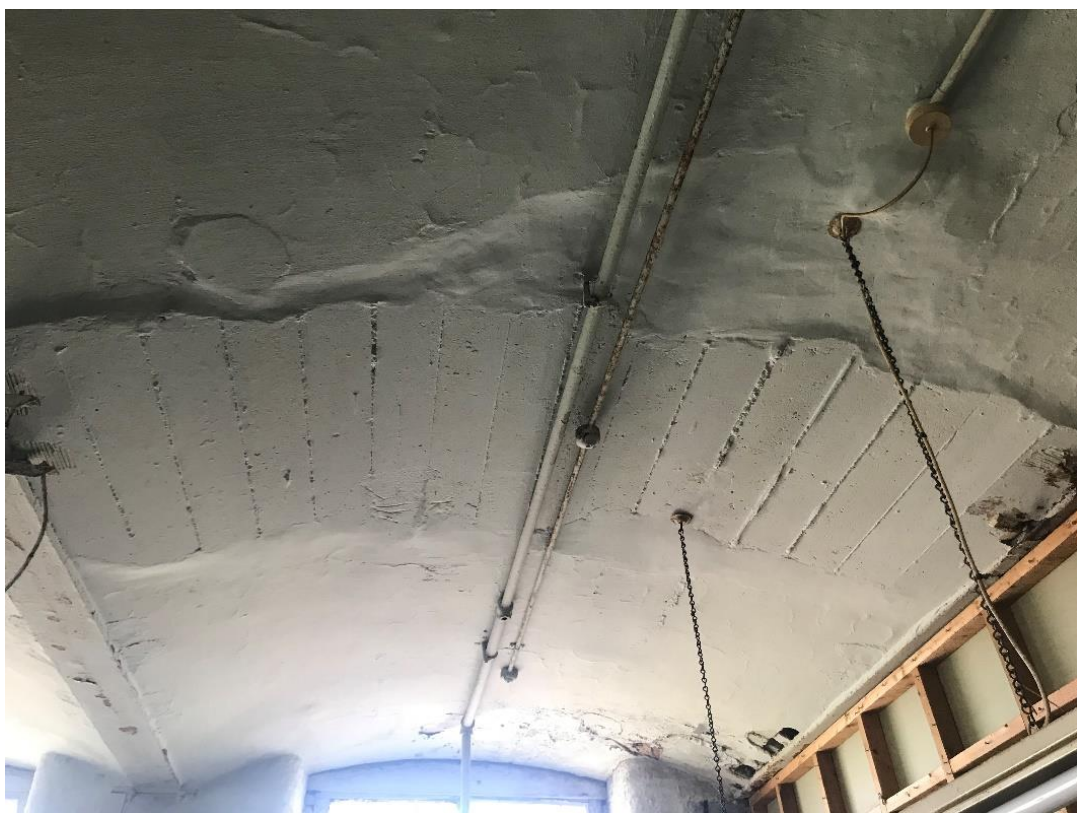
Figure 28: Concrete Patch Repair to Arch Soffit

Patch repairs appear to have been carried out the masonry jack arches in the north west wing of the fourth floor. Refer to figure 27 which appears to show concrete patch repairs to the soffit of masonry.

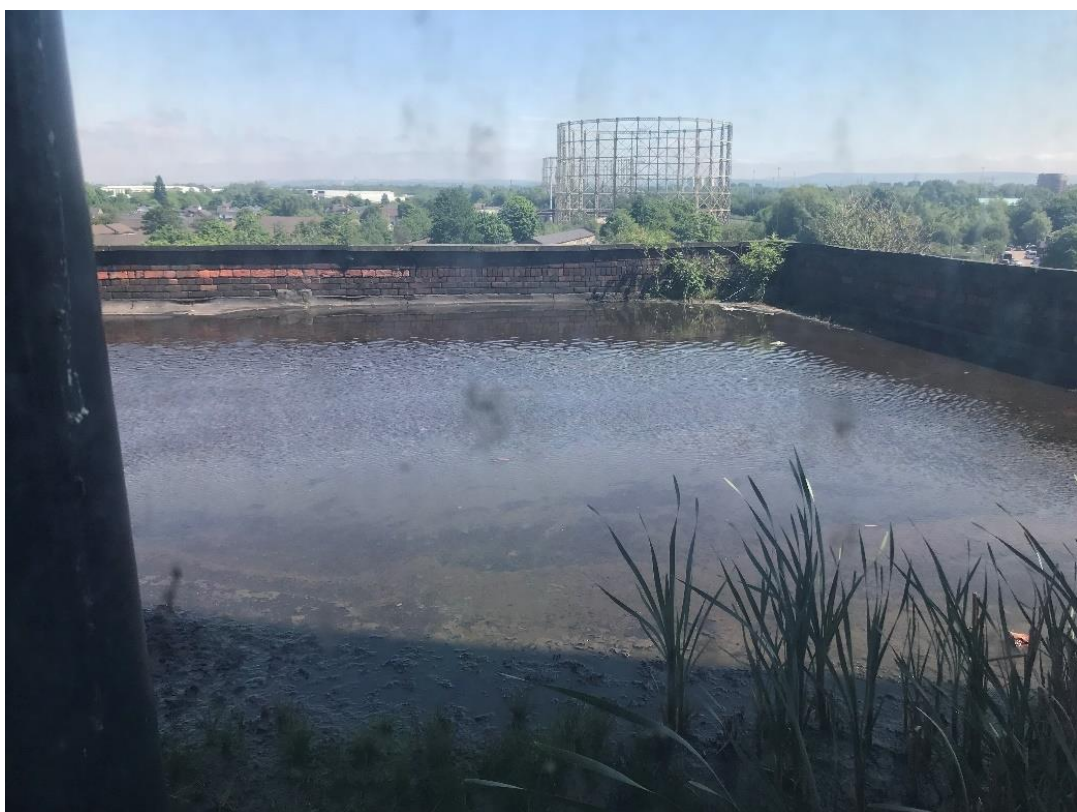
Figure 29: Water Ponding on Waste House Roof

The roof of the original waste house (fourth floor) has inadequate drainage and water is currently ponding on the roof at a large depth. This could be a cause of the significant corrosion of reinforcement within the roof slab which is described in section 3.2.9. Refer to figure 28.

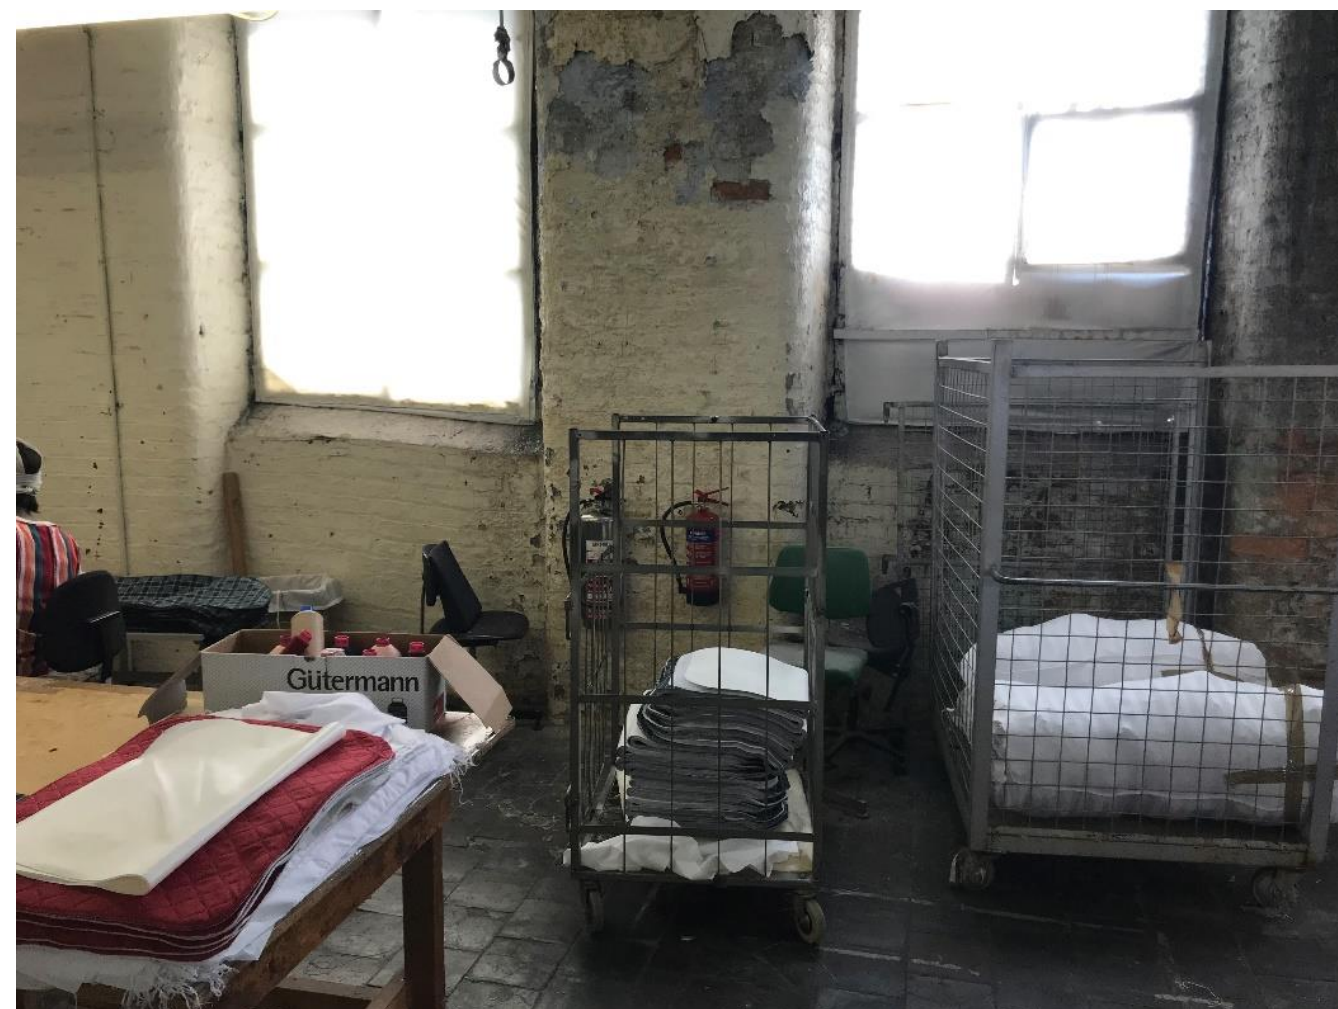
Figure 30: Obvious Drop in Cill and Floor Level

The settling of rear wall described in previous sections continues throughout the lower levels. This occurs across 4No bays and is evident through visual signs of distress in the structure. There is an obvious drop in cill level across the four bays with associated cracking to adjacent spandrel panels and masonry panels beneath cills. With this there is also an obvious drop and undulation of the floor level. Refer to figure 29.

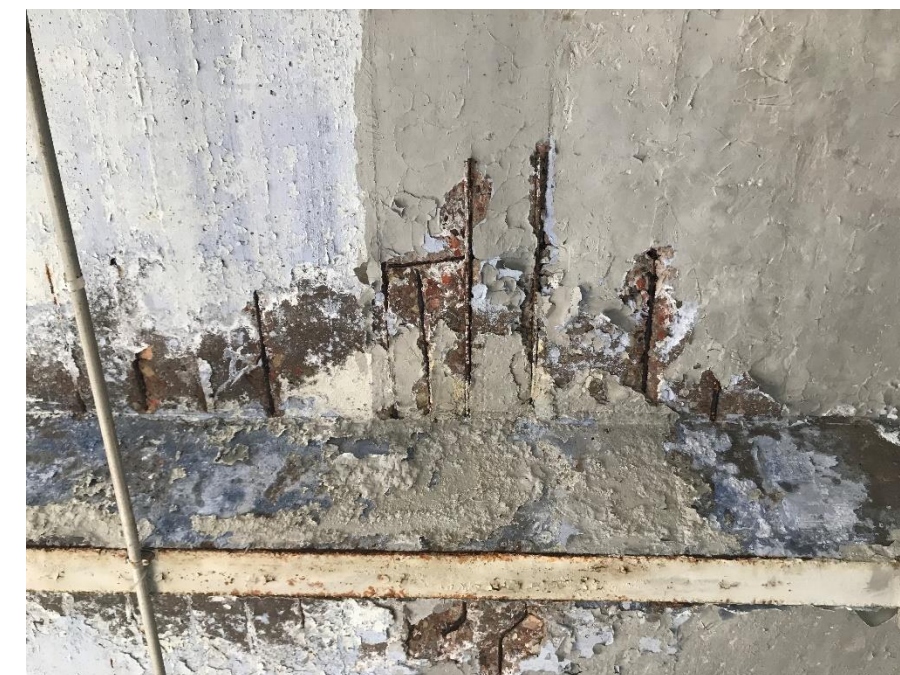
Figure 33: Stained Slab Soffits and Corroded Reinforcement

Roof slab soffits are significantly damaged and present corrosion to the reinforcement throughout. In some instances, loss of cover to reinforcement has caused lapped reinforcement to become loose and peel away from concrete. Refer to figure 32.

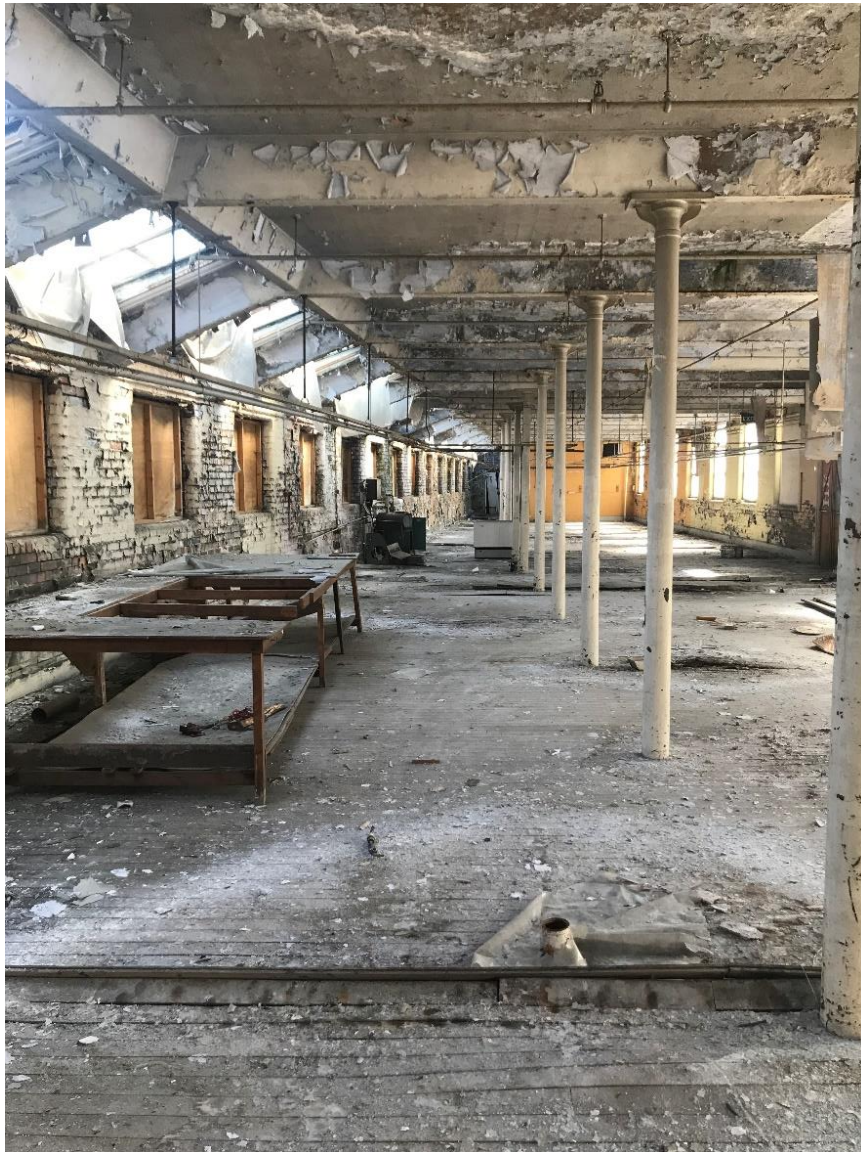
Figure 34: Warped Timber Floorboards

Water ingress has also caused damaged to timber floor finishes. Timber boards have warped and distorted which is most probably caused by a combination of long-term saturation and swelling and water damage. Refer to figure 33.

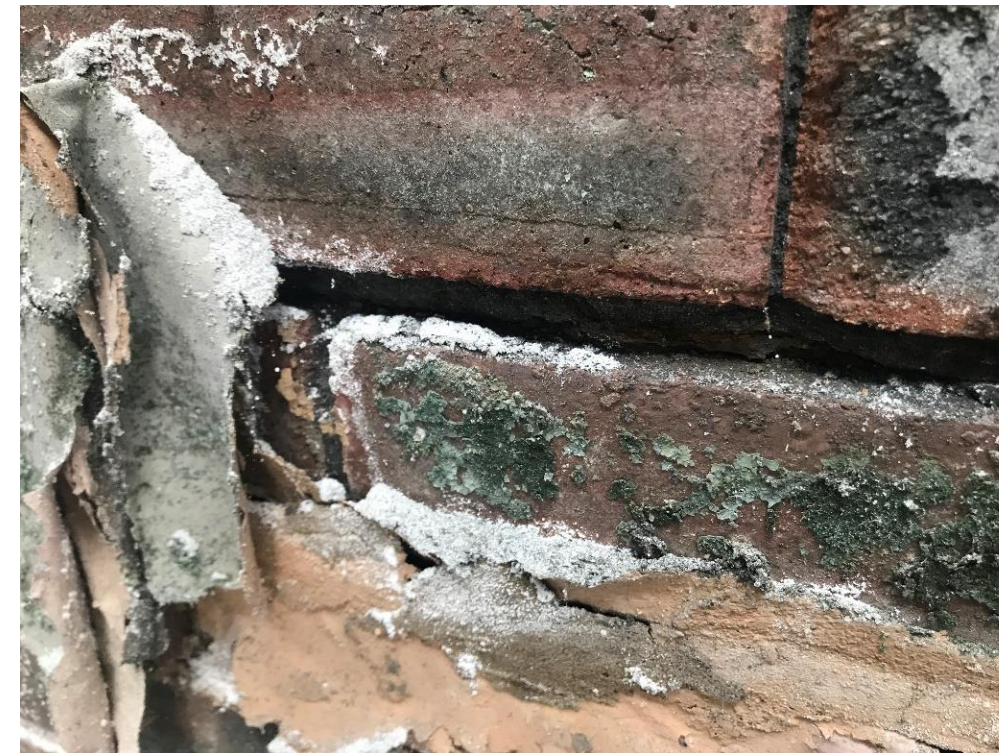
Figure 35: Corroded and Expanded Bed Joint Reinforcement

Within the brickwork it is evident that bed joint reinforcement has been used. Across the floor plate a singular bed joint has opened up due to the corrosion and subsequent expansion of the steel reinforcement within. Refer to figure 34. This may lead to the formation of a hinge in the wall and potential movement.

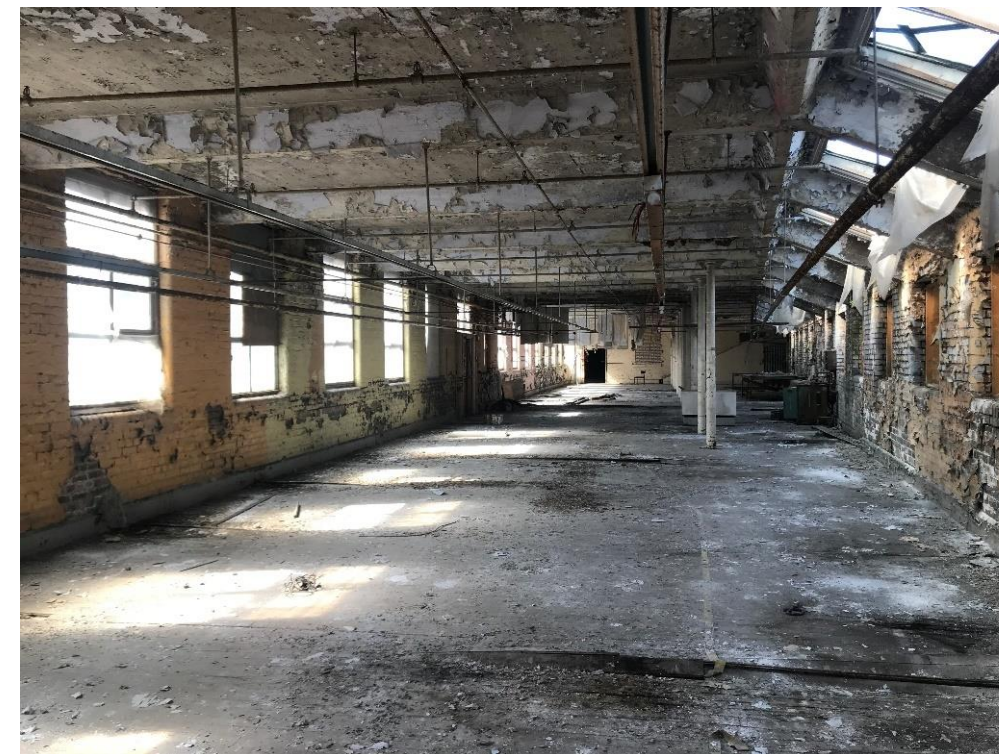
Figure 36: General Efflorescence Staining to Masonry

There is generally a lack of pointing to masonry and efflorescence staining to the internal masonry wall faces throughout the third floor extension. Refer to figure 35.

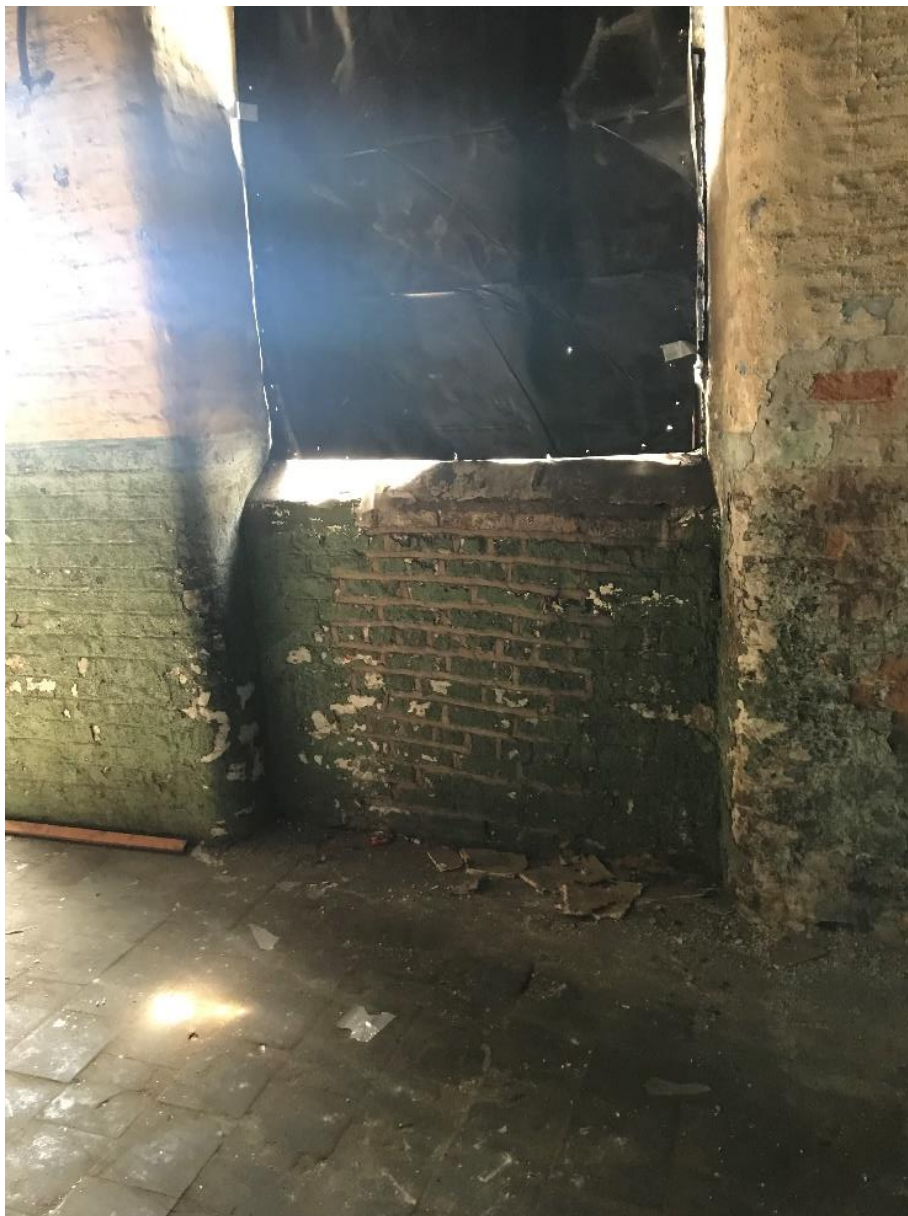
Figure 39: Settled Wall Fronting Ashton Canal

The settling of rear wall described in previous sections continues throughout the lower levels. This occurs across 4No bays and is evident through visual signs of distress in the structure. There is an obvious drop in cill level across the four bays with associated cracking to adjacent spandrel panels and masonry panels beneath cills. With this there is also an obvious drop and undulation of the floor level. Refer to figure 38. Despite a drop in cill levels, apart from cracking observed, the mortar bed joints appear to be unaffected. It could therefore be that bed joints which have opened up due to the perceived drop in level have retrospectively been repointed.

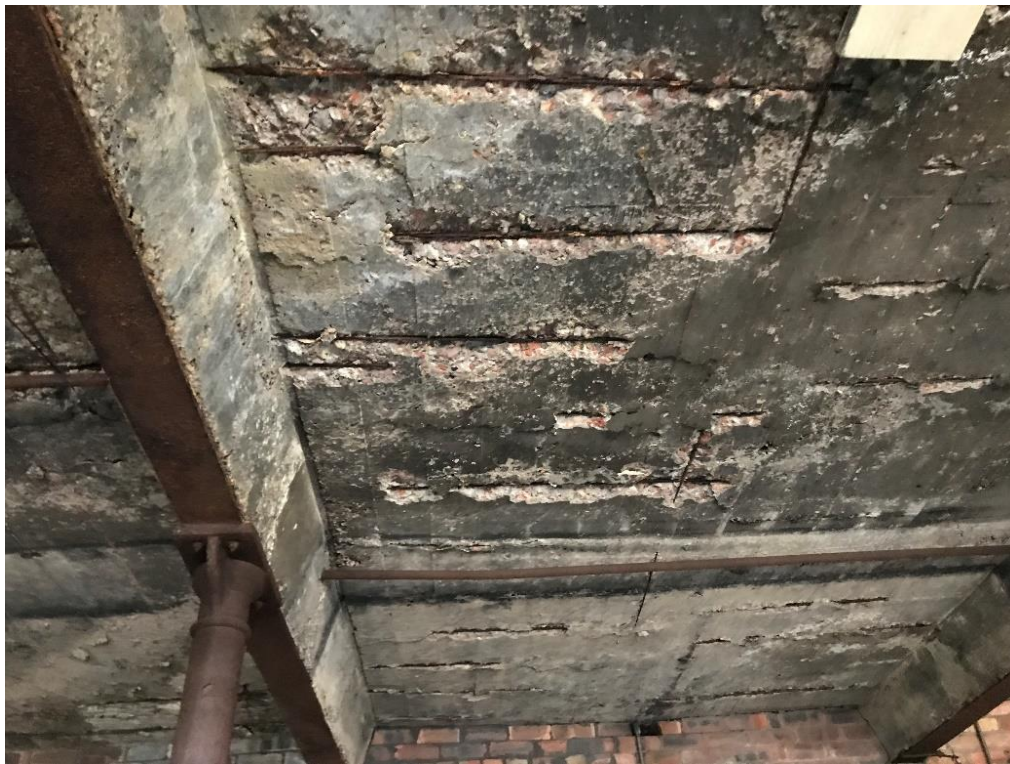
Figure 41: Spalling of Concrete due to Water Ingress and Corrosion of Reinforcement

Within the former waste house there is significant damage to the roof slab due to water ingress. As described in 3.3.8 the drainage of the roof above is poor and water is currently ponding. This may be the cause of water ingress and subsequent corrosion of reinforcement and loss of concrete to the soffit of the third floor. The condition of this roof is very poor and will require immediate attention. Refer to figure 40.

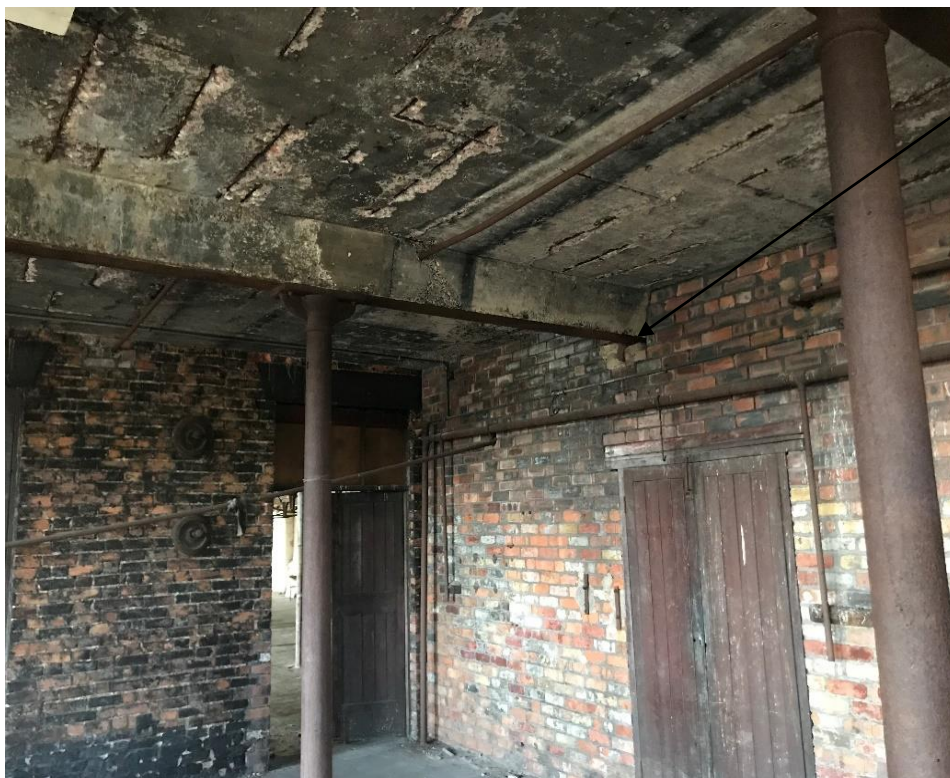
Figure 42: Failed Beam Bearing

Within the waste house a single bearing support of the main cast iron steelwork has failed and caused the slab to drop. There appears to have been some attempt to resolve this though this is not particularly successful. Refer to figure 41.

Failed beam bearing
causing drop in roof
slab
