Job Title
Brunswick Place

Prepared for
Maryland Securities

Report Type
Structural Appraisal

Date
06/05/2021

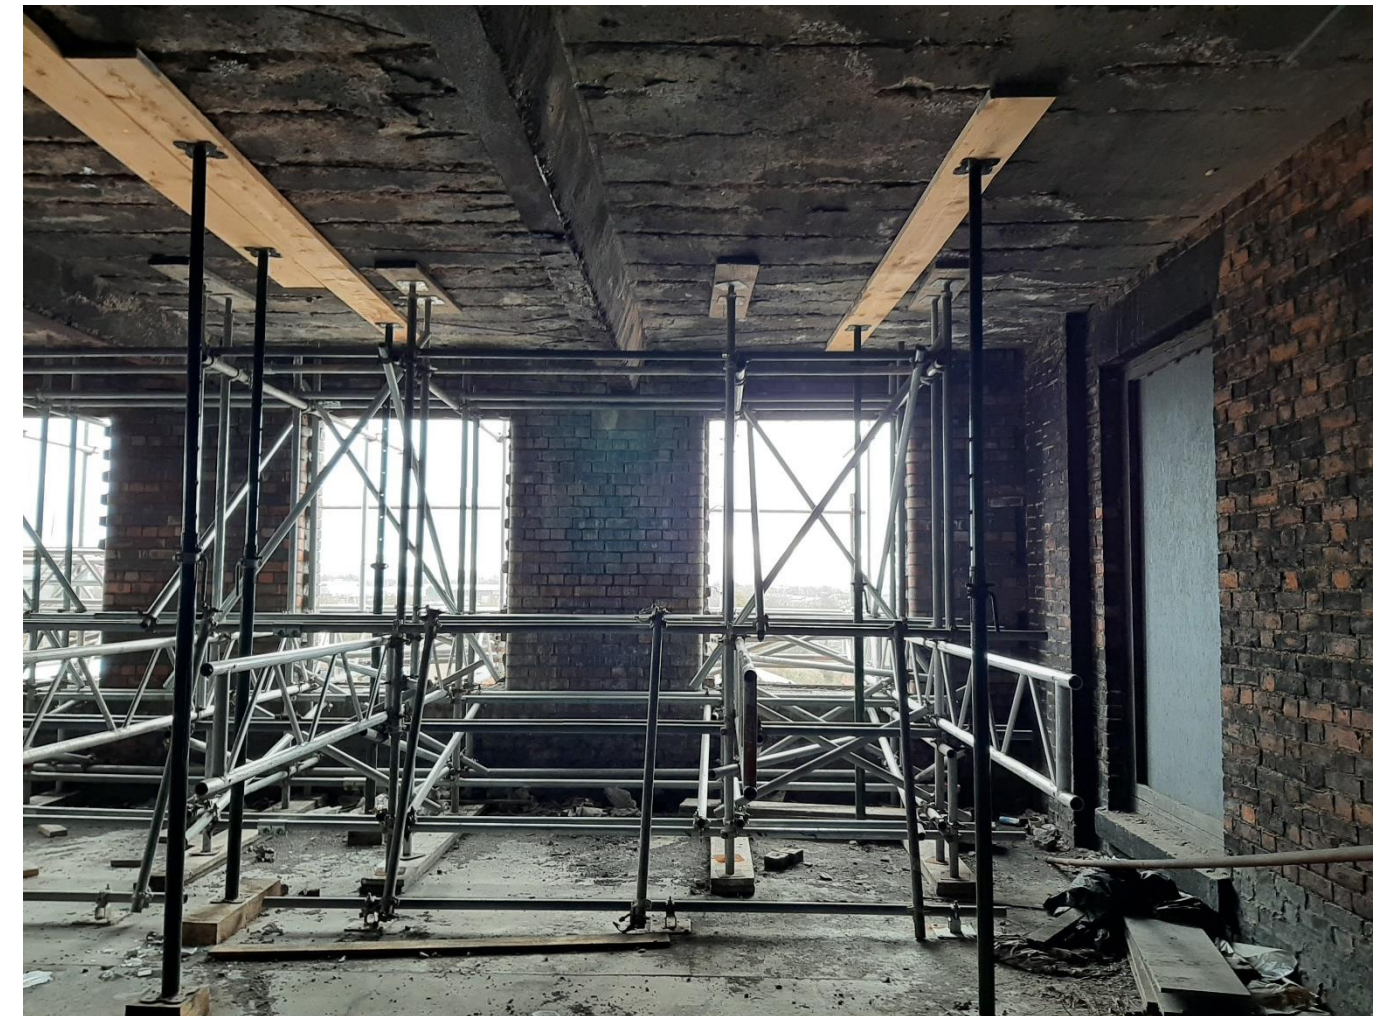
Figure 43: Propping Installed by Client to Third Floor Former Waste House and Repair work started.

A series of works recently undertaken were observed within the waste house at third floor. These have presumably been carried out as part of a repair strategy to a recent failure of lintels on the north east elevation of the waste house.

Referring to figure 42 scaffold can be seen to have been installed to temporarily support the roof slab as the lintels in questions were replaced. It is also apparent that the internal leaf of the masonry wall has also been rebuilt.

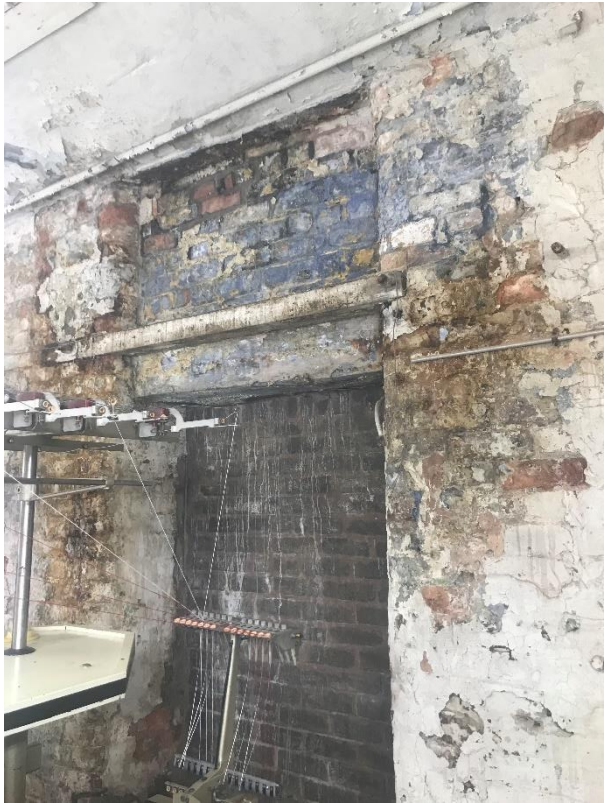
Figure 49: Significant Water Staining and Damage to Brickwork

To the south west elevation of the main wing (fronting the Ashton Canal) significant water staining and damage is evident to a bricked up former opening. Refer to figure 48.

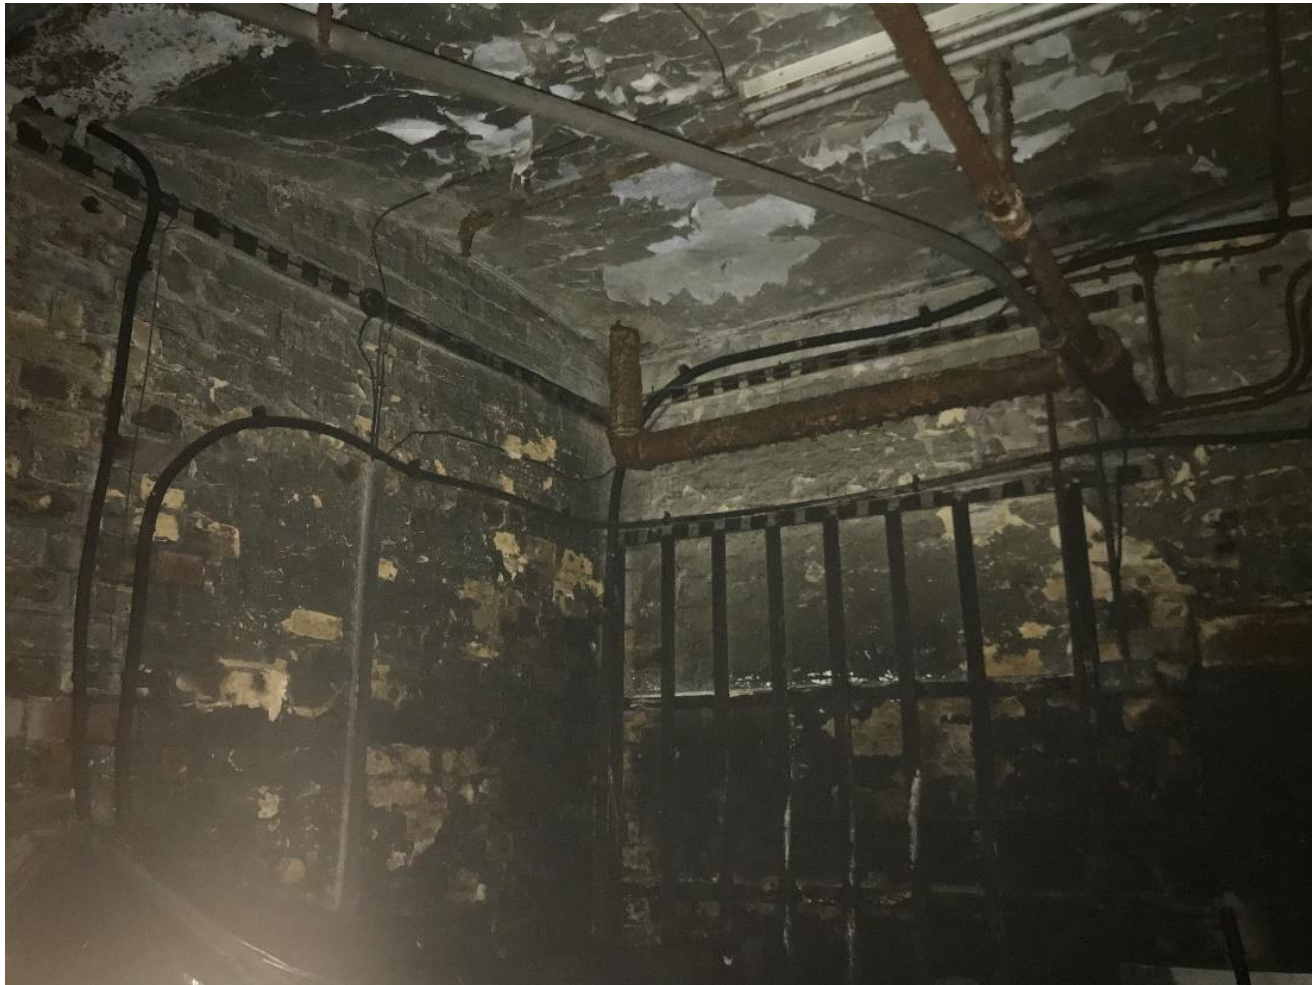
Figure 58: Significant Staining to Walls

Within a small portion of the north east wing (fronting Bradford Road) the ground floor area shows significant staining due to smoke and dust. The use and former use of this area is unknown. Refer to figure 57.

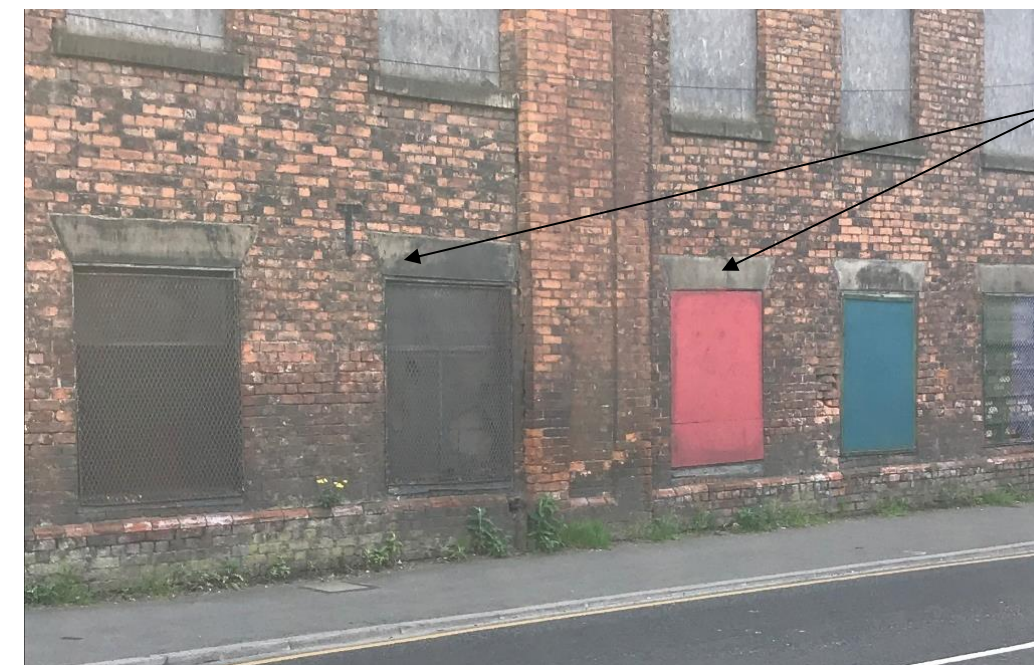
Figure 63: Damaged Masonry Pier and Associated Lintels

Dropped and distorted lintels. Possible cause due to peeled pier

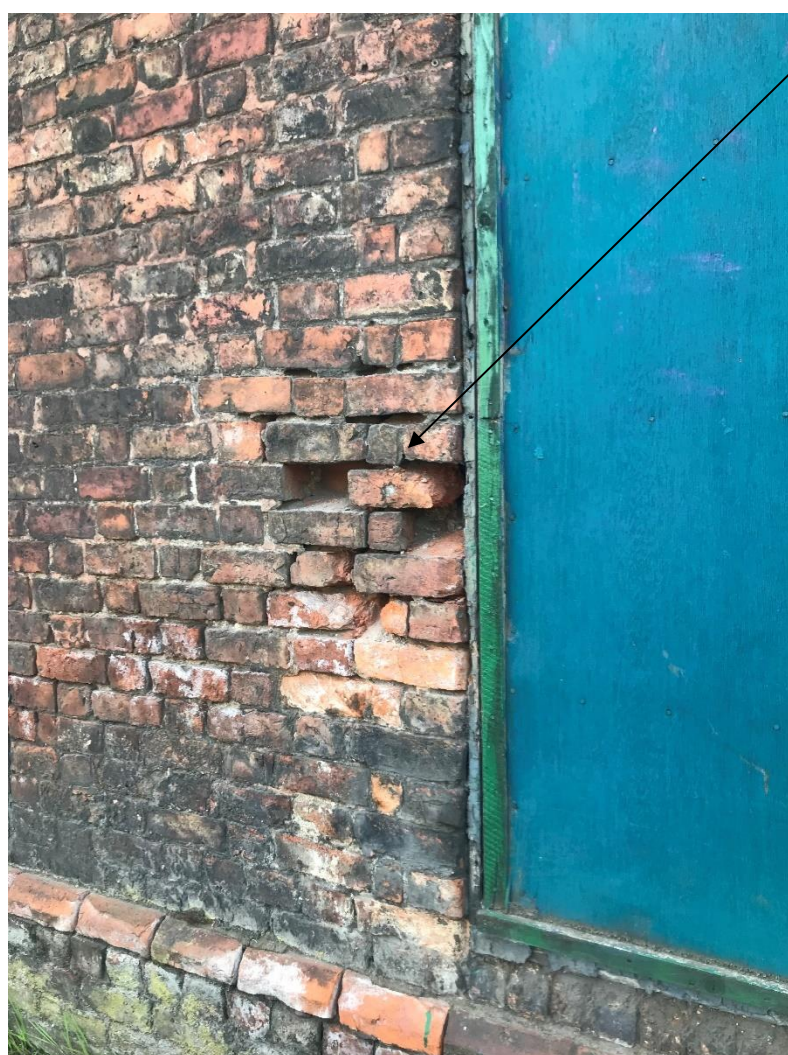
General loss of masonry units locally along with pointing loss.

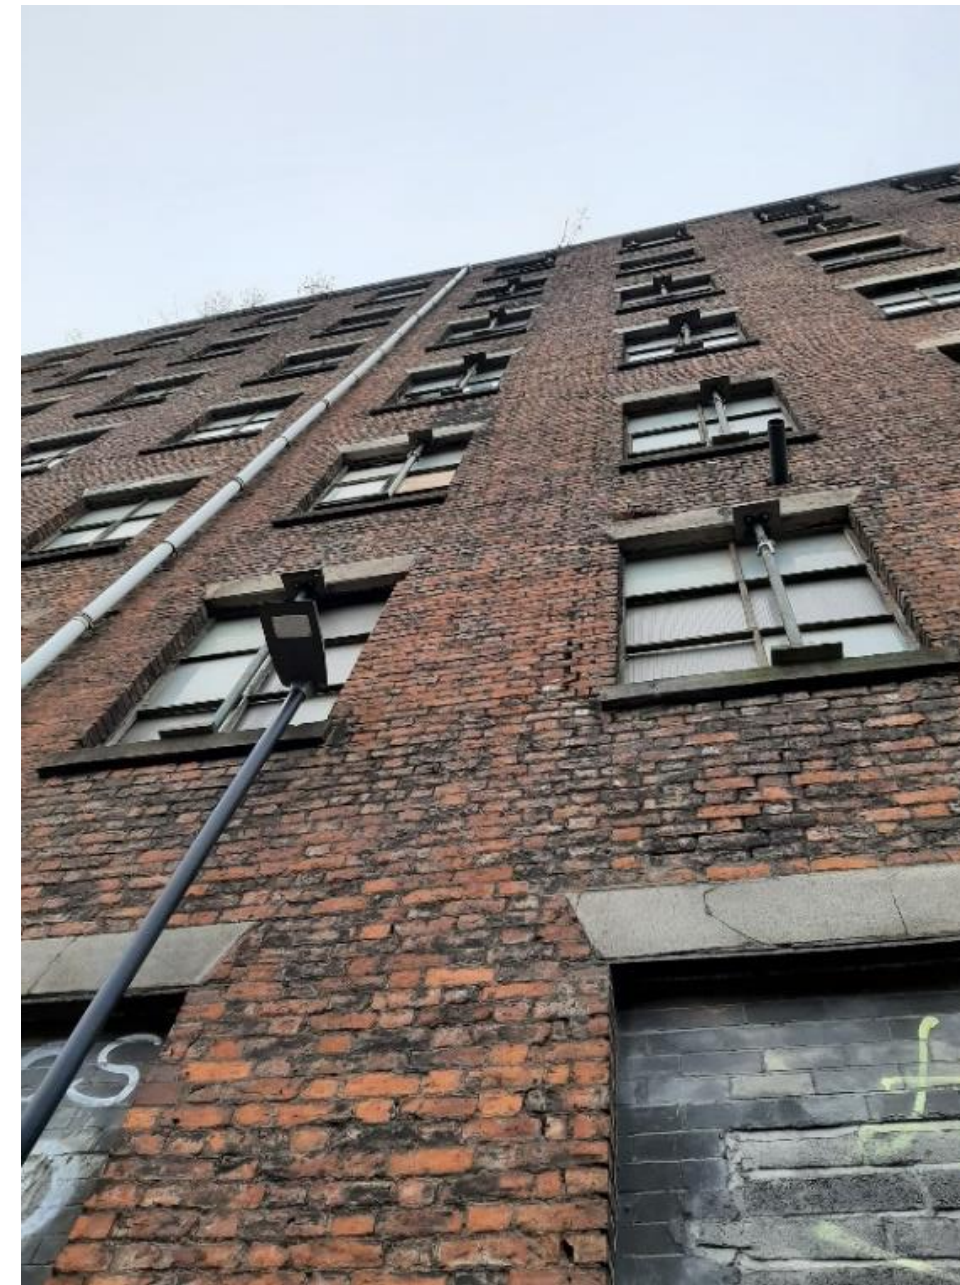
Figure 69: Lintel Props Elevation 3

Lintel failures exist all along elevation 3. This includes cracking of the concrete lintels with some evidence of dropping and cracking of the masonry panels above. This has recently been addressed by the installation of a series of steel acro props. These act to temporarily support the lintels and mitigate against any further deterioration. The locations of these interventions are shown in Appendix A – Structural Investigation Notes and can also be seen in Figure 69.

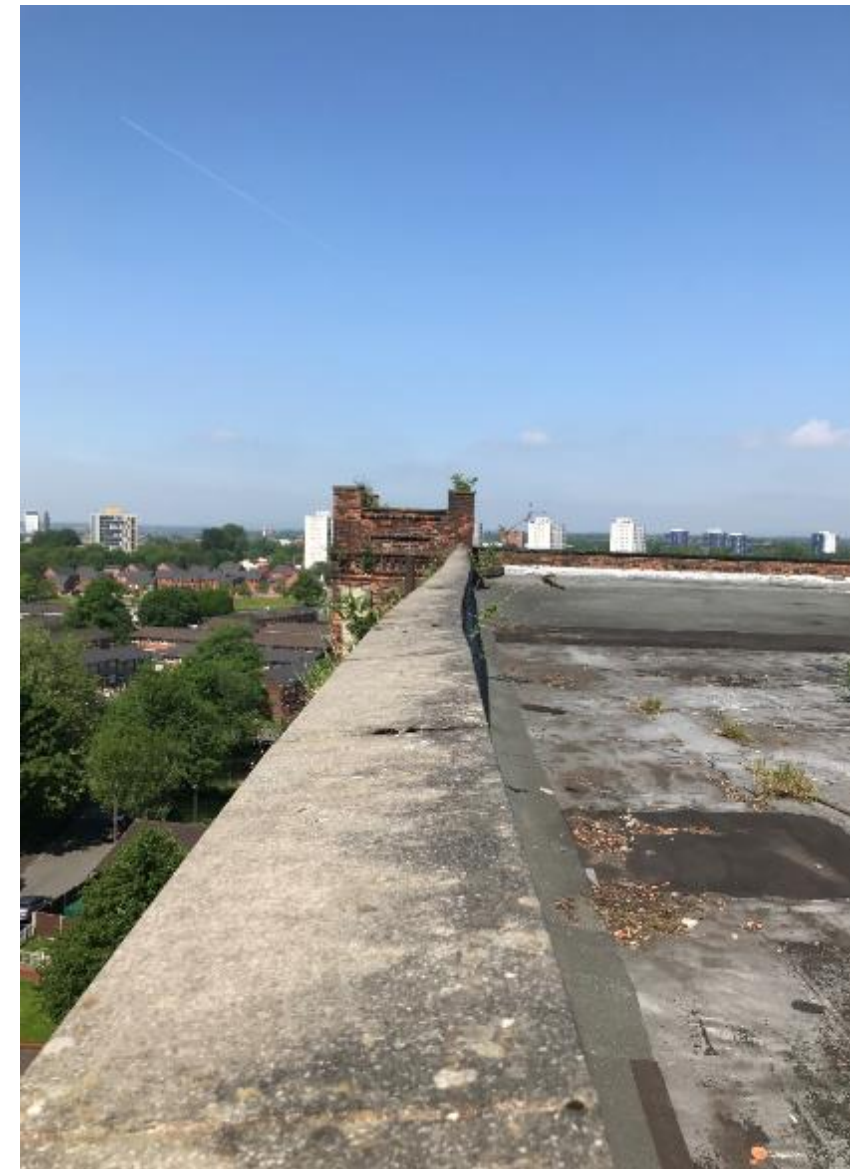
Figure 70a: Bowing Parapet.

To the right of elevation 3 towards the interface with elevation 2 the parapet appears to be "peeling away" from the adjacent areas. This correlates to the area observed on the roof where the parapet appears to be leaning outwards. (Figure 70.a) The brickwork in this area appears to be in poor condition. In this location overgrown vegetation can be seen, it is most likely this is the cause of poor condition of masonry parapet in this location. Refer to figure 71.

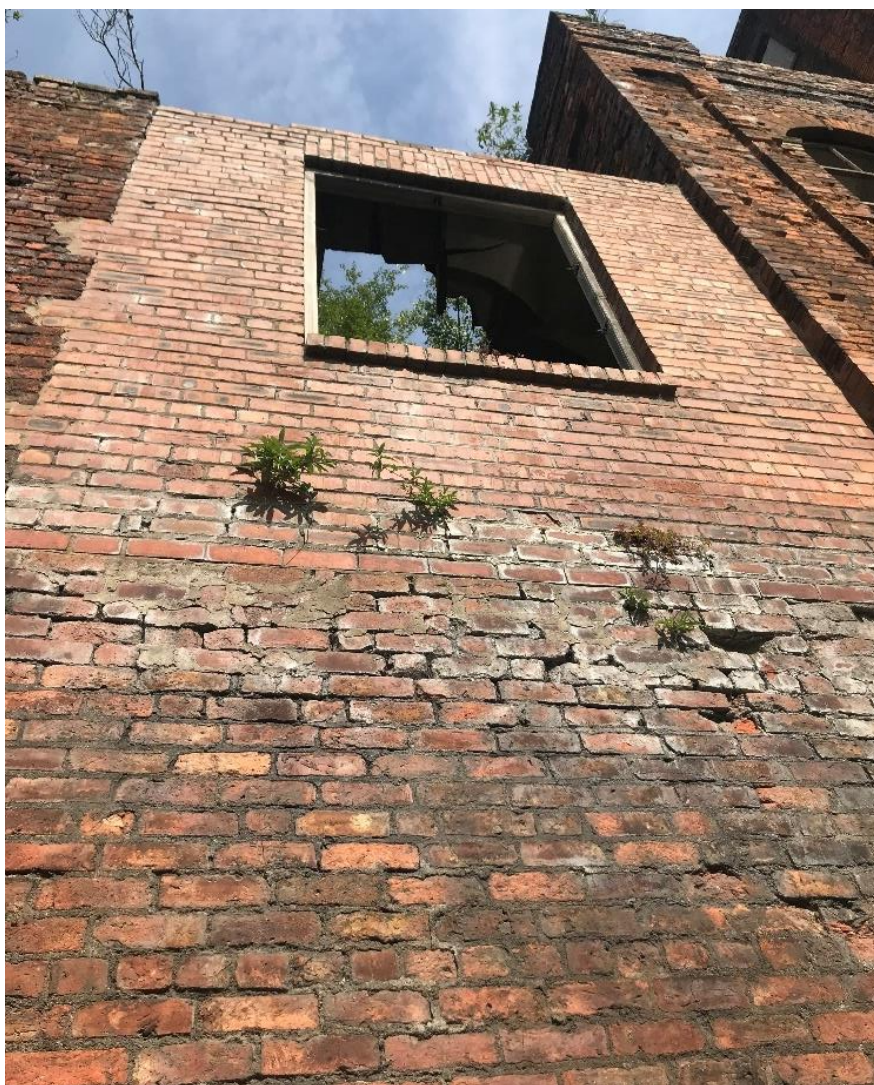
Figure 71: Reconstructed Boiler House Wall

To the southern end of façade at the location of the former boiler house a significant amount of spalling has occurred across the façade. The end panel to boiler has historically been rebuilt in engineering brick. Refer to figure 71.

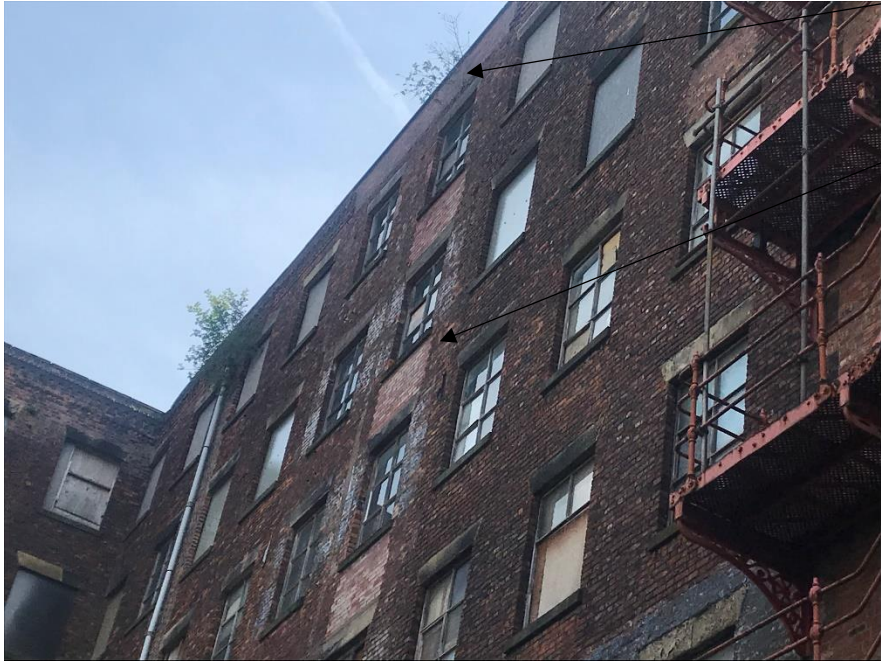
Infilled section of parapet and vegetation growth

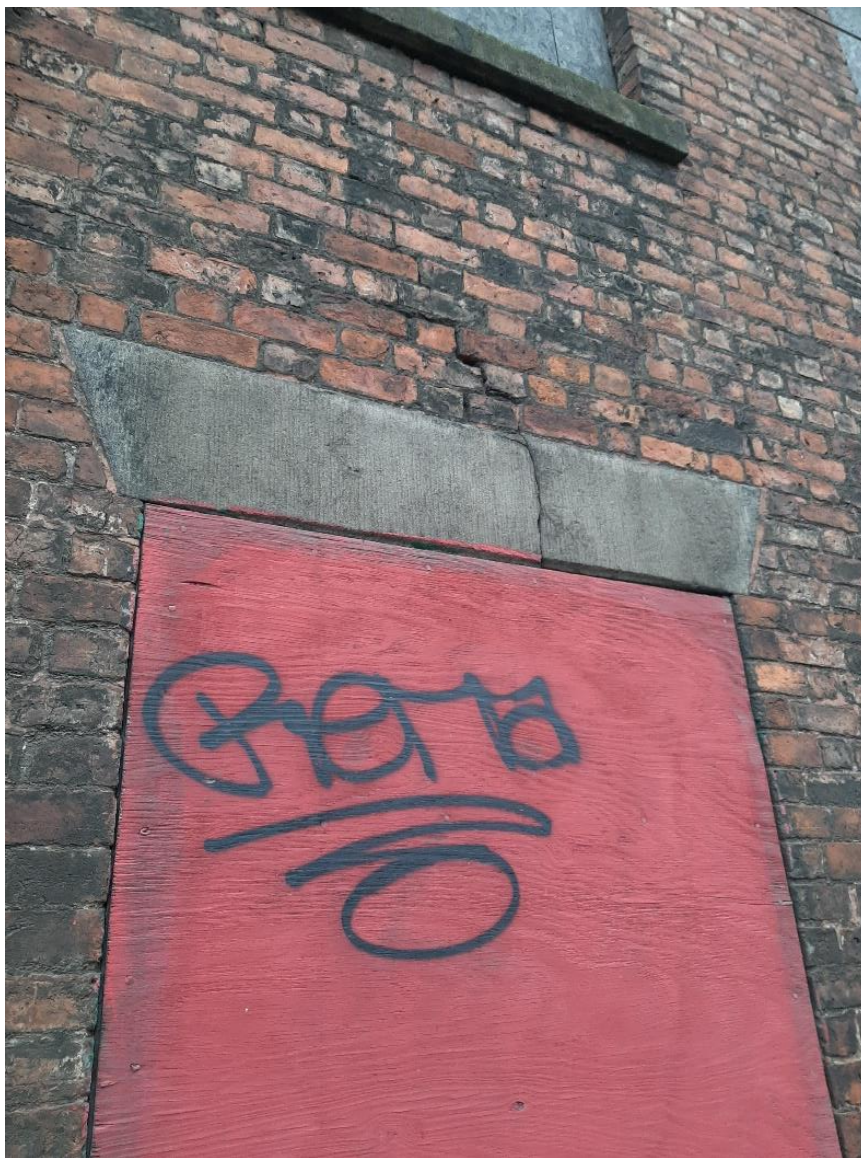
Figure 93: Typical Lintel Failure

As described most elevations present failed lintels over openings which will be addressed. At present it is estimated that circa 20% of all lintels require attention and are showing signs of structural distress. See figures below showing typical lintel failures.
