## **Brunswick Mill, Manchester (Grade II listed): Summary Statement of Window Condition**

**5 May 2021**

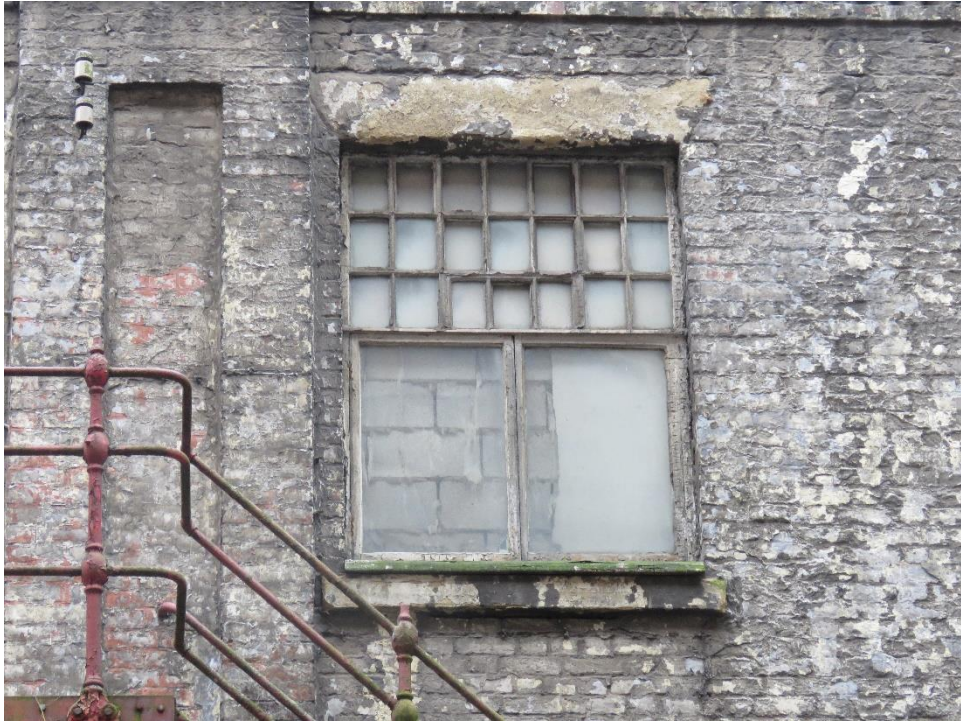
- iii. The original windows to Brunswick Mill are expected to have been a fixed window with a possible central openable section, but this is not definitively known. It is believed that only one section of an original window survives from this period, on the south elevation of the entrance block (Figure 1). The window was not closely inspected during the survey due to access restrictions.

**Fig. 1.** The multi-pane upper section of this inner courtyard window is believed to be the only surviving section of original window to the mill.

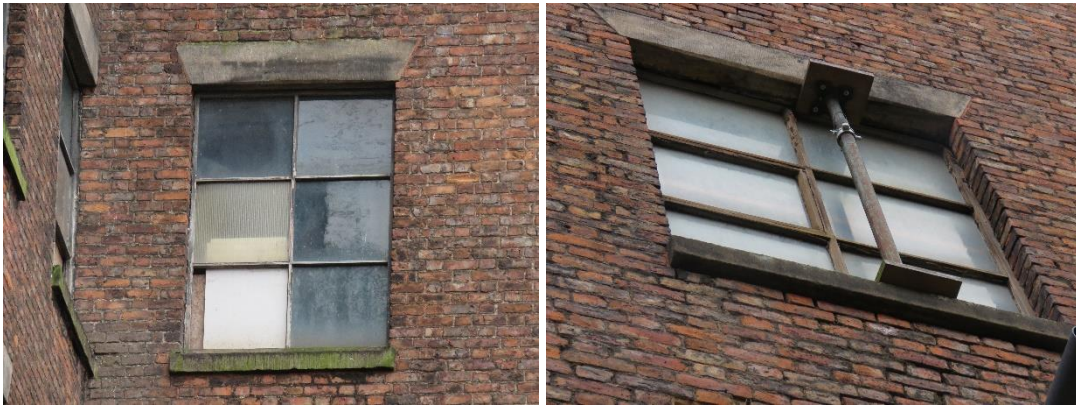
**Figure 2 (left): Timber framed 6 pane window with no openable panes, and Figure 3 (right): With a single middle pane that is openable.**

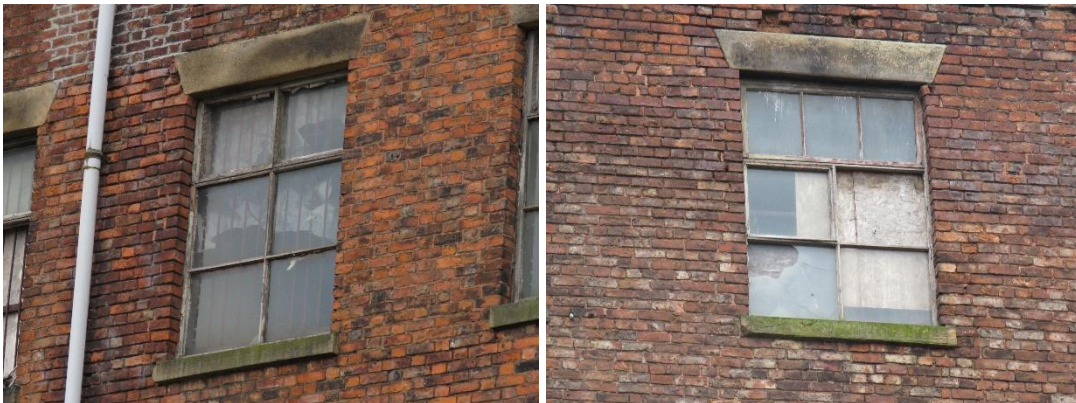
**Figure 4 (left): 6 pane window with top two panes hinged at the bottom of the frame to be openable, and Figure 5 (right): 3 over 4 window.**

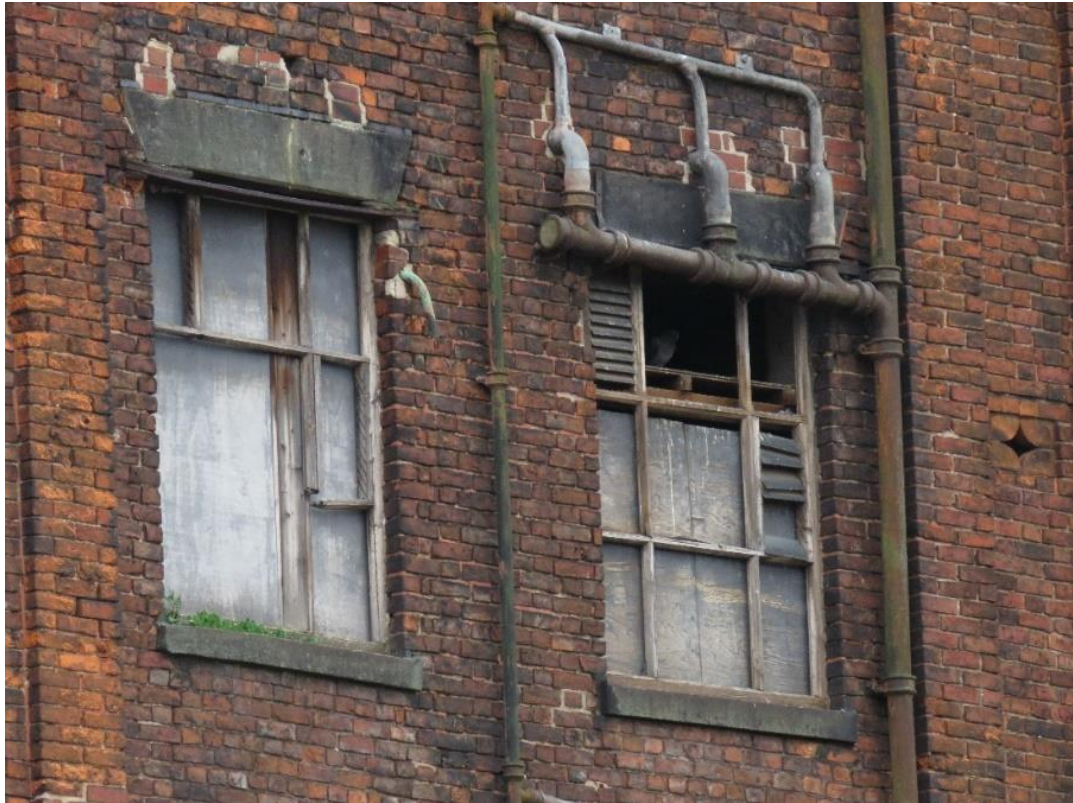
**Figure 6: Windows with ventilation louvre panels.**

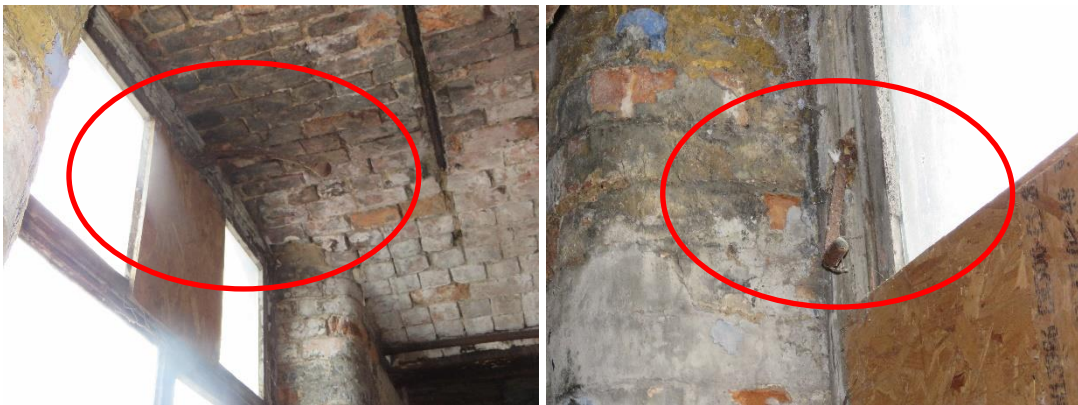
**Figures 8 and 9: Internal view showing opening mechanism and window stay of windows with tilting top pane.**

- vi. The openable elements of windows have been predominantly painted or screwed shut and the survey did not attempt to open any of the windows due to the risk of instability in the glazing. Some of the windows have their original ironmongery, including opening mechanism and window stays. These mechanisms are an early example of this window type that was later adapted by metal window manufacturers such as Crittall.

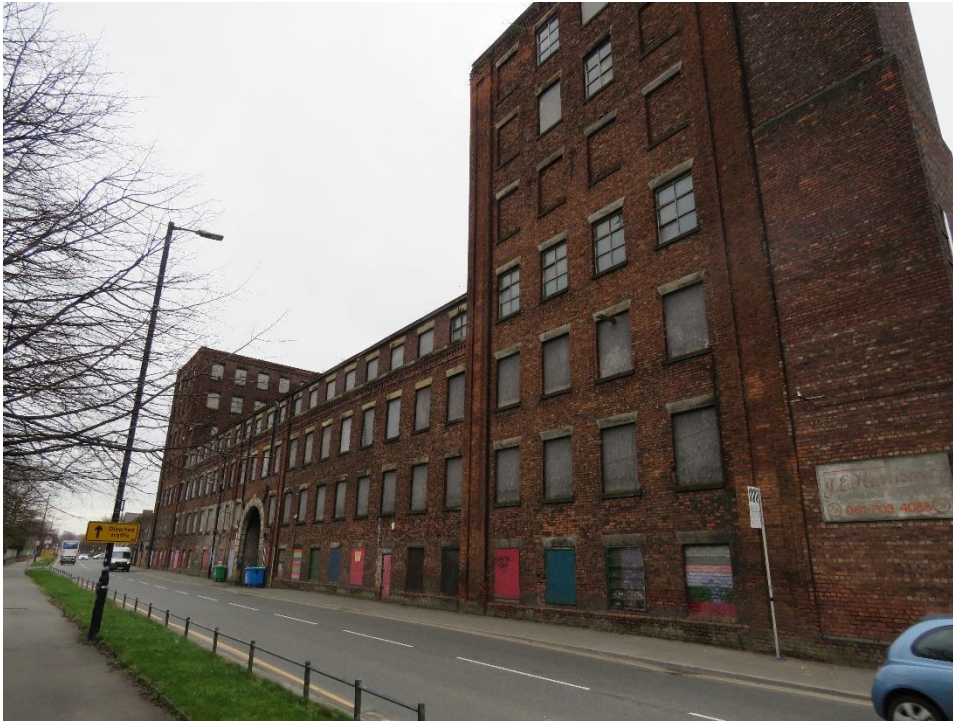
**Figure 10: General view of the north elevation showing number of blocked up window openings.**

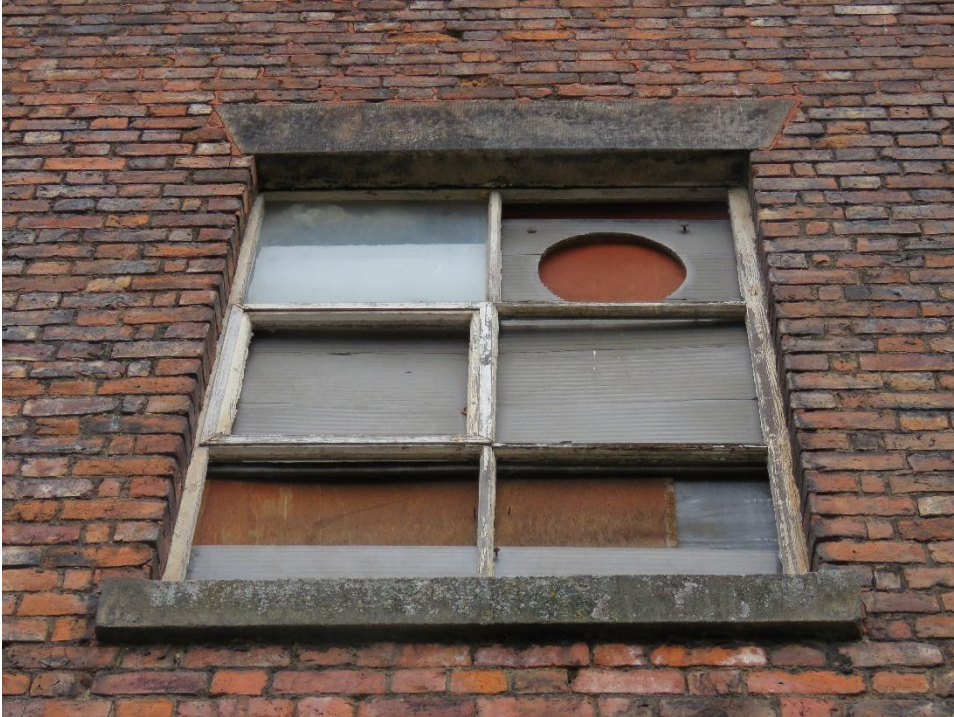
- iii. Most windows have completely lost their coatings of paint and the glazing putty has largely failed. The use of modern oil-based paints has also been used to some areas which has flaked and failed. Poorly applied glazing putty has also allowed water ingress and caused premature failure of the seal.

- iv. Many of the windows have had panes of glass replaced with a modern plate glass, are cracked, have had vents installed, covered with a timber plyboard or a corrugated plastic sheet.

**Figure 11: Typical condition of a surviving timber framed window with replaced / missing / broken panes, flaking paint and boarded over.**

- ii. Where it is proposed to repair the existing windows, we would recommend that all windows are removed and repaired on a workbench rather than in situ.

- iii. Rotten sections of timber need to be cut out and timber splice repairs undertaken. All flaking paint is to be stripped and all glazing putty cut out. New traditional glazing to match the surviving original glazing should be sourced and installed with new glazing putty. The windows would then need to be re-decorated (leaving exposed timber to the moveable faces of the timber) and reinstated. Externally, the junction between the timber frame and brickwork should be finished with a burnt sand mastic and internally with a chalk based caulk. Internal timber cills should be repaired where they survive.

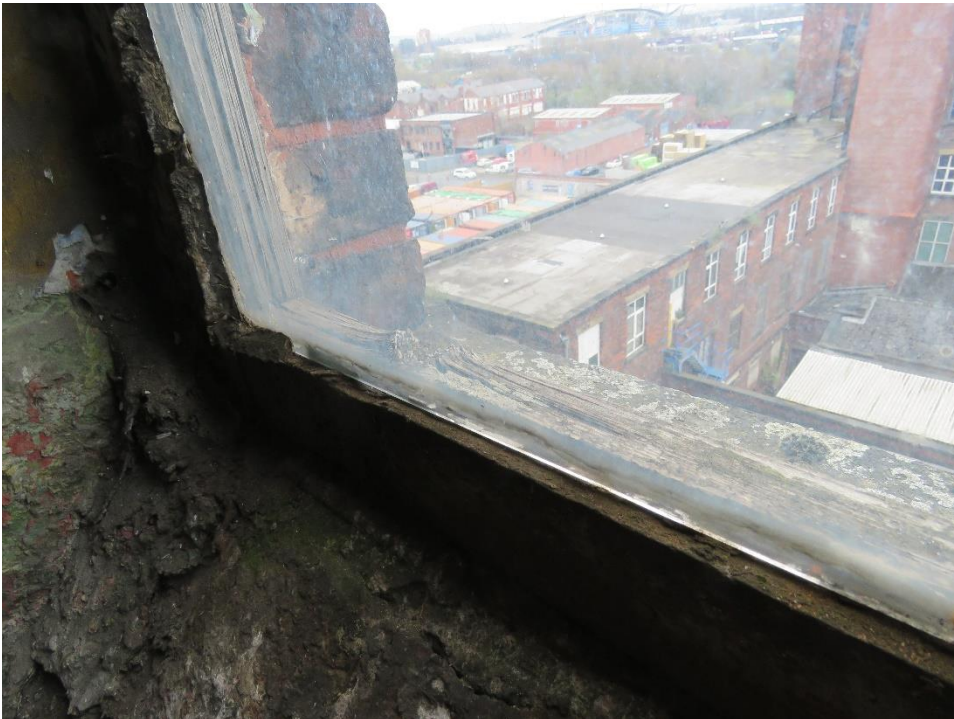
- v. Some of the windows have suffered from timber decay, primarily due to the loss of paint coverings to the cill, but this issue only seemed to be to isolated areas. Further survey would be required to assess the extent of timber decay, which would require specialist access to be arrange.

**Figure 12: View of cill showing flaking paint, failed glazing putty and minor timber decay to cill.**
