Claire Collett
Archicollett
34 Plover Way,
London
SE16 7TT

Condition Report Veined Carrara Marble Chimney-piece
GFF 88 Seymour Street, London W2 2JJ

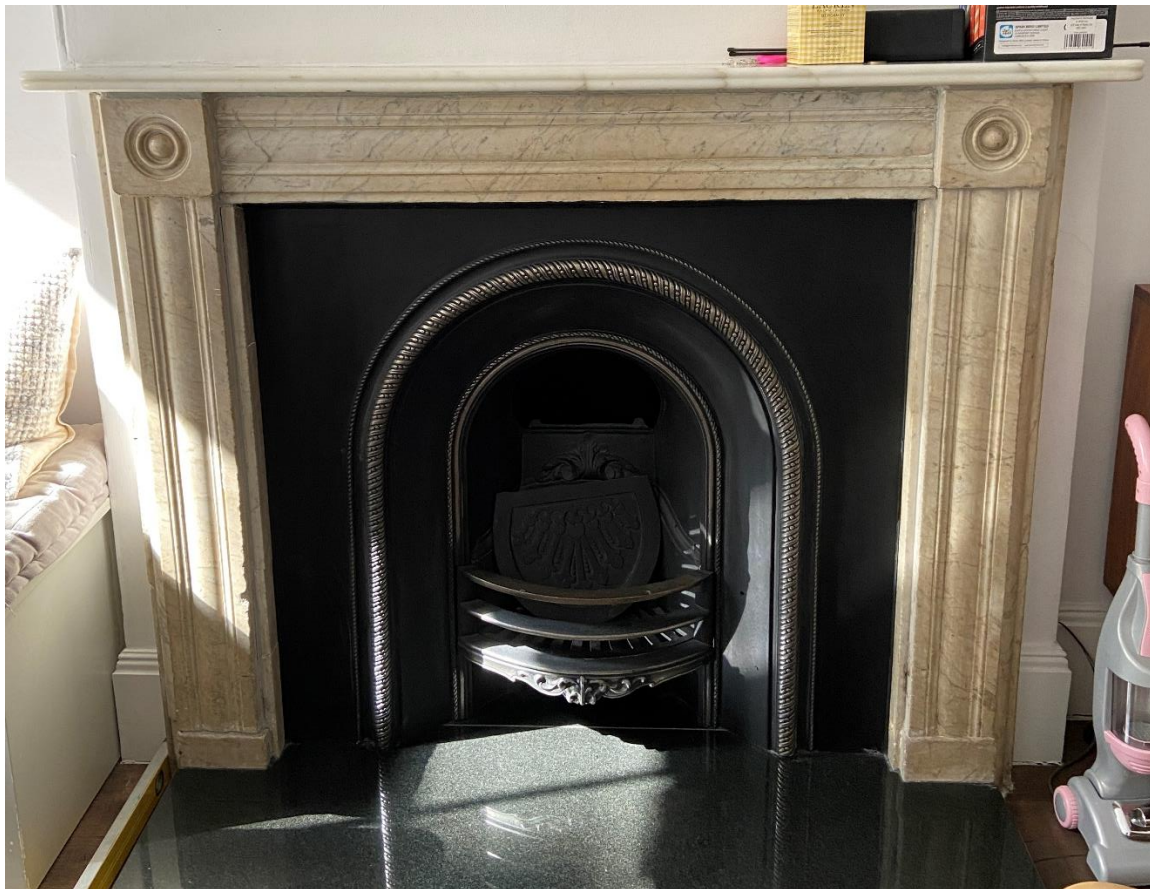
The chimney-piece in the GFF room of 88 Seymour Street, an early 19th century English marble chimney-piece composed from thin sections of veined Italian Statuary probably dating to 1815-1820. The current black granite/marble slab is raised and a recent introduction as also the late Victorian style stove grate.

The condition of much of the chimney-piece is reasonable, both jambs, their plinth blocks, moulded panels, the frieze and turned Paterae are un-broken although elements of both outgrounds have broken. The surface of the marble is discoloured from atmospheric conditions (coal smoke) combined with having been previously painted, so much of the surface appears *flat*. Traces of paint are still present in many of the less accessible areas, including the underside of the Cornice (shelf) and junction of the upper frieze mouldings to the flanking blockings as also within the crevices of the right-hand Paterae shown below. There is however, in keeping with its age, substantial wear to the plinths and considerable mechanical damage to the inner edges of the elements that surround the fireplace opening particularly to the left-hand side.

Given the reasonable condition of the chimney-piece, it is our recommendation that the chimney-piece is removed, repaired and re-installed. Given the existing evidence of separation, we envisage that the jambs, frieze and plinth blocks should be possible to remove, with ease, but will separate into component parts during the removal process and there may have been heat damage to the internal returns and soffit. Restoration work should allow for the replacement of the later Cornice with one in veined marble, unmoulded to the edge, but extending the same distance as that present, which should accord with the historic marble as best possible. The restoration work should further allow for the removal of all soot/debris from the rear faces of all the historic marble elements and any supporting sections of stone. All of the broken and fractured elements will require re-joining and re-enforcing and the joints coloured to match the veining present as best possible. Test trials for the removal of the existing paint on the surface should be applied as also for the application of poultices, for the extraction of Coal soot and smoke staining. Further allow for the full re-assembly of elements to form component parts and the replacement of the historic supporting stones (Frieze liner and blocking stones for jamb elements and plinth block elements) within the chimney-piece and cramping elements (using copper wire) and the application of a coat of Micro crystalline wax to all surfaces on completion.

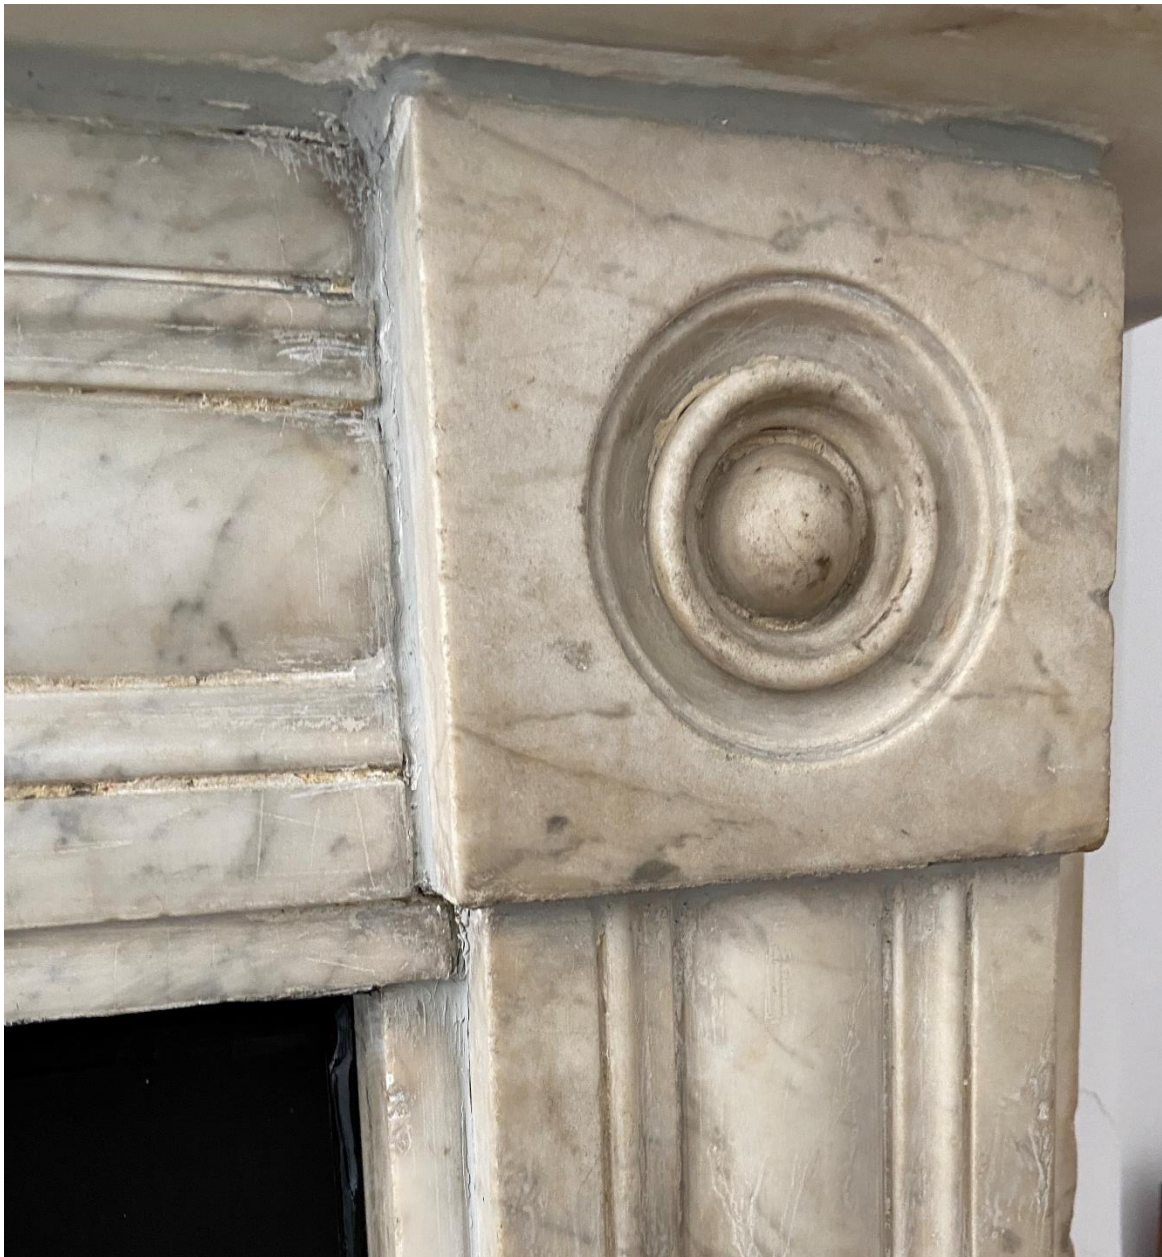
Detail showing areas of residual paint within the deeper crevices of the frieze moulding, junction with the blocking. The chimney-piece appears to be out of alignment as exemplified by the large plaster joint to the underside of the Cornice junction with the blockings and frieze where the white plaster joint has been *bodge* painted a light grey. Note the deep dirt impregnation to the centre of the paterae.

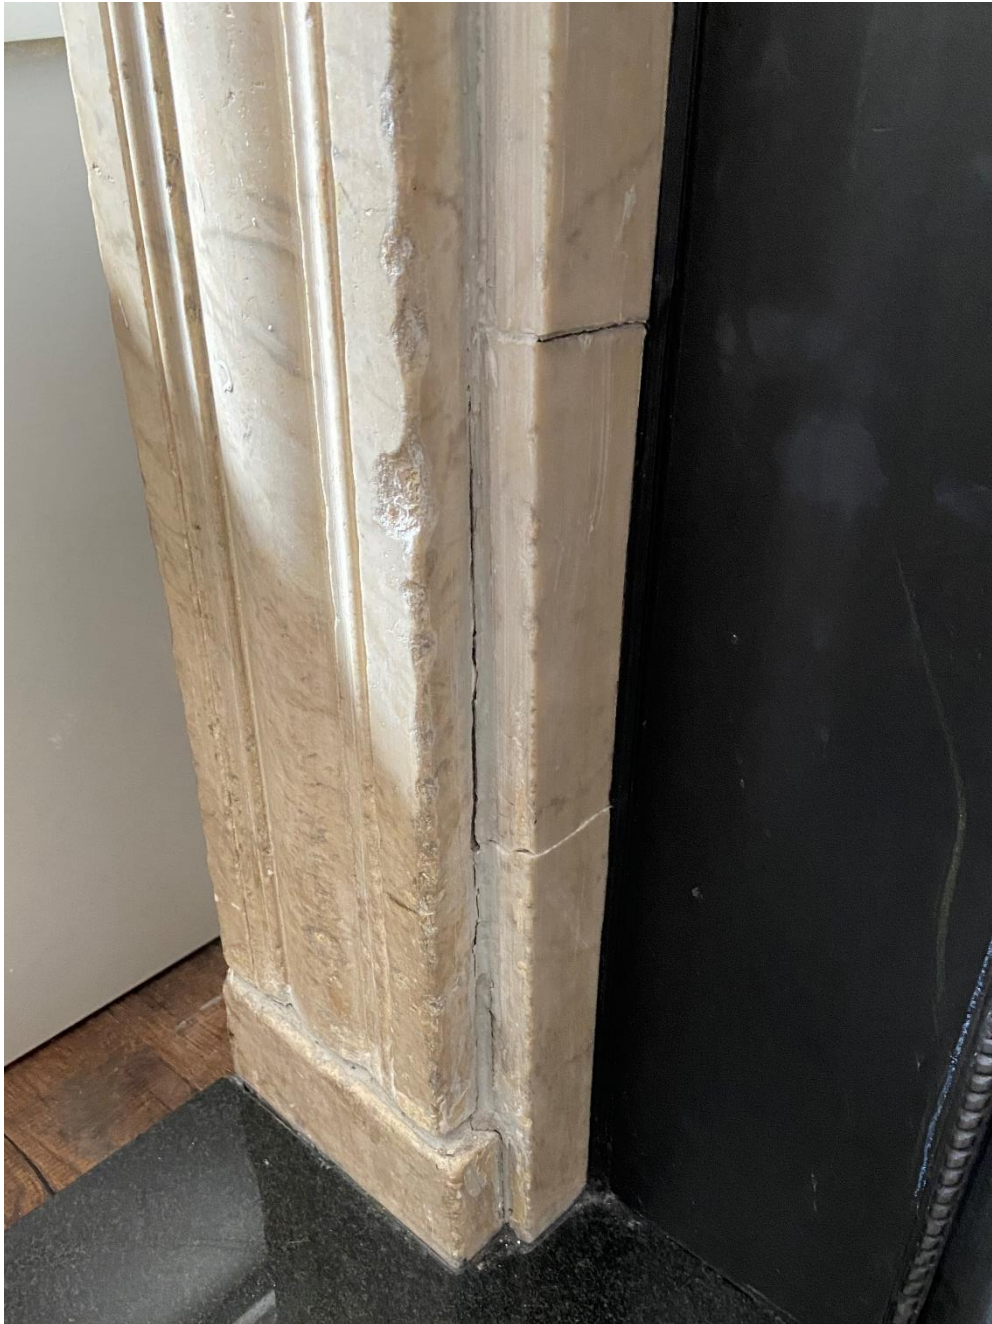
Areas of mechanical damage, such as this are generally the result of wear and tear from its use as a means of heating and lighting 1820-1960, the damage often caused by mechanical impact by fire tools or coal buckets/scuttles. The damage is severe on the inner edge of the left-hand jamb as shown below.

The inner edge of the left hand -jamb showing severe mechanical damage to the inner edges of the marble pillasters, probably as a result of impacts by metal objects such as fire tools and coal scuttles. Note the break to the internal returns, some of which appears to be the result of movement.

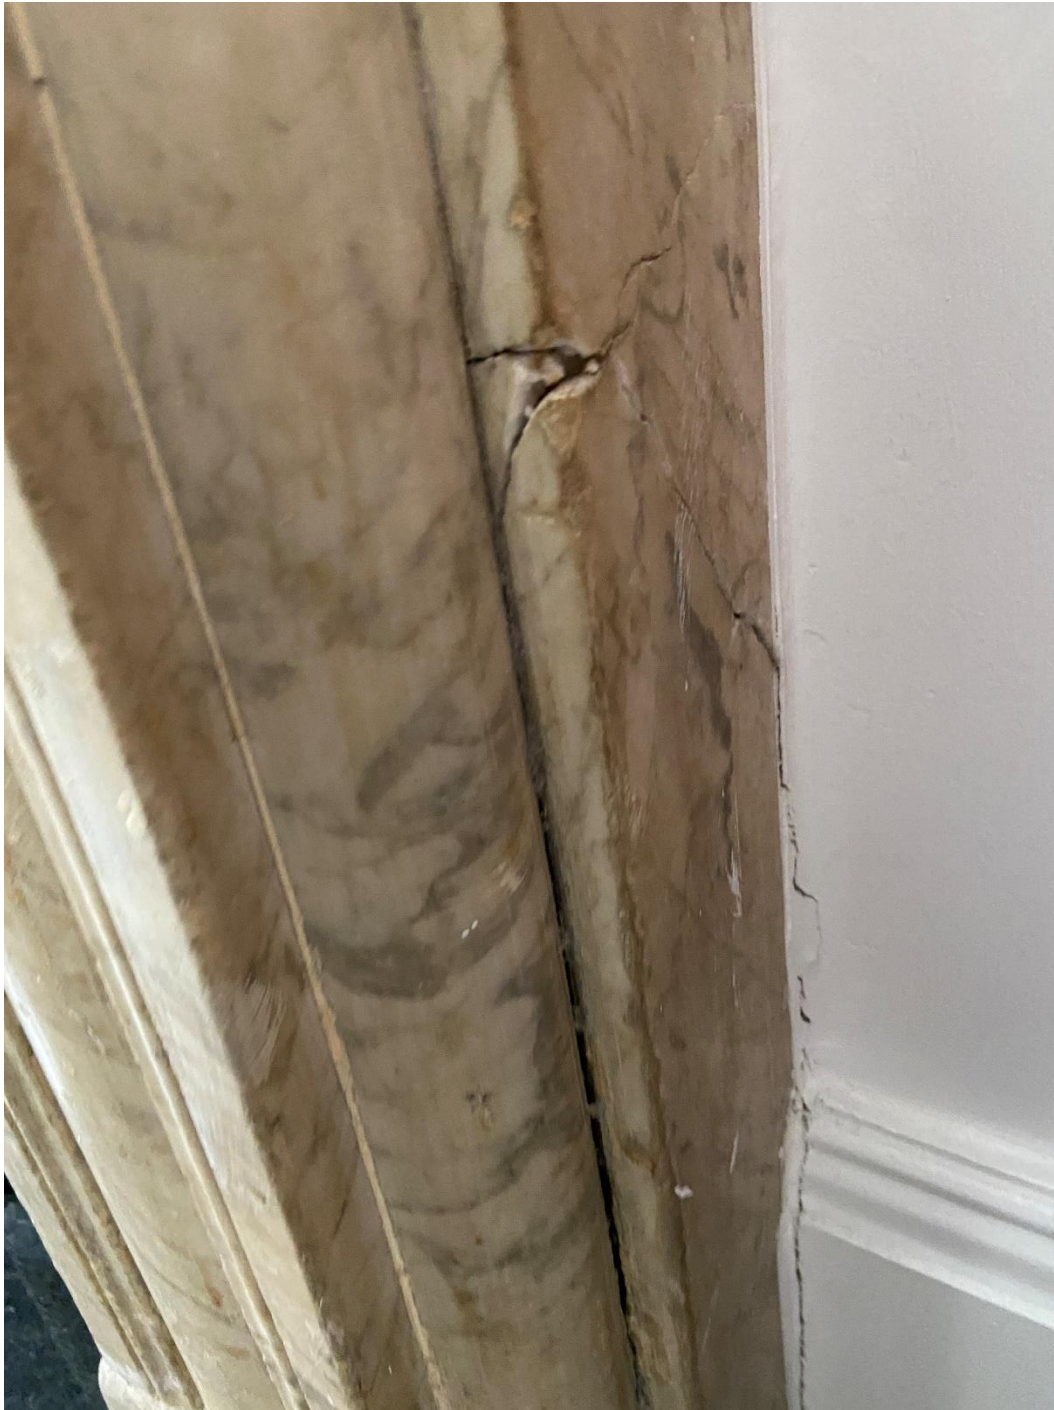
The chimney-piece appears to have moved, perhaps as a result of recent modifications such as the introduction of a new in-congruous raised black slab and the introduction of a reproduction Victorian style stove grate. Alternatively, the movement may be the result of the age of the property and faults within the supporting brick arch within the flooring. Evidence for this can be seen in the below detail of the right-hand jamb where the outground has fractured and the elliptical moulding to the front has become disconnected from the outground.

Detail of the right-hand jamb showing the elliptical moulding which is beginning to separate from the out-ground which has in itself broken. Similar separation and fractures are present within the left-hand jamb. Such separation can have been the result of unsympathetic installation work or movement within the building.

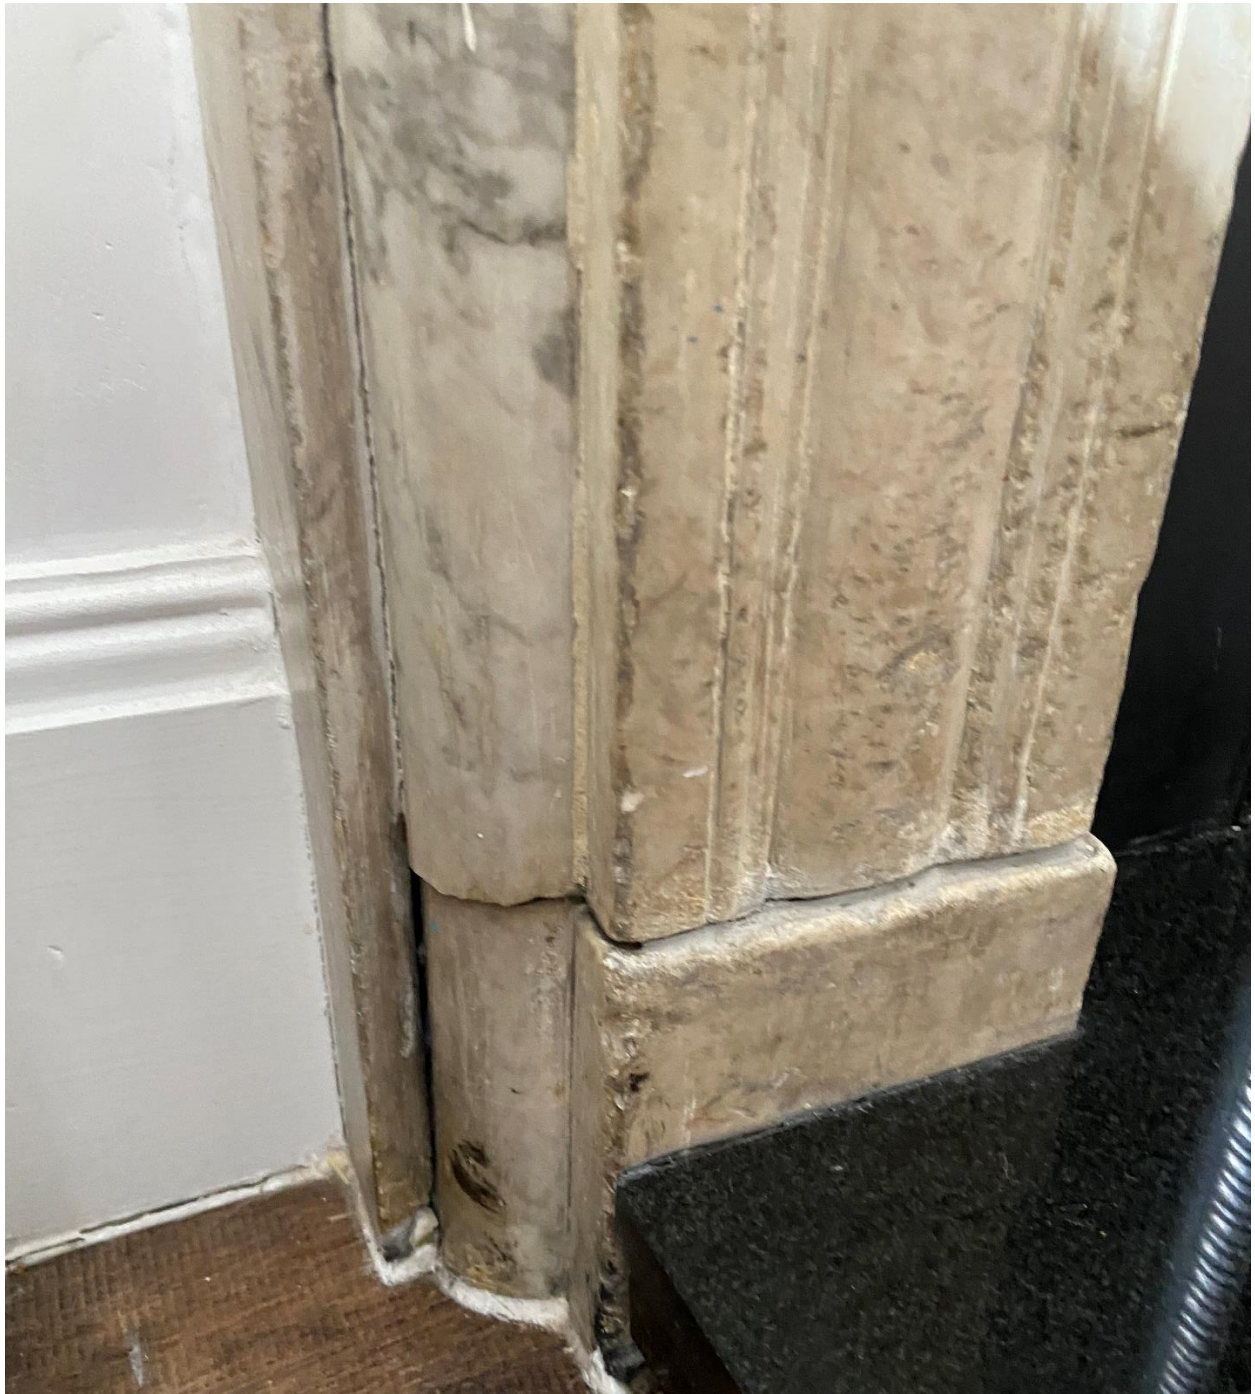
The base of the left-hand jamb showing that the plinth block has '*dropped*' and the adjacent elliptical moulding that forms part of the outground has broken as a result. This is often an indicator that the supporting brick arch within the flooring has moved or sagged. Further breaks occur further up the elliptical moulding and also in the outground return. Note the height of the recently introduced Black marble/granite raised slab. This greatly detracts from the presence of the historical feature and should be removed. Should the original historic slab be present beneath the later flooring and in good condition, this should be removed and restored, or a new marble slab installed in a veined white marble that accords with the historic chimney-piece as best possible.

We would recommend that if the original historic marble slab remains within the original flooring and can be removed and restored this should be affected, or if not a matching veined marble slab sourced and re-installed with the chimney-piece. This should extend the full width of the chimney-piece at flooring level, projecting perhaps as much as 50% of its extent. Note site visit indicates the slab projection to be broadly 52", 1321mm. The later, modern black marble slab and stove grate will need to be lifted and removed during removal of the chimney-piece, so the contractor should allow for all disconnection as required (gas/electric). The existing brick arch should be inspected for structural integrity in order that once re-installed, any structural re-enforcement that may be required has been completed so that there is adequate support for the years ahead.

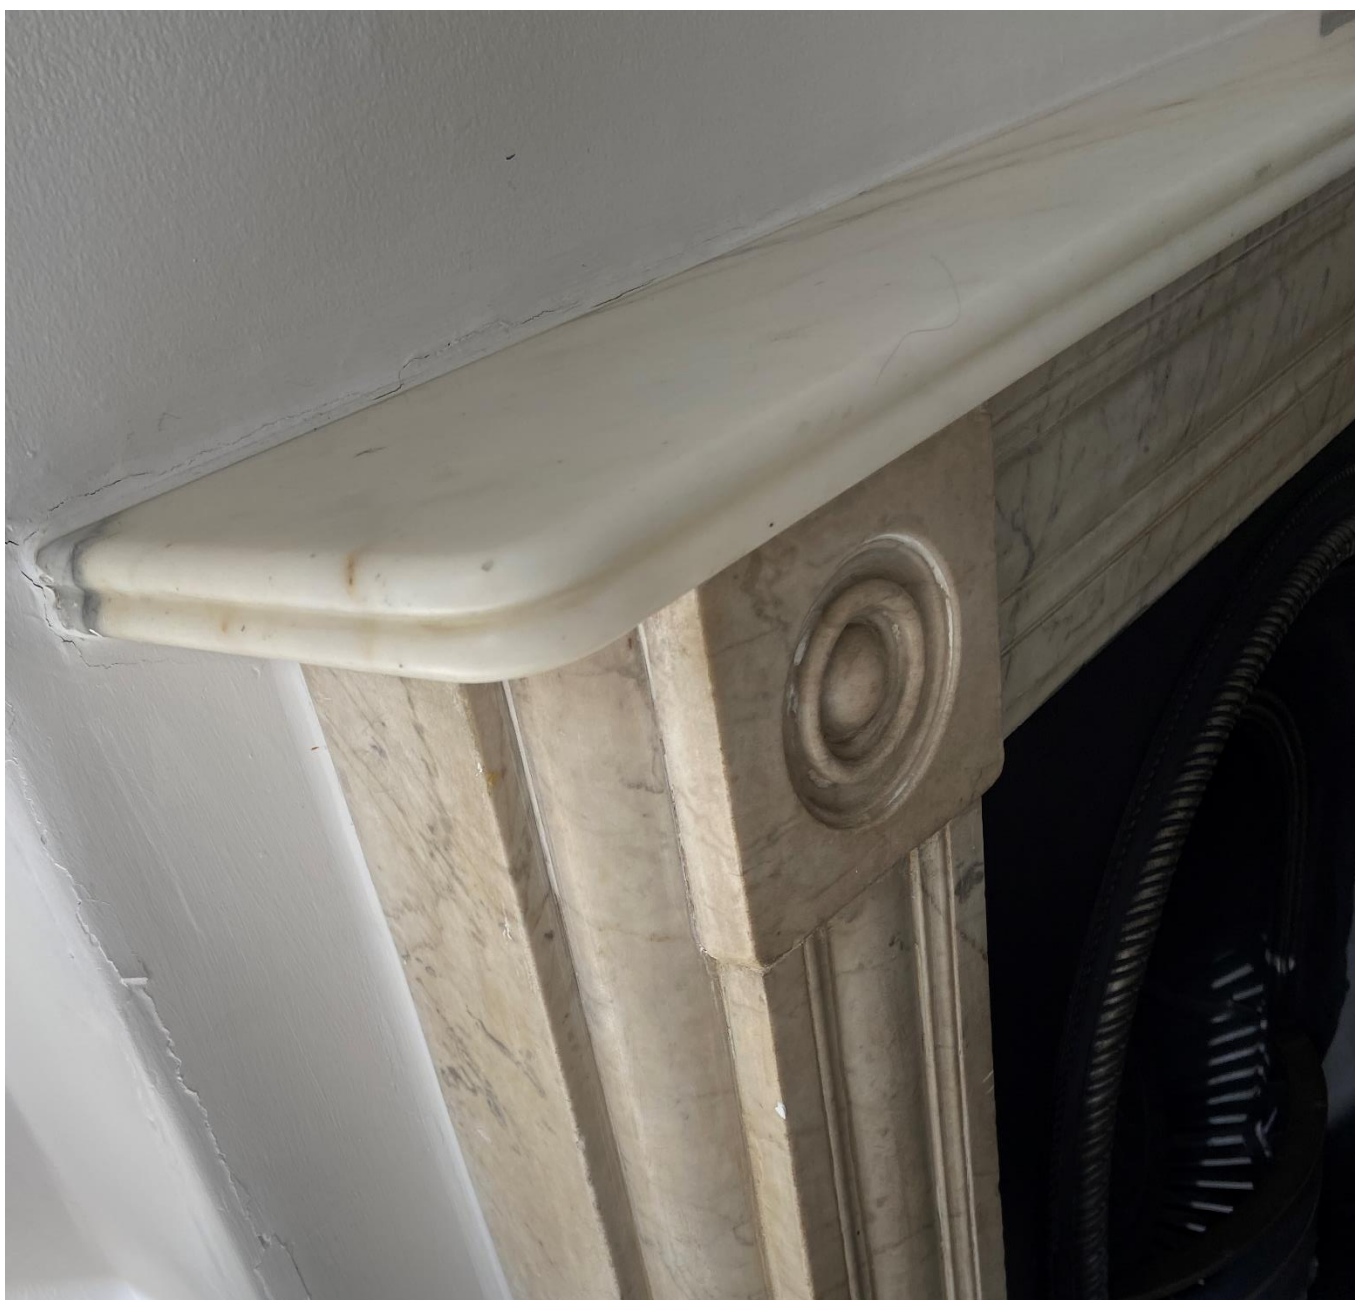
View of the top of the Cornice or shelf of the chimney-piece. This is a recent introduction, formed from a modern, white marble, which does not accord with the veined marble seen in the historic original. It is our recommendation that this is removed and replaced with a veined moulding without the profile to the outer edge, following a related design published by the early 19th century architect W.F. Pocock, with his 1811, *Modern Finishings for Rooms*
