# Arboricultural Appraisal Report

## Subsidence Damage Investigation at:

The Orchard  
Dulwich  
London  
SE21 7EW

CLIENT:	Crawford & Company
CLIENT REF:	SU2004772
MWA REF:	SUB210121-8275
MWA CONSULTANT:	Mark Johnson (FdSc; MArborA)
REPORT DATE:	03/03/2021

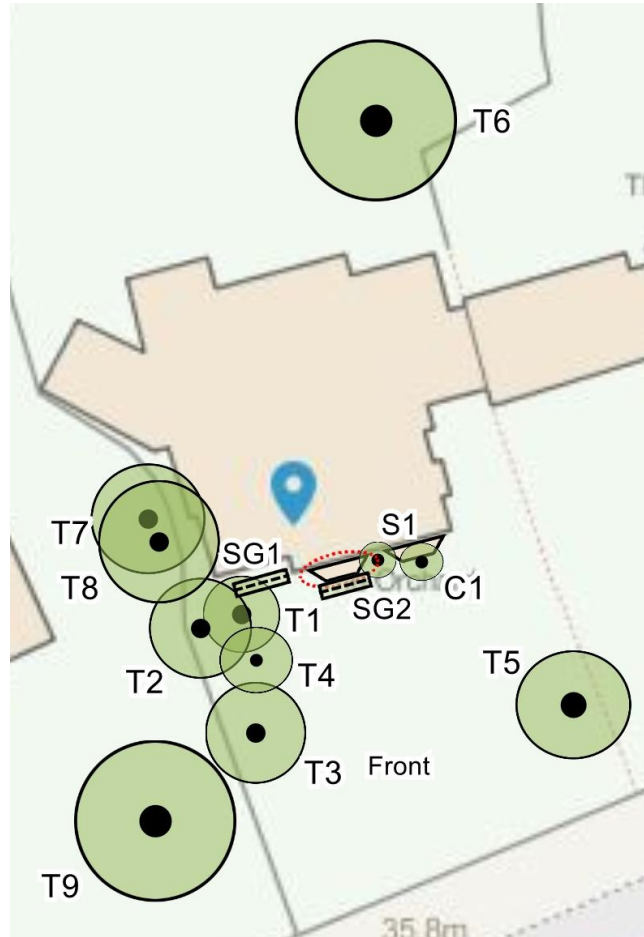
Site Plan

Our survey has identified vegetation within influencing distance of the building with a current potential to influence soil volumes below foundation level. The vegetation considered to be most significant in relation to the current damage is T1, T2, T3, S1 and SG2.

Approximate areas of damage

If an arboricultural solution is to be implemented to mitigate the influence of the trees considered to be responsible for the damage we recommend that T1, T2, T3, S1 and SG2 are removed. Other vegetation recorded presents a potential future risk to building stability and management is therefore recommended.

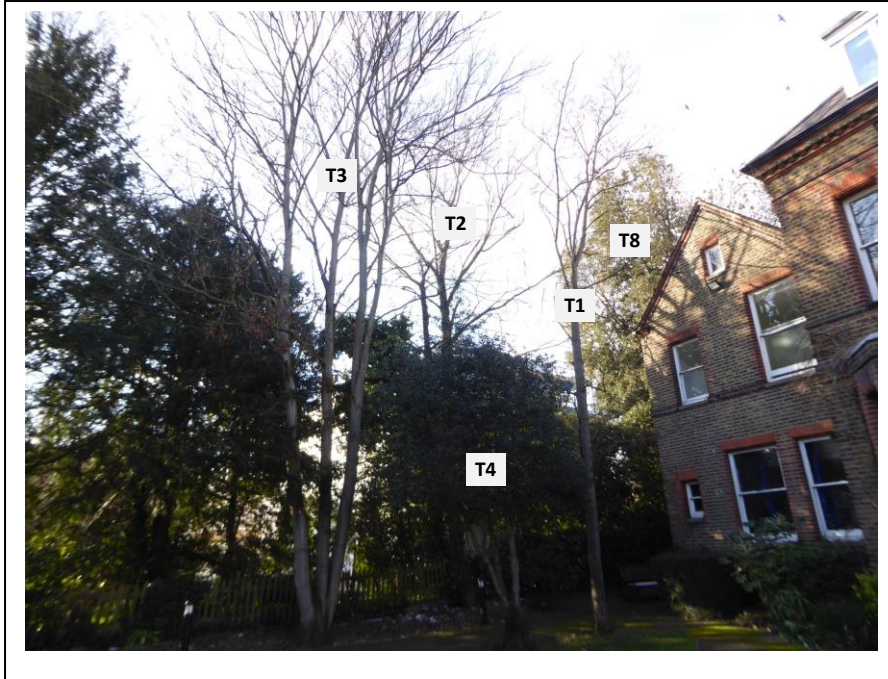
View of T3, T2, T4, T1 and T8

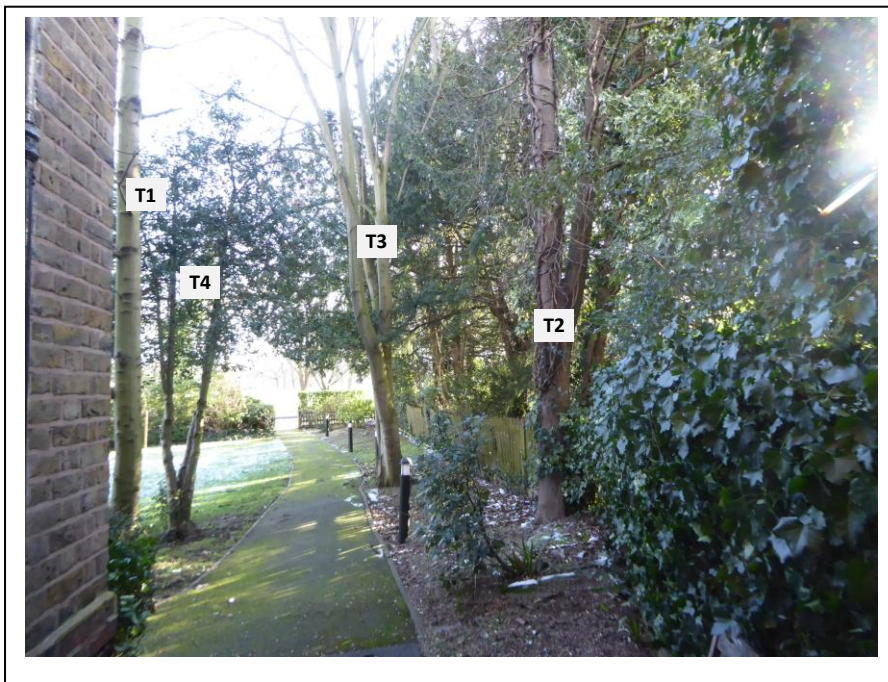
View of T1, T4, T3 and T2

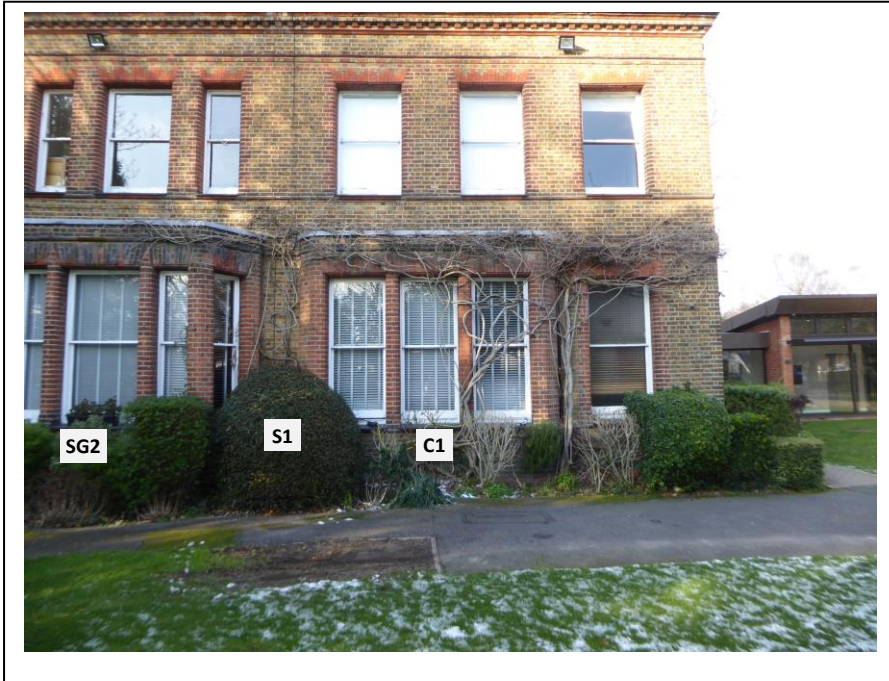
View of SG2, S1 and C1

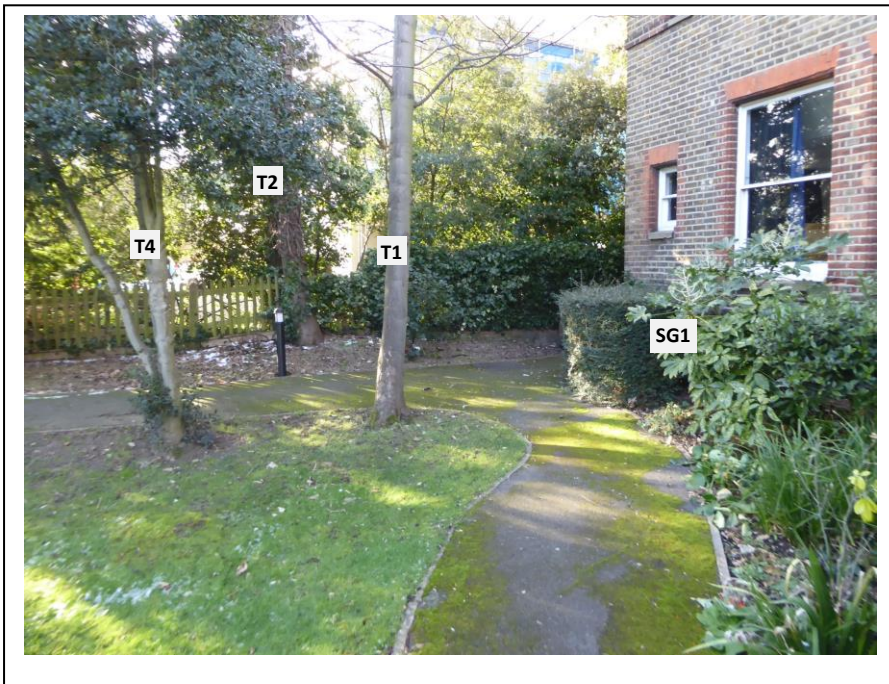
View of T4, T2, T1 and SG1
