TECHNICAL REPORT ON A SUBSIDENCE CLAIM

Crawford Reference: SU2004772

**Dulwich College
The Orchard
Dulwich
London
SE21 7EW**

SUBSIDENCE CLAIM

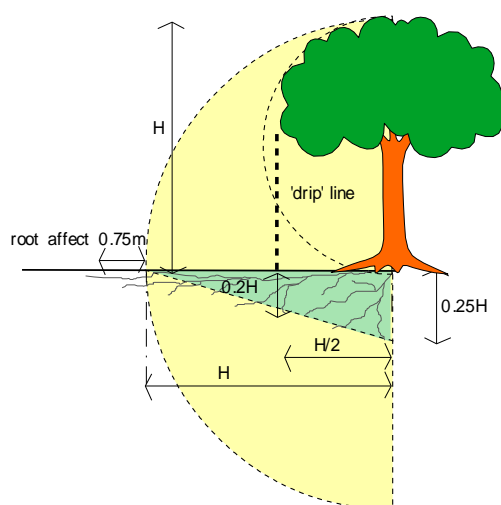
Type	Height	Distance	Ownership
Sycamore	10 m	4 m	Owners
Sycamore	13 m	9 m	Owners
Holly	5 m	5 m	Owners
Oak	12 m	20 m	Owners

See sketch. Tree roots can be troublesome in cohesive (clay) soils because they can induce volumetric change. They are rarely troublesome in non-cohesive soils (sands and gravels etc.) other than when they enter drains, in which case blockages can ensue.

The cause of the movement needs to be dealt with first. We have completed a Soil Risk Analysis (VISCAT Assessment) and we are satisfied that your sycamore trees can be removed.

We will obtain a quotation for the recommended tree works and undertake statutory checks for Preservation Orders or whether the trees are in a Conservation Area.

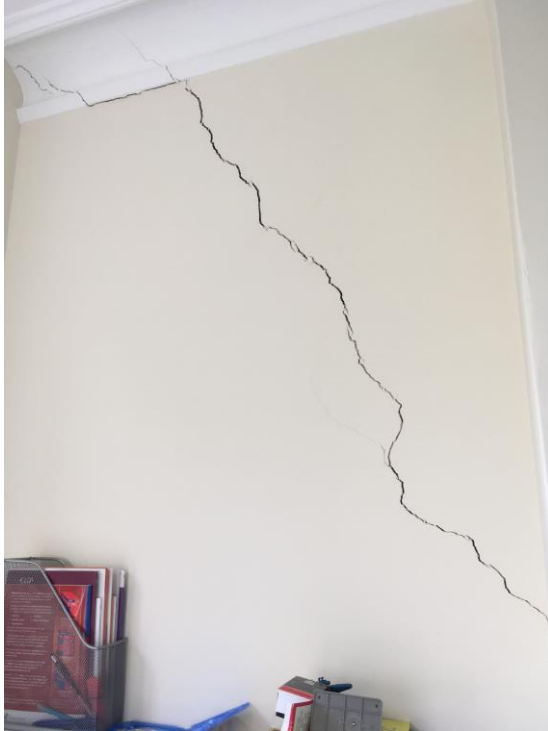
Front bedroom

Middle bedroom (FF front)

Diagonal cracking at high level to partition wall near window, extending onto cornice <5mm width.

Crack at junction of wall and window frame <2mm width.

Cracking at low level to partition wall near window <1mm width.

Cracking to ceiling generally <1mm width.

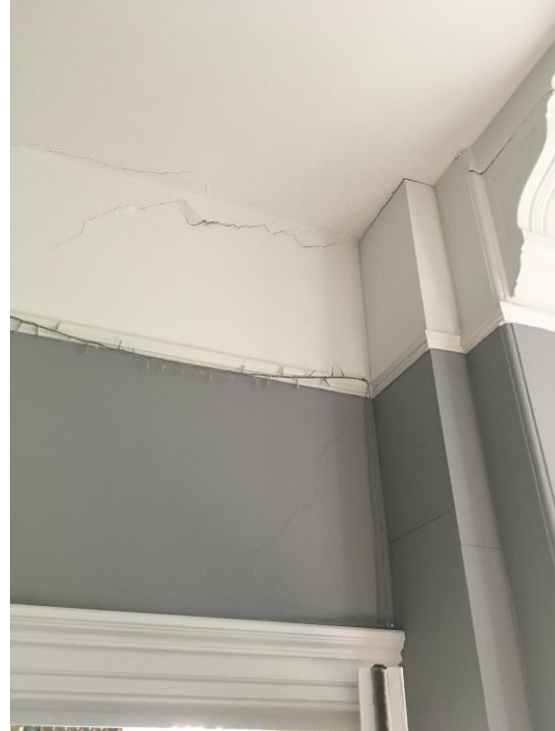
Lounge (front)

Lounge (GF front)

Cracking to ceiling across bay <1mm width.

Cracking generally to wall and ceiling above kitchen door <1mm width.

Vertical cracking to wall where bay meets front elevation <1mm width.

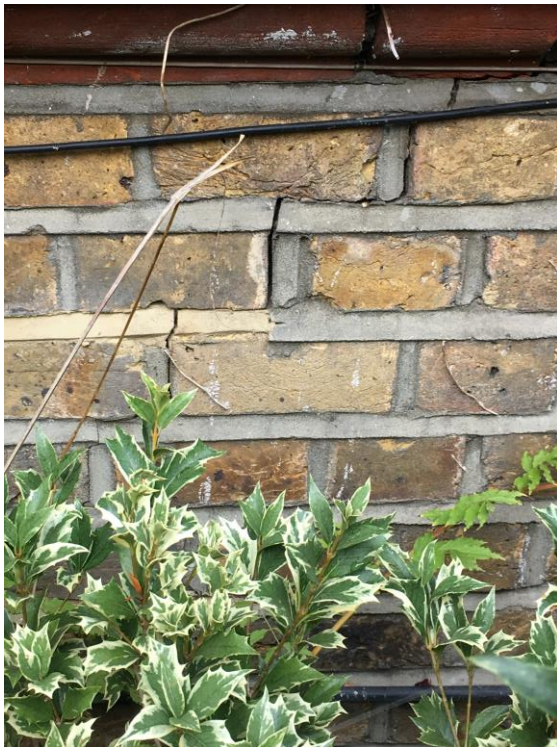
Bay brickwork

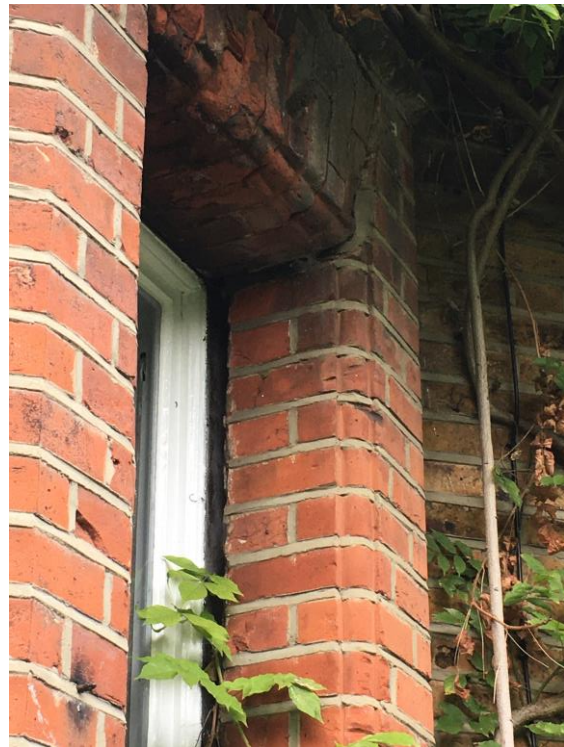
Bay brickwork

- Sloping stone cills to bay window.
- Bowing/leaning brickwork pillars to RHS of bay window.
- Missing mortar to brick arch over RHS window in bay.
- Stepped cracking to brickwork at centre of bay window <3mm width.
- Missing mortar fillets to bay window.
- Cracked brickwork top LHS of front bedroom window <4mm width.

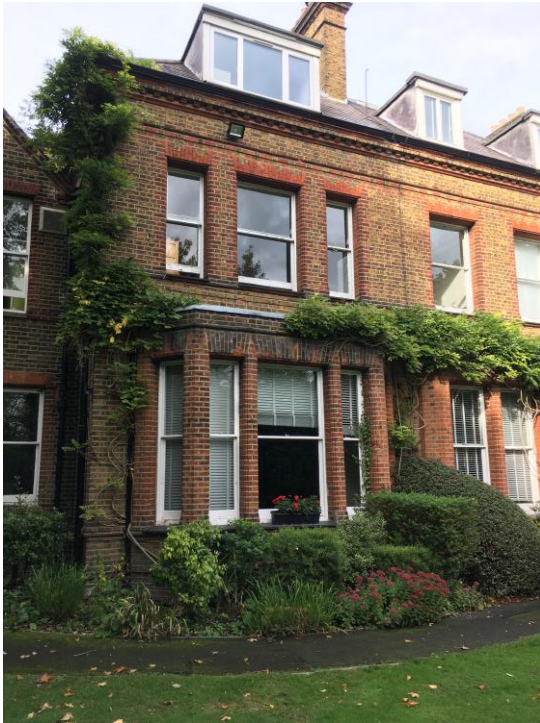
The pattern and nature of the cracks is indicative of an episode of subsidence. The cause of movement appears to be clay shrinkage.

The timing of the event, the presence of shrinkable clay beneath the foundations and the proximity of vegetation where there is damage indicates the shrinkage to be root induced. This is a commonly encountered problem and probably accounts for around 70% of subsidence claims notified to insurers.

Affected front bay structure

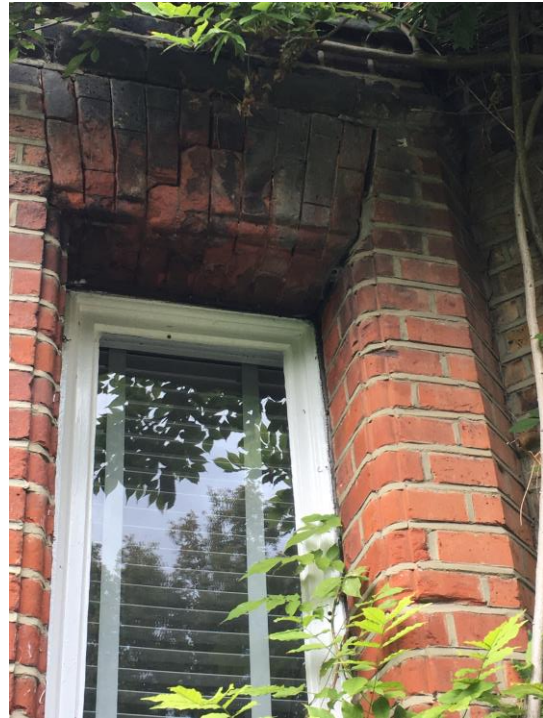
Missing mortar to brick arch

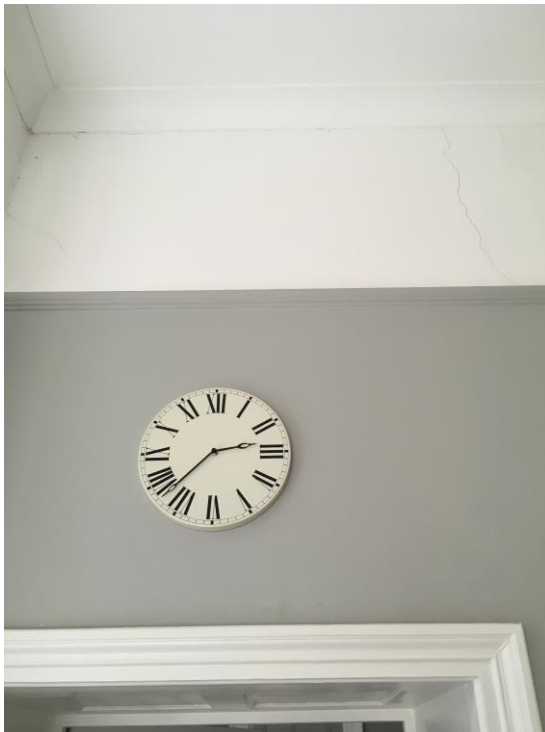
Cracking along top of windows <2mm width.

Cracking generally to wall above lounge door, extending onto cornice <1mm width.

Kitchen (lounge doorway)
