Structural Appraisal

Stubbins House
Stubbins Lane
Catteral

Date: 17th May 2017

Reference: 3079-17

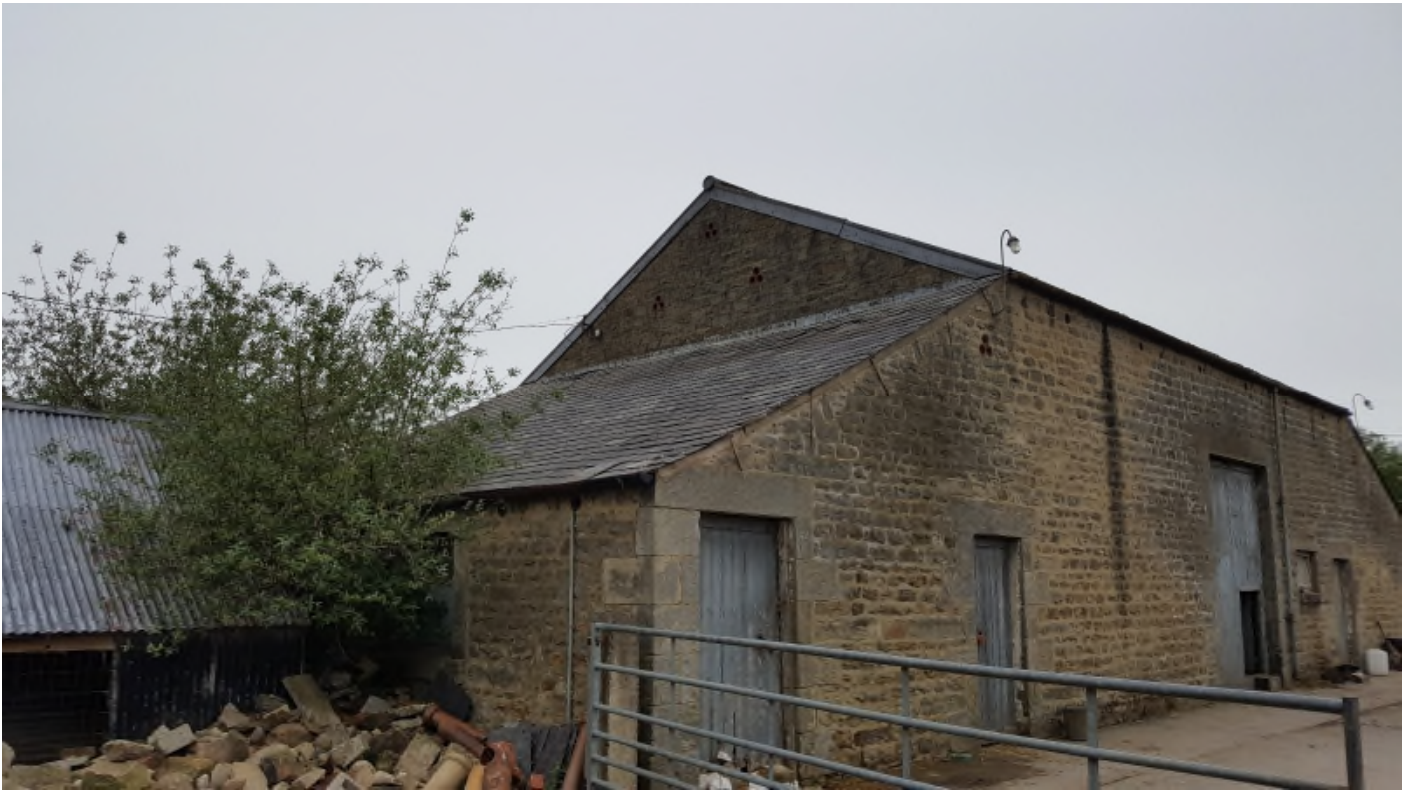
Elevation - Wall 1

We note minor loss of vertical alignment to the left hand side of the large barn door opening, due to past movement of the foundations. The movement is not excessive and there are no visual signs to indicate any recent movement.

Overall the wall has satisfactory vertical alignment and is in a sound structural condition.

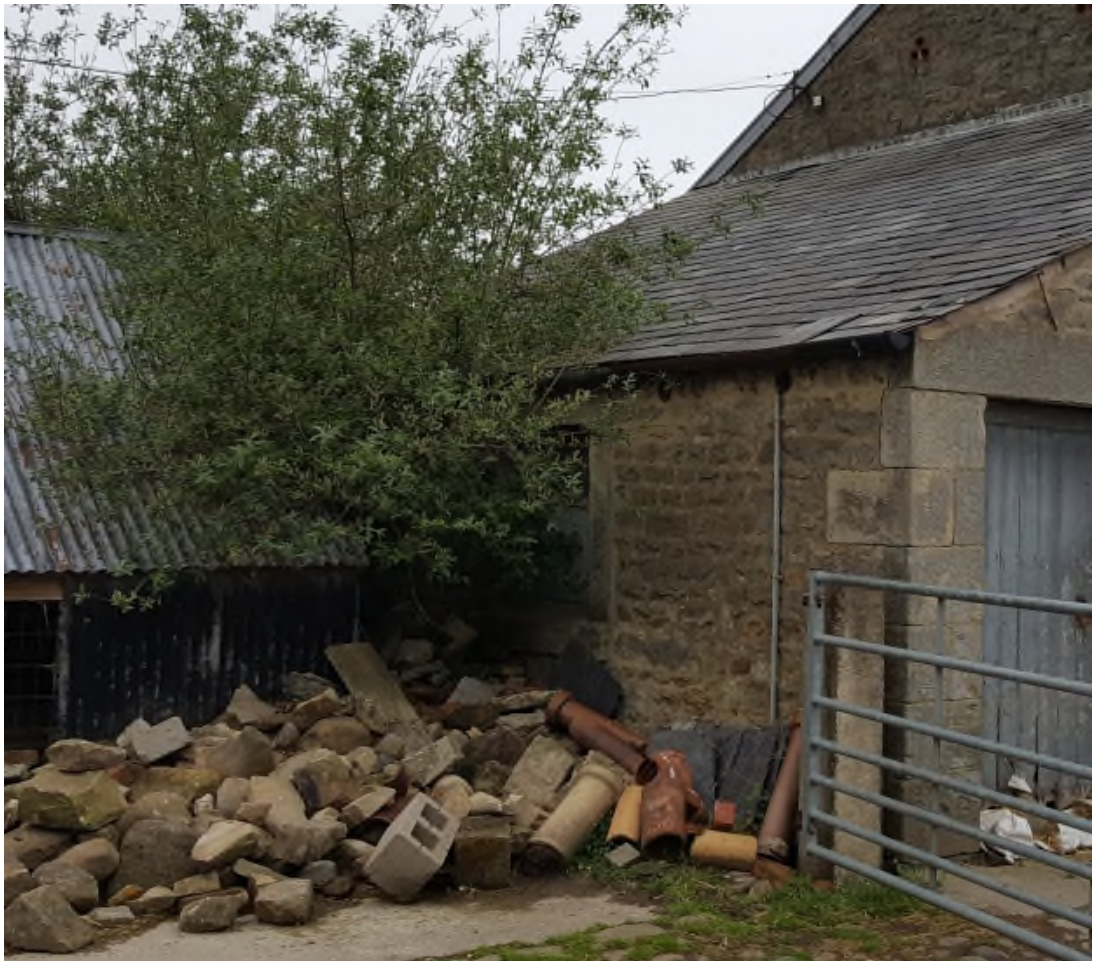
Elevation – Wall 2

The East side stone window surround and the immediately surrounding stonework has suffered from outward movement, particularly noticeable at eaves height and caused from past roof spread.

We note minor cracking to the right hand side corner of the wall, consistent with past differential settlement of the foundations. The cracking is not excessive and there are no visual signs to indicate any recent movement.

The minor cracks to the right hand side of Wall 2 should be raked out with a mechanical grinder, wedged and packed with cementitious mortar and repointed.

The window and small section of surrounding stonework to Wall 2 has suffered from outward movement in the past. We would therefore recommend that this section of wall is taken down and rebuilt to correct alignment.

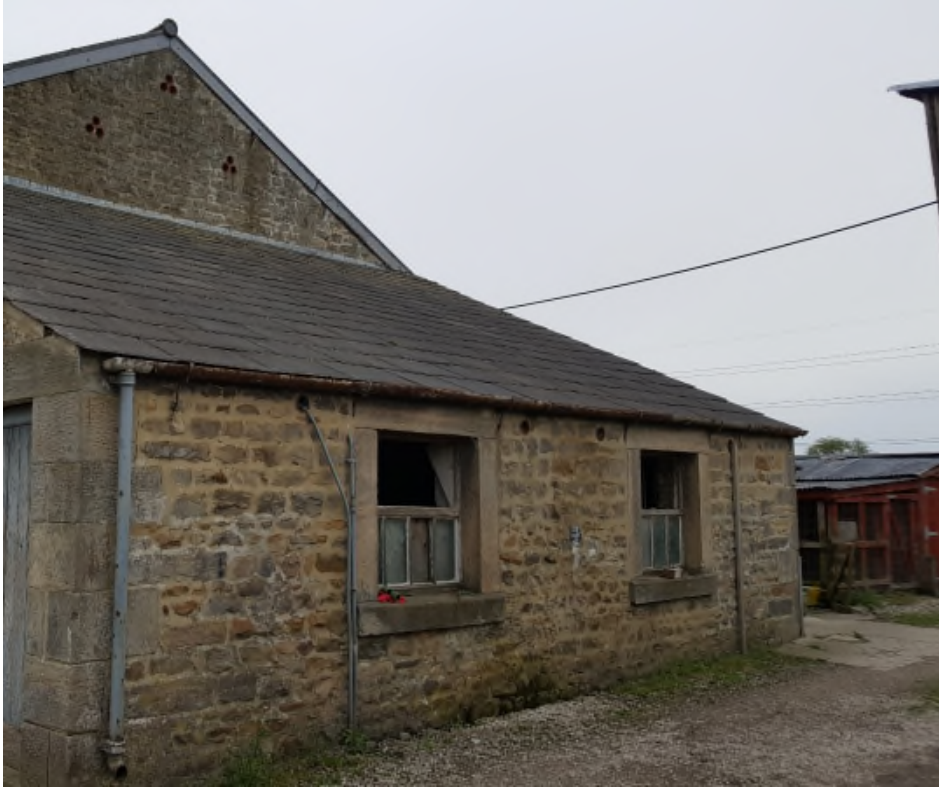
Elevation – Wall 3

We note slight loss of vertical alignment to the stone window jambs. However, the loss of alignment is not excessive and the wall overall has reasonable vertical alignment.

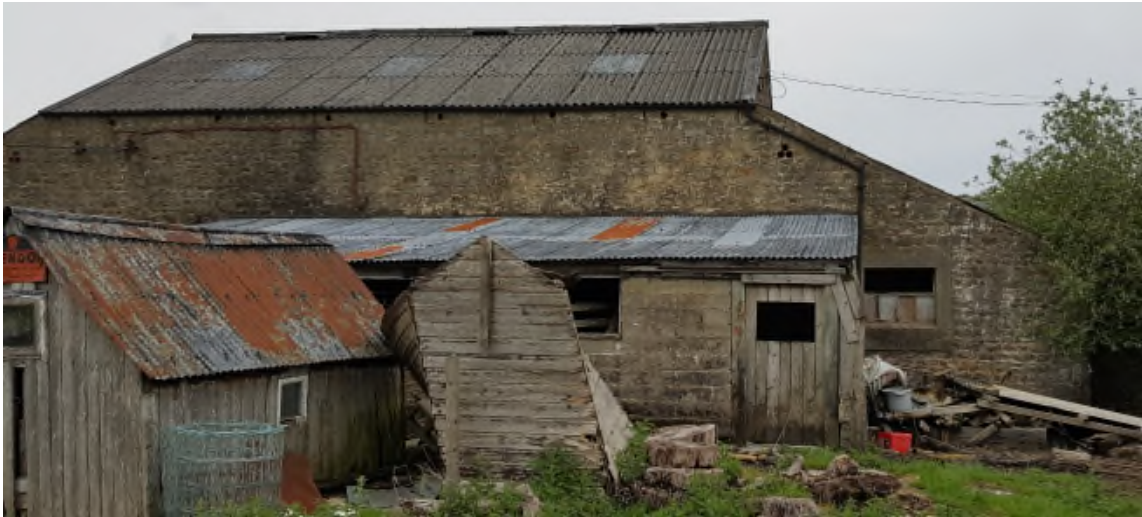
The wall has a slightly undulating vertical and horizontal profile. Although slightly undulating the wall has reasonable horizontal and vertical alignment and is in satisfactory structural condition.

Elevation – Wall 4
(Lean to block work/sheeted building omitted from this report)

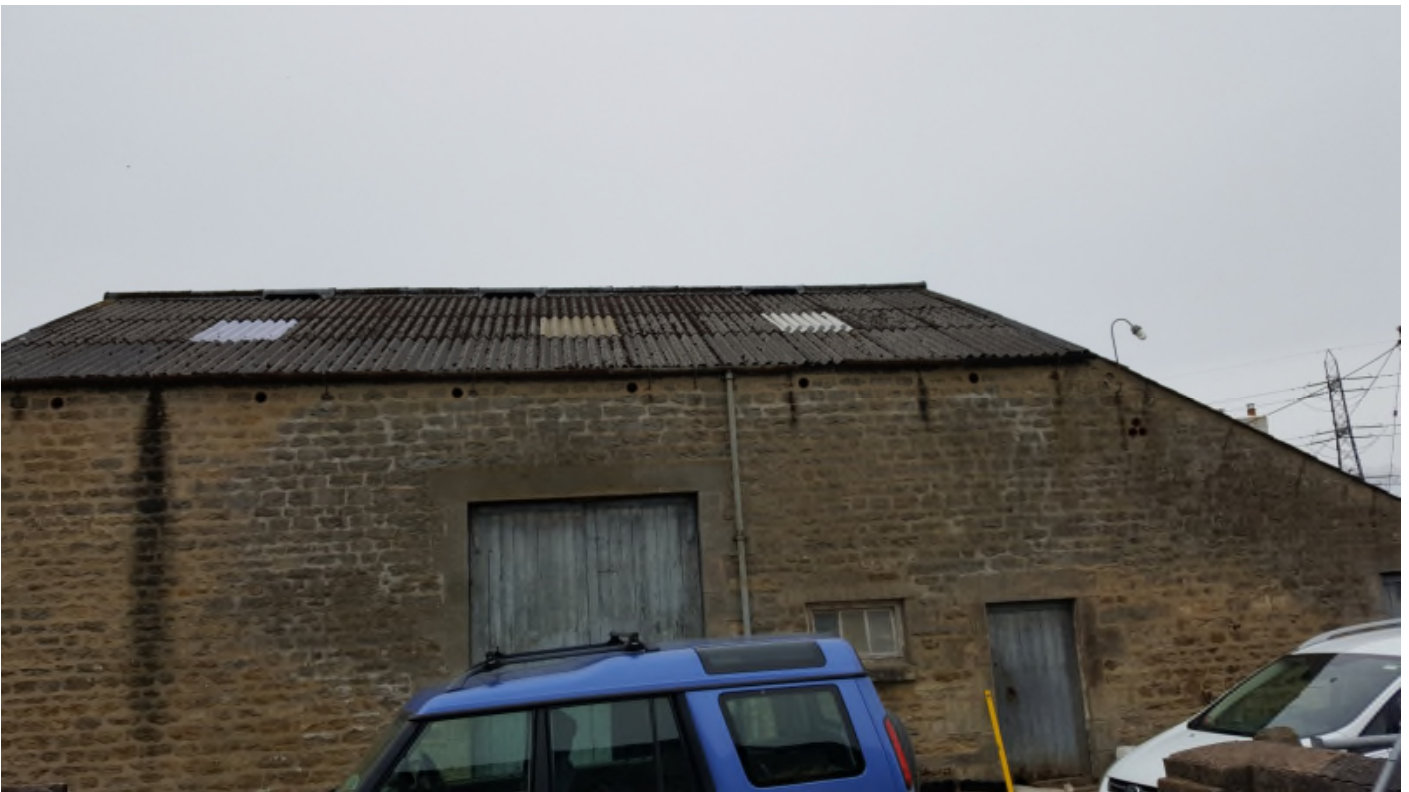
Roof profile from Wall 1

Externally when viewed from ground level the roof, although slightly undulating, has reasonable horizontal alignment.

We understand that the existing roof of the two storey section of the barn is to be taken off and replaced with new, although the kingpost trusses are being retained. We recommend that prior to removal of the roof, all the walls are stabilised with a braced scaffold to prevent the possible collapse of the walls during the alterations to the building and possible high wind conditions.

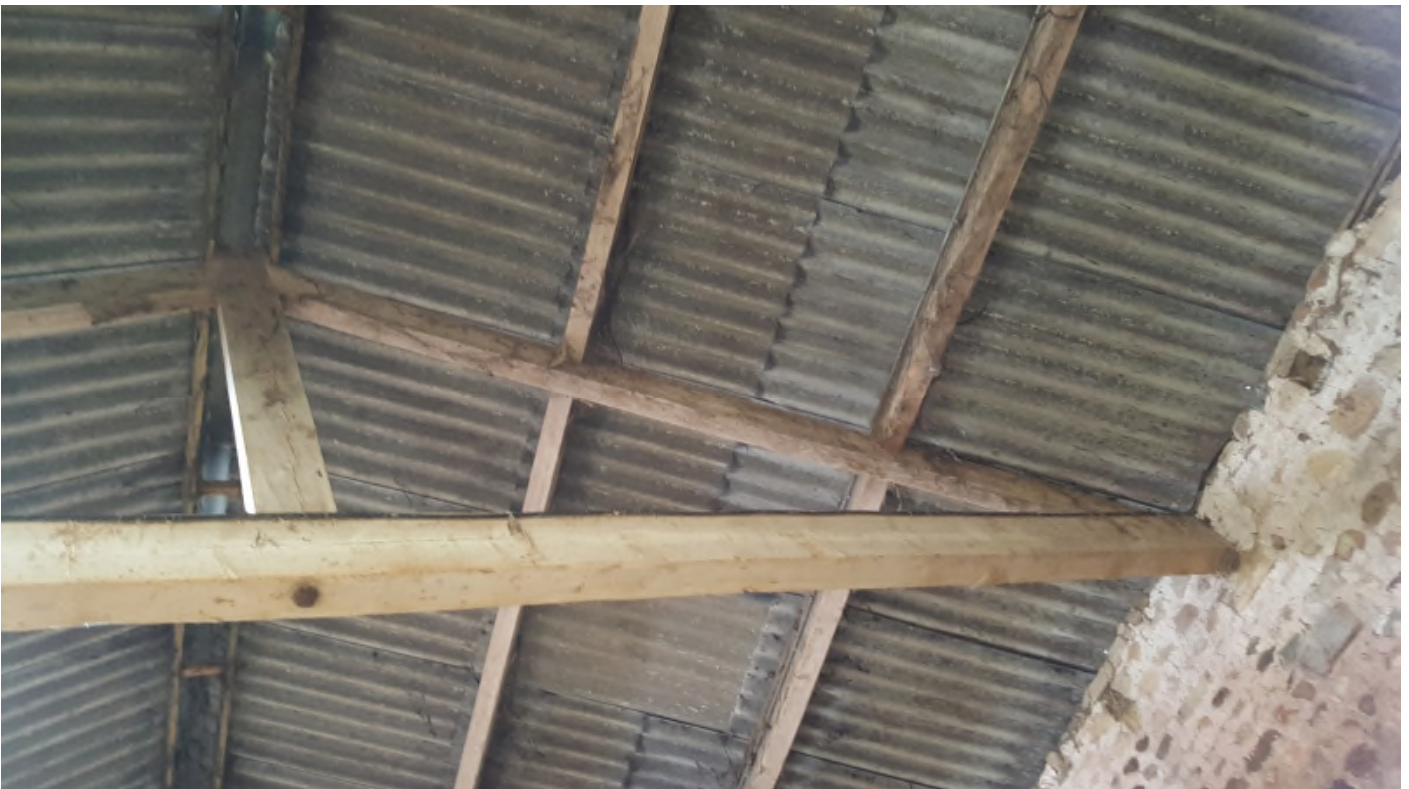
Internally the timber roof members appeared to be in satisfactory structural condition with no undue deflections noted.

Internal – two storey section – showing king post truss and sheeted roof

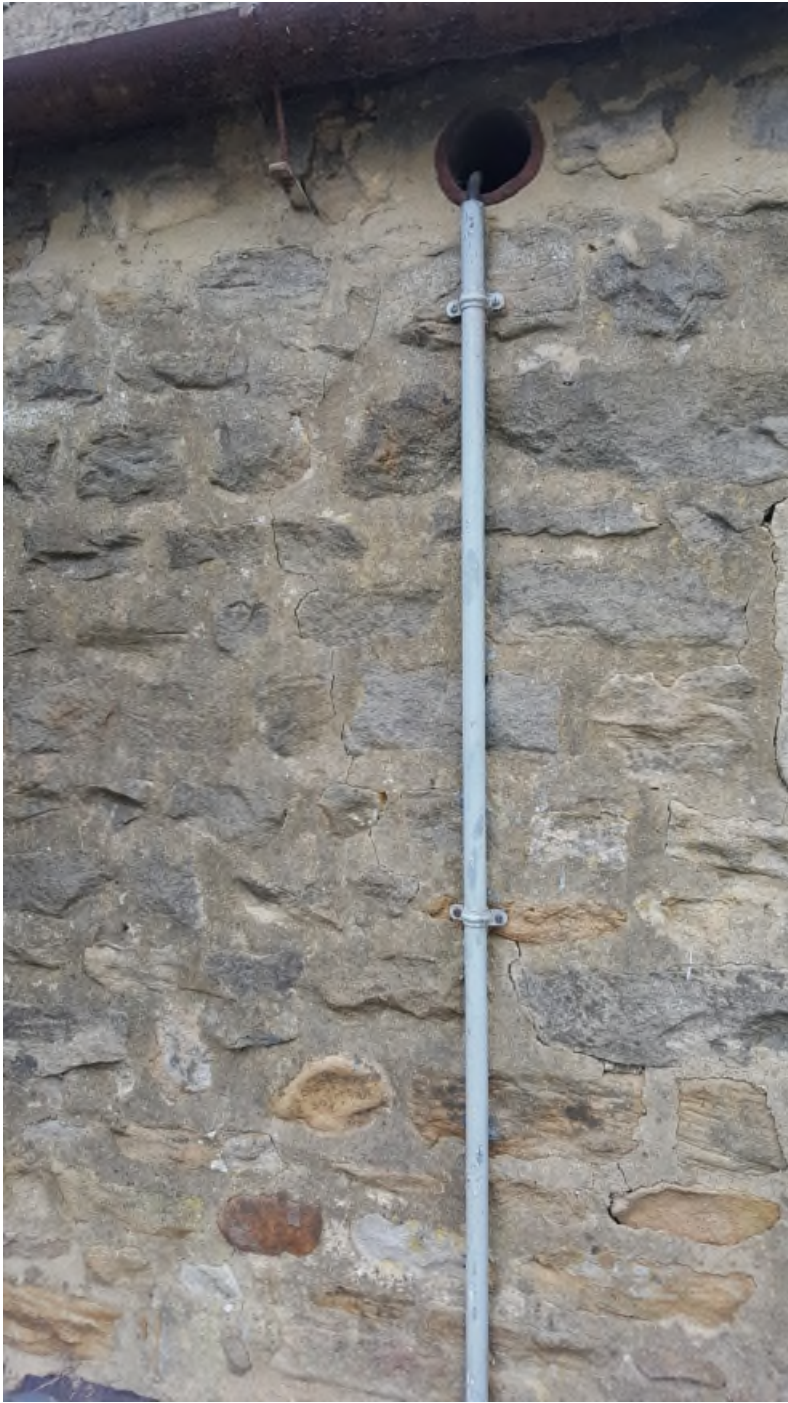
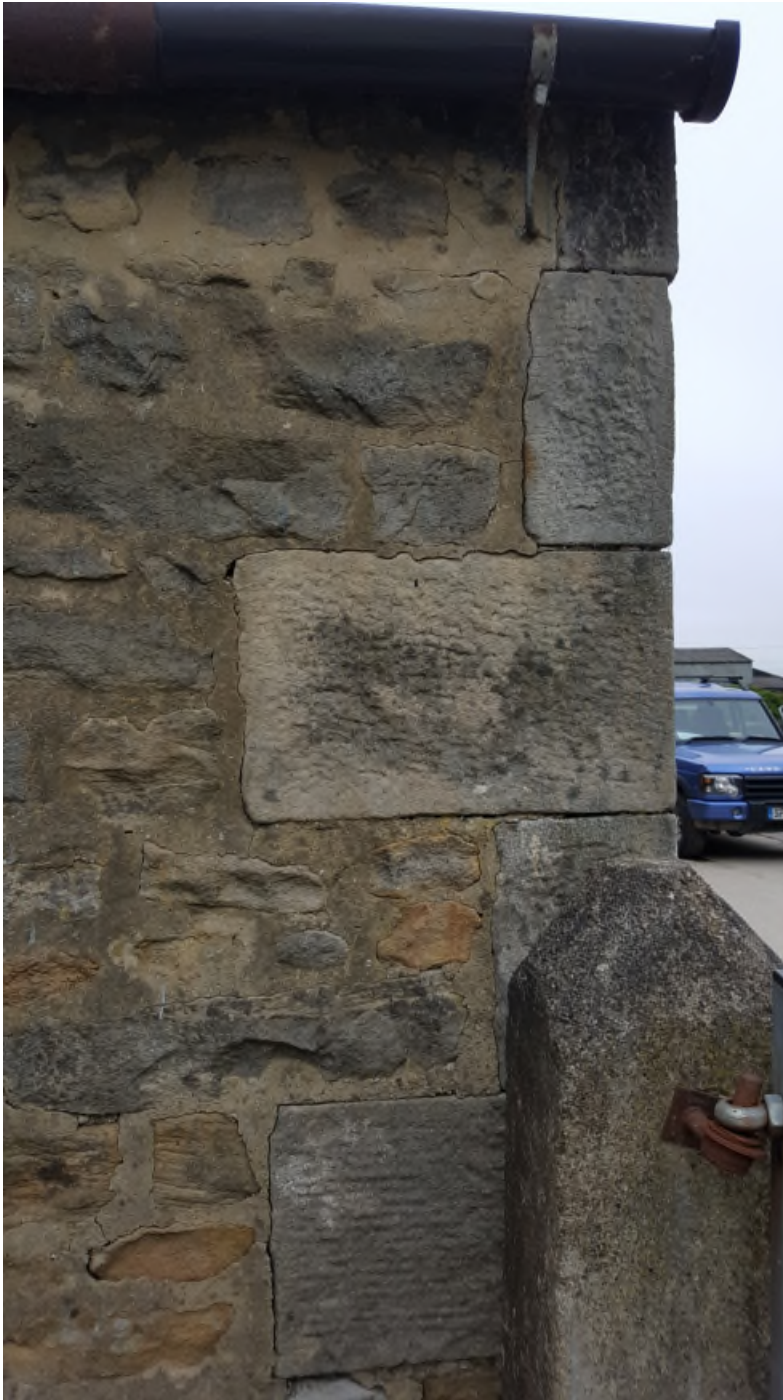
Minor cracking to right hand side – Wall 2

Minor cracking right hand side – Wall 2

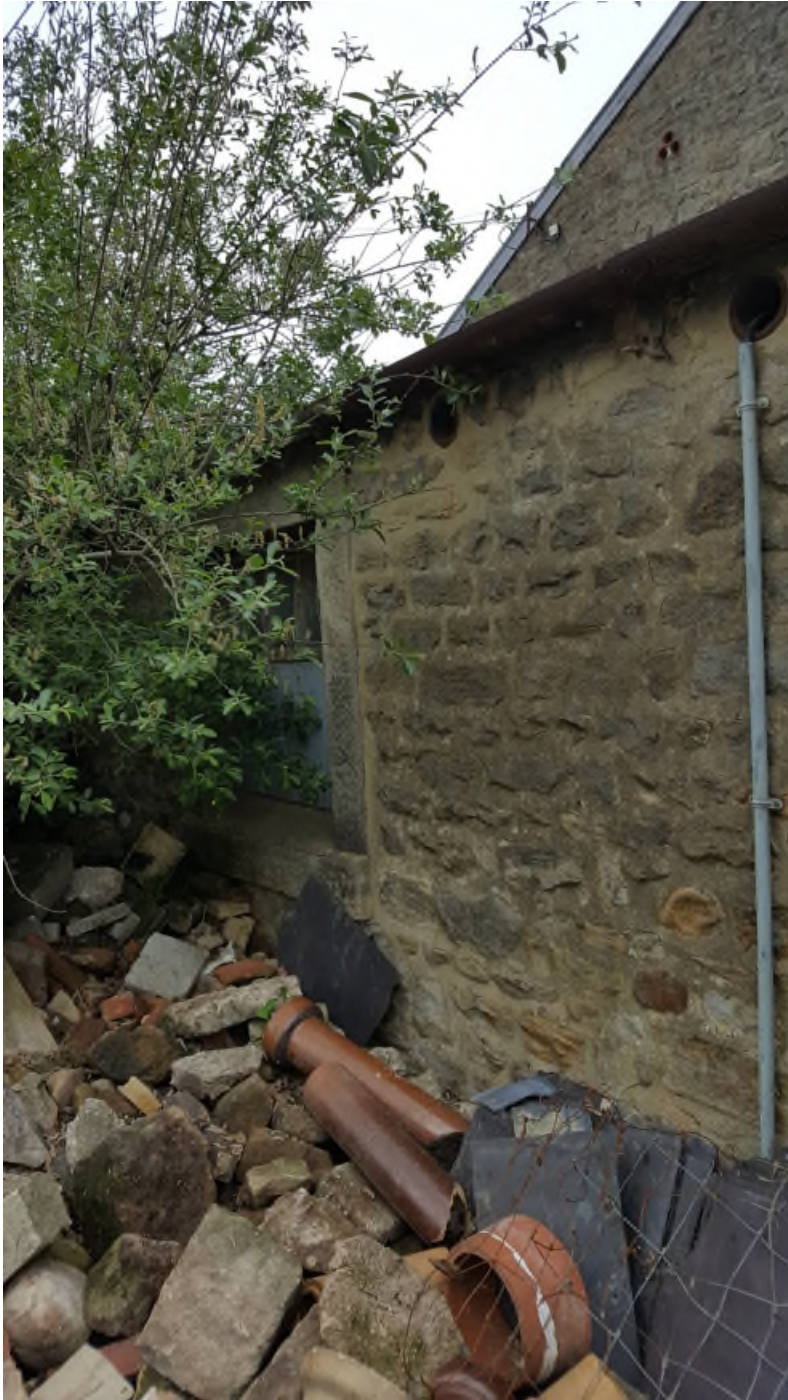
Outward movement to window and surrounding stone – Wall 2
