ARBORICULTURAL REPORT & Impact Assessment to **BS5837:2012 at:**

Land at
Priory Farm,
Retford,
South Leverton,
DN22 0BY.

Prepared for:
Artreum Ltd

Reference: AWA 3731

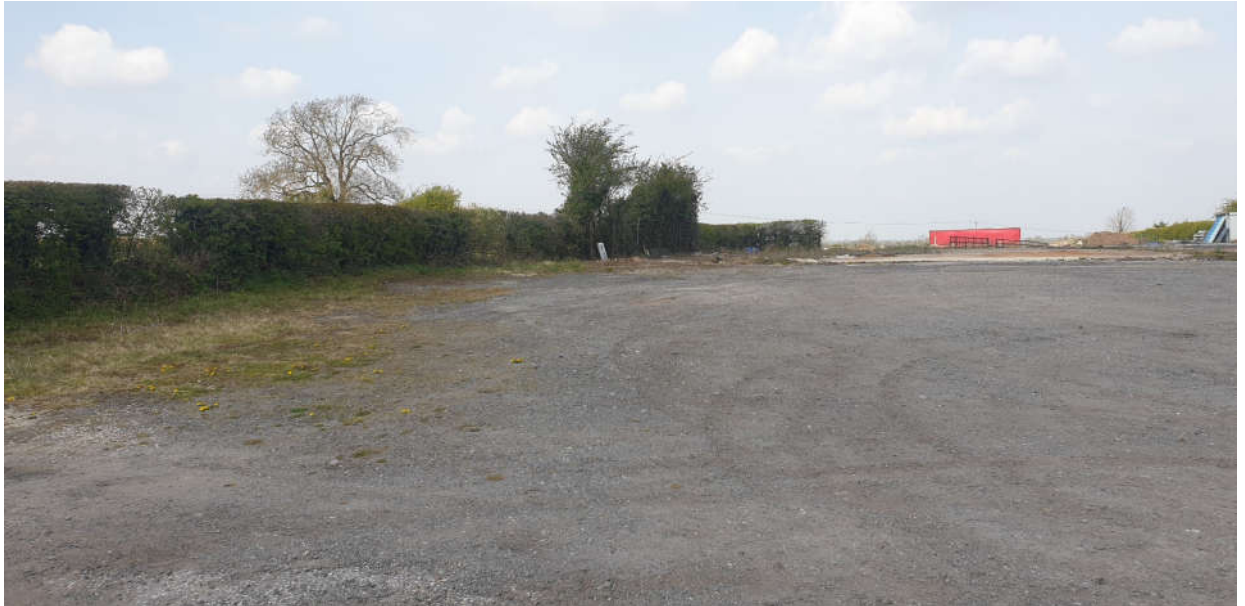
- 3.2.8 The hedgerow on the western boundary is comprised predominantly of Hawthorn with occasional Elder and Hazel (G6). Historically, the hedge has been well managed through regular flailing, with a central section that appears less managed and more naturalistic. Whilst only of low arboricultural value, the hedge is in keeping with the surrounding landscape character, provide ecological value to the site and have the potential to provide screening to any development at the site.

Photo 1: G6, Looking North West.

4.2.2 The northern section of hedge (G6) will need to be removed from the curtilage of property 3 in order to facilitate the development requirements. The remaining hedge is to be pruned back from the east. It will likely tolerate this work and if the remaining hedge is well managed it will provide good future amenity value for the planned development.

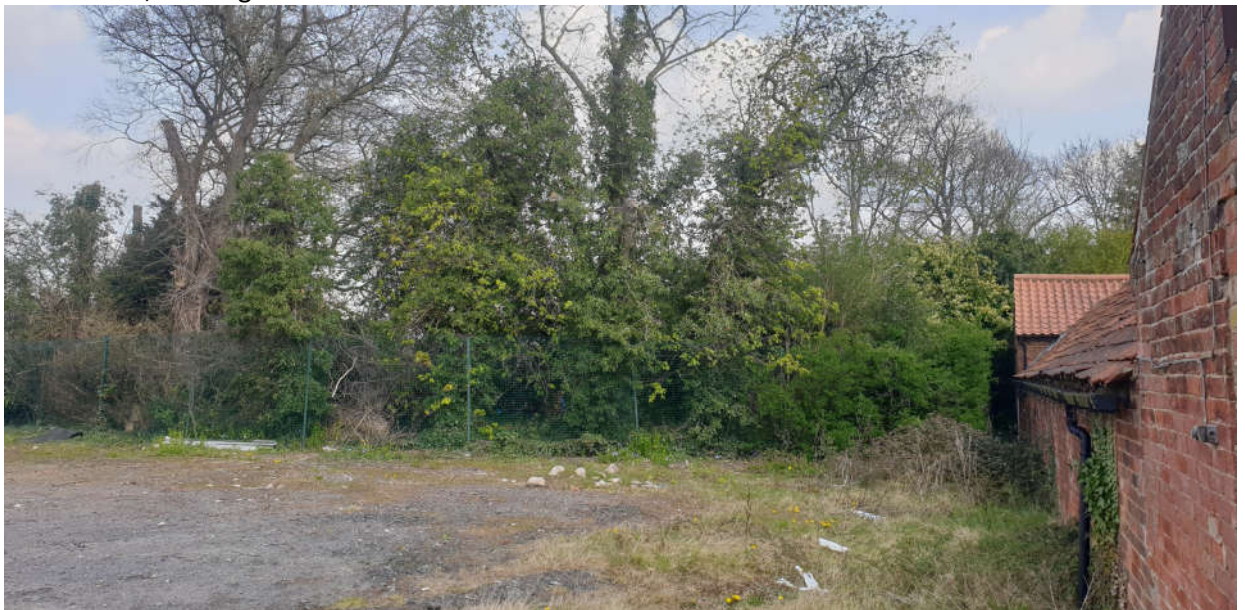
- 3.2.6 The trees T1 to T4 have all been heavily pruned, removing most of the Western canopy near to the boundary fence. This work has resulted in large

pruning wounds and stubs. The work has reduced the value and long-term prospects of the trees; however, collectively the group still provides reasonable visual amenity.

- 3.2.7 Within this group there are two very heavily pruned - or topped – trees that have been reduced to standing monoliths (as detailed on the attached tree plans). Future management options for these trees includes removal or management as standing deadwood monoliths/eco poles.

Photo 2: T1 to T4, Looking East

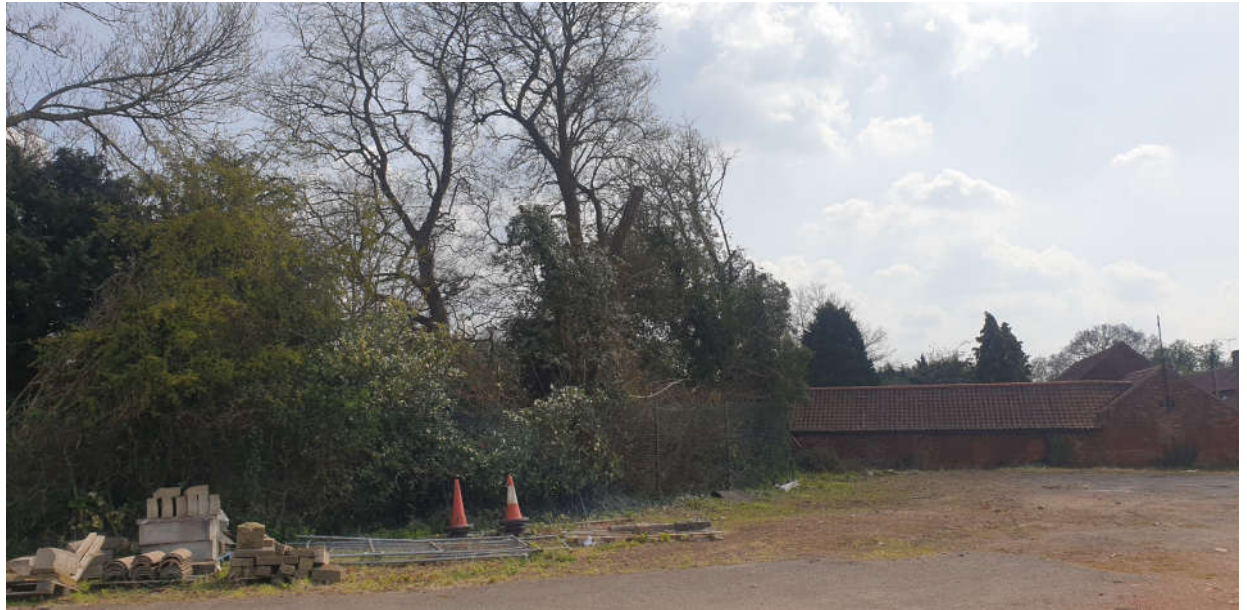
Photo 3: T1 to T4, Looking South

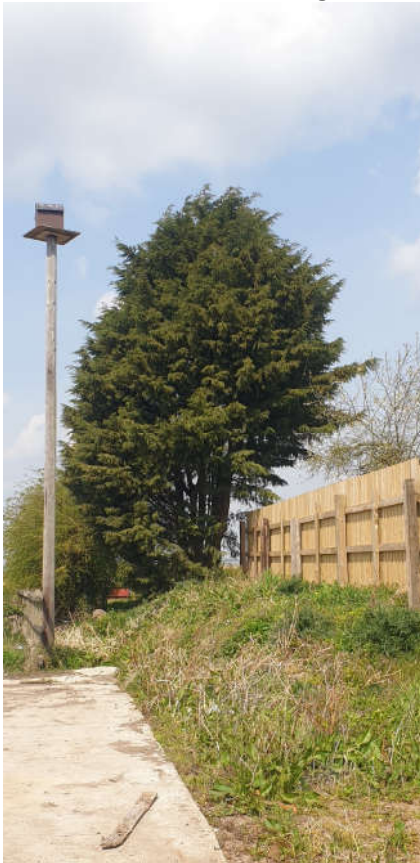
- 3.2.9 An early mature multi stemmed conifer (T5) is situated just outside of the north boundary of the site. This tree is not note-worthy, yet it forms a useful visual screen to the nearby power station.

Photo 4, T5, Looking North

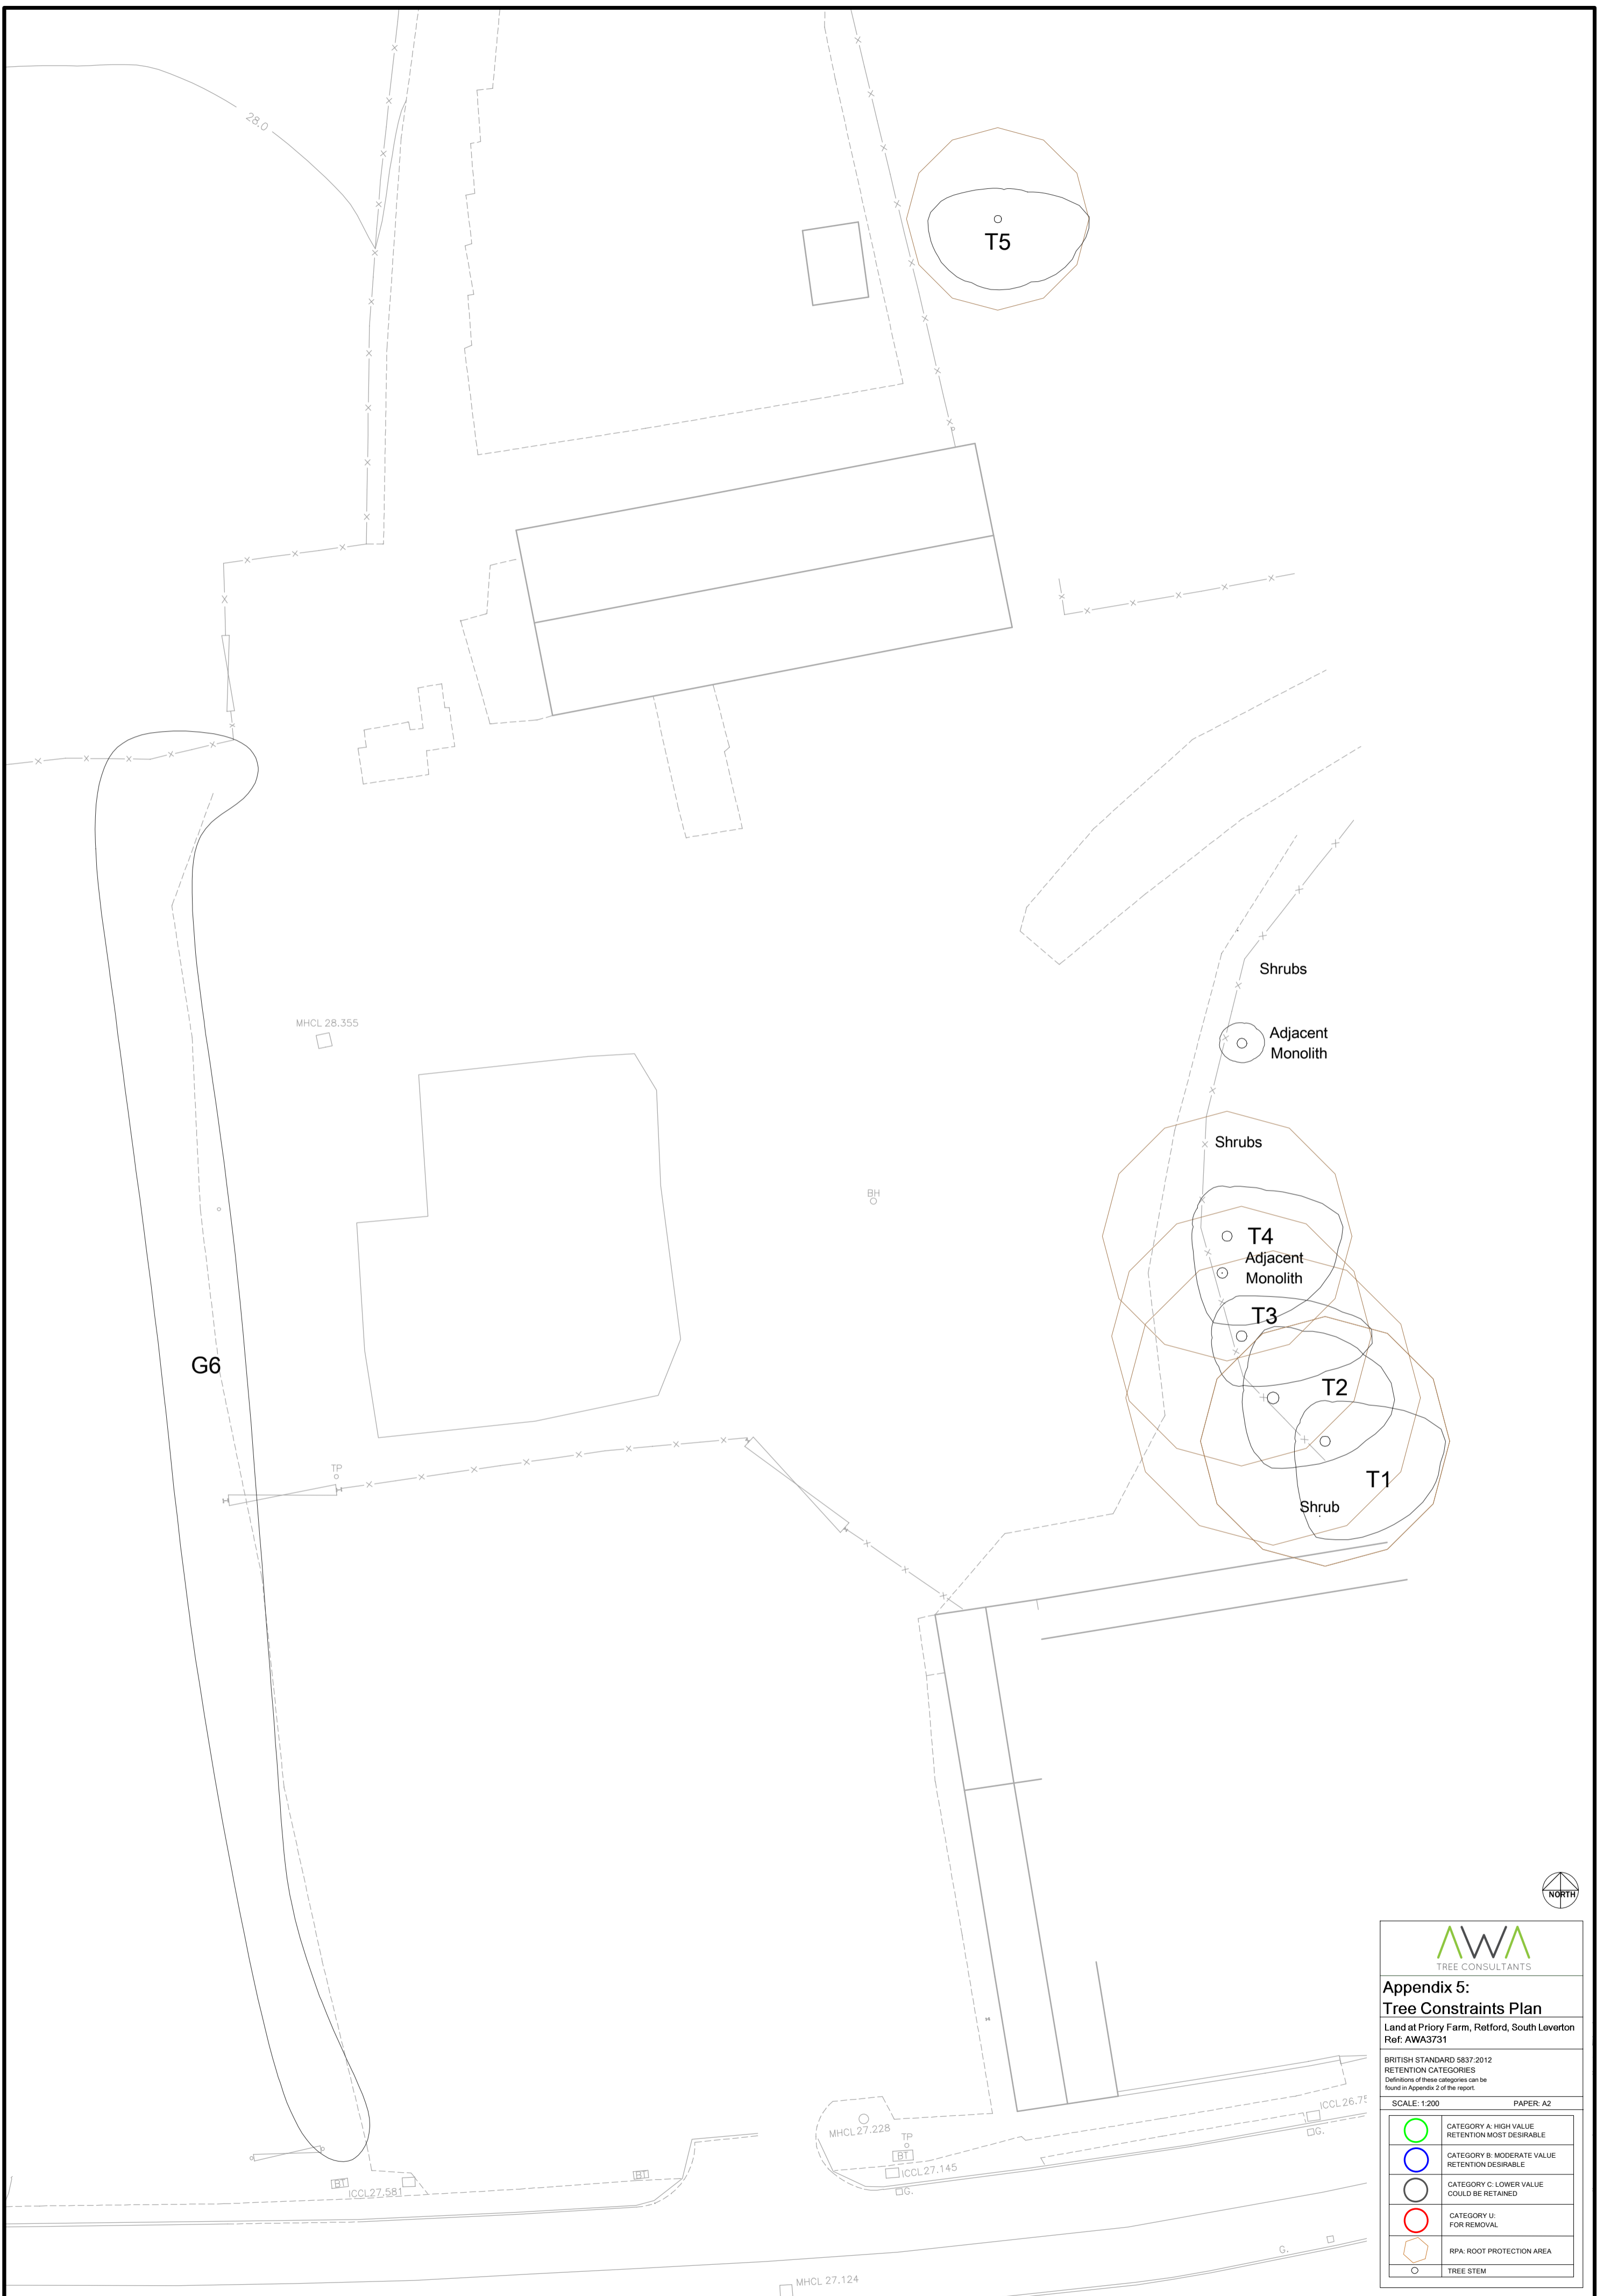
Appendix 5:
Tree Constraints Plan
 Land at Priory Farm, Retford, South Leventon
 Ref: AWA3731

- 3.2.11 The tree Root Protection Area (RPA) detailed on the Tree Constraints Plan at Appendix 5 has been used as a layout design tool, to inform on the area around a tree where the protection of the roots and soil structure is treated as a priority.

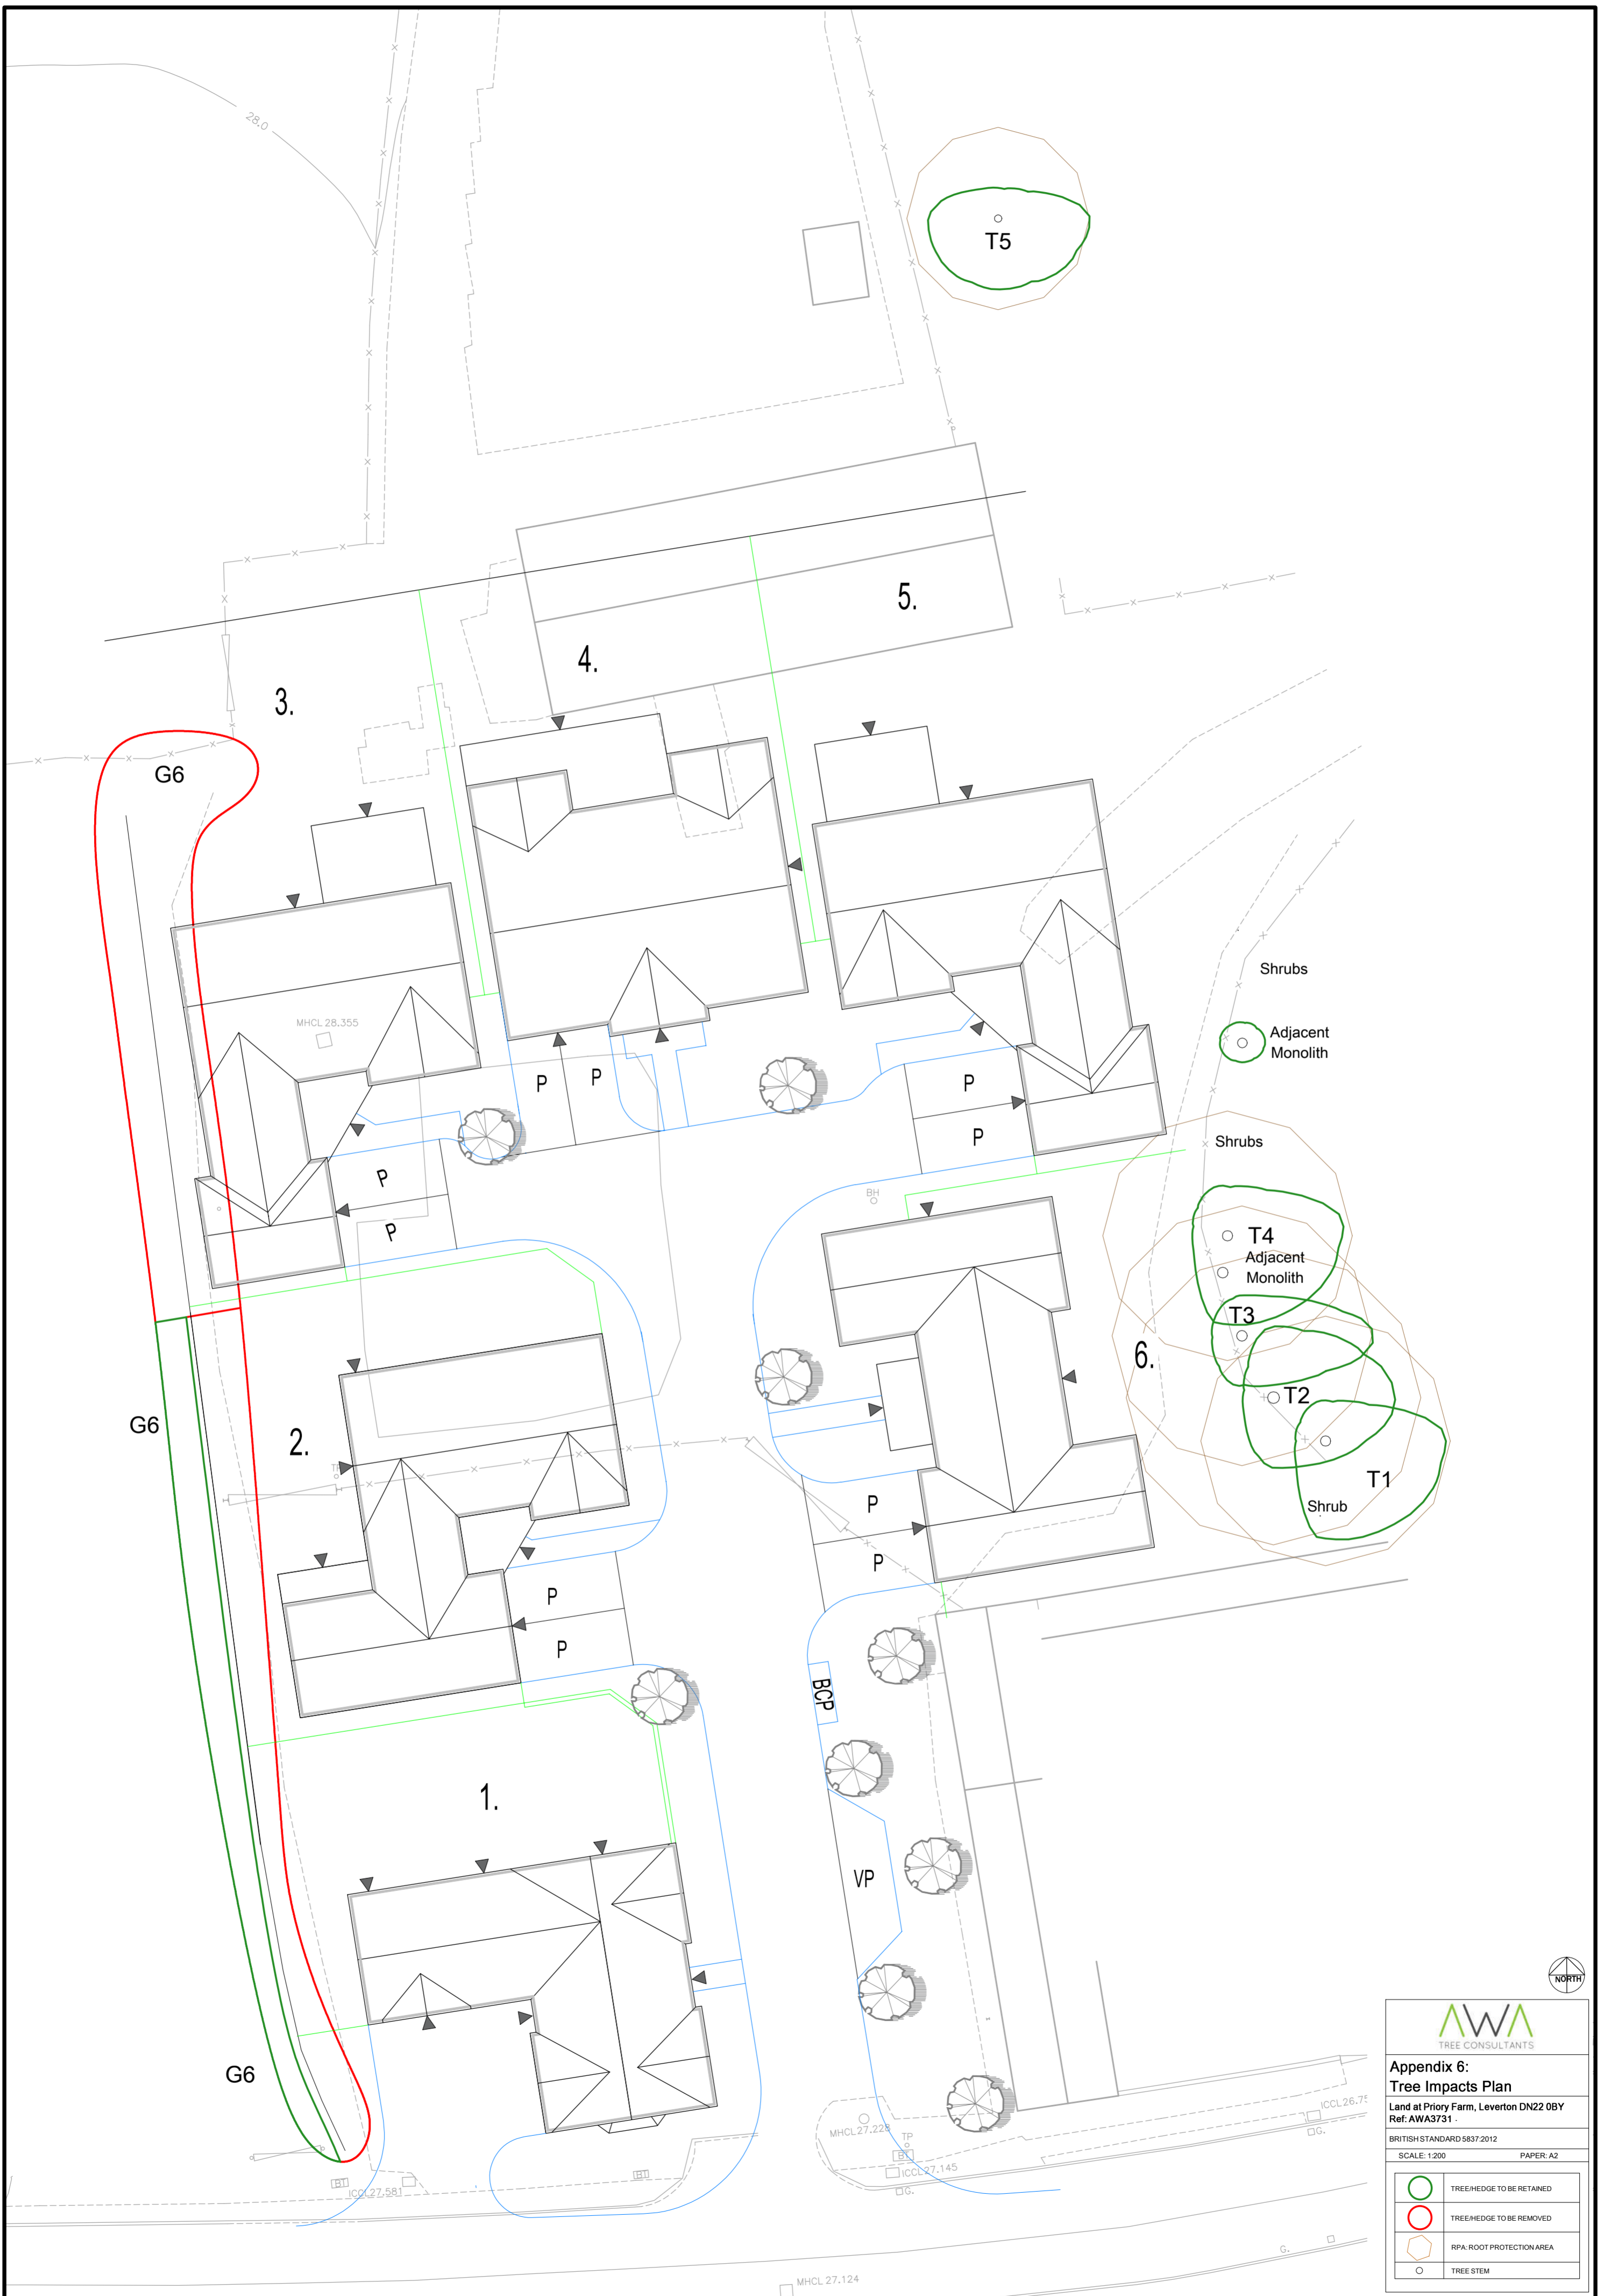
Appendix 6:
Tree Impacts Plan
Land at Priory Farm, Leverton DN22 0BY
Ref: AWA3731

4.3.2 Potentially damaging activities are proposed in the vicinity of retained trees. A proposed new residential property encroaches close to the RPA of retained adjacent tree, T4. Construction within the RPA, can have negative impacts on tree roots. However, the retained tree should remain largely unaffected by the works, provided care is taken during construction.

4.4.1 The retained trees will require protection by fencing in accordance with BS 5837: 2012, during the development phase.
