# Principal Staircase Report

## S.1 Structural Condition Appraisal

Curtins Ref: B077572-CUR-ZZ-ZZ-RP-S-00003

Site Address: Cuerden Hall, Shady Ln, Bamber Bridge, Preston PR5 6AZ

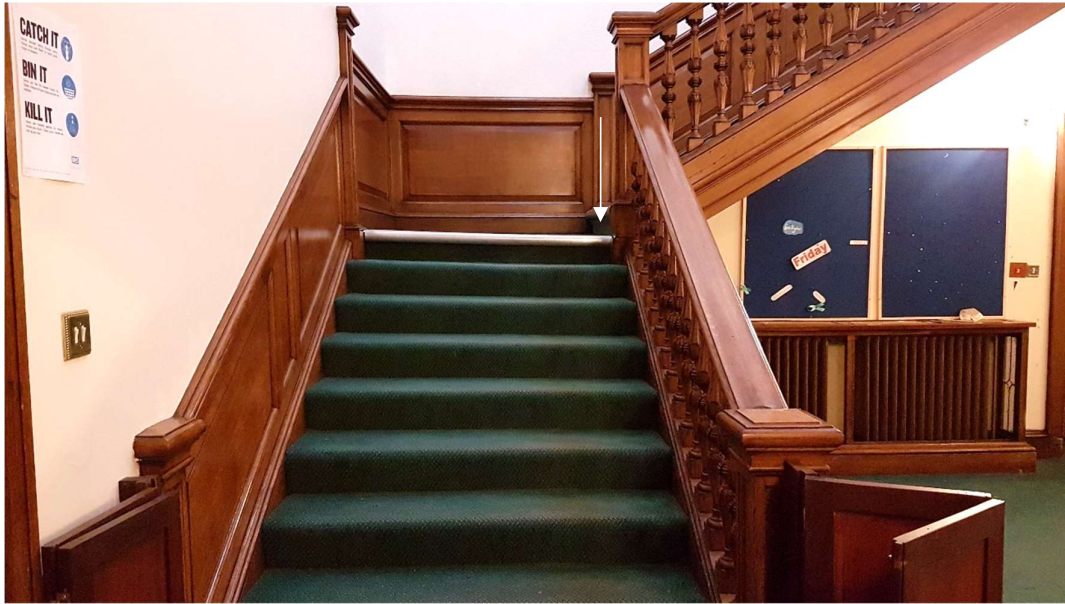
- 3.1 The geometry of the timber staircase is cranked down towards the outer stinger throughout. This displacement can be seen in the floor finishes both on the staircase and on the balcony.
- 3.2 The amount of displacement increases as you approach the first-floor balcony landing where it reaches ca 40mm vertical displacement between opposite sides of the same step.
- 3.3 Modern finishes cover the timber elements so their condition could not be assessed.

Figure 5: Stairs cranked down towards outer stinger throughout.

- 5.2 We therefore do not propose any repairs or adjustments to this staircase at this time if it can be avoided, and instead propose to undertake a load test for the type of loading that it is likely to experience to determine its capacity.

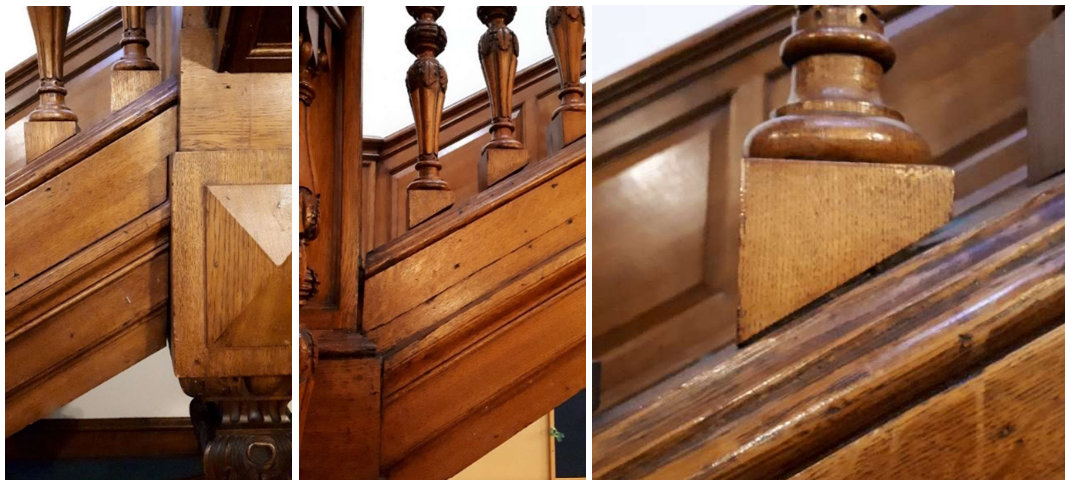
- 3.4 Ca 5-10mm open joint between stringers and post at corner landings.
- 3.5 Ca 5mm gap between balusters and stringer.

Figure 6: Evidence of movement in timber stringer and baluster connection. Note gaps at interface and at connection with post.

- 4.4 We can also see an open joint between the individual balusters and the stringer and we can therefore conclude that the stringer has moved independently to the balusters and therefore that the balustrade works independently to the stairs and does not provide any additional support or restraint.
