Client: **SHENTON GROUP**

Project: **CUERDEN HALL**

Orig Title: **SURVEY RECORD DRAWINGS, BASEMENT AND ATTIC FLOOR PLANS**

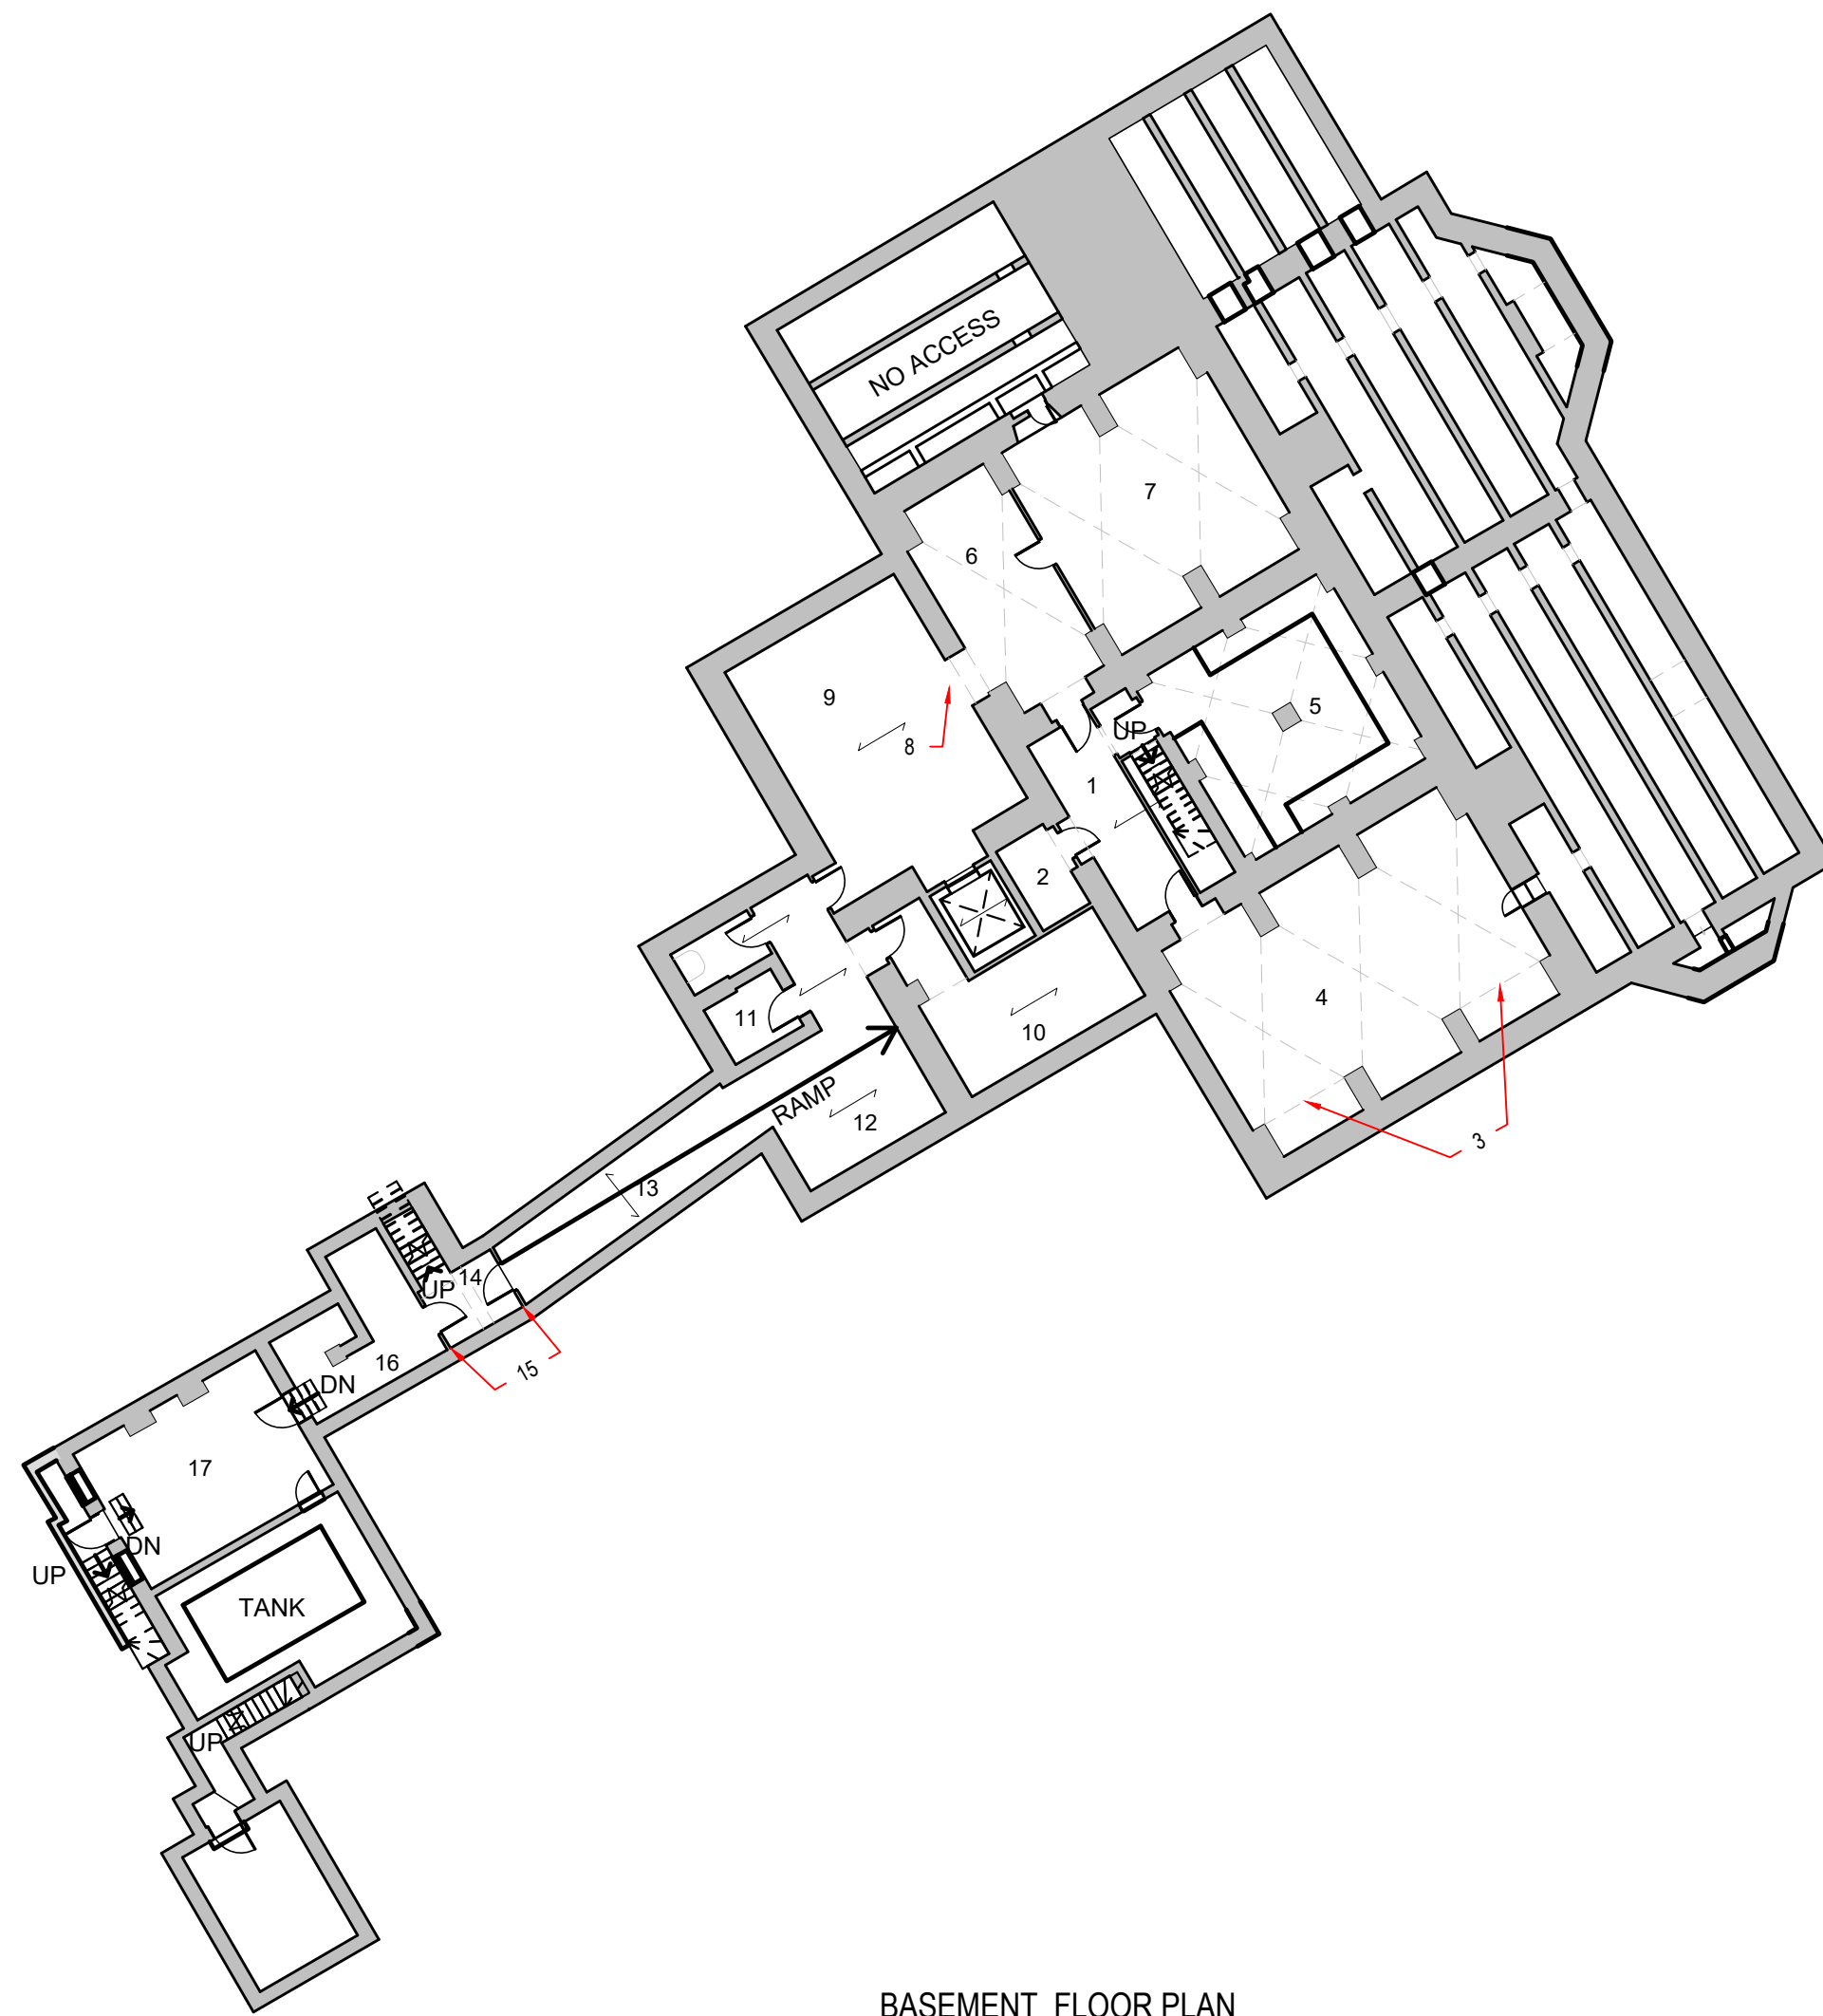
BASEMENT FLOOR PLAN

ZONES 01-03a: BASEMENT

1. BARREL VAULT CUT OFF AT CROWN TO MAKE WAY FOR STAIRCASE. HOLES IN VAULT FOR SERVICES VERTICALLY SUPPORTED BY BLOCKWORK WALL. REMNANTS OF VAULT HAS BEEN REMOVED. CONCRETE FLOOR ABOVE. ARCHED OPENING HAS BEEN WIDENED. MASONRY CORBELLING EITHER SIDE OVER JAMBS. CONSOLIDATE MASONRY.

2. STEEL BEAMS THROUGH BARREL VAULT SUPPORTING MASONRY AND SERVICES. CORRODING AT EMBEDDED END (CIRCA 20MM DELAMINATION + CIRCA 3MM SECTION LOSS).
3. GEOMETRY OF QUADRIPARTITE VAULTS SOUND. NO STRUCTURAL DEFECT OF NOTE.

4. NO STRUCTURAL DEFECT OF NOTE QUADRIPARTITE VAULTS. SHELVING MADE OF SOLID STONE SLABS ARRANGED VERTICALLY AND SOME ARE UNSTABLE.
5. NO STRUCTURAL DEFECT OF NOTE TO QUADRIPARTITE VAULT.

6. NO STRUCTURAL DEFECT OF NOTE TO QUADRIPARTITE VAULT.
7. NO STRUCTURAL DEFECT OF NOTE TO QUADRIPARTITE VAULT.
8. SHALLOW ARCHED OPENING APPEARS TO HAVE ARTICULATED AND FLATTENED. JAMBS LEAN OUT AT SPRINGER POINT.

9. NO STRUCTURAL DEFECT OF NOTE TO THIS ROOM ALTHOUGH CHECK BELOW FINISHES.
10. SERVICES RUNNING THROUGH VAULT. NO STRUCTURAL DEFECT OF NOTE.
11. HALF OF VAULT REMOVED IN THIS BAR. CROWN DETAIL UNKNOWN.

12. GEOMETRY OF BARREL VAULT FLATTENED SLIGHTLY. SOME BRICK UNITS HAVE SLIPPED. SERVICES HAVE BROKEN THROUGH BARREL VAULT AT THIS LOCATION.
13. NO STRUCTURAL DEFECT OF NOTE TO BARREL VAULT.

14. 2 NO. STEEL BEAMS SUPPORTING WALL ABOVE.
15. BLOCKWORK WALLS.
16. NO STRUCTURAL DEFECT OF NOTE ALTHOUGH SERVICES RUNNING THROUGH WALLS.
17. STEEL BEAMS AND AERATED CONCRETE FLOOR ABOVE. NO STRUCTURAL DEFECT OF NOTE TO MASONRY.

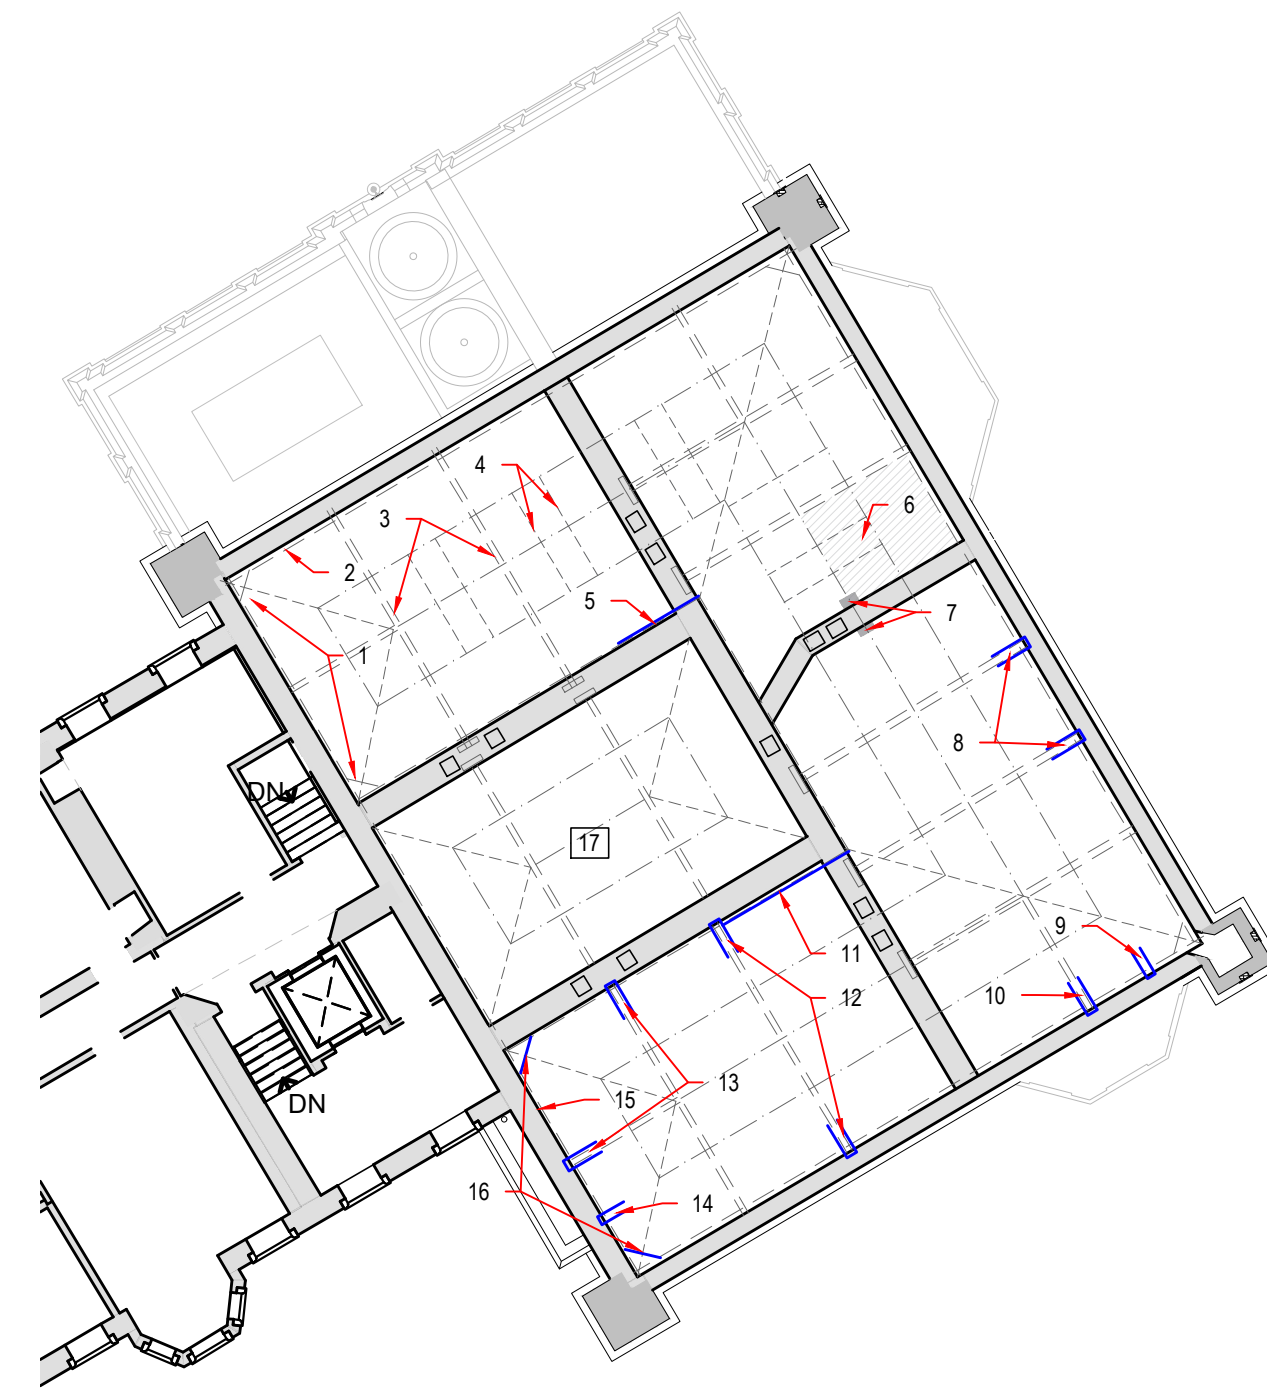
WYATT WING ATTIC PLAN

ZONE 01: WYATT WING - ATTIC

1. DIAGONAL TIMBER BRACES SUPPORTING HIPPED ROOF
2. DEEP WALLPLATES
3. KING POST TRUSSES WITH IRON TIE STRAP BETWEEN TIE BEAM AND VERTICAL STRUT
4. TIMBER SECTIONS TYING COMMON RAFTERS AT 3RD POINTS BETWEEN TRUSSES
5. STEEL PLATE BOLTED TO WALLPLATE ALONG THIS SECTION
6. COMMON RAFTERS ON THIS SLOPE HAVE BEEN DOUBLED UP
7. CORBELLED BEARING FOR PURLIN ON BOTH SIDES OF MASONRY PEAK
8. SPLICE REPAIR TO TRUSS BEARING
9. SPLICE REPAIR TO INTERMEDIATE BEAM BEARING
10. SPLICE REPAIR TO TRUSS BEARING
11. STEEL C-SECTION BOLTED TO WALLPLATE.
12. SPLICE REPAIR TO TRUSS BEARINGS BOTH SIDES
13. SPLICE REPAIR TO TRUSS BEARINGS
14. SPLICE REPAIR TO INTERMEDIATE BEAM BEARING
15. WALLHEAD BADLY REBUILT WITH BRICK SIZED CONCRETE BLOCKS
16. DIAGONAL STEEL BRACES BELOW TIMBER BRACES SUPPORTING HIPPED ROOF
17. NO ACCESS

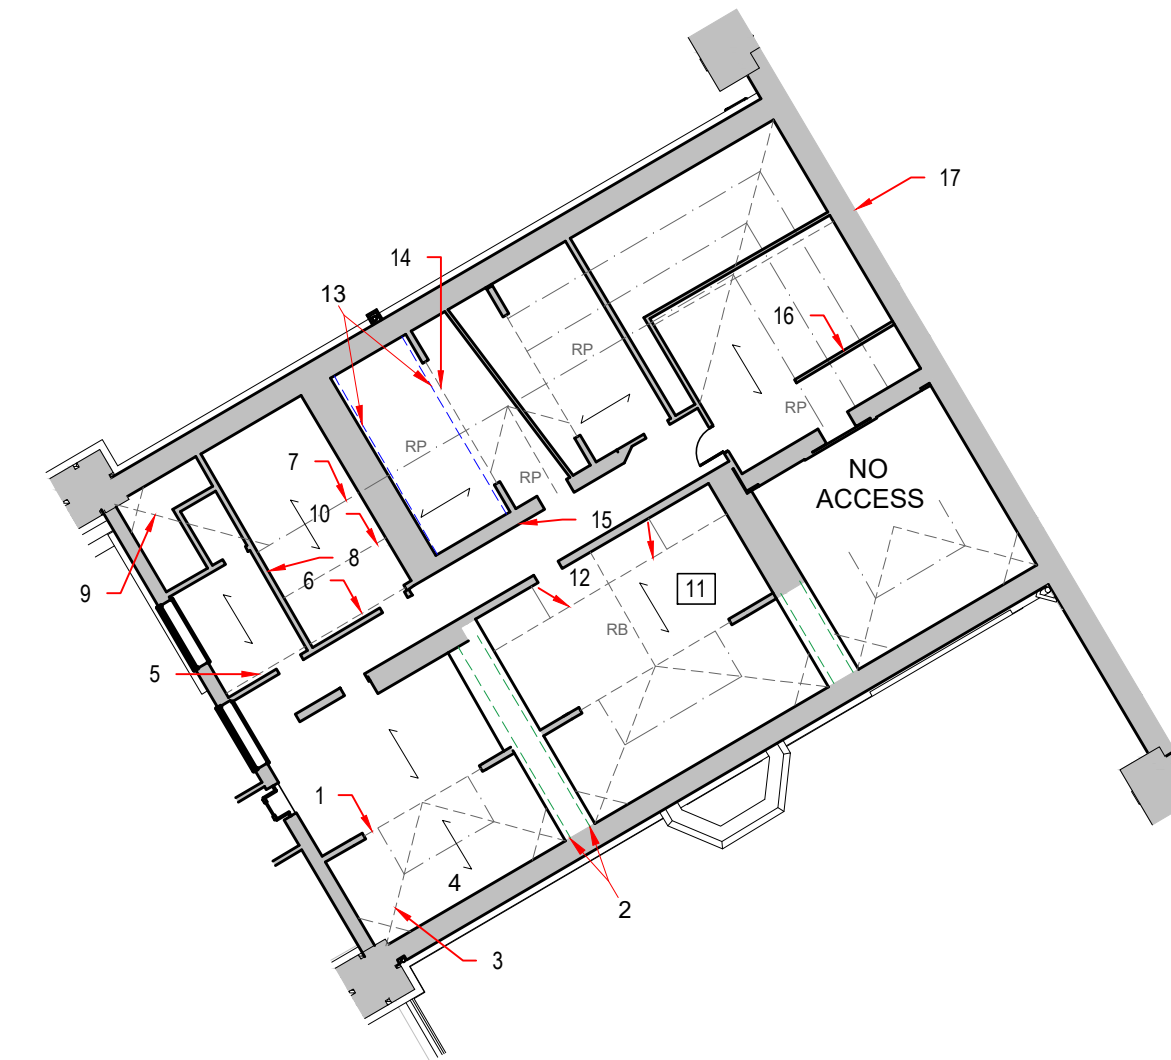
CENTRAL WING ATTIC PLAN

ZONE 02: CENTRAL WING - SECOND FLOOR ATTIC

1. THE BEAM OF TRUSS CUT (SEE SECTION). FLOOR SAGS ABOVE TIE AT FLOOR LEVEL.
2. NO. BRESSUMMER BEAMS TAKE THE LOAD OF THE TRUSS.
3. TRIANGULAR CROSS SECTIONS OF HIPPED RAFTERS ARE NOTCHED TO RECEIVE PURLINS AND ARE DECAYED. BEARS ON A PIECE OF TIMBER, WHICH IS IN TURN SUPPORTED BY A DIAGONAL TIMBER SITTING ON THE WALL ON ONE SIDE AND THE BRESSUMMER BEAM ON THE OTHER.

4. WALL PLATE AND THIS SECTION OF HIPPED ROOF APPEAR NEW / RECENT AND IN GOOD CONDITION.
5. TIMBER BRESSUMMER
6. STEEL BEAM
7. TRUSS CUT AS IN ITEM 1.
8. PARTITION SITTING ON FLOORBOARDS. CIRCA 20MM GAP BETWEEN FLOORBOARDS AND PARTITION ON THIS SIDE. CIRCA 15MM GAP ON WALL AT CEILING INTERFACE. FLOOR SAGS BOTH SIDES.

9. HIPPED RAFTER AS IN ITEM 3.
10. SMALLER TRUSS BEARING ON PARTITION.
11. AS IN ITEMS 1-4. RIDGE BOARD APEX DETAIL.
12. PURLINS CRANKED DOWN TO COMMON RAFTERS. BOXED OUT AS A TRUSS.

13. STEEL BEAMS. RETAIN PARAPET?
14. TRUSS CUT AS IN ITEM 1 BUT HAS NO BEARING.
15. MASONRY WALL.
16. PRINCIPAL RAFTER FROM TRUSS SUPPORTED ON PARTITION. PURLINS SPAN ON TO PRINCIPAL RAFTER WHILE SUPPORTING COMMON RAFTER.

17. PRINCIPAL TRUSS SUPPORTED ON TIMBER PARTITION ON FLOORBOARDS. PRINCIPAL RAFTER BEARING CUT OFF. SUPPORTS HIP JUNCTION (SEE SECTION).
