**1 Office Wing Elevation 1 (OE1) Repairs w/Demo**  
 I : 100

**PROJECT**  
 Cuerden Hall, Chorley

**TITLE**  
 Proposed Repair Elevations Sheet 06

**DRAWING NUMBER**  
 240729-PUR-00-XX-DR-A-2205

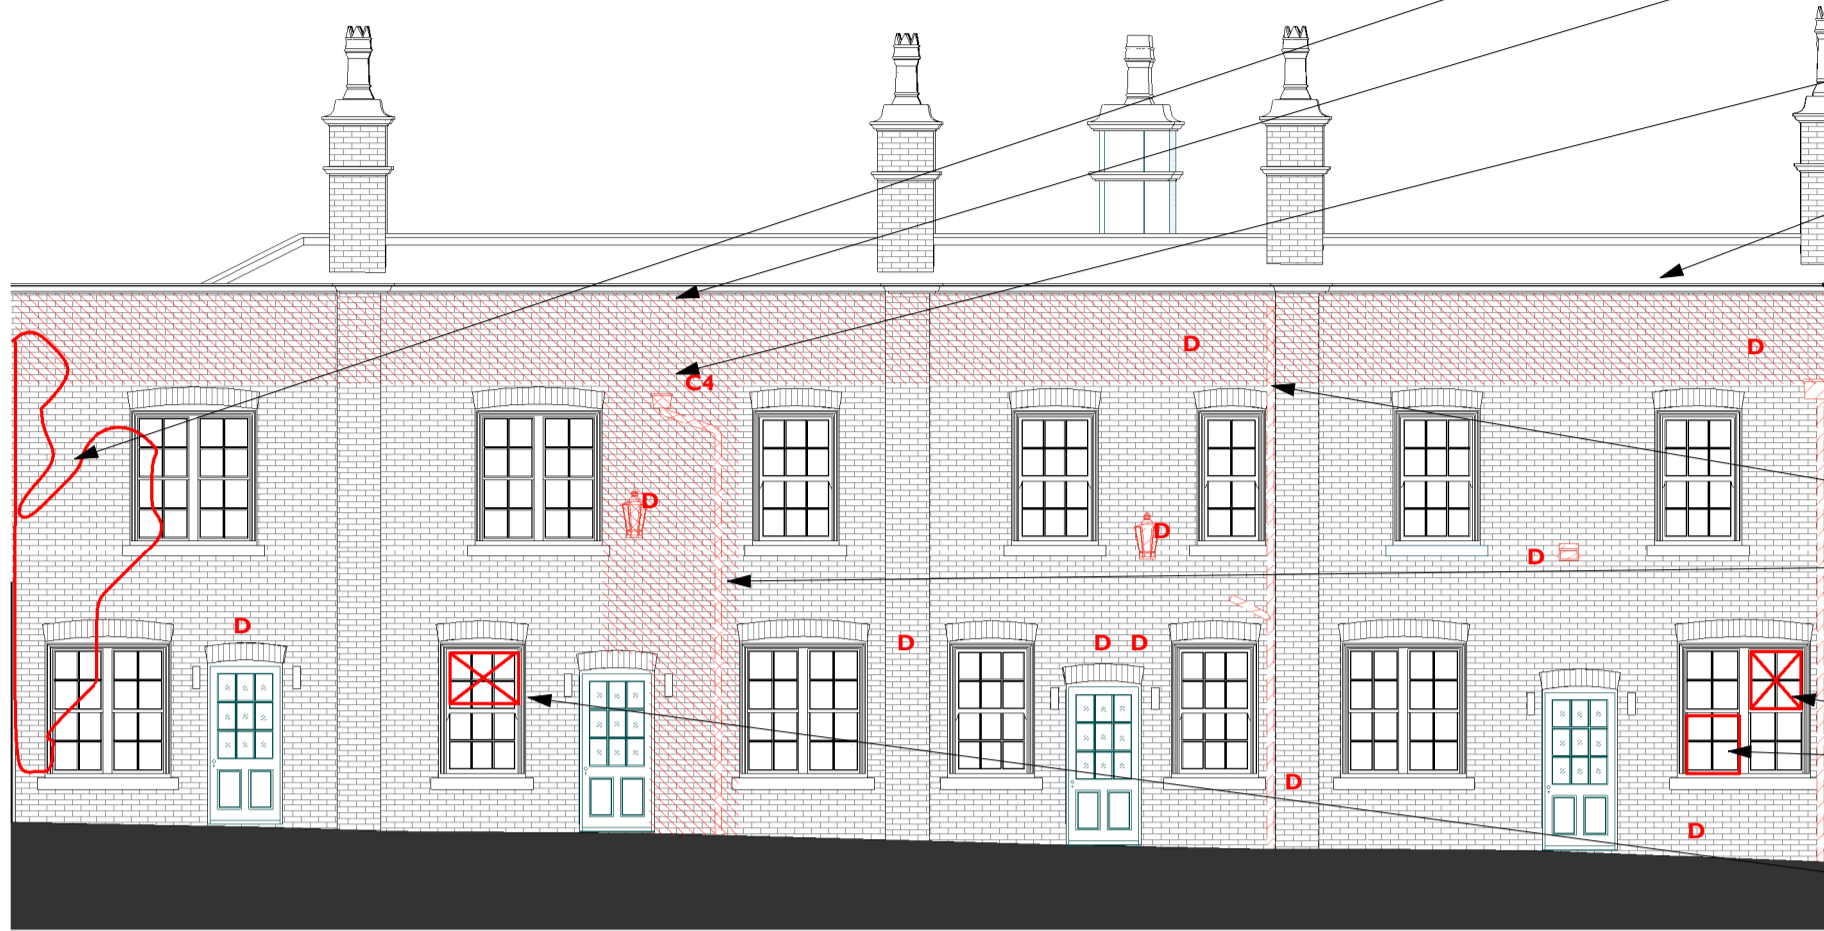
- Remove ivy from elevation and allow for repairs.
- Allow to carefully dismantle sections of parapet and re-build with matching bricks. Install lead DPC below parapet copings.
- Remove vegetation growth from sump.
- Allow to remove coping stones and iron cramps, re-pin full length of elevation. Point joints. Install
- Allow for 15% replacements to cover breakages and 5 no stone indents.
- Remove modern plastic rwp and hopper and replace with cast iron / aluminium with ears.
- Remove existing RWP and SVP. RWP to be replaced with cast aluminium / iron alternative with ears.
- Re-instate top sash window with matching glazing bars to replace existing louvre. Remove grill to bottom left sash.
- Remove existing fan from top sash. Re-instate sash with glazing bars.

Type A1 - Repointing standard brickwork joints with lime mortar- 100%  
 Type B1 - Indent repair to brickwork. - 10%  
 Type C1 - Doff clean - 100%  
 Type C3 - Clean stonework - Stone coping and stone sills

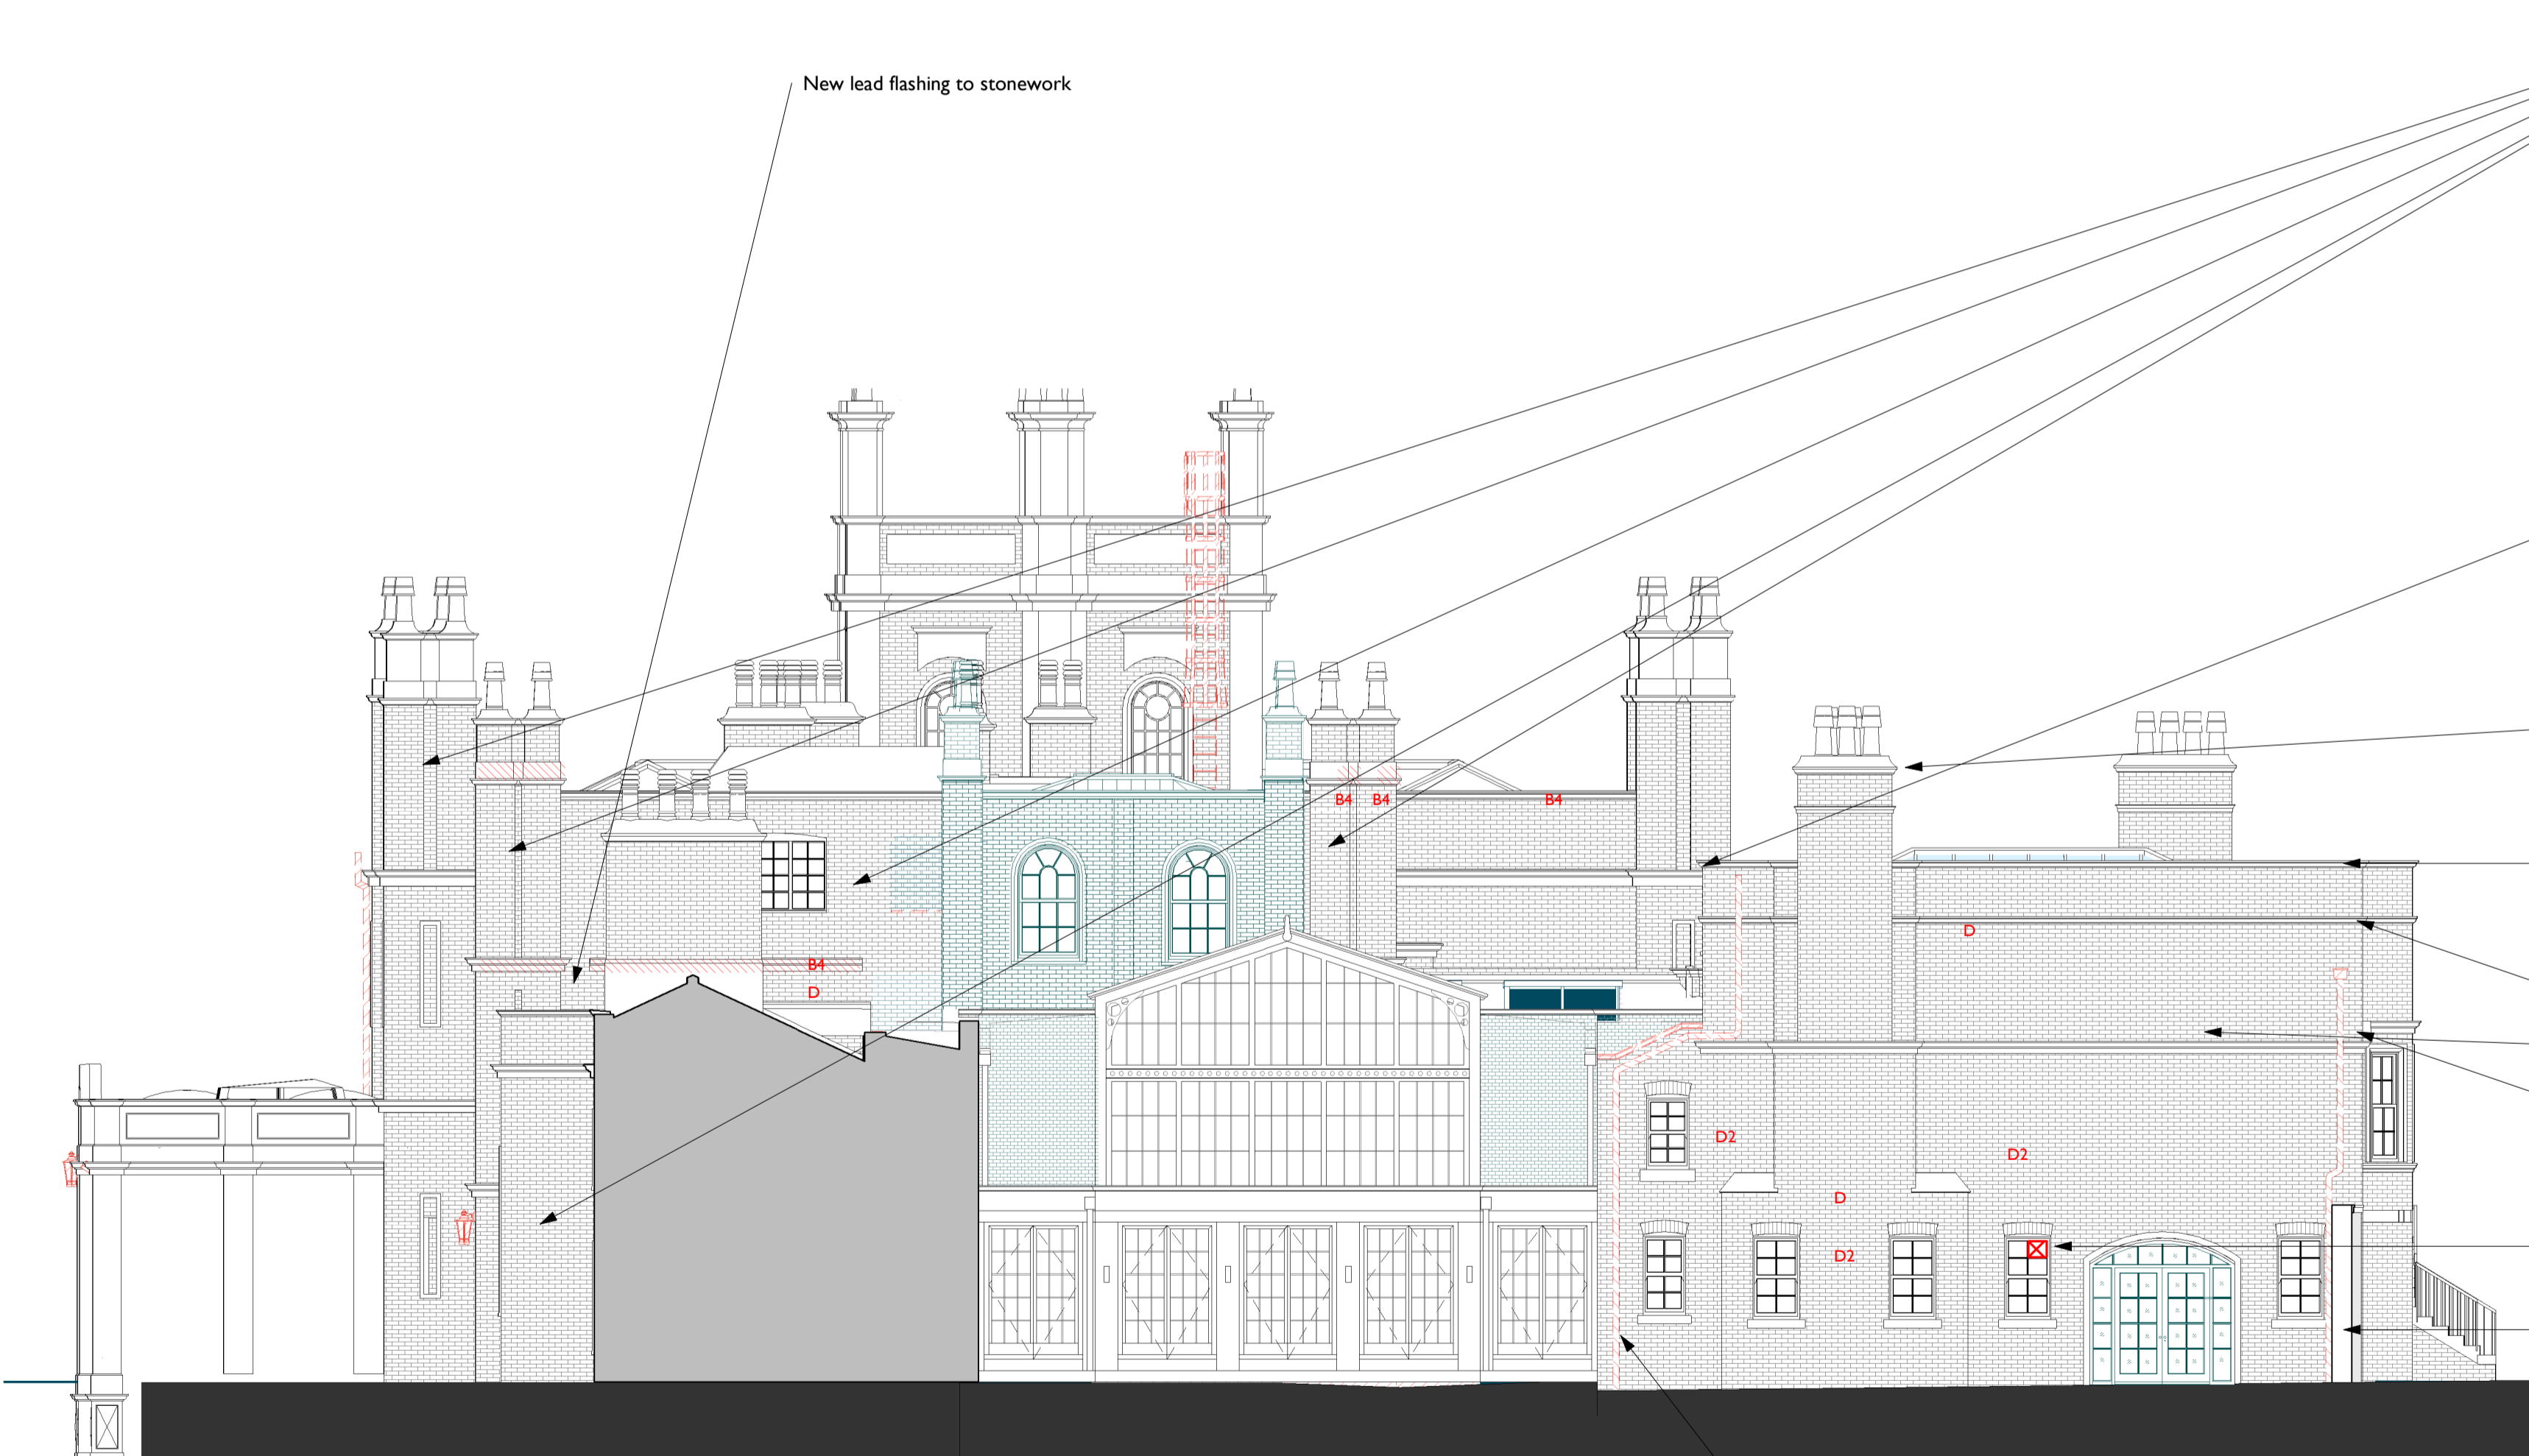
**2 Office Wing Elevation 2 (OE2) Repairs w/Demo**  
 I : 100

- North Parapet  
 Parapet wall leaning outwards. Allow to take down and rebuilt.  
 Repoint stone string course.  
 100 % Type A repointing  
 15% B1 brick replacement

- New lead flashing to stonework
- West Elevation 1717 House.  
 Allow to remove coping stones and iron cramps, re-pin full length of elevation. Point joints.  
 Allow for 15% replacements to cover breakages and 5 no stone indents.  
 Repoint stone string course.  
 100 % Type A repointing  
 15% B1 brick replacement  
 100% C1 Doff

- Allow to renew former cast iron down pipe and hopper with cast iron / aluminium. Circa 800mm height
- Chimney to be taken down to suitable level as noted by S.E and rebuilt. Flashing and new terracotta pots with caps to be installed.

- Allow to remove coping stones and iron cramps, re-pin full length of elevation. Point joints.
- Allow for 15% replacements to cover breakages and 5 no stone indents.

- Repoint open joints to stone string courses.
- Existing SVP to be carefully removed.
- Remove fan from glazed window.
- Garden wall to courtyard.
- Remove vegetation off wall.  
 100% Type A pointing to both sides.  
 30% B1 Brick replacements to both sides.  
 100% C1 Doff Clean.  
 Remove stone copings, re-bed and pin. Allow for 25% new copings to match existing.

- Additional allowance for unknown repairs.
