Client: SHENTON GROUP

Project: CUERDEN HALL

Draw Title: SURVEY RECORD DRAWINGS, FIRST FLOOR PLAN

Project Code: 077572 - CUR - ZZ - 01 - DR - S - 20003 - 02

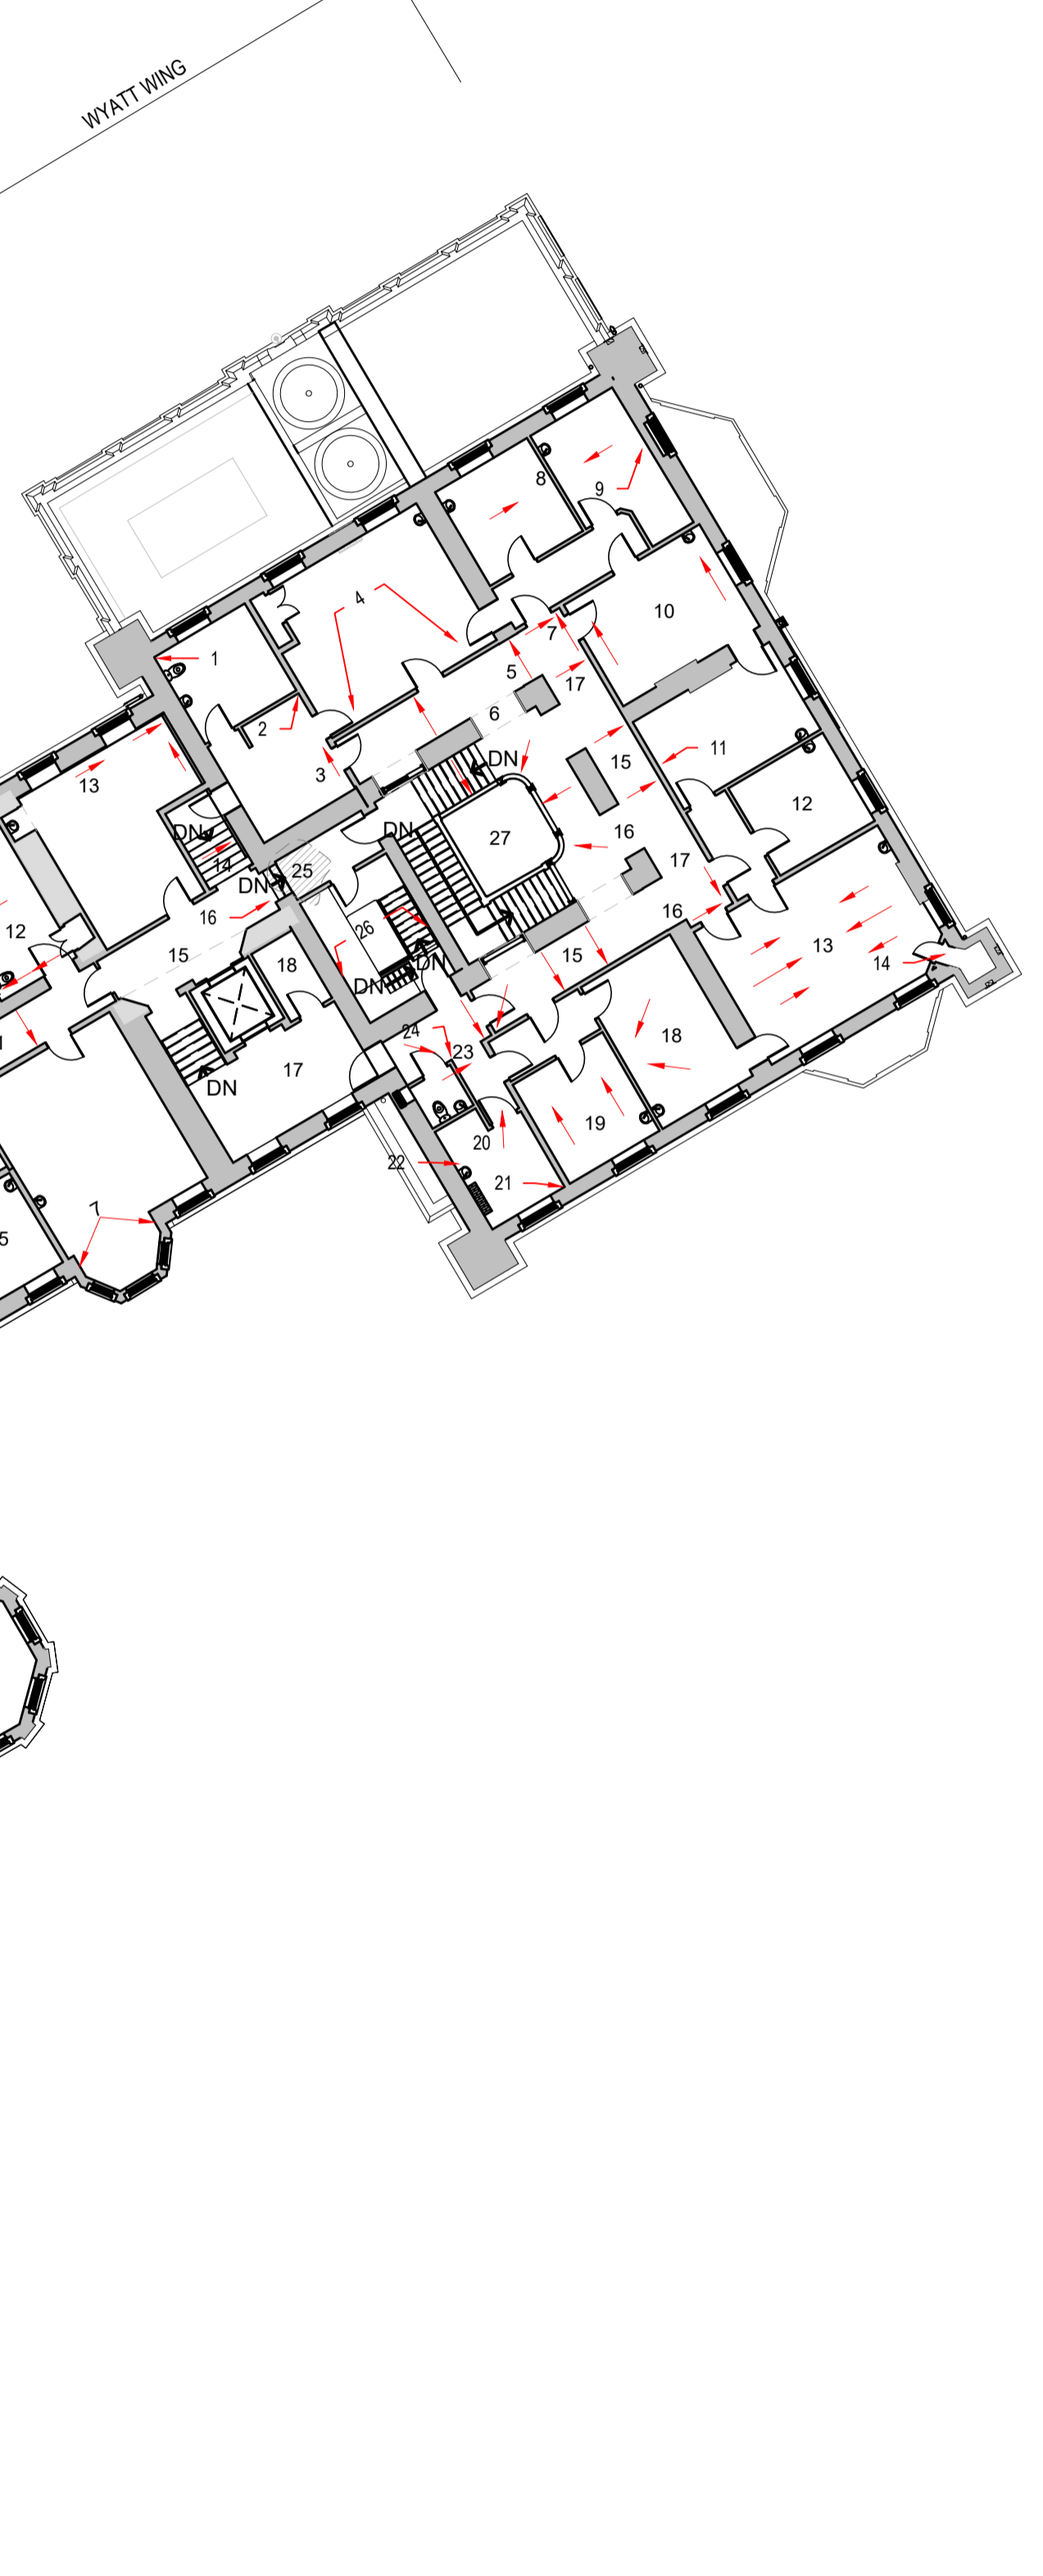
FIRST FLOOR PLAN
1:200

- STABLEYARD COTTAGES - INTERNALS FIRST FLOOR
1. 10-15MM DIAGONAL CRACK FROM CORNER REDUCING TO HAIRLINE AT LOW PURLIN BEARING. ALL THE WAY THROUGH THE WALL.

2. 20MM GAP AT CENTRE STRUT CONNECTION AND CIRCA 30MM OFFSET.
3. BOTH END BEARINGS OF TRUSS DECAYED. SECTION LOSS TO BE CONFIRMED BY TIMBER ROT SPECIALIST. STRUCTURAL REMEDIAL WORKS MIGHT BE REQUIRED.

4. 30MM GAP AT CENTRE STRUT CONNECTION. ALSO OFFSET?
5. RIDGE BOARD ON END BAY AS OPPOSED TO RIDGE PURLIN THROUGHOUT.
6. END BEARINGS OF TRUSS OK. SITTING ON TIMBER PADSTONE.

7. TIMBERS AT CORNER DETAIL DECAYED.
8. INTERNAL GABLE APPEARS OK.
9. TRUSS BEARING OK.
10. TRUSS BEARING DECAYED AND SITTING ON DECAYED TIMBER.
11. EMBEDDED END DECAYED. LOCALISED BULGE IN MASONRY BELOW. MASONRY UNITS BELOW SEVERELY DECAYED.

12. BEARING OK.
13. TIMBER LINTEL OF OPENING THROUGH INTERNAL GABLE EXTENDS TO CORNER AND IS CRANKED DOWN.
14. RIDGE BOARD THROUGHOUT.
15. COARSE DIAGONAL CRACKING RADIATING FROM WEST BEARING OF LINTEL UP TO ALL PURLIN BEARING LOCATIONS DIRECTLY ABOVE. LINTEL TENDS DOWN TO EAST. APPEARS TO HAVE ROTATED AND EASTERN BEARING RE-BUILT WITH MODERN BRICKS.

16. 10MM CRACK IN CORNER INTERFACE. NEW WALL UNBONDED.
17. BEARING OK.
18. NOTCH AT MIDPOINT (LEAVING ca 50% CROSS SECTION) AND JUST BEFORE BEARING (ca 60% REMAINING CROSS SECTION) AT NODE WITH RAFTER. SOME DECAY AT THIS BEARING.

19. SLIGHTLY DIFFERENT TRUSS. KING POST STOPS PART WAY AND SUPPORTS HORIZONTAL MEMBER WHICH JOINS RAFTERS UNDER UPPER PURLIN BEARINGS. PIER BUILT TO ENLARGE TRUSS BEARING. FLUMB AND OK.

23. CORBELLED MASONRY TO SUPPORT DIAGONAL STEEL ELEMENT.
24. DIAGONAL TIMBER BRACE SUPPORTING HIPPED ROOF IS DECAYED.
25. STEEL BEAMS PERHAPS RESTRAINING THE GABLE END.

26. DIAGONAL STEEL ELEMENTS SUPPORTING LOWER PURLIN BEARING LOCATIONS AND HIPPED RAFTER.
27. BOTTOM OF HIPPED SECTION MISSING.
28. DIAGONAL TIMBER BRACE SUPPORTING HIPPED ROOF IS DECAYED.

29. ACCESS PLATFORM BEHIND PARAPET VISIBLE INTERNALLY ALONG WHOLE ELEVATION.
30. ARCH BRACED KING POST TRUSS HAS BEEN STRENGTHENED. THE BEAM DOUBLED UP AND BOLTED THROUGH. STEEL TIE INSTALLED BETWEEN PRINCIPAL RAFTERS BELOW LOWER PURLIN LOCATION. VERTICAL STRAP BOLTED THROUGH TYING ELEMENTS TOGETHER. TOP OF DIAGONAL SECTION OF OLD HIPPED ROOF CUT OFF.

31. 30-40mm THICK CRACK THROUGH FULL THICKNESS OF WALL.
32. LARGE STONE UNITS IN WALL IN THIS SECTION.
33. 5-7mm THICK CRACK ALONG JAMB OF INFILLED OPENING.

34. LOOSE MASONRY BELOW PURLIN BEARING AND AT WALLHEAD.
35. COARSE CRACK AT INTERFACE ca 15mm THICK.
36. MORE TYPICAL KING POST TRUSSES ABOVE CENTRAL SECTION OF ENTRANCE WING.

37. STRUCTURE OF BELL TOWER ABOVE IS OFFSET FROM TRUSS SUPPORTS. ADDITIONAL TIMBER PURLINS AND OTHER ELEMENTS TO FORM SUPPORT STRUCTURE.
38. NO ACCESS INTO ROOF SPACE ABOVE ARCH ED ENTRANCE.

39. NO ACCESS INTO ROOF SPACE.
40. TIMBER AND STEEL DIAGONAL BRACES SUPPORTING HIPPED ROOF.

- COURTYARD COTTAGES - INTERNALS FIRST FLOOR / ROOF
1. BEAM HIDDEN BY MODERN CEILING FINISHES. APPEARS TO HAVE BEEN PULLED OUT CIRCA 50MM.
2. KING POST TRUSS SUPPORTING RIDGE BOARD. THE BEAM RETAINING EXTERNAL FLANK WALL, WHICH IS LEANING OUT. LOOSE MASONRY UNITS AROUND THE BEAM BEARING. FLOOR JOISTS IN THIS SECTION CIRCA 200MM DEEP.

3. LOOSE MASONRY AT WALL HEAD ALONG WALL.
4. STOCKY TIMBER PURLINS, ROTATED TO SLOPE.
5. PURLIN BEARING ON END OF INTERNAL MASONRY GABLE WALL. LOOSE MASONRY AT BEARING.

6. PURLIN BEARING ON MASONRY UNITS BUILT OFF TIMBER SECTION SPANNING BETWEEN MASONRY GABLE AND FLANK WALL.
7. TIMBER EDGE BEAM DECAYED. SOME COMMON RAFTERS IN THIS AREA TOO.

8. KING POST TRUSS AS BEFORE. BUT BOXED OUT STEEL TIE BEAM HAS BEEN INSTALLED NEXT TO TRUSS TIE BEAM.
9. EVIDENT LEAK IN THIS SECTION. TRUSS TIE BEAM LIKELY DECAYED.

10. MISSING MASONRY BELOW PURLIN BEARING. ASSUME BEAMS IN FLOOR FOLLOW TRUSS LOCATIONS.
11. CEILING STILL PRESENT IN THIS SECTION SO NO ACCESS TO ROOF STRUCTURE. ASSUME HIPPED. EDGE BEAMS AROUND PERIMETER DAMP AND DECAYED. DIAGONAL BEAMS IN CORNER APPEAR OK.

- COURTYARD WING - INTERNALS FIRST FLOOR
1. NO STRUCTURAL DEFECT OF NOTE.
2. DAMP AND HAIRLINE CRACKS THROUGH FINISHES.
3. DAMP STAINS ON FINISHES IN THIS CORNER. NO STRUCTURAL DEFECT OF NOTE.

4. HAIRLINE VERTICAL CRACKS IN FINISHES. NO STRUCTURAL DEFECT OF NOTE.
5. NO STRUCTURAL DEFECT OF NOTE.
6. DAMP AND HAIRLINE CRACKS THROUGH MOULDING OF BAY WINDOW. NO STRUCTURAL DEFECT OF NOTE TO REST OF THE ROOM.

7. WINDOW AND DOOR OPENING CRANKED TO WALLS EITHER SIDE. MOULDING AT CEILING INTERFACE BOWS OUT ON FLAN CIRCA 20MM.
8. CLEAR WATER INGRESS ABOVE WINDOW OPENING. CHECK TIMBER SAFE LINTEL FOR ROT. FINISHES DAMAGED.

9. PARTITION WALL SAGS OVER ITS LENGTH. PROBABLY SITTING ON FLOORBOARDS WITH NO SUPPORT FROM WALL BELOW.
10. FLOOR A BIT BOUNDY.
11. FLOOR IN CORRIDOR SLOPES DOWN.

12. DOOR AND WINDOW OPENING. WALLS AND FLOOR SLOPE DOWN TO PARTITION. SOUNDS HOLLOW.
13. WALLS AND WINDOW OPENINGS CRANKED DOWN TO CORNER.
14. STAIRS CRANKED DOWN SLIGHTLY TOWARDS WALL.

15. NO STRUCTURAL DEFECT OF NOTE TO THIS SECTION OF CORRIDOR.
16. ARCH ED OPENING HEAVILY STAINED FROM WATER INGRESS AND MOULD. GEOMETRY APPEARS SOUND.
17. NO STRUCTURAL DEFECT OF NOTE TO STAIRS.

18. NO STRUCTURAL DEFECT OF NOTE TO CUPBOARD.
19. NO STRUCTURAL DEFECT OF NOTE.
20. NO STRUCTURAL DEFECT OF NOTE.
21. NO STRUCTURAL DEFECT OF NOTE.
22. NO STRUCTURAL DEFECT OF NOTE ALTHOUGH FLOOR FEELS UNEVEN.

23. NO STRUCTURAL DEFECT OF NOTE TO CORRIDOR. MASONRY WALLS EITHER SIDE CIRCA 400MM THICK (2 BRICKS).
24. OUTER WALL LEANS OUT SLIGHTLY. MAX DISPLACEMENT OVER WINDOW OPENING.

25. ROOF APX DETAIL IS RIDGE BOARD WITH COMMON RAFTERS SPANNING TO THE WALLHEAD. NO STRUCTURAL DEFECT OF NOTE.

- CENTRAL WING - INTERNALS FIRST FLOOR
1. CORNER DAMP. SOLUBLE SALTS PUSHING TILES OFF WALLS.
2. FLOOR SLOPES DOWN SIGNIFICANTLY.
3. CRANKED DOOR OPENING.

4. FLOOR SLOPES DOWN.
5. NORTH SPRINGER OF ARCH LOWER THAN SOUTHERN ARCH OK.
6. CRACKS IN FINISHES THROUGH ARCH.
7. DOOR OPENINGS AND FLOOR CRANKED TO CORNER. FLOORS SLOPE DOWN TO PARTITION.

8. DAMP AND WATER INGRESS VISIBLE ON WALL BEHIND BLOCKED UP WINDOW OPENING.
9. CEILING AND FLOOR SLOPES DOWN TO PARTITION BUT WINDOW ON ELEVATION SQUARE. HAIRLINE CRACK ALONG CEILING AND MOULDING INTERFACE.

10. HAIRLINE DIAGONAL CRACK IN FINISHES.
11. NO STRUCTURAL DEFECT OF NOTE.
12. FLOOR SAGS SIGNIFICANTLY TOWARDS THE CENTRE OF THE ROOM. INTRUSIVE INVESTIGATIONS REQUIRED TO FLOOR STRUCTURE BELOW.

13. TOWER CUPBOARD DAMP.
14. FLOOR IN CORRIDOR SLOPES DOWN SIGNIFICANTLY TOWARDS PARTITIONS. CIRCA 20MM IN PLACES.
15. FLOOR FEELS SOLID AND RAISED IN AREAS WHERE A MASONRY WALL IS RUNNING BELOW.

16. EASTERN SPRINGER OF THESE ARCHES CIRCA 20-40MM LOWER. APPEAR TO BEAR ON PARTITION. GEOMETRY ARTICULATED WITH HAIRLINE CRACKS THROUGH MOULDING AT CROWN.

17. FLOOR SAGS TOWARDS MID POINT OF PARTITION.
18. FLOOR SLOPES DOWN SIGNIFICANTLY CIRCA 80MM.
19. FLOOR SLOPES DOWN SIGNIFICANTLY CIRCA 50MM.
20. TILES ARE BULGING OFF THE WALL.

21. 1-2MM CRACK IN MOULDING.
22. FLOOR SLOPES IN CORRIDOR.
23. SEVERELY CRANKED DOOR OPENING.
24. CLEAR AND ACTIVE WATER INGRESS IN THIS CORNER OF THE TWO STOREY STAIRWELL SPACE. MASONRY SATURATED. ARCH BELOW SATURATED.

25. VERTICAL 5MM CRACKS ABOVE ARCH ED WINDOW OPENING IN STAIRWELL LANTERN.
26. STAIRS AND LANDING CRANKED DOWN TO STRINGER CIRCA 40-50MM.

20. BEARING OK.
21. CORNER PARTLY BONDED. RELATIVELY TIGHT. CONSOLIDATE AT EAVES LEVEL.
22. OPENING IN MASONRY GABLE PARTIALLY BLOCKED UP (ONLY OUTER SKIN). UNBONDED, UNFINISHED JAMBS AND LINTEL. NO BEARING. RE-BUILD AND CONSOLIDATE MASONRY CORNER INTERFACE.
