# Principal Staircase Report

## S.1 Structural Condition Appraisal

Curtins Ref: B077572-CUR-ZZ-ZZ-RP-S-00003

Site Address: Cuerden Hall, Shady Ln, Bamber Bridge, Preston PR5 6AZ

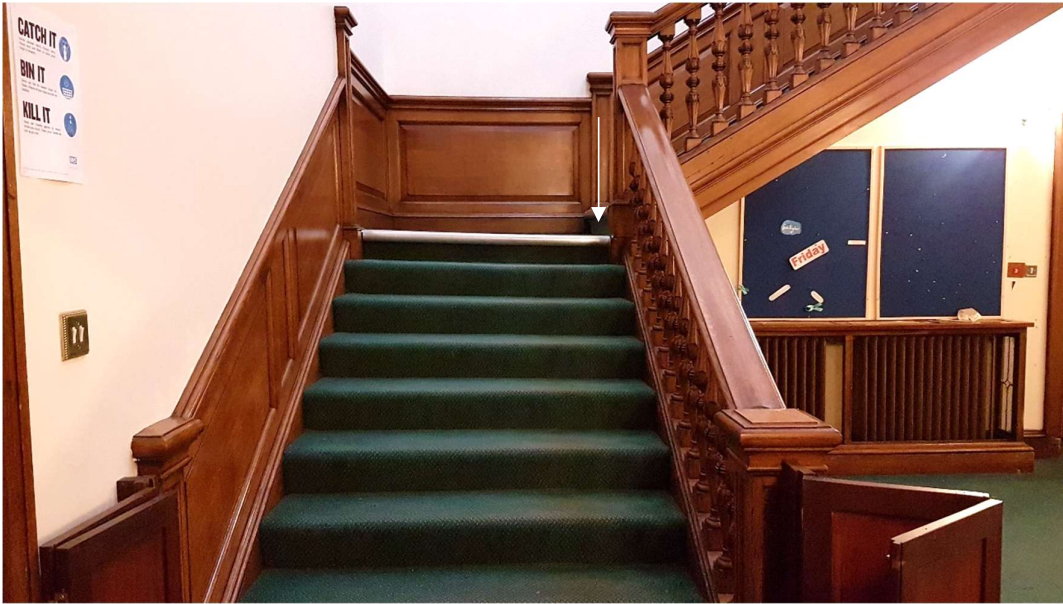
- 3.1 The geometry of the timber staircase is cranked down towards the outer stinger throughout. This displacement can be seen in the floor finishes both on the staircase and on the balcony.
- 3.2 The amount of displacement increases as you approach the first-floor balcony landing where it reaches ca 40mm vertical displacement between opposite sides of the same step.
- 3.3 Modern finishes cover the timber elements so their condition could not be assessed.

Figure 5: Stairs cranked down towards outer stinger throughout.

- 5.2 We therefore do not propose any repairs or adjustments to this staircase at this time if it can be avoided, and instead propose to undertake a load test for the type of loading that it is likely to experience to determine its capacity.

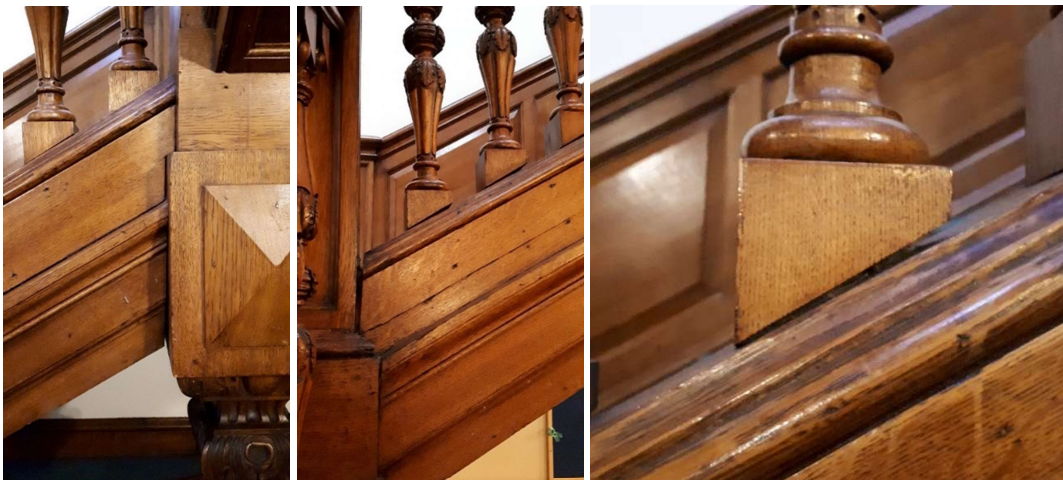
- 3.4 Ca 5-10mm open joint between stringers and post at corner landings.
- 3.5 Ca 5mm gap between balusters and stringer.

Figure 6: Evidence of movement in timber stringer and baluster connection. Note gaps at interface and at connection with post.

- 4.4 We can also see an open joint between the individual balusters and the stringer and we can therefore conclude that the stringer has moved independently to the balusters and therefore that the balustrade works independently to the stairs and does not provide any additional support or restraint.

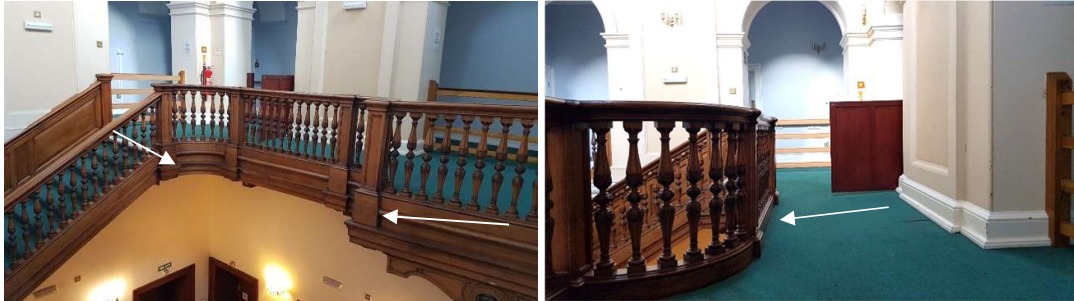
- 3.6 The carved cantilevering brackets supporting the balcony and the balcony finishes are also cranked down towards the centre of the stairwell (ca 50-60mm).
- 3.7 Modern finishes cover the timber elements.

Figure 7: Cranked geometry of balcony elements towards centre of stairwell. Notice the shadow below the open halfdoor.

- 4.8 The balcony suffers noticeable vertical deformation.
- 4.9 As described in section 4.6, the balcony (like the stairs) feels solid underfoot with no immediate deflection under the imposed load of walking.
- 4.10 Therefore, this deformation is believed to be a result of long term creep. Under a similar mechanism to that described in section 4.7
- 4.11 The deformation of the balcony above may also have contributed to reduced vertical support at the top of the stairs which has translated down through the outer stringer into the flights below.

- 5.4 If the results of this load test are not satisfactory, remedial solutions would then have to be undertaken. This could range from something like a sign limiting the amount of people allowed on the stair at a time, to full propping and heavier engineering works to 'lift' the staircase up, and anything in between depending on what is required. A practical "half way" resolution would be to lift the floorboards on the balcony and add timber firrings to level the floor, or to overlay the existing boards.

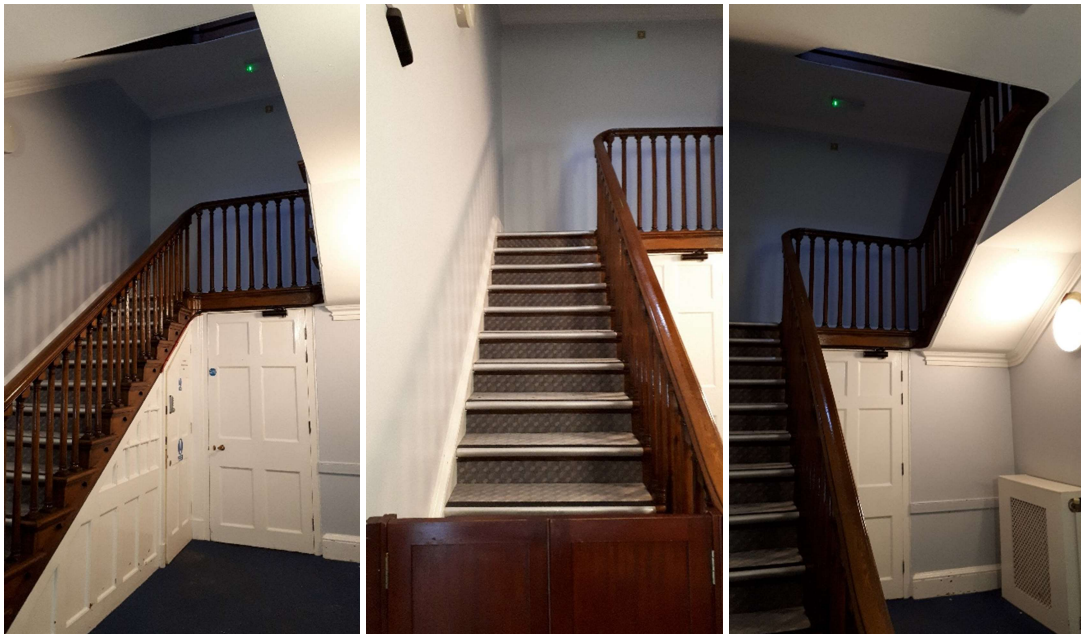
- 3.8 There is a slight downward crank of the stairs towards the outer stringer.
- 3.9 It is supported at ground floor by partition walls beneath.
- 3.10 Likely to have beam supporting last step at each dog-leg landing.
- 3.11 Modern finishes cover the timber elements.

Figure 8: Service dogleg stair has an open stringer and steps are cranked down very slightly towards outer stringer.

- 4.12 There is a slight downward crank of the stairs towards the outer stringer, but this might be the outworking of changes in the timber rather than strictly structural deficiencies in support.
- 4.13 This staircase needs to be load tested or intrusively investigated.

- 5.6 We also recommend a load test to be undertaken on the service stair to confirm it is suitable for the proposed loading that it will be subject to.

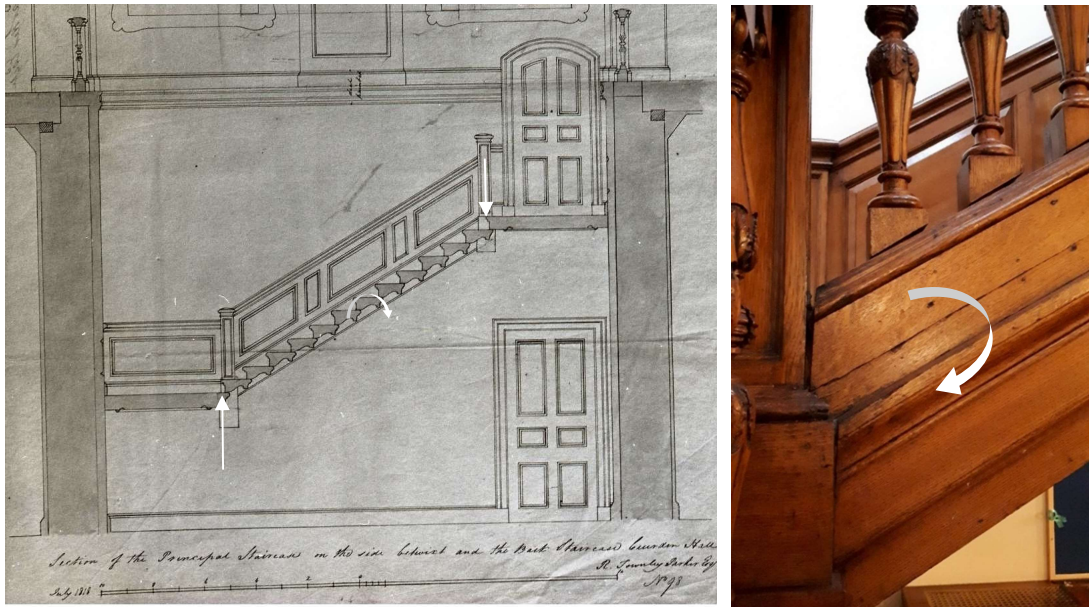
Figure 9: Evidence of movement with open joints between stringer and corner 'post'.

- 4.3 The pattern of these open joints is appropriate in the context of the construction of the stair described above where there is a backwards rotation. The stringer appears to hold each flight together and let the multiple elements act as one. It is therefore not surprising to see that the joint between the stringer and the post is tight at the bottom and open at the top at the bottom of a flight but the other way around at the top of the flight of stairs (illustrated in the image above).
