Tunnel Condition Report

S.1 Structural Condition Appraisal

Curtins Ref: B077572-CUR-ZZ-ZZ-RP-S-00001

Site Address: Cuerden Hall, Shady Ln, Bamber Bridge, Preston PR5 6AZ

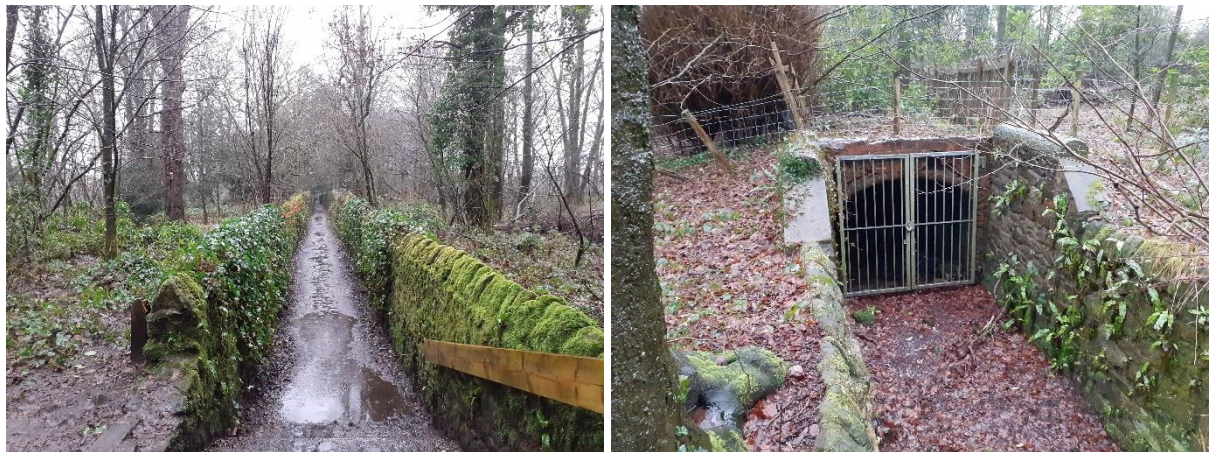
Figure 2: Pathway looking north (left) and south entrance of tunnel (right).

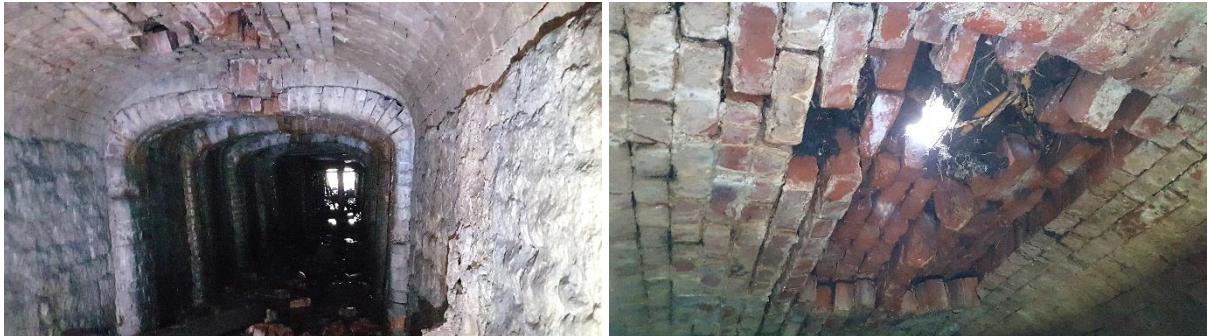
- 4.1 The geometry of the masonry barrel vault is severely deformed. The walls on either side of the passage are leaning out and the arching vault has flattened.
- 4.2 The north section of the tunnel is partly collapsed and a hole is visible above. There is clear skin separation in this area.

Figure 3: Deformed masonry barrel vault (left), and collapsed sections of vault with loose masonry units (right).

- 5.1 It appears that the section of tunnel was constructed in a cut and fill manner. The soil on either side of the tunnel masonry walls appears to have then deformed over time in response to the thrust from the arching structure.
- 5.2 This has resulted in the springing points of the arched masonry slowly being pushed further from each other and the span increasing significantly. The tunnel barrel vault and supporting arches have therefore formed a mechanism illustrated by the diagram below.

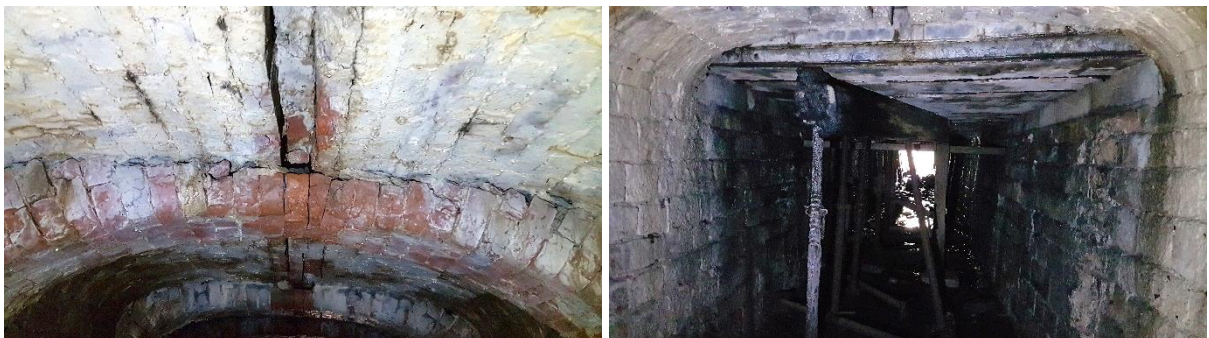
- 4.3 Loose masonry units were observed throughout particularly around the open joints at the crown.
- 4.4 The arches are unbonded to the masonry walls and the bricks at the crown have been cut to suit a deformed shape.

Figure 4: Arches unbonded and thinner at crown as if cut to fit deformed shape (left), and filler joist below road (right).

- 5.3 Multiple alterations / strengthening measures appear to have been attempted on the tunnel in the past. The arches are unbonded to the masonry walls and appear to be a later addition as the bricks at the crown have been cut to suit a deformed shape.

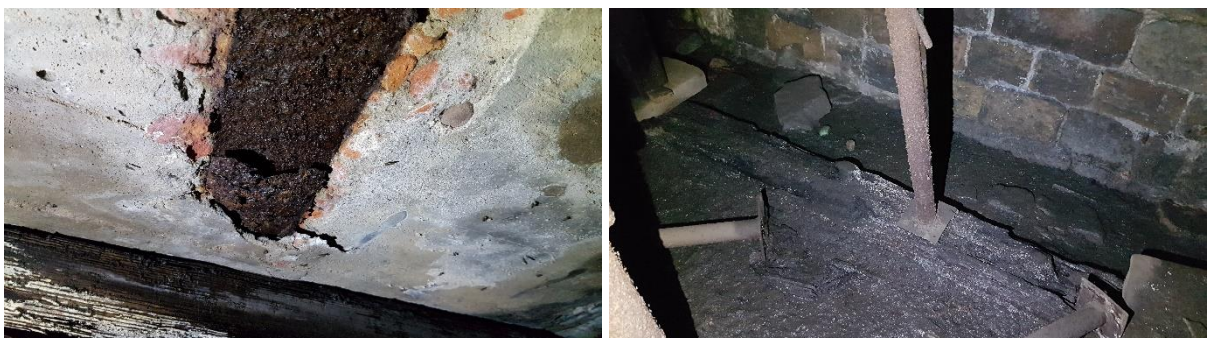
- 4.5 The top section of the tunnel directly below the road has been replaced by a filler-joist system possibly with a concrete relieving slab (investigations required to prove) resulting in the hump in the road above.
- 4.6 The below the road section, acrow props are corroding and the timber beams they were bearing on are decayed.

Figure 5: Concrete spalled and joists corroded (left), acrow props are corroding and the timber beams decayed (right).

- 5.4 The top section of the tunnel directly below the road has been replaced by a filler-joist system with concrete relieving slab resulting in the hump in the road above. The underside of the joists are corroding and have been propped with acrow props between timber spreader beams.

- 5.5 The acrow props are corroding and the timber beams have decayed to the point where these measures are no longer touching the filler-joist floor above rendering them ineffective.

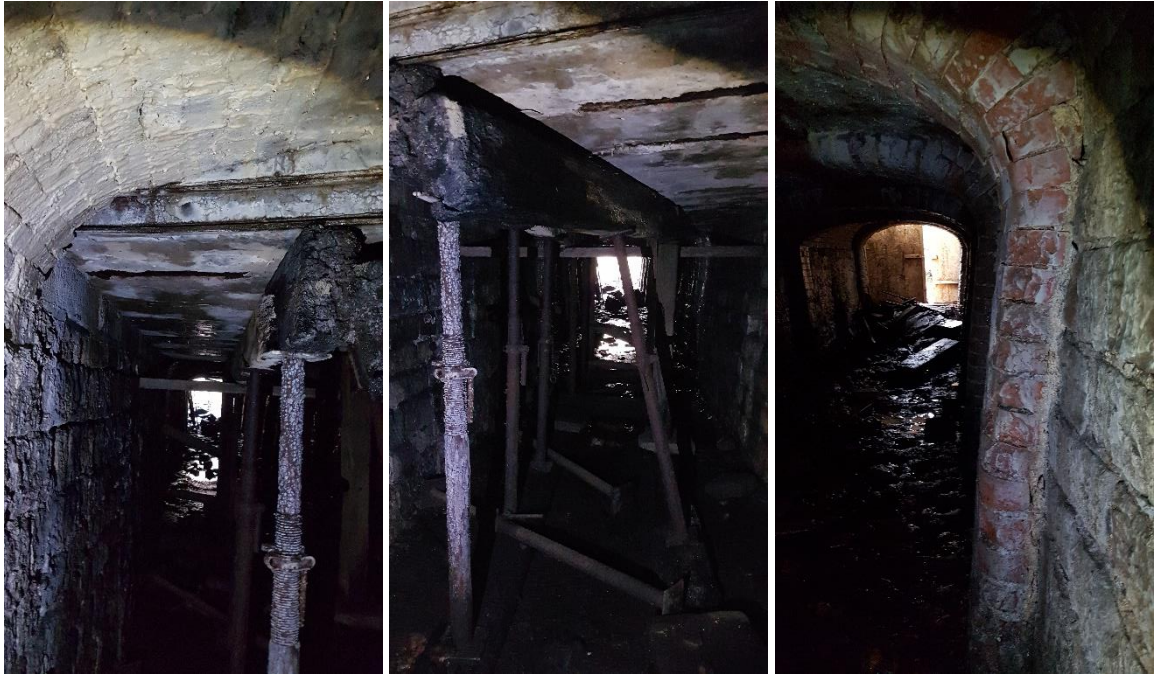
Figure 6: Filler joist section propped (left and centre), verticality of walls deformed (right).

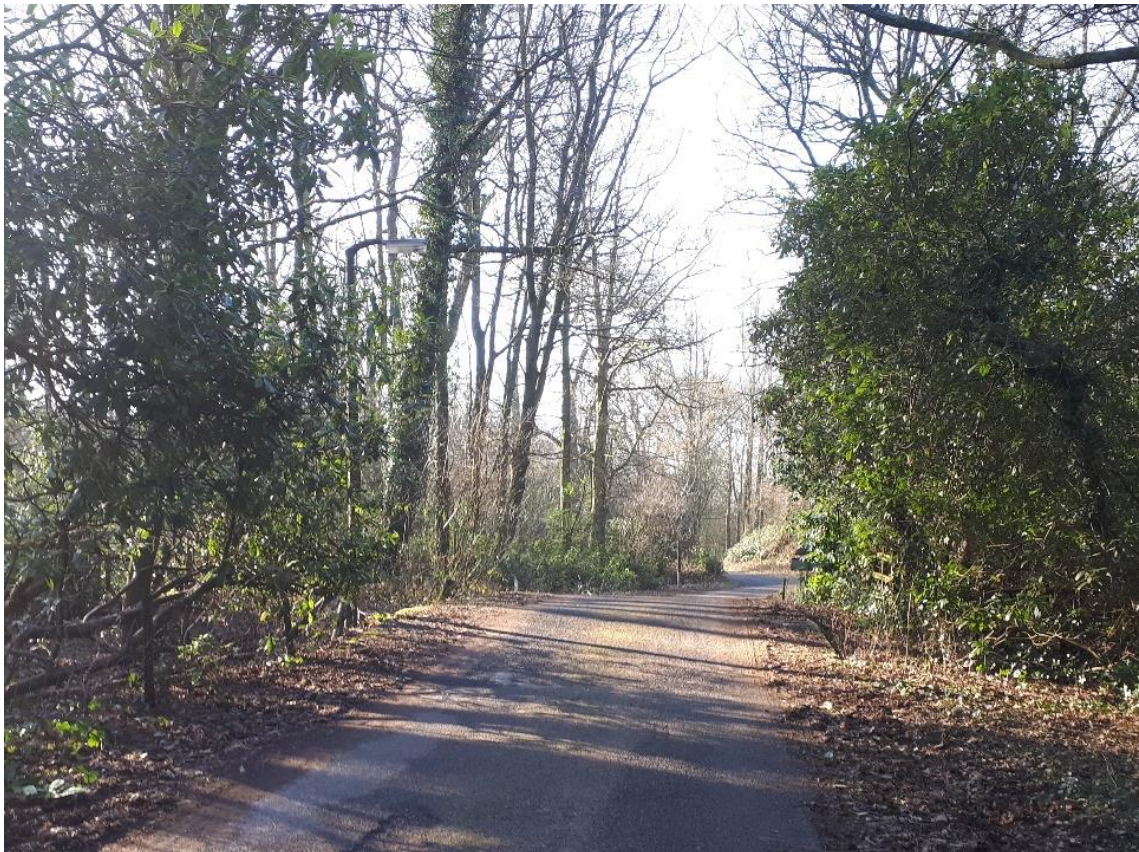
4.7 No deformation or structural defects were noted in carriageway finishes above tunnel.

Figure 7: View of the hump in the road above tunnel looking west.

- 5.6 The carriageway crossing over the bridge does not show signs of distress/ deformation. In this respect, engineering judgement suggests that the bridge is suitable for light vehicles i.e cars only.

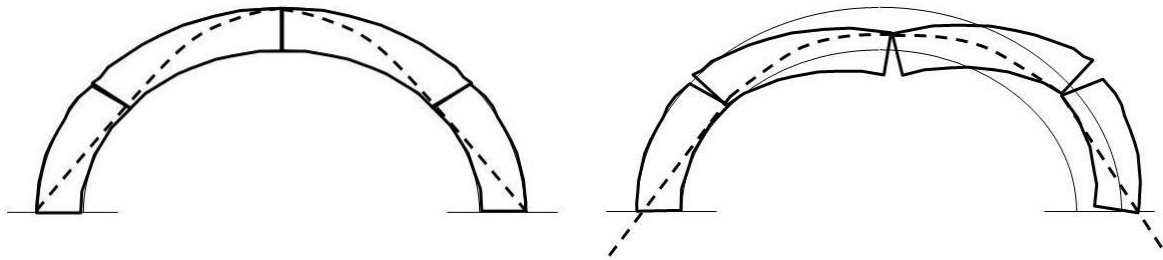
Figure 8: Thrust line through undeformed barrel vault (left), collapse mechanism created in deformed barrel vault (right)

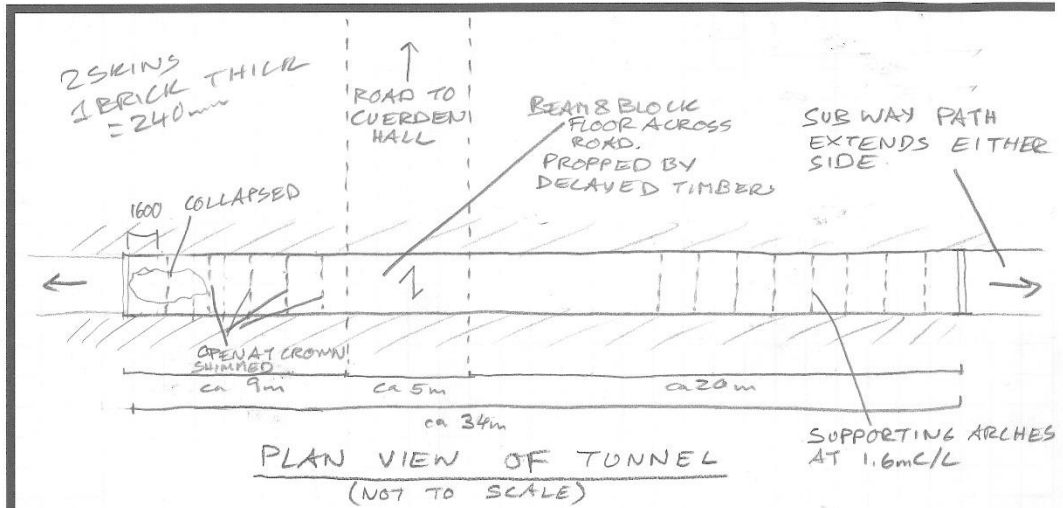
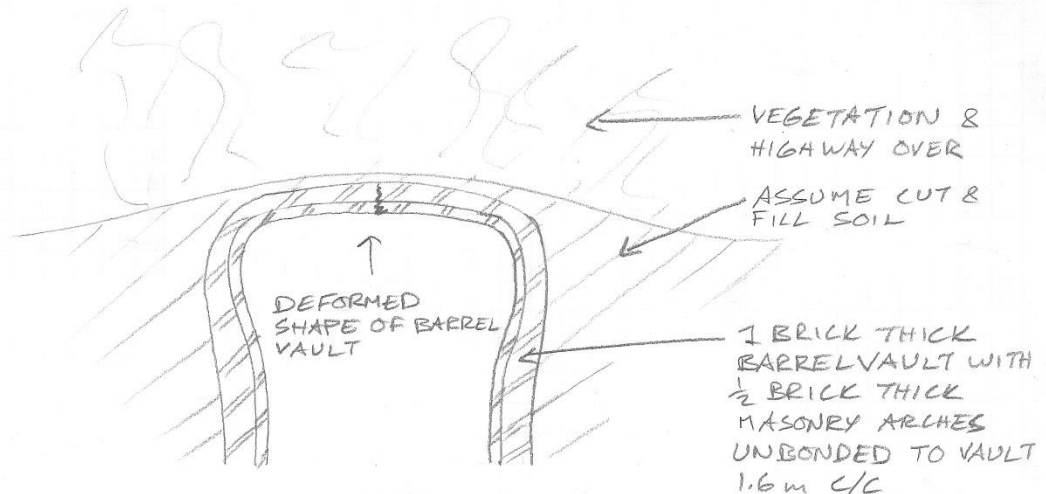
- THIS TUNNEL IS IN A DANGEROUS CONDITION
- THE BARREL VAULT IS PARTIALLY COLLAPSED
- SOME OF THE ARCHES HAVE COLLAPSED, THE REMAINING ARCHES ARE UNBONDED.
- APPEARS TO BE A CUT & FILL PASSAGE WHERE THE SOIL ON EITHER SIDE WAS NOT COMPACTED/ STRONG ENOUGH TO RETAIN THE THRUST FROM THE ARCHING BARREL VAULT. THIS HAS LED TO ITS ARTICULATION TO THE POINT OF SUBSEQUENT COLLAPSE
- TOP DOWN INVESTIGATION REQUIRED OF REINFORCEMENT BELOW ROAD.
- CAREFUL DEMOLITION & EITHER REBUILD OR INFILL REQ.
