Client: SHENTON GROUP

Project: CUERDEN HALL

Orig Title: SURVEY RECORD DRAWINGS, GROUND FLOOR PLAN

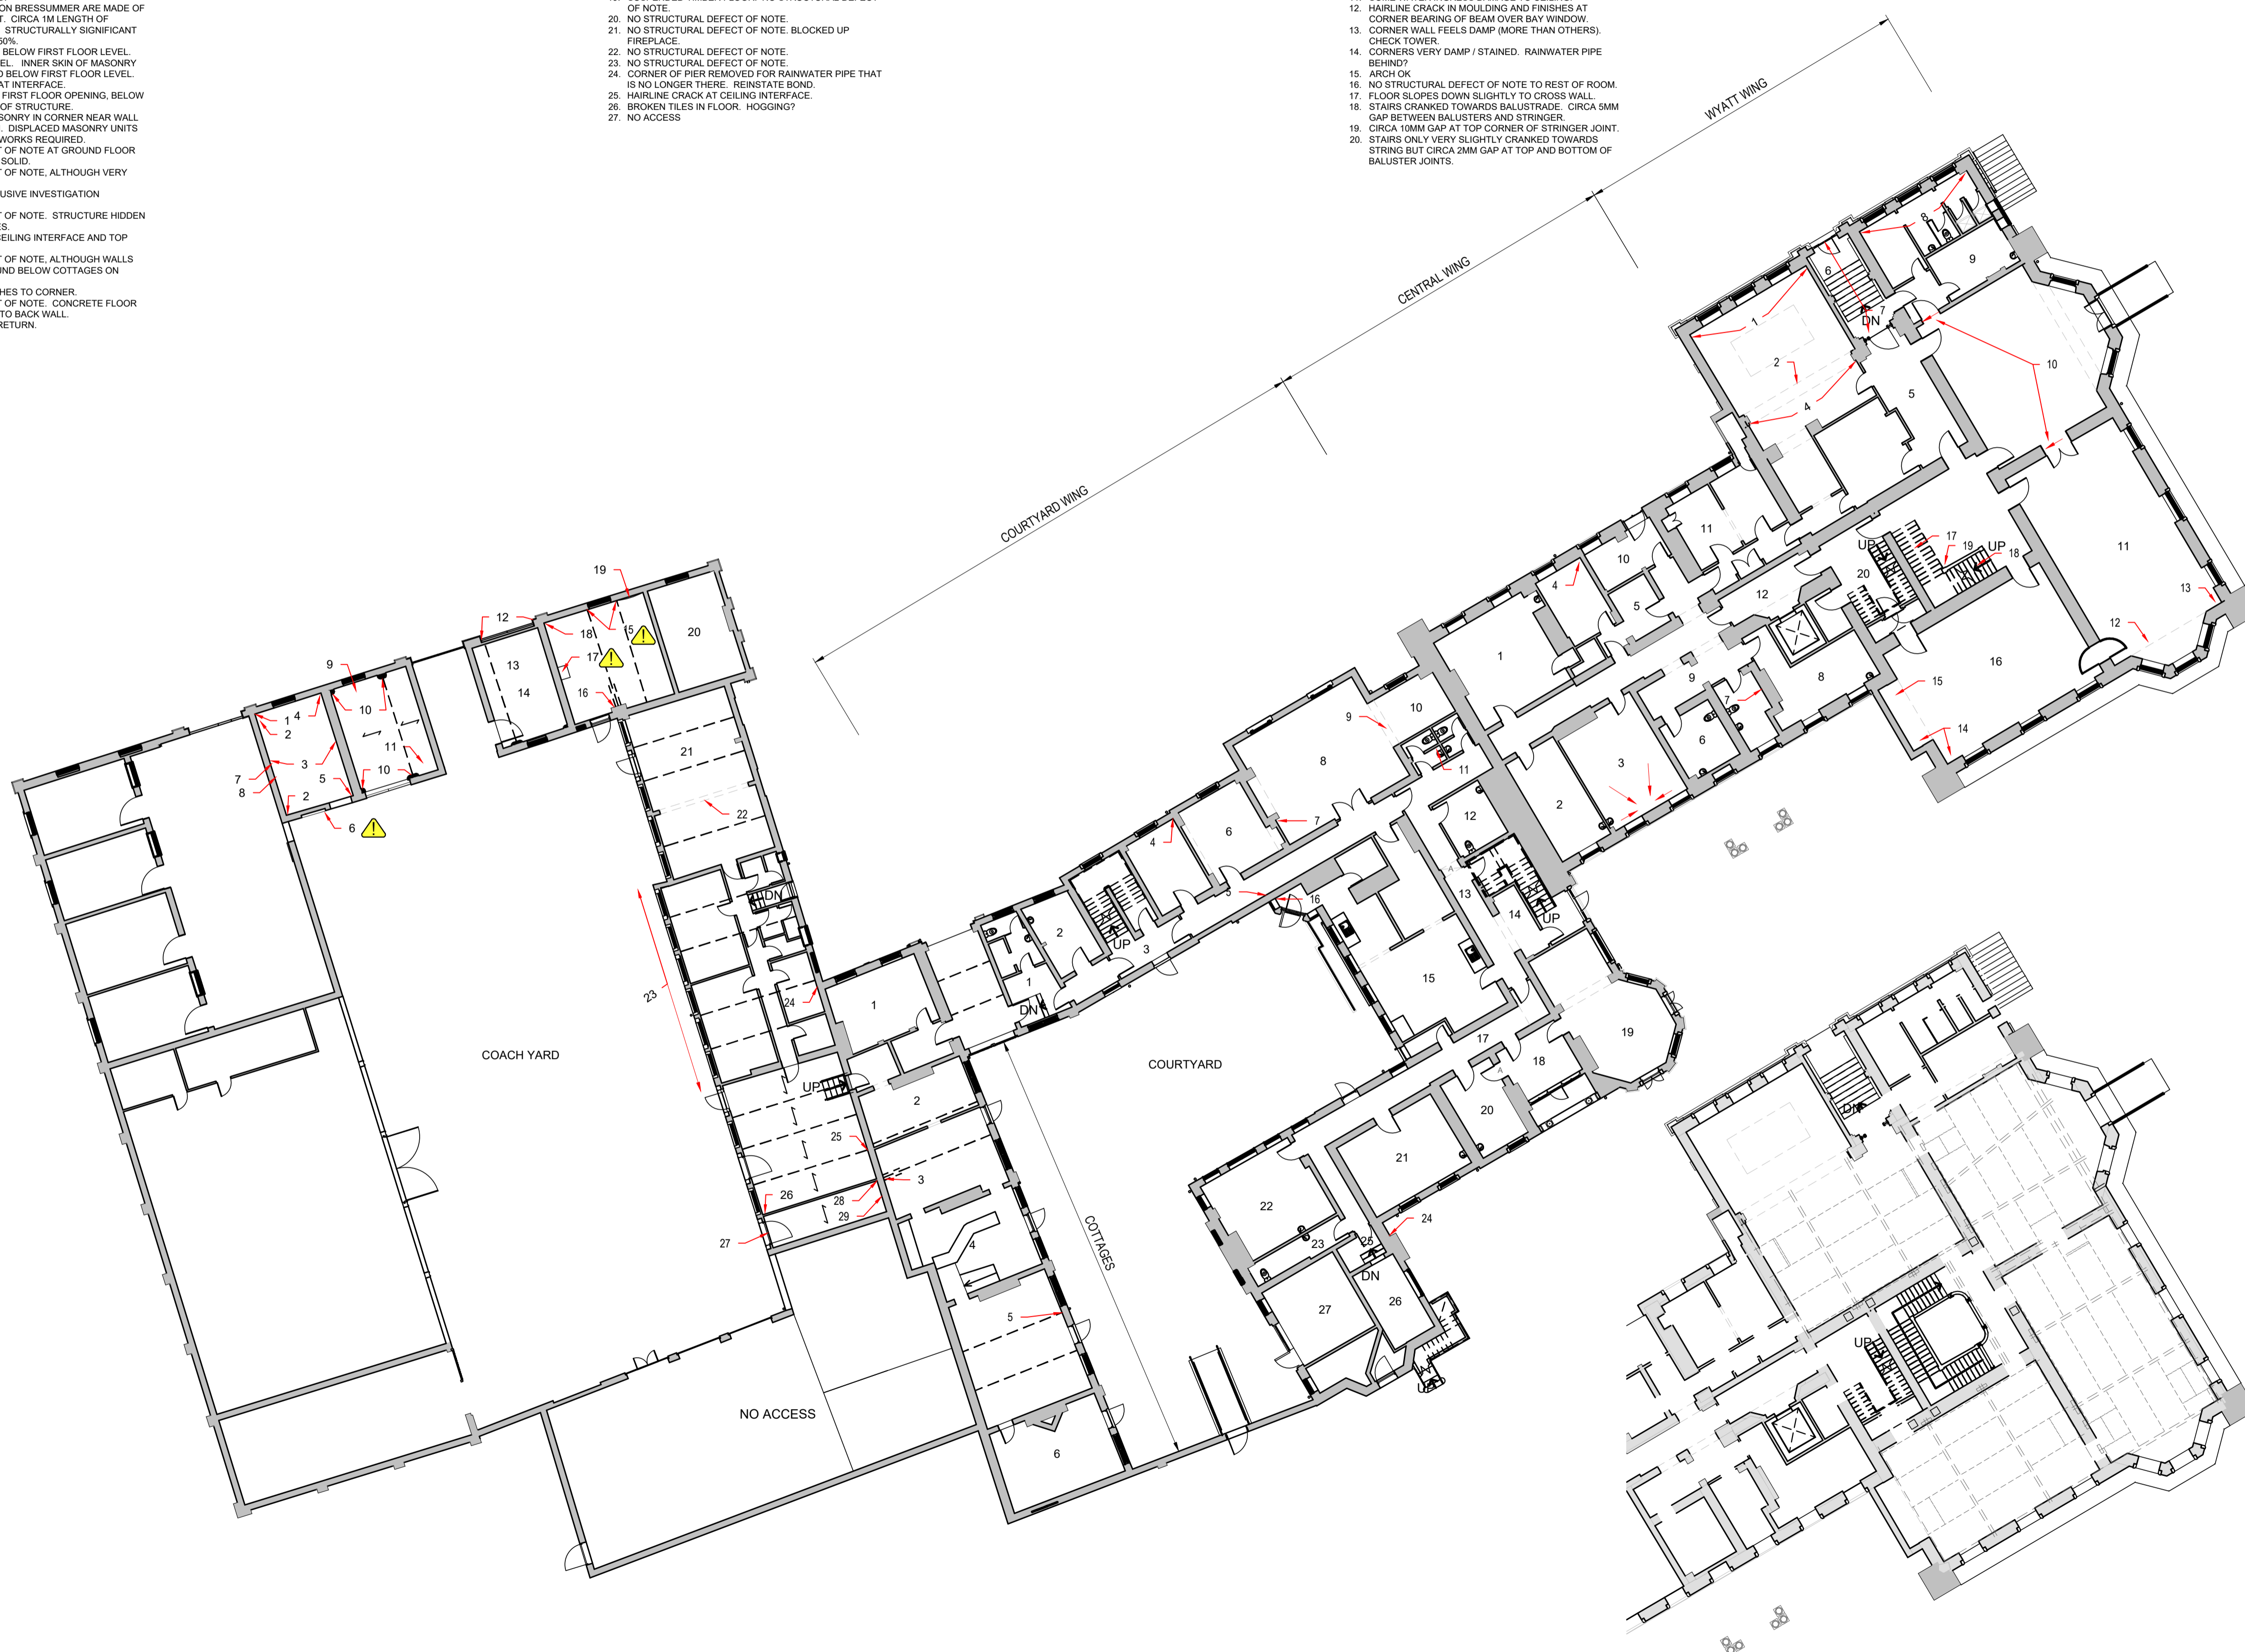
GROUND FLOOR PLAN
1:200

- CORNER BOND APPEARS TIGHT.
- DIAGONAL ROOF MEMBER EMBEDDED IN WALL EITHER SIDE DECAYED. STEEL BRACE ADDED.
- POTHLES FOR JOISTS IN MASONRY WALL EITHER SIDE.

- HAIRLINE CRACK UP CORNER RETURN.
- UNBONDED CIRCA 3-4MM GAP AT BUTT JOINT INTERFACE.
- THIS FLANK WALL SECTION IS IN POOR CONDITION. INTERNAL MASONRY SKIN UNSUPPORTED ABOVE FLAT ARCHED OPENING. MASONRY UNITS MISSING / LOOSE. WALL BUCKLES IN SECTION.

- LOOSE / DISPLACED / MISSING MASONRY AT WALL HEAD REVEALS OUTER FLANGE OF EMBEDDED STEEL COLUMN. EMBEDDED TIMBER LINTEL DECAYED OVER INFILLED OPENING.

- INFILLED ARCHWAY. GEOMETRY SOUND.
- PIERS APPEAR WELL BONDED TO EXTERNAL MASONRY.
- JOISTS BUT NO FLOOR ABOVE.
- OUTLINE OF CIRCULAR WINDOWS VISIBLE INTERNALLY. SOLID CONCRETE FLOOR.

- NO STRUCTURAL DEFECT OF NOTE AT GROUND FLOOR. BRESSUMMER BEAMS DECAYED (CIRCA 400-1000MM FROM WALL). SECTION LOSS VISIBLE. SOME REMEDIAL TIMBER INSTALLED BUT INEFFECTIVE. REMEDIAL REPAIRS / REPLACEMENT REQUIRED.

- REMEDIAL ROT REPAIRS ON BRESSUMMER ARE MADE OF TIMBER. CHECK FOR ROT. CIRCA 1M LENGTH OF BRESSUMMER DECAYED. STRUCTURALLY SIGNIFICANT SECTION LOSS VISIBLE - 40%.

- CHIMNEY UNSUPPORTED BELOW FIRST FLOOR LEVEL. STOPS UNDER ROOF LEVEL. INNER SKIN OF MASONRY BEHIND IS UNSUPPORTED BELOW FIRST FLOOR LEVEL. LOOSE MASONRY UNITS AT INTERFACE.

- LOOSE MASONRY ABOVE FIRST FLOOR OPENING. BELOW CORNER BEARING OF ROOF STRUCTURE.
- LOCALISED BULGE IN MASONRY IN CORNER NEAR WALL HEAD. SKIN SEPARATION. DISPLACED MASONRY UNITS CIRCA 4MM. REMEDIAL WORKS REQUIRED.

- NO STRUCTURAL DEFECT OF NOTE AT GROUND FLOOR LEVEL. FLOOR APPEARS SOLID.
- NO STRUCTURAL DEFECT OF NOTE, ALTHOUGH VERY DAMP.
- BEAMED OPENING? INTRUSIVE INVESTIGATION REQUIRED.

- NO STRUCTURAL DEFECT OF NOTE. STRUCTURE HIDDEN BEHIND MODERN FINISHES.
- HAIRLINE CRACKING AT CEILING INTERFACE AND TOP 500MM OF CORNERS.
- NO STRUCTURAL DEFECT OF NOTE, ALTHOUGH WALLS SHOW DAMP FROM GROUND BELOW COTTAGES ON OTHER SIDE.

- HAIRLINE CRACK IN FINISHES TO CORNER.
- NO STRUCTURAL DEFECT OF NOTE. CONCRETE FLOOR SLOPES STEEPLY DOWN TO BACK WALL.
- OPEN JOINT IN CORNER RETURN.
- INFILLED OPENING.

- OLD PLANT ROOM. SOLID FLOOR. NO STRUCTURAL DEFECT OF NOTE. STRUCTURE HIDDEN BY FINISHES.
- NO STRUCTURAL DEFECT OF NOTE TO KITCHEN. STRUCTURE HIDDEN BEHIND MODERN FINISHES. CHIMNEY BLOCKED.
- STEEL SPLICE REPAIR VISIBLE ON BEAM END.
- NO STRUCTURAL DEFECT OF NOTE. STRUCTURE HIDDEN BEHIND MODERN FINISHES.
- STRUCTURE HIDDEN BEHIND MODERN FINISHES. EXTERNAL WALL IS DAMP EVEN AT CEILING LEVEL. CHECK BEAM EMBEDDED ENDS FOR ROT.
- NO STRUCTURAL DEFECT OF NOTE, ALTHOUGH HAIRLINE CRACKS IN FINISHES AROUND INFILLED OPENING.

- NO STRUCTURAL DEFECT OF NOTE TO BATHROOM AND ENTRANCE.
- NO STRUCTURAL DEFECT OF NOTE.
- NO STRUCTURAL DEFECT OF NOTE.
- CORNER DAMP. RAINWATER PIPE LOCATION EXTERNAL. CLEAR WATER INGRESS.

- NO STRUCTURAL DEFECT OF NOTE.
- EMBEDDED METALWORK / MACHINERY IN WALL. NO STRUCTURAL DEFECT OF NOTE.
- DOUBLE HEIGHT SPACE.
- BEAMED OPENING CRANKED DOWN.

- NO STRUCTURAL DEFECT OF NOTE TO ALCOVE.
- NO STRUCTURAL DEFECT OF NOTE TO BATHROOMS.
- MINOR CRACKING IN CEILING FINISHES. NO STRUCTURAL DEFECT OF NOTE.

- NO STRUCTURAL DEFECT OF NOTE TO CORRIDOR.
- NO STRUCTURAL DEFECT OF NOTE TO STAIRWELL AND AREA UNDER STAIRS.
- NO STRUCTURAL DEFECT OF NOTE TO KITCHEN. STRUCTURE HIDDEN BEHIND MODERN FINISHES.

- EVIDENCE OF WATER INGRESS BEHIND TILES.
- NO STRUCTURAL DEFECT OF NOTE TO CORRIDOR.
- NO STRUCTURAL DEFECT OF NOTE. ARCH GEOMETRY SOUND.
- SUSPENDED TIMBER FLOOR. NO STRUCTURAL DEFECT OF NOTE.

- NO STRUCTURAL DEFECT OF NOTE.
- NO STRUCTURAL DEFECT OF NOTE. BLOCKED UP FIREPLACE.
- NO STRUCTURAL DEFECT OF NOTE.
- CORNER OF PIER REMOVED FOR RAINWATER PIPE THAT IS NO LONGER THERE. REINSTATE BOND.

- HAIRLINE CRACK AT CEILING INTERFACE.
- BROKEN TILES IN FLOOR. HOGGING?
- NO ACCESS.

- NO STRUCTURAL DEFECT OF NOTE.
- NO STRUCTURAL DEFECT OF NOTE.
- FLOOR SLOPES SLIGHTLY TO PIER BETWEEN WINDOWS. WINDOW OPENING CRANKED IN SAME DIRECTION.
- WATER INGRESS AND SOLUBLE SALT PENETRATION VISIBLE AT GROUND FLOOR LEVEL.
- NO STRUCTURAL DEFECT OF NOTE.
- EMBEDDED METALWORK / MACHINERY IN WALL. NO STRUCTURAL DEFECT OF NOTE.
- SOME HAIRLINE CRACKING THROUGH FINISHES AT CROWN OF ARCH.
- NO STRUCTURAL DEFECT OF NOTE.
- NO STRUCTURAL DEFECT OF NOTE. ARCH GEOMETRY SOUND.
- NO STRUCTURAL DEFECT OF NOTE.
- NO STRUCTURAL DEFECT OF NOTE.

- WATER INGRESS IN TWO NORTHERN CORNERS OF ROOM.
- SOME MOVEMENT IN THE MOULDING AROUND THIS BEAM LOCATION IS APPARENT. HAIRLINE TO 10MM GAP THROUGHOUT. FROM OLD PLANS IT APPEARS A BEAM IN THE FLOOR ABOVE BEARS ONTO THE MIDPOINT. INVESTIGATE CONDITION OF BEAM.

- INFILL STRUCTURES OPEN TO THE CEILING ABOVE. SOME HAIRLINE CRACKING VISIBLE IN MOULDING ON CORNER RETURNS.
- NO STRUCTURAL DEFECT OF NOTE TO ENTRANCE. SIGNIFICANT WATER INGRESS / DECAY IN THIS FRONT SECTION. SOLUBLE SALTS PENETRATING THROUGH MASONRY AT FARISES. FABRIC REPAIR AND REPOINTING REQUIRED.

- ARCH GEOMETRY OK BUT JOINTS HAVE OPENED AT CROWN INTRADOS, PARTICULARLY ABOVE INTERNAL DOOR. MICROGROUT REQUIRED.
- WATER INGRESS EVIDENT THROUGHOUT BUT PARTICULARLY IN CORNERS. SOLUBLE SALTS PUSHING TILES OFF THE WALL.

- NO STRUCTURAL DEFECT OF NOTE.
- DOOR OPENINGS CRANKED DOWN SLIGHTLY. NO STRUCTURAL DEFECT OF NOTE TO ROOM.
- SOME WATER INGRESS DAMAGE TO CEILING.
- HAIRLINE CRACK IN MOULDING AND FINISHES AT CORNER BEARING OF BEAM OVER BAY WINDOW.

- CORNER WALL FEELS DAMP (MORE THAN OTHERS). CHECK TOWER.
- CORNERS VERY DAMP / STAINED. RAINWATER PIPE BEHIND?
- ARCH OK.
- NO STRUCTURAL DEFECT OF NOTE TO REST OF ROOM.

- FLOOR SLOPES DOWN SLIGHTLY TO CROSS WALL.
- STAIRS CRANKED TOWARDS BALUSTRADE. CIRCA 5MM GAP BETWEEN BALUSTERS AND STRINGER.
- CIRCA 10MM GAP AT TOP CORNER OF STRINGER JOINT.

- STAIRS ONLY VERY SLIGHTLY CRANKED TOWARDS STRING BUT CIRCA 2MM GAP AT TOP AND BOTTOM OF BALUSTER JOINTS.
