SHENTON GROUP

CUERDEN HALL

**SURVEY RECORD DRAWINGS,
STABLEYARD EXTERNAL ELEVATIONS**

077572 - CUR - ZZ - ZZ - DR - S - 21003 - 02

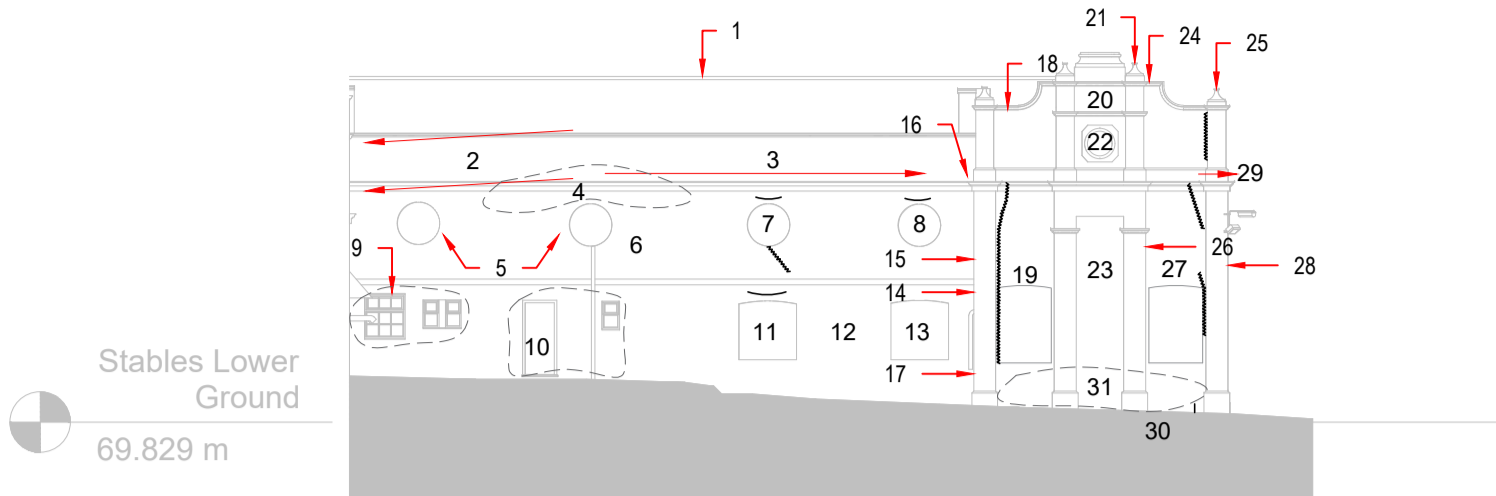
ELEVATION L
1:200

ZONE 04 : ELEVATION L

1. RIDGELINE UNULATES.
2. TOP OF PARAPET AND STRING COURSE TEND DOWN TOWARDS THE COURTYARD INTERFACE FROM SECOND CIRCLE FEATURE CIRCA 30MM.
3. TOP OF PARAPET AND STRING COURSE TEND DOWN TOWARDS DECORATED GABLE FROM SECOND CIRCLE FEATURE CIRCA 30MM OVER LENGTH.

4. OUTWARD BOW ON PLAN OF WALL AT THIS LOCATION. STRING COURSE AND PARAPET FOLLOW OUTWARD BOW.
5. GEOMETRY SOUND TO CIRCULAR FEATURES. BED JOINTS OF INFILL MASONRY TEND TO LEFT, COMPARED WITH SURROUNDING MASONRY.

6. BED JOINT UNULATES SLIGHTLY IN THIS SECTION ALTHOUGH NO STRUCTURAL DEFECT OF NOTE.
7. MASONRY ABOVE CROWN OF CIRCULAR FEATURE SAGGING SLIGHTLY. GEOMETRY OF CIRCULAR FEATURE APPEARS FLATTENED / PUSHED IN ON LOWER RIGHT SIDE. DIAGONAL HARKLINE CRACK WITH OPEN JOINTS TRACKING DOWN FROM THIS LOCATION.

8. MASONRY ABOVE CIRCULAR FEATURE SAGS SLIGHTLY AND OPEN JOINTS AT CROWN. GEOMETRY TO BOTTOM OF CIRCLE APPEARS CUSPED.
9. AN ALTERATION APPEARS TO HAVE TAKEN PLACE AT GROUND LEVEL TO INSTALL TWO SMALL WINDOWS IN A DIFFERENT STYLE TO THE OTHER ELEVATIONS. CEMENT POINTING NOW CRACKED IN PLACES. WELL BONDED TO SURROUNDING MASONRY.

10. ANOTHER ALTERATION FOR A LINTELLED DOORWAY AND A SMALL WINDOW. RELAYED WITH MODERN BRICKS AND CEMENT MORTAR. PARTLY BONDED TO EXISTING EITHER SIDE BUT INEFFECTIVE IN PLACES. REPOINTING OR CONSOLIDATION RECOMMENDED.

11. MASONRY ABOVE FLAT ARCH SAGS AS FLAT ARCH HAS ARTICULATED. OPENING REASONABLY SQUARE BUT BED JOINTS IN INFILL PANEL TEND DOWN TO LEFT, AS DOES INFILLED CILL.

12. UNSUCCESSFUL ATTEMPTS HAVE BEEN MADE FOR FABRIC REPAIR OF INDIVIDUAL BRICKS WHERE THESE HAVE SPALLED DUE TO EMBEDDED METAL WORK. ORIGINAL MASONRY LAYED IN A VARIETY OF ENGLISH GARDEN BOND.

13. RELATIVELY SQUARE. ALTHOUGH SLIGHT HOG IN CILL.
14. ALTERATION ABOVE OPENING IN RETURN. NEW LINTEL AND CEMENT MORTAR ABOVE. SOME BRICKS CORBELLING ABOVE DOWNPIPE.

15. CRACKING AT CORNER RETURNS 10MM WEST SIDE (MASONRY PANEL LOOSE AND HANGING ABOVE LINTEL) AND 30MM EAST SIDE.
16. STRING COURSE ON RETURN LEANS WEST (INTO PAGE).

17. PIER BOWS OUT VERTICALLY BOTH SIDES CIRCA 50MM RETURNING A WALLHEAD. MAXIMUM DISPLACEMENT AT HEIGHT OF OPENING ALTERATIONS.
18. TOP OF PIER LEANS OUT CIRCA 20MM OVER HEIGHT. OPEN JOINT BETWEEN TOP OF PIER AND DECORATIVE WALLHEAD CIRCA 15MM.

19. VERTICAL CRACK UP RETURN OF PIER CIRCA 5-15MM THICK DOWN TO JAMB OF INFILLED OPENING BELOW. FLAT ARCH NOT EFFECTIVE FULL THICKNESS.
20. STRING COURSE TENDS DOWN SLIGHTLY TOWARDS CENTRE. VEGETATION GROWING HIGH LEVEL.

21. TOP OF FINIAL BROKEN OFF.
22. GEOMETRY SOUND. CLOCK REMAINS. NO STRUCTURAL DEFECT OF NOTE.
23. GEOMETRY OF PIERS ETC SQUARE. NO STRUCTURAL DEFECT OF NOTE THIS CENTRAL SECTION.

24. OPEN JOINT IN COPING CIRCA 30MM.
25. FINIAL BROKEN OFF.
26. PIER NOT WELL BONDED. JOINTS OPENING AT INTERFACES.
27. CRACKING ALONG FULL HEIGHT OF PIER RETURN INTERFACE. THICKNESS VARIES BETWEEN HARKLINE AND 20MM.

28. OUTWARD LEAN OF CORNER PIER BOTH DIRECTIONS. MAXIMUM DISPLACEMENT CIRCA 40MM AT STRING COURSE LEVEL.
29. STRING COURSE LEANS DOWN TO CORNER.
30. WHOLE GABLE ELEVATION BOWS OUT IN SECTION. MAXIMUM DISPLACEMENT AT MID POINT OF CENTRAL PIERS CIRCA 50-60MM. DECORATIVE PARAPET HEIGHT ABOVE LEANS IN / BOWS IN ON PLAN CIRCA 20MM OVER ITS HEIGHT.

31. FABRIC REPAIR REQUIRED TO MASONRY AT LOWER LEVEL.

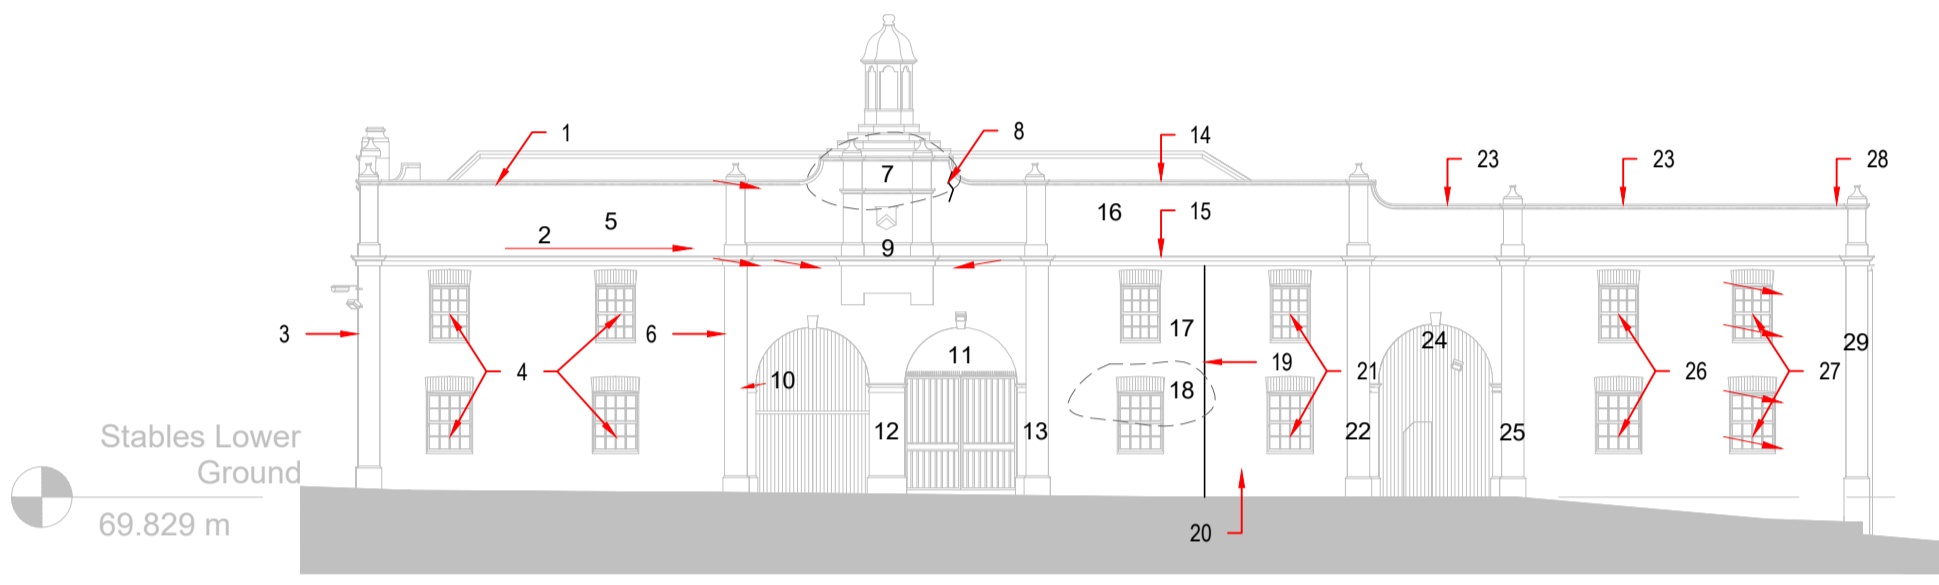
ELEVATION M
1:200

ZONE 04 : ELEVATION M

1. TOP OF PARAPET STRAIGHT AND LEVEL. ALTHOUGH OPEN PERPEND JOINTS BETWEEN COPES.
2. STRING COURSE LEANS DOWN TOWARDS CENTRAL PIERS.
3. CORNER PIER LEANS OUT BOTH DIRECTIONS. PARTLY BONDED TO MASONRY FACADE AT RETURN. 5-8MM THICK CRACK UP RETURN.

4. WINDOW OPENINGS SQUARE. FLAT ARCHES AND STONE CILL NO STRUCTURAL DEFECTS OF NOTE.
5. MASONRY SPALLING AT HIGH LEVEL ON PARAPET. LARGE PIECES ON THE GROUND.

6. MASONRY CENTRAL PIER APPEARS PLUMB FACE ON, BUT LEANS OUT SLIGHTLY AS OBSERVED FROM EAST. HARKLINE TO 5MM THICK CRACK UP LEFT RETURN BUT NONE ON RIGHT SIDE. STRING COURSE LEANS / CRANKED AT HIGH LEVEL.

7. MASONRY IN CENTRAL SECTION OF PARAPET HEAVILY WEATHERED. OPEN JOINT BETWEEN COPES AND VEGETATION GROWING.
8. VERTICAL CRACKING FROM COPES UTIL. HALFWAY DOWN PARAPET.

9. STRING COURSE CRANKED DOWN TOWARDS CENTRAL SECTION.
10. ARCH OPENING GEOMETRY SOUND. LEFT SPRINGER ROTATED. NO STRUCTURAL DEFECT OF NOTE TO ARCH.
11. ARCH GEOMETRY SOUND. ALTHOUGH SKIN SEPARATION WITH INNER ARCH CIRCA 15-20MM AT CROWN. 3 NO. MASONRY UNITS IN ARCH DECAYED / SPALLING.

12. NO STRUCTURAL DEFECTS OF NOTE TO PIER.
13. PIER APPEARS PLUMB BOTH DIRECTIONS. BOTH RETURNS TIGHT.
14. TOP OF PARAPET UNULATES. COPES DISPLACED, OPEN PERPEND JOINTS, TENDING GRADUALLY DOWN TO WEST.

15. STRING COURSE TENDS DOWN TO WEST AND VEGETATION GROWING.
16. PARAPET MASONRY DECAYED AND SPALLING. FABRIC REPAIR REQUIRED.
17. WINDOW OPENING SQUARE. BRICK UNITS IN FLAT ARCH DECAYED.

18. MASONRY HEAVILY DECAYED IN THIS SECTION. OPEN JOINTS BETWEEN BRICK VOISSORS IN FLAT ARCH. FABRIC REPAIR REQUIRED. WINDOW OPENING SQUARE.
19. BUTT JOINT NOT PLUMB AND OPEN CIRCA 10MM GAP.

20. MASONRY IN THIS SECTION ENGLISH GARDEN BOND (HEADER AND 4 STRETCH).
21. WINDOW OPENINGS SQUARE.
22. MASONRY PIER APPEARS PLUMB BOTH DIRECTIONS. RETURNS TIGHT BOTH SIDES.

23. OPEN JOINT BETWEEN COPES ON TOP OF PARAPET, TENDING DOWN TO WEST CORNER.
24. PART OF ARCH OBSCURED BY VEGETATION. GEOMETRY OF VISIBLE SECTION NO STRUCTURAL DEFECT OF NOTE.

25. PIER OBSCURED BY VEGETATION.
26. RELATIVE SQUARE ALTHOUGH OBJECTIVE APPRAISAL OF GEOMETRY PRECLUDED BY VEGETATION AND HOARDING.
27. WINDOW OPENINGS CRANKED DOWN TO WEST CORNER.

28. 30MM GAP BETWEEN COPES.
29. PIER BOWING OUT BOTH DIRECTIONS. RETURNS TIGHT EITHER SIDE.

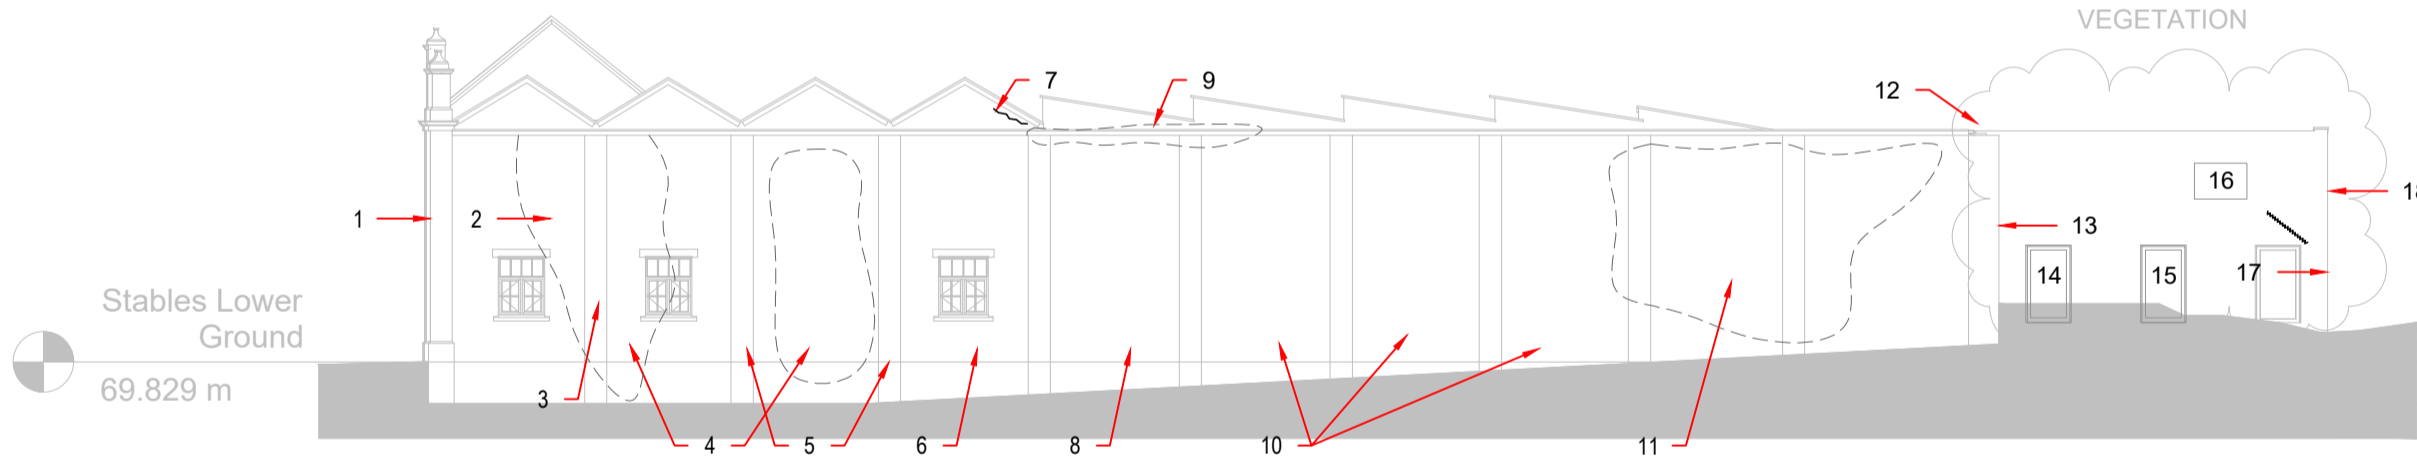
ELEVATION N
1:200

ZONE 04 : ELEVATION N

1. PIER LEANS IN SLIGHTLY OVER ITS HEIGHT, STRAIGHTENING UP AT WALL HEAD.
2. MASONRY SATURATED AND LACK OF MORTAR IN JOINTS. RAINWATER FROM CHANNEL BETWEEN ROOFS APPEARS TO DISCHARGE DIRECTLY ONTO MASONRY.

3. MASONRY PIER WELL BONDED TO GABLE WALLS.
4. VEGETATION COVERS THIS SECTION OF WALL.
5. MASONRY PIERS ARE PLUMB AND WELL BONDED. NO STRUCTURAL DEFECTS OF NOTE.

6. NO STRUCTURAL DEFECT OF NOTE TO THIS GABLE. WINDOW OPENING SQUARE. INDIVIDUAL BRICKS ARE DECAYED.
7. DIAGONAL CRACK ALONG EDGE OF GABLE WALL HEAD. APPEARS ADJACENT EAVES ARE JACKED UP.

8. MASONRY IN THIS SECTION SATURATED AND MOSS GROWTH.
9. GRASS GROWING AT EAVES LINE.
10. NO STRUCTURAL DEFECT OF NOTE TO THESE SECTIONS.
11. THIS SECTION HIDDEN BY VEGETATION. LACK OF MORTAR IN JOINTS.

12. MATURE VEGETATION JACKING OUT TOP 1M OF MASONRY PIER CIRCA 30-50MM. LARGE LOOSE BLOCKS OF MASONRY AT HIGH LEVEL UNSTABLE. TAKE DOWN AND REBUILD WELL BONDED.

13. VERTICALITY OF WALL ELEVATION APPEARS PLUMB.
14. BRICKED UP OPENING. FLAT ARCH ABOVE.
15. BRICKED UP WINDOW OPENING.
16. WINDOW OPENING IN MASONRY. FLAT ARCH ABOVE WITH SPLIT KEYSTONE SLIDING DOWN. DECAYED TIMBER SAFE LINTEL BEHIND. SILL JACKED OUT BY VEGETATION.

17. DIAGONAL HARKLINE CRACK ABOVE DOOR OPENING. SAG IN MASONRY ABOVE FLAT ARCH. TIMBER SAFE LINTEL BEHIND. TOP RIGHT CORNER OF OPENING LEANS OUT.
18. CORNER LEANS OUT OVER ITS HEIGHT.

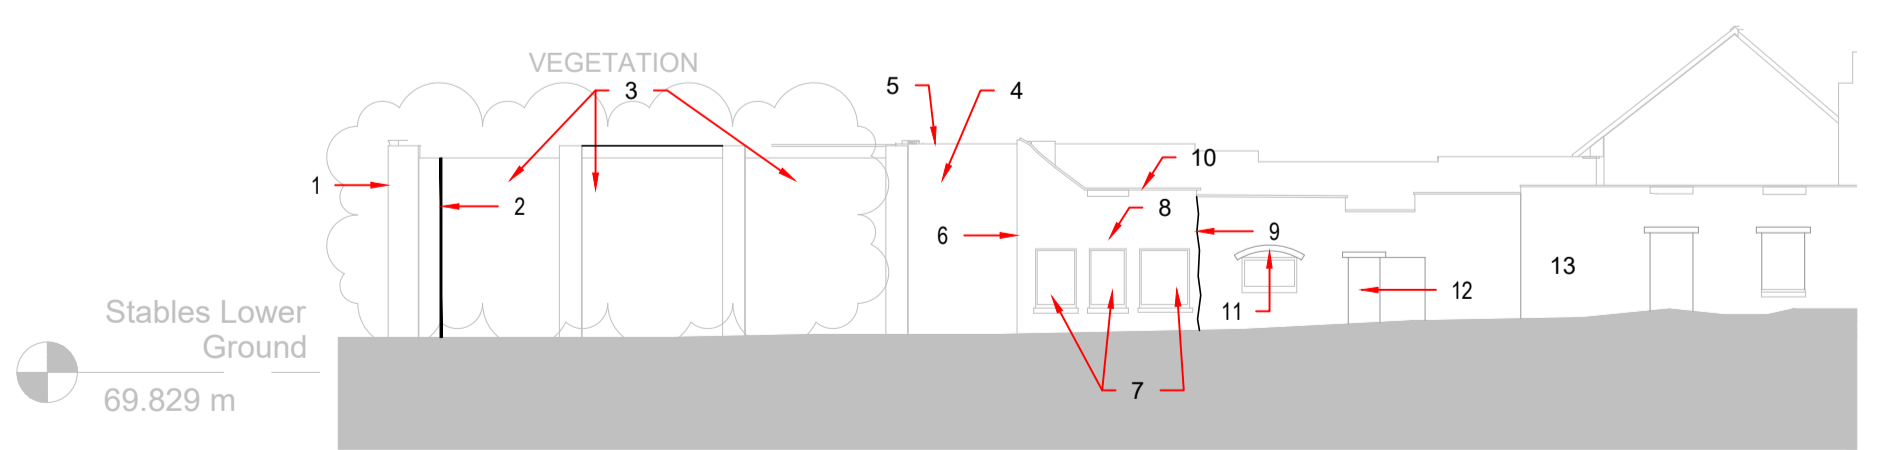
ELEVATION O
1:200

ZONE 04 : ELEVATION O

1. TOP 1M OF PIER LEANS OUT, AS PER ELEVATION N.
2. MASONRY BEHIND RAINWATER PIPE SATURATED AND MORTAR DECAYED IN JOINTS.
3. NO STRUCTURAL DEFECT OF NOTE, ALTHOUGH LOOSE MASONRY AT WALL HEAD.

4. 7 NO MATURE TREES IN CLOSE PROXIMITY TO WALL IN THIS SECTION. THESE MAKE IT DIFFICULT TO APPRAISE VERTICALITY. BUT WALL APPEARS TO BE LEANING OUT OVER ITS HEIGHT.

5. DISPLACED COPES IN THIS SECTION.
6. CORNER PLUMB LOOKING NORTH.
7. GEOMETRY OF BRICKED UP WINDOW OPENINGS APPEAR SQUARE. MASONRY WALL BULGES OUT OF PAGE CIRCA 40MM AT THIS LOCATION WITH MAXIMUM DISPLACEMENT ABOVE WINDOWS AND LEANING IN AT WALL HEAD. SKIN SEPARATION, PARTICULARLY OF PIER BETWEEN WINDOWS. CRACKS THROUGH RIGHT FLAT ARCH - FALLING.

8. OPEN JOINT AT BUTT JOINT.
9. COPES DISPLACED AT WALL HEAD.
10. ELLIPTICAL ARCH GEOMETRY SOUND. BLOCKED UP OPENING BELOW. TIMBER LINTEL DECAYED AND FAILING.

11. BLOCKED UP OPENING WITH STONE LINTEL BEARING ON HEAVILY DECAYED TIMBER. BED JOINTS IN MASONRY ABOVE SAGGING.
12. WALL LEANS OUT OVER ITS HEIGHT BY CIRCA 60MM. MAX DISPLACEMENT AT WALL HEAD.
