# Tunnel Condition Report

## S.1 Structural Condition Appraisal

Curtins Ref: B077572-CUR-ZZ-ZZ-RP-S-00001

Site Address: Cuerden Hall, Shady Ln, Bamber Bridge, Preston PR5 6AZ

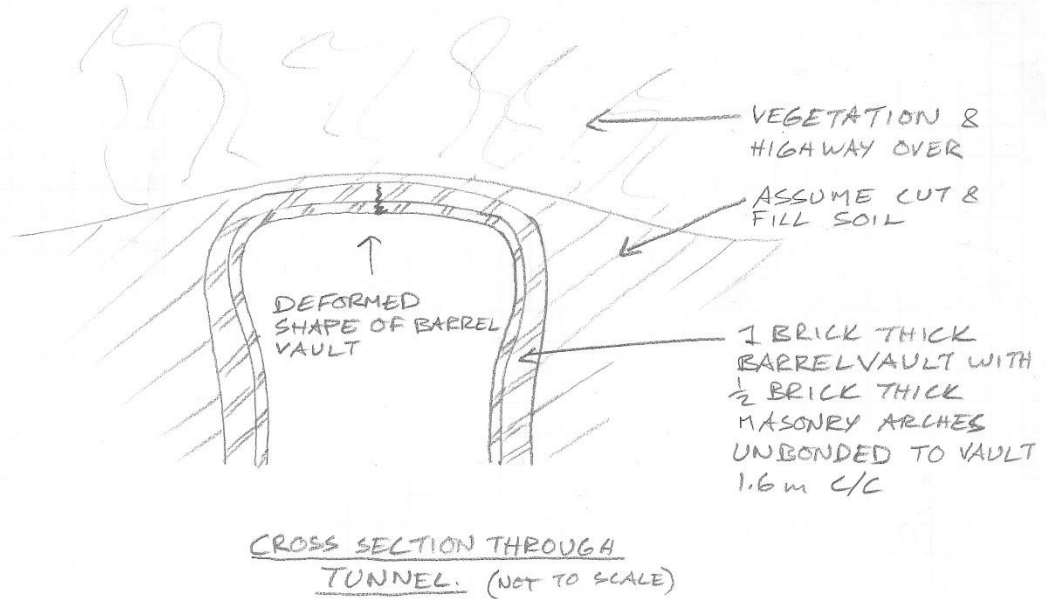
- THIS TUNNEL IS IN A DANGEROUS CONDITION
- THE BARREL VAULT IS PARTIALLY COLLAPSED
- SOME OF THE ARCHES HAVE COLLAPSED, THE REMAINING ARCHES ARE UNBONDED.
- APPEARS TO BE A CUT & FILL PASSAGE WHERE THE SOIL ON EITHER SIDE WAS NOT COMPACTED/ STRONG ENOUGH TO RETAIN THE THRUST FROM THE ARCHING BARREL VAULT. THIS HAS LED TO ITS ARTICULATION TO THE POINT OF SUBSEQUENT COLLAPSE
- TOP DOWN INVESTIGATION REQUIRED OF REINFORCEMENT BELOW ROAD.
- CAREFUL DEMOLITION & EITHER REBUILD OR INFILL REQ.
