Client: **SHENTON GROUP**

Project: **CUERDEN HALL**

Dwg Title: **SURVEY RECORD DRAWINGS, COURTYARD AND STABLEYARD ELEVATIONS**

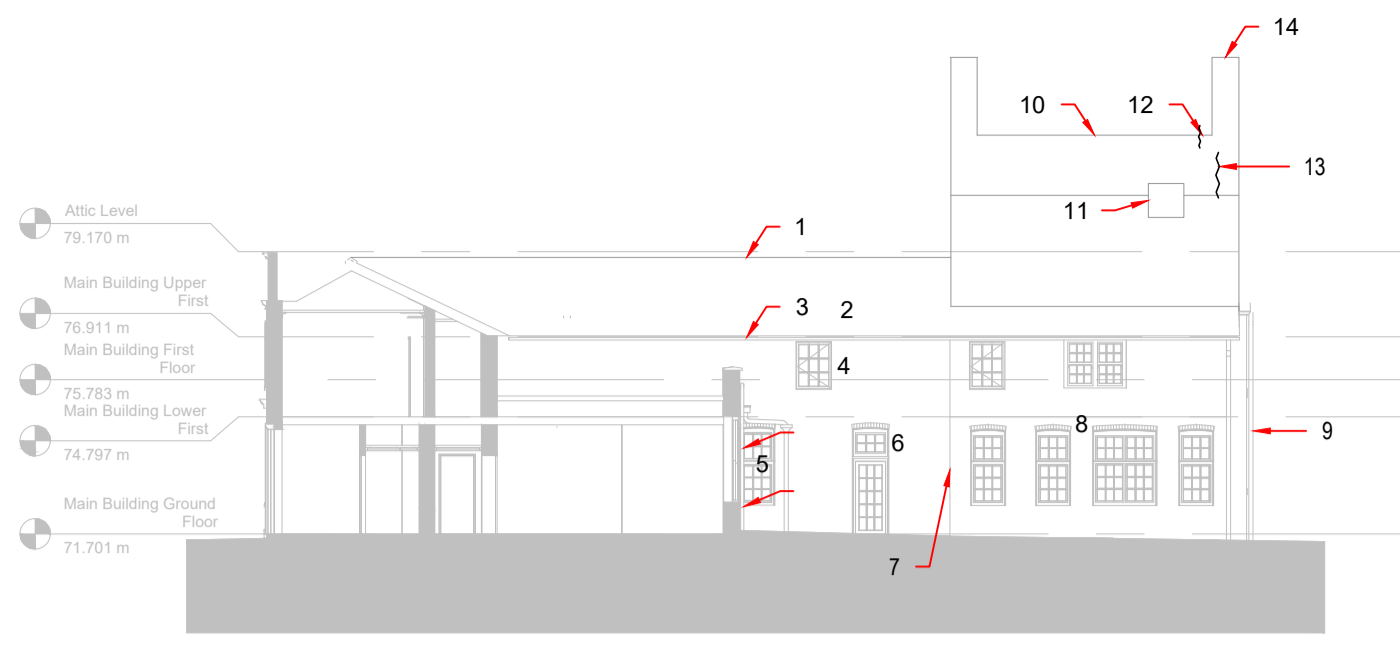
ELEVATION D
1:200

- ZONE 03 : ELEVATION D**
- RIDGELINE STRAIGHT AND LEVEL.
 - ROOF STRAIGHT.
 - EAVES LINE STRAIGHT AND LEVEL.
 - WINDOW OPENING RELATIVELY SQUARE.
 - GROUND FLOOR WINDOW CRANKED DOWN TOWARDS CORNER.
 - DOOR OPENING RELATIVELY SQUARE.
 - JUMP IN WALL ALIGNMENT APPEARS TIGHT.
 - ALL WINDOW OPENINGS SQUARE ON THIS SECTION. NO STRUCTURAL DEFECT OF NOTE.
 - CORNER VERTICALITY PLUMB.
 - WALL HEAD LEANS IN ON PLAN ABOVE STRING COURSE. OPEN PERPEND JOINTS BETWEEN COPIES.
 - JAMBS OF WINDOW OPENING LEANING IN.
 - GAP BETWEEN COPIES CIRCA 20-30MM.
 - TOP OF CORNER LEANS OUT ABOVE STRING COURSE. OPEN JOINTS / LACK OF MORTAR ALONG HAIRLINE CRACK.
 - TOP OF CHIMNEY HEAVILY WEATHERED. FABRIC REPAIR REQUIRED.

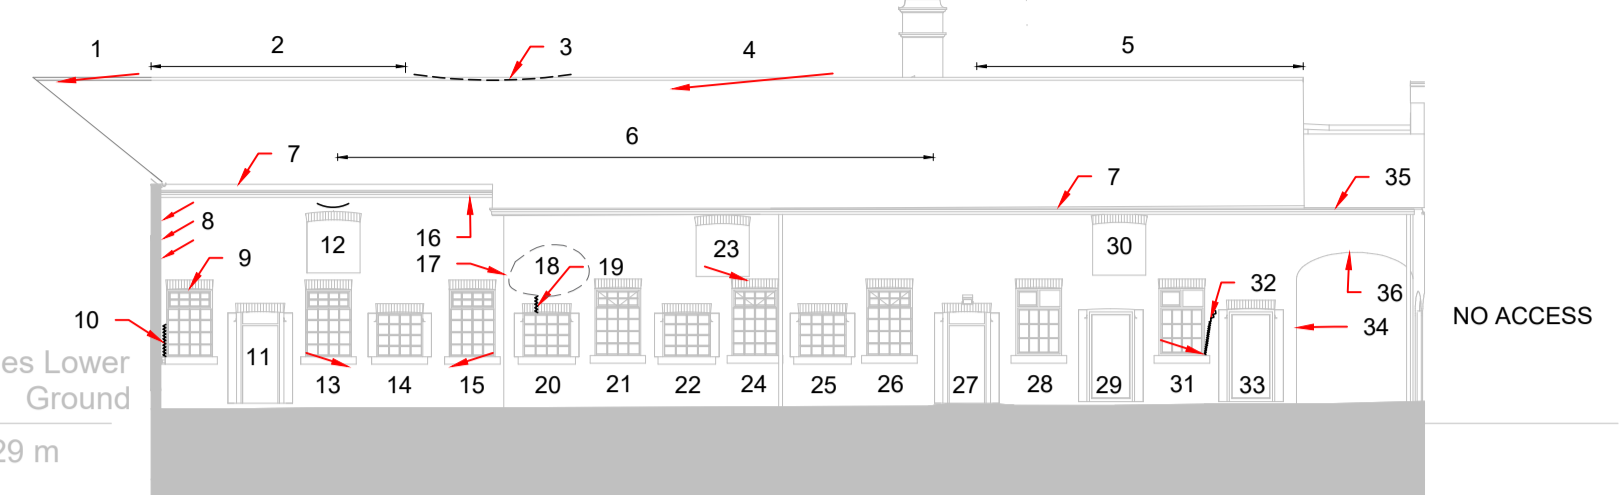
ELEVATION H
1:200

- ZONE 04 : ELEVATION H**
- RIDGELINE TENDS DOWN TO HIP VALLEY.
 - RIDGELINE STRAIGHT AND LEVEL.
 - SAG IN RIDGELINE.
 - RIDGELINE TENDS DOWN.
 - HOG IN RIDGELINE THEN UNDLATES ALONG REST OF LENGTH.

- SLOPE UNDLATES ACCORDING TO RIDGELINE.
 - EAVES LINE STRAIGHT AND LEVEL.
 - CIRCA 5MM CRACK UP RETURN ON WINDOW.
 - SQUARE.
 - BED JOINTS SAG ABOVE SHALLOW ARCH OVER OPENING.

- RELATIVELY SQUARE. PERHAPS VERY SLIGHT CRANK DOWN TO RIGHT.
 - OPENING APPEARS TO HAVE BEEN ALTERED FROM A DOORWAY TO A WINDOW. REINSTATEMENT OF SPANDREL WITH NEWER BRICKS (DIFFERENT SIZE) PARTLY BONDED TO EXISTING. SPLIT CILL AT MIDPOINT.

- RELATIVELY SQUARE. PERHAPS VERY SLIGHT CRANK DOWN TO LEFT.
 - GUTTER SUPPORTED BY TIMBER CANTILEVERS ALONG WHOLE ELEVATION.
 - CORNER BOWS OUT IN BOTH DIRECTIONS. RETURNING AT WALLHEAD.

- OUT OF PAGE BOW OF WALL IN THIS AREA CIRCA 20-25MM.
 - CIRCA 2MM THICK CRACK FROM VENT DOWN TO UNDERSIDE OF FLAT ARCH.
 - OPENING APPEARS TO HAVE BEEN ALTERED FROM A DOORWAY TO A WINDOW. REINSTATEMENT OF SPANDREL WITH NEWER BRICKS (DIFFERENT SIZE) PARTLY BONDED TO EXISTING. SPLIT CILL AT MIDPOINT.

- SQUARE.
 - OPENING APPEARS TO HAVE BEEN ALTERED FROM A DOORWAY TO A WINDOW. REINSTATEMENT OF SPANDREL WITH NEWER BRICKS (DIFFERENT SIZE) PARTLY BONDED TO EXISTING. SPLIT CILL AT MIDPOINT.

- SQUARE. RED JOINT UNDLATING. MASONRY FABRIC DECAYED IN SPANDREL.
 - CRANKED DOWN SLIGHTLY TOWARDS FLAT ARCH.
 - SQUARE. RED JOINT UNDLATING. MASONRY FABRIC DECAYED IN SPANDREL.

- OPENING APPEARS TO HAVE BEEN ALTERED FROM A DOORWAY TO A WINDOW. REINSTATEMENT OF SPANDREL WITH NEWER BRICKS (DIFFERENT SIZE) PARTLY BONDED TO EXISTING. SPLIT CILL AT MIDPOINT. DPM UNDER NEW BRICKS AT GROUND LEVEL WITH NO RETURN.

- MASONRY DECAY ON JAMBS AT LOWER LEVEL. OPENING SQUARE.
 - SQUARE.
 - SQUARE.
 - SQUARE.
 - SILL CRANKED DOWN TO RIGHT. SPLIT CILL AT MIDPOINT.
 - EMBEDDED METAL WITH 2MM CRACK ALONG JOINTS REDUCING TO HAIRLINE AT CILL (LEFT AND FLAT ARCH (RIGHT)).

- ARCH GEOMETRY OK BUT SKIN SEPARATION APPARENT. CIRCA 20MM BOTH IN ARCH AND IN MASONRY ABOVE.
 - JAMBS BOWING INWARDS SLIGHTLY BOTH SIDES OF OPENING AND BED JOINTS ABOVE FLAT ARCH SAG. ARCH APPEARS TO HAVE ARTICULATED BUT NO OPEN JOINTS.

- CORNER RELATIVELY PLUMB BOTH DIRECTIONS.
 - LOOSE MASONRY AND OPEN WALLHEADS.
 - MASONRY FABRIC HEAVILY DECAYED IN ARCH AND IN MASONRY ABOVE. GEOMETRY SHALLOW ARCH BUT OK.

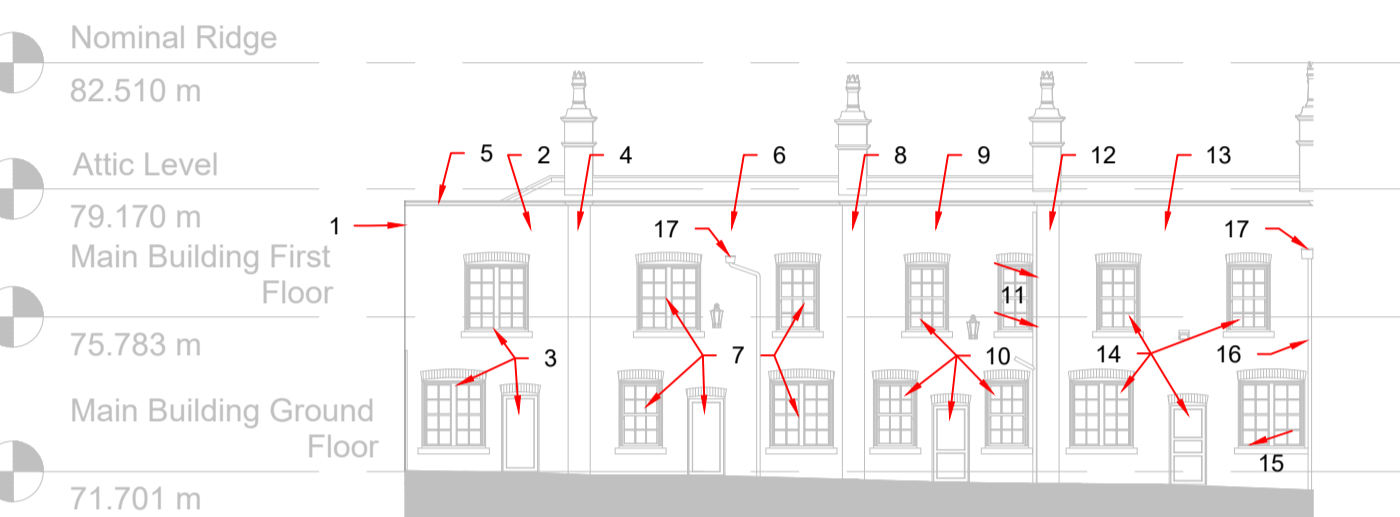
ELEVATION E
1:200

- ZONE 03 : ELEVATION E**
- CORNER LEANING OUT (LEFT) UP ITS HEIGHT, ALTHOUGH DIFFICULT TO APPRAISE BY HOW MUCH DUE TO VEGETATION. ALSO LEANS INTO PAGE FROM FIRST FLOOR TO TOP OF PARAPET CIRCA 100MM.

- REMAINDER OF WALL LEANS IN FROM FIRST FLOOR AND LEANS IN FURTHER AT PARAPET LEVEL CIRCA 100-150MM OVER ITS HEIGHT.
 - RELATIVELY SQUARE ARCHED OPENINGS. GEOMETRICALLY SOUND.

- PIER PLUMB UNTIL PARAPET LEVEL, WHERE IT LEANS IN COMMENSURATE WITH PARAPET.
 - WALLHEAD OF PARAPET LOCALLY LEANS OUT AND 2 NO 10MM THICK CRACKS ARE PRESENT UNDER OPEN PERPEND JOINTS (CIRCA 20-30MM). CHECK FOR SKIN SEPARATION.

- WALLHEAD STRAIGHT AND LEVEL ALTHOUGH PARAPET LEANS IN BY CIRCA 50MM CONSISTENTLY ALONG LENGTH.
 - SQUARE ON THIS BAY.
 - PIER PLUMB UNTIL PARAPET LEVEL, WHERE IT LEANS IN COMMENSURATE WITH PARAPET.

- WALLHEAD STRAIGHT AND LEVEL ALTHOUGH PARAPET LEANS IN BY CIRCA 50MM CONSISTENTLY ALONG LENGTH BUT WITH OPEN PERPEND JOINTS BETWEEN COPIES.
 - SQUARE.

- CRANKED DOWN SLIGHTLY TOWARDS PIER.
 - PIER PLUMB UNTIL PARAPET LEVEL WHERE IT LEANS IN COMMENSURATE WITH PARAPET.
 - WALLHEAD STRAIGHT AND LEVEL ALTHOUGH PARAPET LEANS IN BY CIRCA 50MM CONSISTENTLY ALONG LENGTH BUT WITH OPEN PERPEND JOINTS BETWEEN COPIES.

- SQUARE.
 - CRANKED DOWN ABOVE DRAIN LOCATION.
 - CORNER JOINT TIGHT.
 - DOWN PIPE FROM GUTTER BEHIND PARAPET.

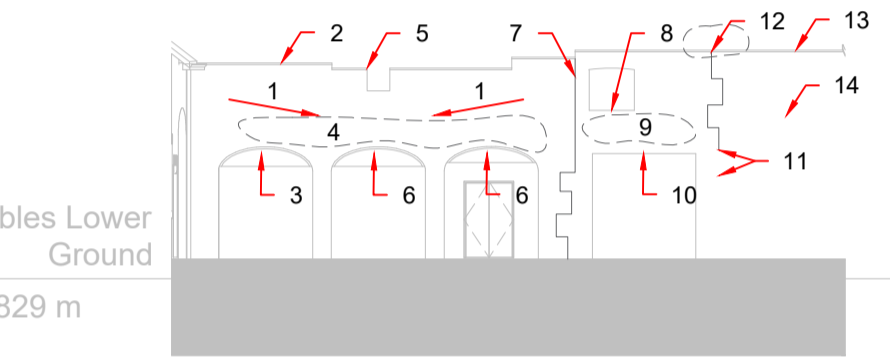
ELEVATION I
1:200

- ZONE 04 : ELEVATION I**
- BEDJOINTS AND WALLHEAD TEND DOWN TOWARDS CENTRE ARCH CROWN.
 - WALLHEAD CAPPED WITH NO MAJOR GAPS BETWEEN CAPPING STONES. MASONRY FABRIC STILL DECAYED AT WALLHEAD.

- ARCH GEOMETRY OK BUT SKIN SEPARATION APPARENT. CIRCA 20MM BOTH IN ARCH AND IN MASONRY ABOVE.
 - PIER LEANS OUT CIRCA 30MM UNTIL SPRINGER BLOCK THEN WALL ABOVE LEANS IN CIRCA 50-55MM UNTIL WEAHEAD. WORST ABOVE SPRINGER LOCATION BETWEEN LEFT AND CENTRAL ARCH BUT OCCURS ABOVE ALL ARCHES. WALL IS FREESTANDING ALONG THIS SECTION.

- MASONRY FABRIC DECAYED / SOME MISSING UNITS AROUND THIS OPENING.
 - ARCH GEOMETRY OK BUT SKIN SEPARATION CIRCA 20MM AND BEDJOINTS SAG ABOVE CROWN.
 - PARTLY / POORLY BONDED BUTT JOINT, BUT TIGHT CROSSWALL BEHIND.

- LOOSE MASONRY ON CILL OF OPENING BUT GEOMETRY SQUARE.
 - BEDJOINTS IN THIS AREA UNDLATE.
 - STEEL LINTELS CORRODING / SLIGHT SAG OVER SPAN.
 - JOINT WELL BONDED AT LOWER LEVEL. PARTLY BONDED HIGHER LEVEL.

- MATURE VEGETATION JACKING UP WALLHEAD CIRCA 20-30MM.
 - MATURE TREE DIRECTLY BEHIND WALL, LIKELY PROPPING.
 - WALL LEANS OUT (INTO PAGE) ALONG ITS HEIGHT CIRCA 80-100MM. RETAINED AT RIGHT END BY TRUSS.

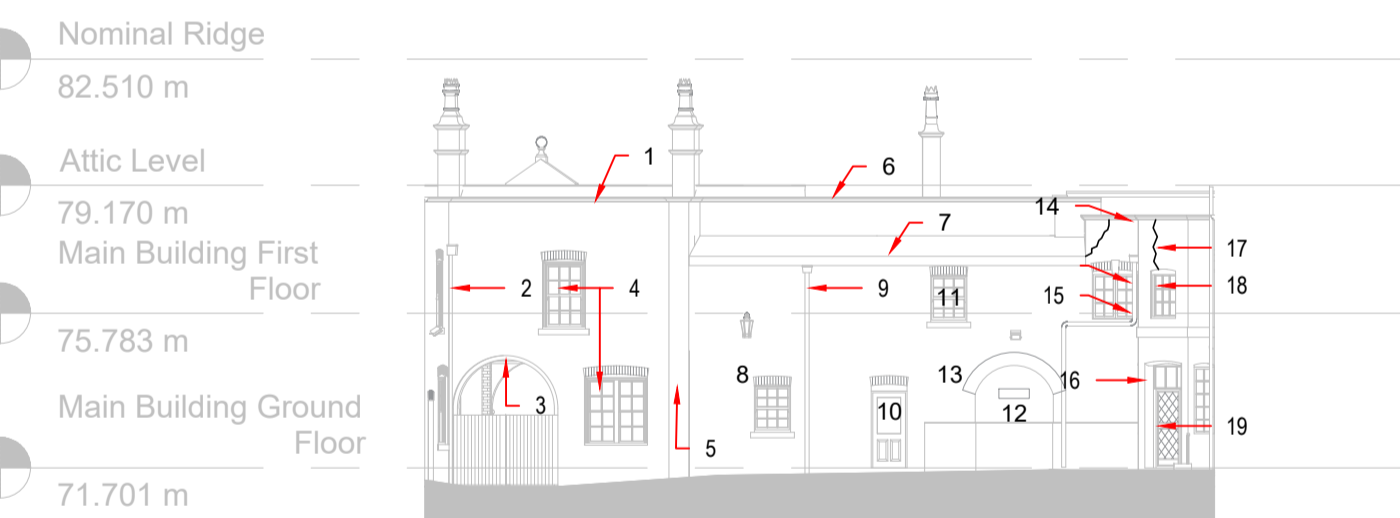
ELEVATION F
1:200

- ZONE 03 : ELEVATION F**
- TOP OF PARAPET STRAIGHT AND LEVEL. OPEN PERPEND JOINTS BETWEEN COPIES, WHICH ARE DISPLACED AT WALL HEAD, BOWING OUT AT MID POINT.

- CORNER BOND TIGHT.
 - ARCH GEOMETRY SOUND. INTRADOS OF INNER ARCH DAMAGED BELOW QUARTER POINTS.
 - WINDOW OPENING SQUARE.
 - PIER PLUMB. NO STRUCTURAL DEFECT OF NOTE.

- TOP OF PARAPET STRAIGHT AND LEVEL. OPEN PERPEND JOINTS BETWEEN COPIES.
 - SLOPE UNDLATES SLIGHTLY, PARTICULARLY ON LEFT SIDE.
 - NO STRUCTURAL DEFECT OF NOTE TO MASONRY THIS SECTION. WINDOW OPENING SQUARE.

- MASONRY FABRIC DAMP BEHIND DOWN PIPE. DEEP PACK POINTING REQUIRED.
 - DOOR OPENING SQUARE.
 - WINDOW OPENING SQUARE.
 - ARCHED OPENING IS BRICK THICK ARCH ON OUTER SKIN. FLAT ARCH INSIDE INFILL BRICK PANEL. ALL WELL BONDED. ARCH GEOMETRY SOUND.

- NO STRUCTURAL DEFECT OF NOTE TO MASONRY WALL ALONG THIS SECTION.
 - TOP OF PARAPET LEANS DOWN TOWARDS CORNER. DIAGONAL CRACK FROM CORNER OF EAVES CIRCA 10-15MM REDUCING TO HAIRLINE BELOW COPIES. WALL HEAD BULGES OUT SLIGHTLY ON PLAN.

- WINDOW OPENING CRANKED DOWN TO CORNER. ARCH GEOMETRY SOUND.
 - MASONRY IN CORNER SATURATED BELOW RAINWATER PIPE.
 - VERTICAL CRACKING DOWN FROM DISPLACED COPIES AT WALL HEAD TO TOP OF FLAT ARCH ABOVE WINDOW OPENING. CIRCA 5-10MM THICK AT WALL HEAD REDUCING TO HAIRLINE.

- WINDOW OPENING SQUARE.
 - DOOR OPENING SQUARE.

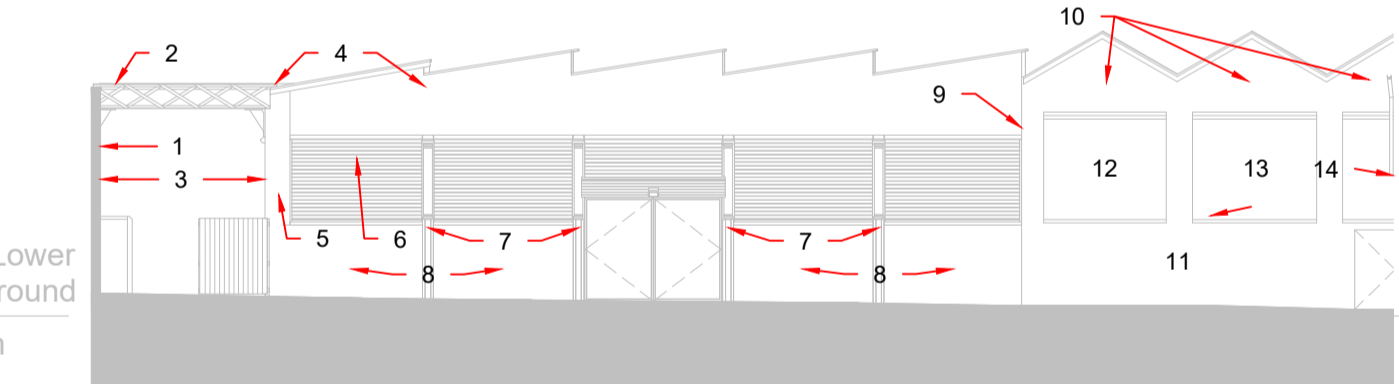
ELEVATION J
1:200

- ZONE 04 : ELEVATION J**
- EXTERNAL WALL LEANING OUT OVER HEIGHT, CIRCA 80MM AT WALLHEAD.
 - IRON TRUSS ACROSS OPENING CRANKED DOWN TO SOUTH. SEVERELY CORRODED - DELAMINATION 2-15MM THROUGHOUT. SOME PARTS CORRODED THROUGH. EMBEDDED STEEL IN MASONRY. JACKING UNITS OUT. TRUSS APPEARS TO HAVE RETAINED (LEFT) WALL LEANING OUT. ELABORATELY DECORATED BRACKET COMING OFF SUPPORTS.

- MASONRY WALLS INSIDE APPEAR RELATIVELY PLUMB BUT COMPRESSIVE TIMBER BRACING IN PLACE.
 - CONNECTION PLATE BETWEEN TRUSSES / BEAM.
 - MASONRY PIER AT THE END OF CROSSWALL. TRUSS BEARING AT WALLHEAD SITTING ON PADSTONE. CORNER PLUMB BOTH DIRECTIONS.

- TIMBER LOUVRES.
 - CAST IRON COLUMNS SUPPORTING BEAM / TRUSS CONNECTIONS AT WALLHEAD. ELABORATELY DECORATED. PAINT MOSTLY INTACT BUT SOME SURFACE CORROSION APPARENT.

- NO STRUCTURAL DEFECT TO NOTE TO MASONRY AT LOWER LEVEL.
 - PLUMB.
 - CABLE PEAKS LEAN IN SLIGHTLY OVER HEIGHT. 0.5 BRICK THICK WITH 1 BRICK THICK PIER AT CENTRE SUPPORTING RIDGE PURLIN.

- NO STRUCTURAL DEFECT TO NOTE TO MASONRY AT LOWER LEVEL.
 - RECESS SQUARE 1.2R BRICK THICK.
 - RECESS SQUARE EXCEPT BOTTOM LEFT CORNER WHERE BEDJOINT SLOPES DOWN.

- MASONRY UNBONDED AT THIS INTERFACE.

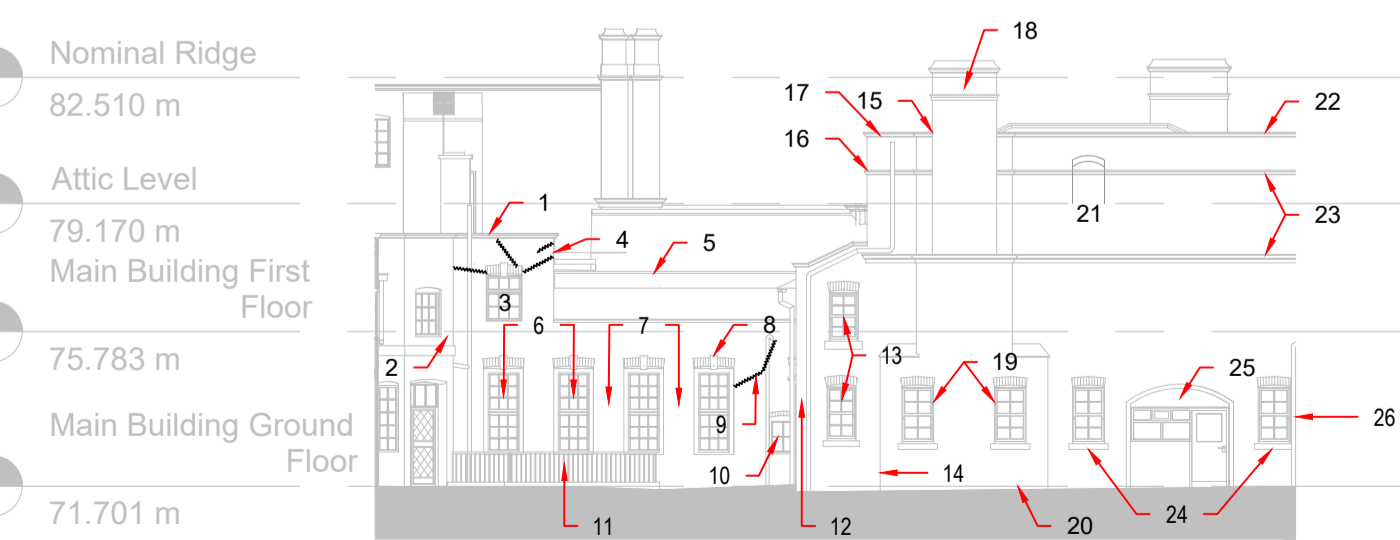
ELEVATION G
1:200

- ZONE 03 : ELEVATION G**
- COPIES AT THE TOP OF PARAPET DISPLACED. OPEN PERPEND JOINTS BETWEEN THEM CIRCA 20MM.
 - JOINT TIGHT AT CORNER INTERFACE.
 - DIAGONAL CRACKING RADIATING FROM FLAT ARCH ABOVE WINDOW. CIRCA 5-10MM THICK AT WALL HEAD OR RIGHT HAND CORNER BUT 2-3MM CLOSER TO WINDOW OPENING. ARCH CRANKED DOWN TO LEFT.

- BED JOINT FAILURE AT CORNER. WHOLE TOP SECTION APPEARS TO BE PUSHED UP AND OUT.
 - TOP OF PARAPET RELATIVELY STRAIGHT AND LEVEL UNTIL LAST 1M ON RIGHT HAND SIDE, WHERE PARAPET AND STRING COURSE LEAN DOWN TO CORNER.

- WINDOW OPENINGS SQUARE.
 - BED JOINTS APPEAR TO BE JACKED UP CIRCA 5-8MM.
 - KEystone APPEARS TO HAVE DROPPED DOWN CIRCA 10MM. OPEN JOINT IN FLAT ARCH.

- 5MM HORIZONTAL CRACK FROM JAMB, REDUCING TO HAIRLINE PAST EMBEDDED METAL AT RAINWATER HOPPER.
 - WINDOW OPENING SQUARE.
 - STAIRS DOWN TO BASEMENT IN FRONT OF WALL.

- CORNER RELATIVELY PLUMB.
 - WINDOW OPENINGS SQUARE.
 - CORNER JOINT WELL BONDED.
 - CORNER JOINT WELL BONDED.
 - PARAPET LEANS OUT FROM STRING COURSE LEVEL CIRCA 10-15MM.

- 40MM GAP BETWEEN COPIES.
 - CHIMNEY APPEARS PLUMB, ALTHOUGH HEAVILY WEATHERED MASONRY ON TOP SECTION.
 - WINDOW OPENINGS SQUARE.
 - MASONRY DECAYED AT LOWER LEVEL.

- EMBEDDED METAL AT HIGH LEVEL.
 - TOP OF PARAPET STRAIGHT AND LEVEL.
 - STRING COURSE STRAIGHT AND LEVEL.
 - WINDOW OPENINGS SQUARE.
 - NO STRUCTURAL DEFECT OF NOTE TO MASONRY ARCH. INFILL WITH MODERN BRICKS.

- CORNER DAMP NEAR RAINWATER PIPE LOCATION.

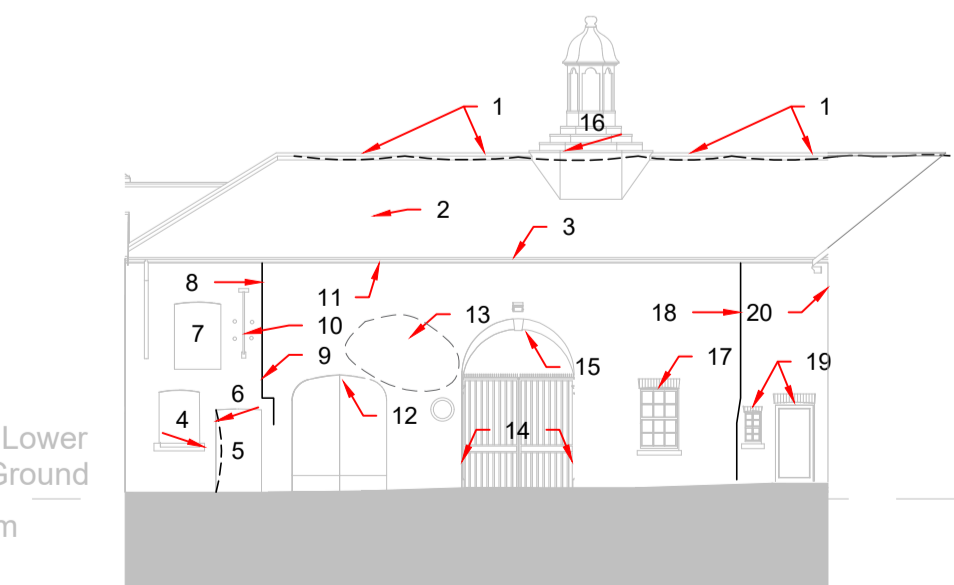
ELEVATION K
1:200

- ZONE 04 : ELEVATION K**
- RIDGELINE SAGGING BETWEEN POINTS OF SUPPORT.
 - SLOPE SAGS ACCORDING TO RIDGELINE.
 - EAVES LINE UNDLATES ALONG LENGTH.
 - FLAT ARCH LINTEL OVER OPENING AND CILL CRANKED DOWN CIRCA 30MM. EVIDENCE OF PAST REPOINTING WORK BELOW BOTTOM LEFT CILL BEARING. CIRCA 15MM FULL THICKNESS CRACK INTERNALLY.

- LOOSE MASONRY IN JAMB OF DOOR OPENING. JAMB APPEARS TO BOW INWARD AS THOUGH PUSHED BY ADJACENT WINDOW CILL. FLAT ARCH ABOVE OPENING CRANKED DOWN TO LEFT. SPRINGER CIRCA 40MM LOWER THAN ON RIGHT.

- FLAT ARCH ABOVE OPENING CRANKED DOWN TO LEFT.
 - FIRST FLOOR OPENING SQUARE.
 - OPEN BUTT JOINT AT THIS CROSSWALL LOCATION. CLEAR OFFSET IN VERTICALITY CIRCA 80MM MAX DISPLACEMENT AT EAVES LEVEL REDUCING TO NIL ABOVE FLAT ARCH.

- OUTWARD (OUT OF PAGE) BULGE IN WALL IN THIS AREA AND LEANING BACK IN UNTIL EAVES LEVEL ABOVE.
 - HEAVY CAST IRON LIFTING / CRANE MECHANISMS.
 - WALLHEAD APPEARS TO HAVE BEEN REBUILT ALONG ELEVATION.

- ARCH GEOMETRY OK ALTHOUGH BEDJOINTS SAG SLIGHTLY ABOVE CROWN.
 - OUTWARD BOW OF WALL IN THIS LOCATION AND LEANING IN TOWARDS EAVES LEVEL.
 - JAMBS OF ARCH OPENING BOW IN SLIGHTLY BOTH SIDES.

- ARCH GEOMETRY OK.
 - BASE OF BELL TOWER CRANKED DOWN TO WEST (LEFT) AND BELL TOWER ABOVE LEANS SLIGHTLY.
 - SQUARE.
 - BUTT JOINT UP WHOLE HEIGHT WIDENING TOWARDS EAVES LEVEL. EVIDENCE OF REPOINTING BUT SINCE CRACKED.

- SQUARE.
 - CORNER CROSSBOND BONDED TIGHTLY ALTHOUGH SOME LOOSE UNITS AT EAVES LEVEL.
