# Shutta Road Retaining Walls Route Report

**Division: CORMAC Consultancy**

**Site name:** Shutta Road, Looe

Report No: CN1701503/01/01

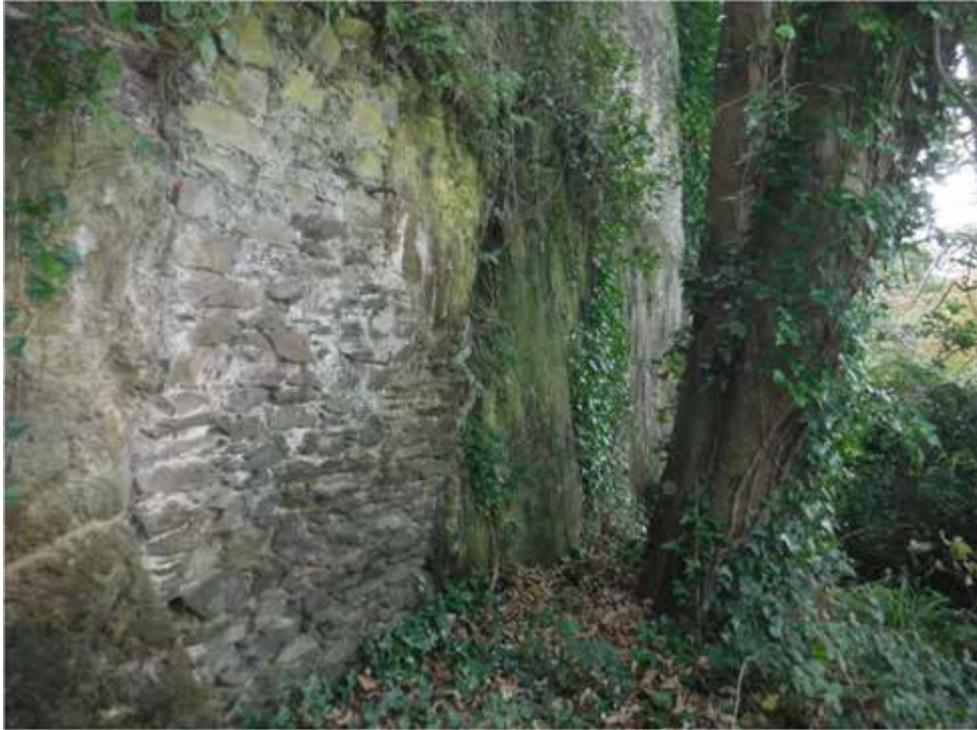
Tree growth was noted at chainage 2m on top of the bedrock which protrudes out by 500mm. A horizontal and stepped crack was also noted at this location measuring 2000x10mm. Numerous mature trees are located at the base of the wall over the length of the structure. A mature sycamore tree was identified at the base of the bedrock measuring 650mm in diameter at ground level at chainage 9m. Refer to photos 4 - 6

**Photo 6: View showing mature tree growth at the base of the wall, chainage 9m**

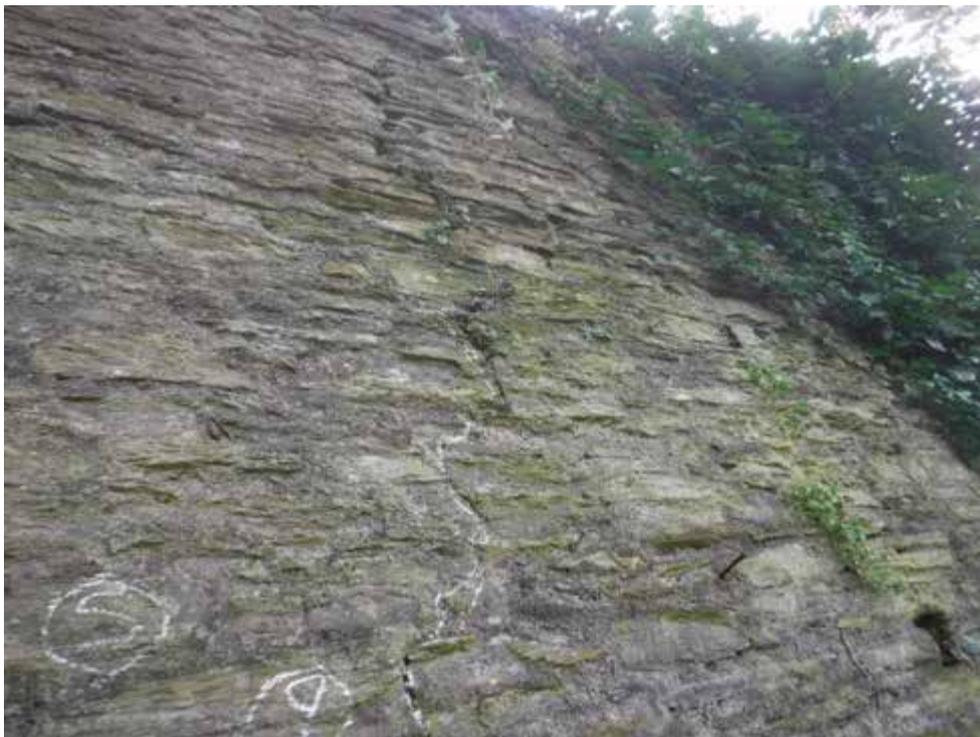
A vertical/stepped crack was noted at chainage 12m measuring 2x2700mm. Refer to photo 7.

**Photo 7: View showing the vertical crack at chainage 12m**

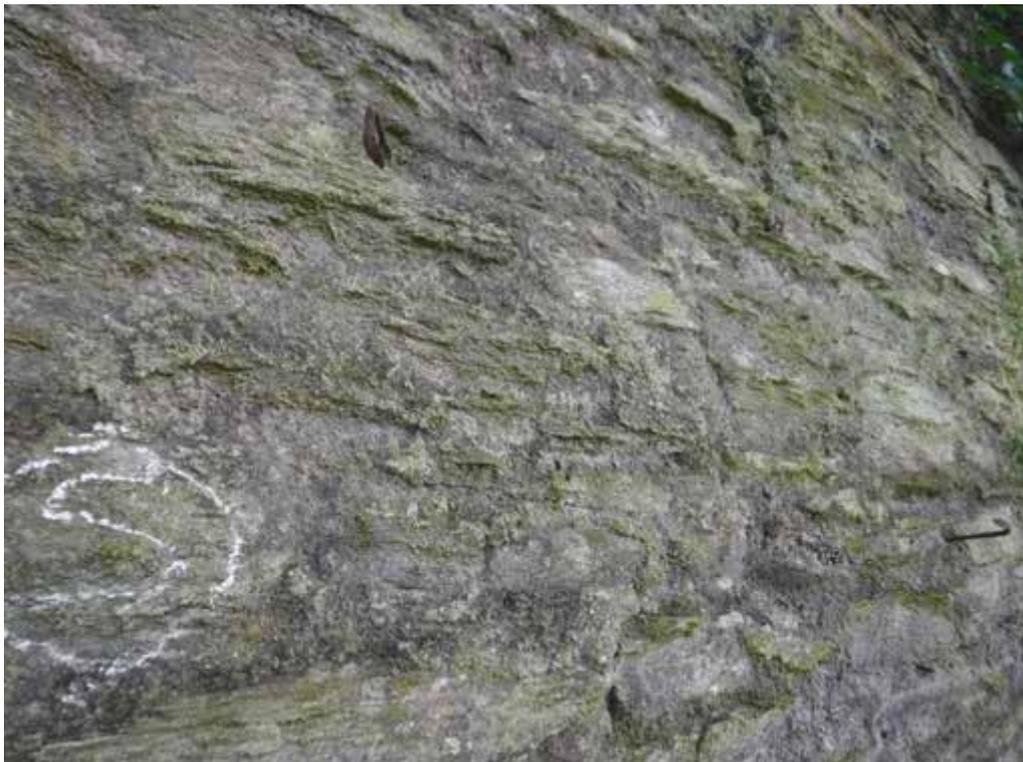
Surface erosion was typical to the stone and mortar; however, no areas of significant joint loss or masonry loss were found to the exposed areas of the wall. Refer to photos 11 – 12.

**Photo 11: View showing the typical condition of the stone and mortar at chainage 15m**

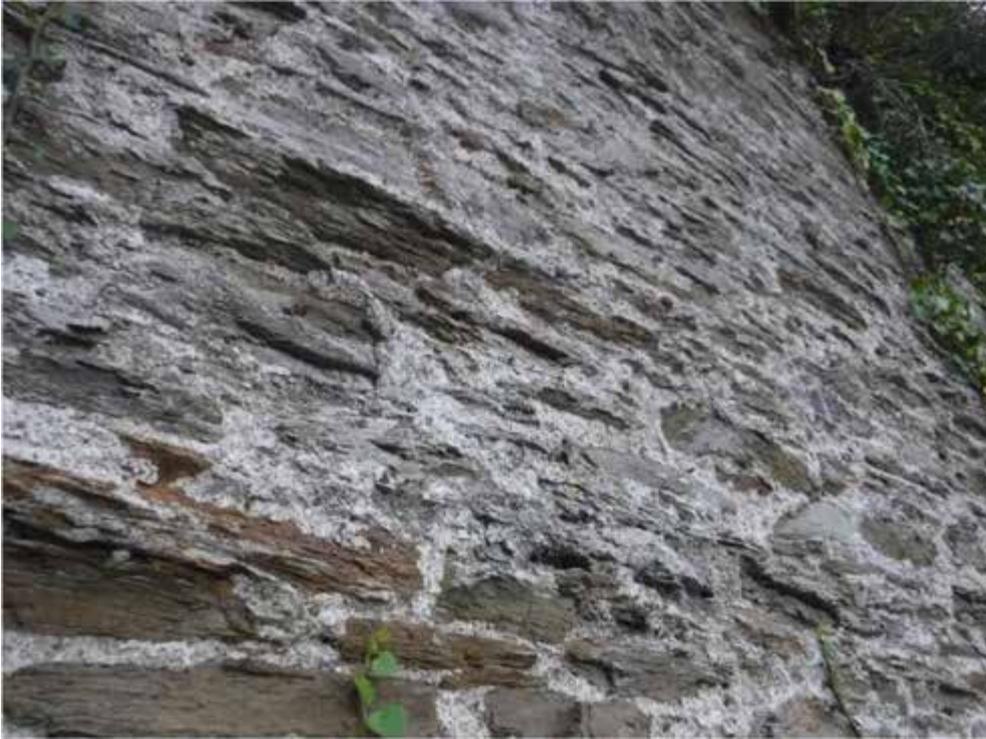
**Photo 12: View showing the typical condition of the stone and mortar at chainage 32m**

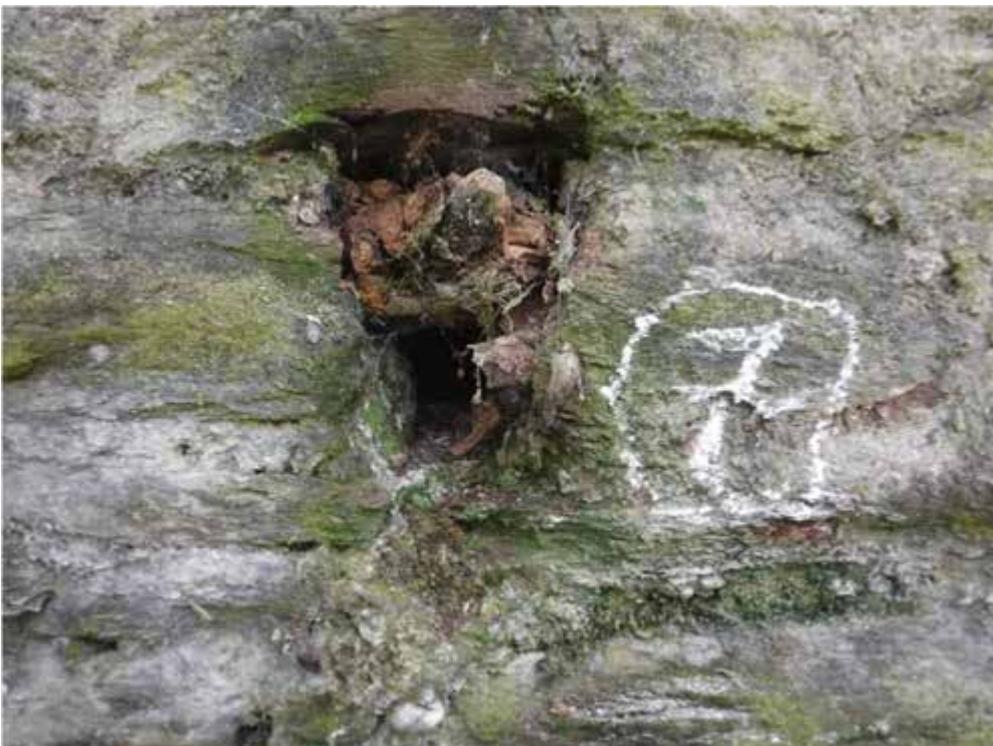
Vegetation growth and root ingress was found to be partially blocking all weep holes in the retaining wall by up to 50%. The locations of the weep holes appeared random and were largely obscured by ivy. Refer to photos 13.

**Photo 13: Typical condition of the weep holes in the retaining wall, 50% blocked**

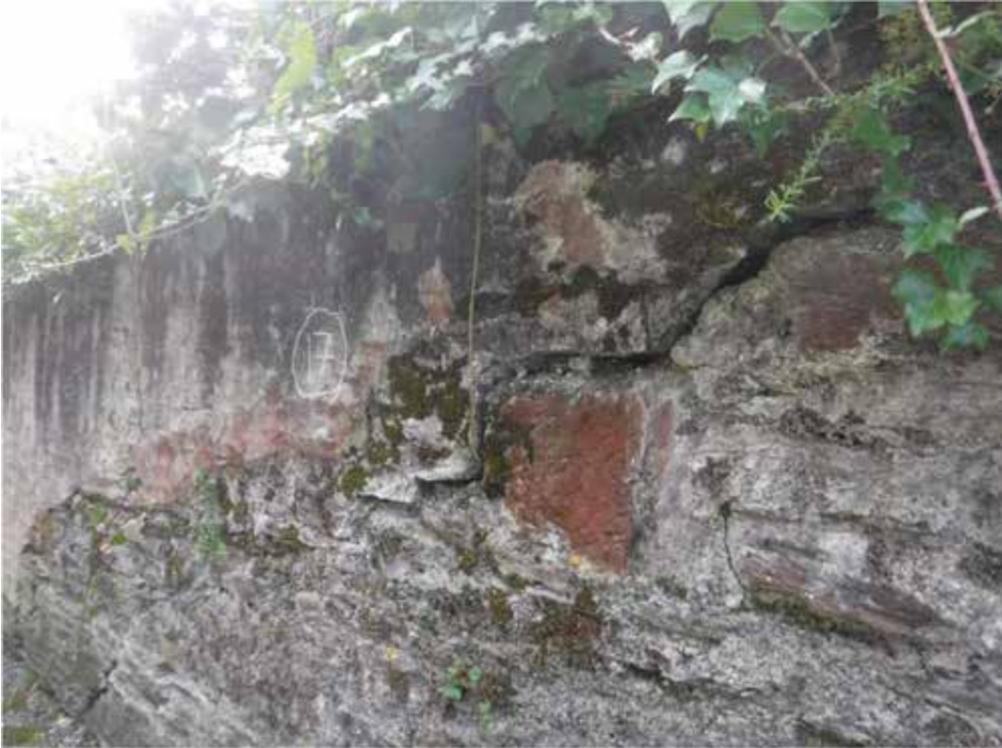
Numerous stepped vertical cracks were identified to the parapet measuring up to 30mm in width. At chainage 31m a vertical and horizontal crack measuring up to 15mm in width was noted. Refer to photos 14 – 16.

**Photo 14: View showing a stepped crack in the parapet towards the south end**

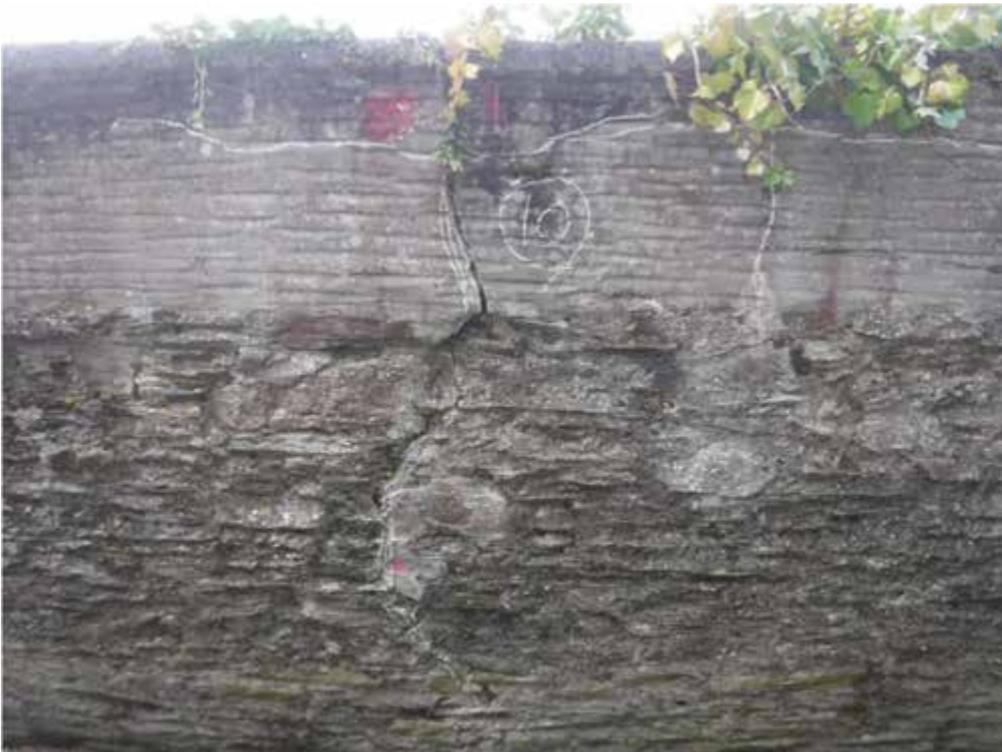
**Photo 15: View showing a vertical and horizontal crack in the parapet at chainage 31m**

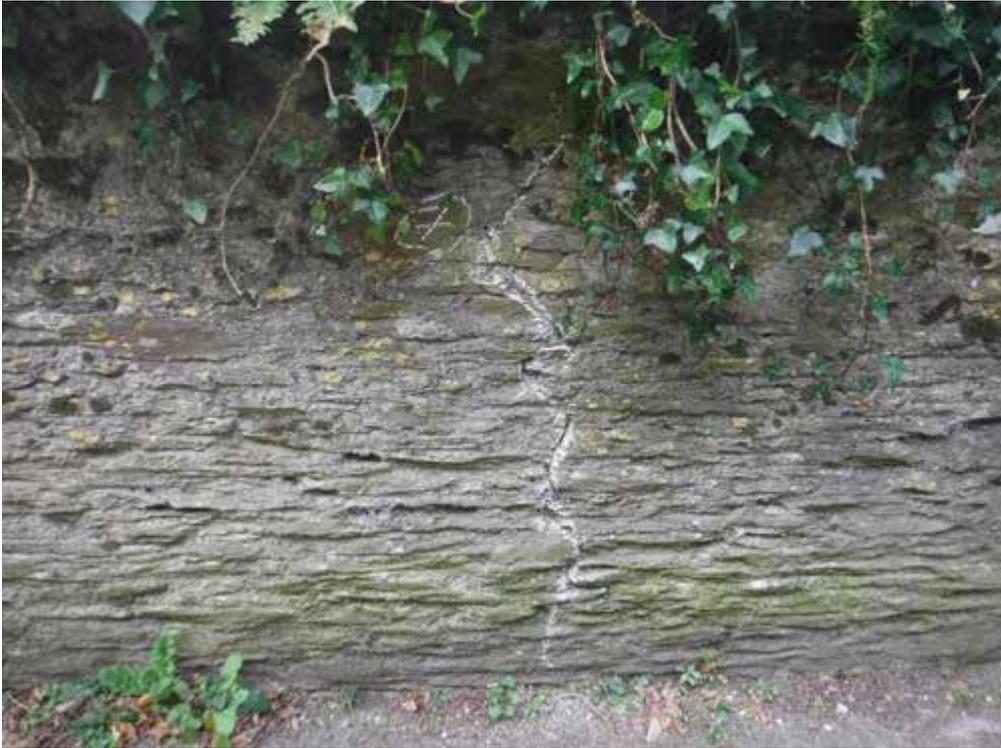
**Photo 16: View showing a typical stepped crack in the parapet at chainage 21m**

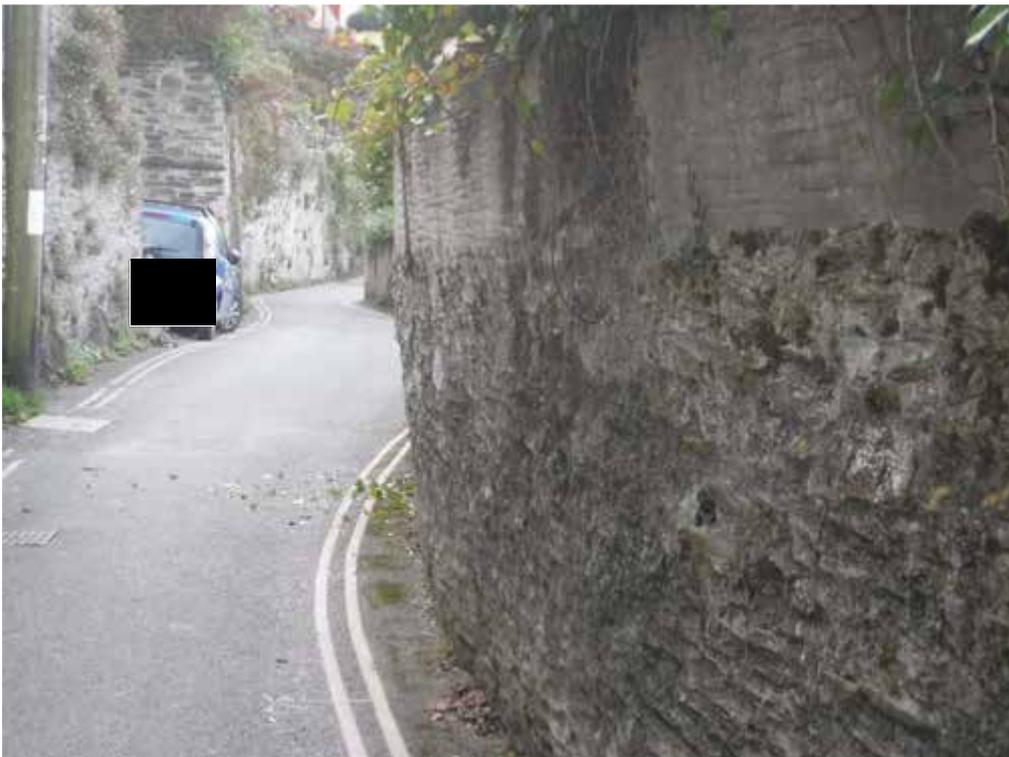
At chainage 25-40m the parapet was found to be leaning towards the carriageway by up to 200mm. A number of the above-mentioned stepped cracks were included within this chainage. Refer to photos 17 – 18.

**Photo 17: View showing the parapet leaning towards the carriageway at chainage 30m (looking south)**

A number of defects identified to elements would give cause for concern in terms of the structure's stability and durability. Vertical/stepped cracks in the parapet and leaning of up to 200mm towards the carriageway should be addressed in the near future; the parapet has an unstable appearance and the later extension seems to be adding to the instability. Vegetation growth, primarily ivy, is obscuring the majority of the structure. Mature tree growth at the foot of the retaining wall and atop the bedrock towards the north end is likely causing the structure damage. Consideration should be made for clearing any vegetation and treating tree stumps with glyphosate plugs to prevent future growth. The erosion and mortar loss shows that the durability has been compromised, therefore consideration should be given to undertaking remedial works and monitoring at future inspections as described below.

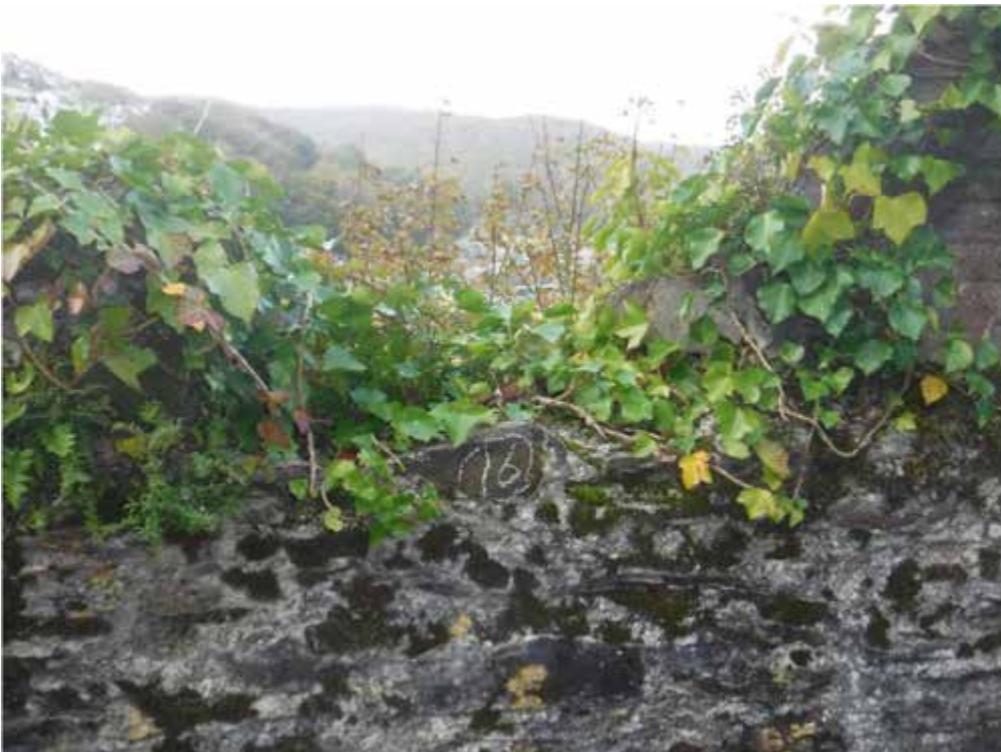
An area of masonry loss was noted to the parapet copings at chainage 49m measuring 720x350x380mm. Towards the north end of the structure the copings were found to be loose. Refer to photos 19 – 21.

**Photo 19: View showing missing coping stones towards the south end of the parapet**

Weathered stone and joint mortar loss noted during this inspection are a result of chemical and physical erosion over time. Masonry loss towards the south end of the parapet and loose masonry at the north end of the parapet could be considered a safety issue, therefore, re-pointing and securing any defective masonry and joints should be a part of a routine maintenance program to ensure the longevity of the wall. The later addition to the wall height should be considered to be reduced in height along with measures to rebuild the wall to address the lean and the cracking throughout the parapet.

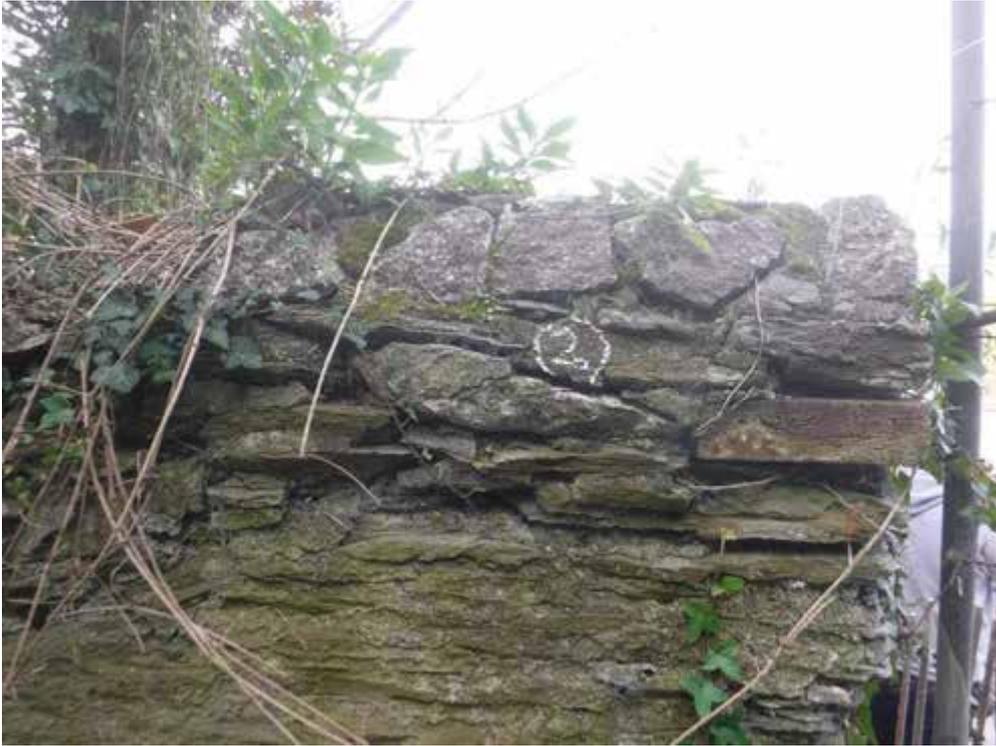
**Photo 20: View showing an area of loose masonry at the north end of the parapet**

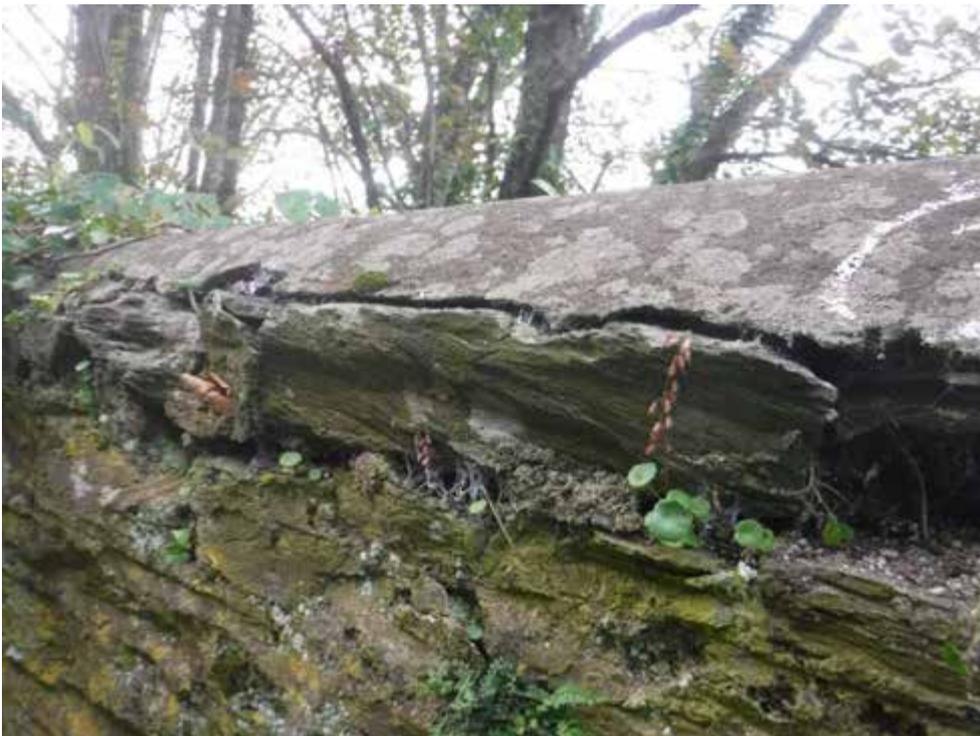
**Photo 21: View showing an area of loose masonry towards the north end of the parapet**

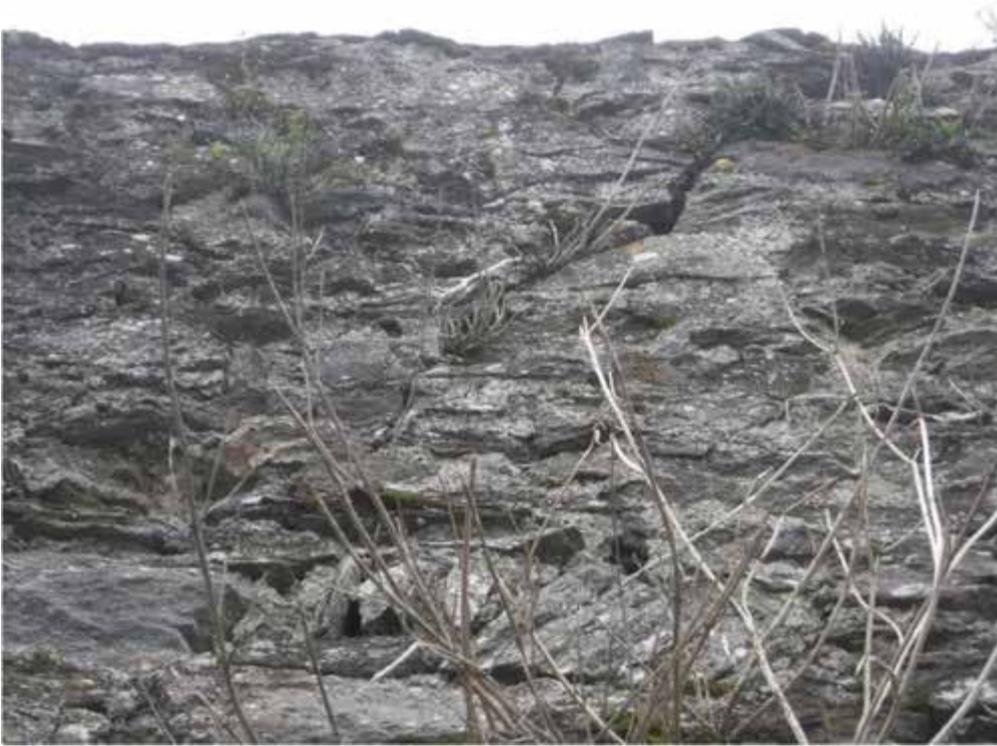
**Photo 4: Vertical crack in the upper section of wall measuring 25mm in width at chainage 20m.**

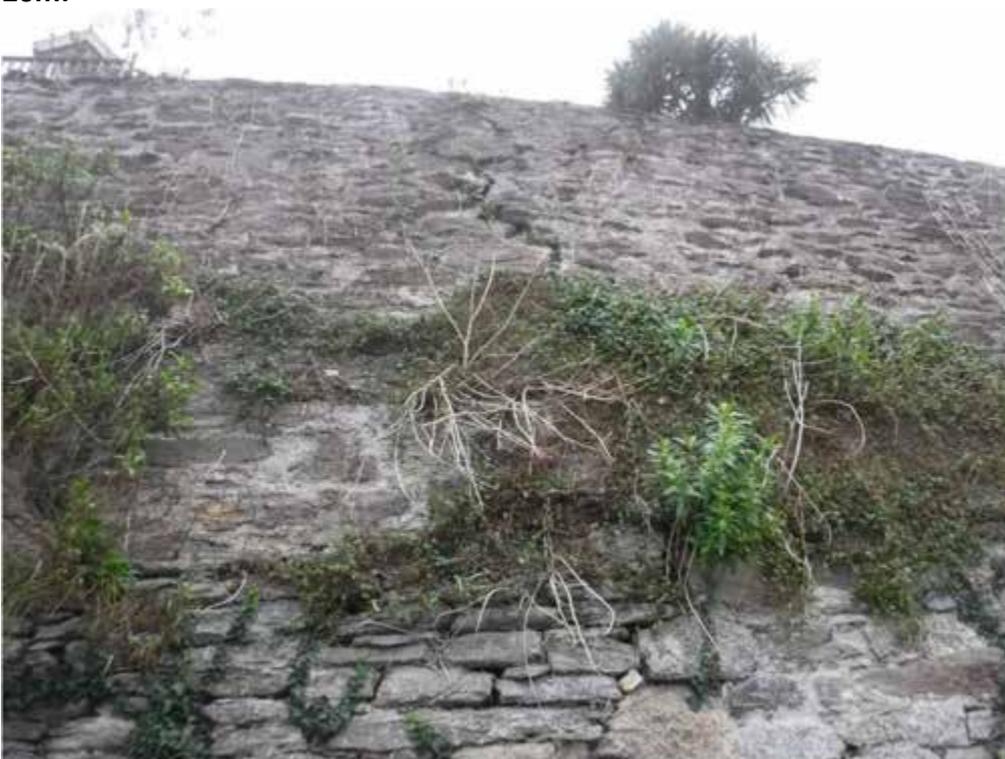
**Photo 5: Vertical crack in the upper section of wall measuring 40mm in width at chainage 26m.**

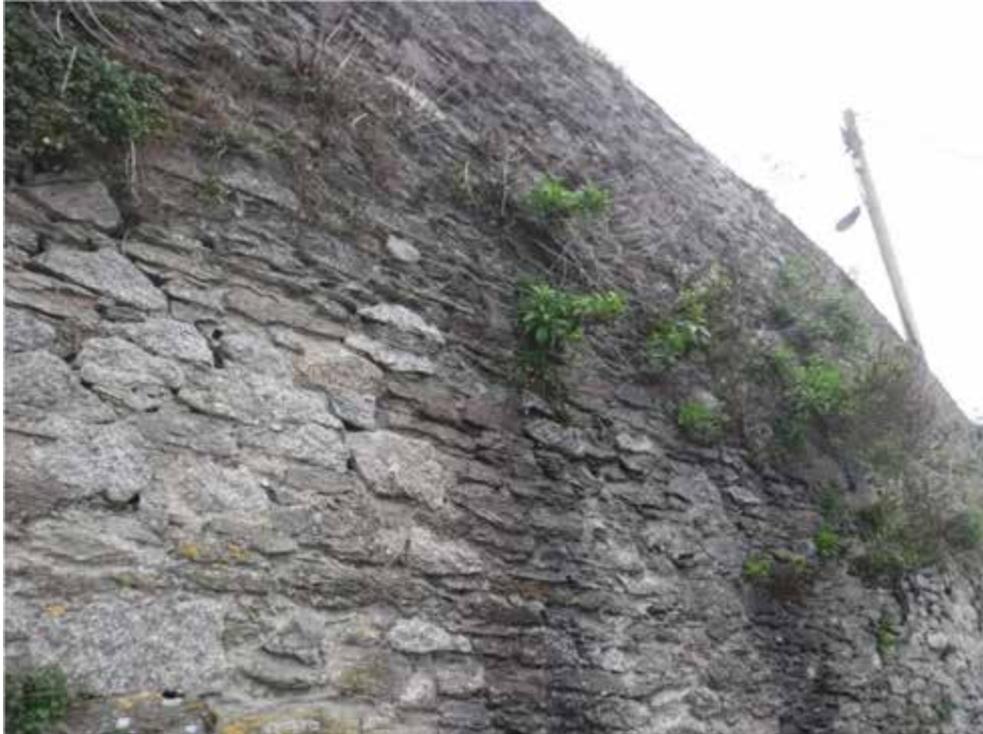
**Photo 6: View showing a band of bulging to the upper section of retained wall over a length of approximately 10m.**

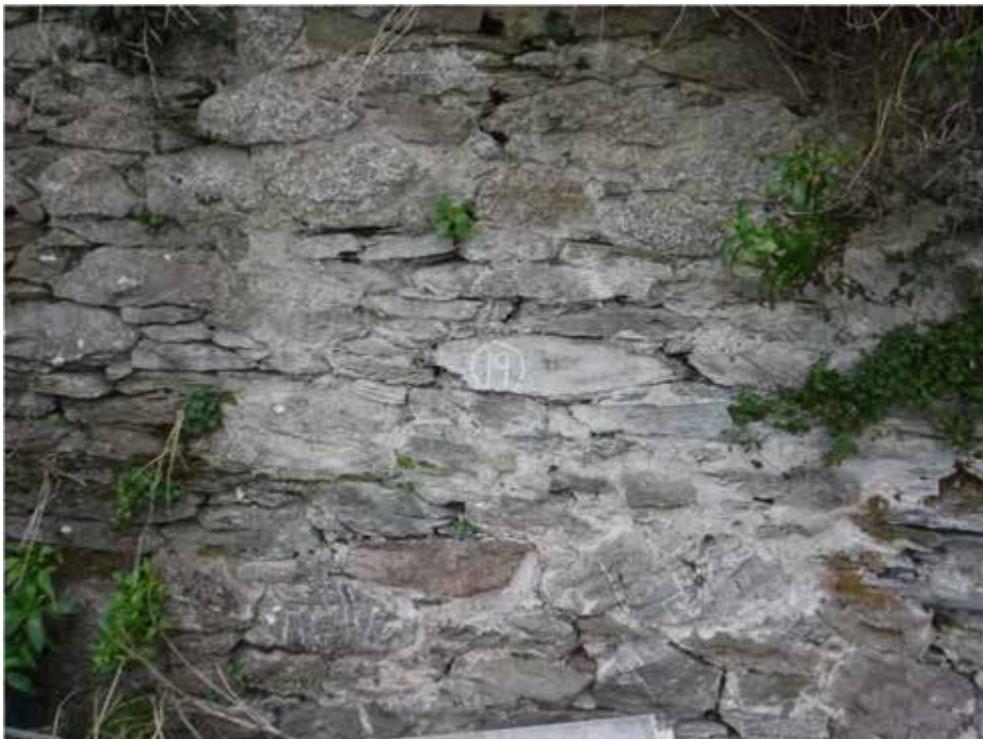
**Photo 7: View showing further cracking in the upper section of the retaining wall (chainage 30m)**

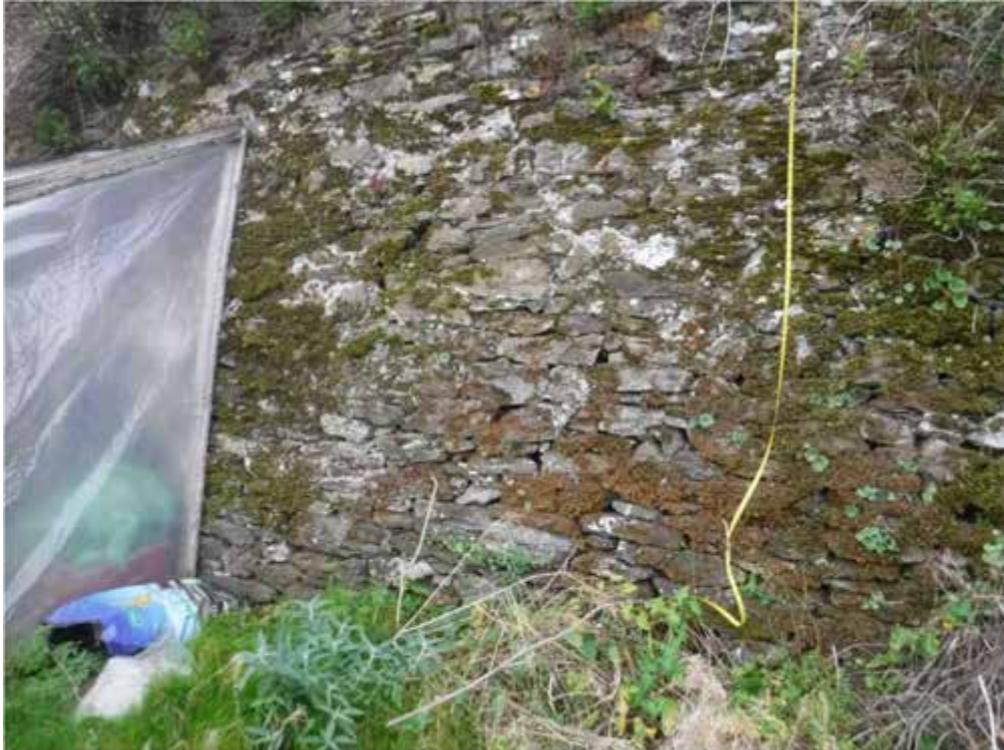
**Photo 8: View showing an area of total joint loss at chainage 10m (upper wall)**

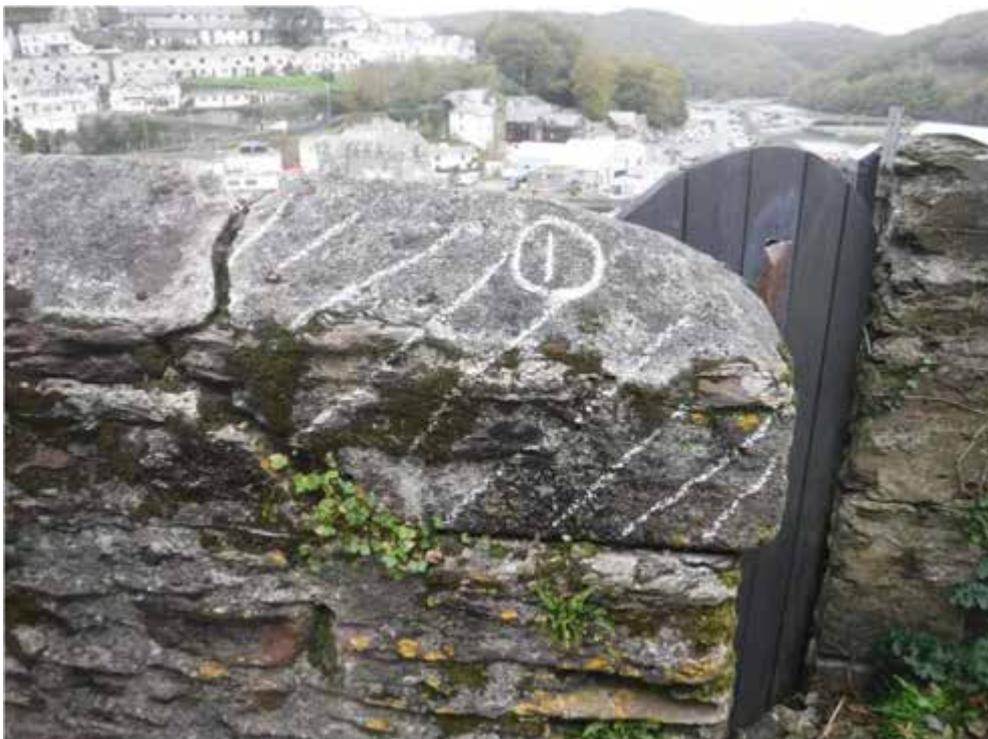
Photo 13: View showing an area of loose masonry at the north end of the parapet.

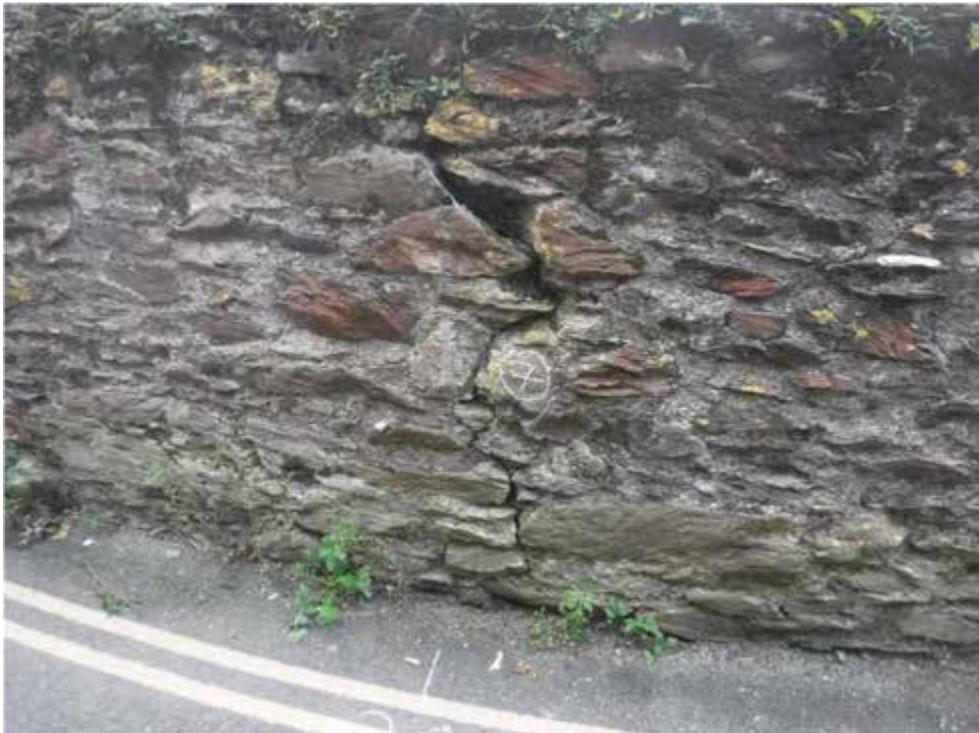
**Photo 14: View showing a vertical crack in the parapet at chainage 20m.**

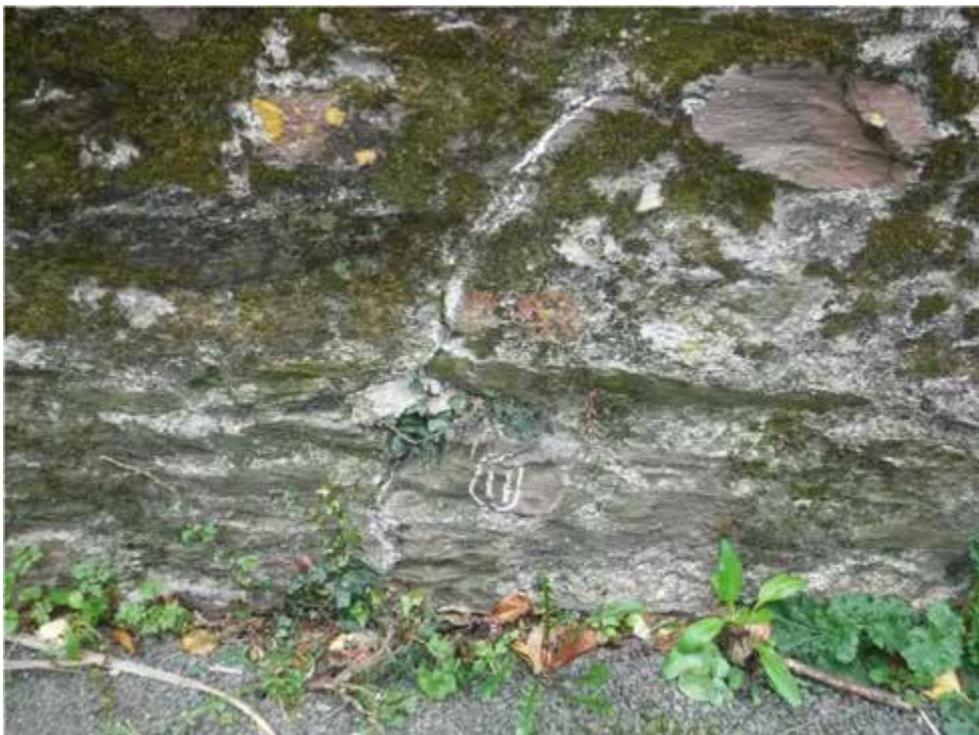
**Photo 15: View showing a vertical crack in the parapet at chainage 26m.**

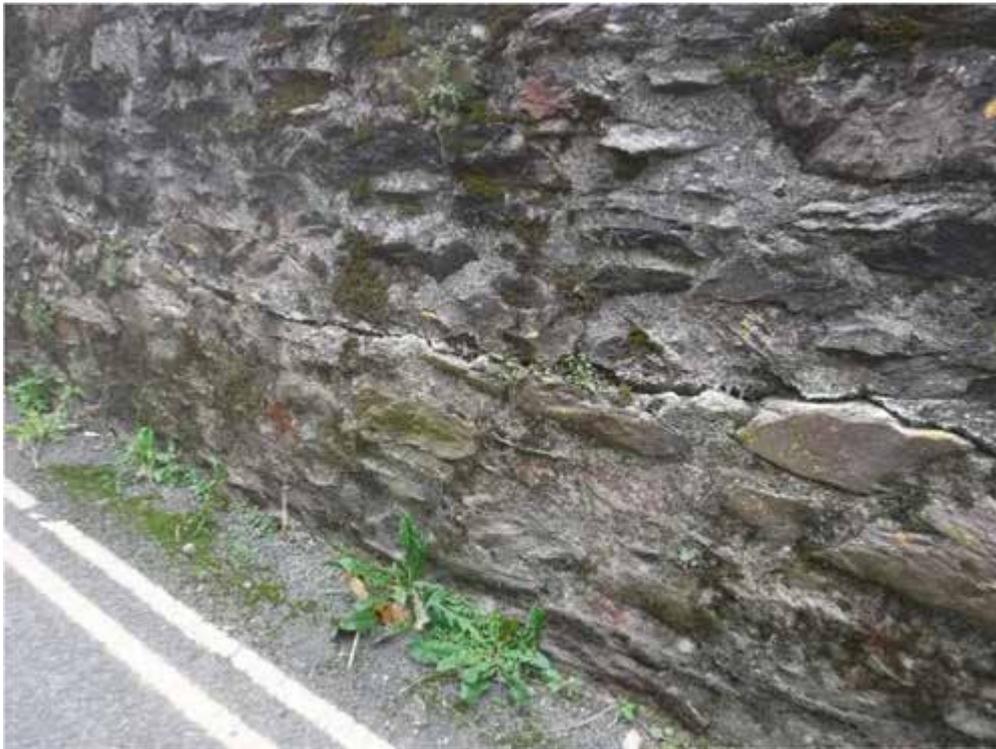
**Photo 16: View showing a horizontal crack in the parapet between chainage 5-11m.**

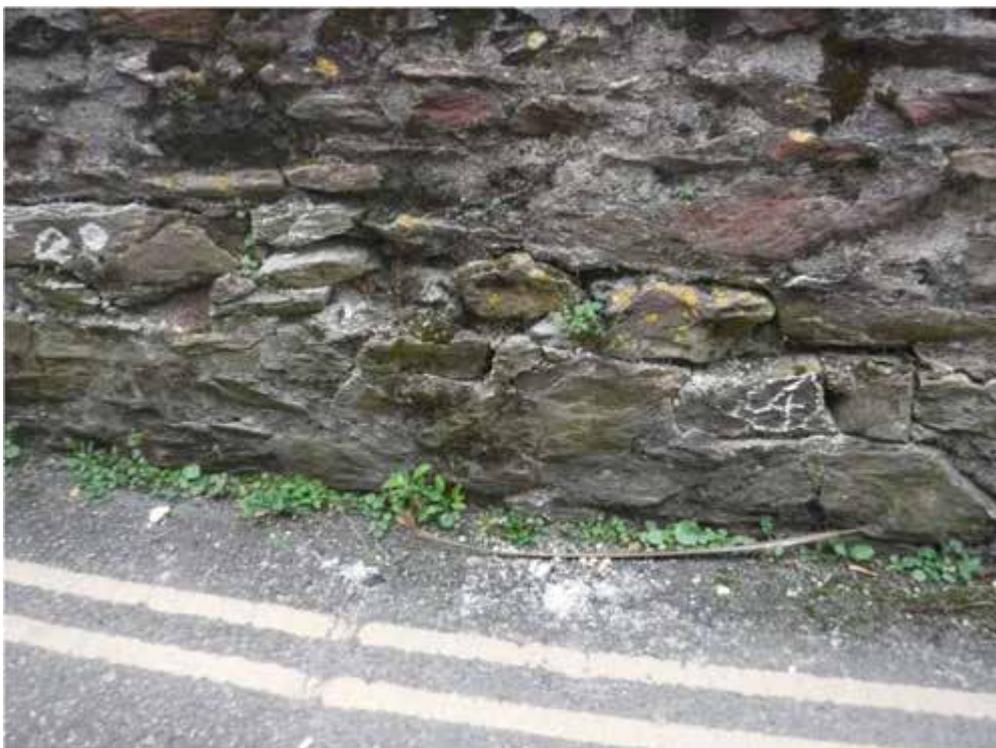
**Photo 17: View showing typical joint loss and erosion to the parapet**

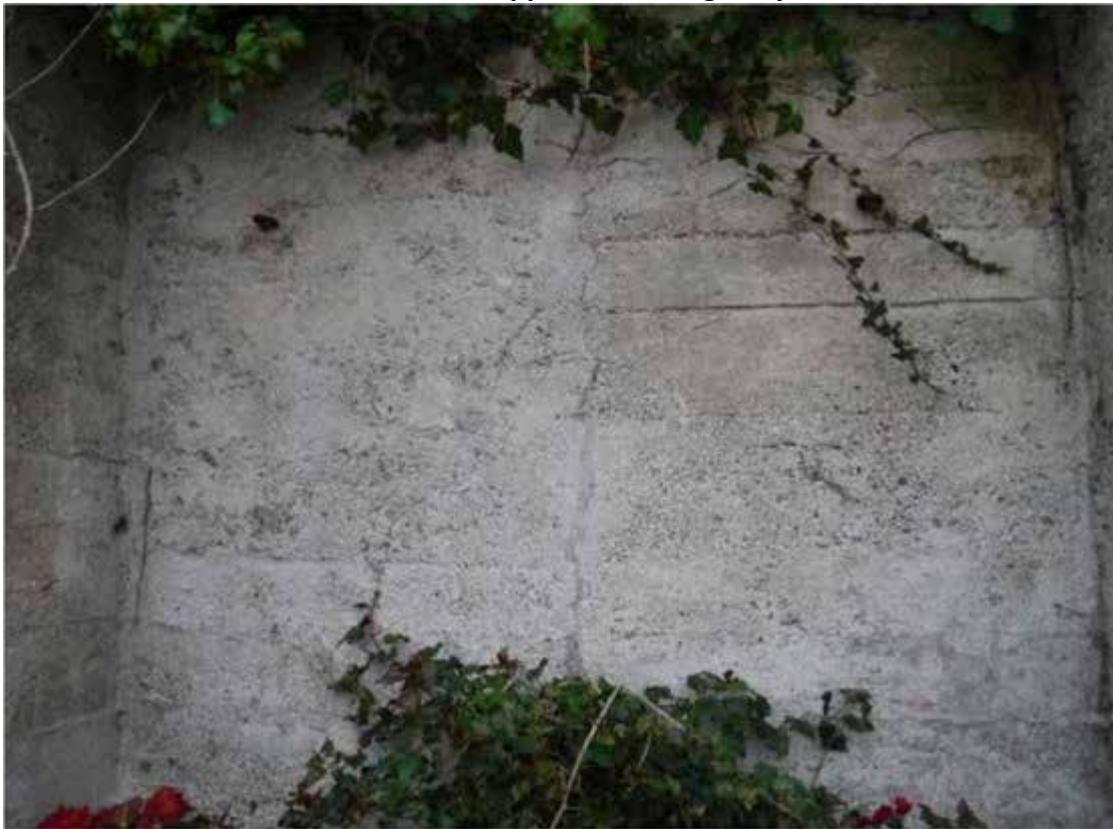
**Photo 21: View showing vertical crack in the upper section of the retaining wall at CH 5m.**

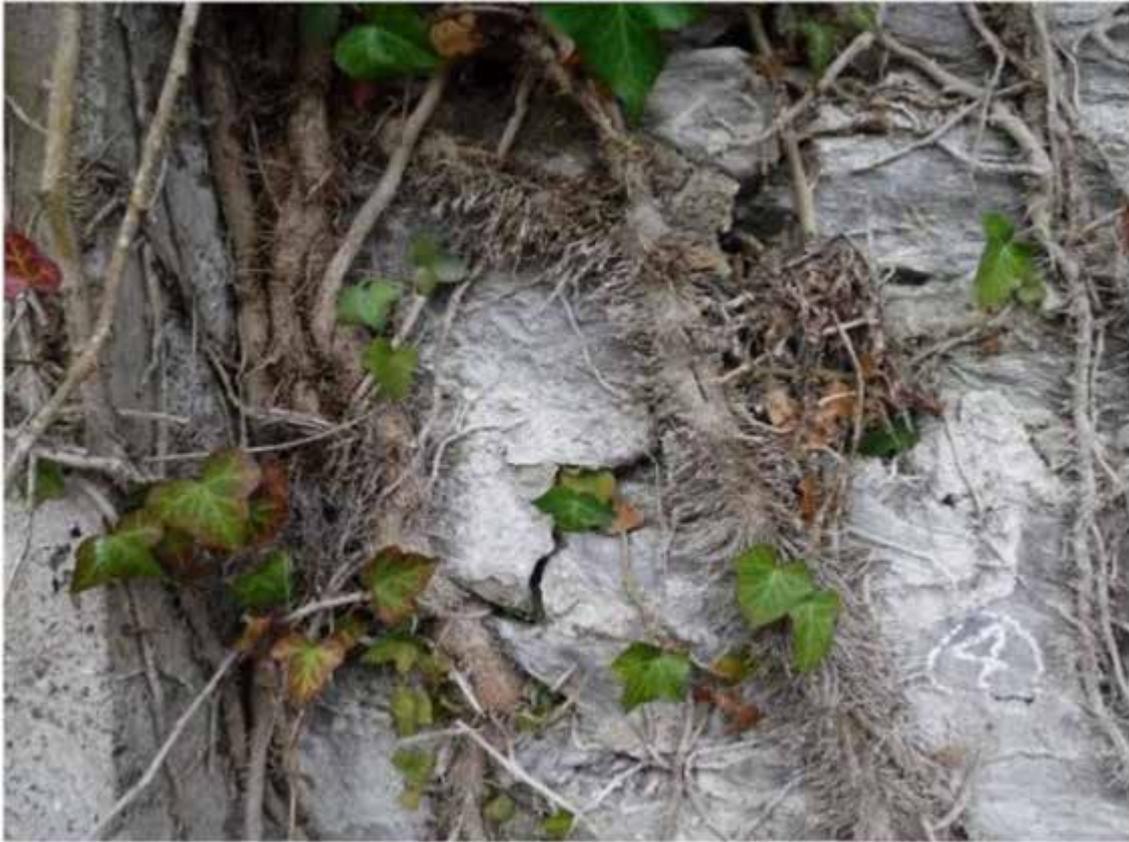
**Photo 22: Detailed view showing a vertical crack in the upper section of the retaining wall at CH 7.5m.**

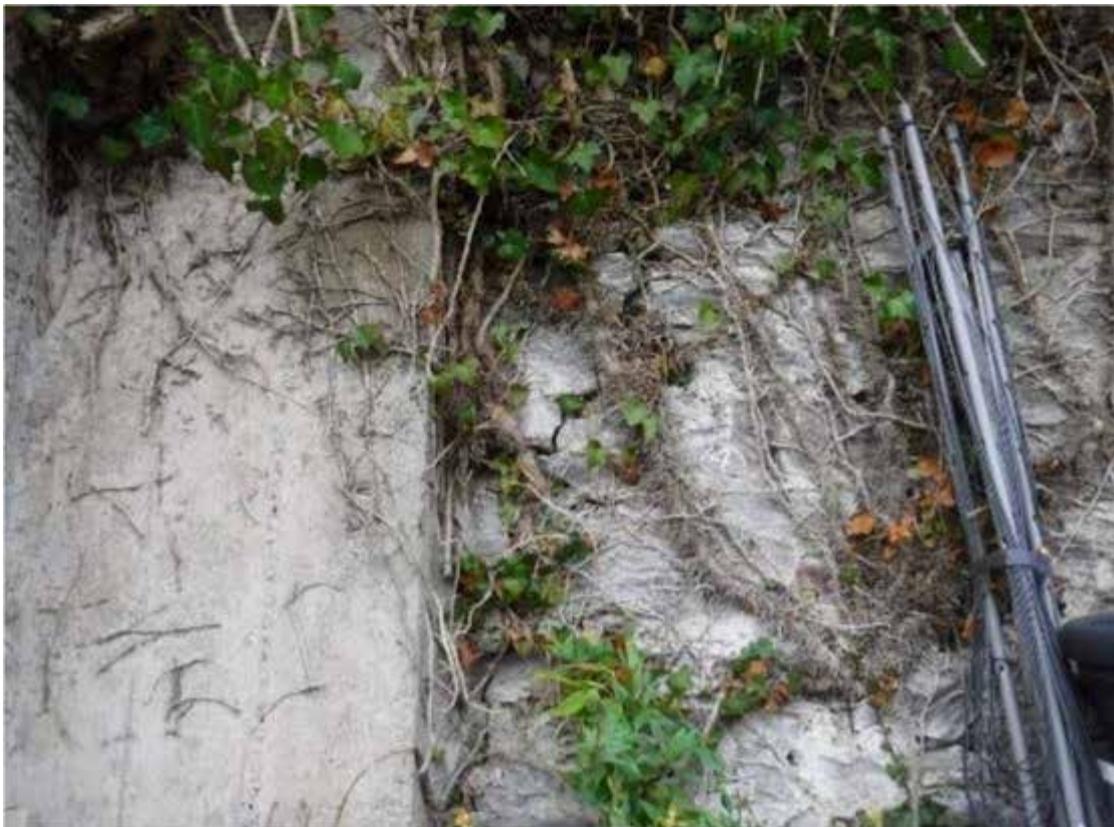
**Photo 23: View showing a vertical crack in the upper section of the retaining wall at CH 7.5m.**

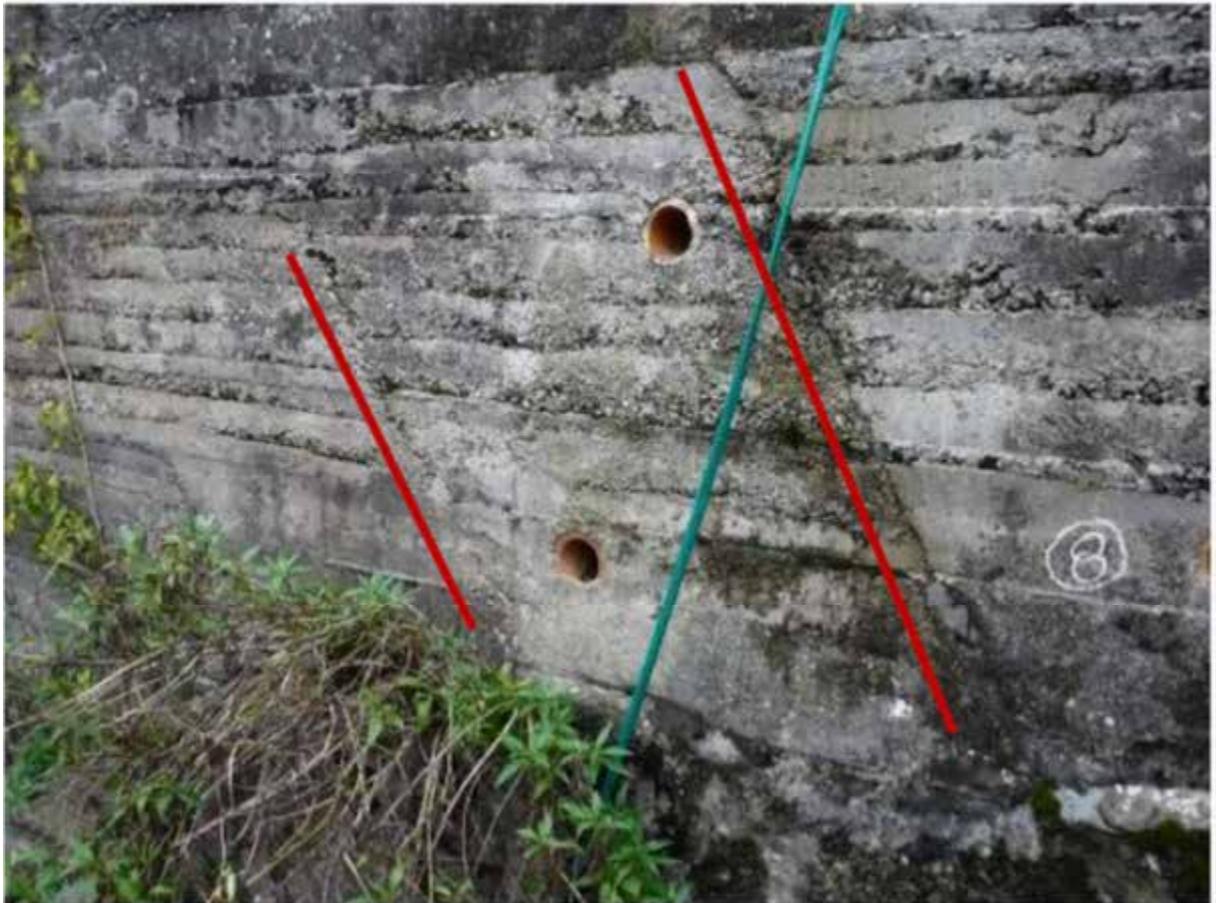
**Photo 26: View showing two diagonal cracks in concrete in the lower section of the retaining wall at CH 9m.**

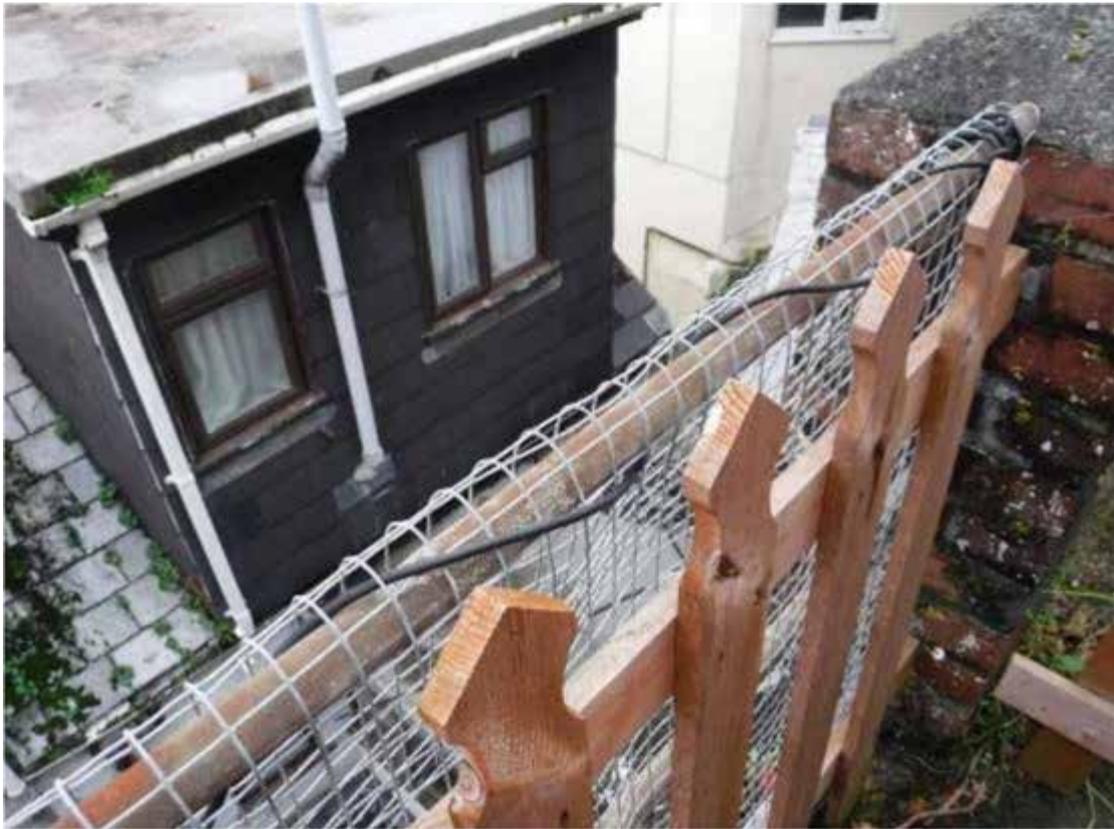
**Photo 35: View showing surface corrosion to the steel parapet above the lower section of the retaining wall.**
