# Shutta Road Retaining Walls Route Report

**Division: CORMAC Consultancy**

**Site name:** Shutta Road, Looe

Report No: CN1701503/01/01

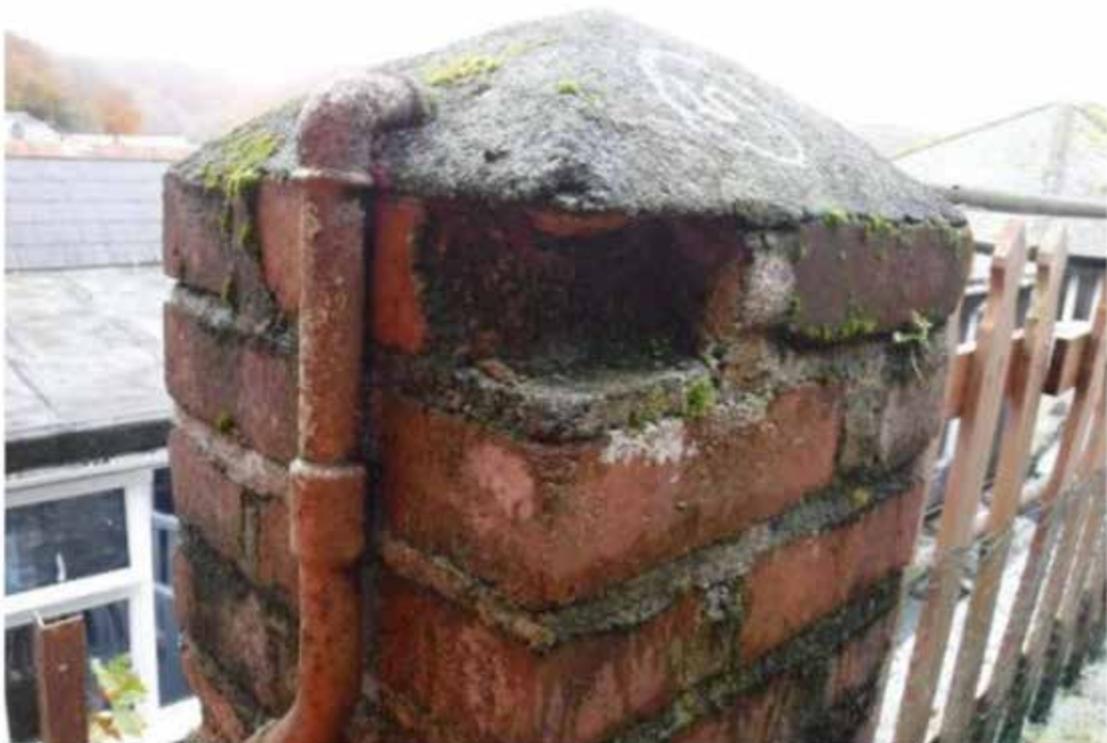
**Photo 38: View showing a spalled brick in the southern end of the parapet above the lower section of the retaining wall.**

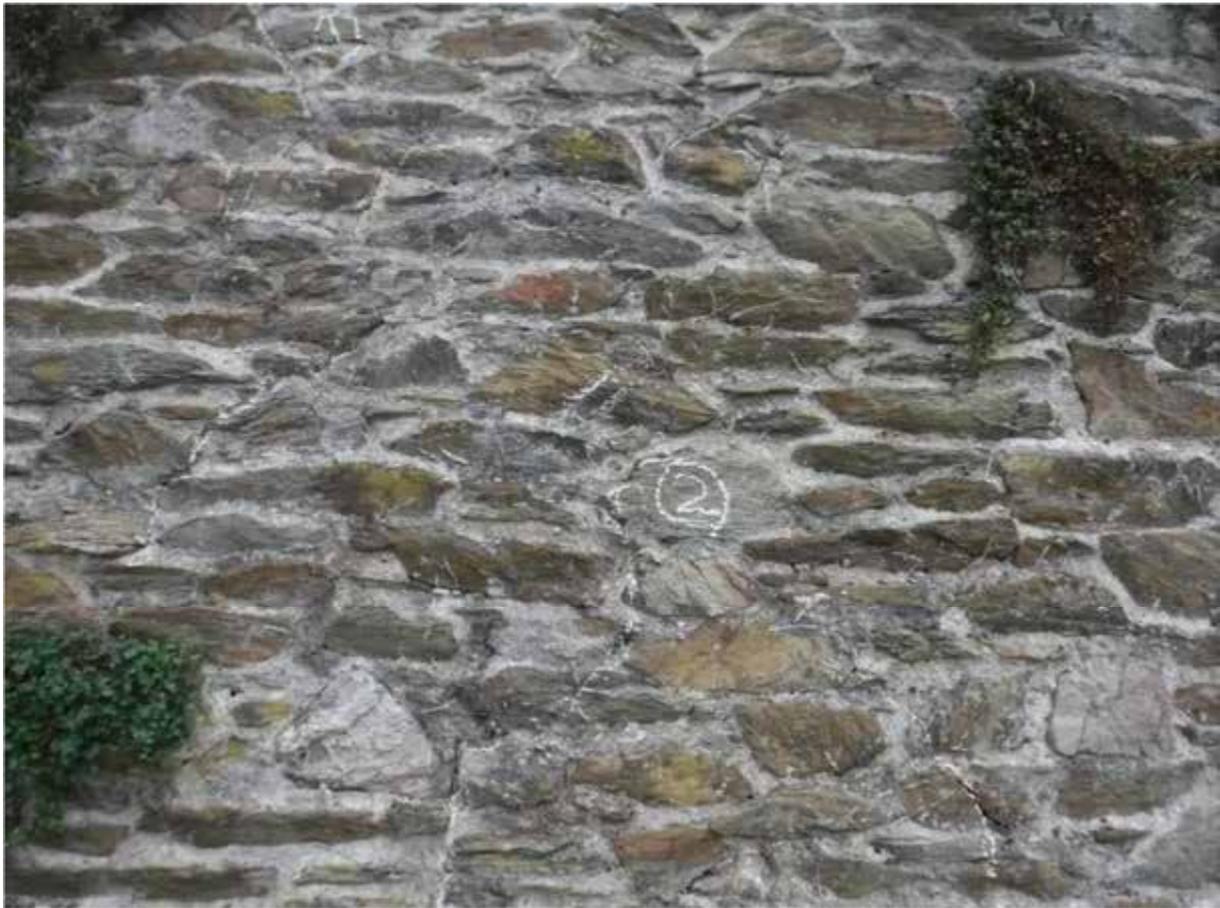
**Photo 2: View showing a vertical crack in the wall at chainage 4m**

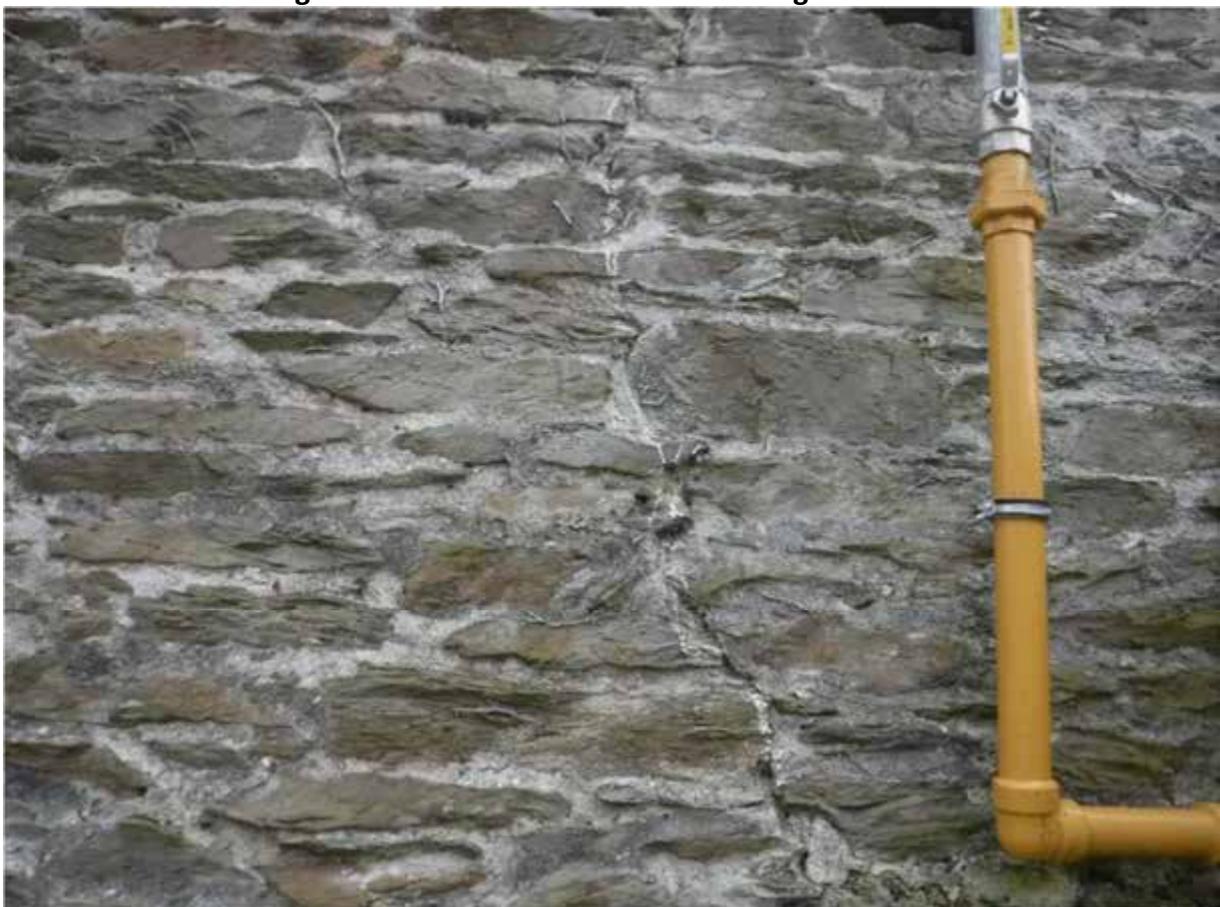
**Photo 3: View showing a 15mm crack in the buttress at the south end of the wall**

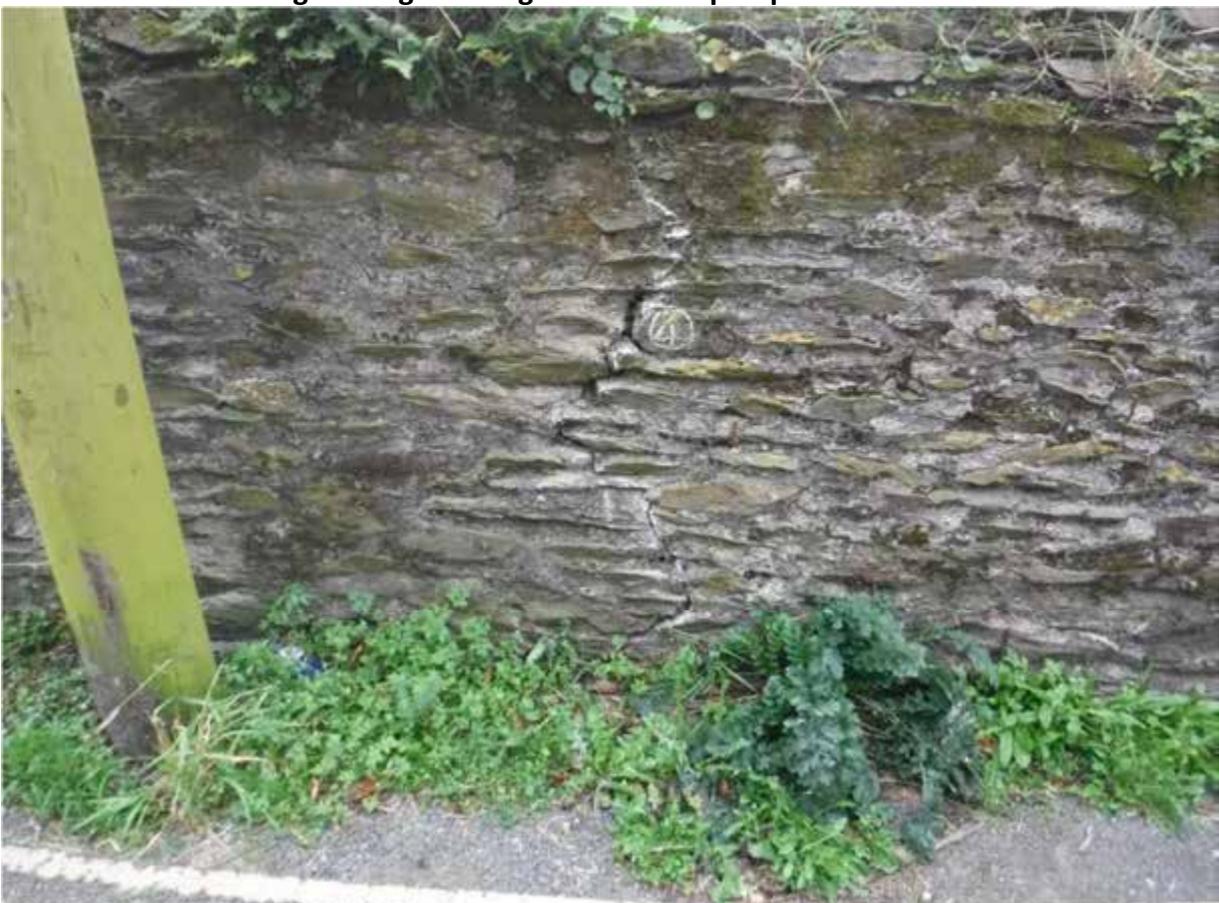
**Photo 9: View showing a vertical/stepped crack in the parapet at chainage 6.5m**

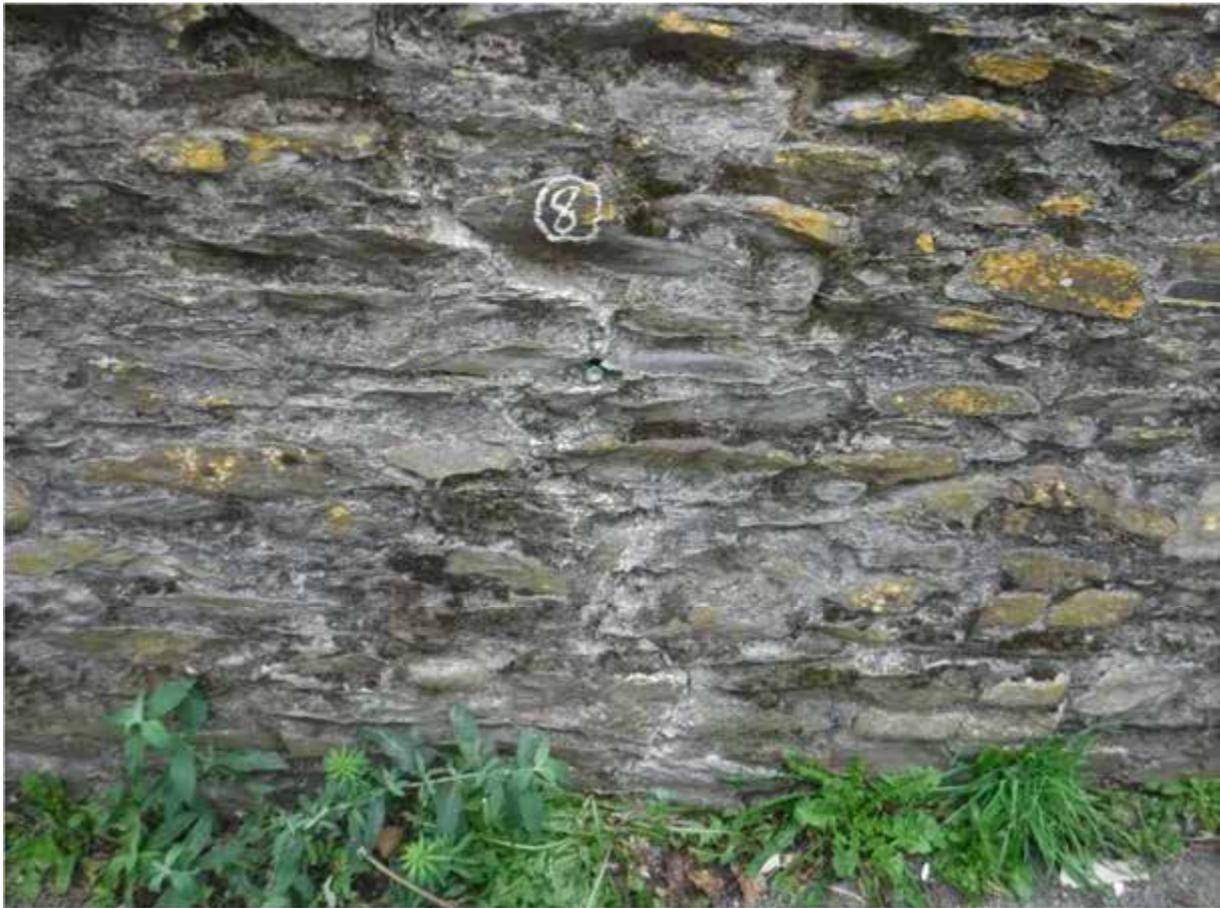
**Photo 10: View showing vertical/stepped cracking in the parapet at chainage 15m**

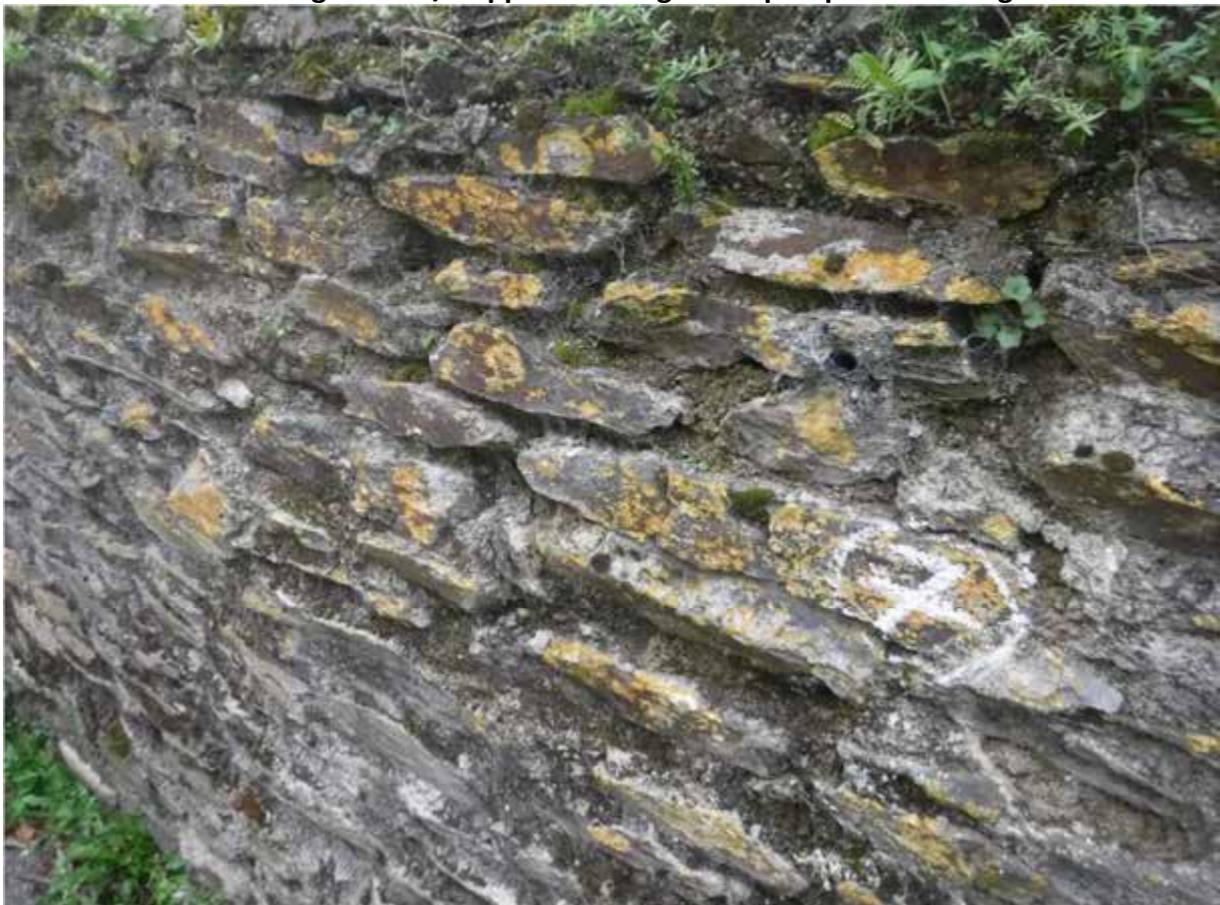
**Photo 11: View showing an area of joint mortar loss to the parapet at chainage 12m**

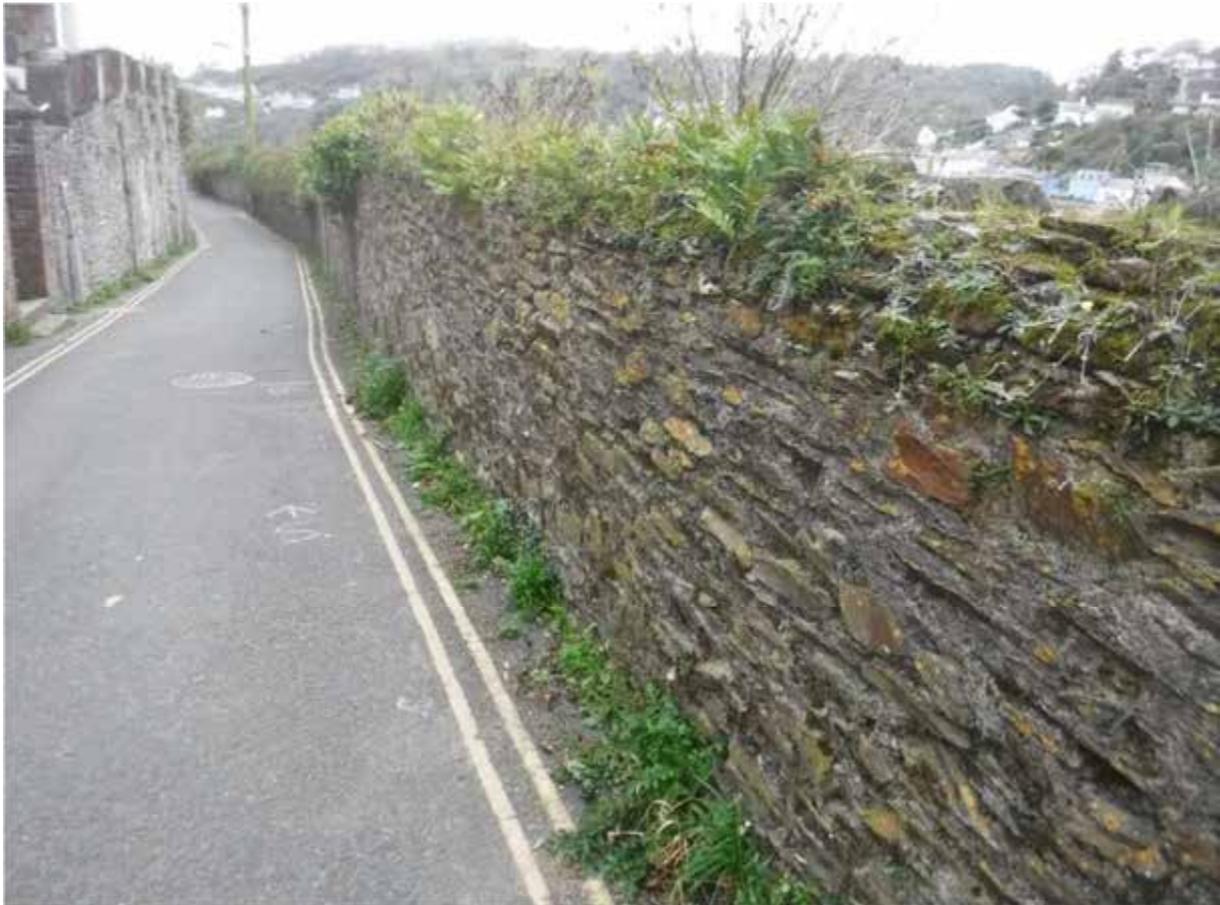
**Photo 12: View showing the typical condition of the parapet overall**

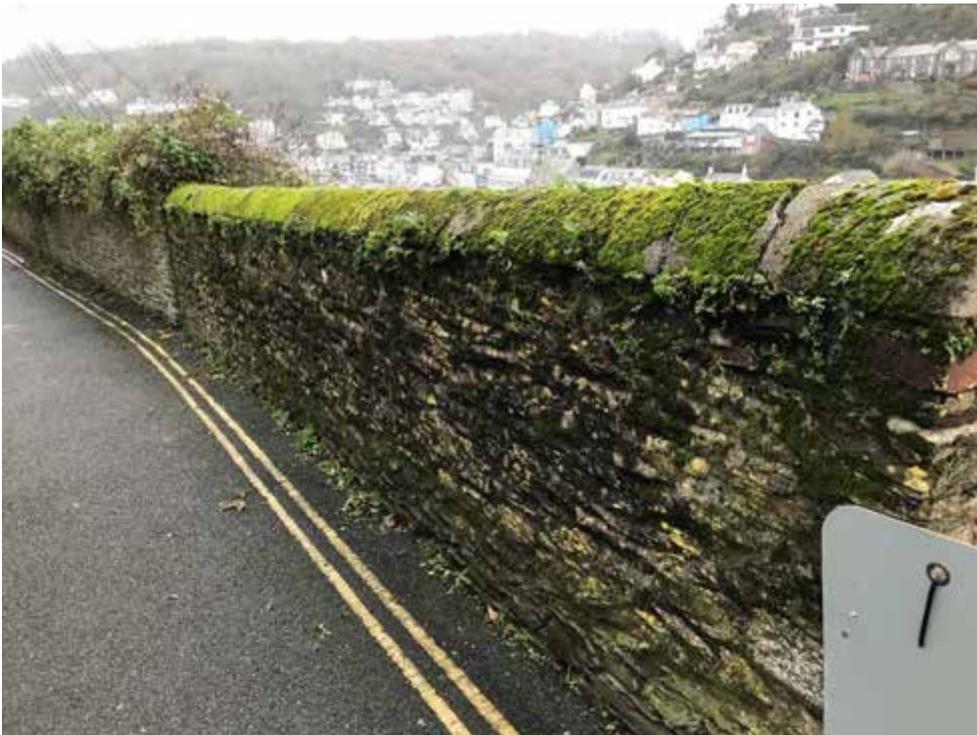
**Photograph 1 : General view of Parapet and road. Note old sign used as barrier. Domed concrete coping cracked and loose.**

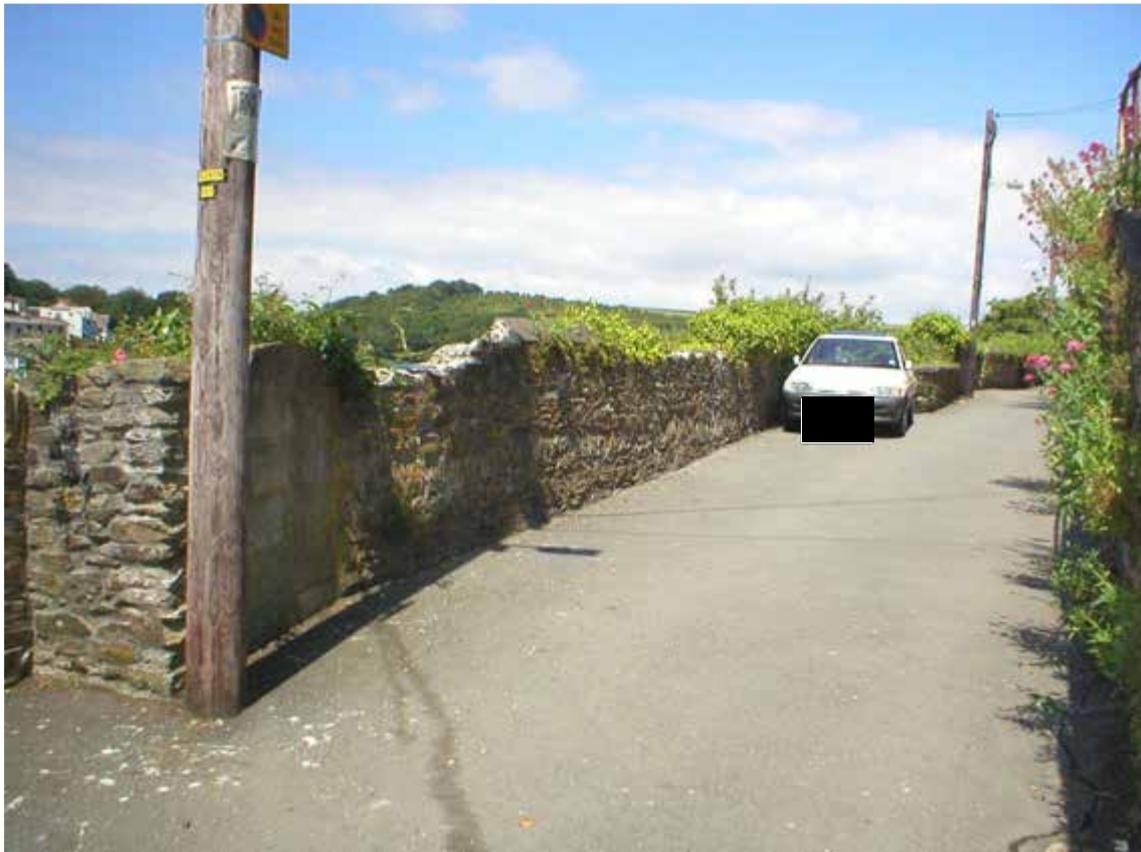
**Photograph 1 : Wesley Terrace (North) looking north. Blocked up access way, damaged missing coping.**

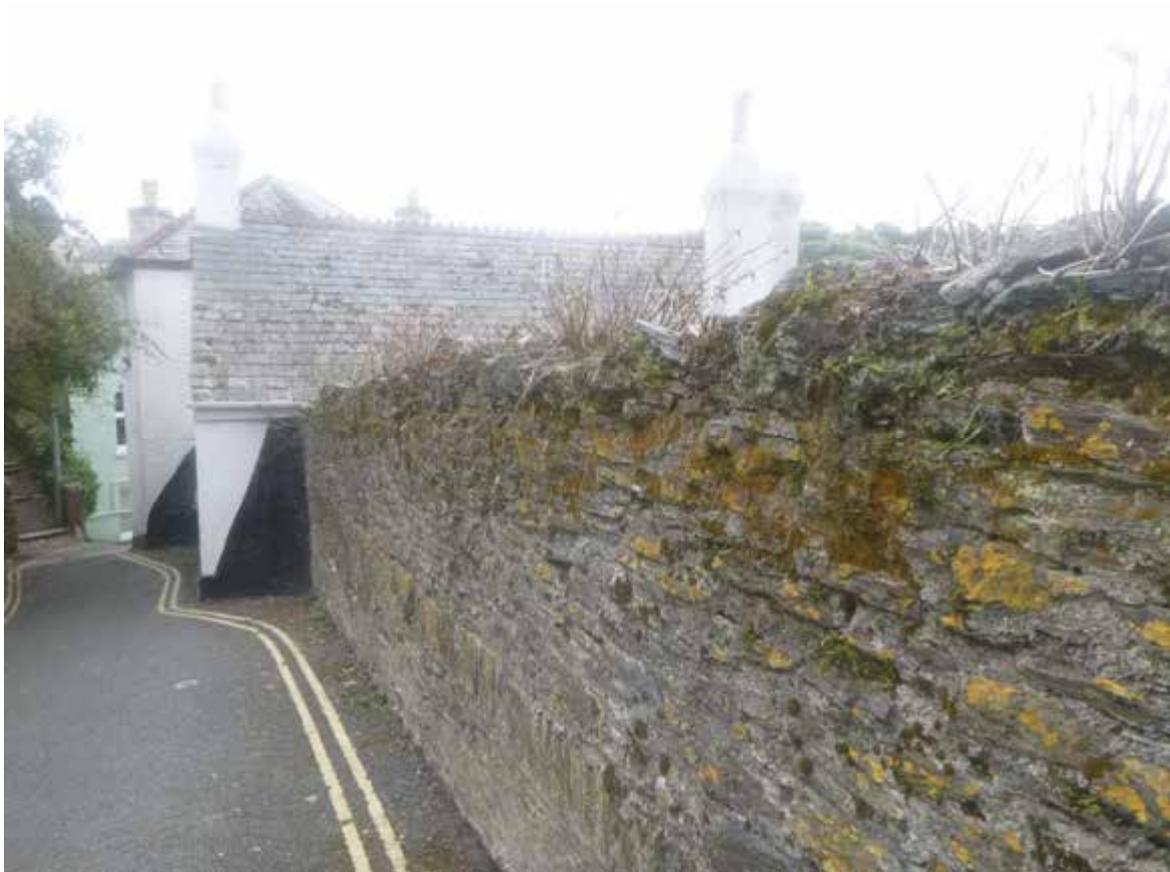
**Photograph 2 : View of road and parapet looking south, coping loose with vegetation**

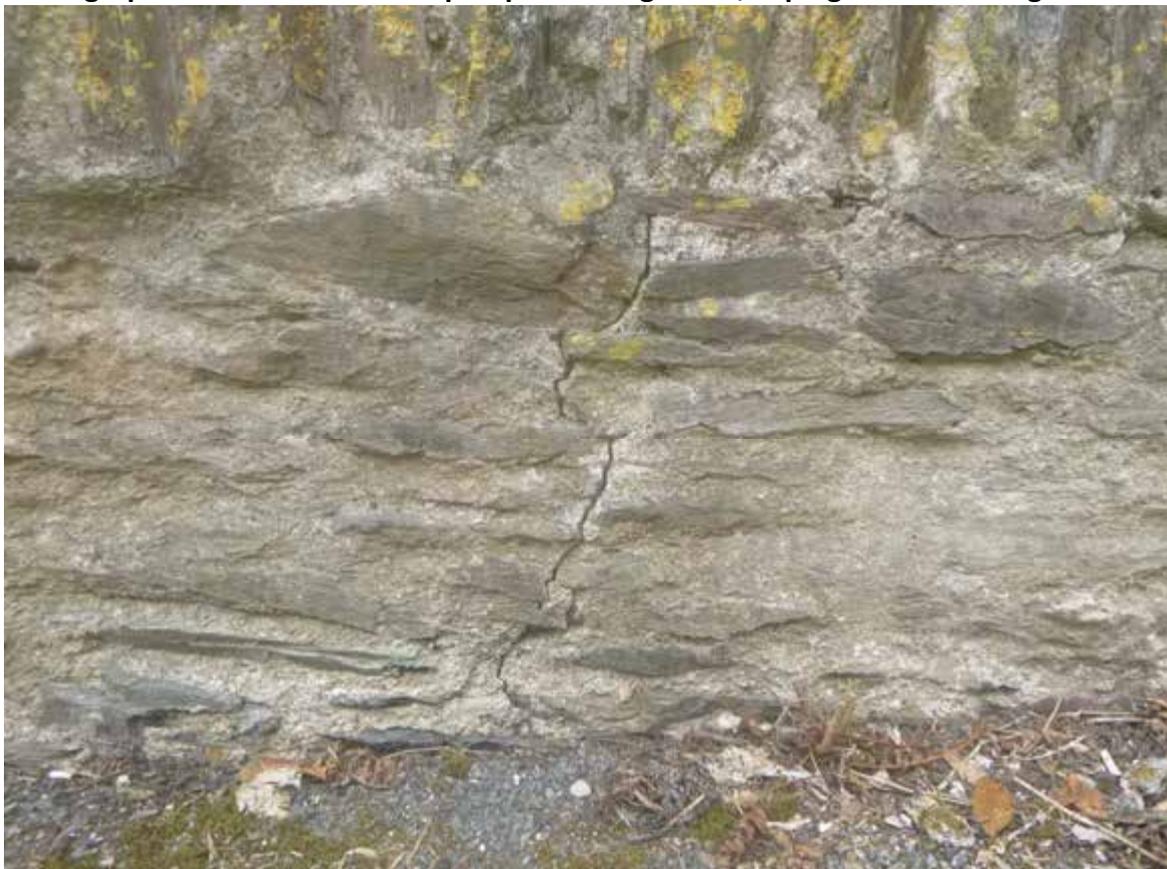
**Photograph 3 : Crack from road to row of vertical coursed stone in the parapet**

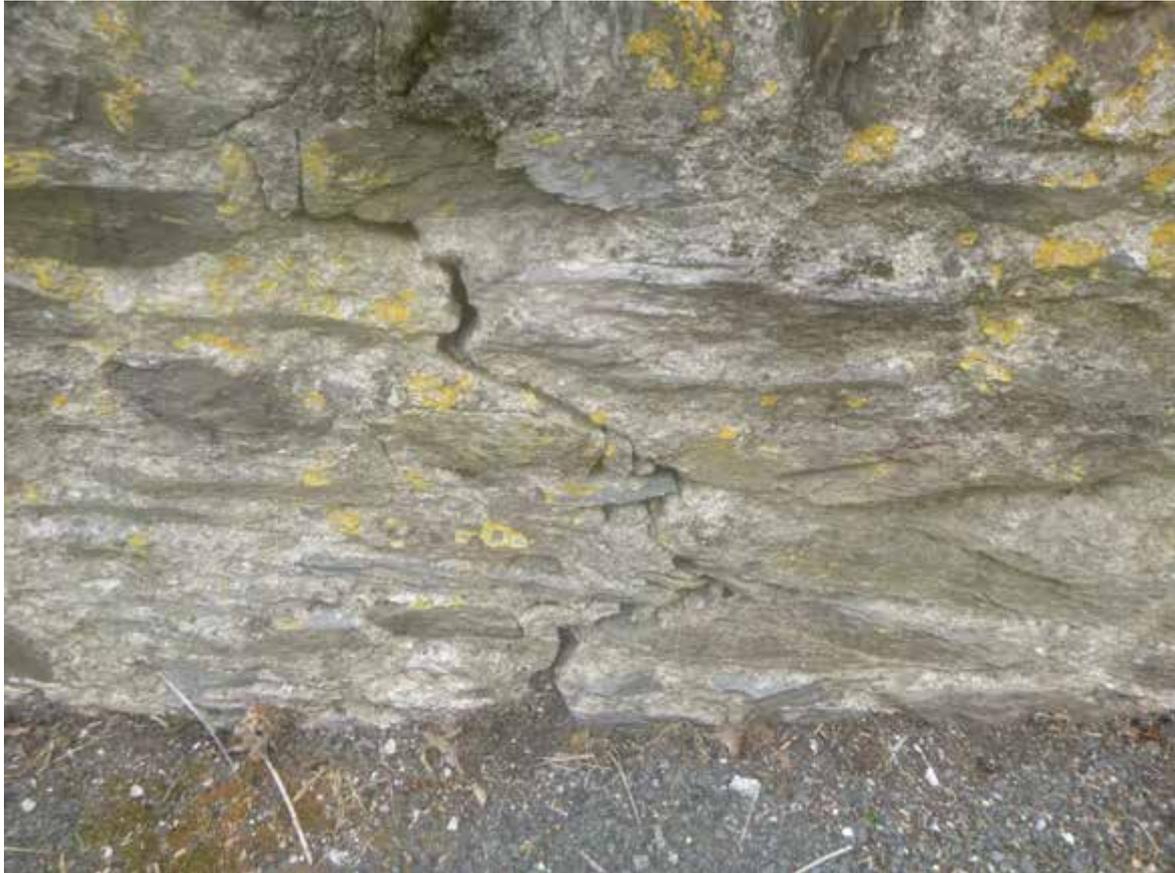
**Photograph 4 : A second crack from the road level through the vertical coursed stone work.**
