DAYTIME BAT SURVEY AT GREENBANK SCHOOL, CHEADLE HULME, CHEADLE

2021

RACHEL HACKING ECOLOGY

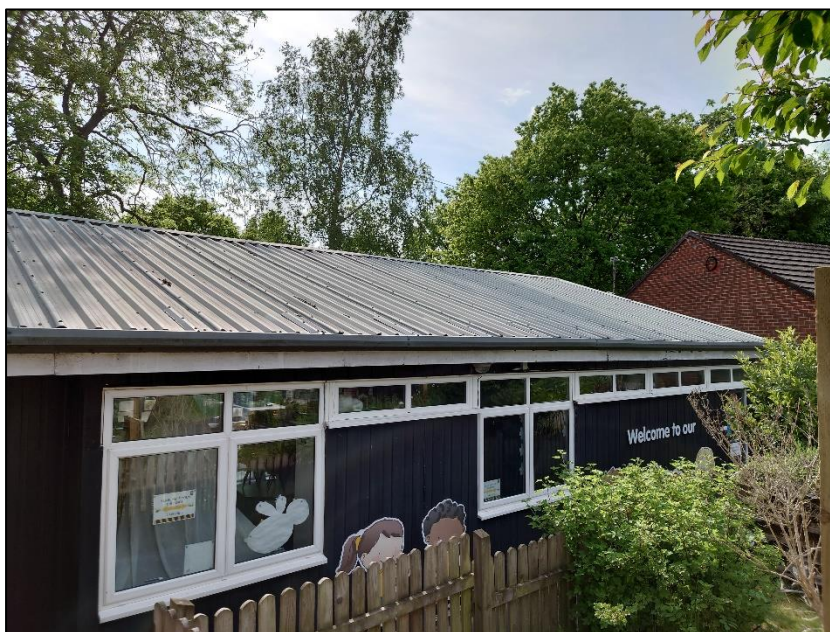
- 3.1 The external brickwork is complete and intact with no areas of damaged bricks or recessed mortar (see Photograph 1). Sections of the walls are wood clad which are well-sealed (see Photograph 2).

Photograph 2 showing the clad gable

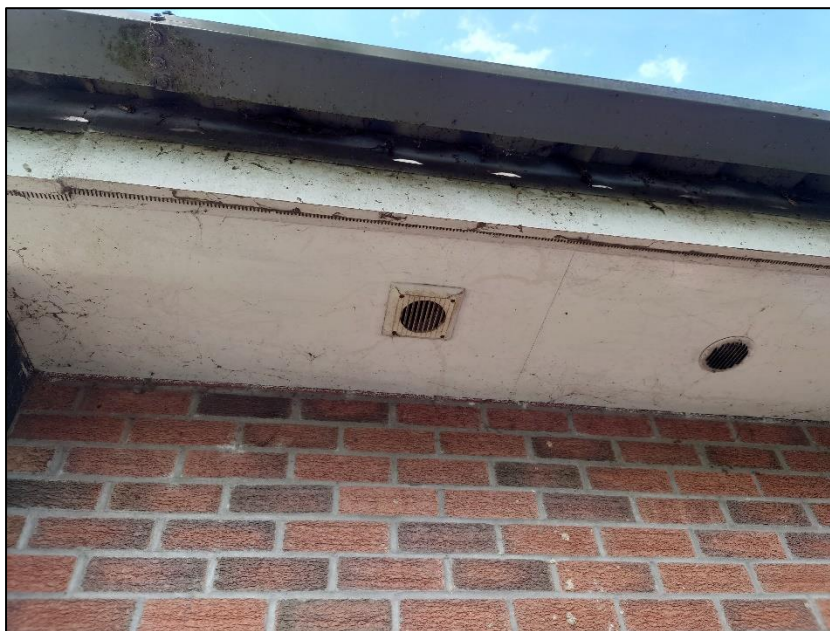
- 3.2 Wooden soffit boards are present which are in good condition with the exception of one gap where the wood is degrading (see Photograph 3). All the windows and doors of the building are framed with UPVC and are well-sealed to the surrounding cladding/masonry (see Photograph 4).

Photograph 3 showing peeling wood on the wooden soffit boards

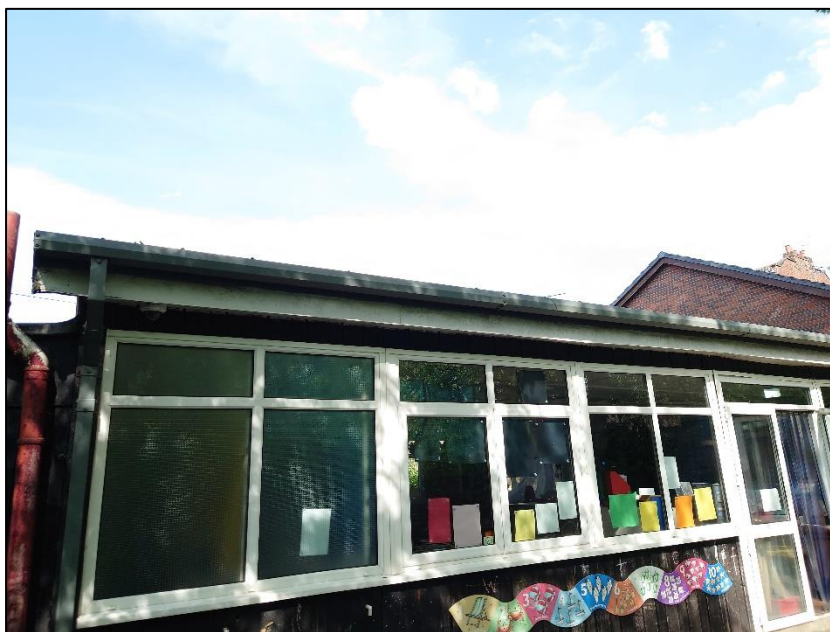
Photograph 4 showing the window and door frames

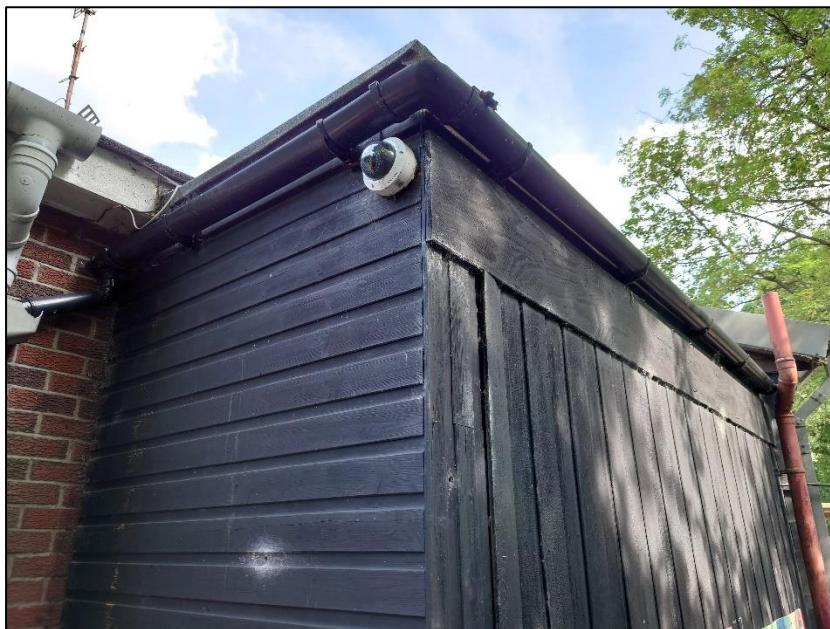
- 3.4 A small single-storey flat-roofed extension exists on the north-western elevation (see Photograph 5). This feature has wooden cladding on all sides. The cladding is in reasonable condition with no gaps or cracks. The flat roof is covered with roof felt. The felt is intact and well-sealed.

Photograph 5 showing the flat roof extension

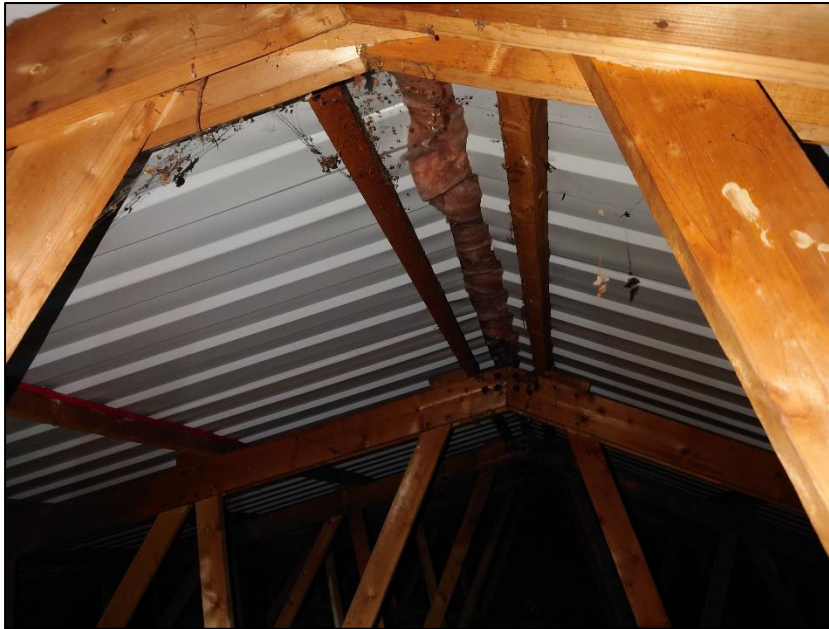
- 3.5 The internal spaces comprise a ground floor which is in use as a school room, offices and toilet facilities. No habitat associated with roosting bats is present. Two roof voids are located above, one large and one small, separated by a partition wall.
- 3.6 The large roof void was fully accessible. The roof void is insulated with rockwool and the roof is unlined (see Photographs 6 and 7). The roof timbers are in excellent condition, free from cracks and crevices bats may exploit.

Photograph 6 showing the roof void

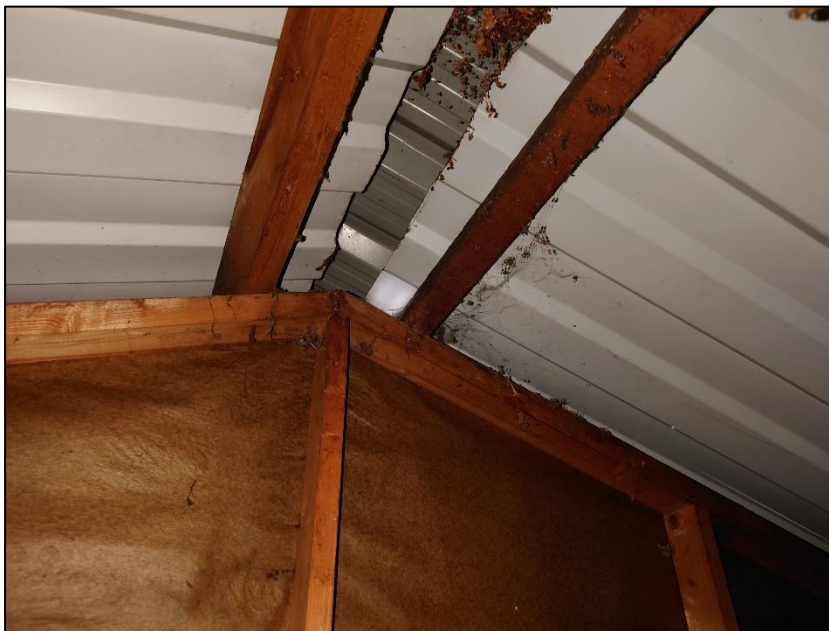
Photograph 7 showing the roof void

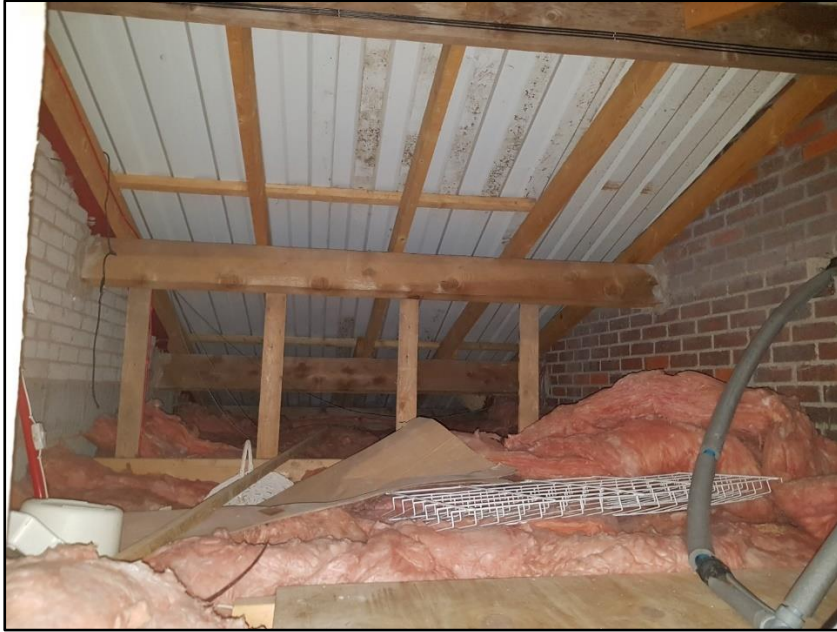
- 3.7 The smaller roof void is well-sealed (see Photograph 8) except for small sections of daylight visible at the edges of the roof. The space is insulated with rockwool insulation. The roof is unlined and the roof timbers are in excellent condition, free from cracks and crevices for bats to exploit. No evidence of bats was found in the roof void.

Photograph 8 showing the smaller roof void

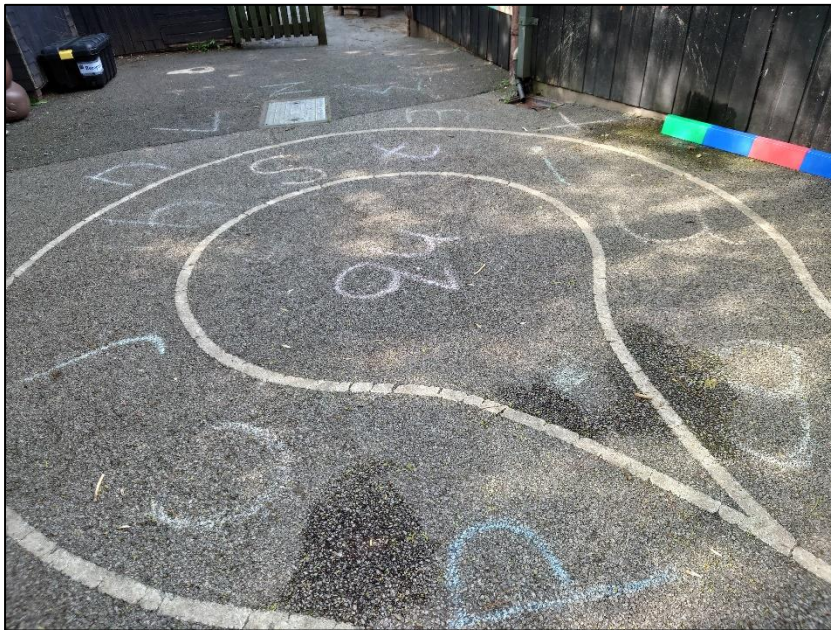
- 3.8 The building is enclosed by hardstanding (see Photograph 9), with introduced shrubs present near to the building. No evidence of other protected species could be found on the site.

Photograph 9 showing the hardstanding on site

- 4.7 It is recommended that work to the vegetation and building takes place outside of the nesting season (which is generally March to August) or that a nesting bird survey is undertaken immediately prior to work commencing.
