SITE INVESTIGATION REPORT

PROJECT : PROPOSED GARDEN CENTRE

ADDRESS : IRVINE ROAD, FAIRLIE

PROJECT REF NO : 09602

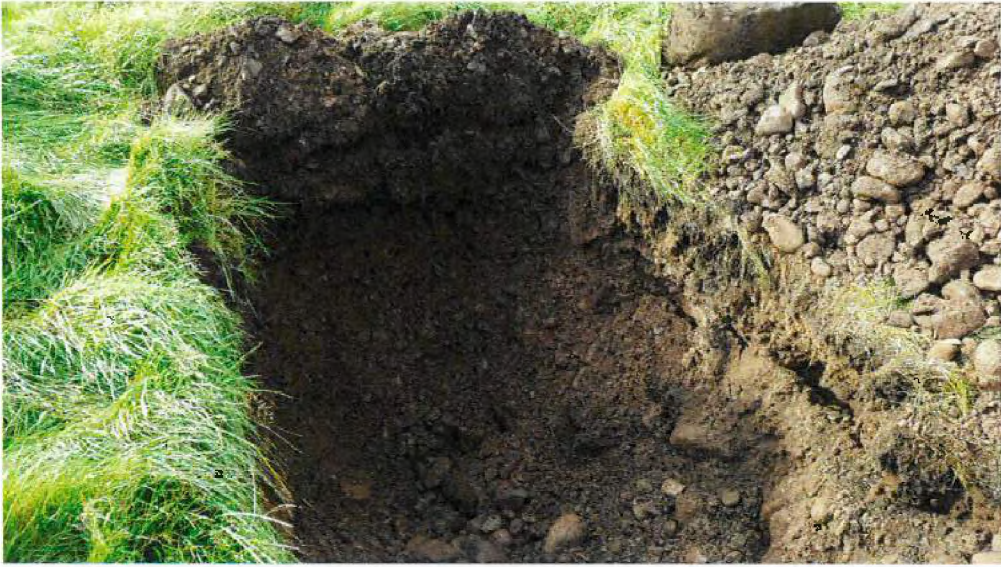
Trial Pit 1

0 – 200	Grass and topsoil
200 – 1800	Light to medium brown loose sands and gravels with stones and cobbles (varying sizes). Slightly damp below 900mm
1800	TP terminated. Sides unstable and falling in

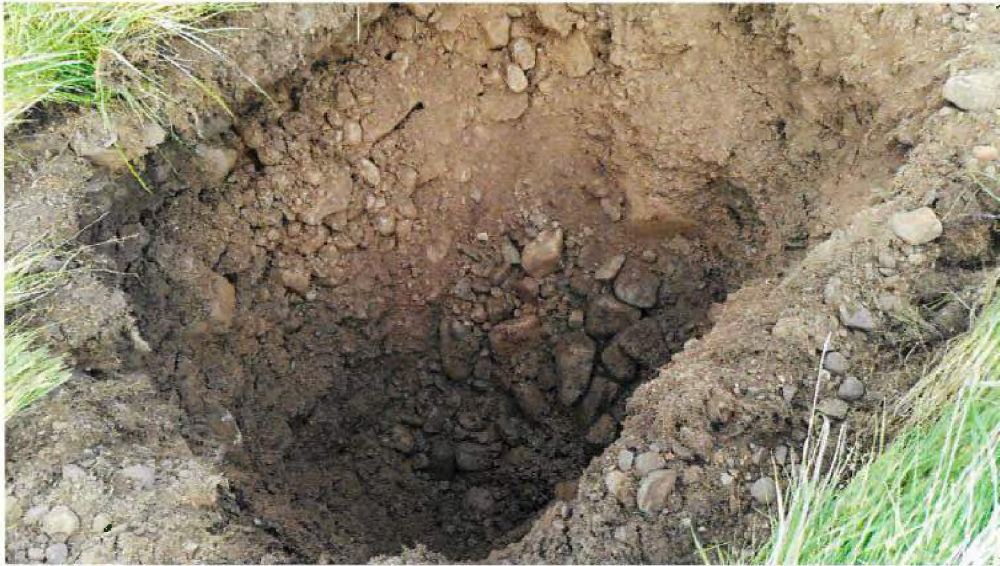
Trial Pit 2

0 – 200	Grass and topsoil
200 – 2000	Light to medium brown silty sands and gravels with stones and cobbles (varying sizes). Slightly damp and holding together
2000	TP terminated

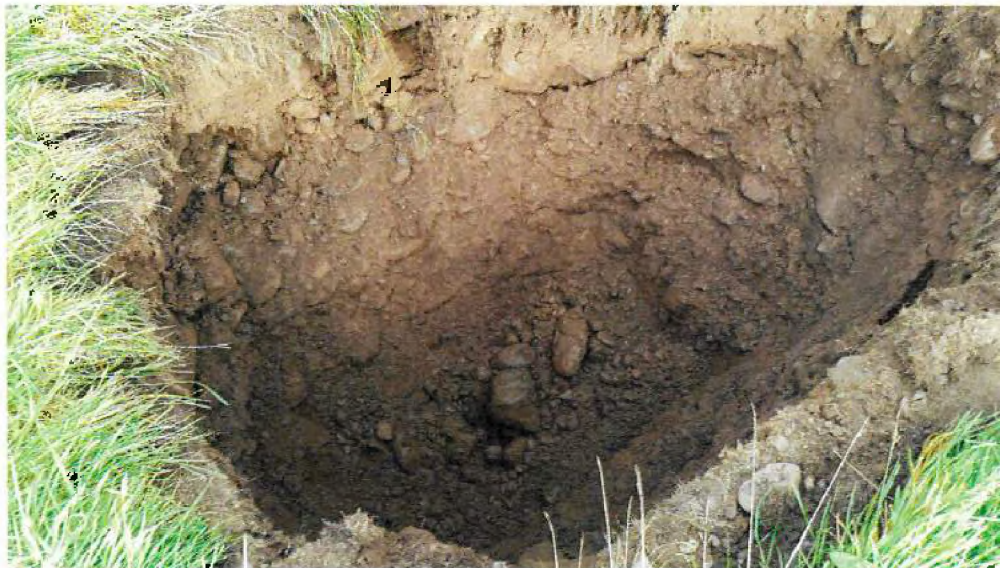
Trial Pit 3

0 – 200	Grass and topsoil
200 – 2000	Light to medium brown loose sands and gravels with stones, cobbles and larger boulders. Slightly damp below 600mm
2000	TP terminated. Sides unstable and falling in

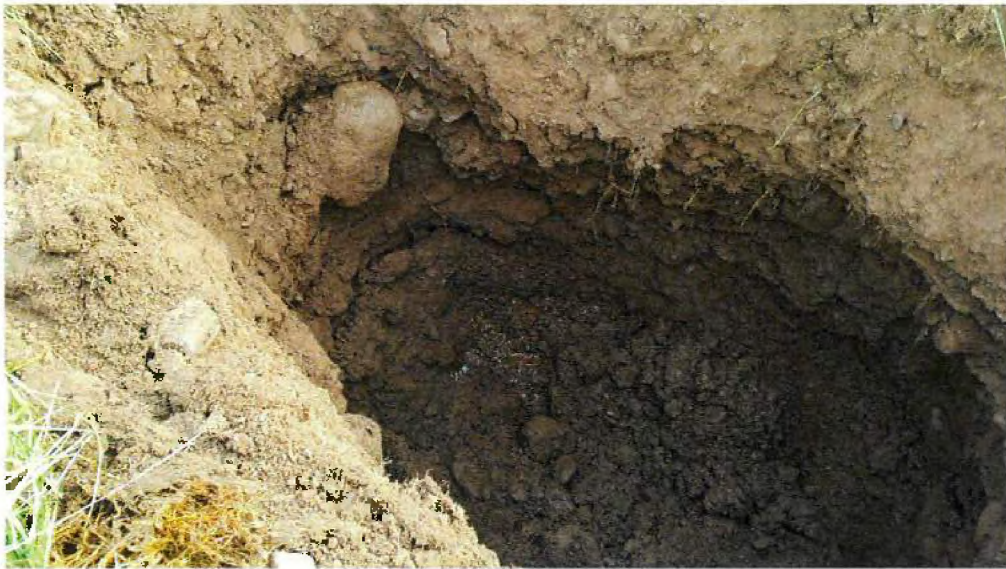
Trial Pit 4

0 – 200	Grass and topsoil
200 – 2000	Light to medium brown silty sands and gravels with stones and cobbles (varying sizes). Slightly damp and holding together at 800mm below FGL. Water trickling in at 1600mm
2000	TP terminated

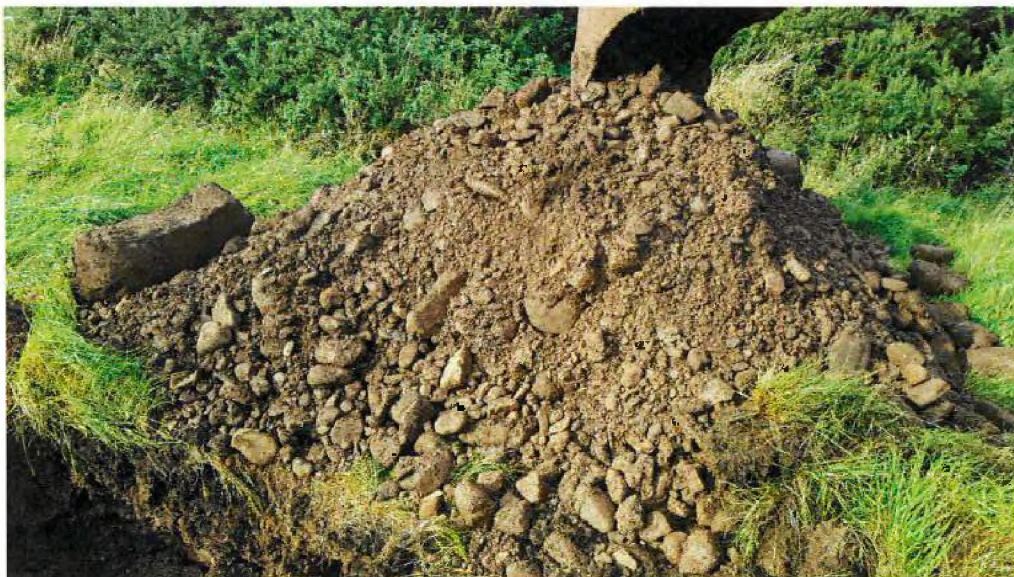
The underlying soils were noted to be grass and topsoil, overlying layers of sands and gravels with stones through, akin to a raised beach material.

Typical Excavated Material

We are of the opinion that the soil conditions would offer a bearing pressure of minimum 75kN/m^2 which based on the applied loads would result in a raft slab foundation due to the loose material encountered. The slab would have mesh through and formed on a layer of compacted hardcore.

Should the foundations excavation reveal areas where large boulders are problematic it may require the use of additional depth of concrete to compensate or the use of compacted hardcore to create a consistent level of formation.

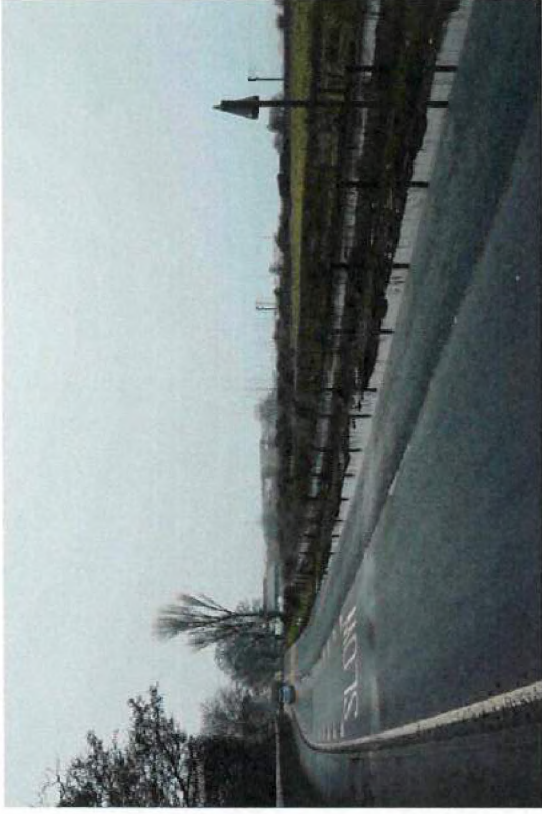
Plate 5: Looking southwest towards subject watercourse. This plate shows pooling of water on the A78 near the foot of the hill (i.e. beyond the site). Photograph taken from NS 21053 56348.

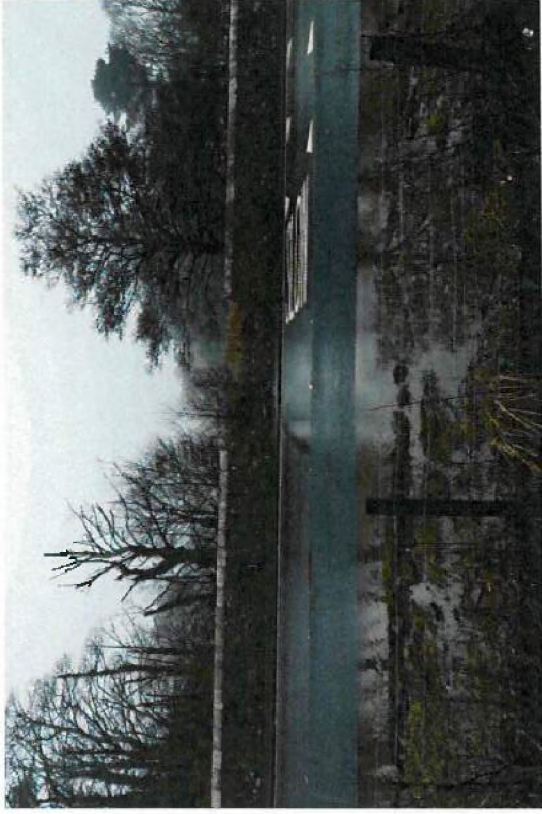
- 3.6 The field shown in plate 11 is already subject to waterlogging due to poor drainage which results in water flowing through a break in the wall adjacent to the A76 (plates 6 and 7) and pooling on the trunk road (plates 5 and 6). Note that the slope of the road is north i.e. away from the site.

Plate 6: Looking east towards the source of the water pooling on the A78. The break in the wall was caused by a car crash. The field behind the wall is poorly drained and run-off flows onto the road. Photograph taken from NS 21035 56338.

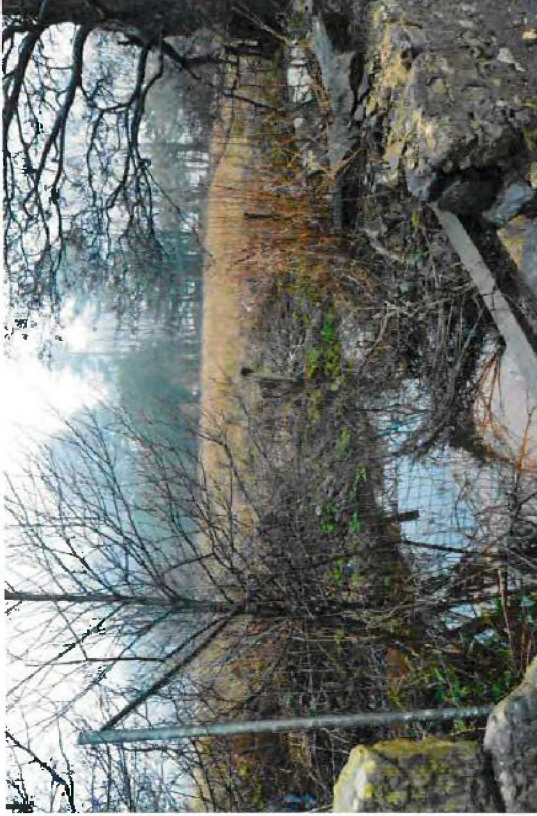
Plate 7: Source of A78 flooding.
Photograph taken from NS 21050 56336.

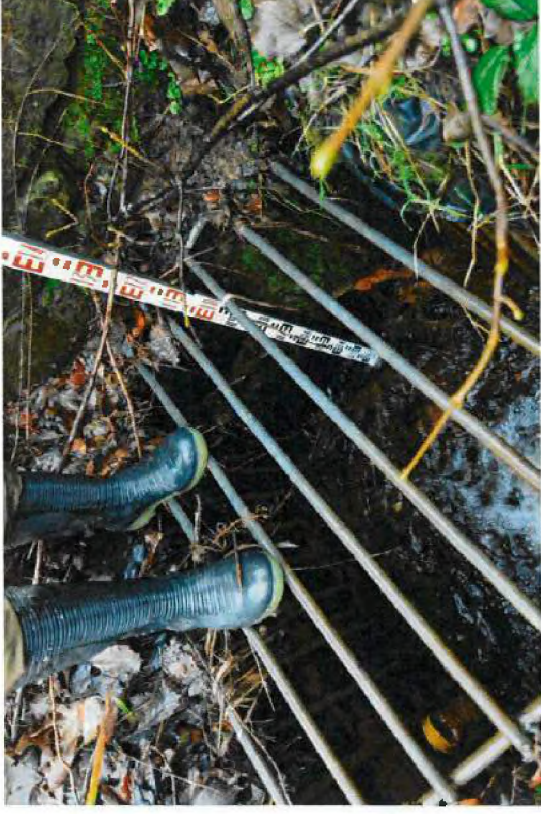
- Constraint to fluvial flow at or towards the site**
- 3.4 The constraint to fluvial flow at the site is the culvert intake (plates 8 and 9). This has an ID of 0.55 m which provides a cross-sectional area of 0.2 m². This is significantly smaller than the minimum cross-sectional area of the open channel which from the site visit and the topographical survey⁽⁴⁾ was estimated to be in excess of 5.0 m². Even when taking into consideration the higher roughness of the open channel and the slightly lower slope it provides significant capacity to convey the maximum discharge from the culvert.

Plate 9: A78 culvert intake (0.55 m ID pipe with corrugated inner walls and wash screen with circa 100 mm spaced bars). Top of wall is c. 2.2 m above screen. Photograph taken from NS 21040 56284.

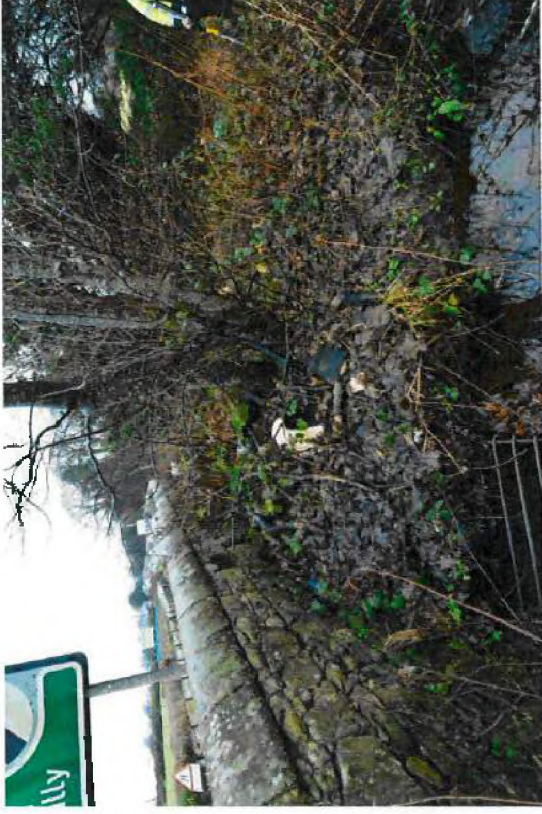
- 3.5 Should the culvert intake be surcharged during a 1:200 year event the flood water will flow north down a steep incline into the field shown in plate 11. The location where flood water would overtop the north bank which is at lower elevation than the south is shown in plate 10.

Plate 10: Watercourse at A78 culvert intake. Flow route during surcharge will be north into adjacent field (next plate). Photograph taken from NS 21040 96283.

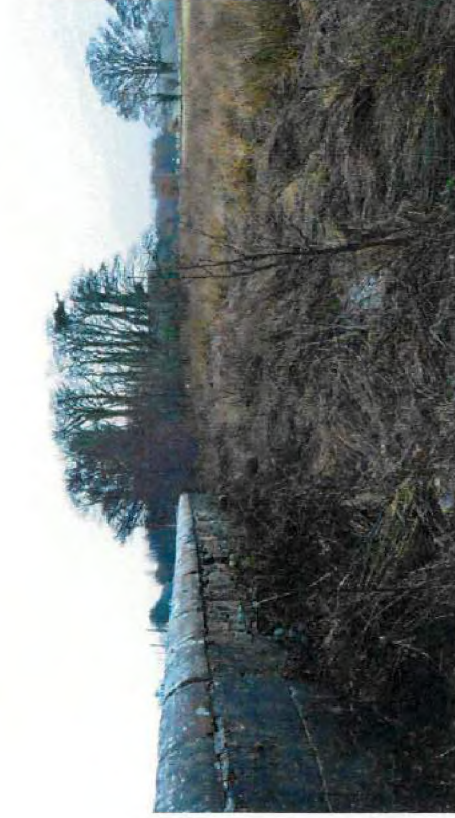
Plate 11: Adjacent field.
Photograph taken from NS 21044 56295.

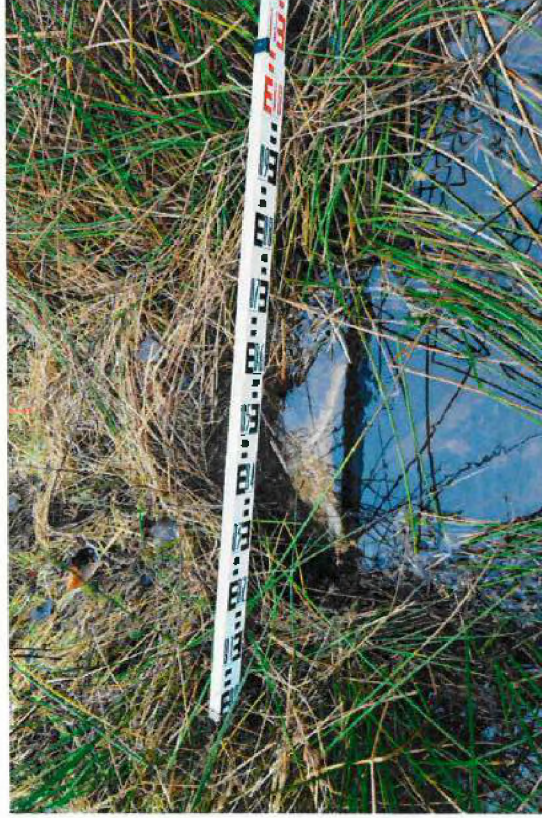
- 3.2 Flow from the catchment enters a 0.55 m ID circular pipe (plate 9) which travels beneath the A76/cycle track and discharges into the open channel (plate 13) towards the north end of the proposed development site (plates 14 to 17). Somewhere beneath the A76/cycle track the 0.55 m ID pipe connects into a 0.55 m H x 0.7 m W ID elliptical vitrified clay pipe which forms the outfall (plate 12).

Plate 12: Culvert outfall (ID: 0.55 m H x 0.7 m W elliptical VCP pipe).
Photograph taken from NS 21022 56294.

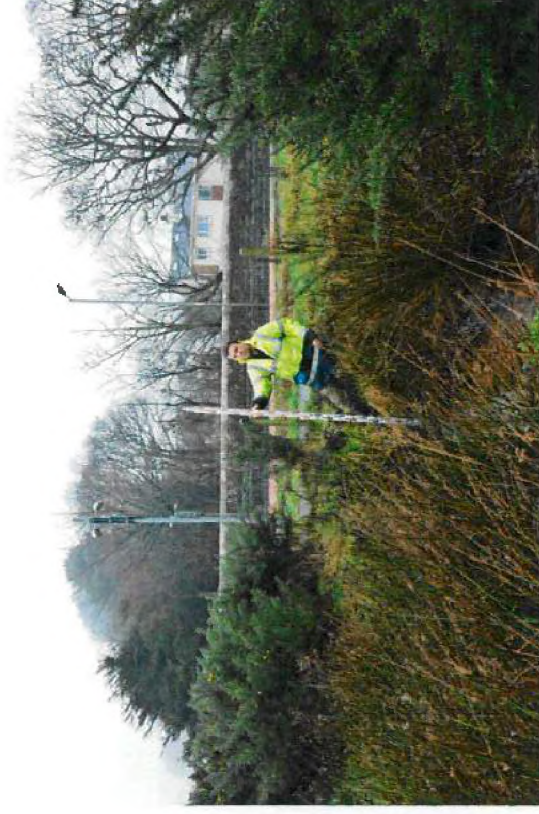
Plate 13: Channel of subject watercourse at culvert outfall.
Photograph taken from NS 21018 56294 looking upstream.
