Tree Survey Report
BS 5837:2012 *Trees in Relation to Design,
Demolition and Construction-Recommendations*

Land at Carbeth

8th January 2021

Prepared by
C. A. Calvey, P.T.I., Tech.Cert (Arbor.A), Cert.Arb (RFS), BA Hons.
THE TREE INSPECTOR (SCOTLAND)

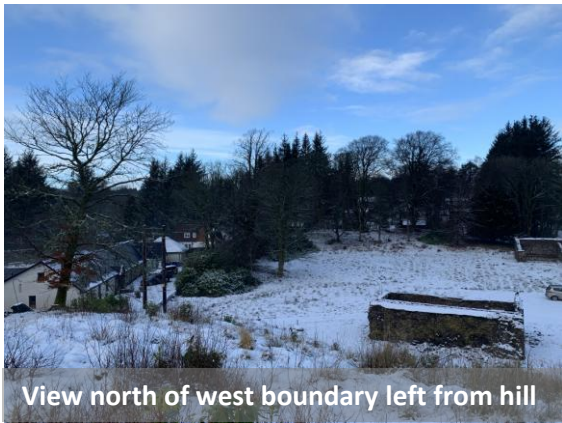
View north of west boundary left from hill

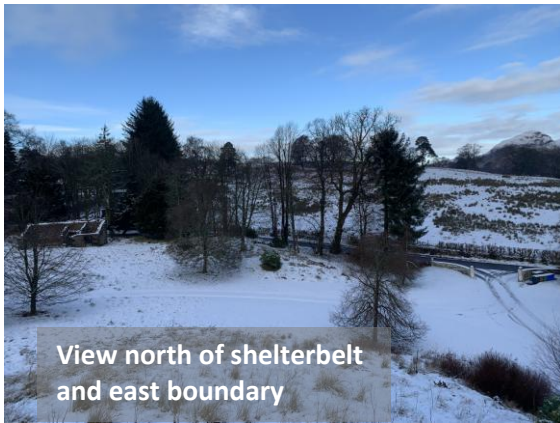
View north of shelterbelt and east boundary

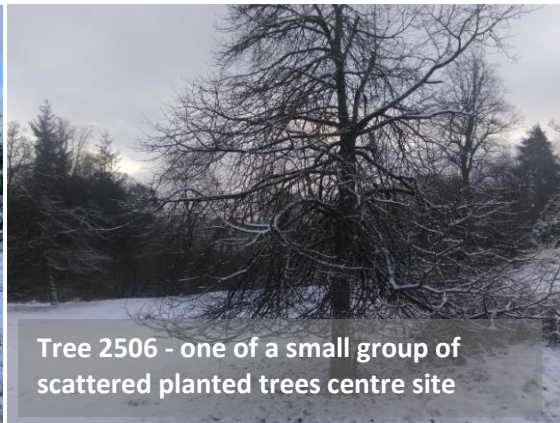
Tree 2506 - one of a small group of scattered planted trees centre site

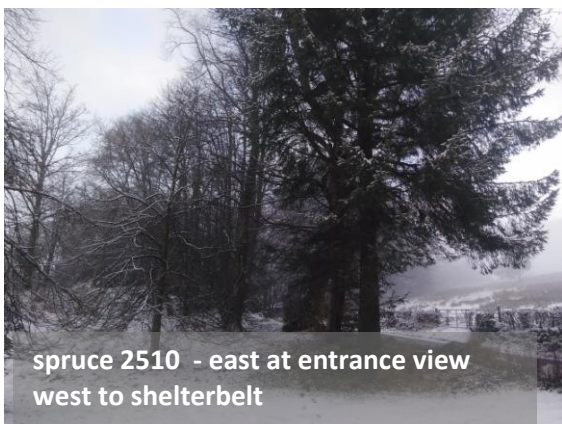
spruce 2510 - east at entrance view west to shelterbelt

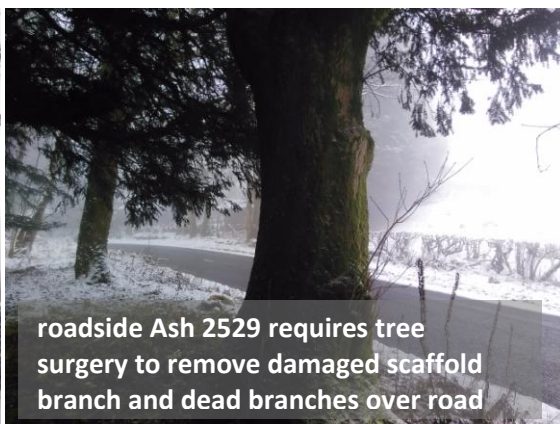
roadside Ash 2529 requires tree surgery to remove damaged scaffold branch and dead branches over road

252794.9 679637.5	2529	Common Ash <i>Fraxinus excelsior</i> <i>Large Primary scaffold overhanging road with cavity at base. Recommended for annual safety inspection.</i>	Mature	18	5	1	800			10	6	3	5	Fair	20 to 40 yrs	5	1	B
252794.3 679634.3	2530	Common Yew <i>Taxus baccata</i>	Mature	10	1	3	400	270	400	5	5	5	5	Good	20 to 40 yrs		1	B

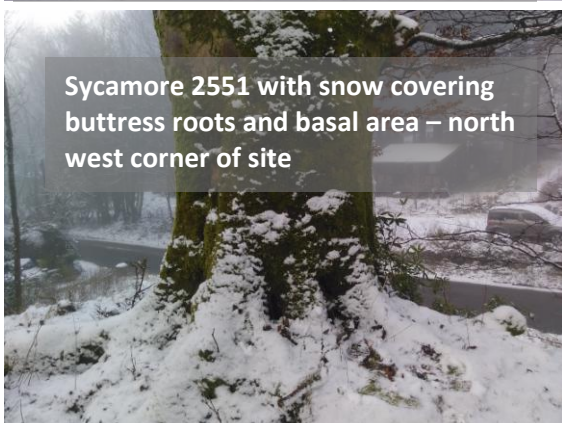
Sycamore 2551 with snow covering buttress roots and basal area - north west corner of site

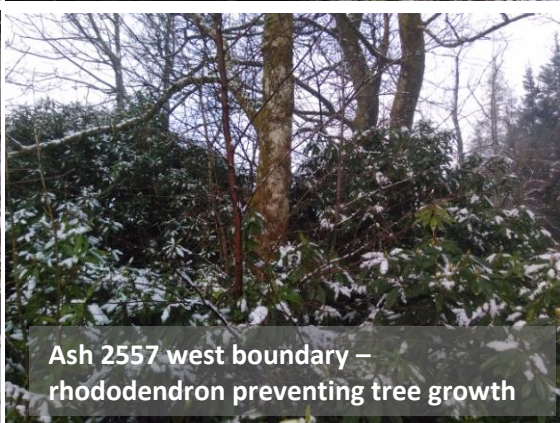
Ash 2557 west boundary - rhododendron preventing tree growth

1. Highly invasive non-native *Rhododendron ponticum* has colonised the tree shelterbelt which is recommended for removal.
2. Trees were surveyed during a period where snowfall had covered the buttress roots and basal areas of most trees such that some pathogens and or basal defects would not be visible. The tree survey results should therefore be regarded as the best case scenario in tree classification and condition. Retained trees should be inspected on a regular basis to ensure their condition meets a duty of care. Please refer to report limitations pages 16-17.
