GROUND STABILITY REPORT
ON
PROPERTY KNOWN AS
HIGHWATER
SHUTTA ROAD, LOOE PL13 1HW
FOR
MR AND MRS L TANSLEY

MAY 2017

| 1.2 | Brief | To inspect and report on the stability of site

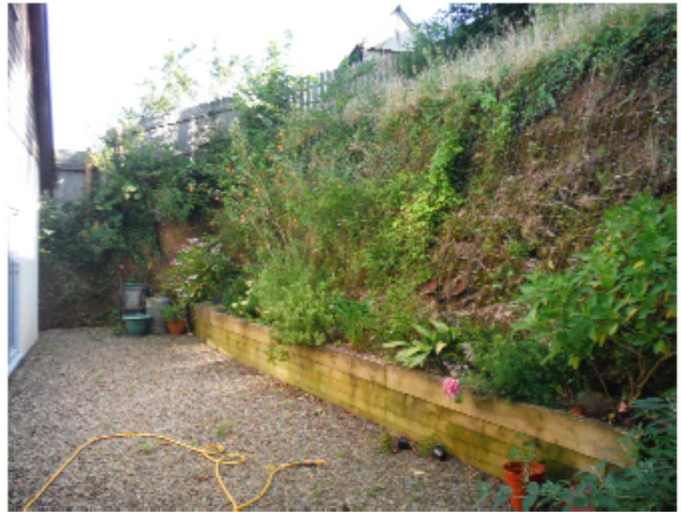
Photograph 1

The high ground to the rear of the property has been excavated to form a cutting which stands at approximately 20 degrees from the vertical as shown in Photograph 1. The cutting is approximately 4 meters in height and its toe is approximately 4 meters from the building.

3.7 The cutting to the rear of the site, Photograph 1, has remained stable since it was cut 10 years ago.

The rock face of the cutting has weathered over the years but its erosion has been limited to the fracture of localized splinters of rock. The face of the cutting has been restrained by the placing of mesh over the exposed strata which has encouraged the growth of vegetation.

There is no indications of slippage or global movement associated with the cutting

The face of the cutting was damp on the day of the inspection but there are no indications of the running water or springs emanating out of the rock .

Cutting into the original ground
to the rear of the property

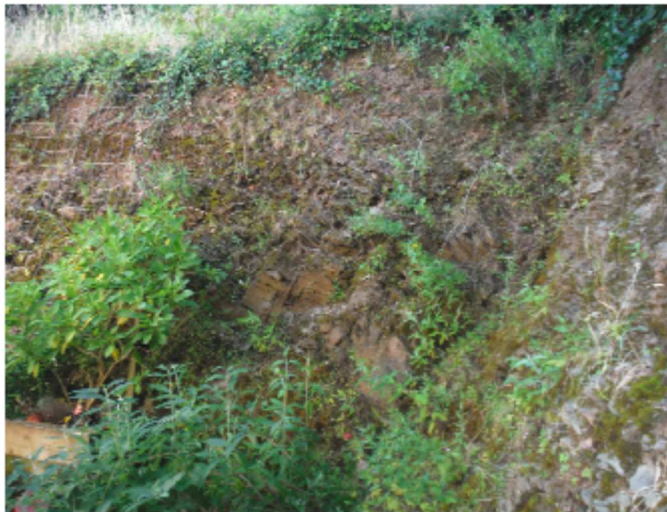
Photograph 2

The strata to the cut face, shown in Photograph 2, indicates that it comprises fractured shale laid in bedding planes generally inclined downwards to towards the south ie perpendicular to the direction of the cut face.

Underlying strata
comprising fractured shale

Mesh has been placed over
the cut face of the strata to
encourage vegetation and
restrain small fragments
from the face .

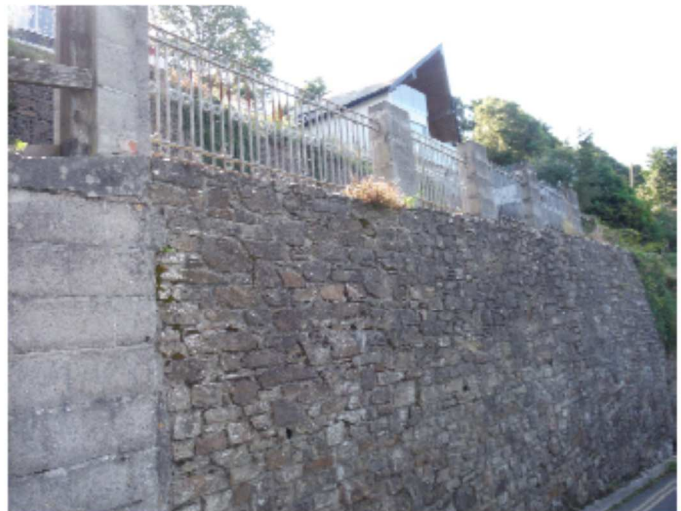
Photograph 3

3.2 The stonework retaining walls to the west of the site, Photographs 3 and 4) are free of cracks and do not exhibit any indications of structural duress. The face of the stonework is reasonably pointed with a lime base mortar. They do not appear to suffer from excessive water seepage through or around the masonry .

Stone retaining wall restraining
the drive

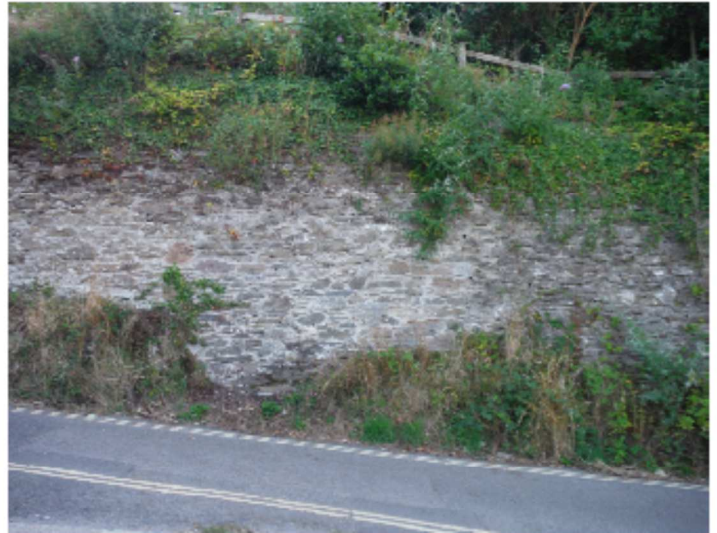
Photograph 4

Lower stone retaining wall
restraining the site below
the property

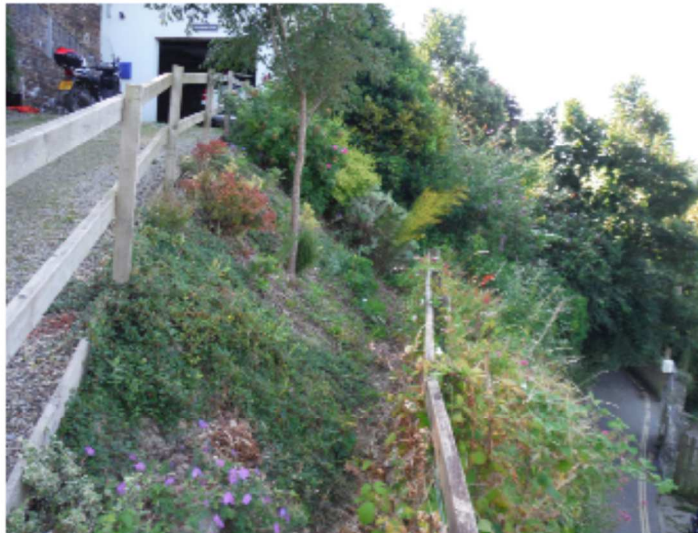
3.3 The ground above the stone walls, Photograph 5 , is firm and has not under gone any slippage.

Original ground to the front of the
property above the retaining wall
shown in Photograph 4 above

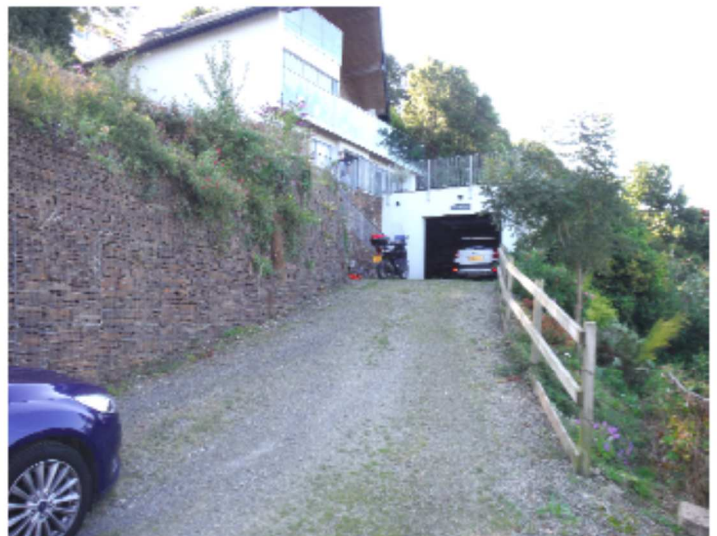
Photograph 6

3.4 The alignment of the stone work restrained within the gabion cages to the driveway is uniform as shown in Photograph 6. No bulging or global movement was noted.

Drive way up from Shutta Road

Drive way and neighbouring site
restrained by stone filled gabions

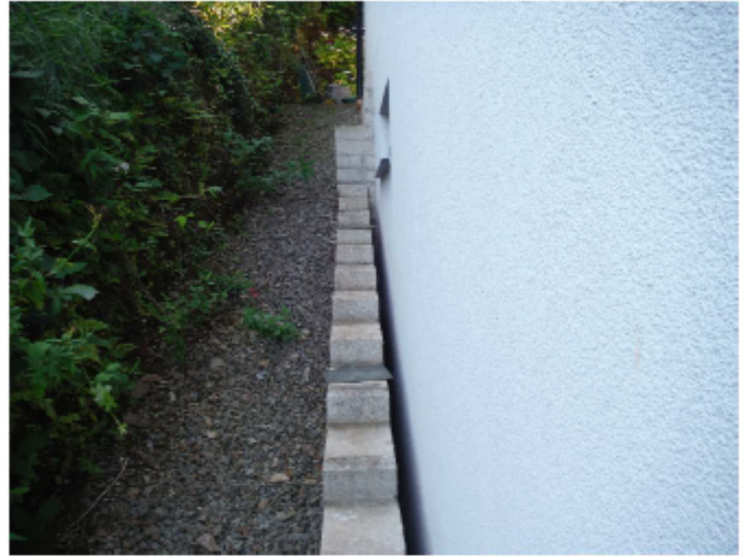
Photograph 7

3.6 The retaining walls surrounding the property, Photograph 7, are straight and true.

Retaining wall to the flank wall
of the property

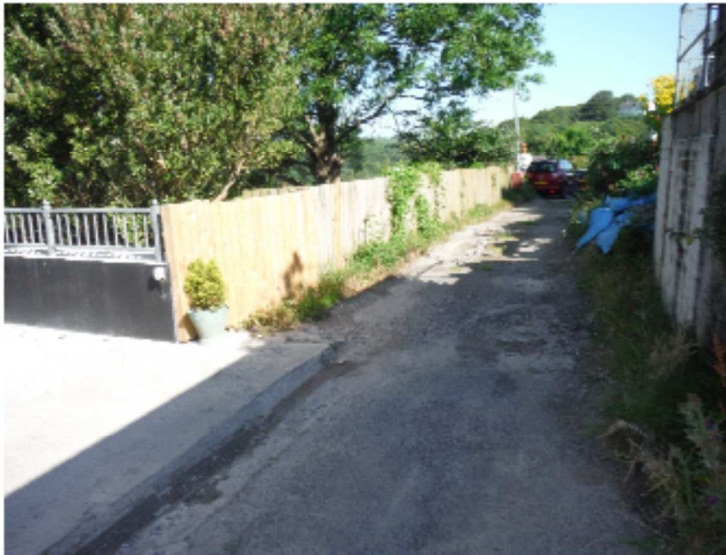
Photograph 8

3.8 The boundary formed between the site and Elm Tree Road is naturally buttressed by approximately 15 meters length of original ground between the top of the cutting and the boundary fence shown in Photograph 8. This buttressing provides a far greater stability to this site when compared to other sites where land owners have formed vertical unrestrained cuttings to the lower side of the road.

Although Elm Tree Road is not paved and relies on natural drainage there is no evidence to suggest that ground water seepage is destabilizing the site.

Gravelled road forming the
east boundary of the site
