## Repairs to the east sole plate at Merryvale House, Ashfield-cum-Thorpe, Suffolk.

Application Reference: DC/21/02026

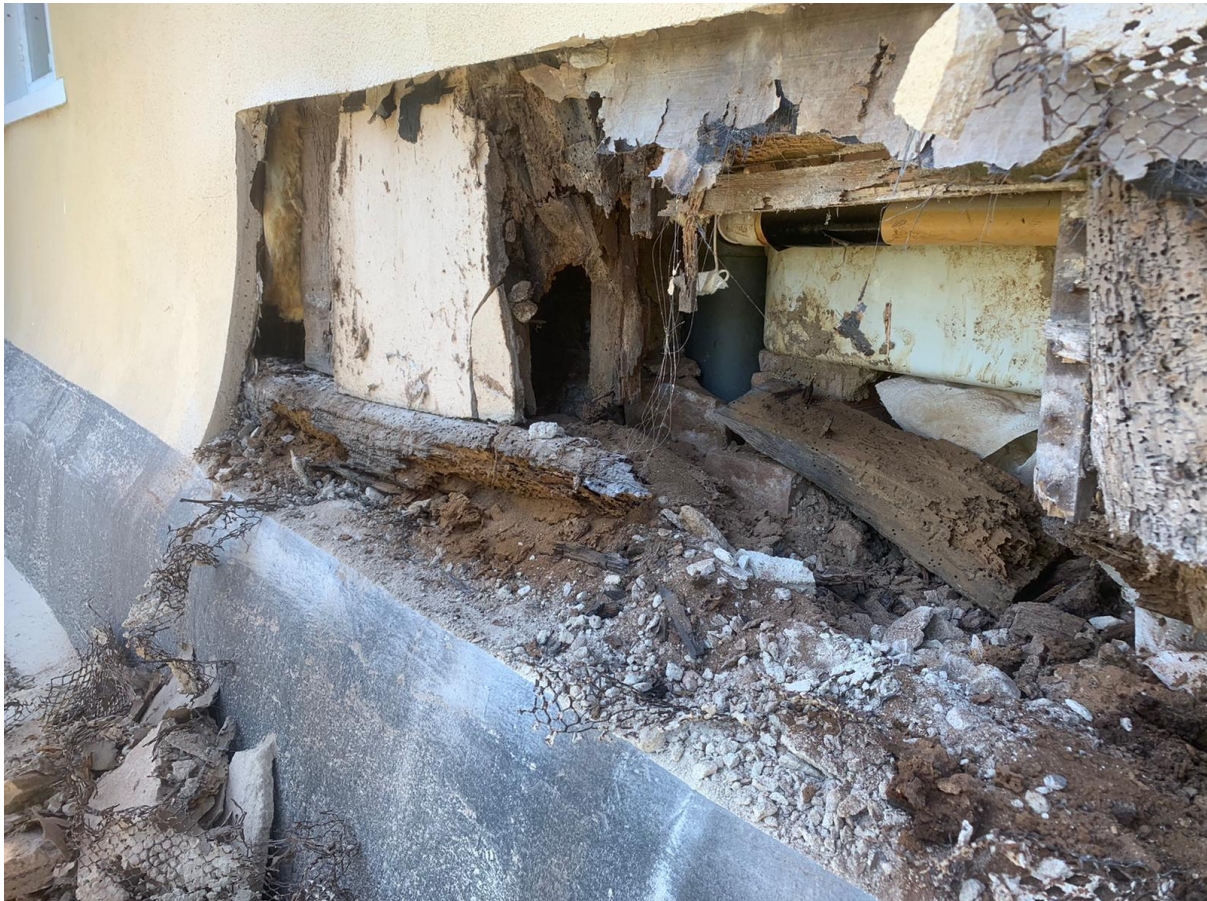
A section of the thick cement-based render was cut from the main area of concern – the image below shows the condition as found with the remnants of plate in a very friable condition and effectively being held in place by the thick, rigid render covering.

The existing shower tray and plumbing can be seen to the right with areas of infill having dislocated and in some areas missing altogether. A section of the 20<sup>th</sup> century infill panel (cement-based) from when the frame was previously exposed is also visible above the rolled section of plate. Note also the condition of the stud at far right.

The original area of concern adjacent to the existing shower will have a short section of new oak sole plate but most of this area will retain the inner third (approx.) of plate with a new section of oak fixed in place with stainless steel coachscrews. These will be countersunk and fixed from the outside and not be visible once the render is repaired. Where the existing tenons are sound they will be retained and clasped into place by the new patch. If any are in poor condition, they will be cut flush to the upper face of the plate and a stainless steel L-bracket used as noted above.

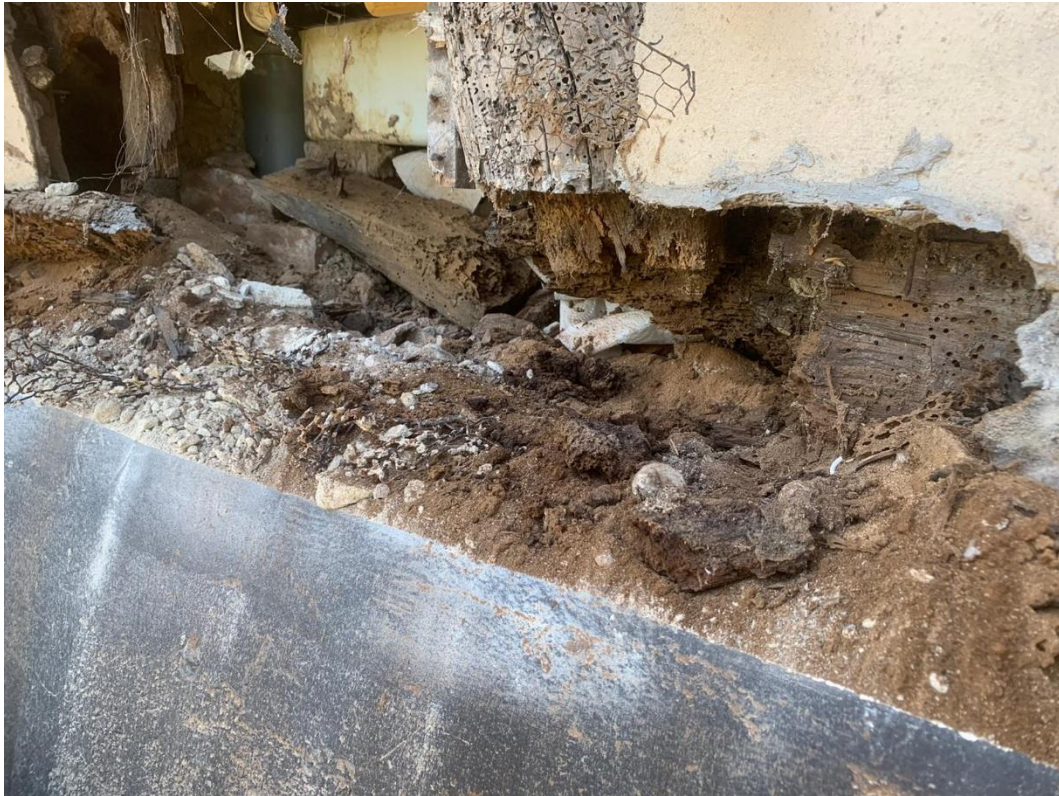
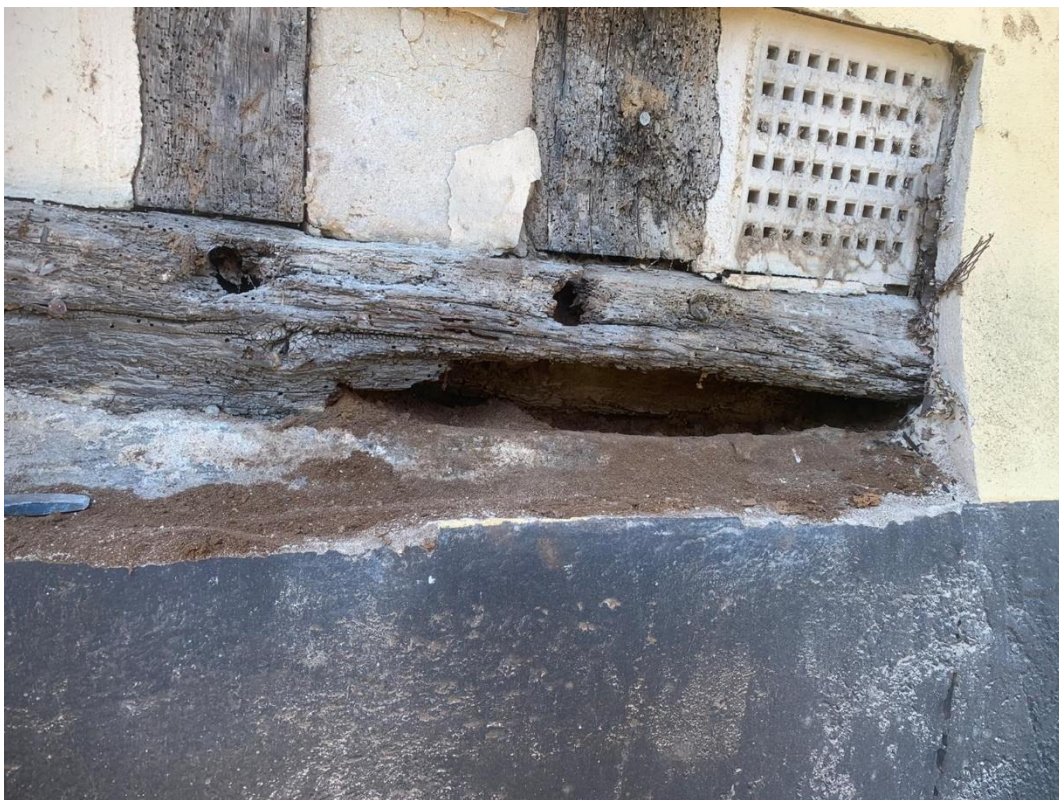
The stud to the right is in poor condition at tenon level but despite the numerous flight holes from emerging woodborers the stud is basically sound from above the shoulder cut.

Further to the right the plate at first appears sound BUT it is entirely hollow and in very poor condition. The air brick dates from when the frame had been exposed.

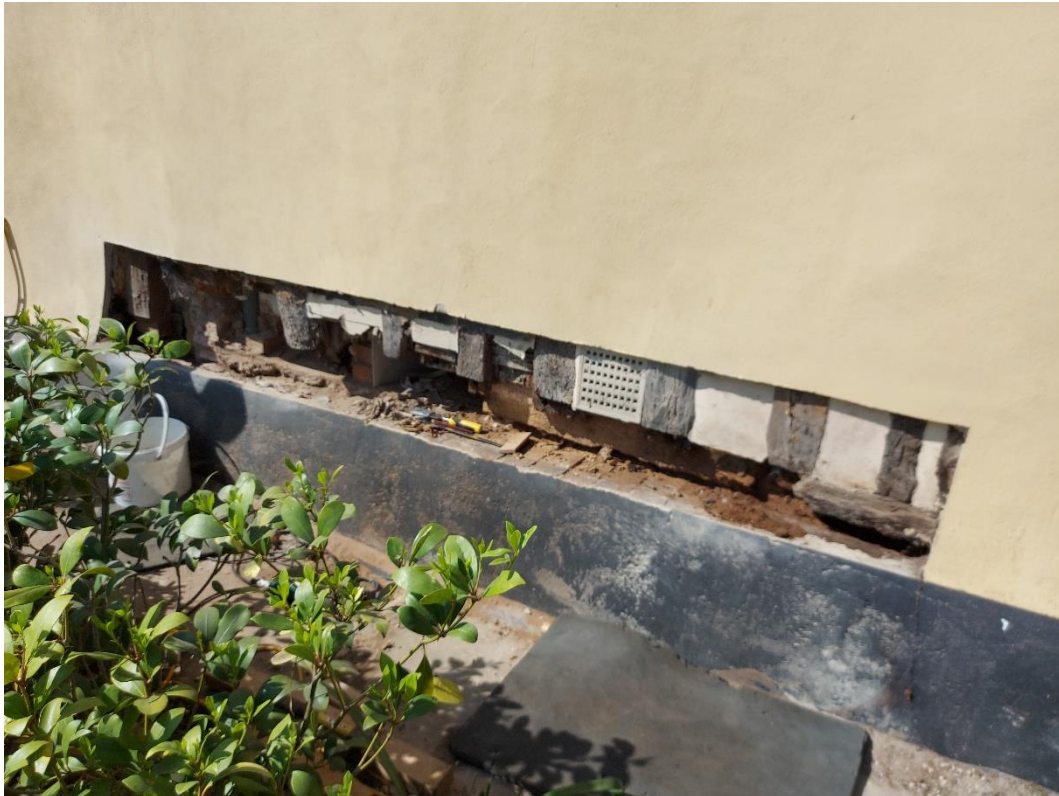
The inner 1/3 of the plate is sound which would allow the use of a patch to the outer face and the retention of most of this internal face. Sound tenons can be retained and the new patch would be housed to clasp them in place then fixed to the remaining timber with stainless steel coachscrews.

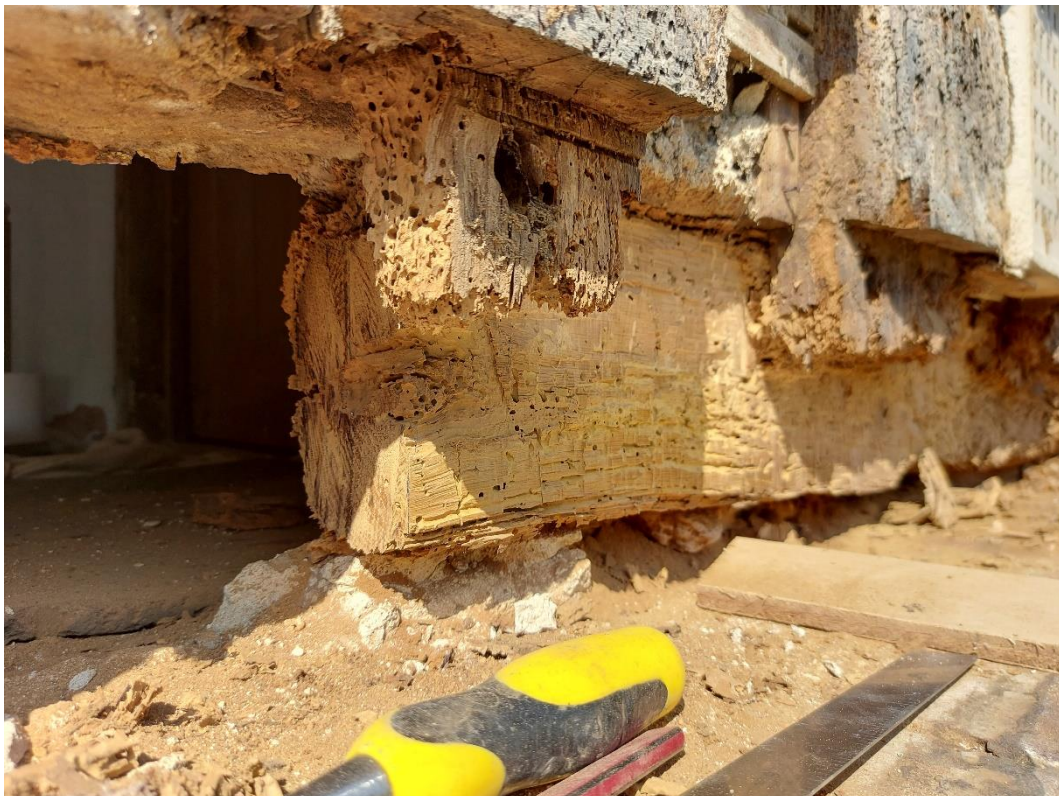
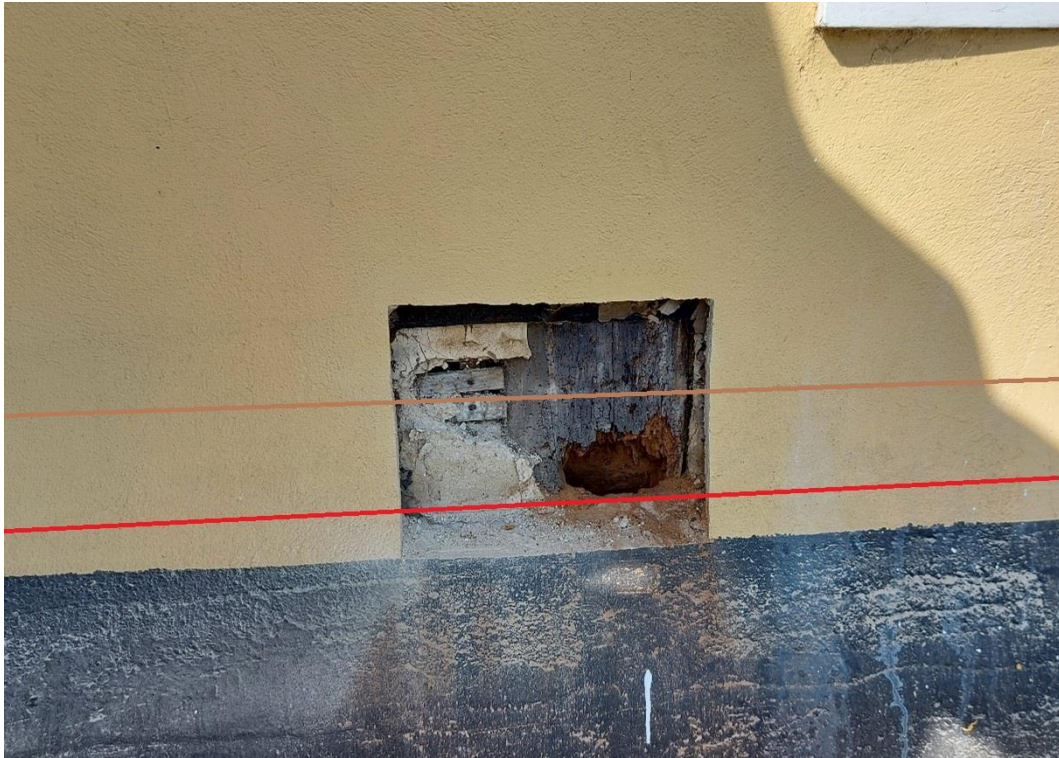
Further to the left we removed a smaller section of render – the plate in this area is more than half under the concrete floor and is in poor condition for at least the outer two thirds, possibly more. The upper face of the plate is shown as a red line. The elm storey post (see below) is in poor condition just above the plate – this post supports a large-section floor rail and carries considerable load. If we installed an entirely new sole plate at this point, to get *above* the concrete floor level our shoulder cut would be as indicated by the orange line above. This would then cut into more sound elm.

The plate to the left side of the shower position and further along, under the storey post should be entirely replaced with new green oak. Where possible, mortice and tenon joinery will be retained but where tenons have decayed too much, simple stainless steel L-brackets will be coach-screwed between the stud and the sole plate. These will be within the infill area and not visible once the work is complete.
