Re: Stoford Developments, ICON Harlow – Statement of Practical Completion

STATEMENT OF PRACTICAL COMPLETION

ICON HARLOW UNIT B ELECTRICAL PROGRESS INSPECTION REPORT

UNIT B SNAG LIST

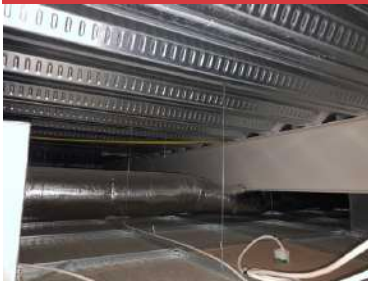
OBSERVATION 15

Stores - PVC conduit to be replaced by metal conduit.

All BWIC to be fire stopped.

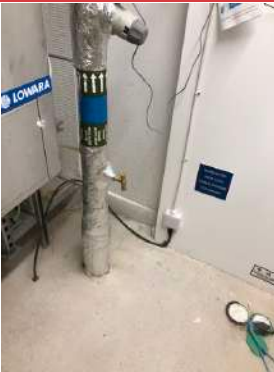
OBSERVATION 25

1F WC service cupboard - plastic conduit to be replaced by metal.

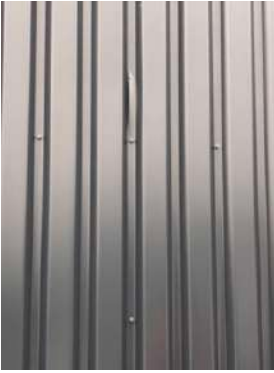
ISSUE 12 TOUCH UP GREEN PANEL

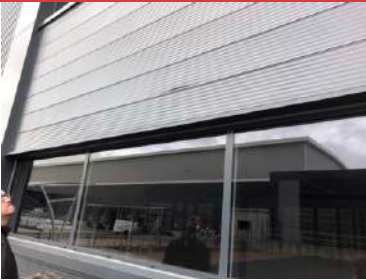
ISSUE 22 REPAIR CLADDING

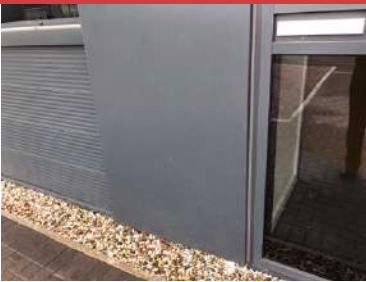
ISSUE 23 REPAIR CLADDING

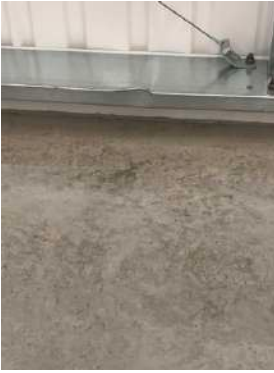
ISSUE 29 COMPLETE INFILL TO BEAM

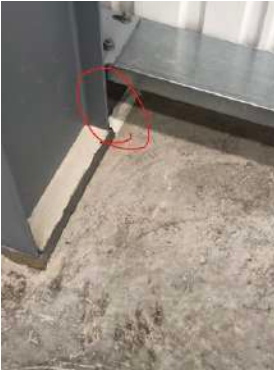
ISSUE 30 REPLACE / REPAIR CLADDING RAILS

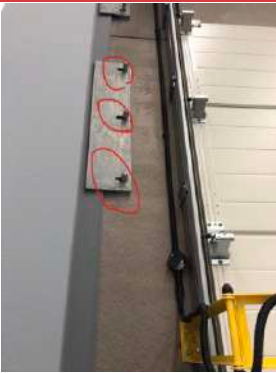
ISSUE 33 REMOVE TAPE

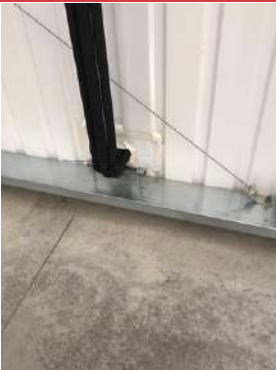
ISSUE 34 REPLACE WASHERS

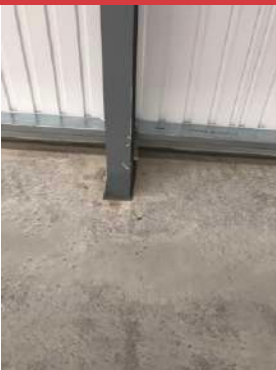
ISSUE 36 CLEAN STEELS

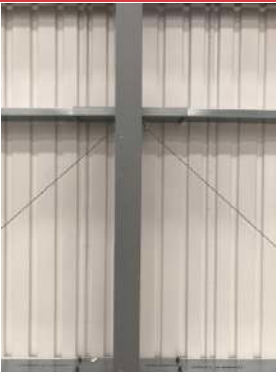
ISSUE 37 REPAIR DAMAGE TO STEEL COLUMN

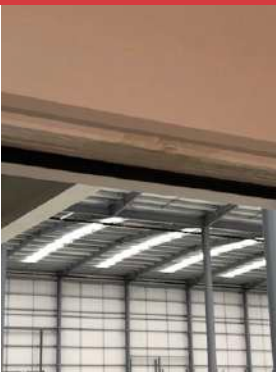
ISSUE 40 GRIND OUT BOLT

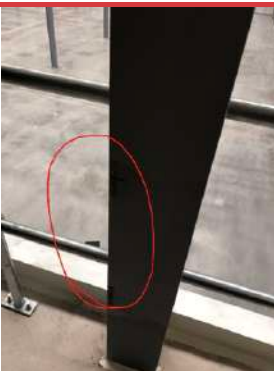
ISSUE 60 DECORATION TO PLANT DECK

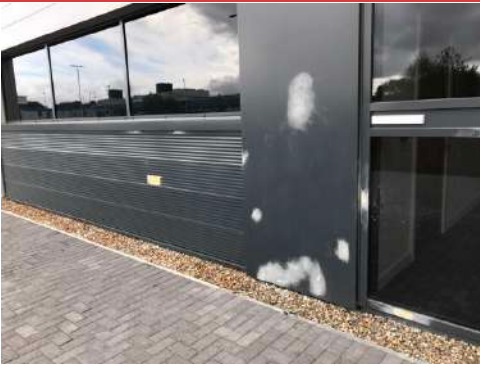
1

Cladding repairs to front of building to be completed.

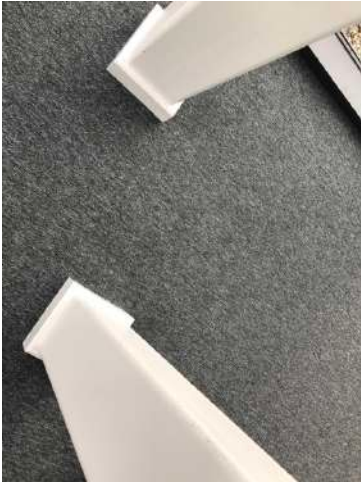
2

Marks to columns in front entrance.

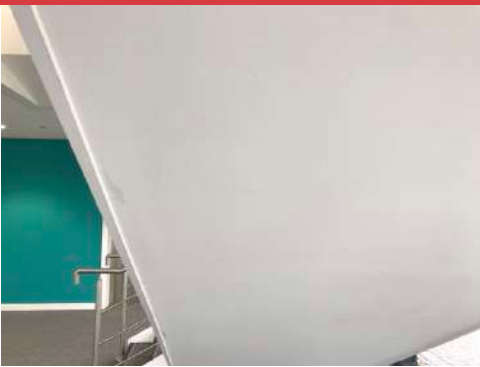
3

Mark understairs.

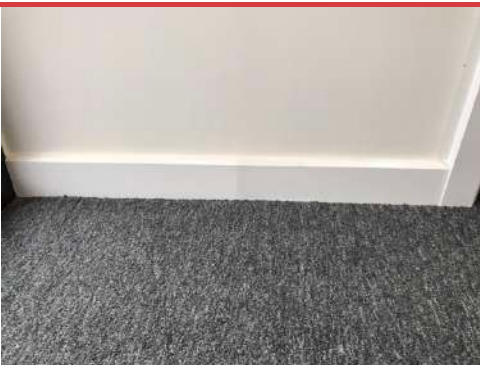
4

Skirting to be repainted.

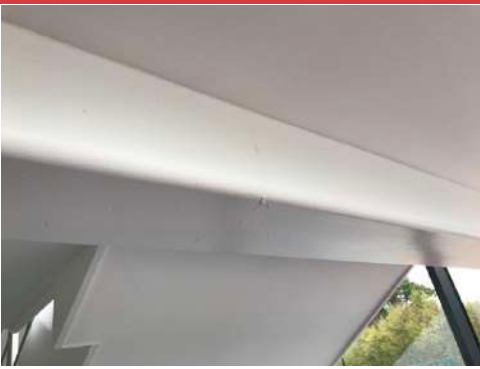
5
Paint splodge under stairs.

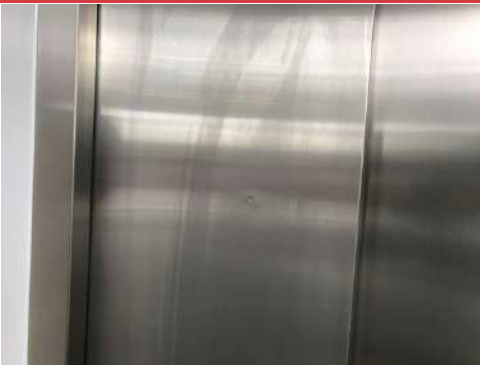
6
Dent in lift door.

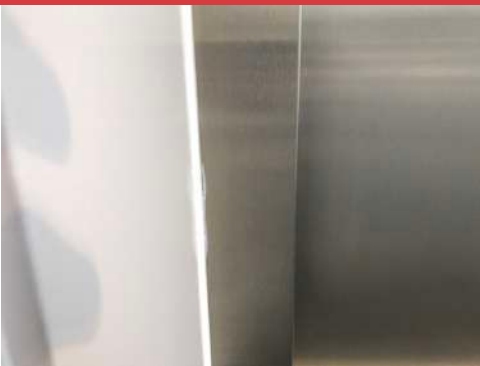
7
Over paint on lift trim.

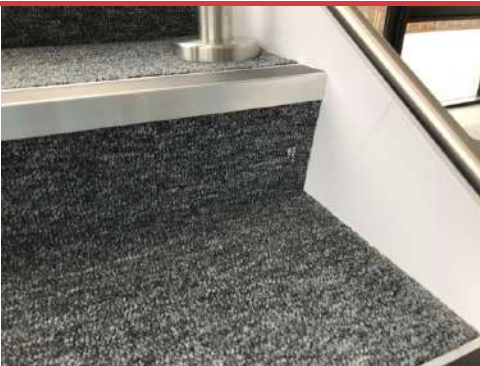
8
General note - Paint on stair carpet.

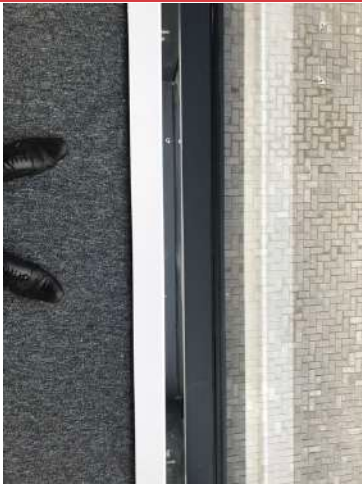
9

General note - Clean curtain walling.

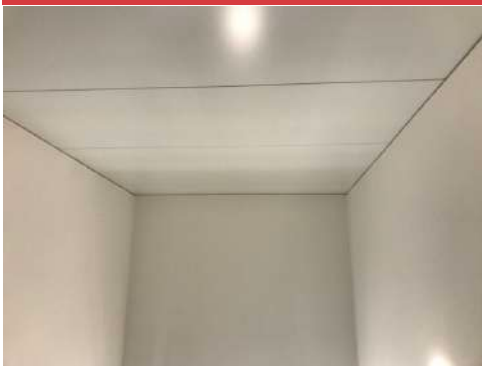
10

Beading to ceiling missing.

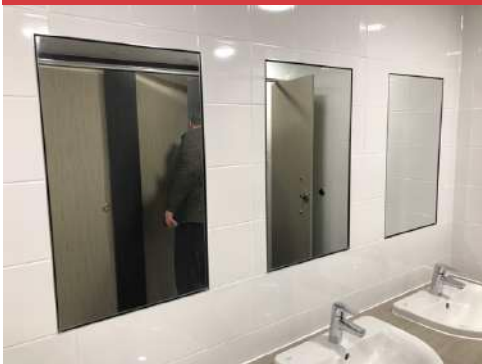
11

Mirrors to have mastic bead around perimeter.

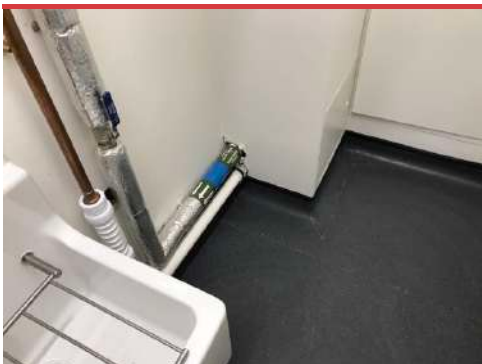
12

Penetration to be tidied.

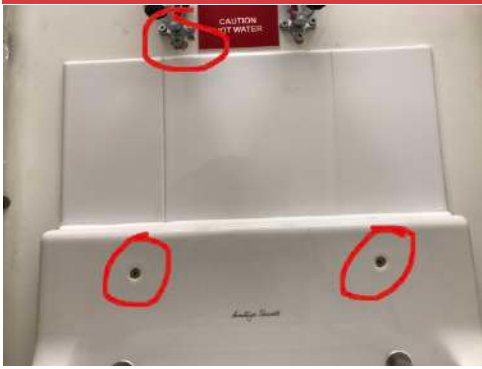
13
Holes around fixings.
Screws not stainless, will rust.

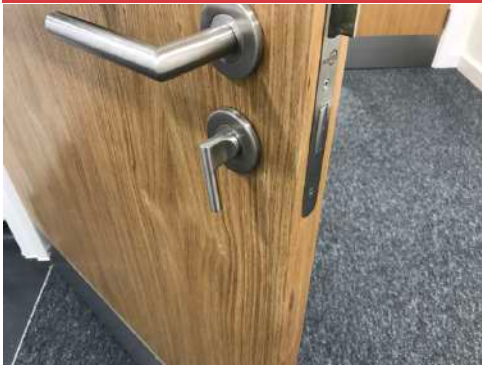
14
Lock handle loose.

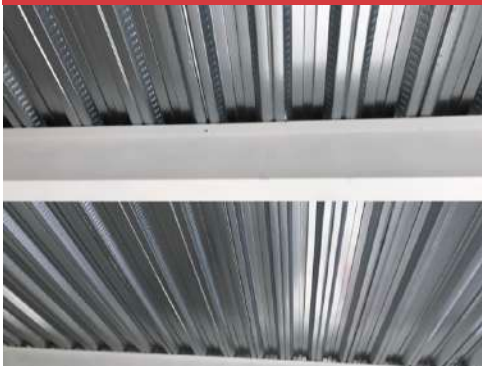
15
Ground floor office space - Blemish on steel work.

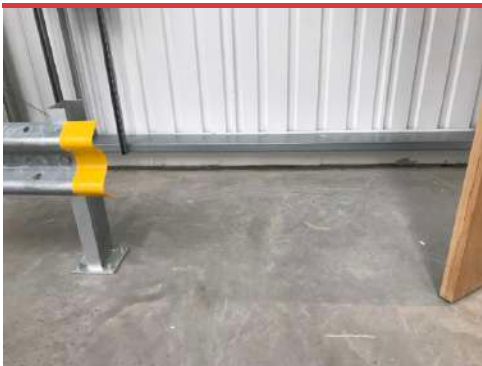
16
Mastic missing .

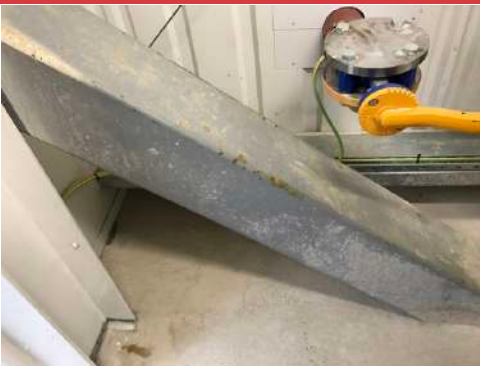
17
Steel work to be painted.

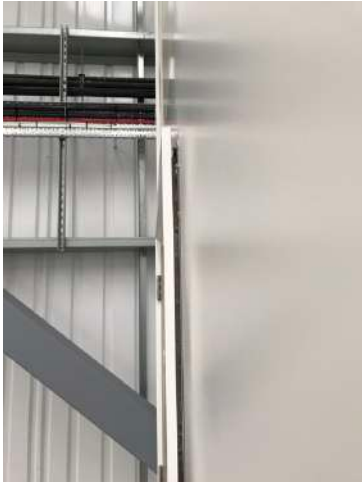
18
Gap to be finished.

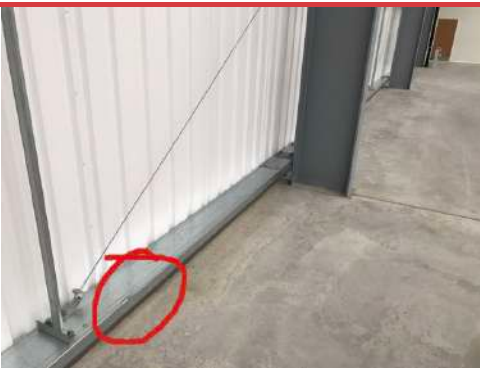
19
Dent in cladding rail.

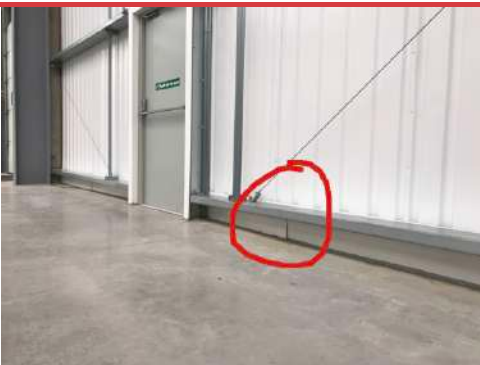
20
Gap in flashing.

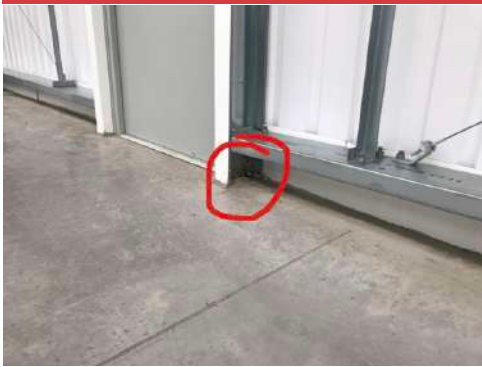
21
Daylight visible.

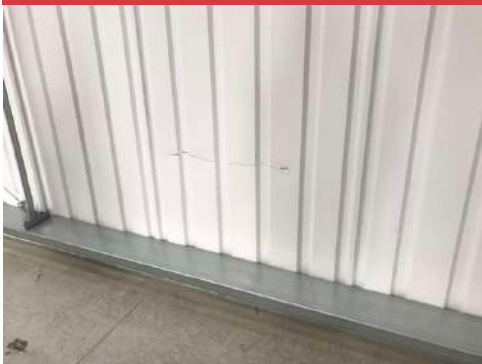
23
Damage to cladding.

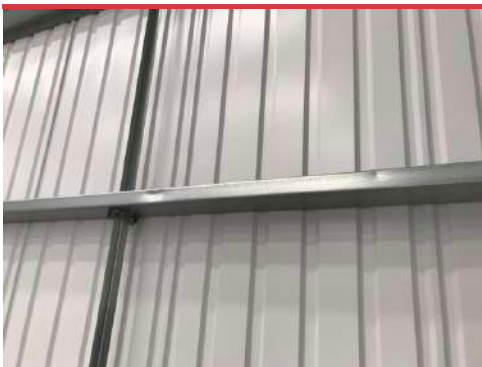
24
Dents in cladding.

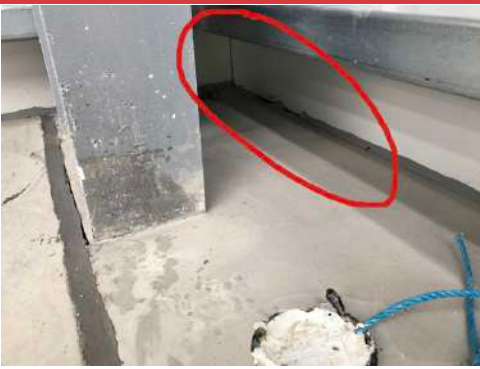
25
Mastic missing.

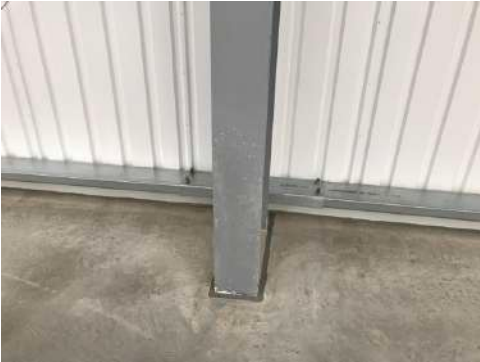
26
General note - Lower sections of steel columns to be painted/cleaned.

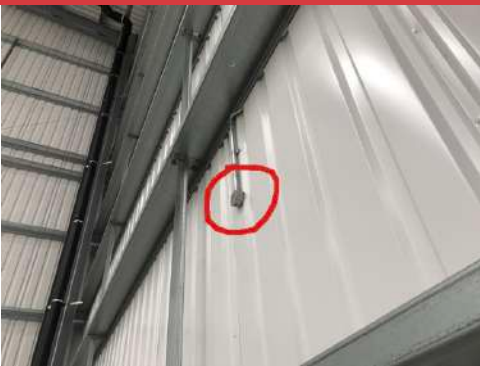
27
Penetration to have mastic.

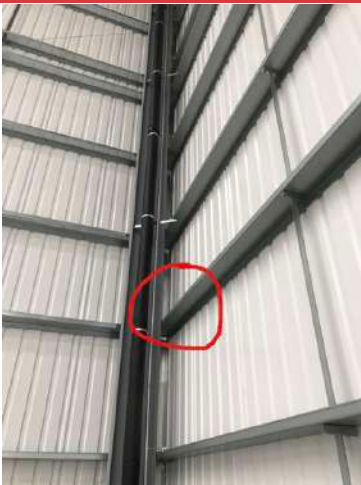
30

Bracket missing.

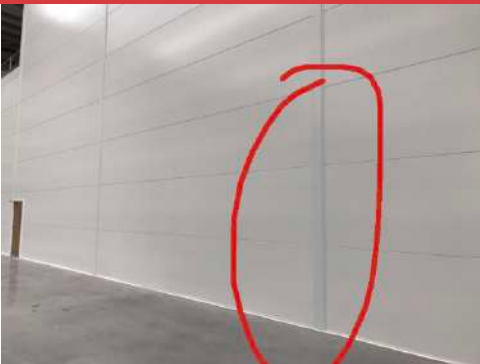
31

Trim wrong colour.

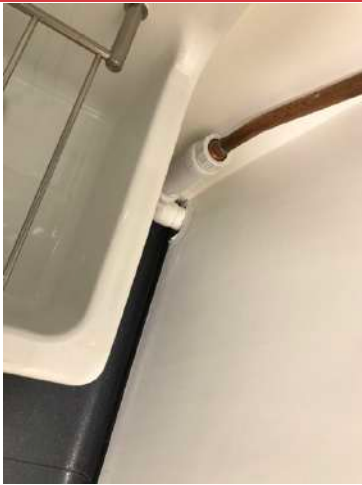
32

Penetration to be tidied.

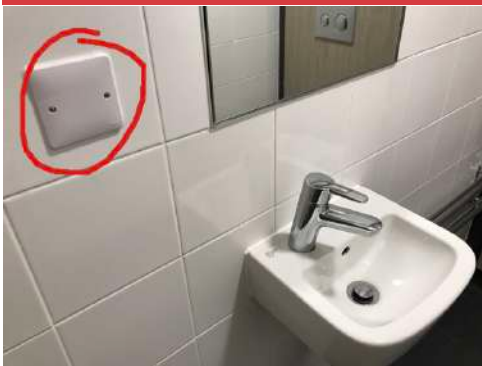
33

Cracked.

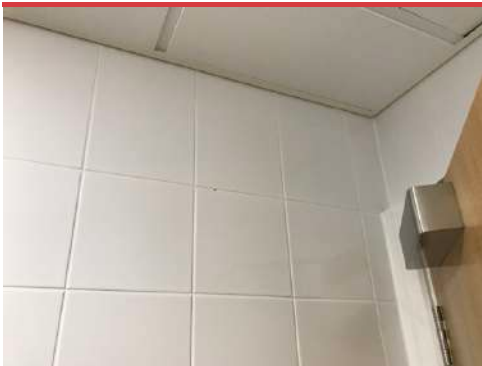
34

Grouting in toilet missing.

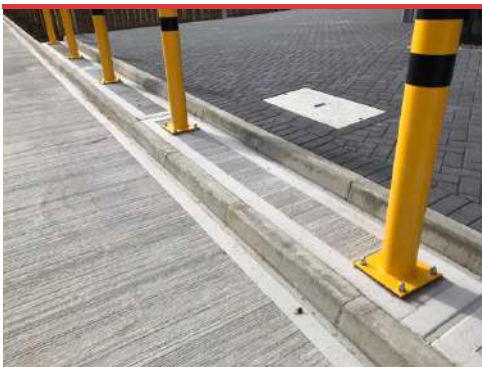
35

Bollards to have bases masticed in.

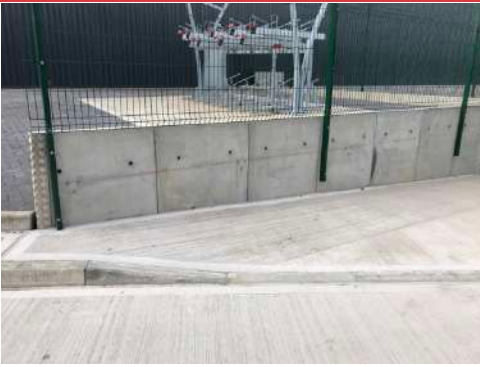
36

Chalk line to be removed. Lifting eyes to be grouted in.

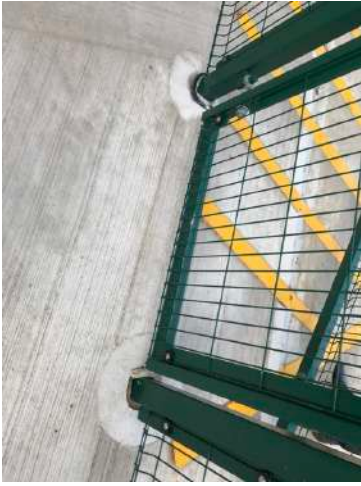
37

To be grouted in.

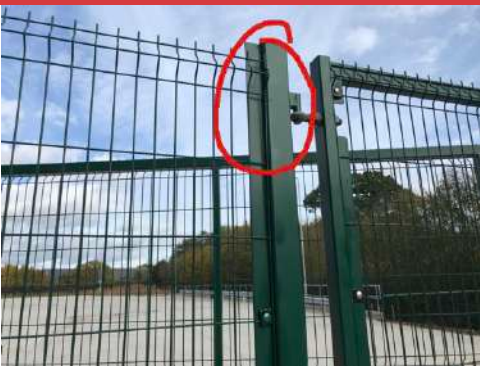
38

Clip missing.

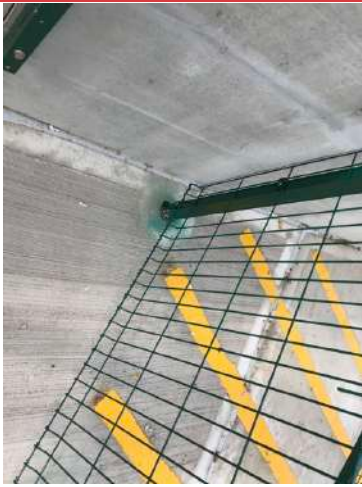
39

Green paint to be cleaned of concrete.

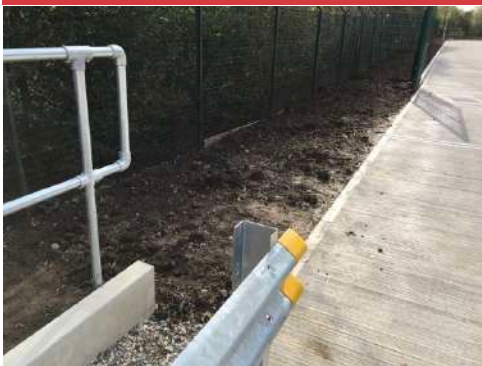
40

Continue gravel board and tidy.

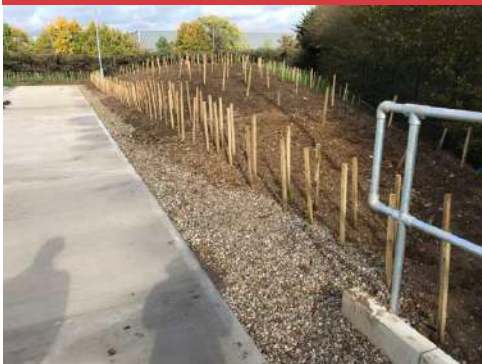
41

Gravel messy, to be tidied.

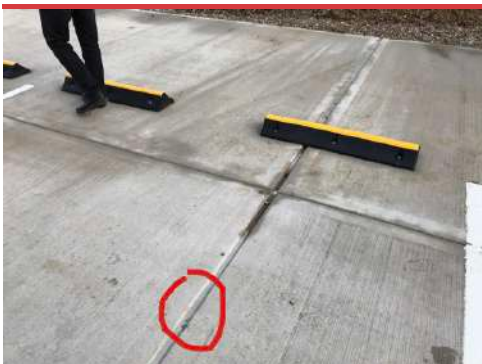
42

Nail in mastic.

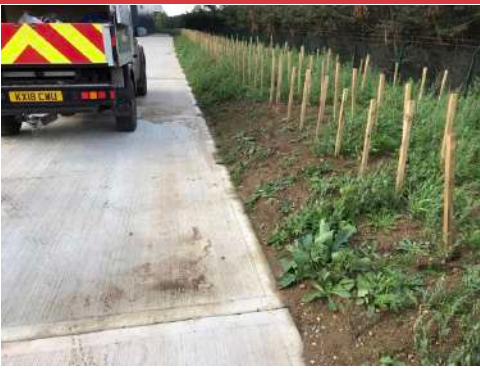
43

Unfinished edge to be re-looked at.

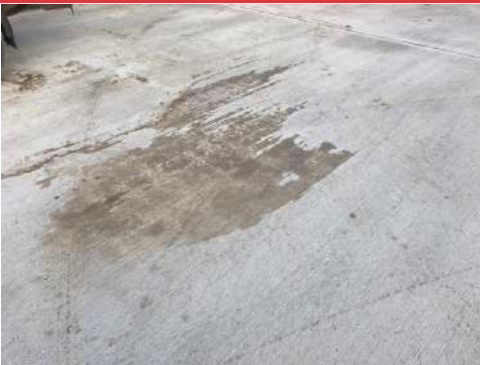
44

Concrete to be clean.

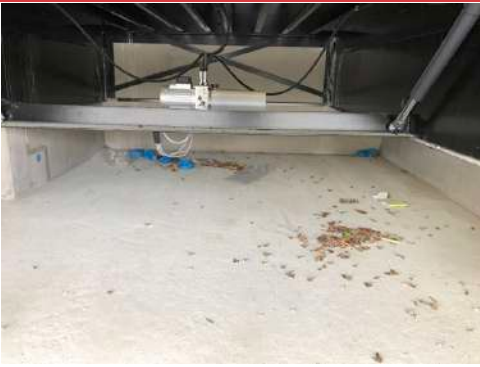
47

Rubbish under dock levellers.

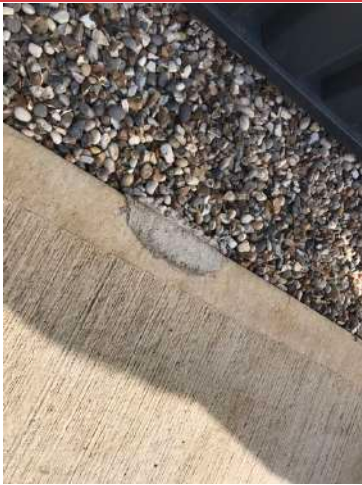
50

Poor resin repairs to rear footpath.

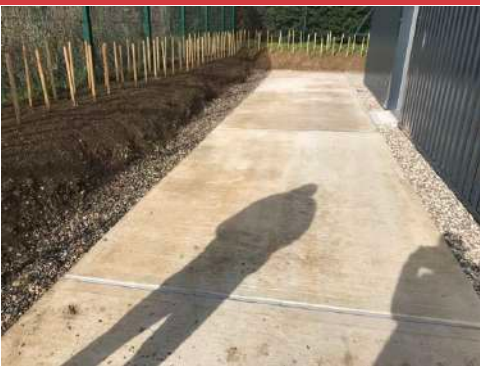
51

Rear footpath to be cleaned.

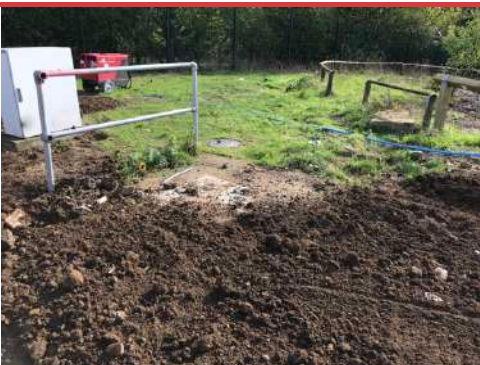
53

Barrier missing.
