CARADOC TREE CARE

11th March 2021

Tree Inspection Report for Church Stretton Town Council

To carry out an aerial inspection of Street Stretton tree, previously inspected and tagged “517”, in Rectory Wood, Church Stretton to view distal crown parts and branch unions. This follows storm damage and branch loss in October 2020.

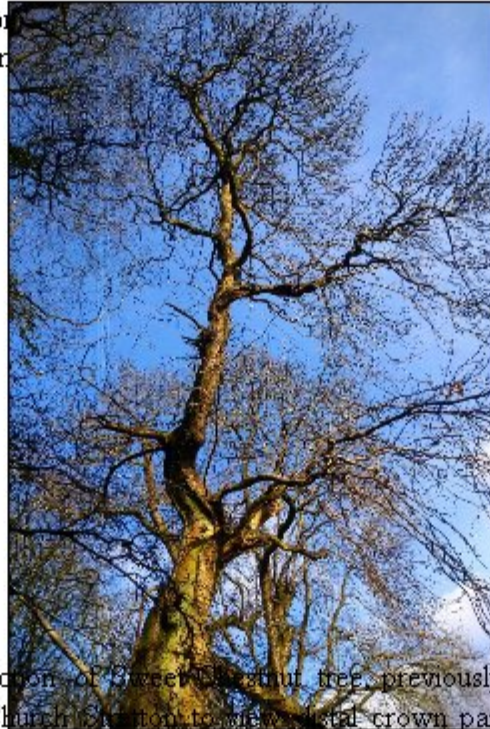
Dead hanging branch on Northerly limb at 10m height, which is itself almost entirely dead. Limb should either be reduced or removed, as the live wood is a strip of bark 100mm wide on a limb of approx. 450mm diameter.

Heartwood exposed appears dead, stable with no visible signs of active decay, but is progressively drying and shrinking. Cracks in the dead wood were probed to a maximum of 75mm depth.

Decay pocket in main fork on South side at 10m height. 150mm x 150mm probed to 200mm depth. Facing upwards and full of wet rotten matter. Side walls of decay cavity probed and were slightly soft.

Lightning strike damage extends to the full height of the tree and has resulted in complete bark loss of 25% to 30% of the bark as a strip of exposed dead wood with adaptive growth along each edge. The dead wood has shrunk away from the live adaptive growth in a number of places up the tree.

Limb at 15m height has lost a branch on the southern side resulting in an extensive break-out wound that extends back to the main stem.

At 2m height significant separation of live wood adaptive growth away from dead wood creating cavity 230mm deep.

The vigorous distal growth and apparent health of the tree creates a problem for this tree due to the lightning damage which has killed a significant strip of bark along the whole tree height. There are some small areas of active decay in the dead heartwood, and the separation of the dead inner heart from the live wood is worrying, as ultimately and inevitably this will happen throughout the tree. With the missing strip of live wood the cross section of the tree is a "C" as opposed to the "O" cross section of a hollow tree, causing a significant weakness to the structure.

This tree is a significant landscape and ecological feature and important locally. Its retention in whatever form is desirable. Doing nothing could result in catastrophic failure by ductile fracture in the main stem, or significant branch loss from the distal crown with the potential for third party damage.

- A significant crown reduction to "veteranise" the tree by reduction to 12m height.
- 20% Crown reduction and crown clean of small dead wood (<100mm diameter).
