THE OLD VICARAGE

HIGH STREET, ABBOTS LANGLEY,
HERTFORDSHIRE, WD5 0AS

HISTORIC BUILDING
RESEARCH

JANUARY 2021

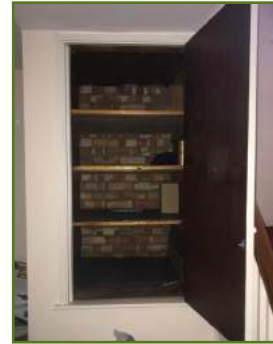
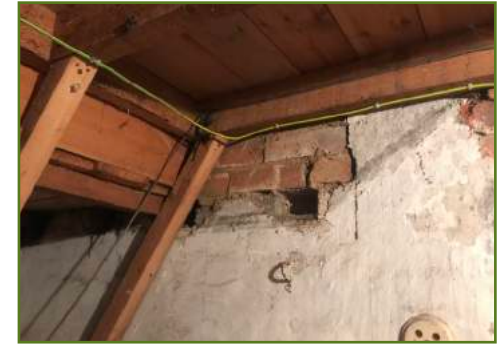
Modern brickwork upwards from height of original quarter landing. Evidence also of staircase being full width of stairwell incorporating what is now the cupboard.

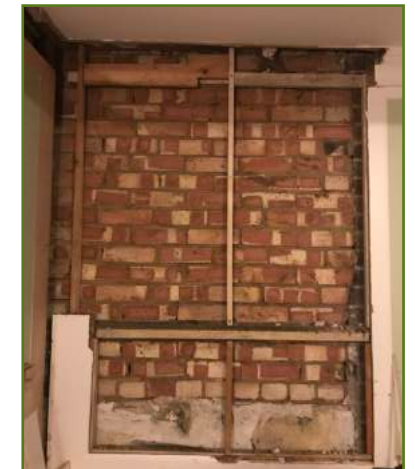
The panelling around the same area in the drawing room was removed to reveal modern brick infill from the quarter landing height of the original staircase upwards. This explains the differences found in the panelling (join lines, method, materials and quality).

Modern brickwork found behind panelling.

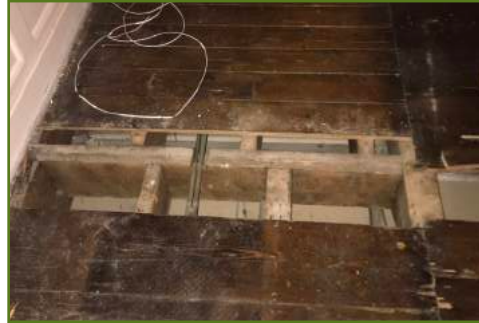
Trimmer and landing found after the removal of floorboards.

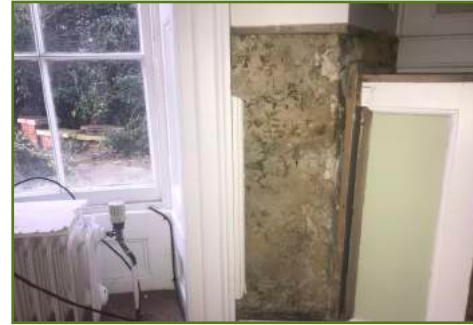
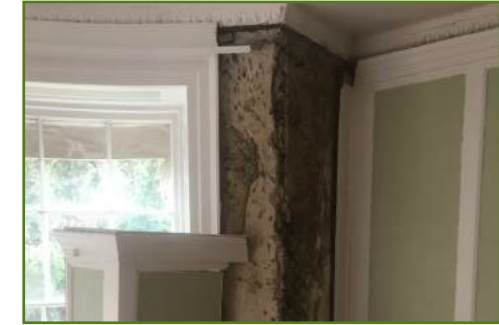
Remnants of floral wallpaper found behind panelling.

The recent removal of part of the panelling of the ground-floor room to assess the damage caused by dampness and beetle infestation, has revealed original floral wallpaper and painted plaster finishes.

Much of the panelling is loose from the walls and it appears there is damp behind much of it. The only way to address this is to remove the panelling and address the damp behind before re-fitting the panelling. In doing so, the opportunity exists to review the various phases of panelling and agree which have historic interest and should be retained and which can be removed.

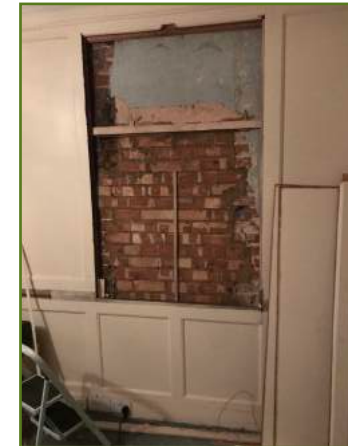
Modern brickwork and remnants of plaster found under panelling in bedroom over drawing room.

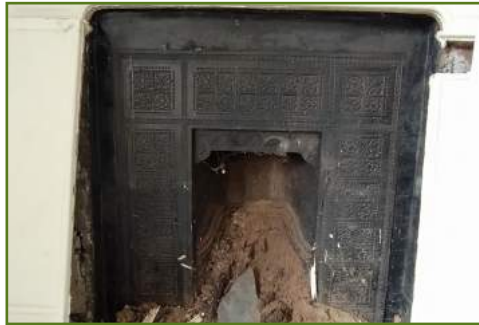
This room has an attractive cast iron fireplace from the late 19th century and the windows retain early shutters. The fireplace was covered by a piece of plywood. The remaining fireplaces have been removed or are concealed. The discovery of the iron cast fireplace in the 19th century extension, suggests that early fireplaces might still remain in-situ.

Concealed Victorian iron cast fireplace.

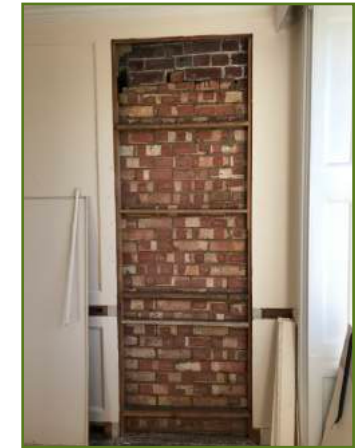
Another area showing different detailing was found in the panelling of this room, against the wall of the early Georgian house, suggesting later alterations. The removal of part of this panelling discovered modern brickwork in the shape of a doorway suggesting direct access between what is currently bedroom 4 and the bedroom over the drawing room (currently bedroom 5).

Modern brickwork blocking original doorway.

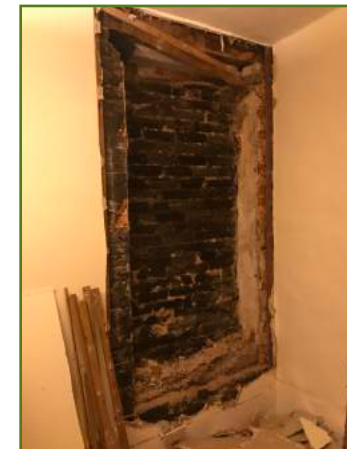
A blocked window was found in the south-west elevation of the original core of the house (in current bedroom 3) concealed under later plasterboard covering. Part of the original render of the window survived along with the low sill height matching the existing windows in the main south-east elevation.

Original blocked window found in south-west elevation of the original core of the building (bedroom 3).
