Ecology Photo Record

Stoneleigh, New Road, Blakeney, GL15 4DG

STONELEIGH

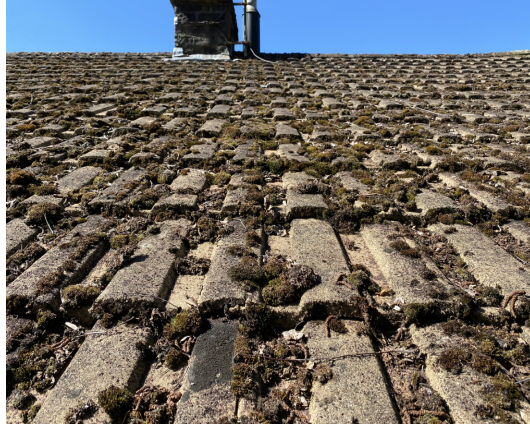
The dwelling and its existing extensions have concrete interlocking roof tiles that are in good condition with tightly butted joints, no visible gaps, or crevices (PHOTO 1). The fascias have no overhangs, and therefore leaving no crevices (PHOTO 2). The roof verges offer no bargeboards, instead they consist of the external rendered finish abutting directly beneath the roof tiles, again offering no gaps or crevices (PHOTO 3).

PHOTO 1 - Neatly butted tiles

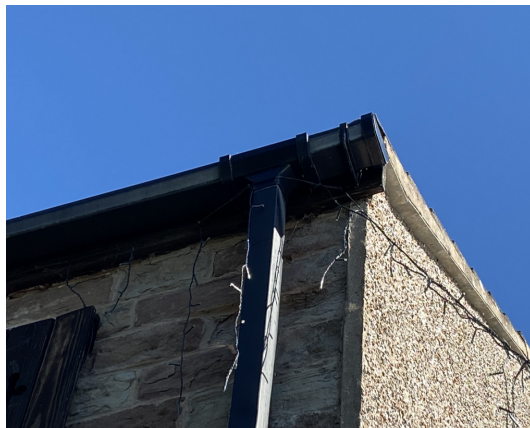
PHOTO 2 - House fascias soffit detail - no gaps

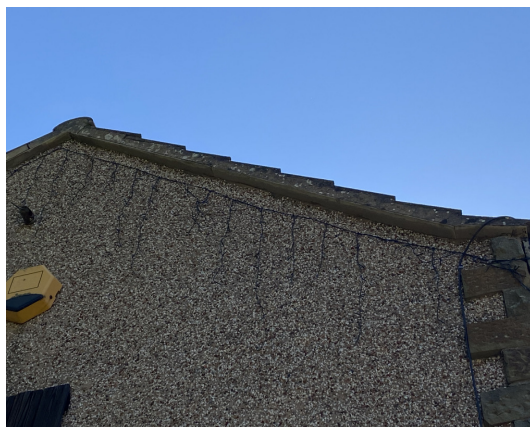
PHOTO 3 - Roof verge

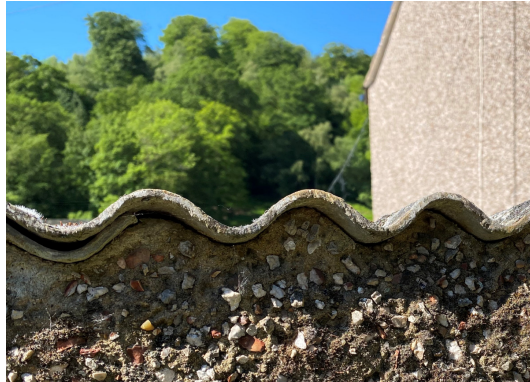
The Utility / Store extensions have an asbestos roof sheet finish. These sheets are in good condition and securely fitted together. At the eaves of these roofs the render has been taken up directly below into the top peaks of the corrugated profile, eliminating any gaps into the building (PHOTO 4). There was also signs of cobwebs, which would suggest no bats are present within these buildings (PHOTO 5).

PHOTO 4 - Render beneath corrugated sheet

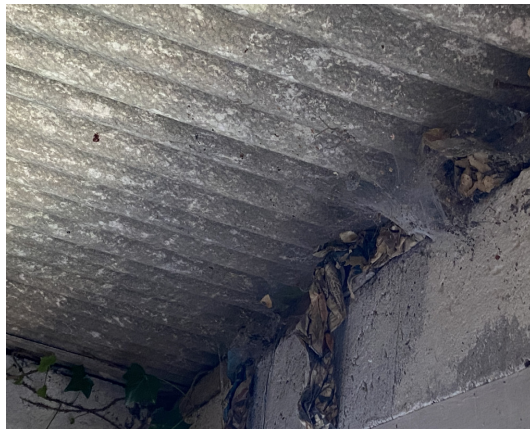
PHOTO 5 - Cobwebs internally within Store building

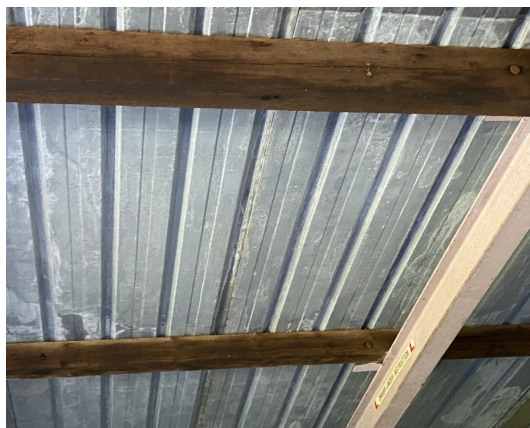
The garage has a metal sheet roof which is again in a very good condition, and well installed (PHOTO 6). The garage has tightly butted fascia boards that offer no points of entry into the building (PHOTO 7).

PHOTO 6 - Neatly installed, good condition roof sheets over garage

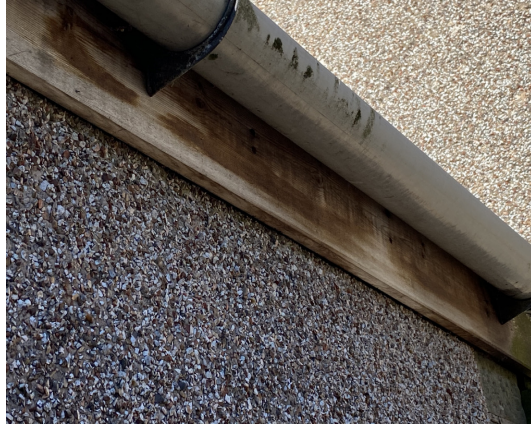
PHOTO 7 - Garage fascias soffit detail - no gaps
