# STRUCTURAL INSPECTION REPORT

CONVERSION OF EXISTING STONE OUTBUILDING

BIRCH COTTAGE, BROCKWEIR

CLIENT:	JOE PAWSON
DOC REF:	JAC_19_014
DATE:	04/10/2019

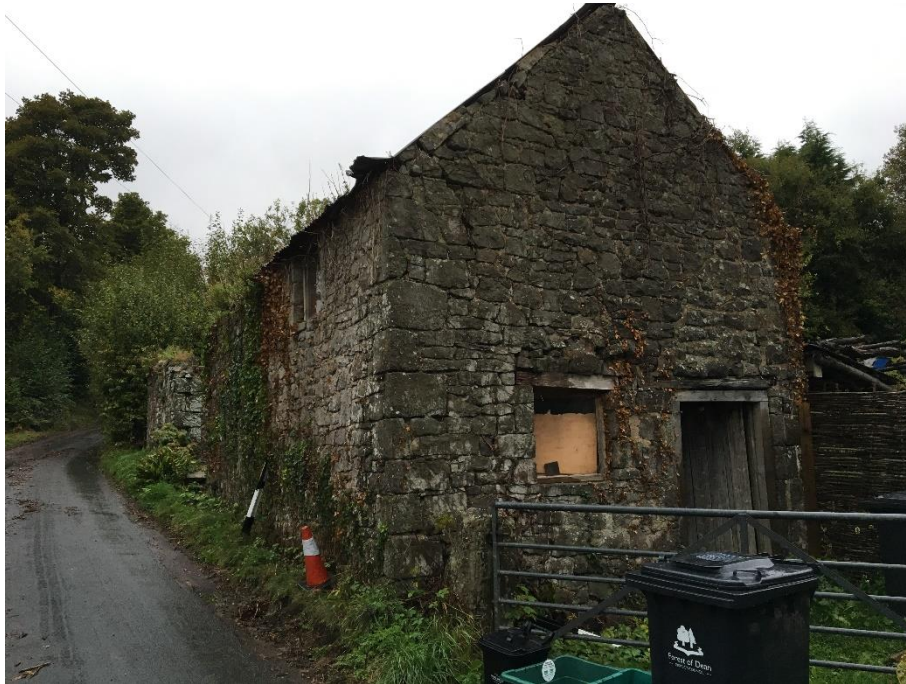
A small section to the south of the existing building retains a corrugated iron roof supported on timbers. The rest of the building has no roof. There is evidence that a mezzanine floor once existed towards the southern end of the barn, however this floor has since been removed.

*Figure 2- Barn south elevation*

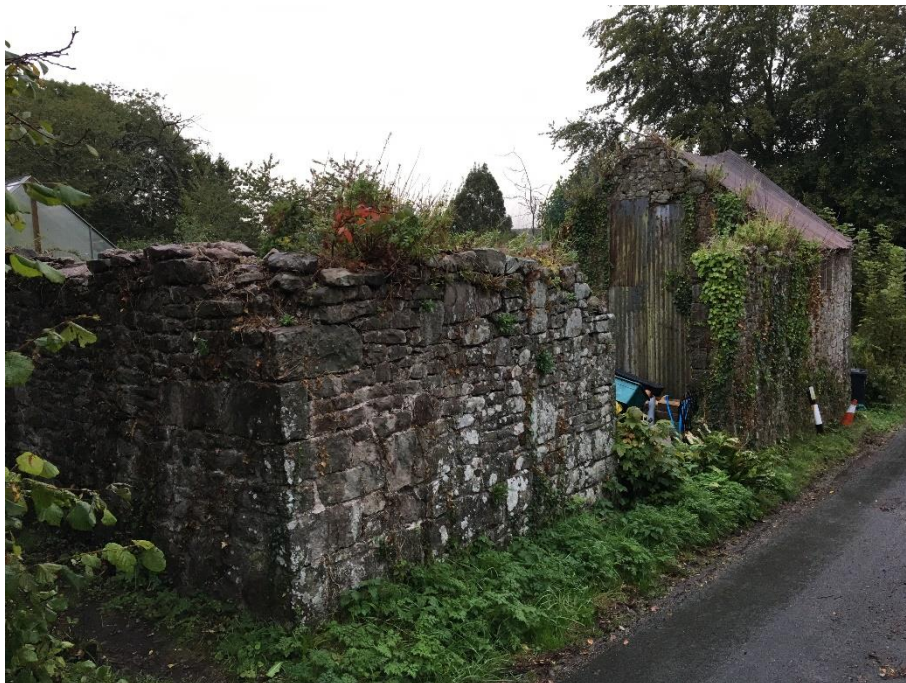
The barn is constructed from traditional stone walls, most of which remain plumb and without significant cracking or deterioration. No damp proof course was observed at the base of the stone walls.

*Figure 3- Barn north-west elevations*

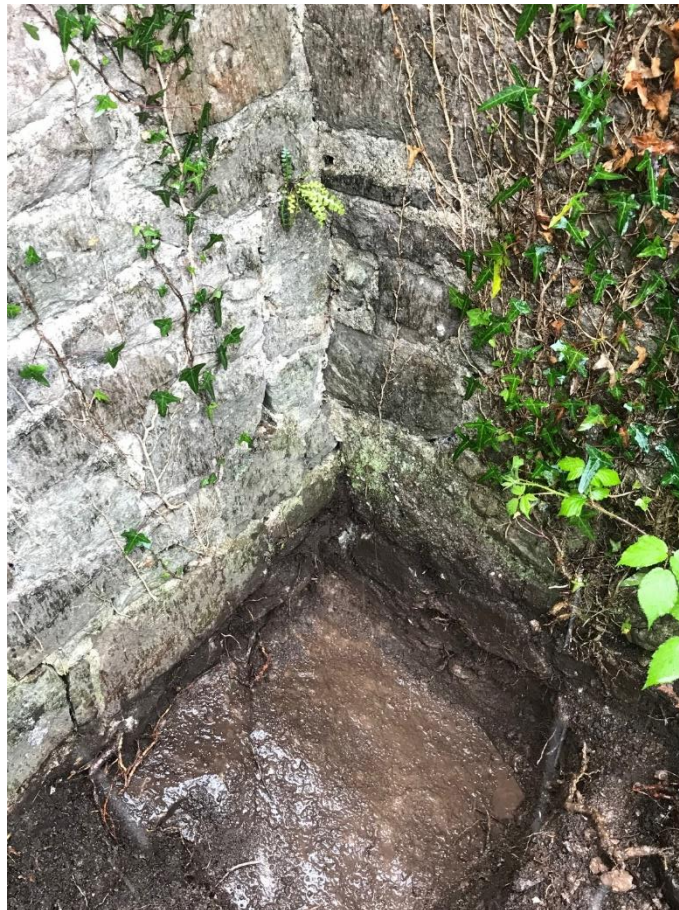
The trial pits found that the walls continued below ground level and are bearing directly onto very large stones / bedrock. All 5 trial pits found bedrock or very large stones to be present approximately 200 – 300mm below the existing ground level. The top 200 – 300mm of soil is primarily organic topsoil type material.

*Figure 4- Trial Pit showing large stone footings*

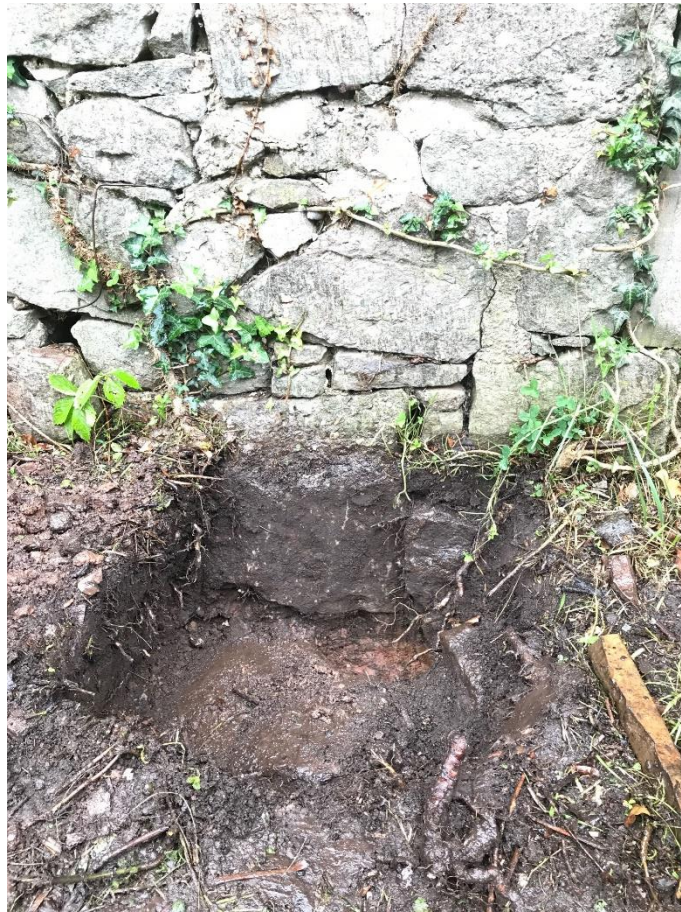
*Figure 5- Additional trial pit showing large stone footings*
