Structural Inspection

Inspection of Barn for Conversion at

**Howard Farm Cottage
Howard Lane
Stratton
Bude
EX23 9TF**

Reference R181107/SI/00/Rev B

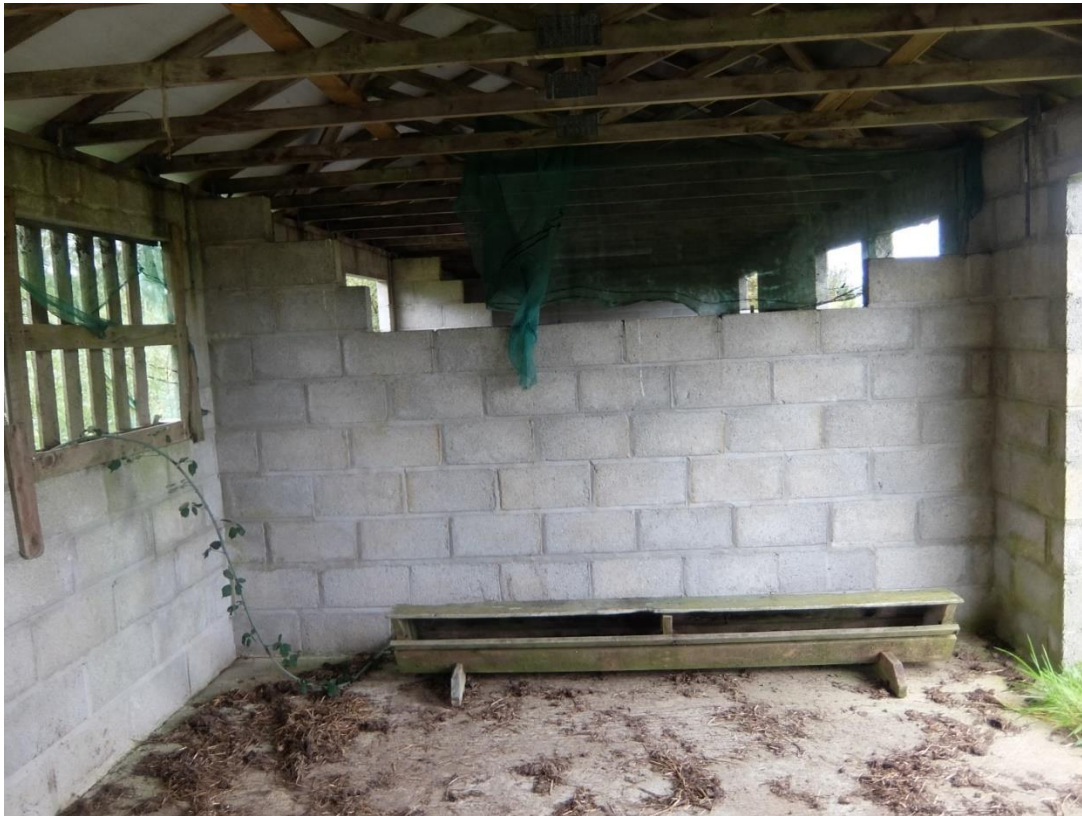
Internal view within Bay 9 looking towards front

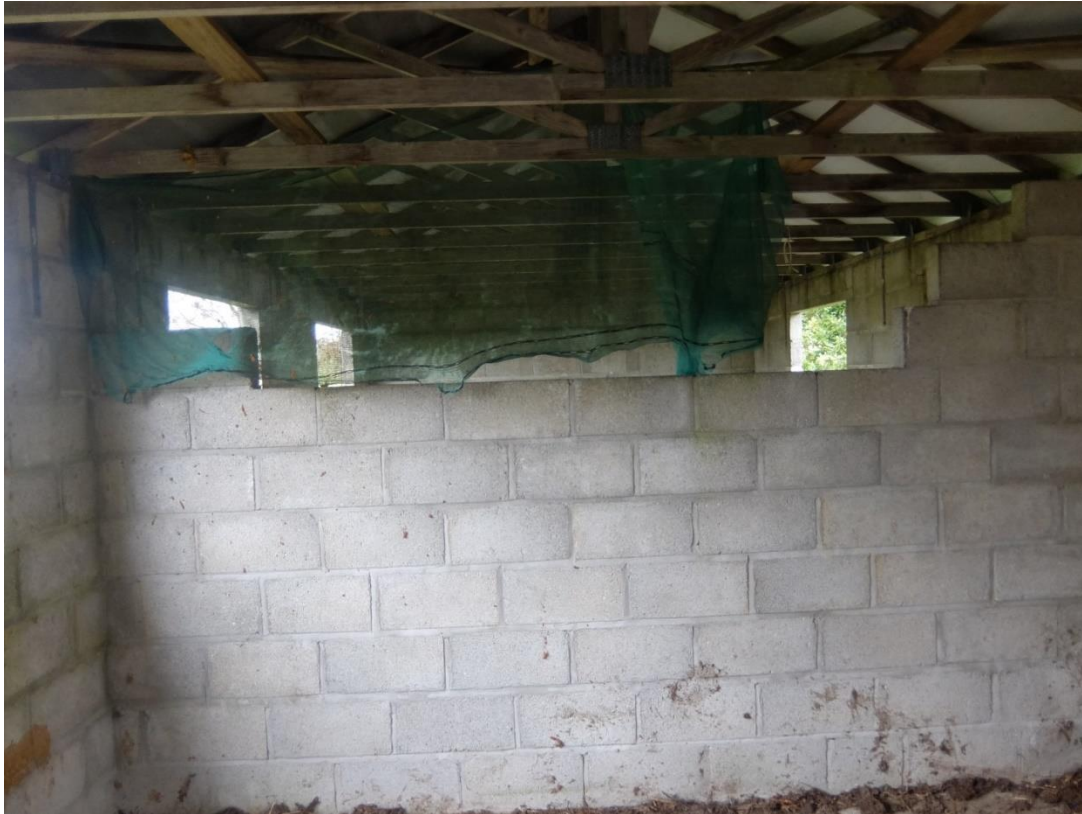
Internal view within Bay 8 looking towards rear

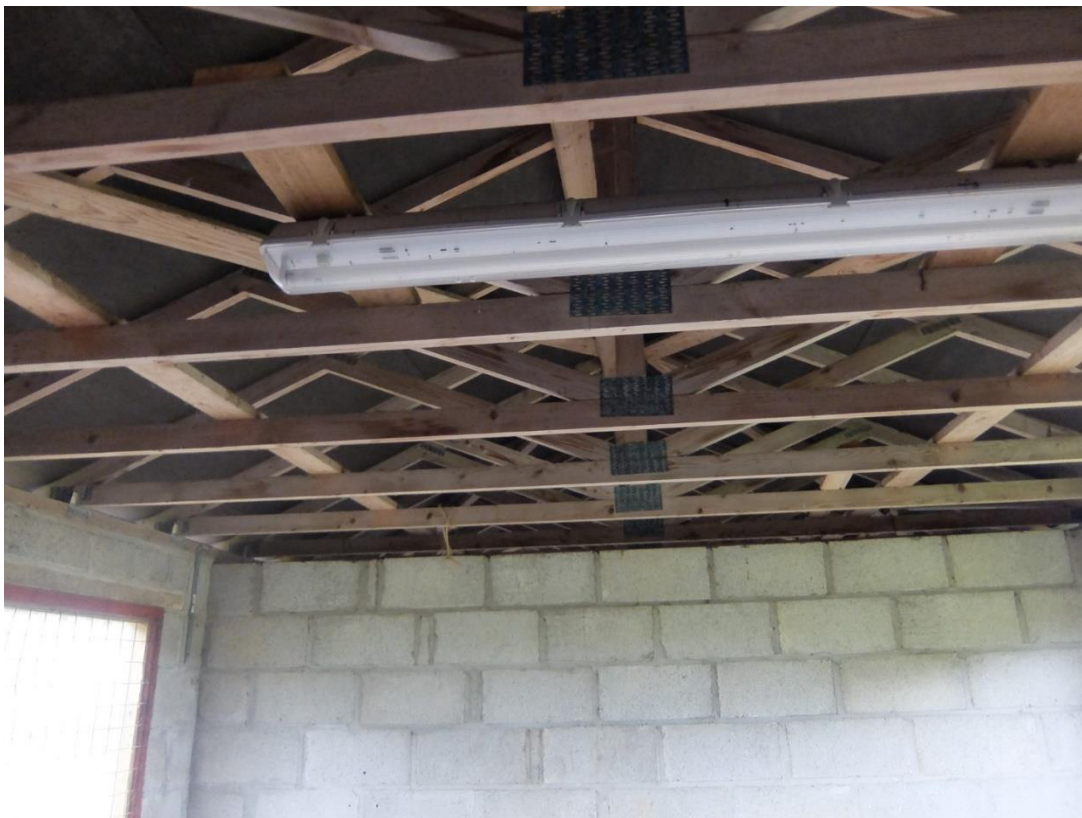
Roof structure showing trusses at close centres with lateral and diagonal wind bracing

3.2.1 The structural roof timbers are in a reasonable condition as is the roof covering with no signs of decay, or water ingress.

3.2.2 It is proposed to provide timber packers off the existing gangnail trusses to raise the ridge up within the central section of the building.

3.2.4 The existing roof covering will need to be removed to allow the valleys and increase in ridge height to be completed with the existing slates reinstated.

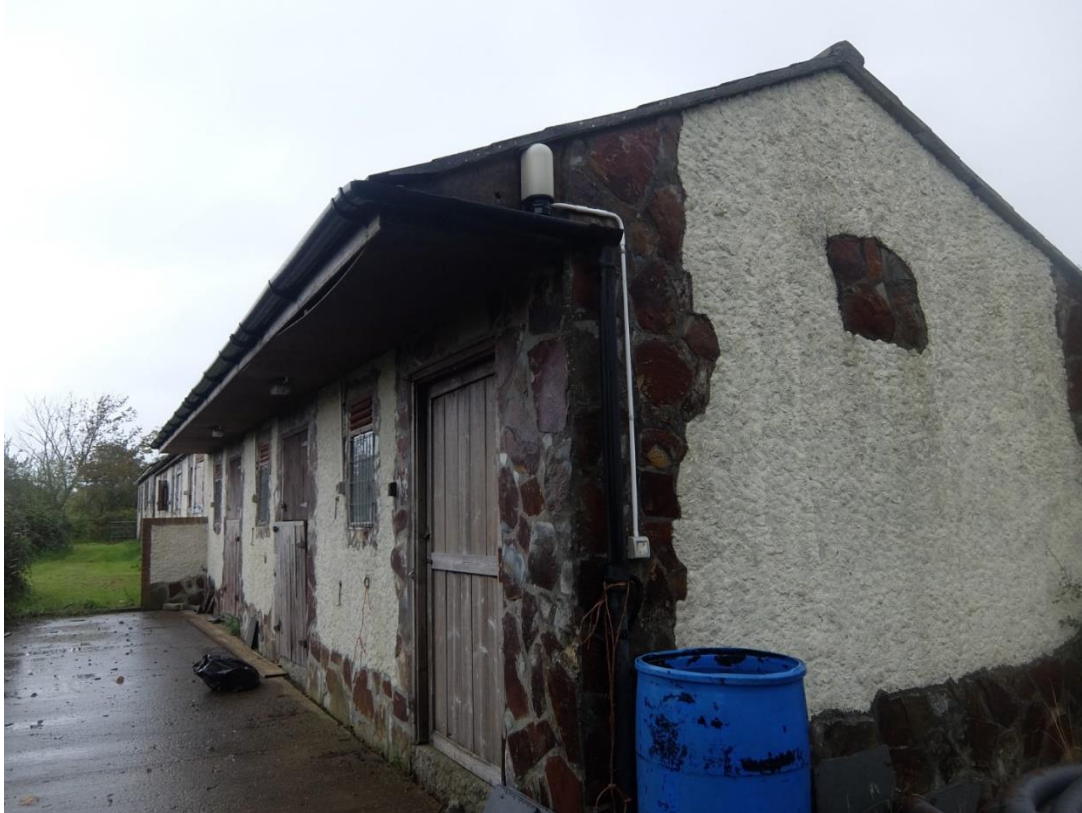
Front and left side elevations of whole building from attached storage bay side

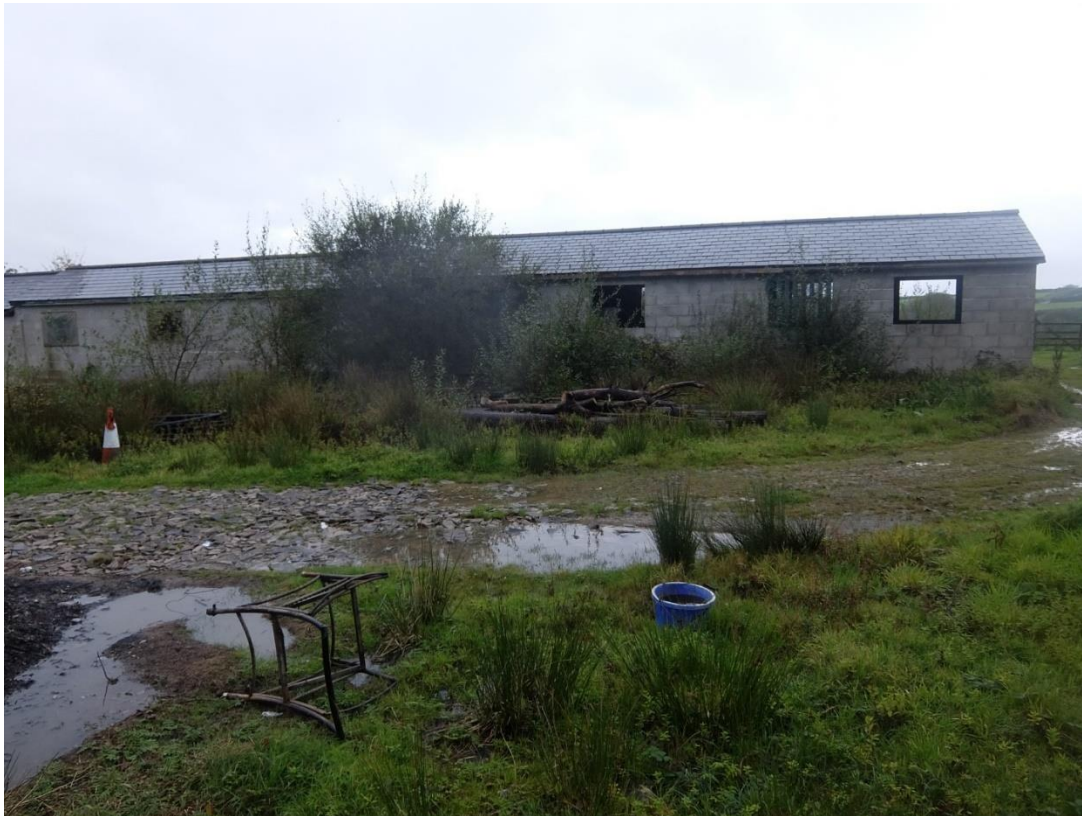
Right side elevation included some of the attached storage bays
