General structural appraisal report on

Stable & Storage Buildings at
Summerleaze Farm
Hobbacott Lane
Bridgerule
EX22 7HB

Ref: 10656_TS_21_A

10.06.21

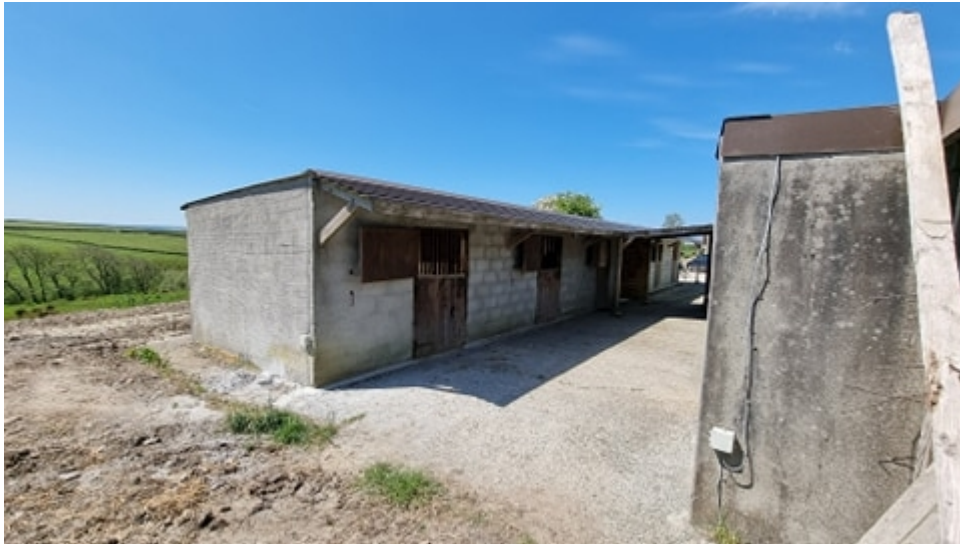
1.1 The external walls of the barn are formed from single skin concrete blockwork with an exposed block finish. In some isolated areas internally and externally the walls are coated with a cement based render.

Photograph 1 – Longer building, concrete block visible

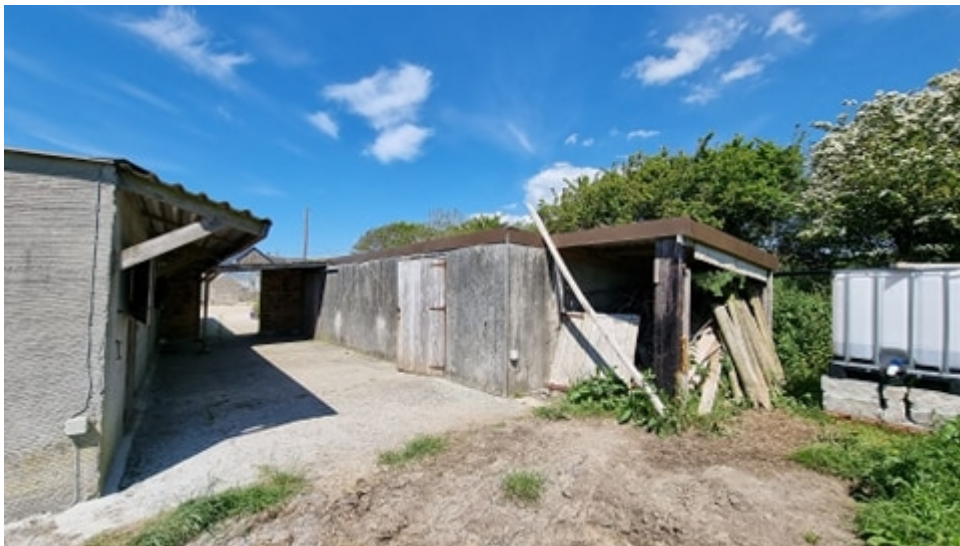
Photograph 2 – Shorter building, rendered externally

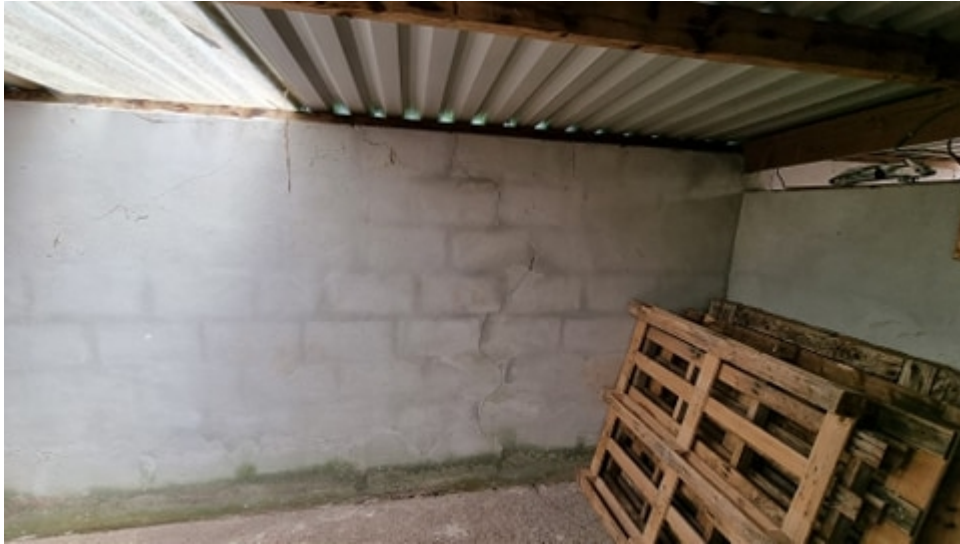
1.3 Vertical staggered cracking was noted to one of the flank walls of the shorter building. This is considered likely due to a lack of lateral buttressing and lack of formal movement joints. The wall will require locally stitching in helical bar up its height to re-bond the blockwork and considerations for the installation of movement joints will be required throughout.

Photograph 3 – Cracking to flank wall of shorter barn

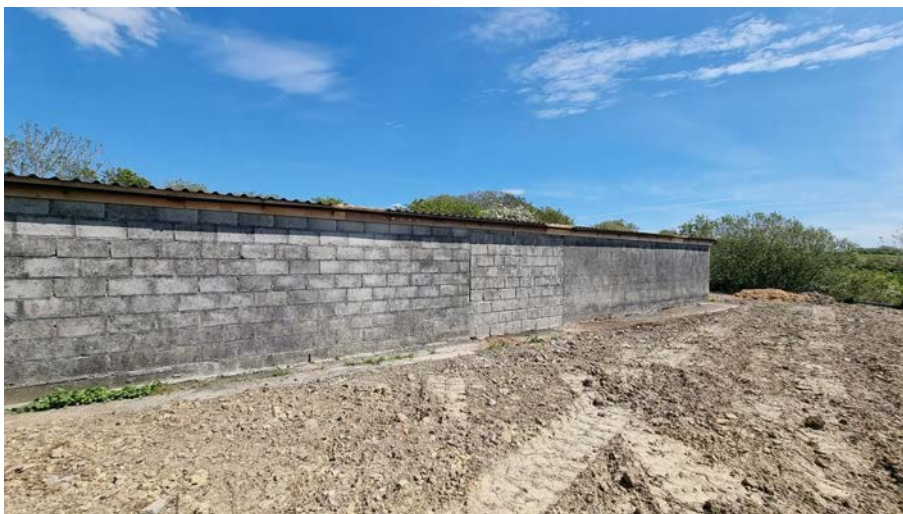
1.3 Some areas of the wall panels have been locally filled with additional blockwork in their history. Most prominent is the rear flank wall of the longer building. The bonding between the blocks at this point should be formalized to ensure continuity, or consideration for movement joints can be given.

Photograph 4 – Masonry infill panel to rear flank wall

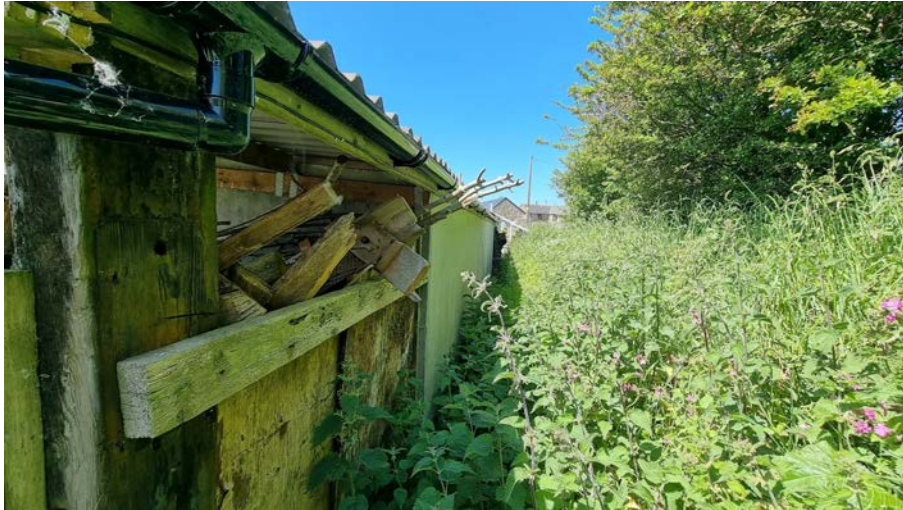
1.4 The flank wall of the shorter section of barn has a build up of foliage against its external face, although is not considered to retain ground. Any local foliage should be cut back to minimize water ingress or entrapped moisture against the wall.

Photograph 5 – Foliage build up to flank wall

- In a number of areas foliage was recorded as existing on, or in close proximity to, the walls of the building. Such growth can trap moisture against the wall fabric which can lead to degradation of the wall surface. Where it is recommended this foliage is removed, it should be cut off at its base and allowed to die back. Pulling such growth, particularly ivy, from the face of the walls can lead to surface damage.

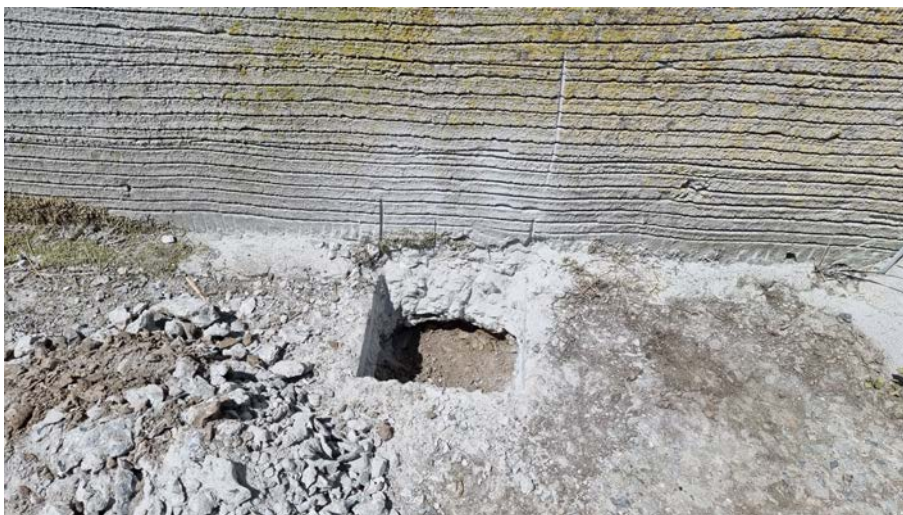
1.5 A trial pit was inspected to the eastern end of the longer building that revealed its footing. The barn appears to be built off a build up of 100mm thick concrete oversite / slab (or raft) founded on a firm gravel sub base.

Photograph 5 – Trial pit excavated to eastern end of building

1.6 The existing footing appears to remain serviceable under its current use with no obvious signs of structural distress to the external walls. However, it is considered that the existing footings would be unlikely to adhere to current building standards if subject to formal calculation. The existing concrete blockwork must not bear an increase of load. It is considered that a careful scheme of adopting a new internal load bearing skin of structural timber frame, or additional blockwork will be required. This can be founded on a new internal footing independent of the existing. An additional timber frame or cavity skin will provide additional restraint to the existing masonry against lateral wind loading.

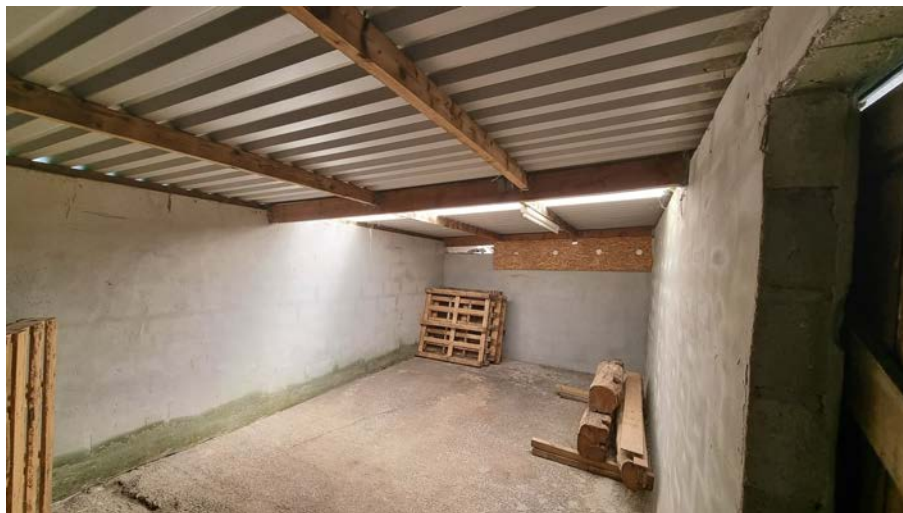
2.1 The ground floor throughout is formed of cast concrete. It is likely the slab is 100mm thick throughout to reflect the external trial pit. The existing slab may be suitable to retain however further internal investigations may be required to confirm. If the existing slab is found to be inadequate internally it is considered likely a new suitably insulated ground bearing floor slab will be required throughout.

Photograph 6 – Concrete floor visible internally

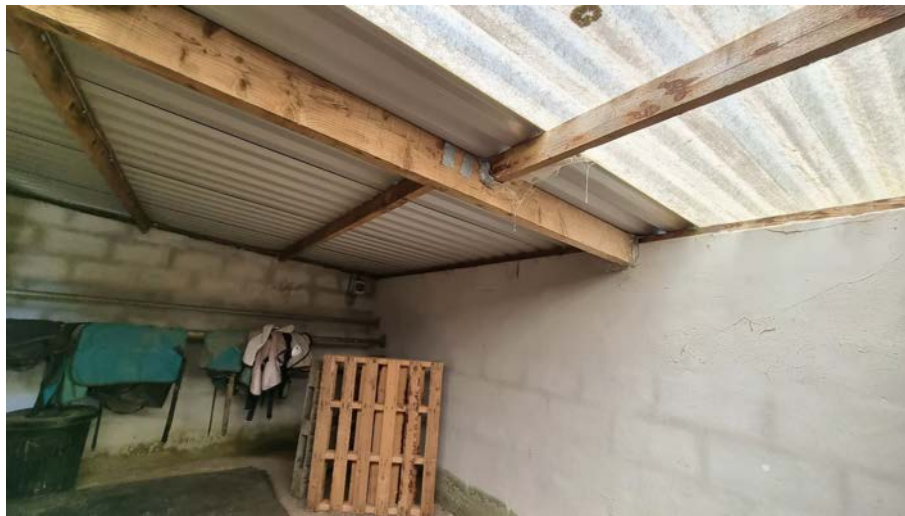
3.1 The roof to both buildings is a modest mono pitched structure formed from principal rafters supporting purlins and corrugated cladding over. The timbers are mechanically fixed at junctions and at their bearings with face fixed proprietary hangers. The roof remains serviceable under its current use with no obvious signs of distress.

Photograph 7 – Existing roof structure

3.1 It is noted the proposed roof on the provided drawings is duo pitched with visible feature trusses and a vaulted ceiling. It is considered to achieve this a new suitably design roof structure would be required throughout.

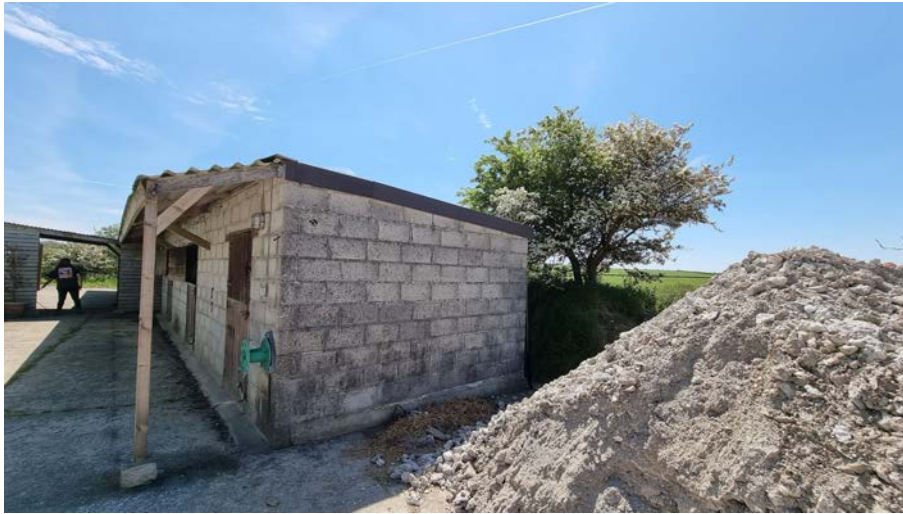
3.2 It is noted the longer building has an ad-hoc overhang to its roof structure supported by timber posts. This would not adhere to current standards and will need replacing upon conversion. Any overhang that is proposed to remain should be designed alongside the new roof structure.

Photograph 8 – Roof overhang detail to flank wall

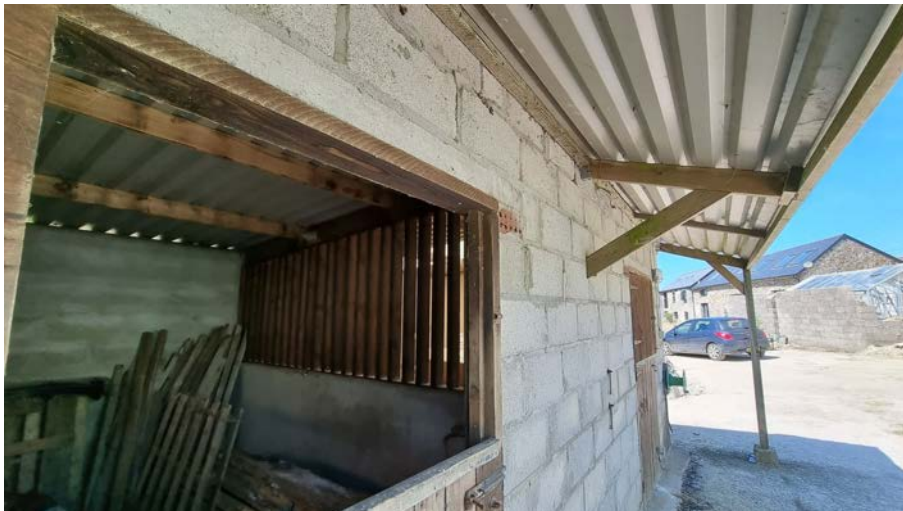
4.1 The lintels throughout are formed from concrete where inspected. Each of these will need to be assessed on a case by case basis alongside the replacement roof for suitability to remain. It is considered likely, if a new structural internal lining is adopted, many of the lintels may be viable to be retained.

Photograph 9 – Concrete lintel to stable opening.

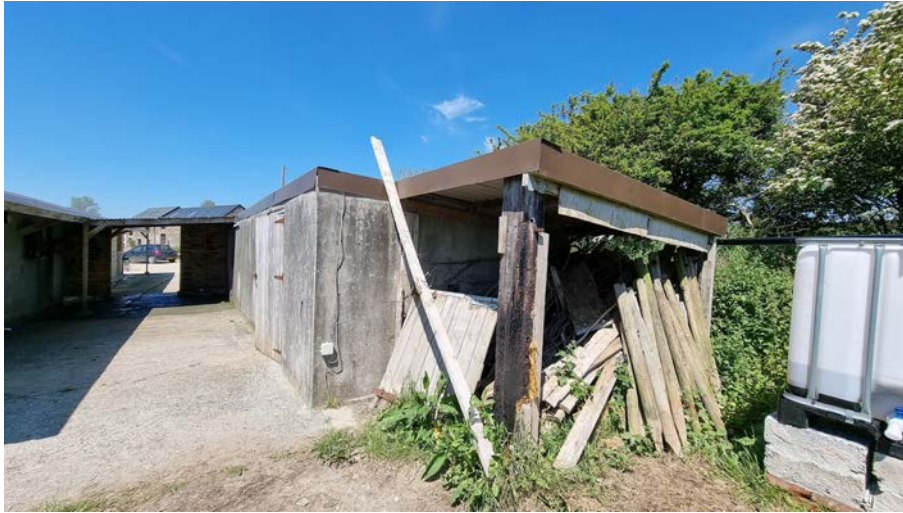
5.1 To the eastern of the shorter building is an open timber frame addition that has suffered in its history from weathering and rot. It is considered this structure is beyond reasonable repair and requires replacement.

Photograph 10 – Timber frame addition to eastern end
