Teesdale • Heritage • Trees

Arboricultural Impact Assessment for Proposals at
27 Main Road, Gainford, Co. Durham, DL2 3BE

14 May 2021

Report 917

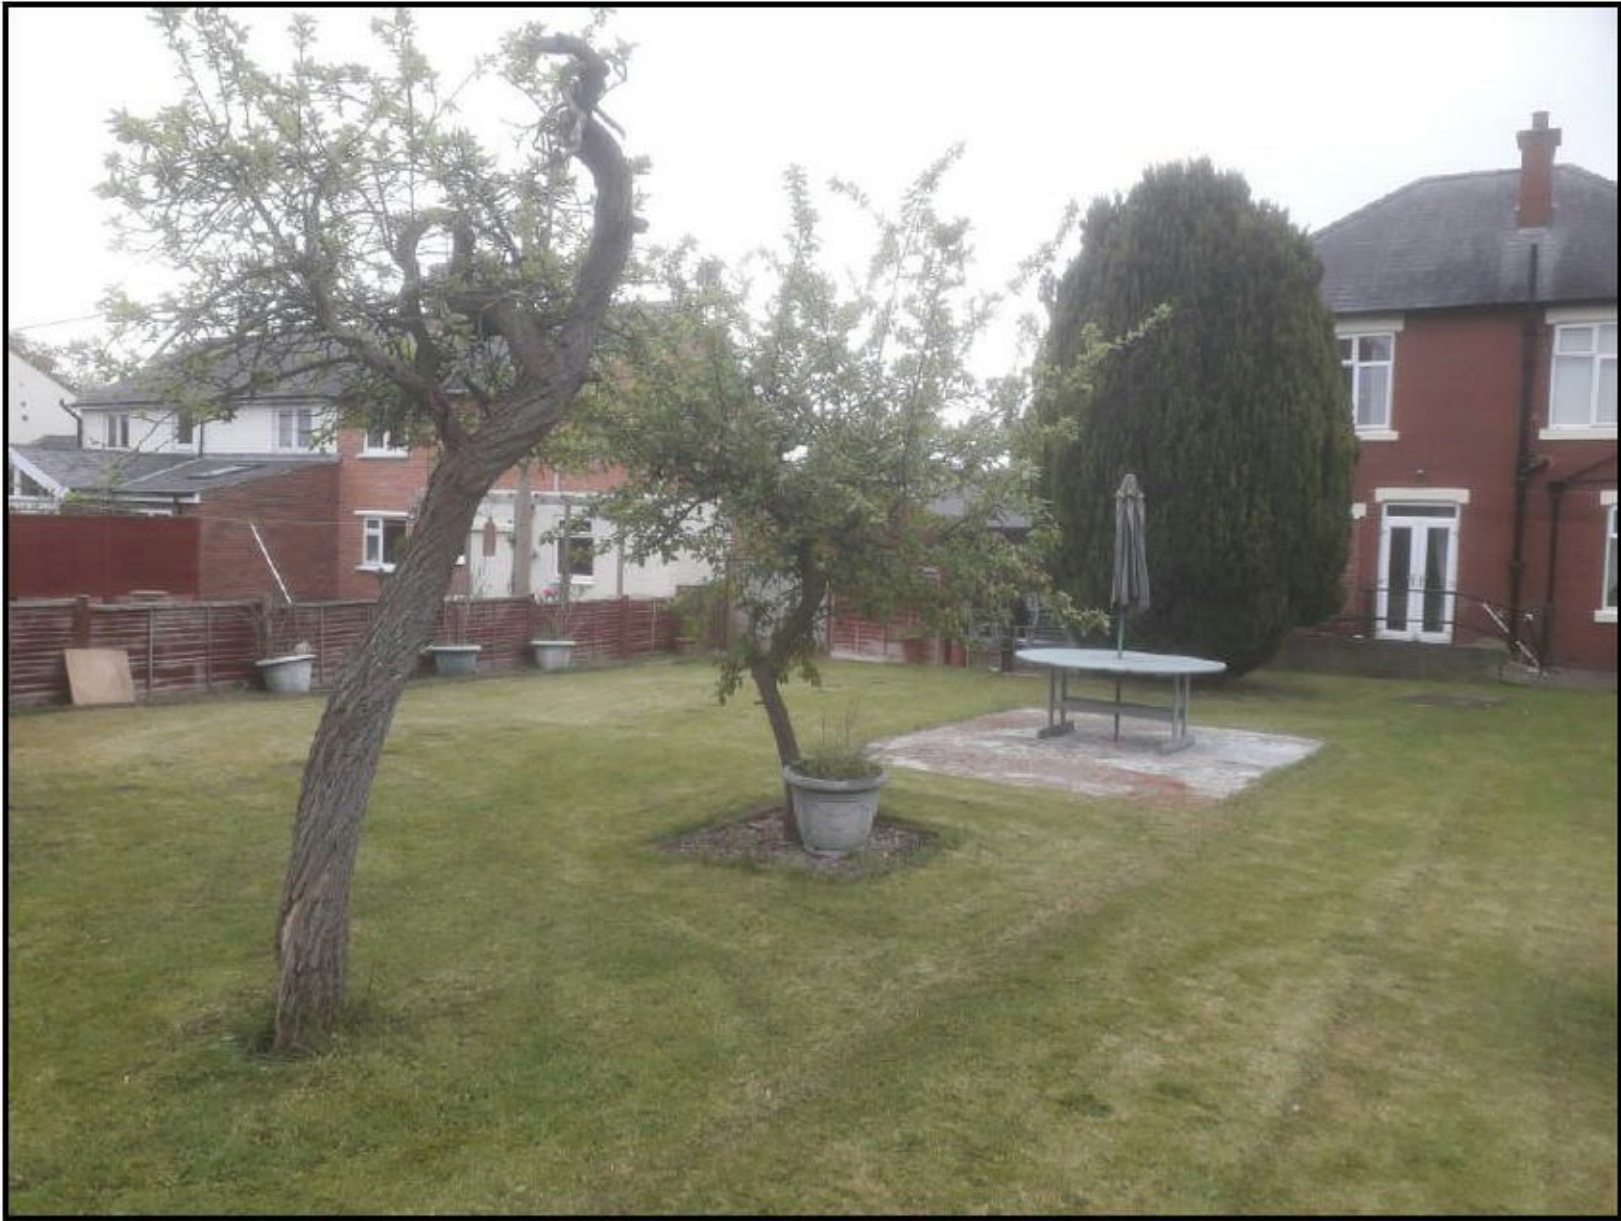
Photo 1 -Trees 3, 5 and 6

Trees	T2 to T8
Groups	None

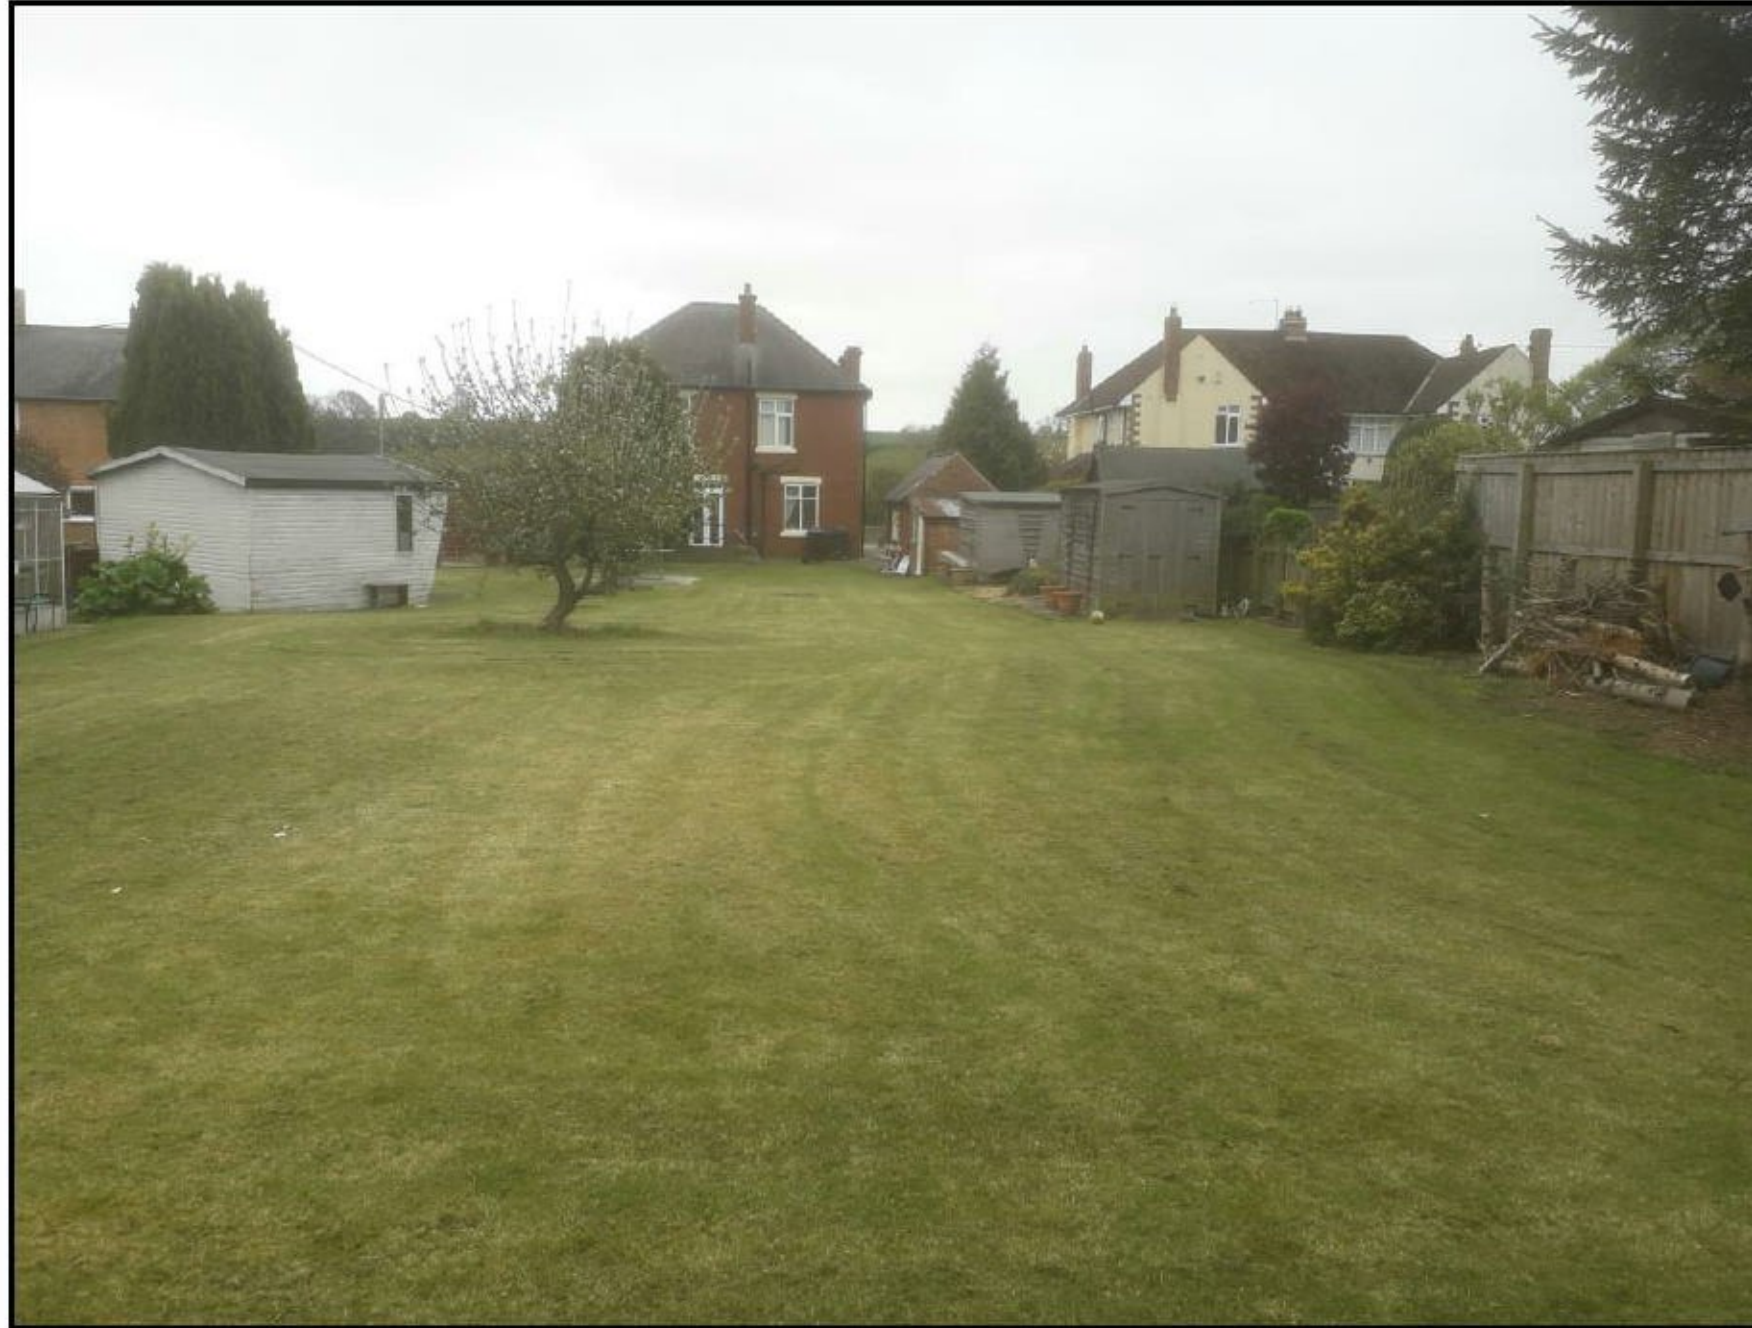
Photo 2- Site seen from the north
