Winter bat habitat assessment *with* Spring addendum
at
the Drama Hall, Computer Suite and Prayer Huts
Kingston University,
Kingston Hill,
Kingston upon Thames.

rev.2 May 2021

Job Title. Rev.2 Dismantling of the Drama hall, Computer Suite and Prayer Huts

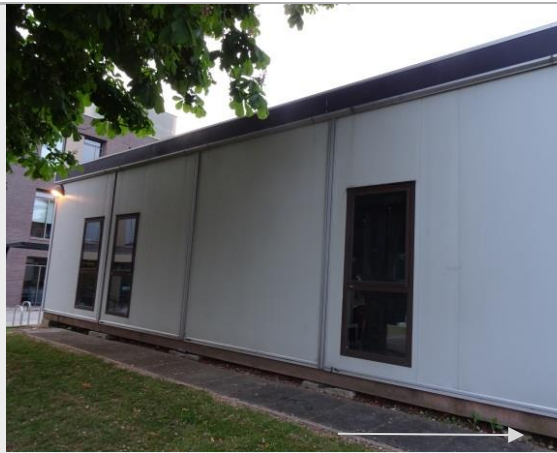
- 3.11 A mammal 'smeuse' or trail was noted going under the building at the south east corner and the soil board was removed with the help of staff. Hardboard flooring had collapsed to block a clear view of the area, but no burrows or dens could be seen.
- 3.12 Mammal hair was noted along with feathers, which might have resulted from an old nest of mouse or bird.
- 3.13 The Drama Hall has no potential for bat ingress. There was potential for larger mammals to go underneath the building.

Photograph 1. South elevation: arrow marks location of animal ingress

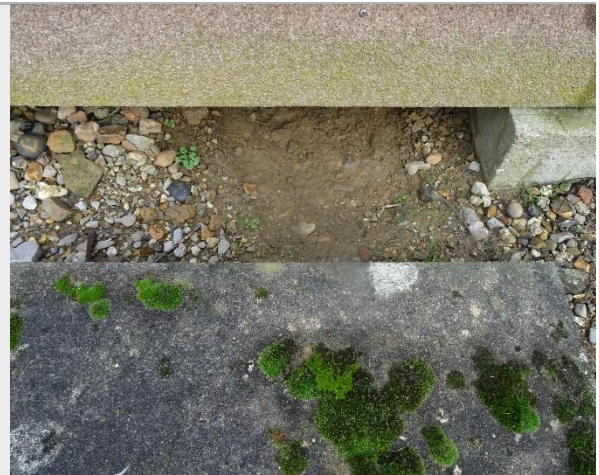
Photograph 2. Animal ingress beneath the building

- 4.2 It must be considered that animals could be denning underneath the building, as ingress has been noted.
- 4.3 There is no-low potential for bats to roost at the Computer suite and Prayer Hut 2 and the dismantling can occur with a team talk and short watching brief on the areas mentioned at any time over the winter.

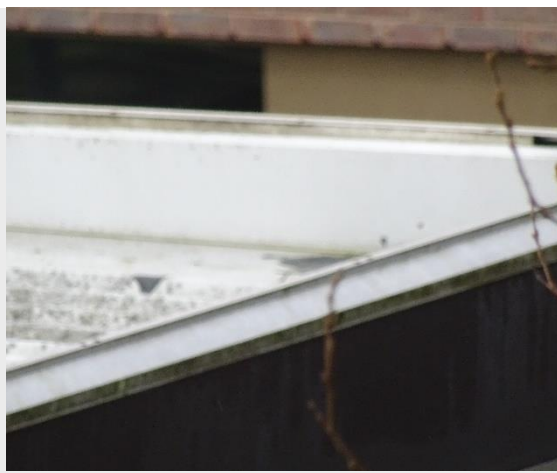
Photograph 3. Upstand of roof: photo taken from Top level- indicates there is no flashing material that bats can infiltrate.

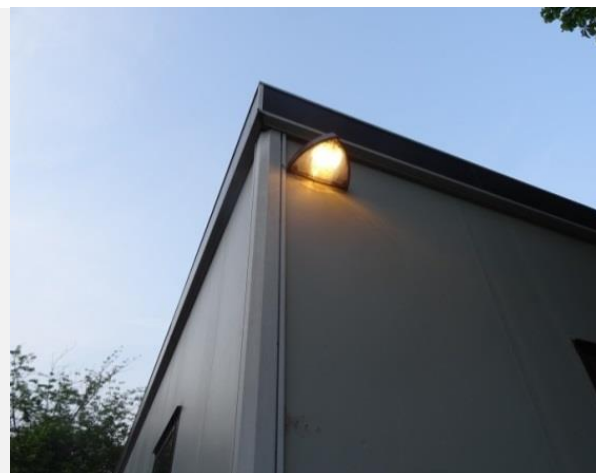
Photograph 4. Indicating the lights that exist at each corner of the building

- 4.1 There is no potential for bats to roost at the Drama Hall. The building has no features that could be of bat interest and is lit beyond the tolerance of most bat species. The vegetation links are also poor with the exception of a horse chestnut tree.

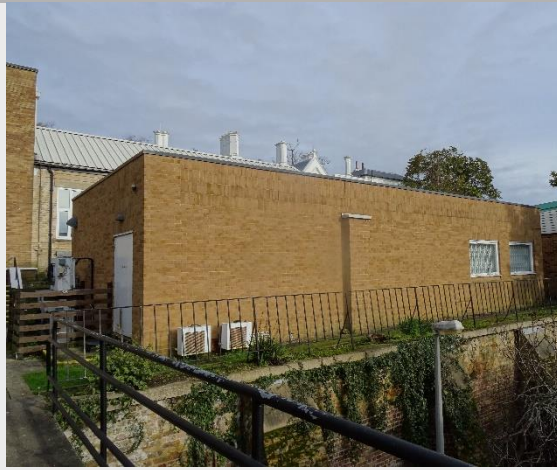
- 3.14 The computer suite was a featureless brick-built block. The roof was asphalted and was secured by a metal finishing strip, which should be difficult for any animal ingress.
- 3.15 However, this is a repeatable feature at the university and bats have been located at the flat roofs (the De Lissa add-on, Bridge House). Although it is unlikely, the possibility must be considered.
- 3.16 For this reason, the building has been determined as no-low potential. The 'low' score, will mean mitigation during demolition will be required.
-

Photograph 5. South elevation of computer suite

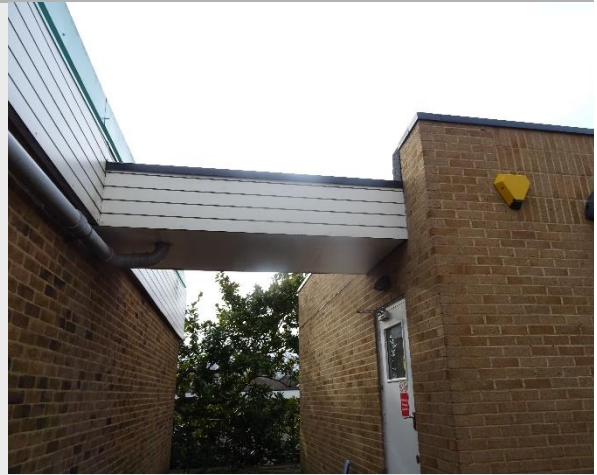
Photograph 6. Services link has cladding but no suitable gaps were found

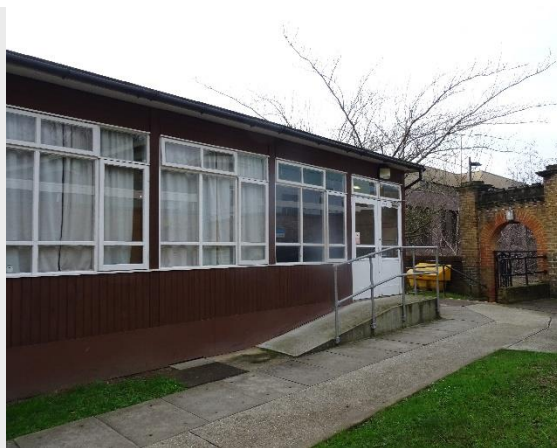
Photograph 7 Hut 2 with access ramp

- 3.17 Prayer Hut 2 was located close to the archway and the wall and is distinguished in this report by its access ramp. The roof line was constructed slightly differently to Hut 1. This involved the eaves construction and the courses of cladding beneath the soffit.
- 3.18 There was damaged cladding on the east wall that could allow bat ingress to the cavity. The potential for bat interest at Hut 2 is no to low potential and the mitigation will be the same as for the Computer suite.

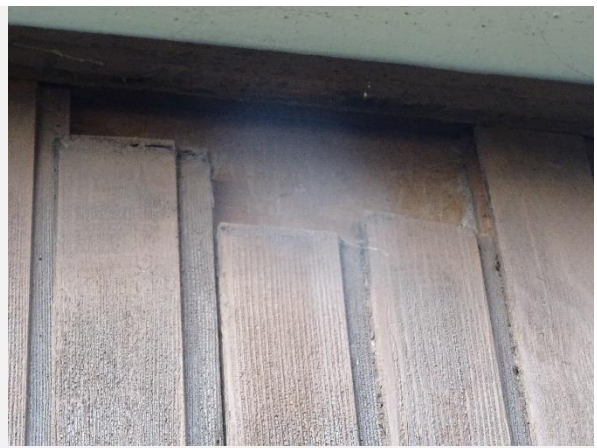
Photograph 8 may have limited potential for access on east flank wall as cladding has gaps

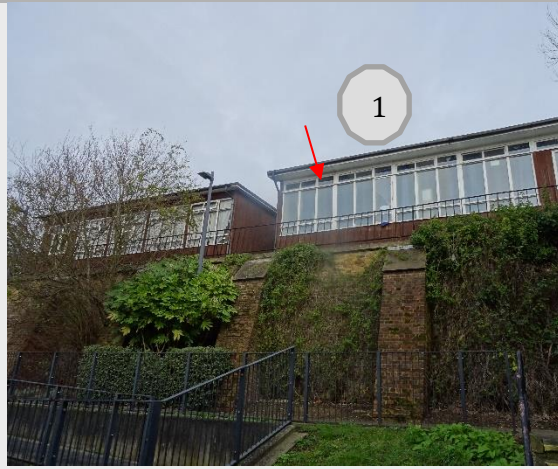
- 3.19 Prayer Hut 1 had several features that would allow bat ingress. These included:
- a large gap in the fascia above windows at the south elevation. This might allow access to the soffit box (photo 10).
 - missing plywood at the soffit box on the south-west corner of the building.
 - a gap in the barge board at the gable apex at the west flank wall (photo 11).
 - gaps in the cladding that would allow access to the cavity. The fabric of the interior wall could be seen using a torch (photo 12).
- 3.20 The potential for bat interest at Hut 1 is scored as 'medium' and the mitigation will be a requirement for a bat emergence survey prior to dismantling.
- 3.21 This survey cannot be undertaken until Spring rising temperatures. The building will need to be dismantled at a later date.

Photo 9. South facing elevation

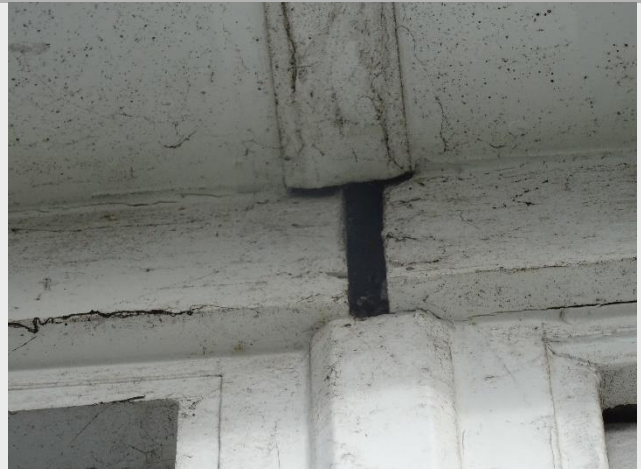
Photo 10. Hole in fascia marked by arrow at photo 9

- 4.4 There is medium potential for bats to use the Prayer Hut 1 and for this reason an emergence survey must be performed prior to dismantling. This means that the building cannot be dismantled until milder temperatures occur (> 10 degrees centigrade night time temperatures).

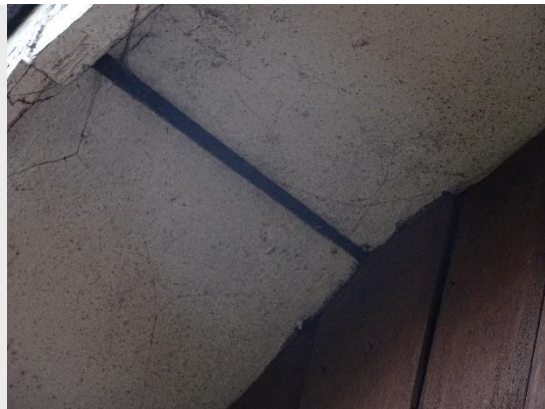
Photo 11. West flank wall gable apex

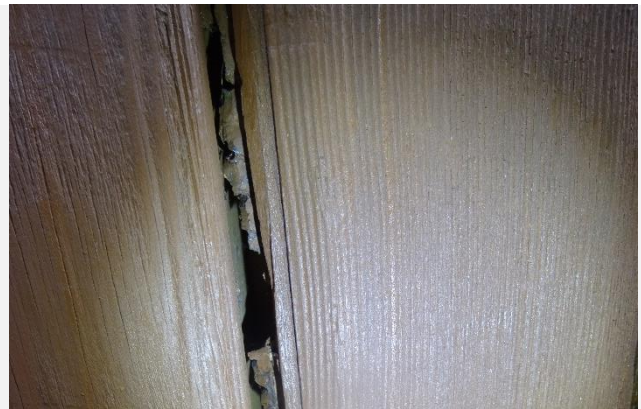
Photo 12. Cladding on west elevation

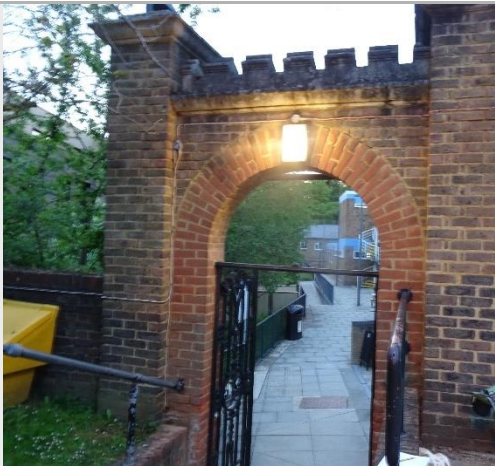
Photograph 1. Nearby lights reflecting onto north elevation of buildings

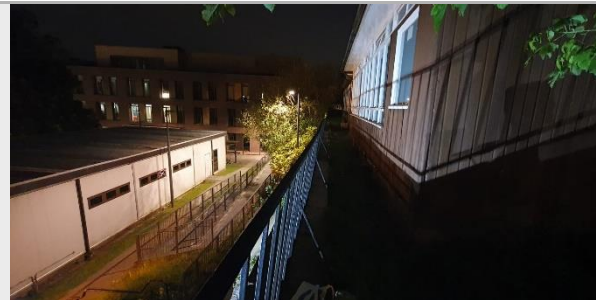
Photograph 2. Reflected light onto the south elevation of the Prayer Hut 1 and the Drama Hall (Photo: S. Sivanesan).

- 1.8 Light spillage was noted on features that might be of potential bat interest, identified in the PBHA report, especially along the south and north elevations (*refer to Photo 2*). At the north elevation there was a faulty light flickering at intermittent intervals. *The features of potential bat interest were therefore not optimised.*

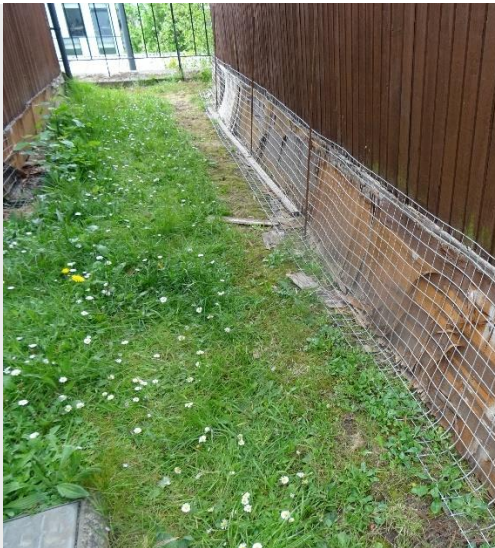
Photograph 3. The area under the buildings has been sealed against animal ingress
