**LAND ADJACENT FINCHES FARM,  
LABOUR IN VAIN ROAD, STANSTED,  
SEVENOAKS, KENT TN15 7NY.**

**PHASE I GEO ENVIRONMENTAL DESK STUDY  
AND PRELIMINARY RISK ASSESSMENT**

**August 2020**

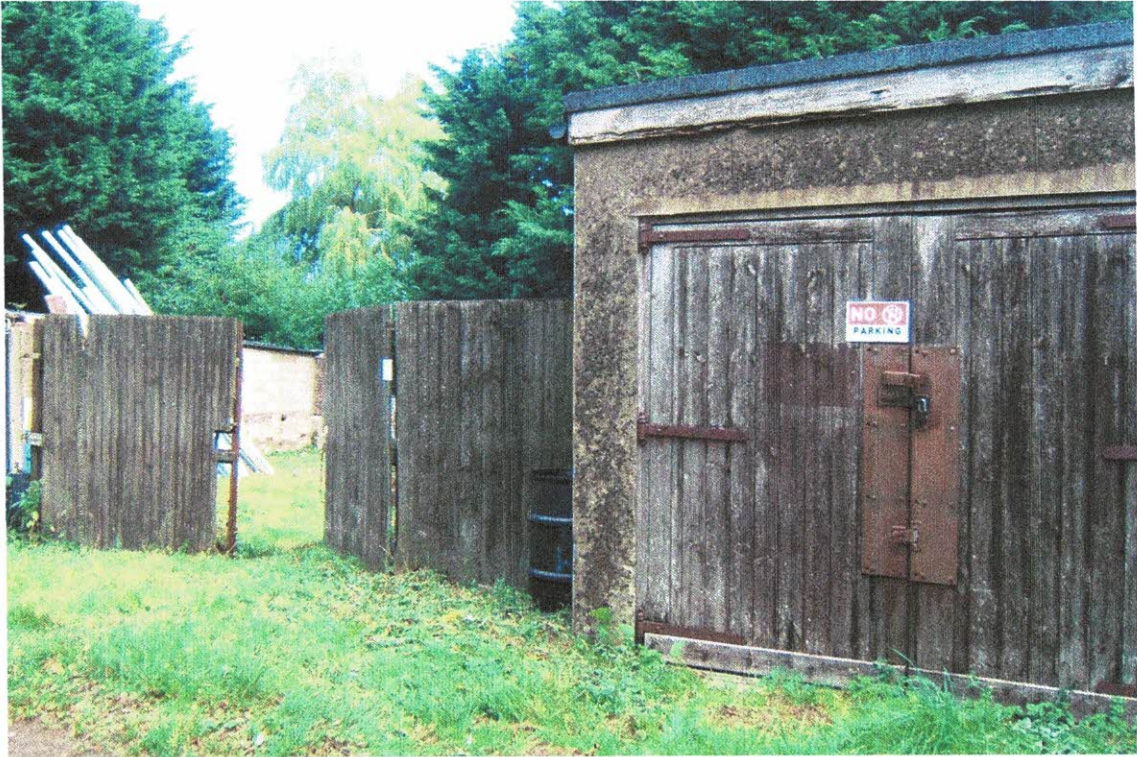
**Plate 1**

- 7.3 The front boundary of the site was secured by a 2.5m high timber fence, access into which was gained via a pair of padlocked timber gates (Plate 1). A single garage of rendered brick construction under a flat felt roof occupied the front, southeast corner of the site, the timber doors of the garage opening directly onto Labour in Vain Road. A second-hand vehicle was stored in the garage (Plate 2). The interior of the garage was in a clean and tidy condition, no evidence of hydrocarbon staining being apparent on the exposed areas of its concrete floor slab (Plate 3).

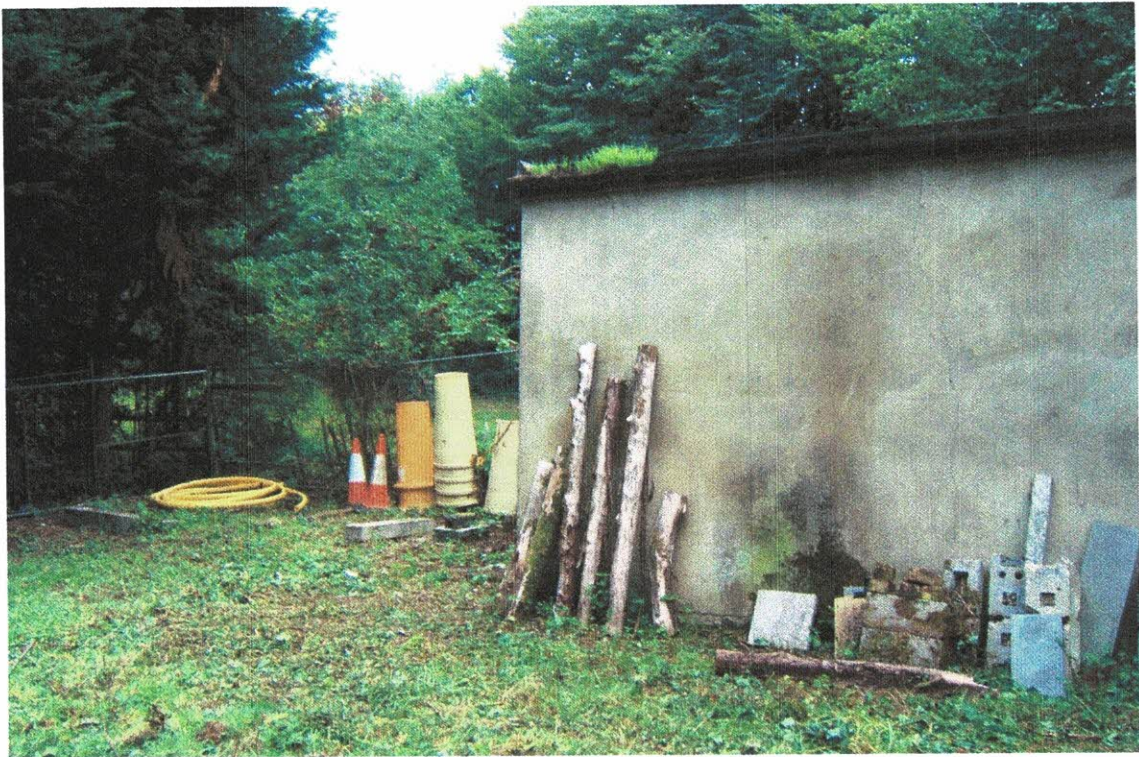
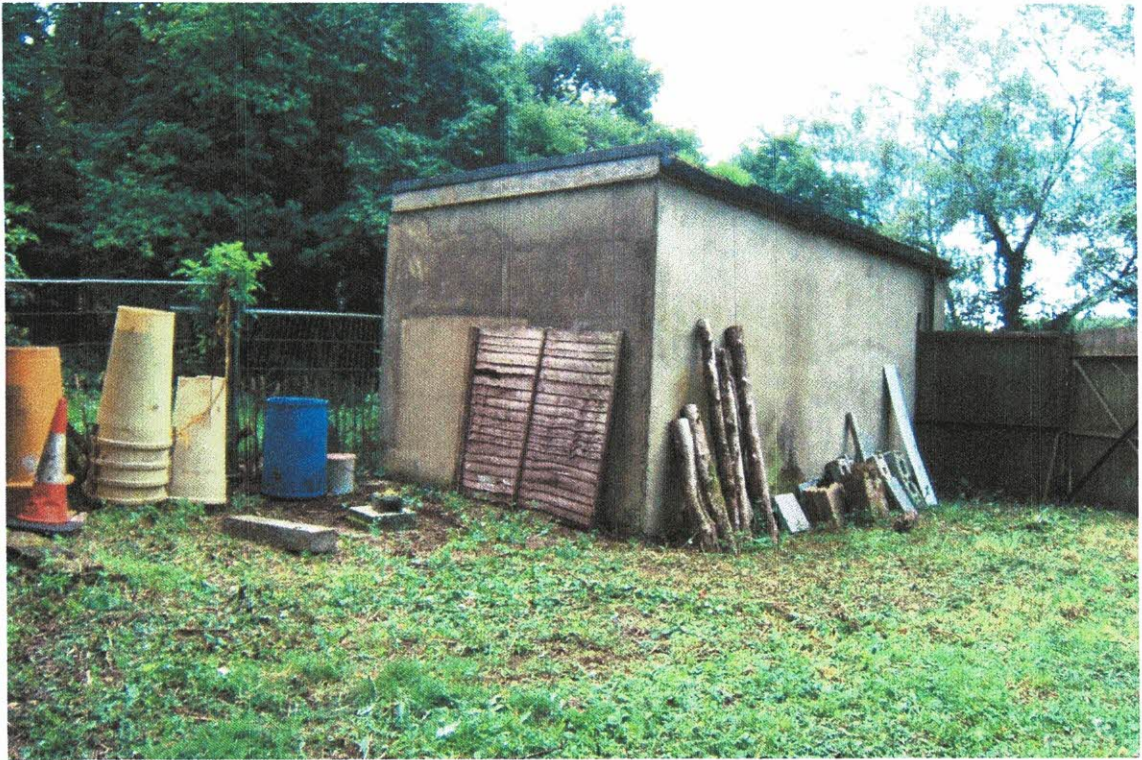
- 7.5 Several railway sleepers and concrete blocks which had previously supported the mobile office remained to the rear of the garage in the site's northeast corner, together with a roll of plastic pipe, several road cones and plastic water butts (Plate 4 and Plate 5). A number of logs, fence panels and concrete blocks were stored alongside the garage.

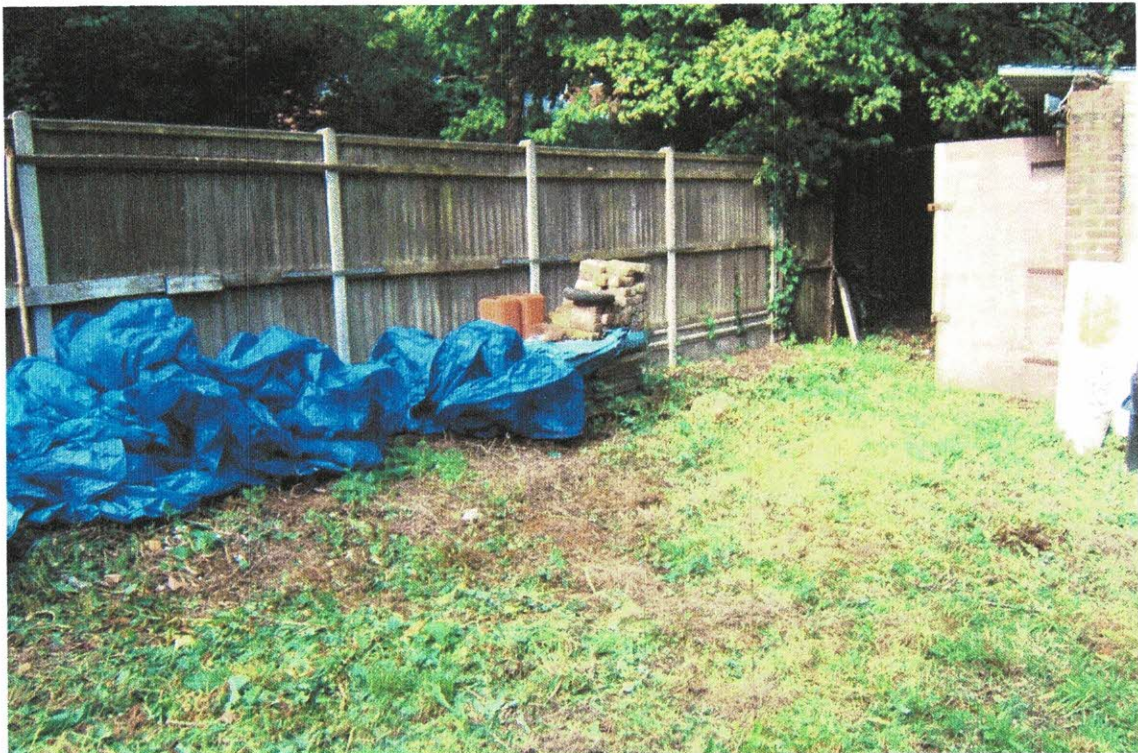
**Plate 6**

- 7.6 Bricks and concrete blocks were also stacked on a timber pallet at the front of the site, alongside a large tarpaulin (Plate 6).
- 7.7 The west section of the site supported a rectangular building of brick and block construction under a corrugated steel roof (Plate 7). A number of plastic pipes and pieces of timber were leant against the east side of the building.

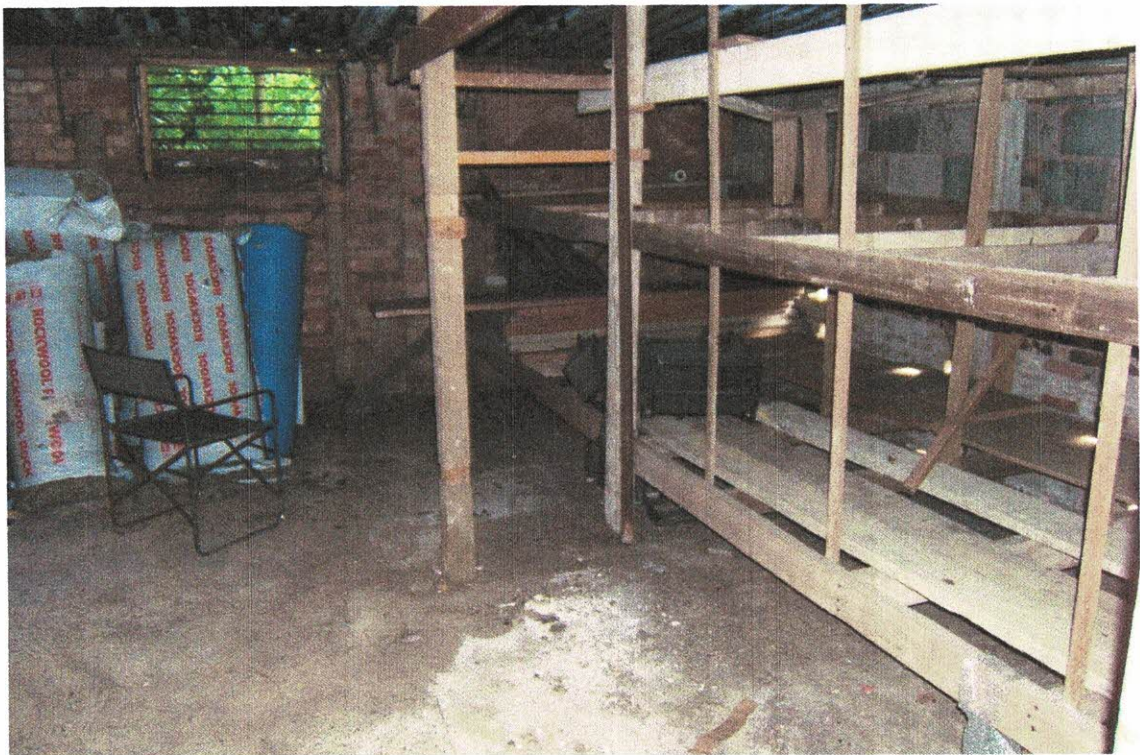
**Plate 8**

- 7.8 Entry into the building was gained through a pair of padlocked timber doors, the inside of the building being generally devoid of contents with the exception of a few packs of insulation material and a chair (Plate 8). Timber racking located in the east side of the building had been generally cleared of its contents, only a few lengths of

timber remaining. The concrete floor of the building was of a clean appearance other than an area of staining caused by rainwater leakage from the roof.

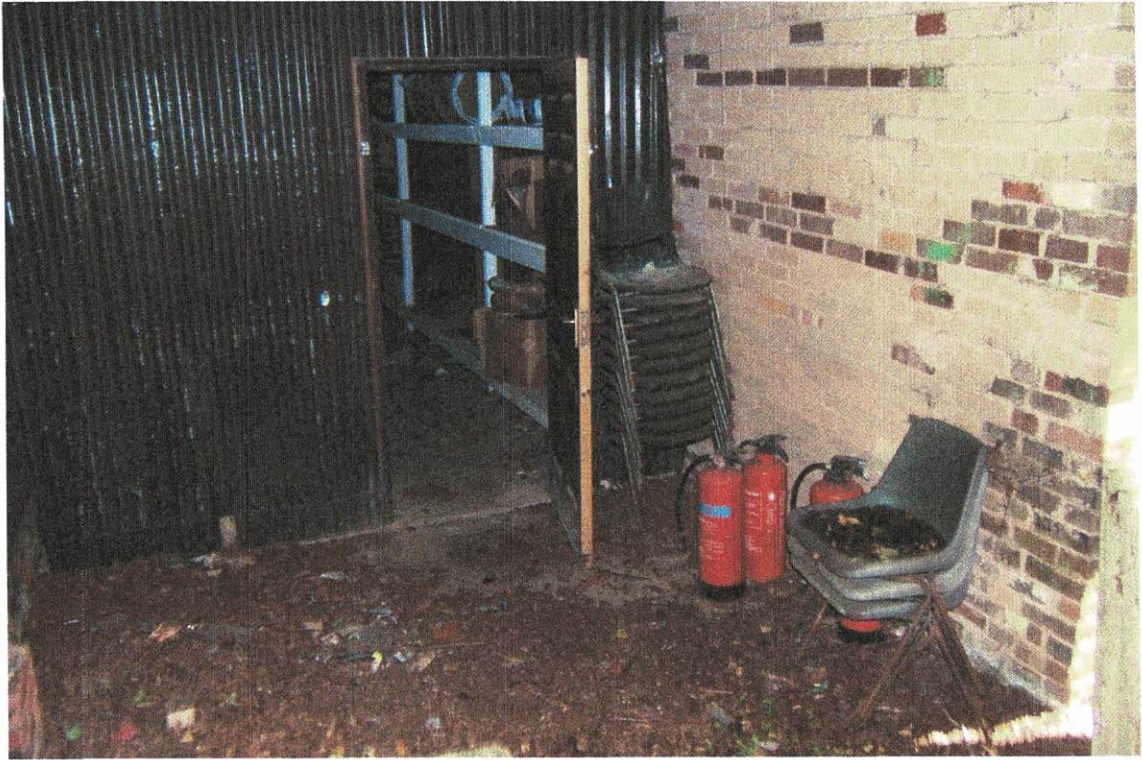
**Plate 9**

- 7.9 A timber lean-to under a corrugated steel roof was located alongside the west elevation of the larger store, a small area of concrete forming the ground surface at the front of the structure. Four fire extinguishers and three stacked chairs were placed on the concrete surfacing (Plate 9).

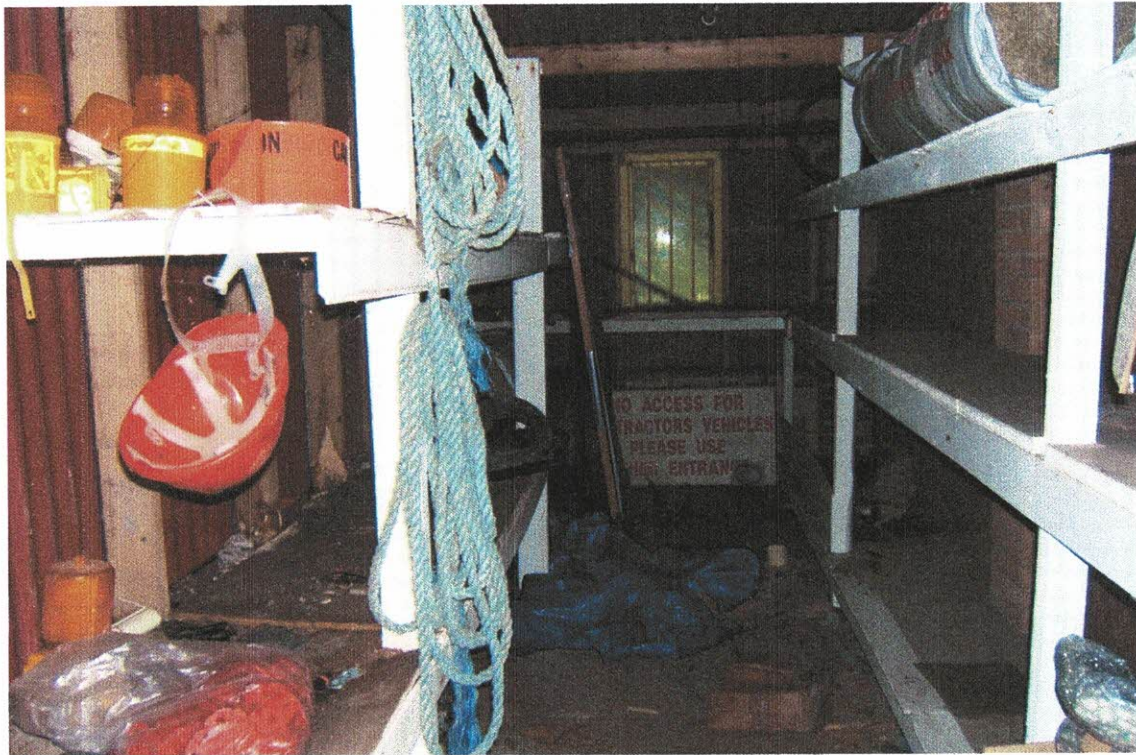
**Plate 10**

- 7.10 Access into the lean-to was provided by a timber door, various items of PPE, temporary plastic barriers and packages of insulation materials being observed to remain on racking inside the structure (Plate 10). The concrete floor of the structure was of a clean and unstained appearance.

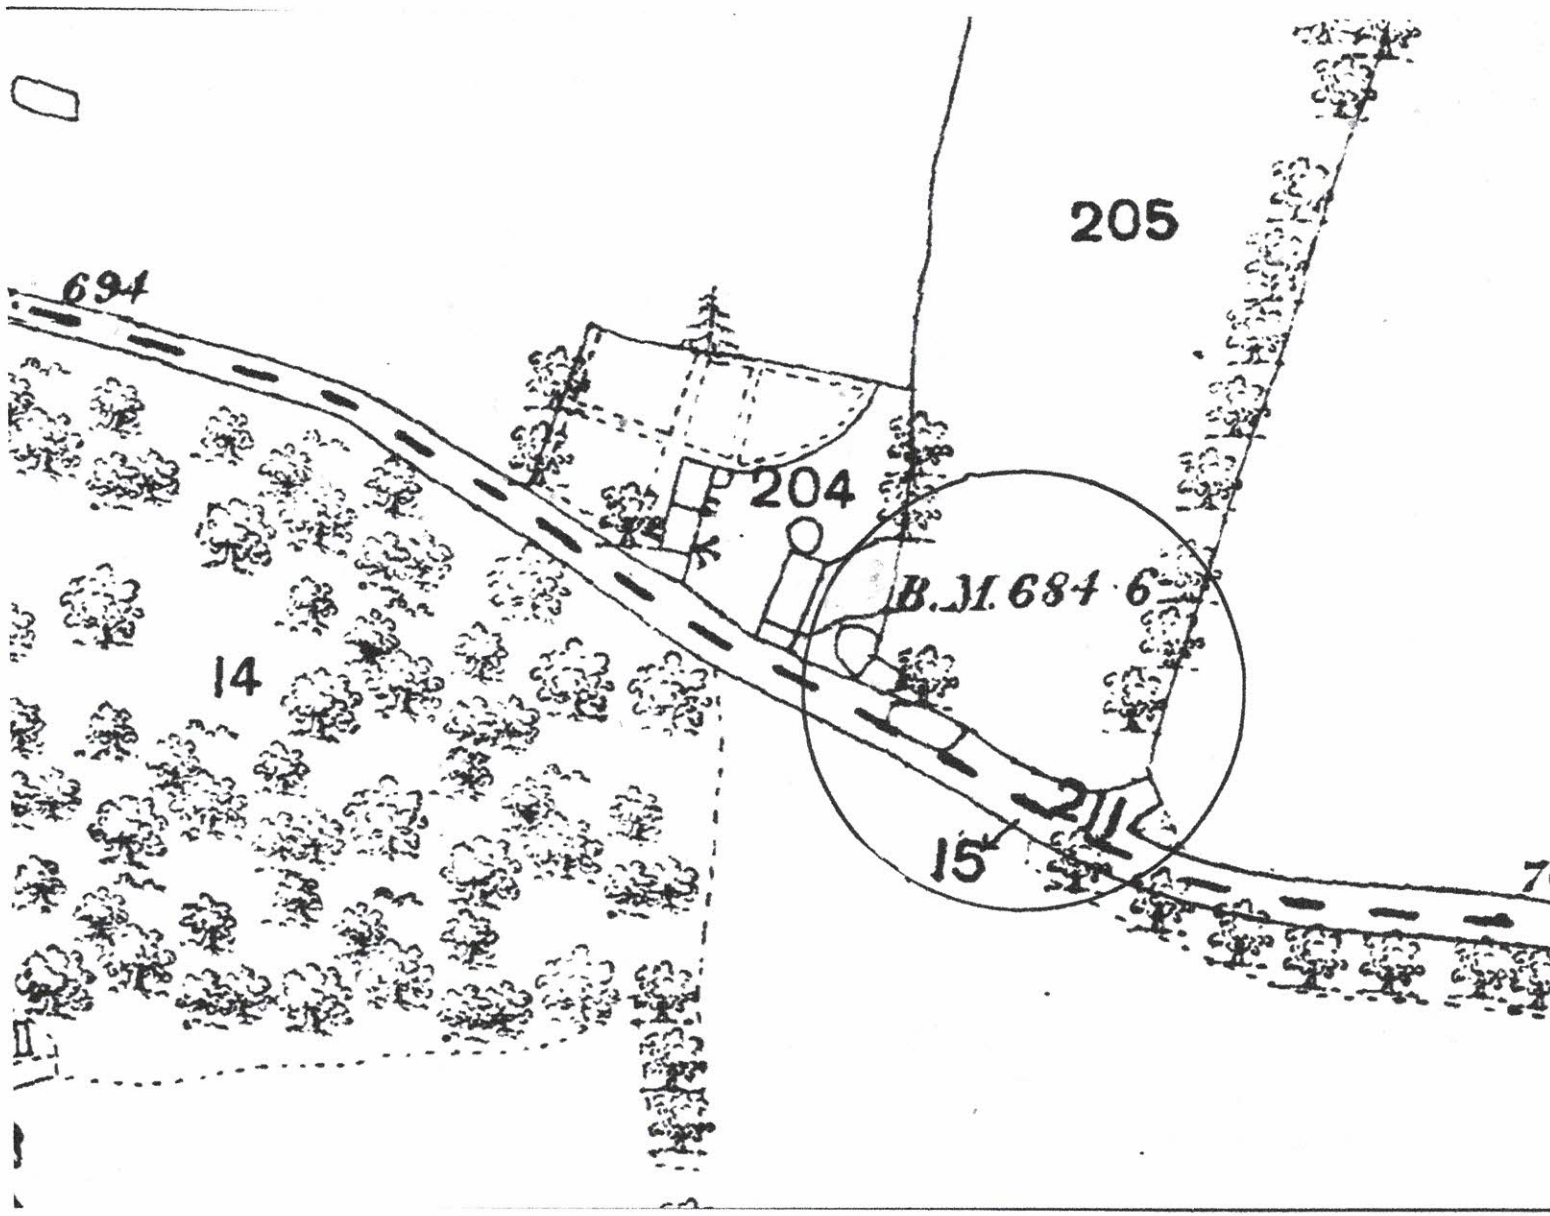
Land adjacent Finches Farm, Labour in Vain Road, Stansted. OS map scale 1:1250: 1871-1890.

*On site:* The site is undeveloped, comprising open agricultural land located on the north side of a country lane. A small building or animal enclosure is denoted on the front, southwest corner of the site.

*Off site:* A complex of farm buildings is situated on adjacent land to the west of the site, an associated pond possibly used as a sheep wash being in evidence next to the site's southwest corner. The area surrounding the site comprises mainly open agricultural land with hedgerows. Extensive deciduous woodland is located within 50m to the southwest of the site.

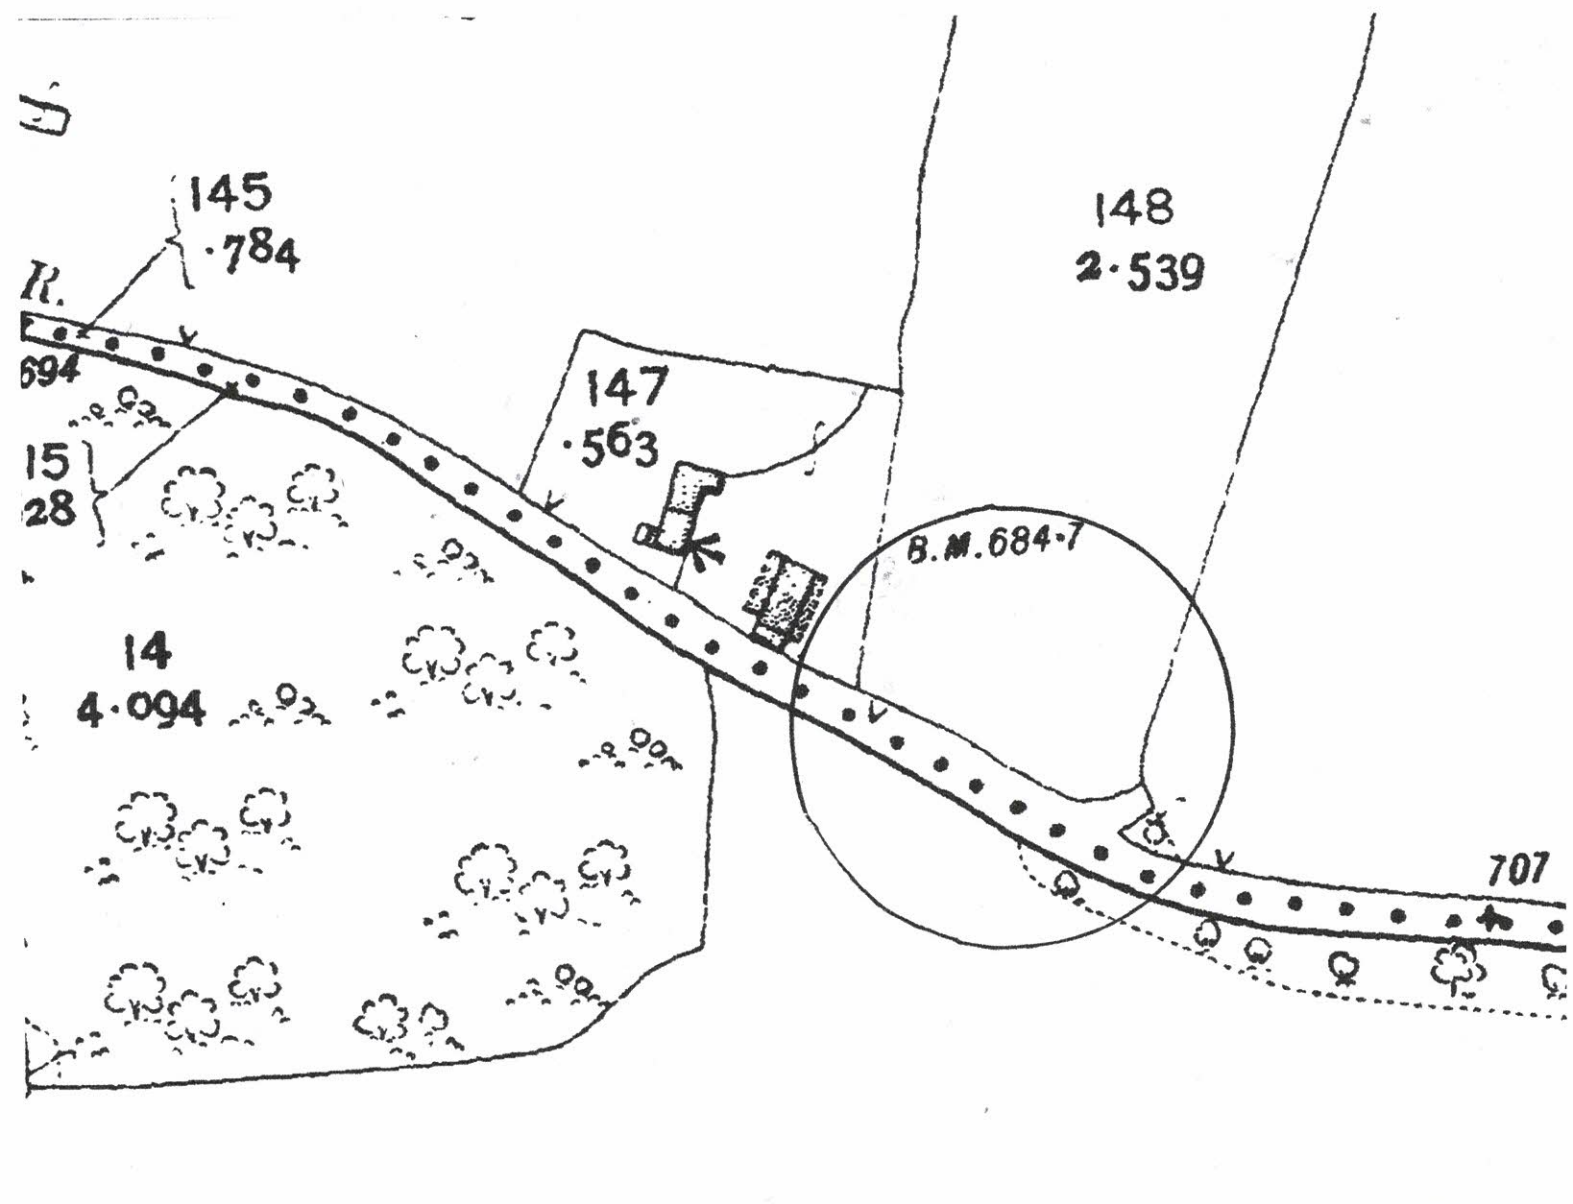
Land adjacent Finches Farm, Labour in Vain Road,  
Stansted. OS map scale 1:1250: 1907-1923.

*On site:* The building/enclosure has been removed from the southwest corner of the site.

*Off site:* The former pond to the southwest has been infilled.

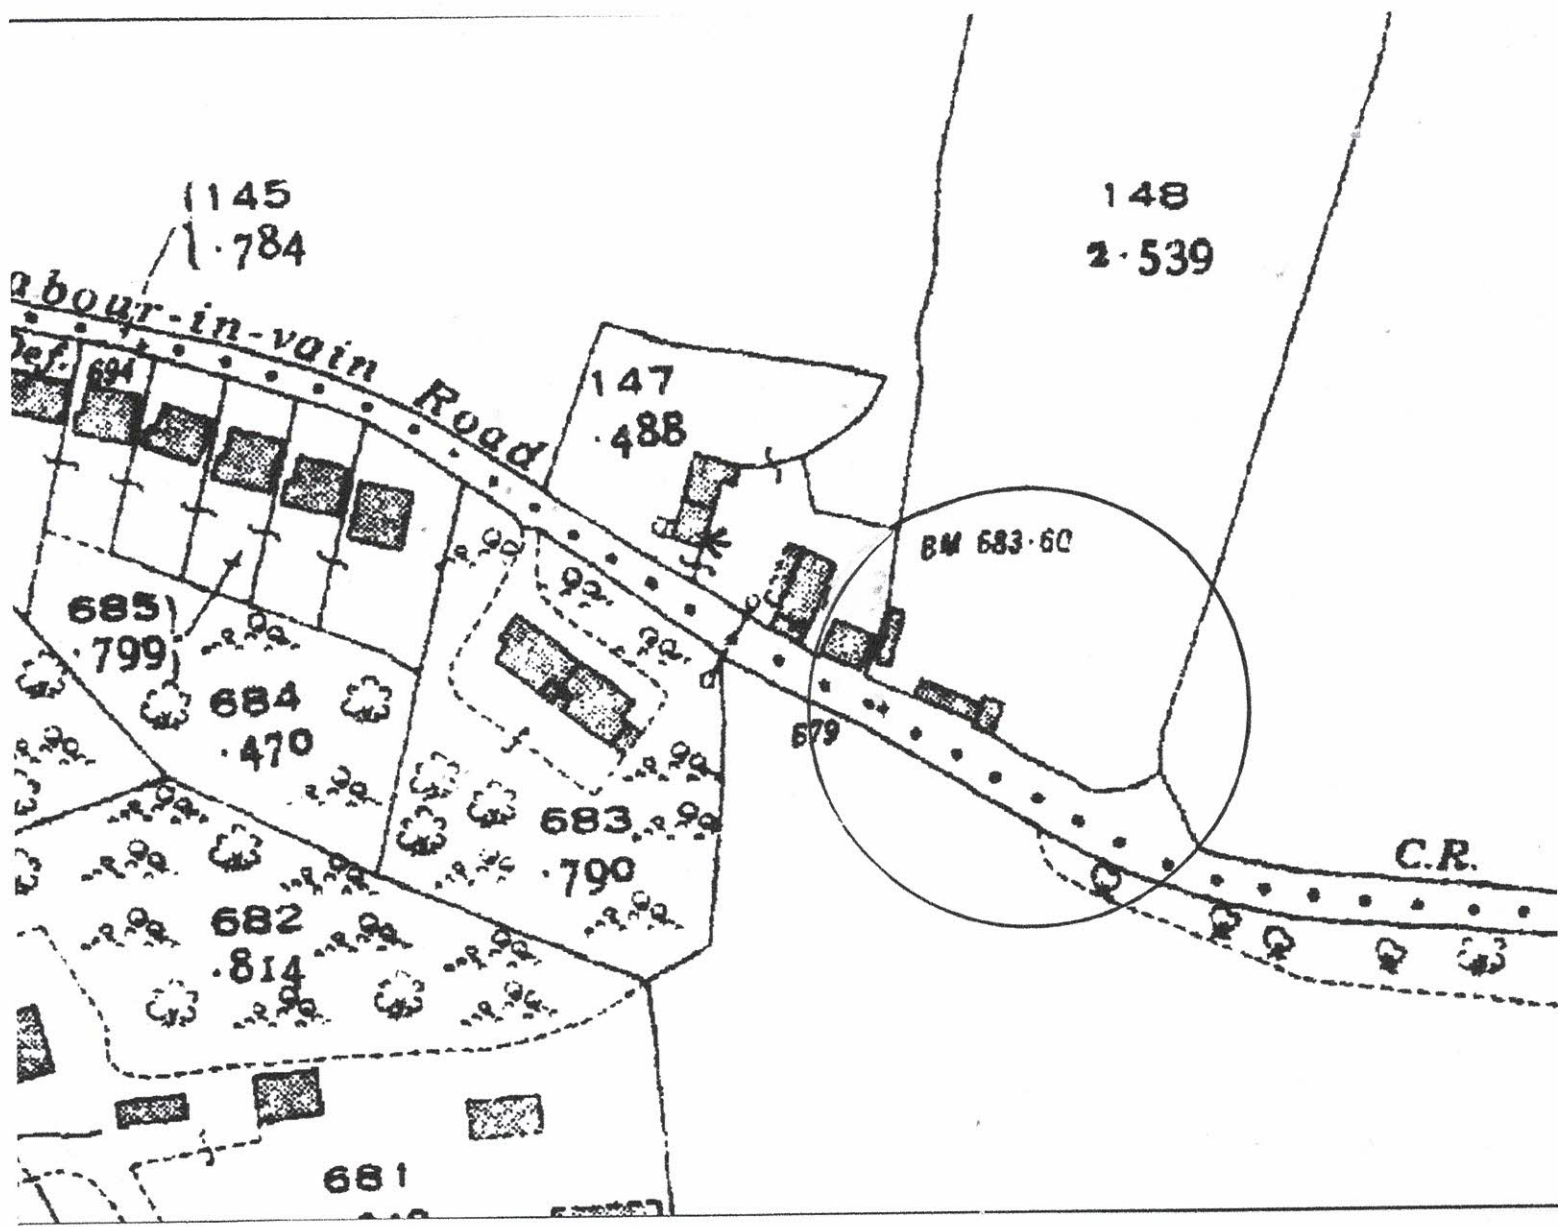
Land adjacent Finches Farm, Labour in Vain Road, Stansted. OS map scale 1:1250: 1929-1952.

*On Site:* Three small rectangular buildings of agricultural appearance have been constructed in the southwest section of the site.

*Off Site:* A larger, roughly square building has also been constructed within the farm complex, adjacent to the site's southwest corner. An adjoining pair of possibly residential buildings are denoted within 50m on the site of the former woodland to the southwest. Detached dwellings are also now in evidence within 100m to the west and southwest.
