**The Thatched Cottage,
Bradfield,
Essex**

Historic Building Record

The Thatched Cottage, Wix Road, Bradfield, Essex

Heritage Asset Assessment

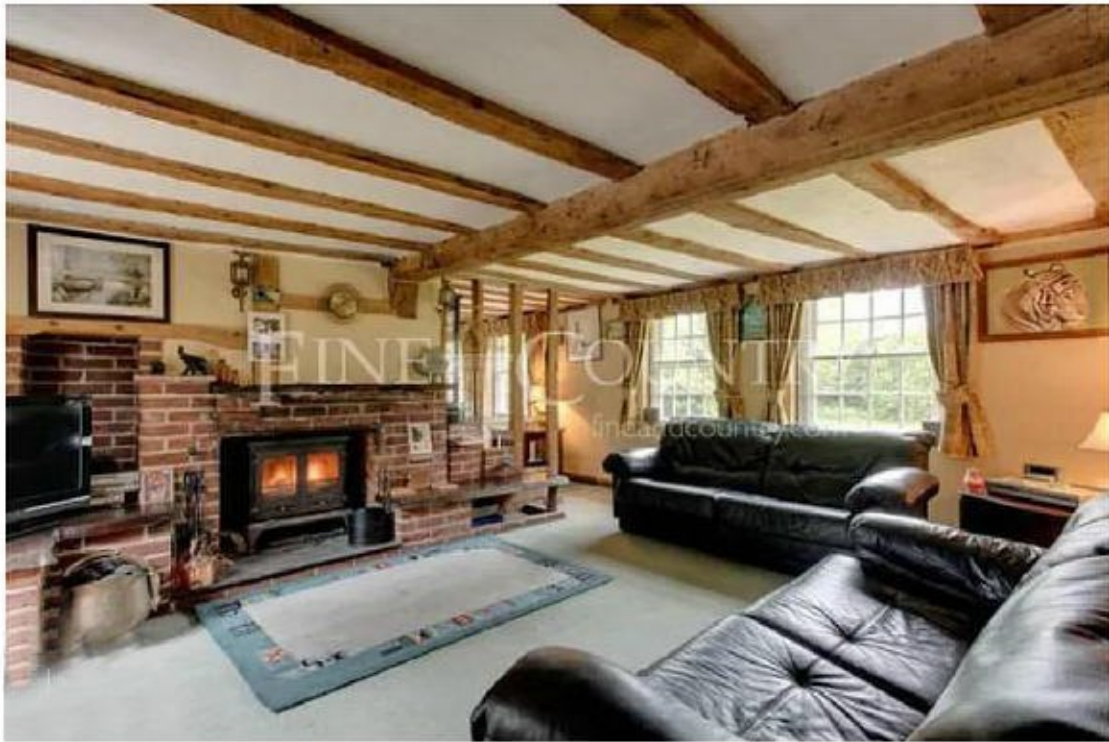
Figure 9a

The central lounge, as labelled in figure 12, showing the modern fireplace in the original chimney to the south-east. From the sales particulars of 2016. Compare illustration 7. The lower storey survived the fire largely undamaged.

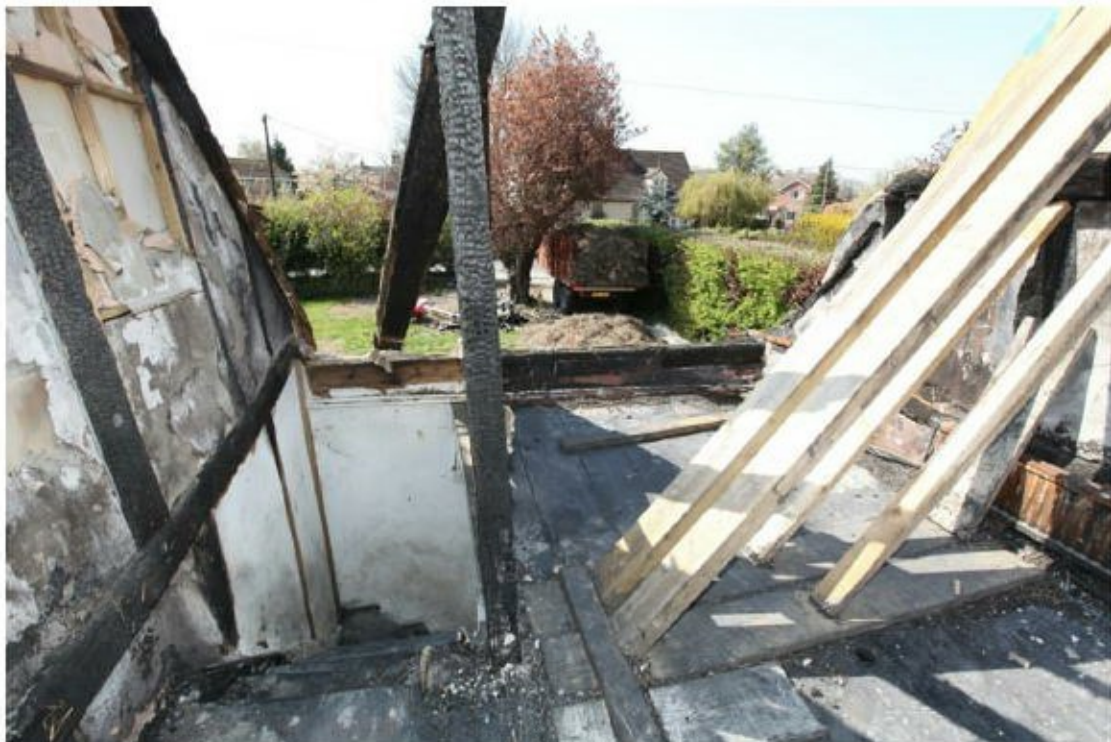
Illus. 22. The 19th century stair landing in the service chamber looking south-west with the half-hipped gable on the right. The right-hand half of the roof-plate is original but is hidden by later boarding and has been replaced with a new oak timber on the left.

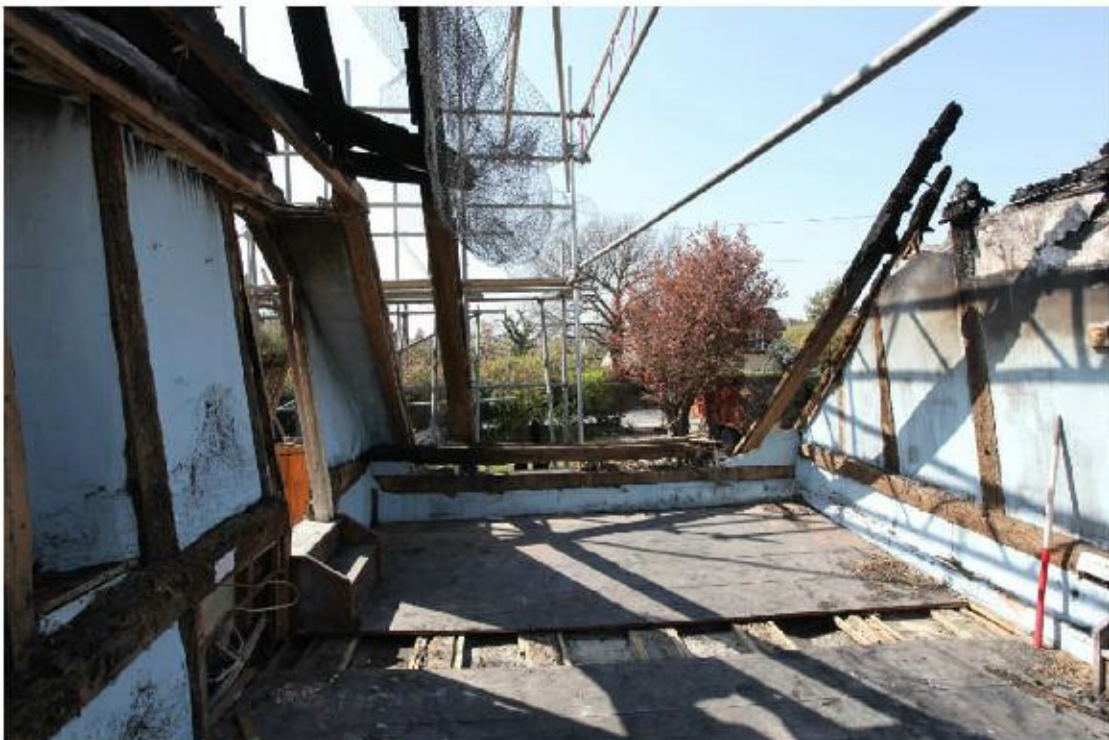
Illus. 28. The central hall chamber showing the largely intact, fully framed partitions of the probable parlour bay and service bays to the right and left respectively. The modern softwood floorboards are laid directly onto the ground-floor ceiling joists with plasterboard infill. The south-western roof-plate in the rear has been entirely renewed in modern oak.

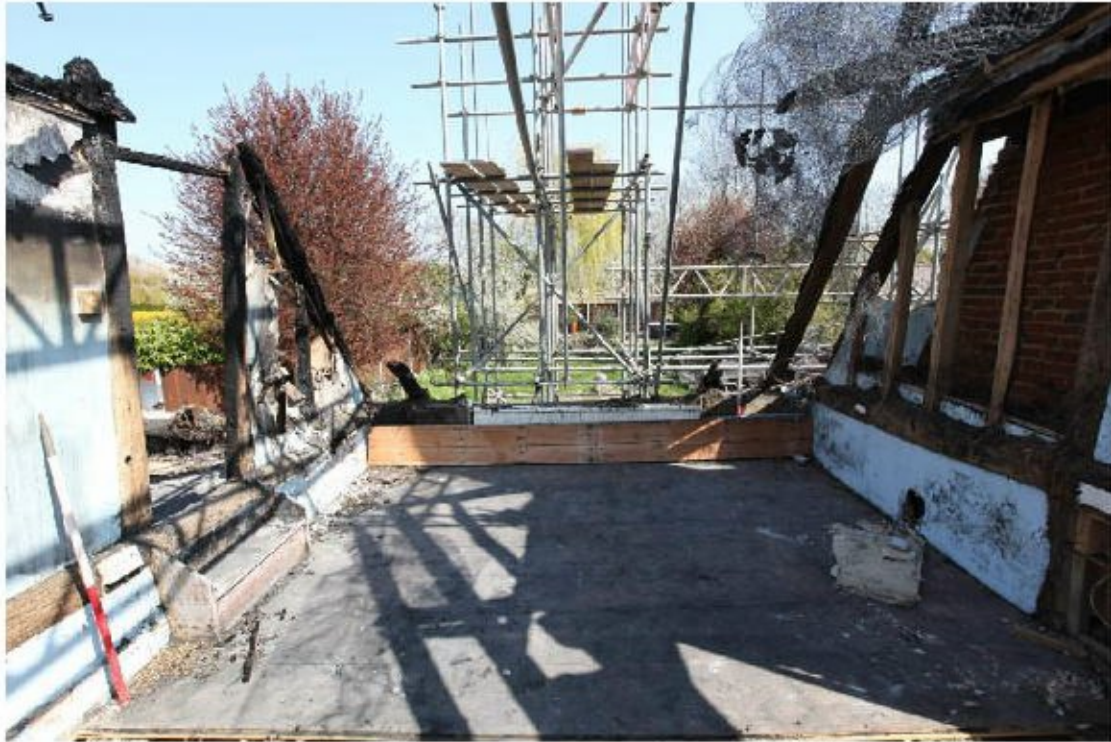
Illus. 29. The central hall chamber from the south-west showing the rear roof-plate which, like its front counterpart, has been completely renewed in modern oak.

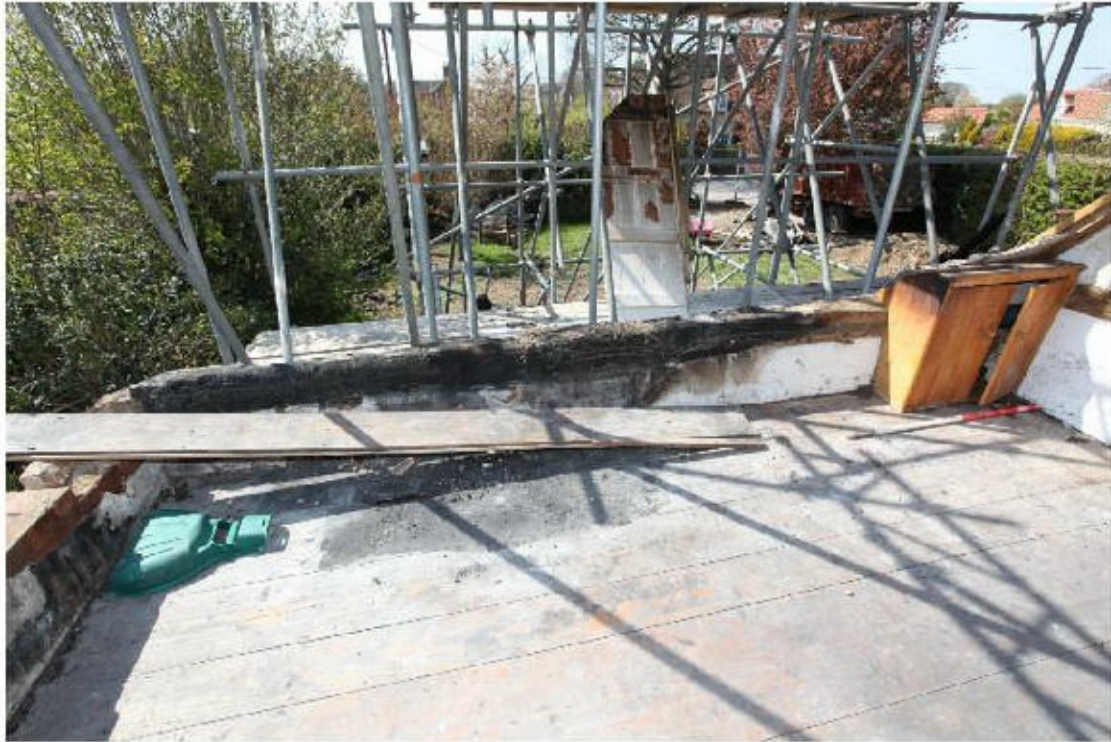
Illus. 33. The south-western roof-plate of the south-eastern bay with the gable to the left. This timber contains some pegged mortices for original studwork, albeit charred and difficult to identify, but now rests on 19th century brickwork. A dovetail joint for a missing tie-beam that flanked the original chimney is visible to the left of the modern cupboard on the right.
