MASONRY DAMP INVESTIGATION OF LOWER GROUND FLOOR AT 7 WIMPOLE STREET

JOB NO. 153.75

20 APRIL 2021

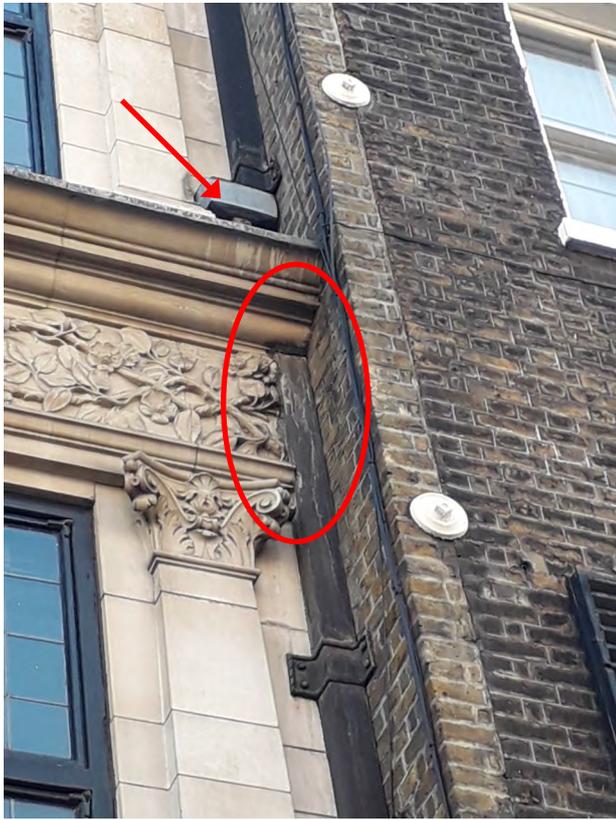
Fig 1:

- 1 Roof drainage: The parapet gutter below the mansard roof was served by 2 square section downpipes at the north and south ends of the elevation. These were in fair condition but surface 'streaking' on the south downpipe, immediately below the drip course above the first-floor windows, indicated intermittent escape of water, possibly from a hopper serving sanitary facilities on the interior mounted immediately above the drip course moulding. Downpipes passed through the pavement structures and bypassed the access staircase to the lower ground floor area and discharged below ground level. Adjacent to the entrance doorway the north downpipe was deformed, consistent with intermittent physical impact, which may reduce the downpipe capacity and increase the risk of blockage and overflow on future occupancy

West elevation, upper south side; showing 'streaking' on downpipe surface indicating intermittent escape of water from the roof drainage system and a hopper linked to the downpipe serving sanitary facilities on the interior

H+R assume that the roof drainage system will be extensively overhauled on proposed refurbishment. Consideration should be given to repair or replacement of the damaged section of the north downpipe at upper ground level and for possible introduction of access eyes for inspection and maintenance. H+R also assumed that the secondary waste drainage systems associated with multiple sanitary facilities on the interior will be removed on proposed refurbishment. If additional sanitary connections are made to the mixed drainage system, these should be installed fully in accordance with Building Regulations and local authority bylaws and provided with adequate access for routine inspection and maintenance on future occupancy

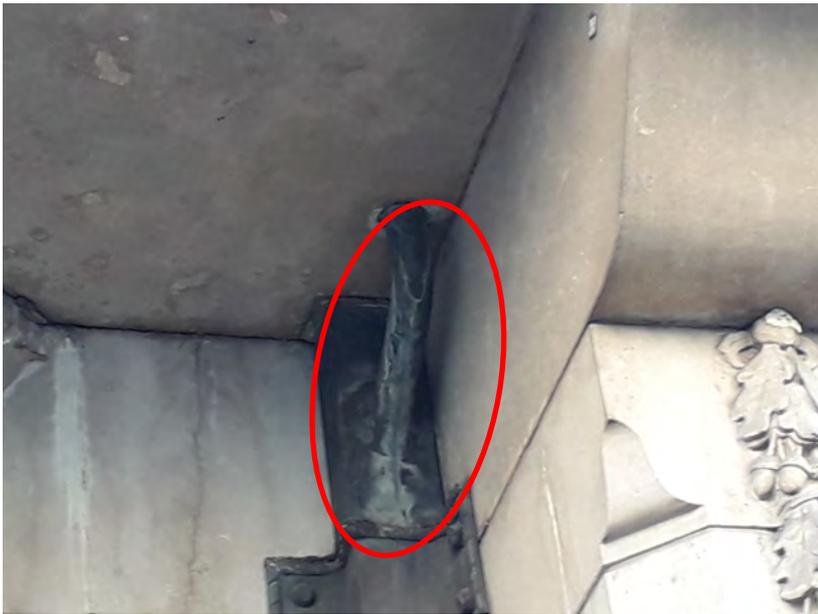
Fig 2:

West elevation, south side; showing connection between small diameter drainpipe serving the first-floor balcony and the south downpipe. Note streaking on the small diameter pipe surface which may indicate water draining around the pipe from the balcony, indicating obstructed drainage and an increased risk of surface water draining into the structure

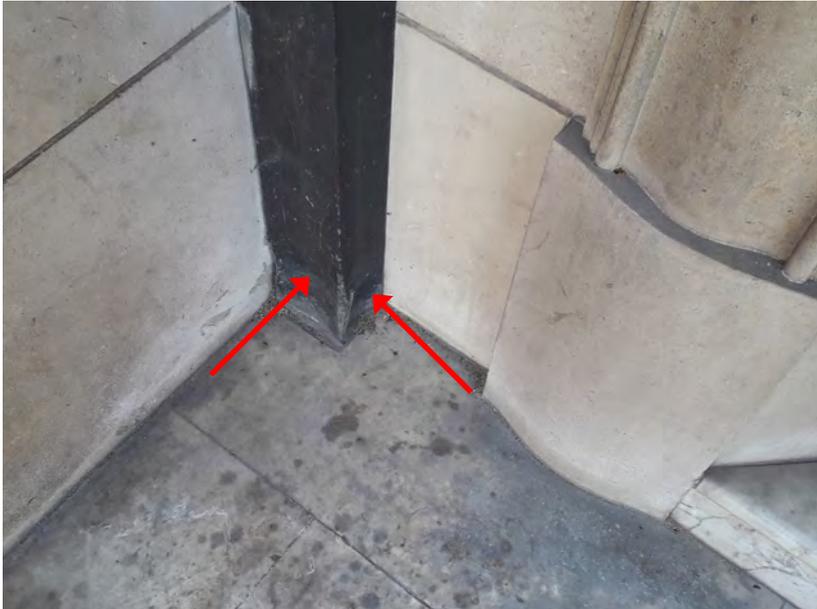
Fig 3:

Upper ground floor, west elevation, north side; showing indentations in the box section downpipe, restricting the rainwater pipe cross section area and increasing the risk of blockage and overflow

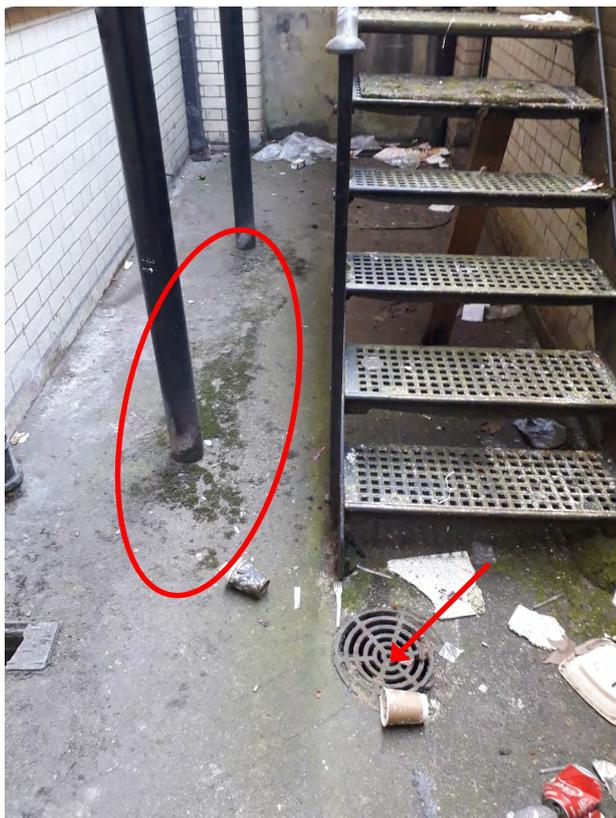
Fig 4:

West 'area' at lower ground floor level; showing surface drain serving hardstanding free of significant obstructions. Note biological growth on the hardstanding surface below the upper ground floor bay window structure, where water drained from the façade above onto the area concrete paving

All below ground pipework serving surface drains should be inspected in detail, using CCTV as required and allowance should be made for all necessary cleaning, repair and upgrading to ensure that surface water is drained clear of the masonry and foundations of the structure at all times. The drainage system should be re-inspected and certified as free of damage or obstruction on completion and handover

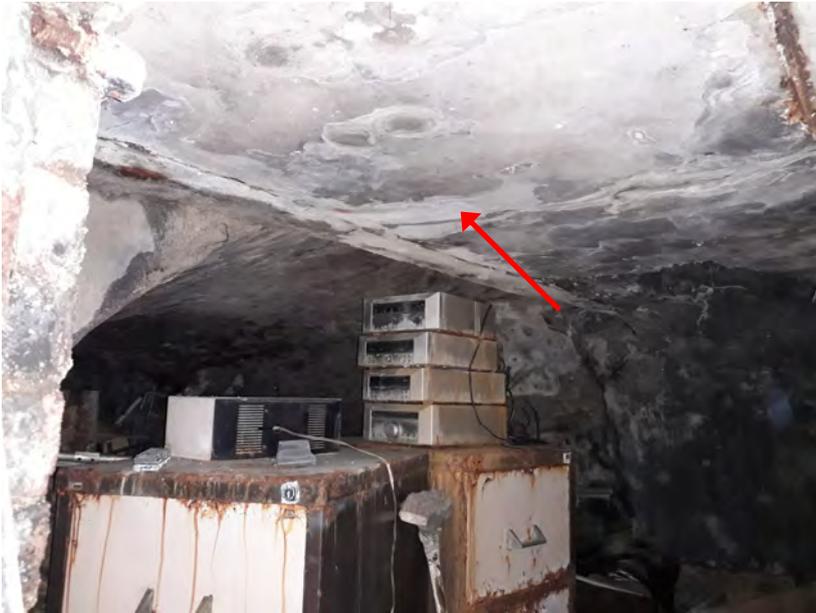
Fig 5:

- 4 Vaults on west side: The central and north-western vaults had been partially 'tanked' with a cementitious render waterproofing system on a previous refurbishment. This system also extended across the vaulted section of the south-west vault and the horizontal soffit of the lobby to the central vault and WC. Cement render showed extensive surface efflorescence of hygroscopic salts and evidence of water from below ground draining through cracks and other defects, indicating that the existing waterproofing system was approaching or had exceeded the end of its service life. Exposed brickwork on the south side of the south-west vault was patently damp, where water appeared to be draining into the vault around the bearing end of a steel joist supporting the footway above. The joist was extensively corroded which may have reduced its strength

West elevation, north-west vault; showing progressive failure of the cementitious waterproofing system installed on a previous refurbishment

Allowance should be made for inspection of steel joists and other structural lintels etc. by a suitably qualified Structural Engineer. Subject to the proposed use of the vaults on future occupancy, provisional allowance should be made for installation of a fully detailed drained cavity waterproofing system, discharging to a sump equipped with duplex pumps and control switches, possibly located externally in the west 'area'. If the vaults are to be used solely for refuse storage, storage of items not vulnerable to moisture or condensation or as non-electrical plant rooms, it may be adequate to provide grade 2 waterproofing as described in BS 8102:2009. Works may include treating walls with a suitable salt resistant and vapour permeable decorative finish as directed by the Architect, providing adequate through and cross ventilation for the control of airborne moisture and condensation and the installation of floor drains. H+R can provide further advice on remedial detailing if required

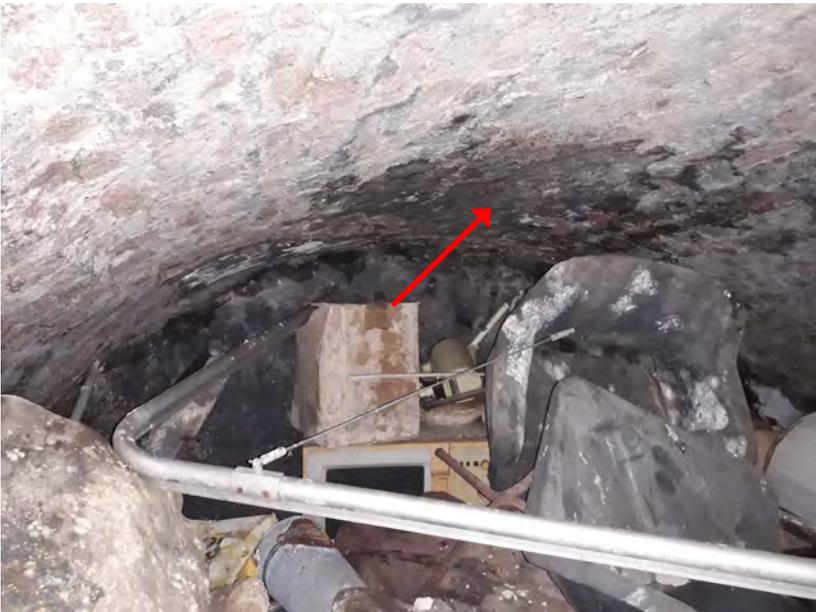
Fig 6:

West elevation, north-west vault below street level; showing exposed brick vaulted ceiling in fair condition, with evidence of intermittent water penetration through the structures above

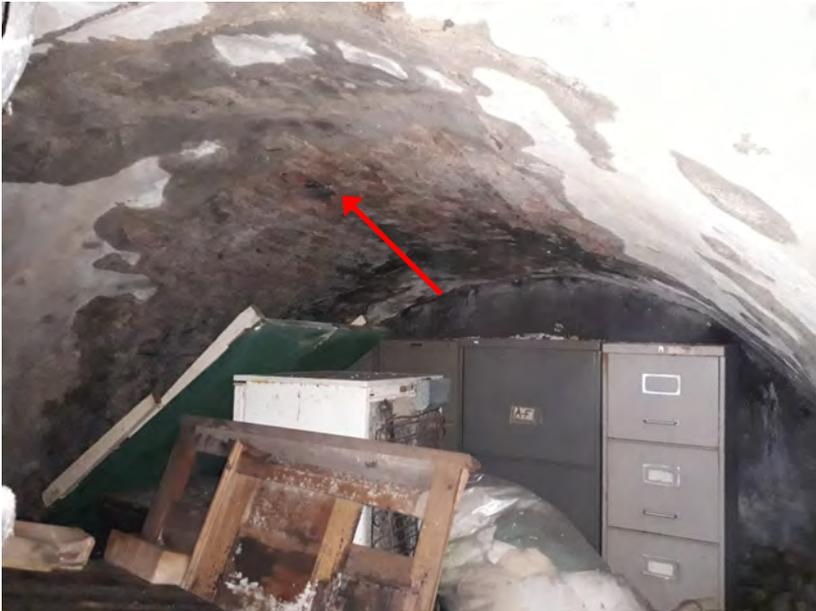
Fig 7:

West elevation, central vault below roadway; showing widespread damp staining where the cementitious waterproofing render applied on previous refurbishment had fallen away at the centre of the roof profile

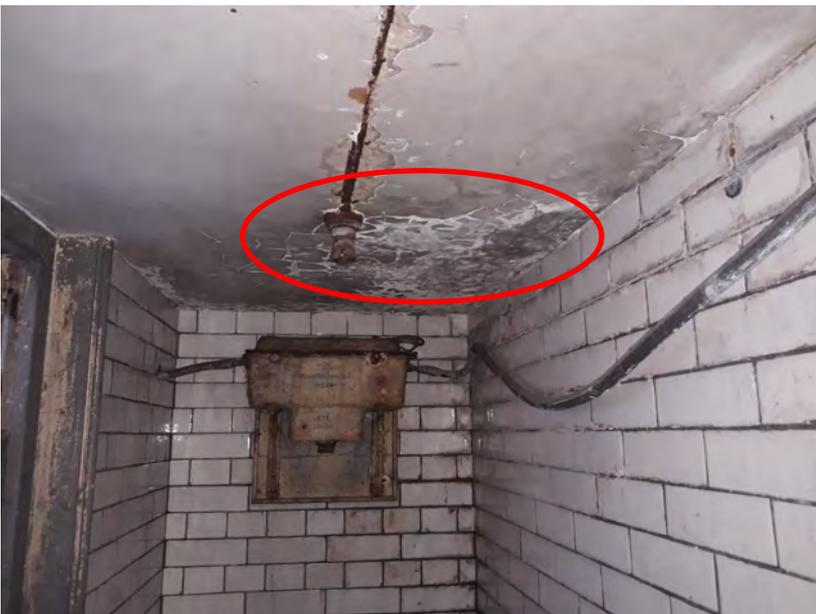
Fig 8:

West elevation, WC below street paving; showing salt efflorescence and staining to ceiling finishes, indicating progressive failure of the cementitious waterproofing system installed on previous refurbishment

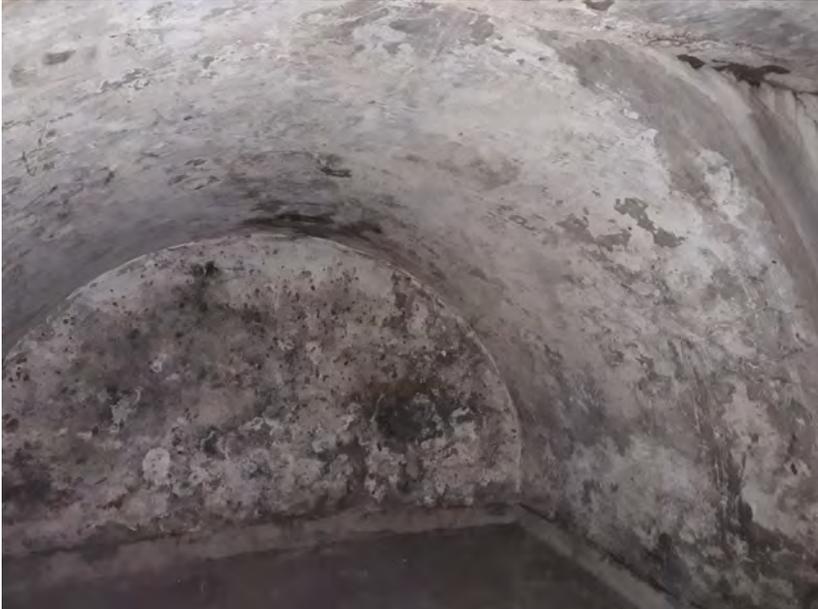
Fig 9:

West elevation, south-west vault below paving; showing progressive failure of the cementitious waterproofing system, with extensive surface efflorescence of hygroscopic salts

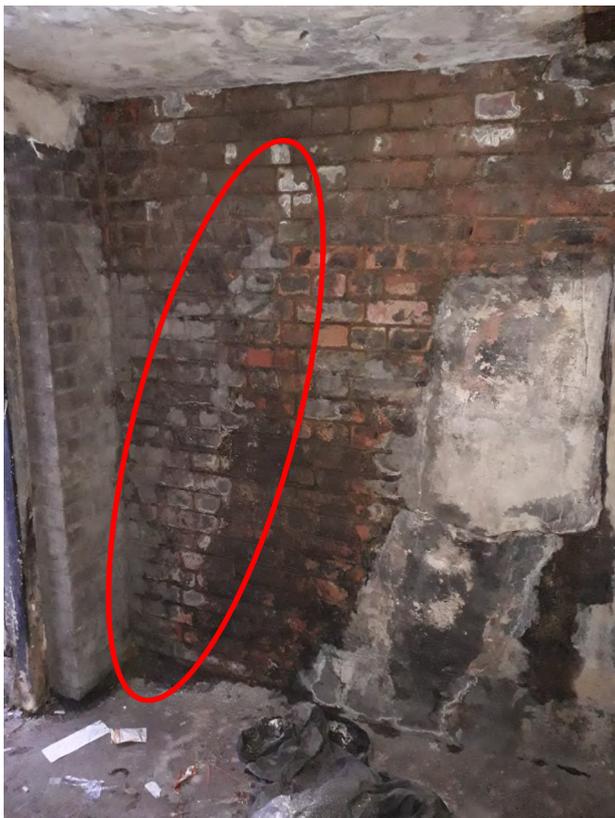
Fig 10:

West elevation, south-west vault below paving, south side; showing patently damp brickwork and salt efflorescence at the brickwork 'drying band', where water was draining through the structure at the wall/ceiling junction

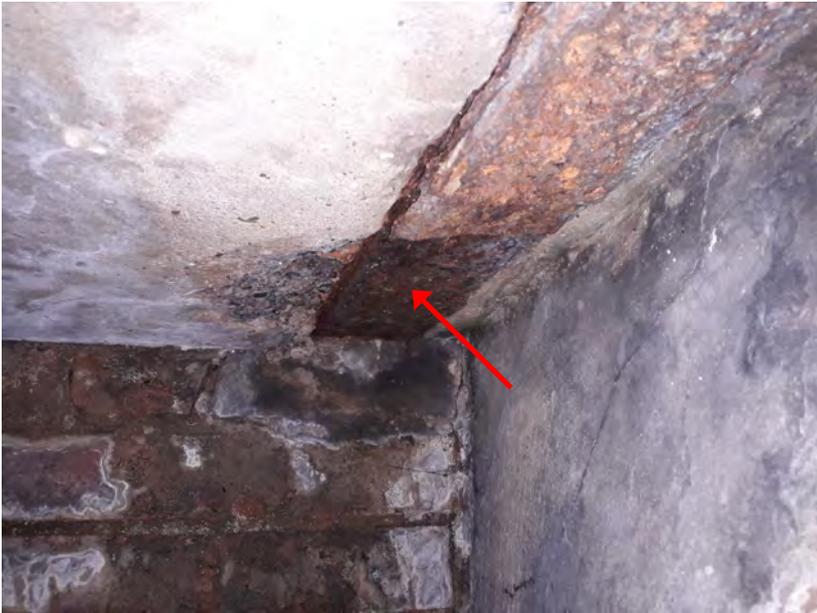
Fig 11:

West elevation, south-west vault below paving; showing south bearing end of typical steel joists supporting ceiling structures and paving above. The degree of corrosion to the steel components may be structurally significant

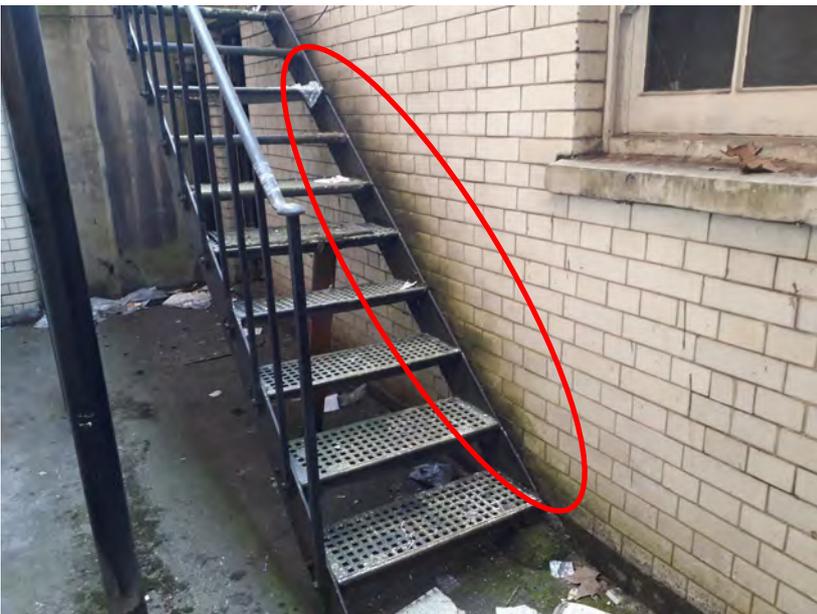
Fig 12:

West side of lower ground floor 'area' on west side; showing biological growth colonising wall finishes, where rainwater was focused onto structures by the open tread access stair

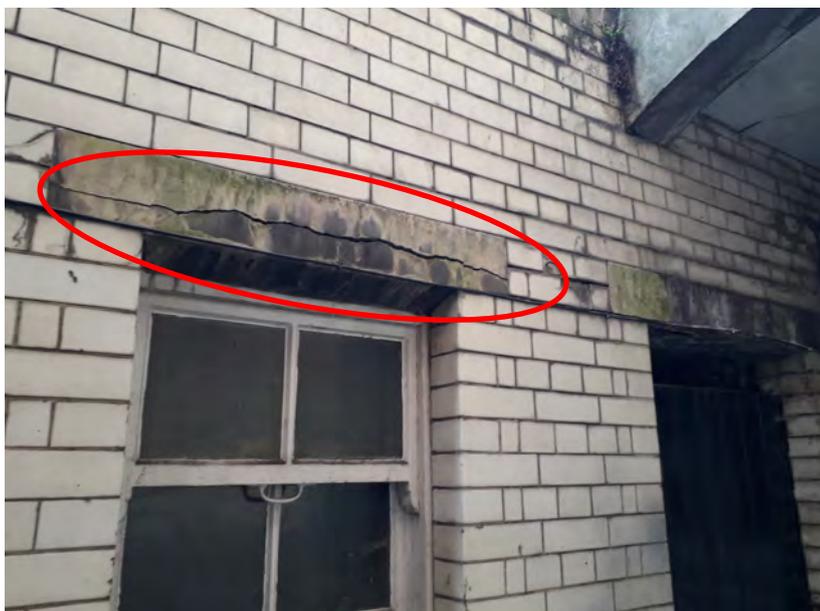
Fig 13:

Lower ground floor, area on west side; showing cracks in lintels and masonry above the door and window heads to the vaults and WC below paving to the west. These defects were allowing surface water to drain into masonry and may be structurally significant

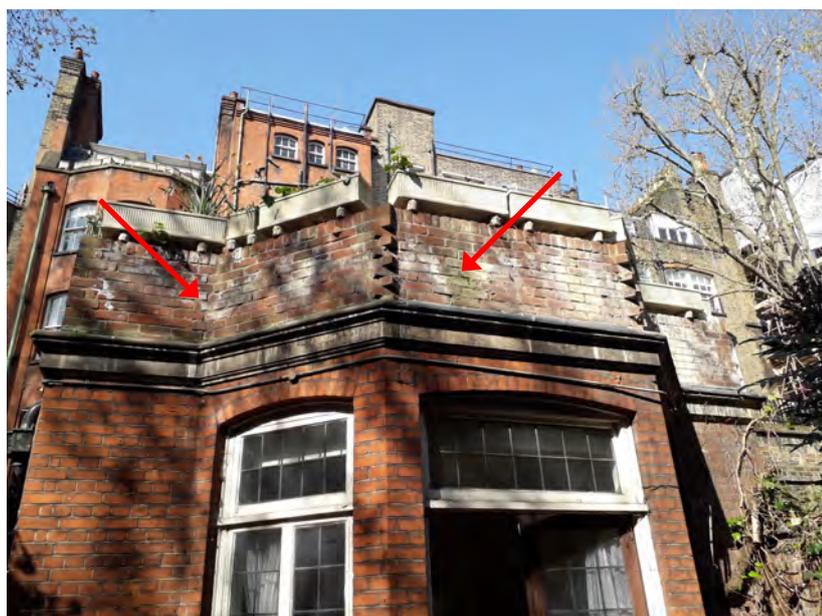
Fig 14:

East elevation; showing parapet wall to east extension affected by biological growth and surface deposition of soluble minerals and salts

If the raised parapet walls towards the east of the east extension are to be retained on proposed refurbishment, consideration should be given to re-detailing them with projecting copings and damp-proof courses as present elsewhere. Retained copings should be refurbished, raking out loose material from joints and replacing in a suitable lime mortar mix

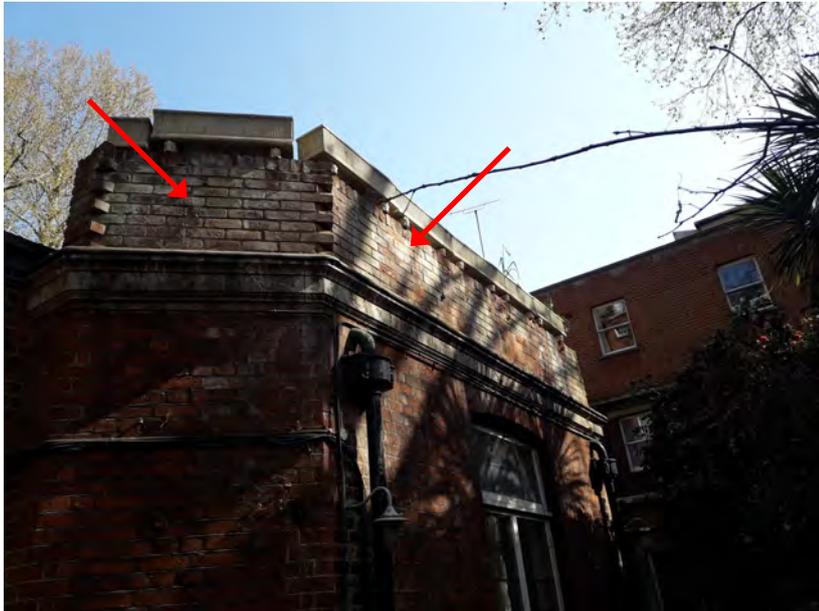
Fig 15:

East elevation, south side of east extension; showing parapet wall masonry, assumed to have been added on a previous refurbishment, affected by intermittent water penetration and the surface deposition of soluble minerals and salts

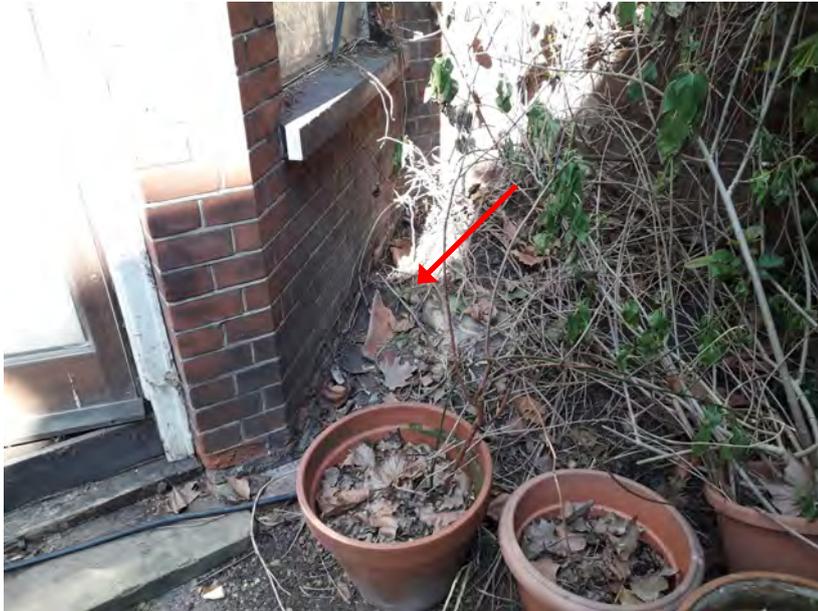
Fig 17:

East side of east extension, to north of entrance doorway; showing raised external ground levels bridging the horizontal damp-proof course and increasing the risk of the damp penetration to the interior

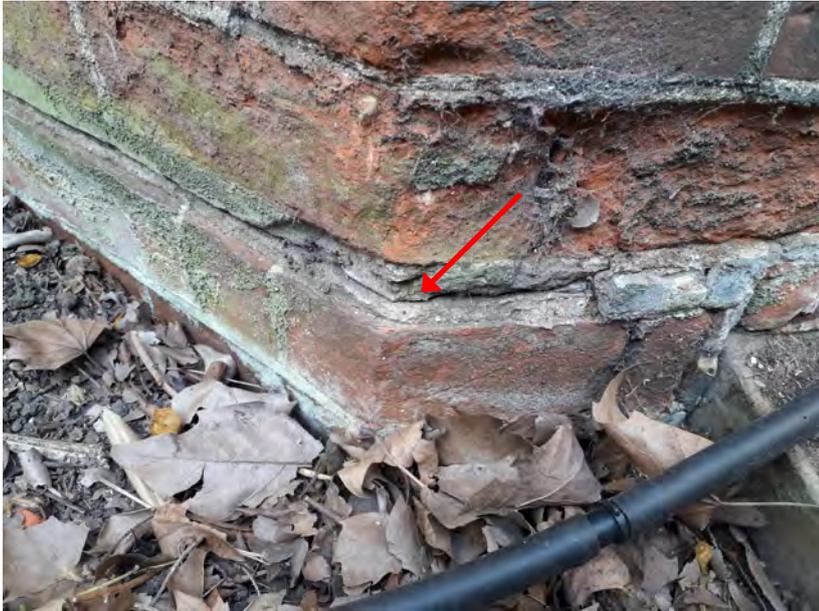
Fig 19:

East extension, east side; showing multiple slate horizontal damp-proof course exposed adjacent to the entrance doorway. Note surface erosion of brickwork above the dpc following intermittent saturation and the action of frost

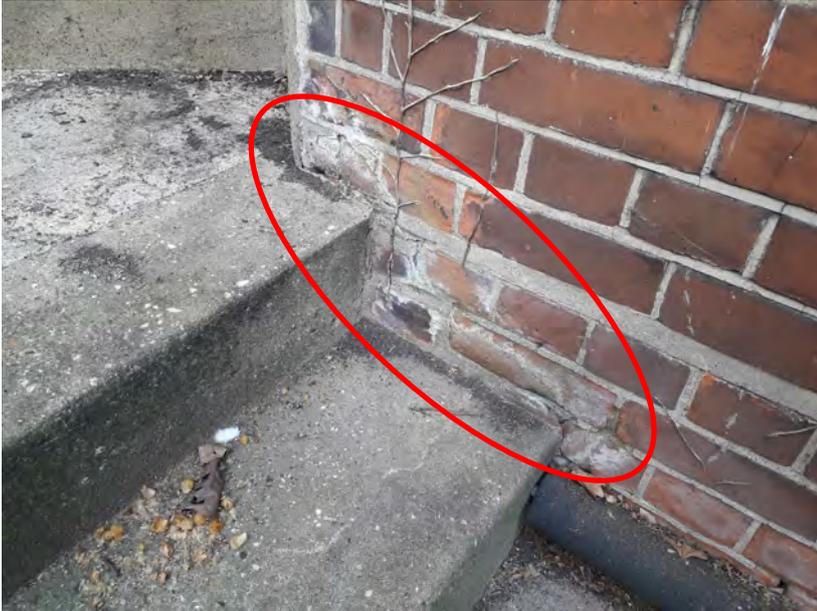
Fig 21:

East extension, south side; showing steps up to a raised walkway reaching the level of the dpc, increasing the risk of surface water draining into brickwork above. Note surface efflorescence of hygroscopic salts on brickwork, consistent with intermittent water penetration

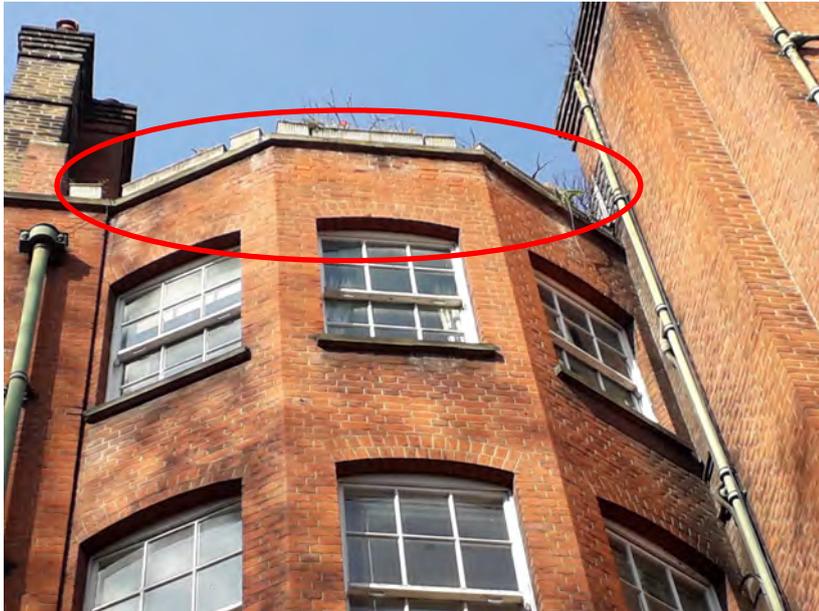
Fig 23:

East elevation at high level; showing salt efflorescence affecting brickwork below the copings of the bay window terrace. Copings were in poor conditions with open joints allowing surface water to drain into the structures beneath

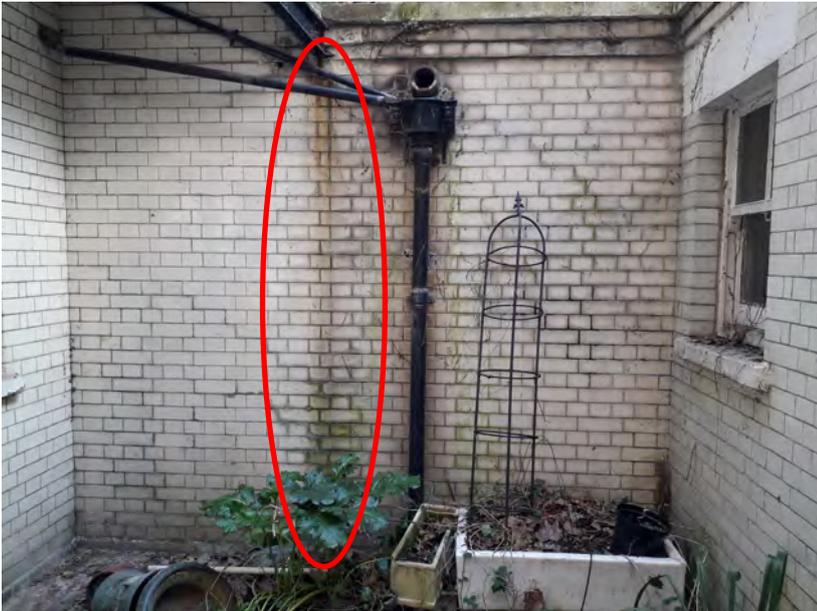
Fig 25:

Lower ground floor east courtyard, east side; showing staining and biological growth to glazed brick surfaces where water had drained over the façade from ground level above

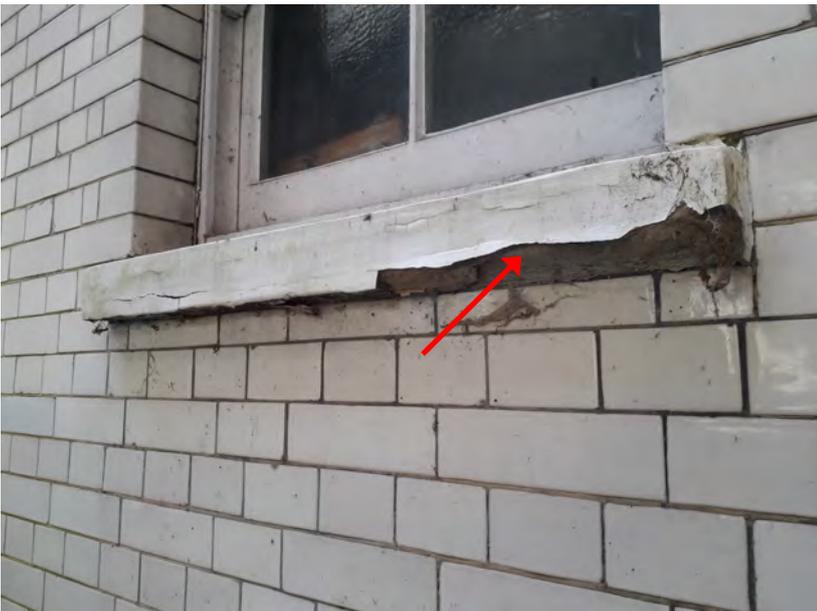
Fig 26:

Lower ground floor courtyard on east side, central window to south; showing damage to the external sill profile, allowing surface water to drain into structures beneath the window opening

Allowance should be made for insitu repair or replacement of damaged external masonry sills and for reinstatement of effective drip rebates, to throw surface water clear of structures below window glazing and openings. The provision for roof drainage at the south-west corner should be modified to include a gutter on the north side of the flat roofed area, to prevent surface water draining onto hardstanding at the base of the wall and splashing back onto the façade

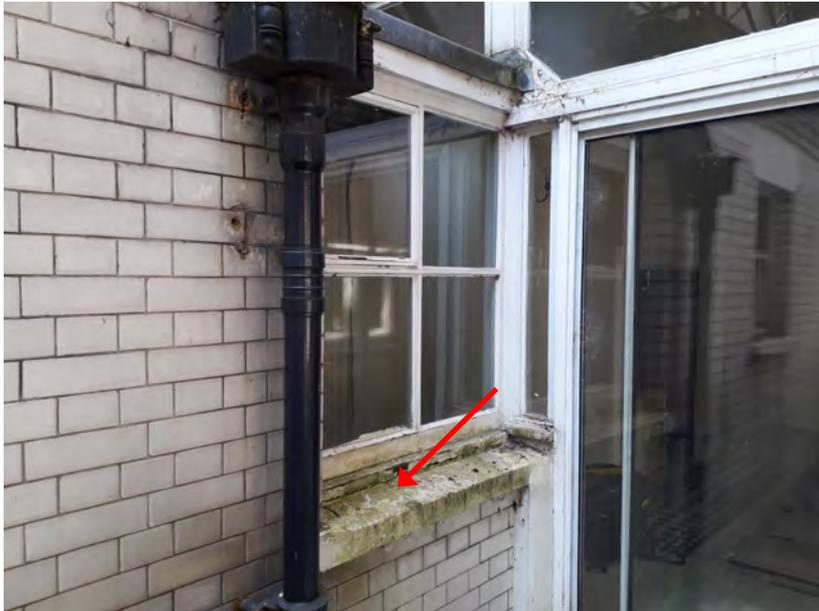
Fig 27:

Lower ground floor east courtyard, west side of south wall; showing biological growth on window sills where water drained from the edge of a small flat roof immediately above. See fig.24

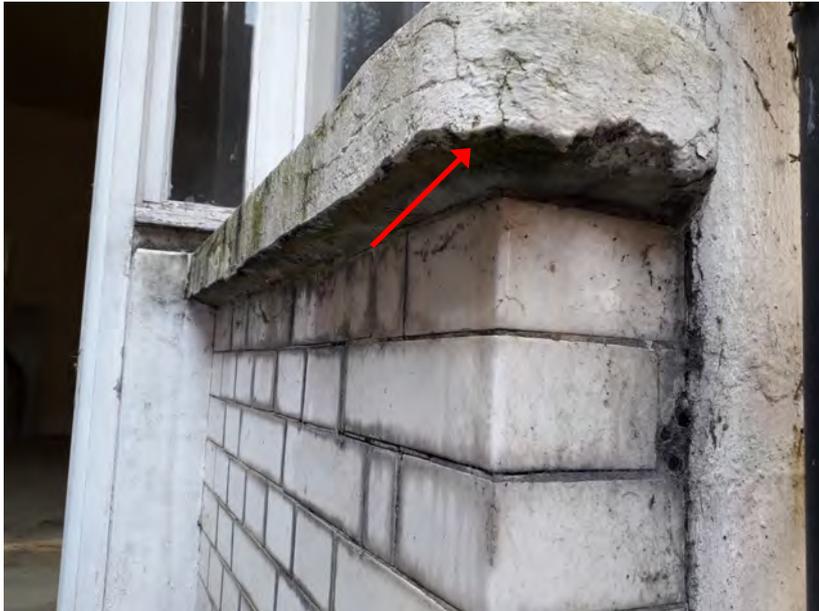
Fig 29:

Lower ground floor east courtyard, north-west corner; showing erosion of drip profiles to external masonry sills, allowing surface water from glazing to drain into structures beneath

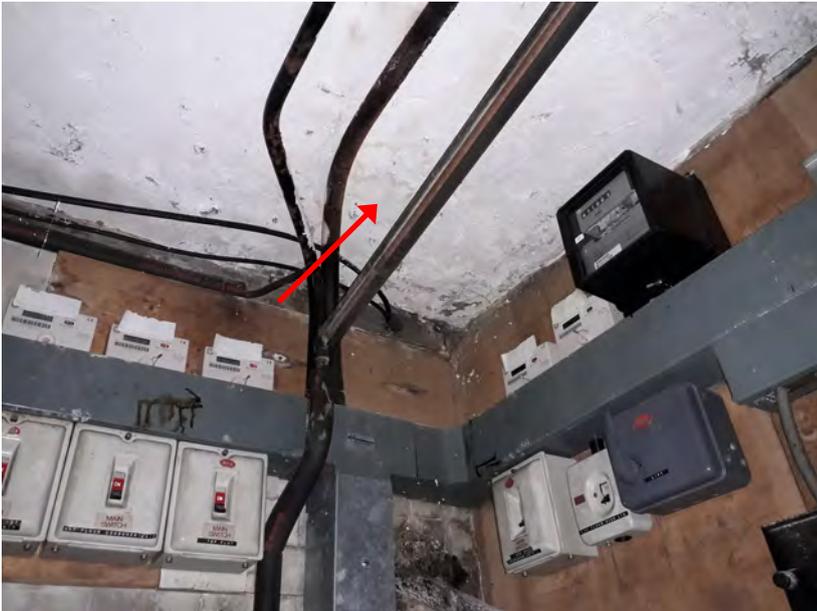
Fig 31:

- 1 Electrical inlet room: Salt efflorescence and failure of decorative finishes were noted on the ceiling of the electrical inlet room to the north-west. This was consistent with cold-bridge condensation through the structure giving access to the main entrance doorway at upper ground floor level

Lower ground floor, north-west corner; showing salt efflorescence and failure of decorative finishes applied to the soffit of the electrical inlet room, where a cold-bridge was likely to be present to the exterior, supporting intermittent surface condensation

No urgent remedial works are required, subject to the general specification for refurbishment. Adequate ventilation should be provided throughout the lower ground floor for the control of airborne moisture and condensation

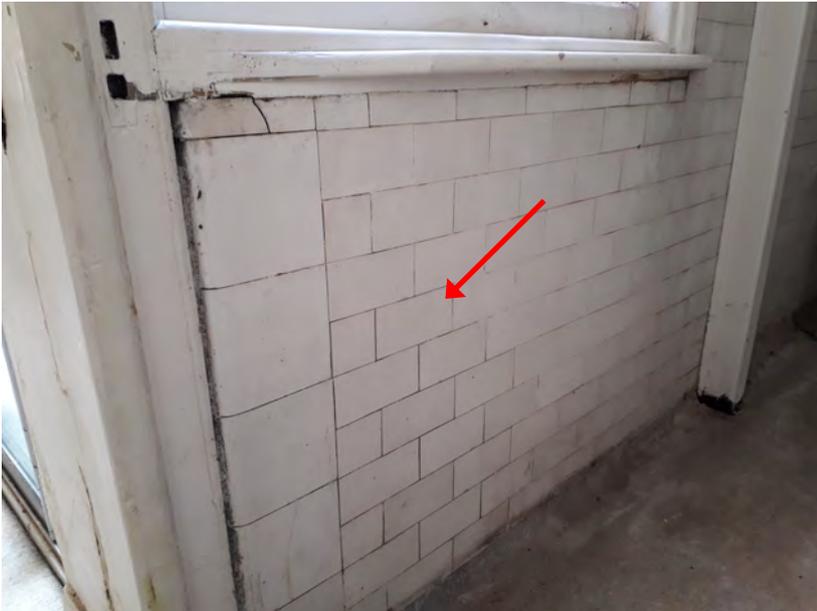
Fig 33:

Lower ground floor, service corridor to south-east; showing generally good condition of historic tiled finishes to external wall illustrated in fig.28 above. The structure behind the tiles was vulnerable to water penetration following the failure of the provision for roof drainage and bridging of the physical damp-proof course by raised external ground levels

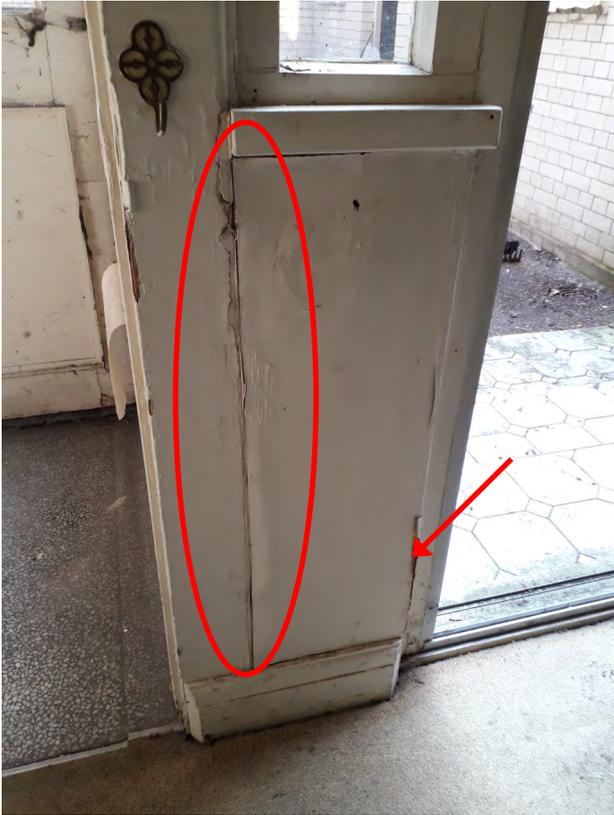
Fig 35:

- 2 South east room of main house: Staining and salt efflorescence were observed, affecting decorative finishes adjacent to the doorway leading to the east lower courtyard, where bridging of the horizontal dpc and defects in external drainage systems had created damp conditions in masonry locally. Some lining papers adjacent to the doorway had also blistered and lifted from the substrate on the west side, indicating damp conditions in the structures behind

Lower ground floor, south-east room in main house; showing salt efflorescence damage and staining to the north of the French doors to the exterior, consistent with defective external drainage and bridging of the horizontal dpc

Works described elsewhere in this report should be undertaken to restore the effectiveness of the existing horizontal wall dpc and to repair external drainage systems. Damp affected walls in the south-east room of the main building should be stripped of existing finishes to allow detailed inspection of the masonry behind, taking care to avoid impact and vibration damage to the historic tiling in the corridor on the south side. Allowance should be made for installing ventilated dry linings over exposed masonry, based on vertical studded plastic isolating membranes, to protect vulnerable materials and finishes during and after refurbishment. Details provided by the Architect, approved by H+R and similar to those included at Appendix D should be used throughout. H+R can provide further advice on remedial detailing if required

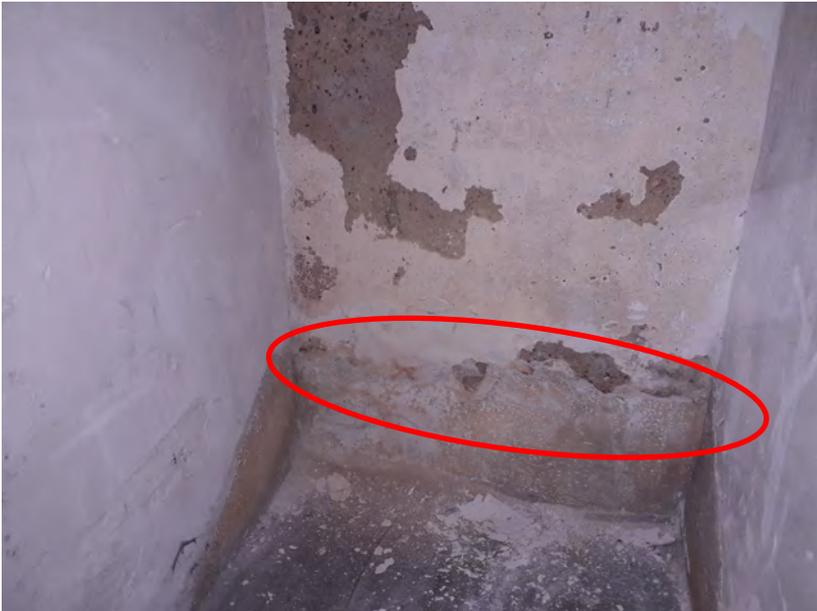
Fig 37:

- 4 Wine store on north side: Wall surfaces were extensively eroded at the base of the north wall, which was assumed to be shared with the neighbouring property. Damage was consistent with chronic moisture migration from below ground to the wall surface and the effects of intermittent interstitial condensation during and since previous occupancy. The wine store was unventilated and this would have increased the risk of intermittent condensation where warm moisture laden air from other parts of the property tended to migrate to under ventilated and less frequented areas, including the wine store and other ancillary spaces of the lower ground floor

Lower ground floor, wine cellar on north side; showing damage consistent with interstitial salt efflorescence at low level in the north-east corner, with widespread detachment of film-forming paint finishes from the breathable lime render substrate

No urgent remedial works are required. No chemically injected horizontal damp-proof courses or cementitious render tanking systems are required or recommended. Allowance should be made for through and cross ventilation of all habitable rooms, service spaces and enclosed voids on future occupancy, as directed by the Architect, for the effective control of airborne moisture and condensation. The use of film forming paint systems should be avoided on masonry which is vulnerable to historic damp

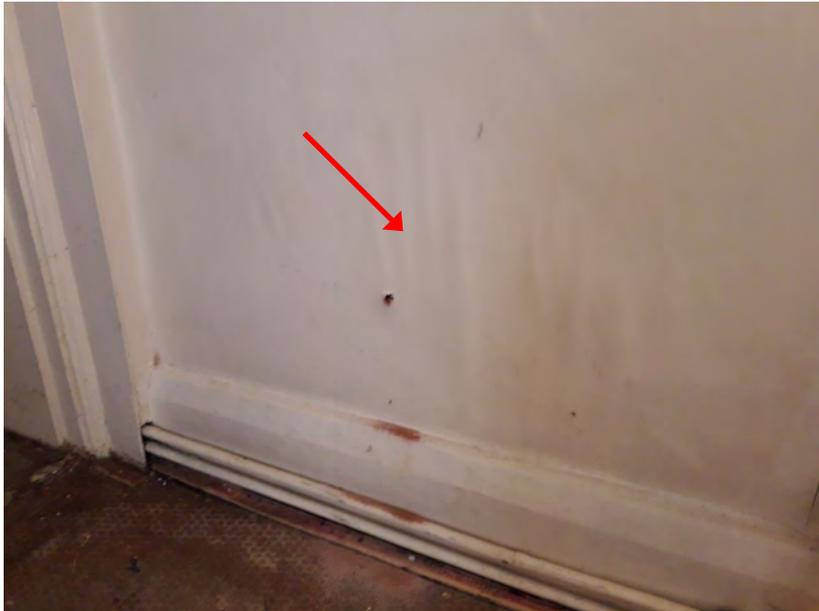
Fig 39:

- 3 East room below east wing: Wall lining papers had blistered and fallen away on the north side. Exposed plaster was wet to the touch and masonry behind was found to contain surplus residual moisture on analysis of samples, as described at Section 3.3. below

Lower ground floor, east room of east wing/extension; showing blistering of decorative wallpapers where excess residual moisture was present in the wall behind and there was a vulnerability to intermittent condensation

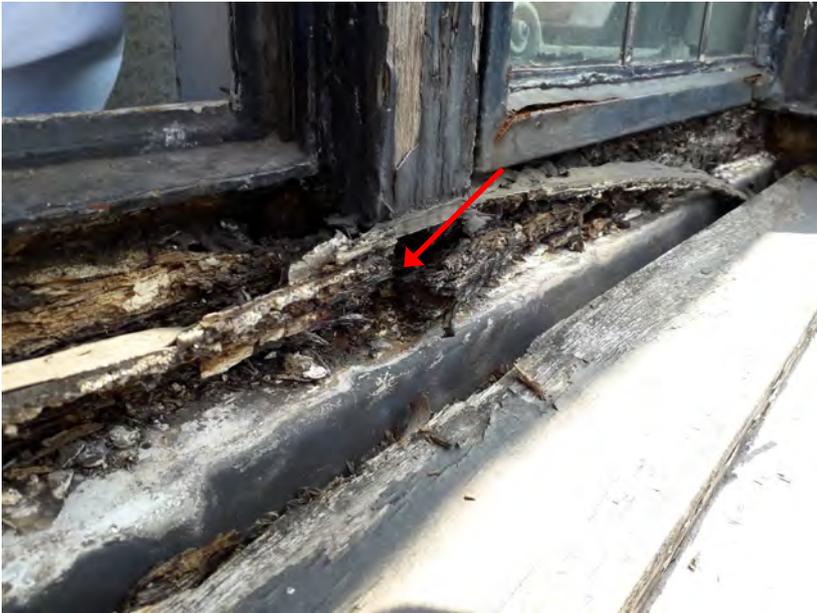
Fig 41:

Exterior of window opening shown in fig. 40 above, with external sill profile detached and decayed, allowing water penetration

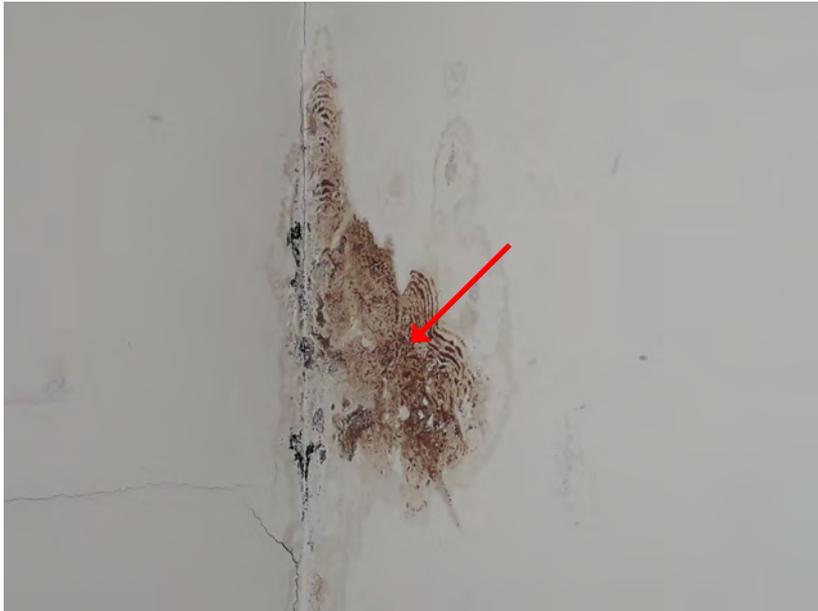
Fig 43:

Staircase between third and fourth floors, south-east corner; showing staining to decorative finishes, consistent with damp penetration and the action of decay organisms

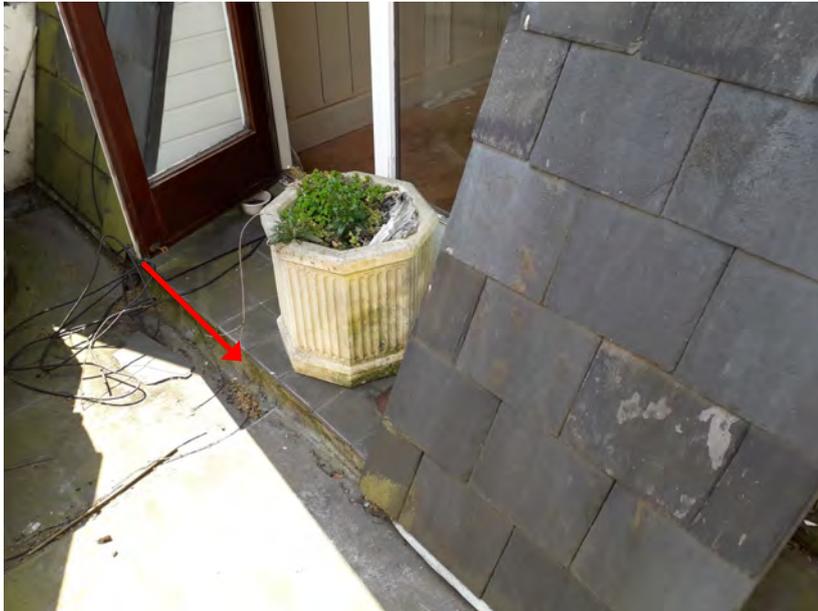
Fig 45:

Fourth floor, south-east room; showing structures likely to be allowing water penetration above the damaged ceilings illustrated in fig. 44 above

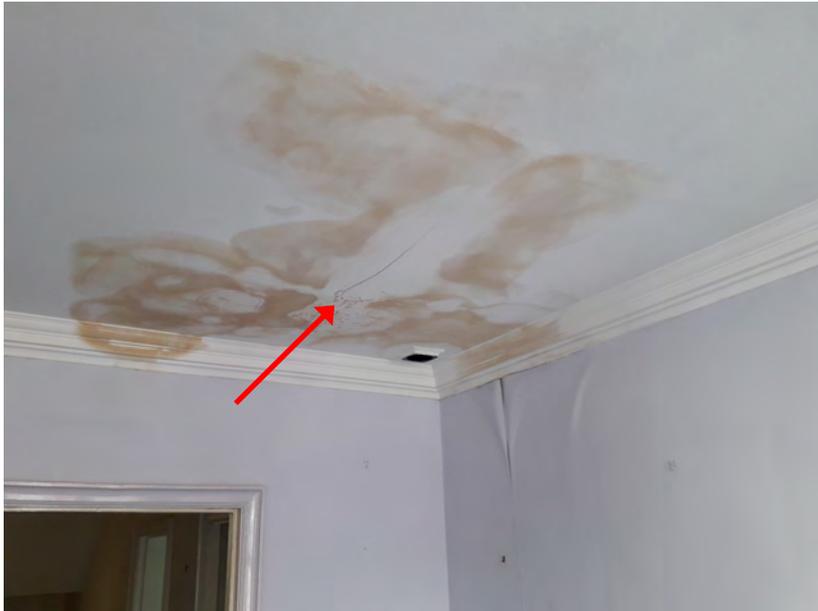
Fig 47:

Third floor, north-west room; showing stained and detached ceiling linings, consistent with escape of water from plumbing systems on the floor above

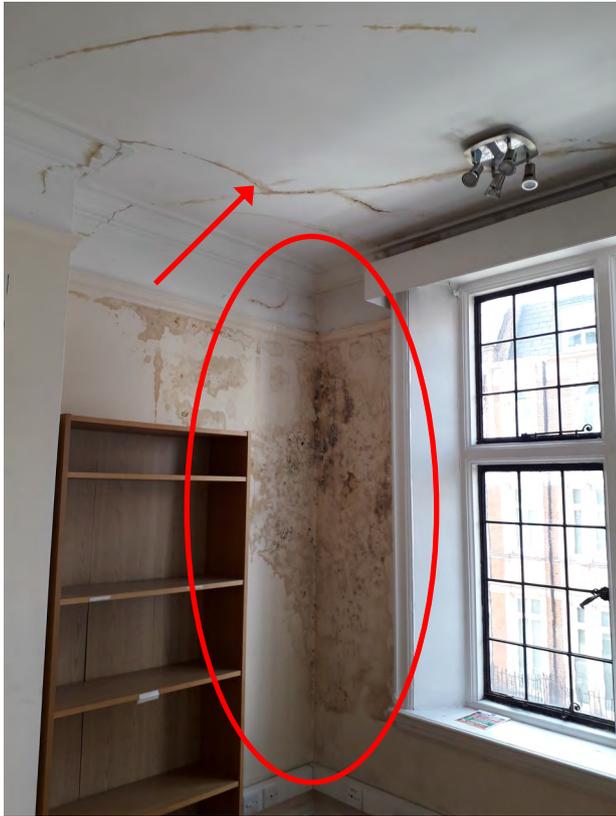
Fig 49:

Second floor, south-west corner; showing staining and discoloration of paint finishes, with mould growth on wall surfaces consistent with water penetration following failure of provision for roof drainage on the exterior, or escape of water from building services on the floor above

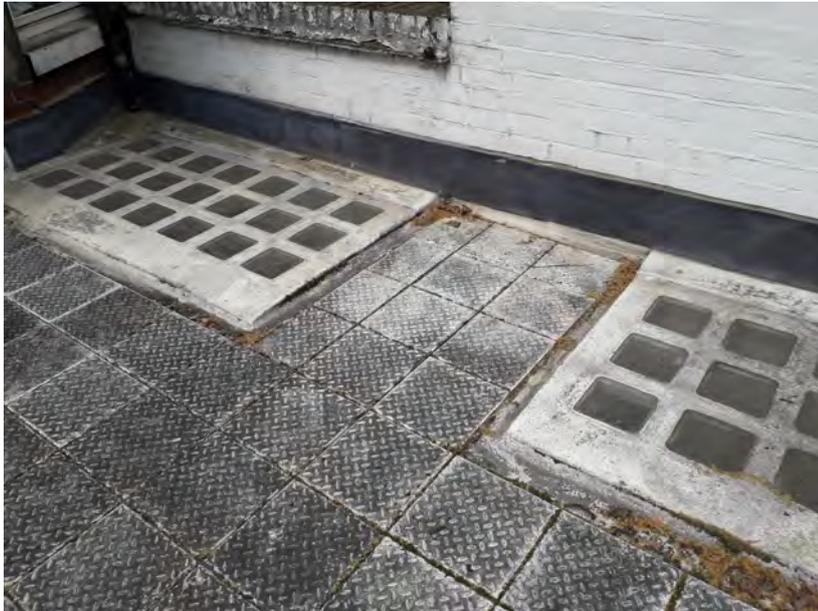
Fig 51:

East terrace at first floor level, north side; showing asphalt waterproofing around concrete framed glazed skylights, where damage associated with water penetration was identified below

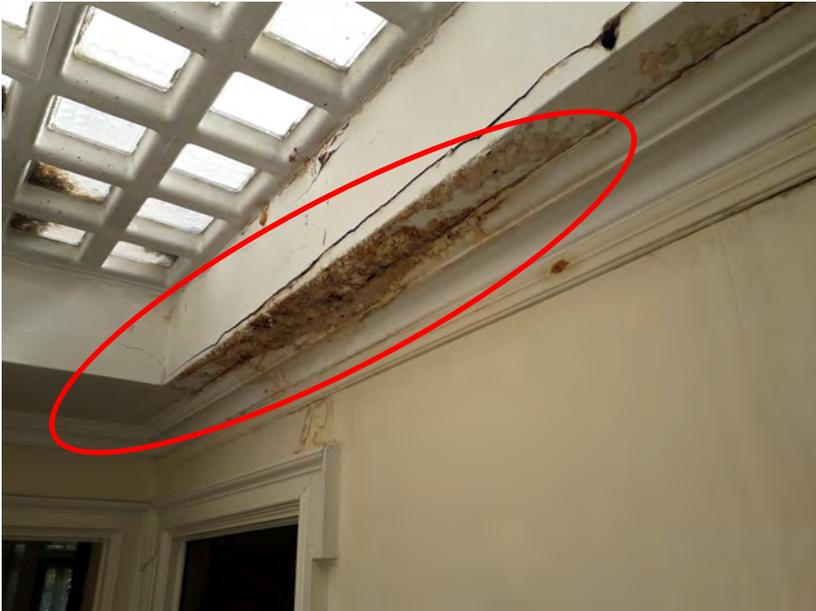
Fig 53:

Ground floor, east corridor; showing damage to decorative finishes and plaster around the concrete framed skylight shown in fig. 51 above, consistent with intermittent water penetration through the terrace waterproofing system

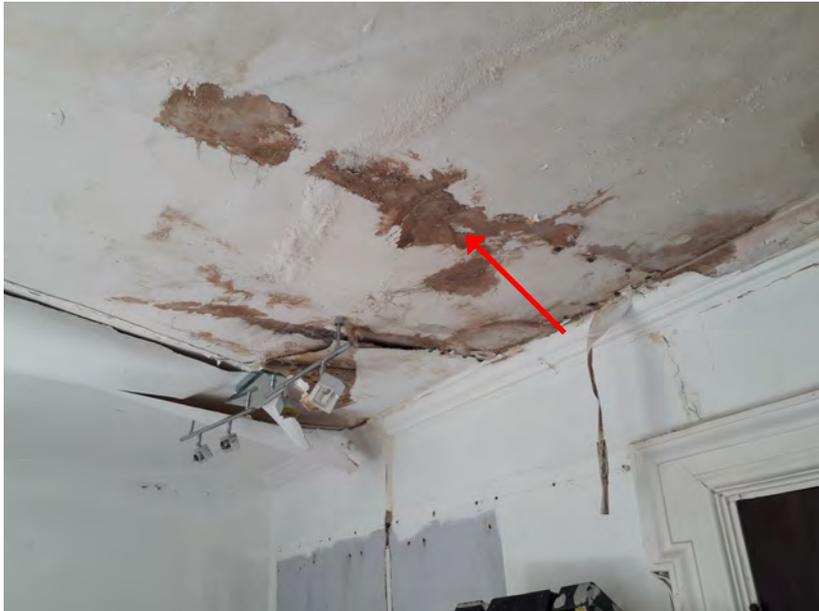
Fig 55:

Upper ground floor, central room of east wing; showing failure of ceiling finishes and mycelium of timber decay organisms, consistent with intermittent failure of the provision for waterproofing to the terrace above
