Ref: 21 / 43971  
Date: May 2021  
Prepared by: Steve Ainge

**CLIENT:  
BLETSOES  
OAKLEIGH HOUSE  
THRAPSTON  
NORTHANTS  
NN14 4LJ**

**VISUAL STRUCTURAL  
INSPECTION OF  
AMERICA FARM,  
WARMINGTON  
PE8 6UP**

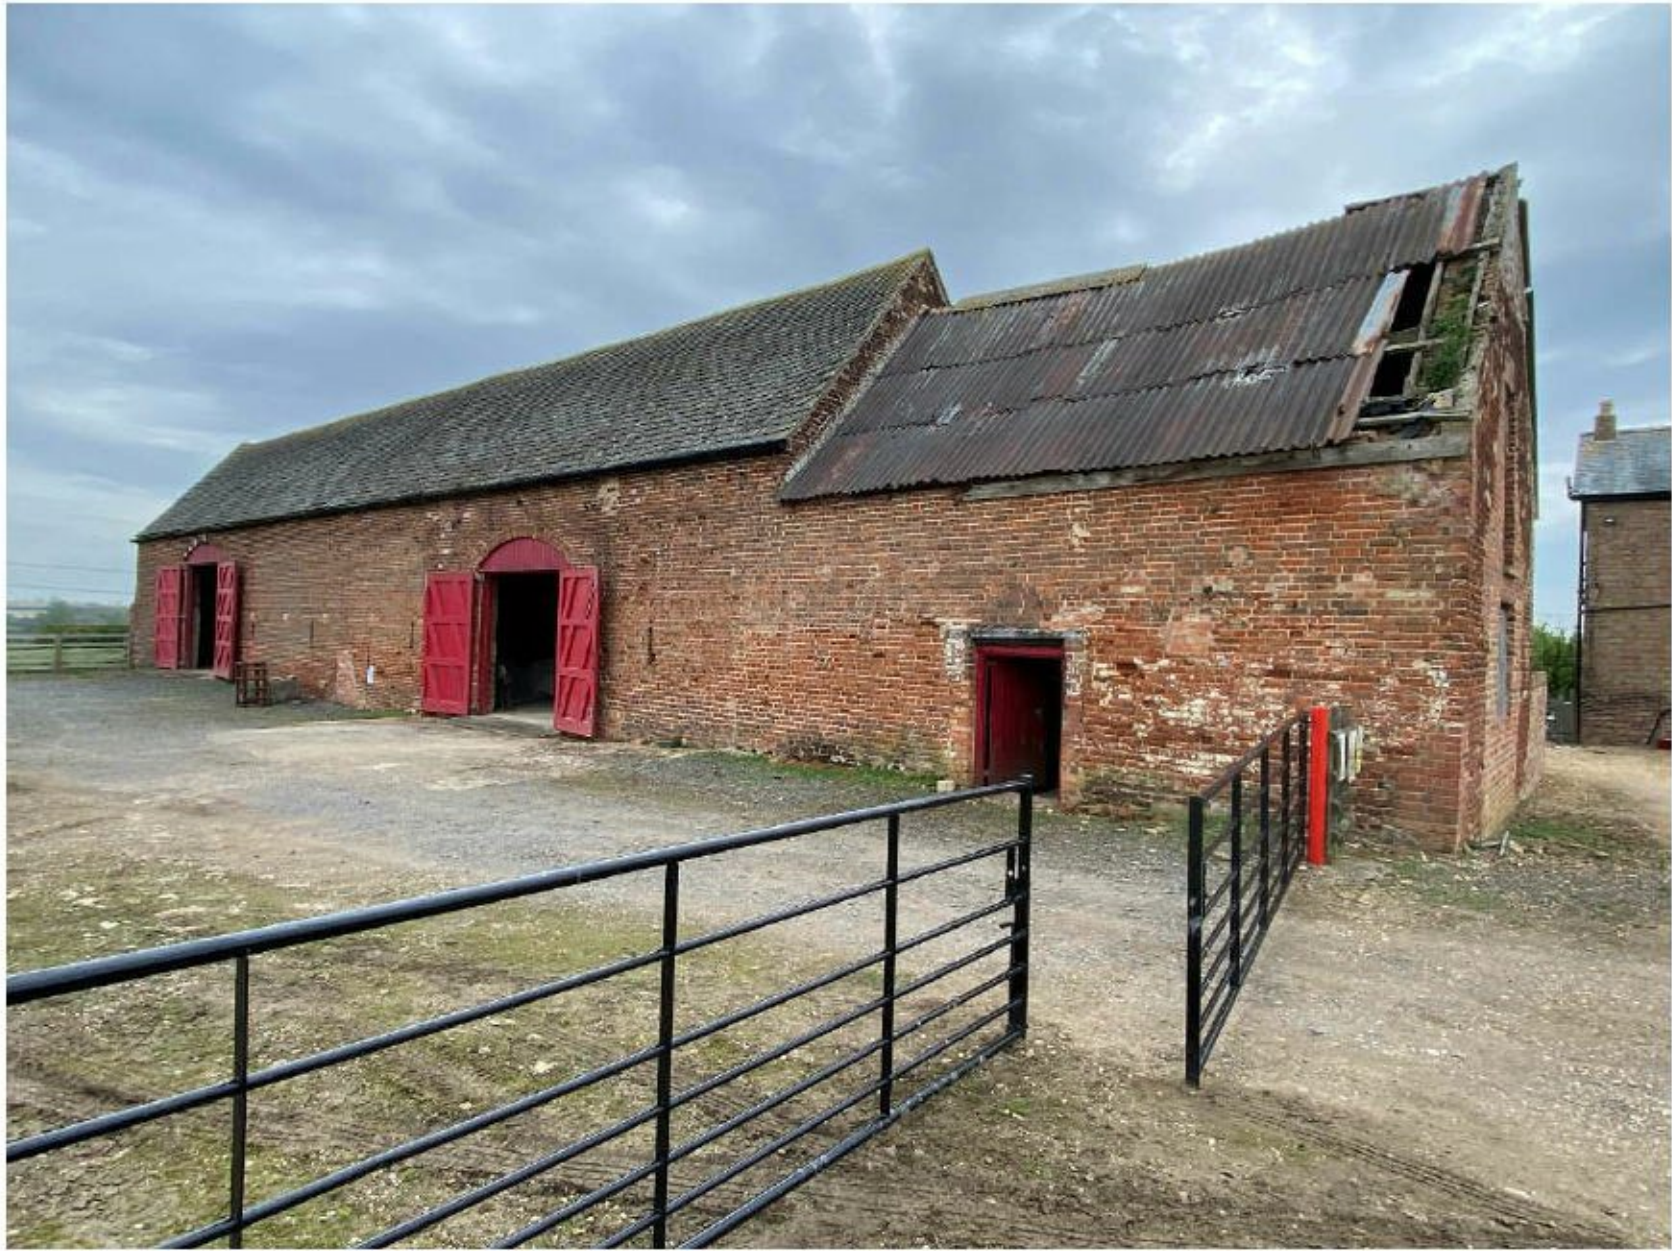
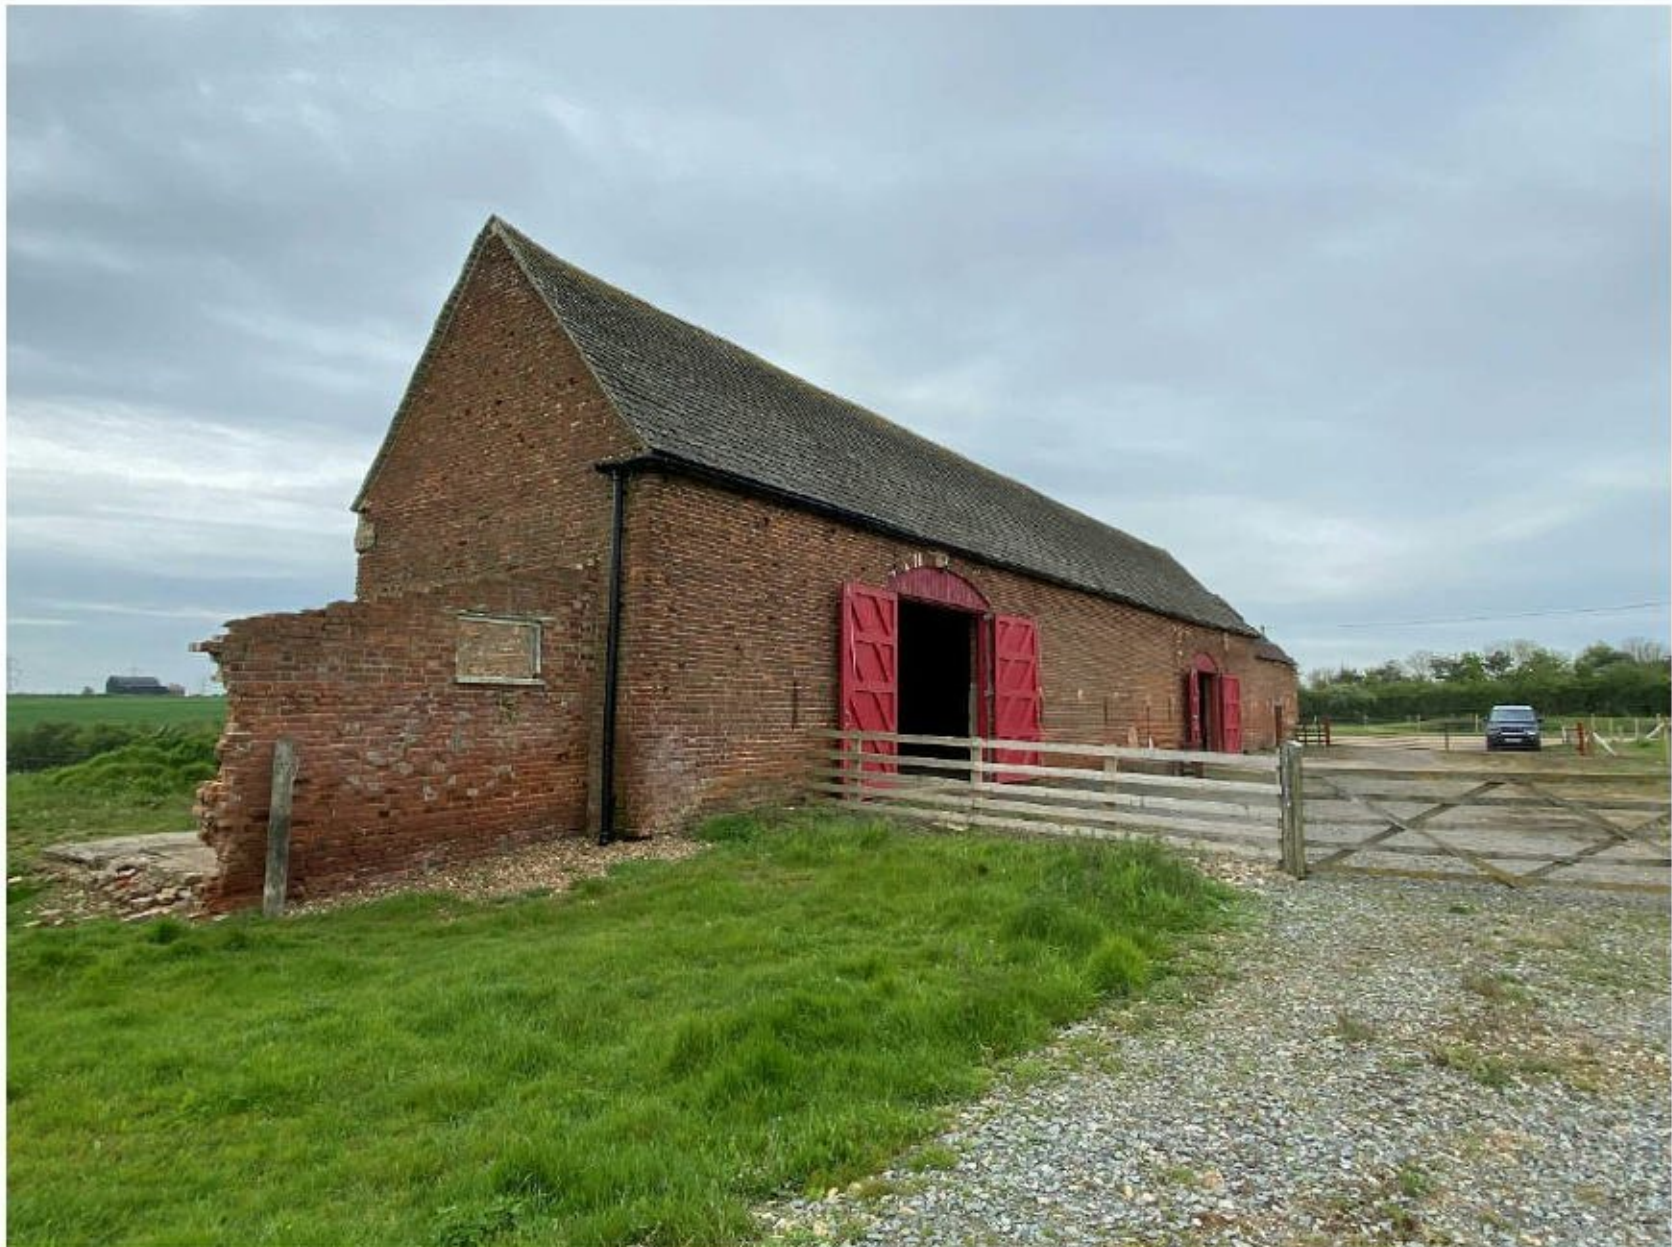
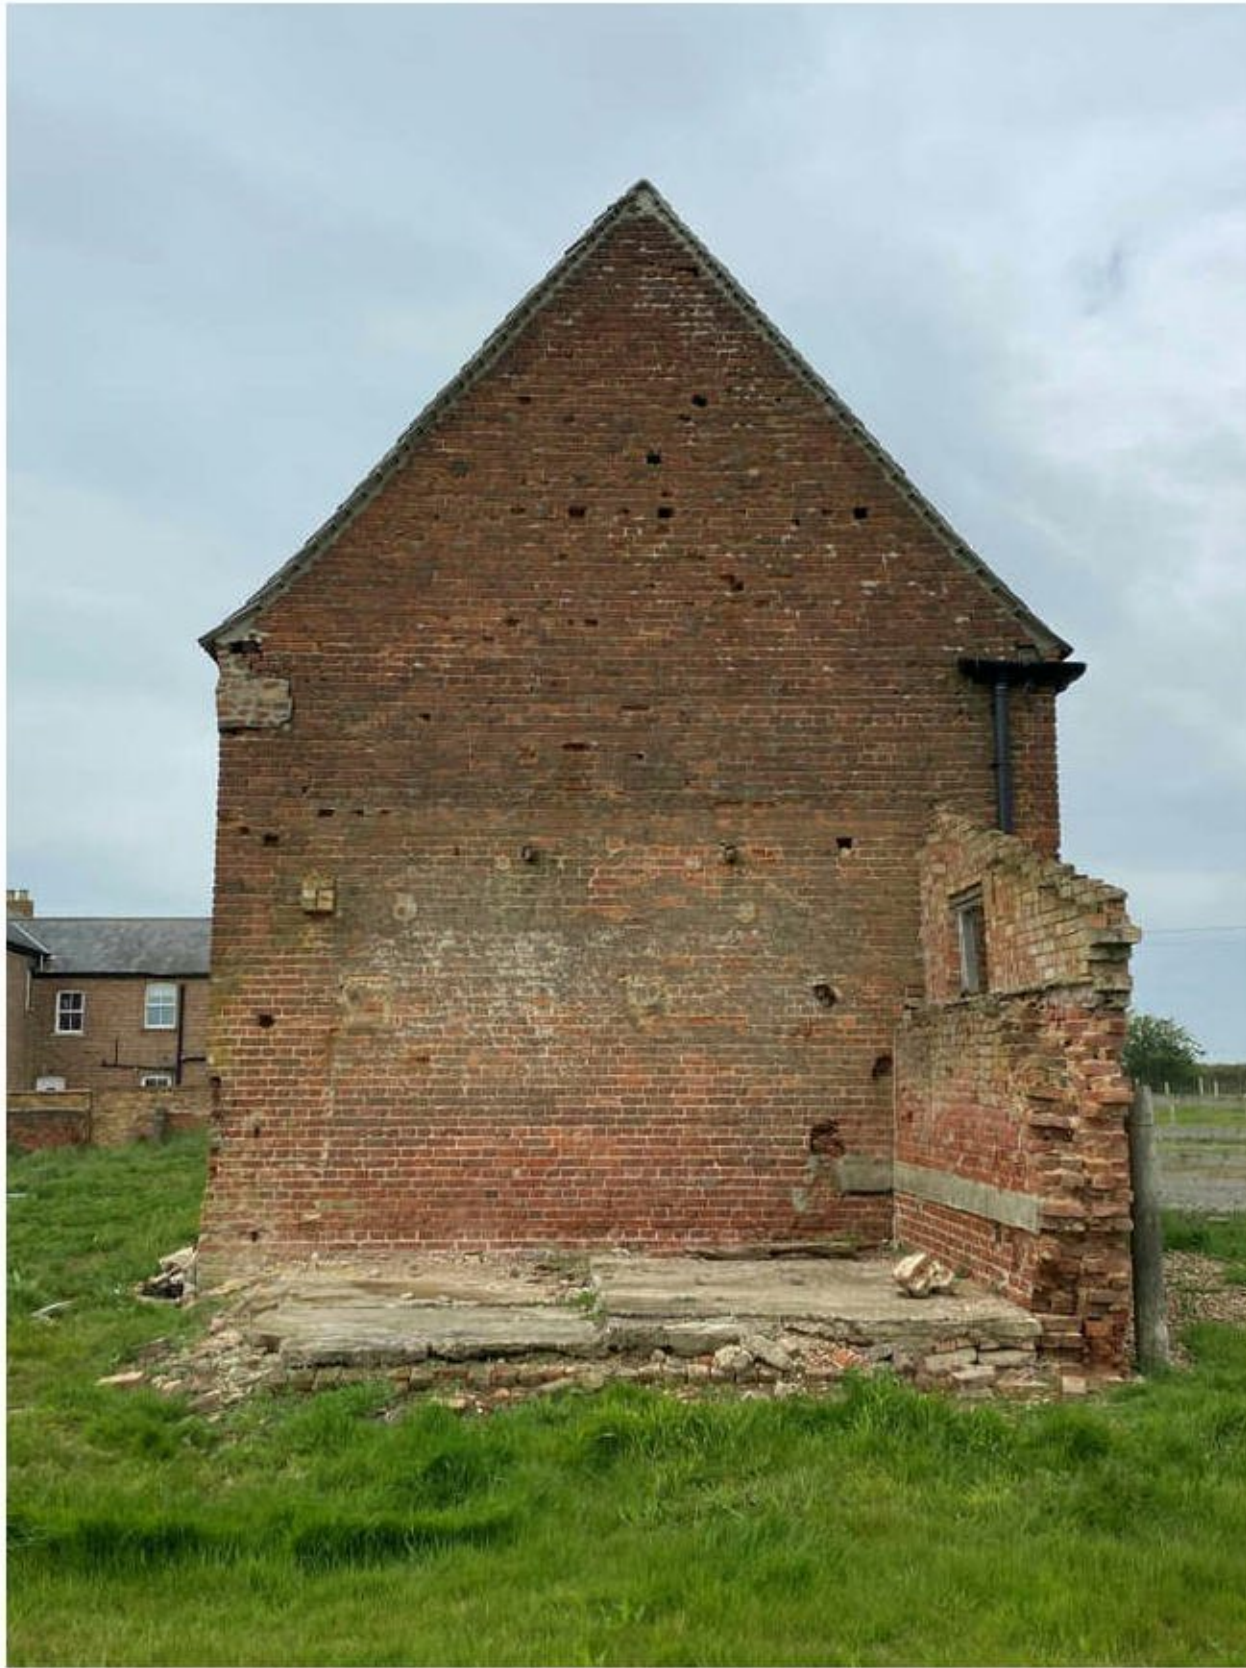
2.1.1 In principle, Barn 1 is a traditional, double height, brick built, Agricultural Barn with a tiled duo-pitched roof covering. (Please refer to Photographs 1 – 3 in Appendix 'A').

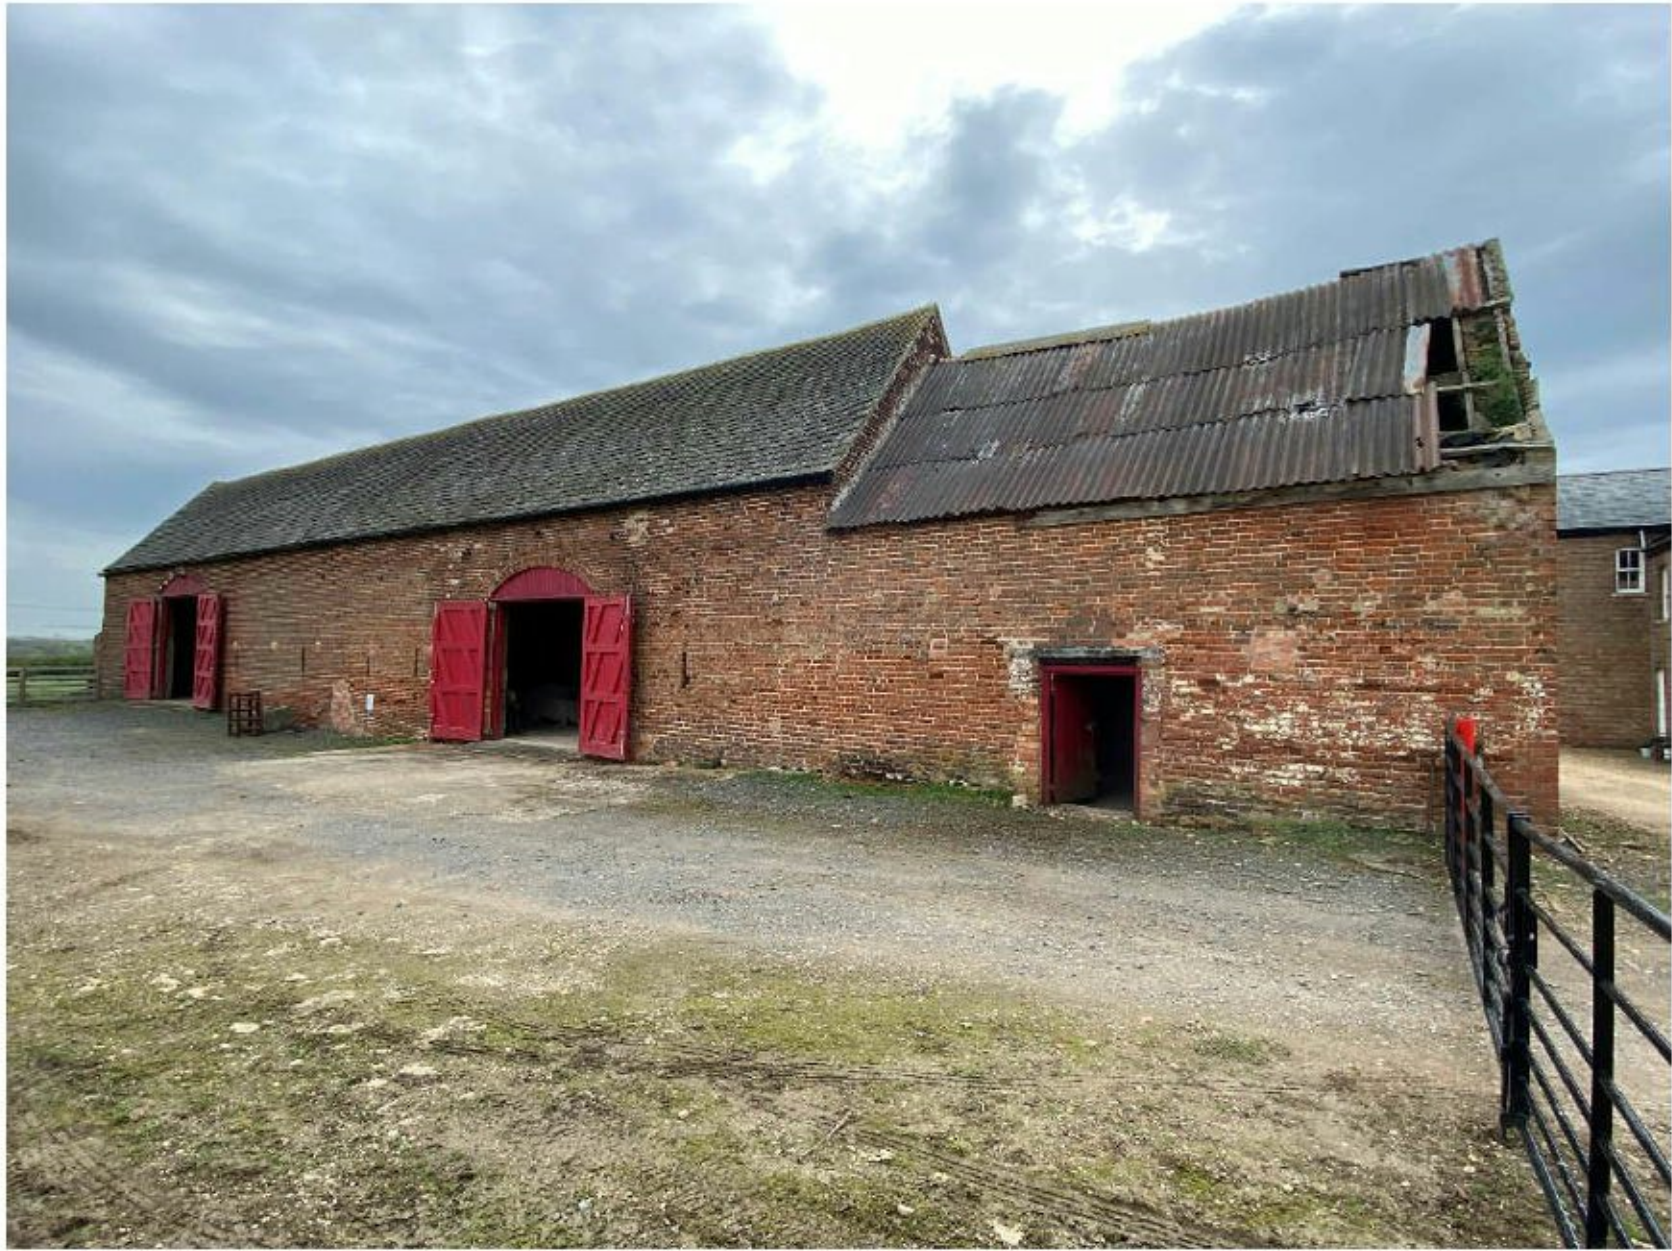
2.1.2 Barn 3 is partially of similar construction, but has a lower roof located to the South. The eaves and ridge heights are lower, albeit the pitch of the roof remains the same and the roof is covered with profile metal sheet rather than the tiling. (Please refer to Photograph 4 in Appendix 'A').

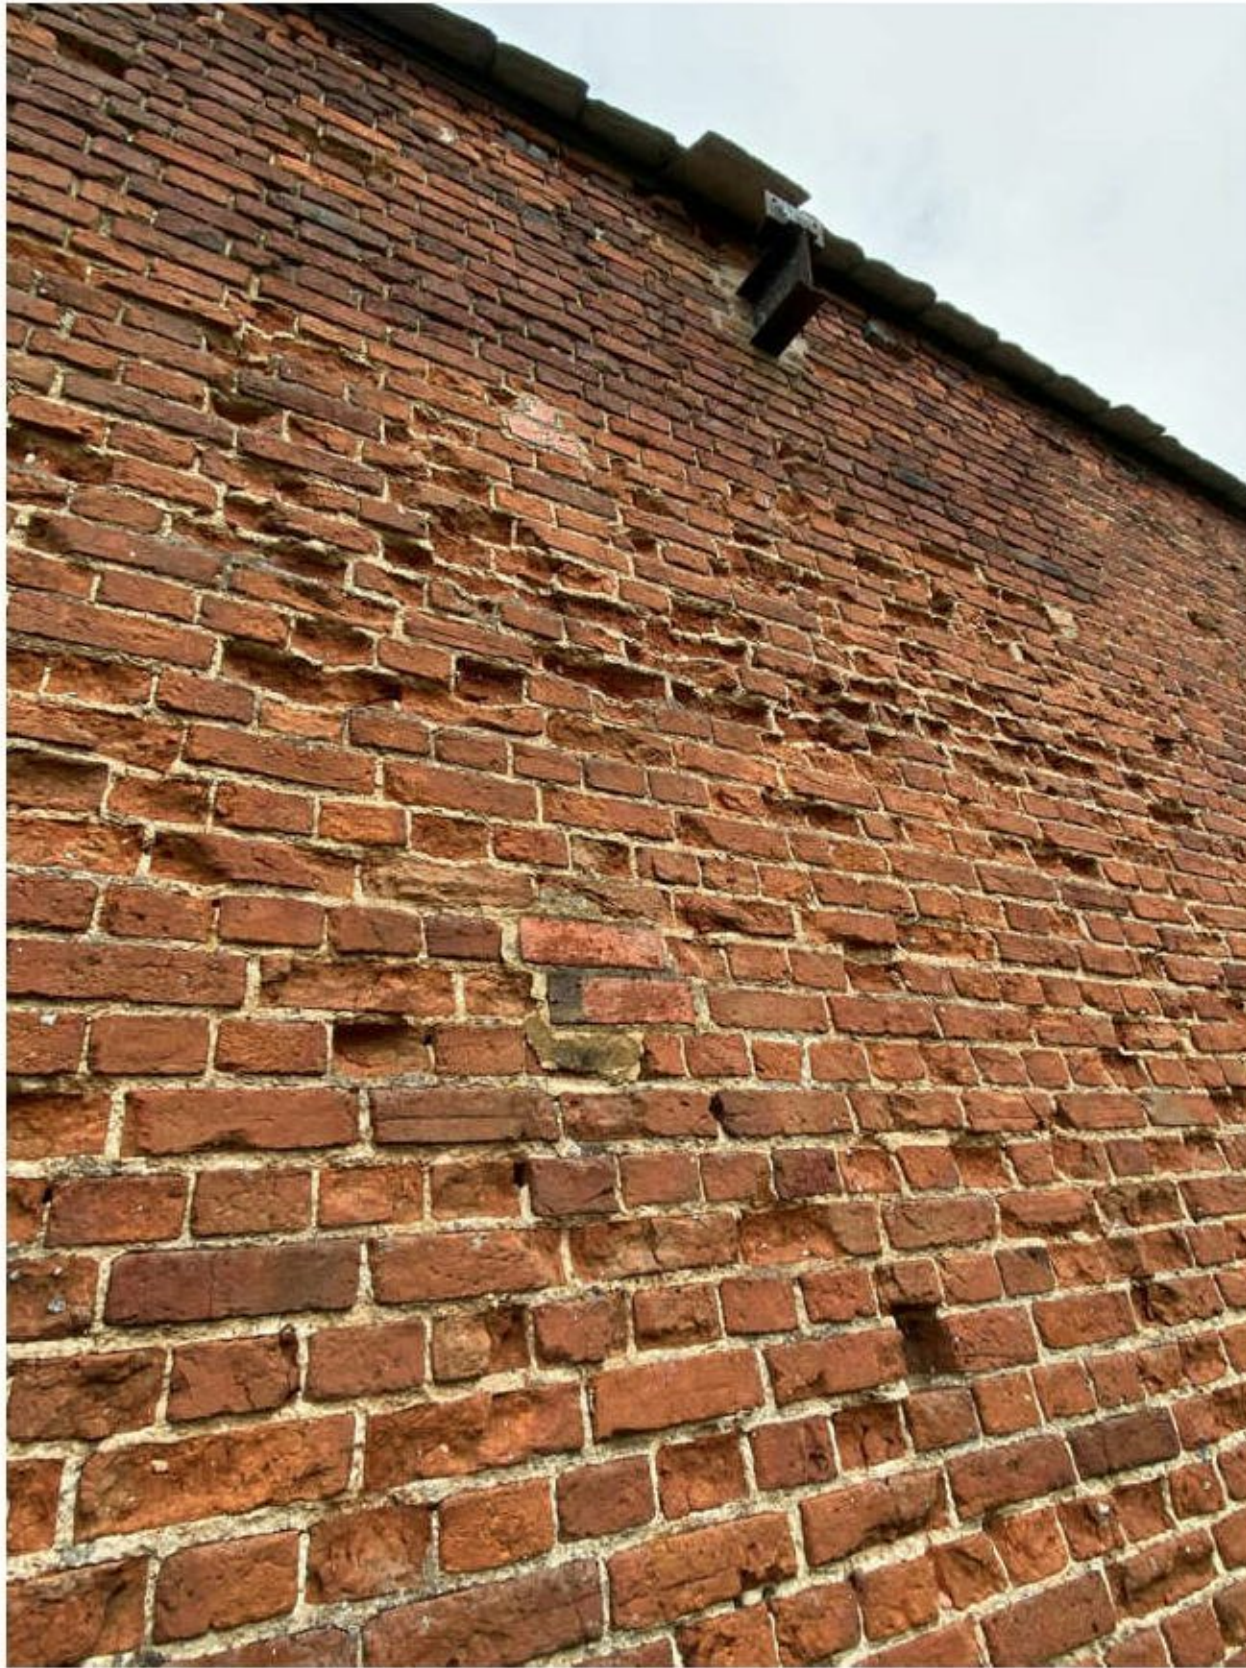
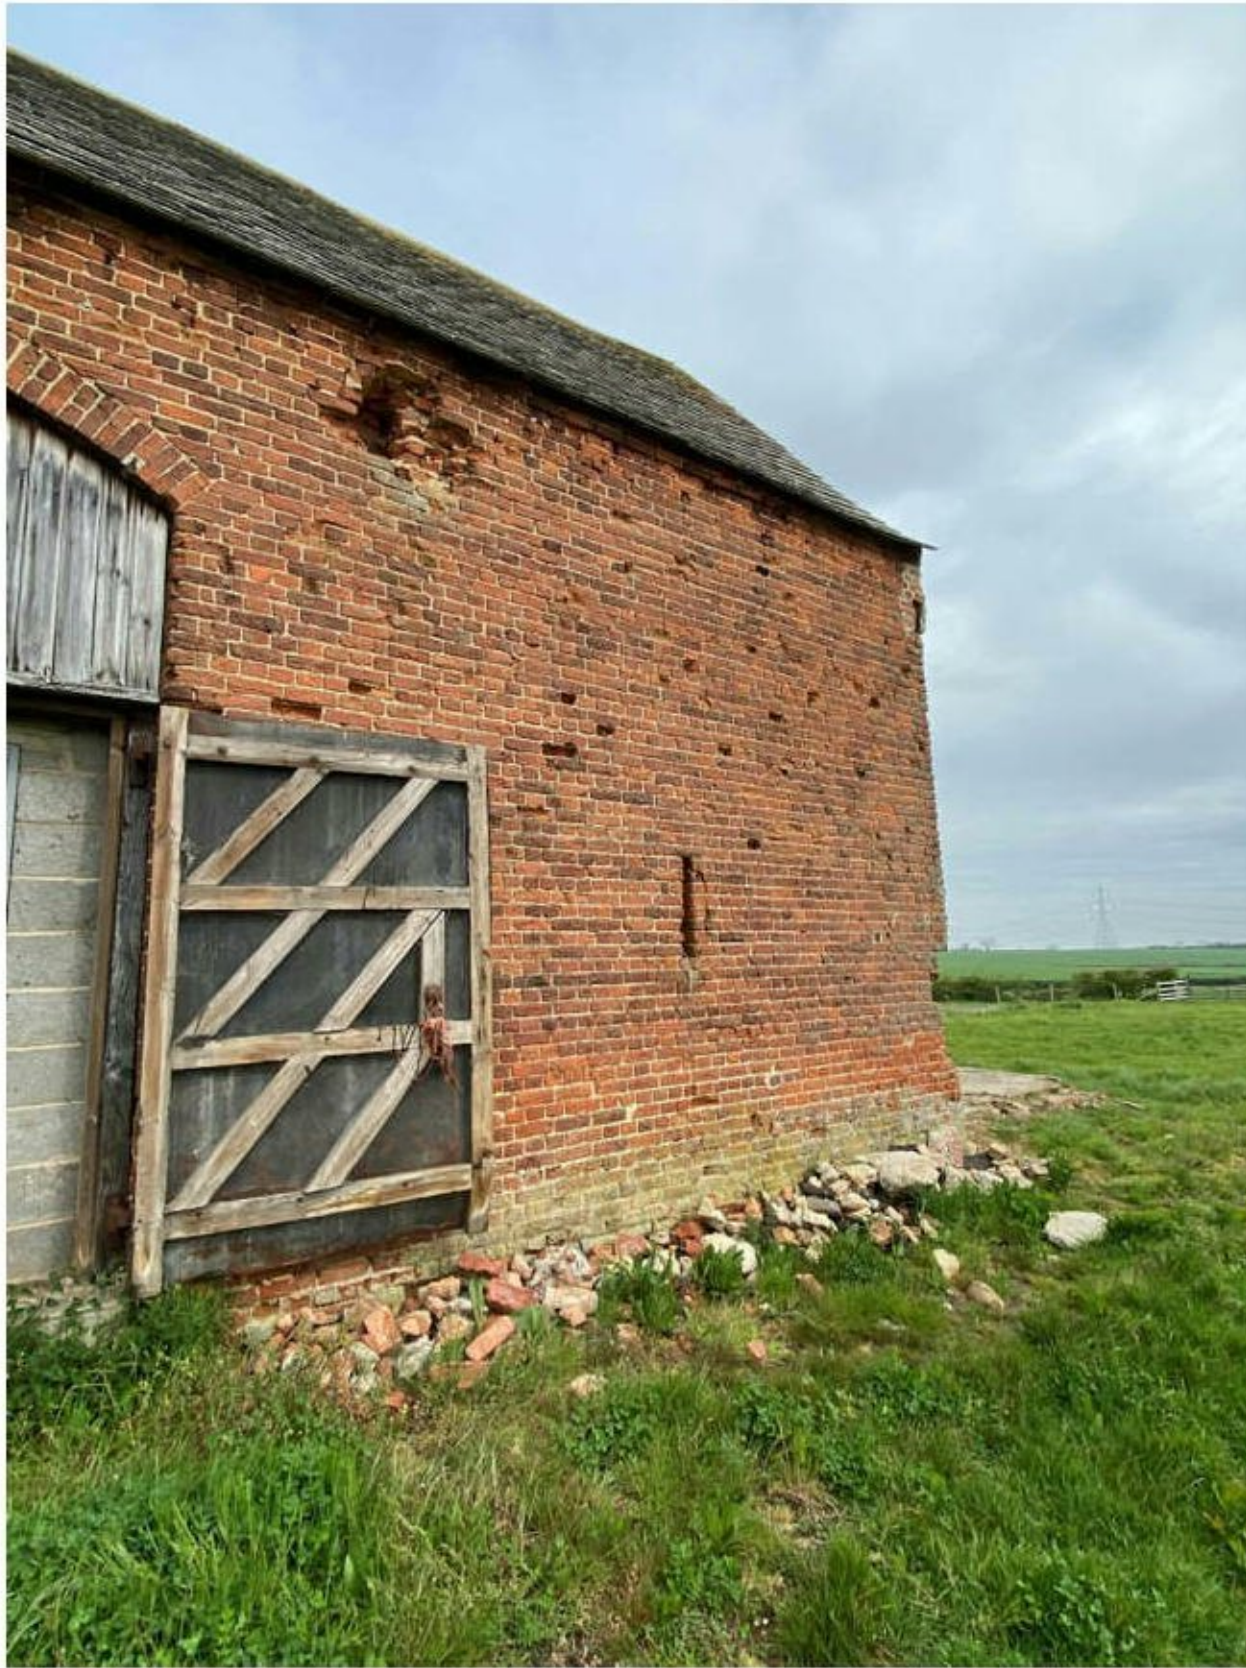
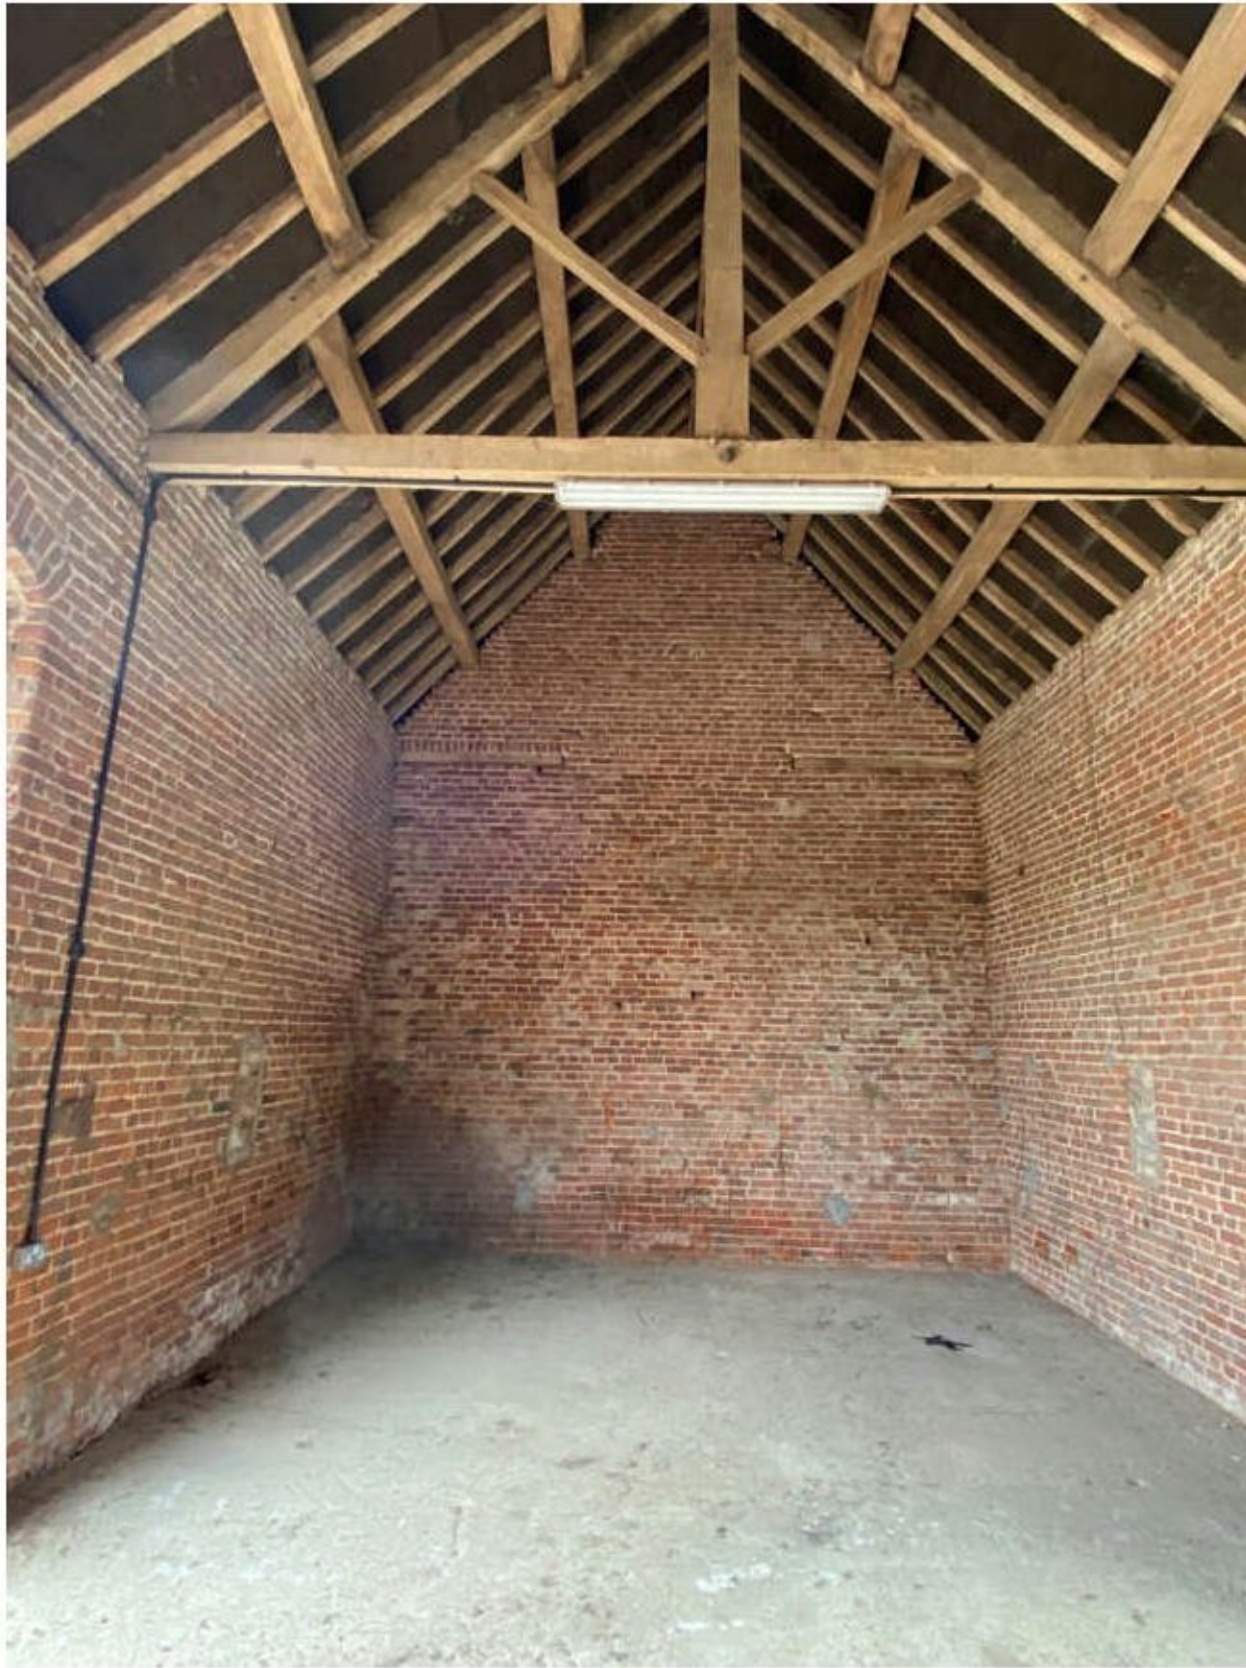
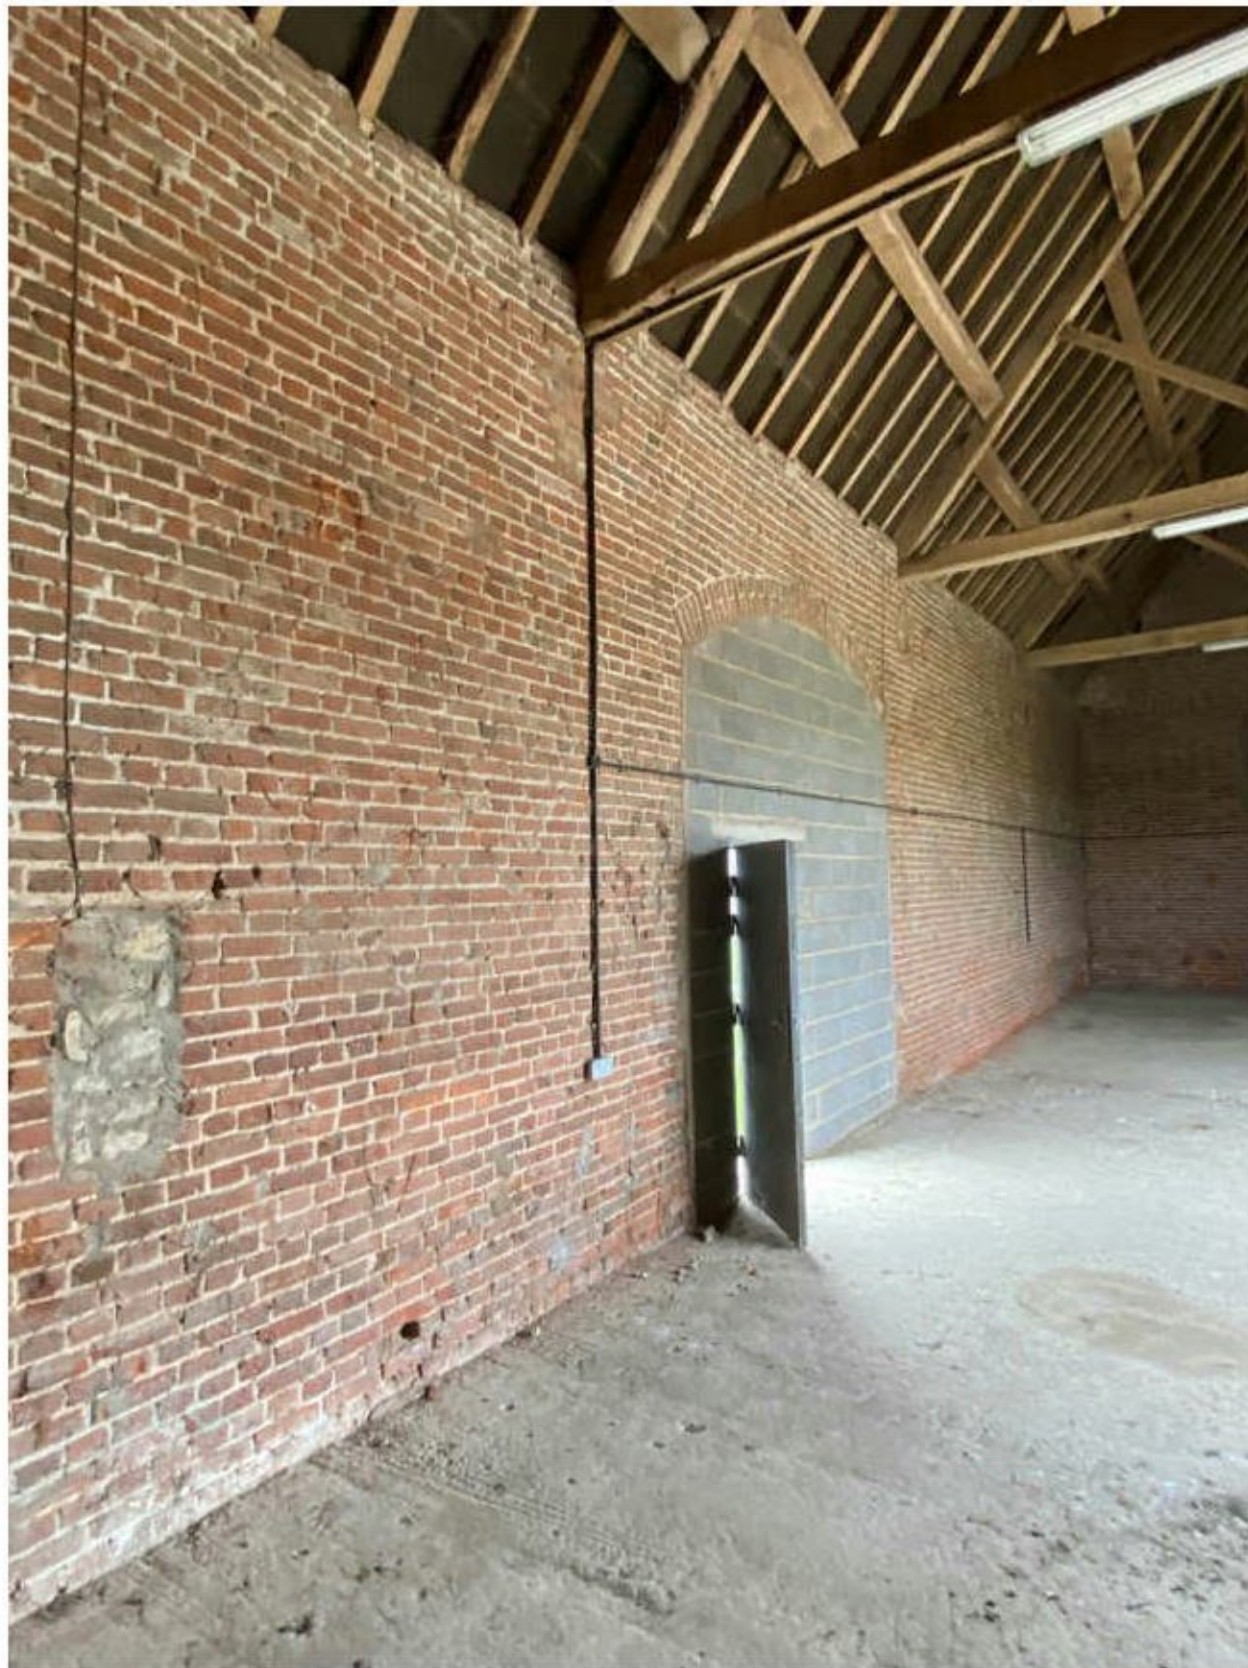
2.1.3 In principle, this is a 450mm thick brick walled Barn that has several internal gables which divide up the space. The extended lower pitched roof to the Southern end is also of similar construction albeit the ridge and eaves level are lower. The 450mm thick walls are generally in good condition given their type and age and are vertical and relatively plumb. There will be the requirement to replace spalled brickwork and carry out repointing where necessary as well as some minor localised rebuilding in patches around the Barn. But generally, this is in reasonable condition. (Please refer to Photographs 5 – 8 in Appendix 'A').

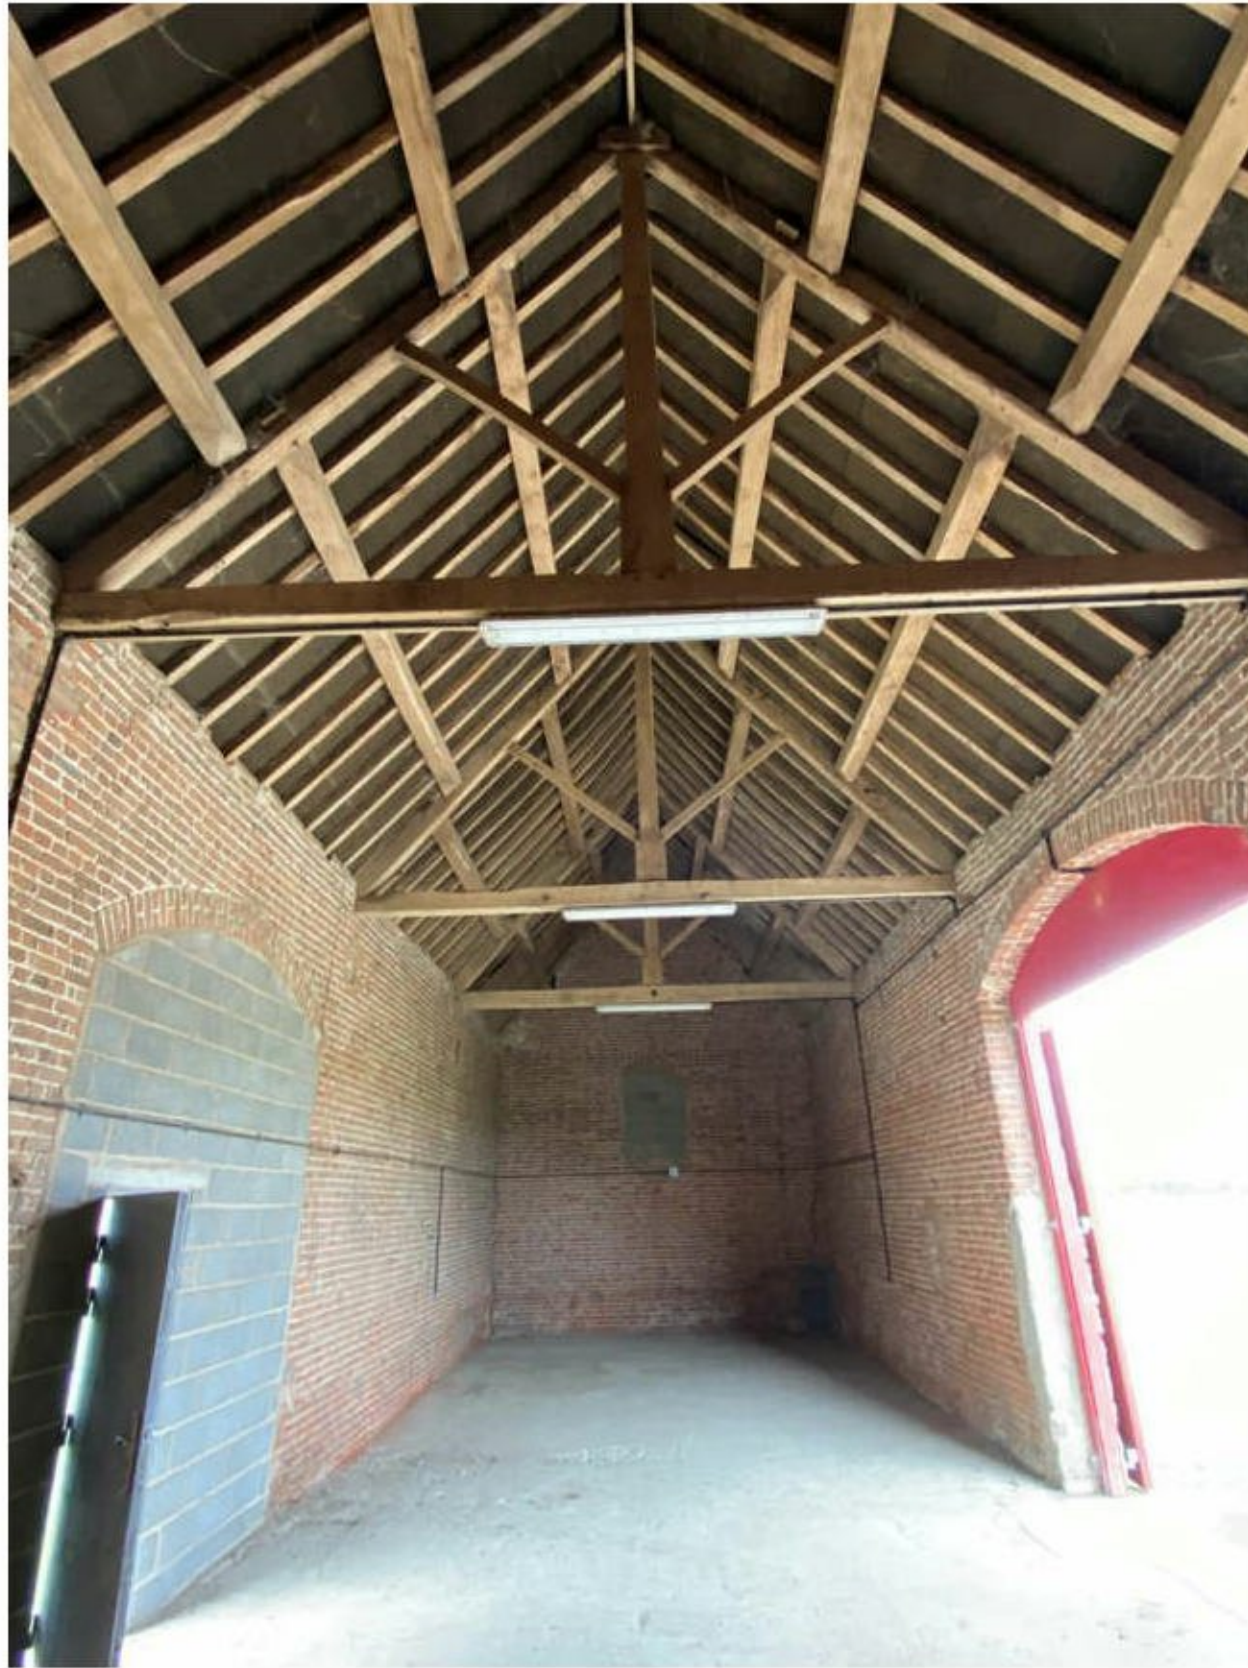
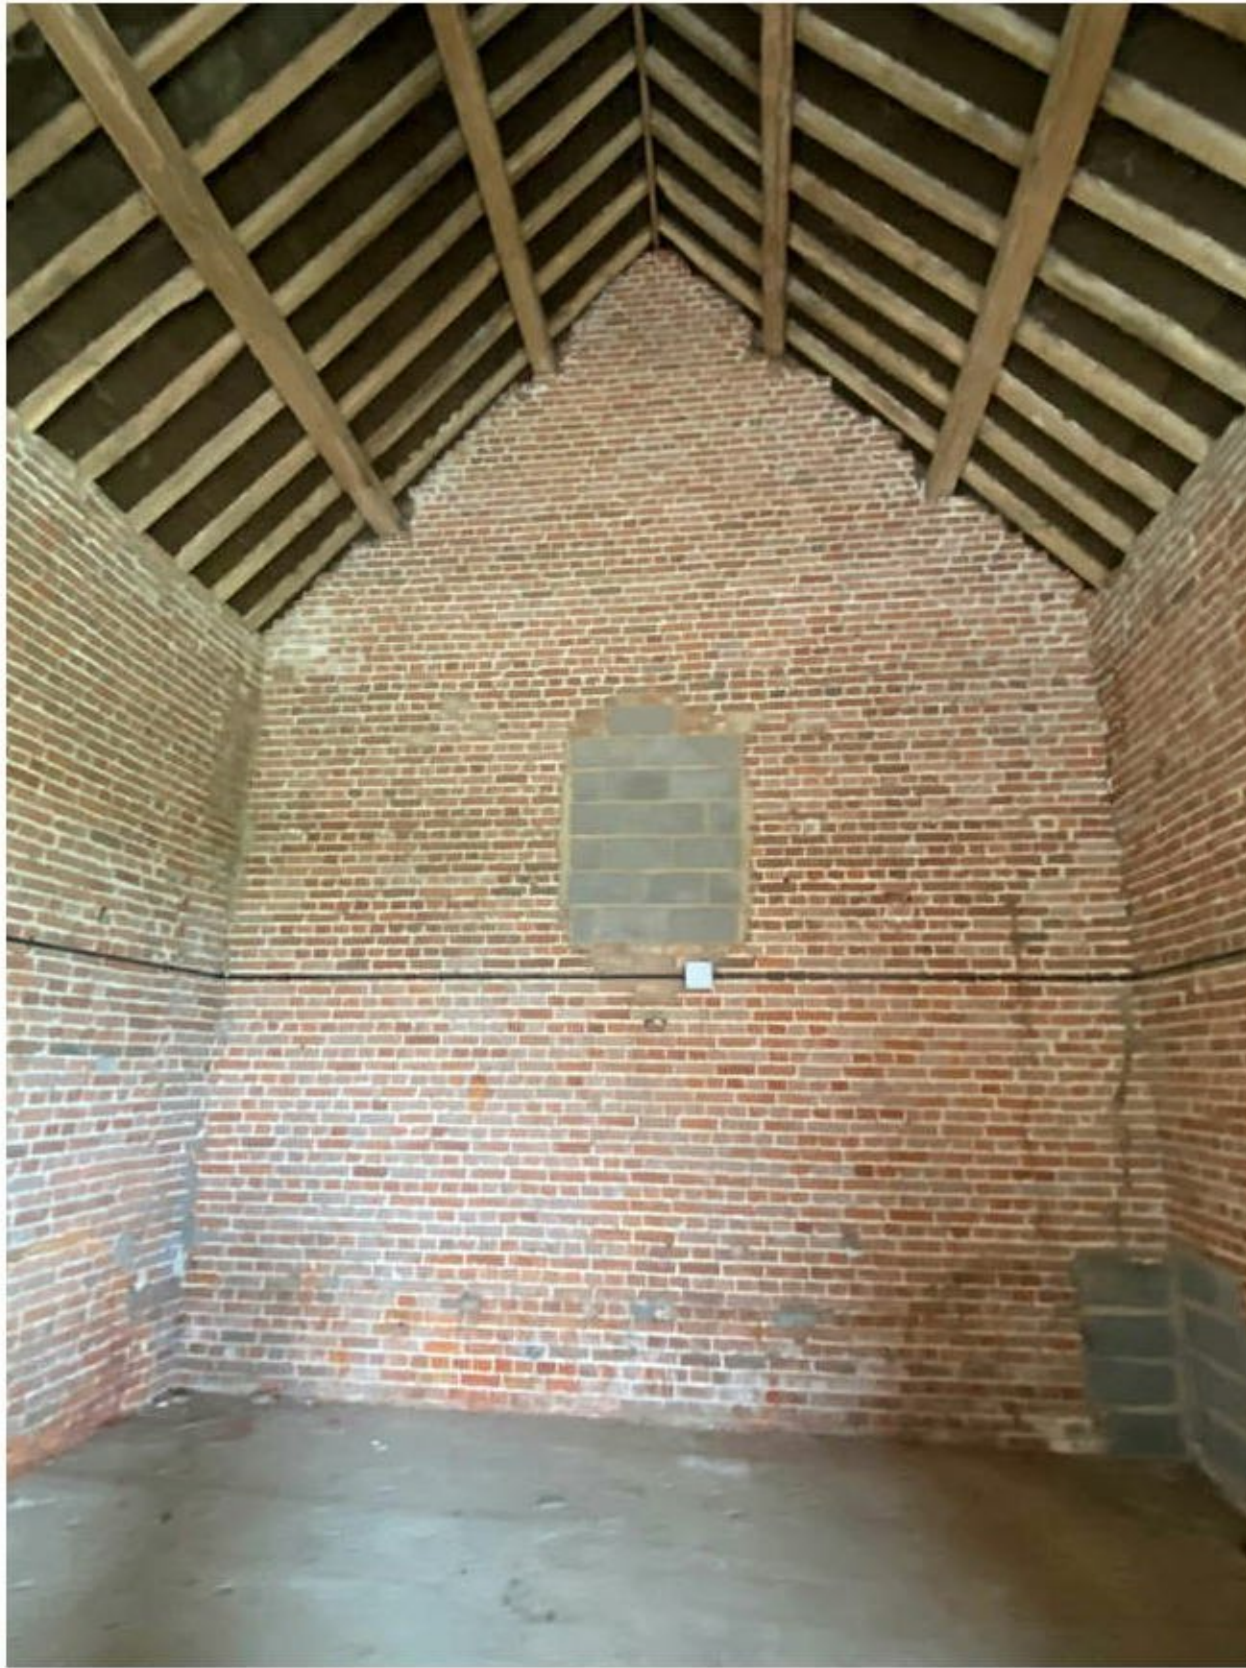
2.1.4 The roof structure consists of king post trusses supporting 4No. timber purlins which span the length of the Barn. In turn these support sawn cut timber rafters that hold the roof covering as previously mentioned. We can confirm that there is no undue deflection to any of the purlins or roof trusses in the higher portion of the Barn and confirm they are generally in good condition. (Please refer to Photographs 9 & 10 in Appendix 'A').
