Ref: 21 / 43971  
Date: May 2021  
Prepared by: Steve Ainge

**CLIENT:  
BLETSOES  
OAKLEIGH HOUSE  
THRAPSTON  
NORTHANTS  
NN14 4LJ**

**VISUAL STRUCTURAL  
INSPECTION OF  
AMERICA FARM,  
WARMINGTON  
PE8 6UP**

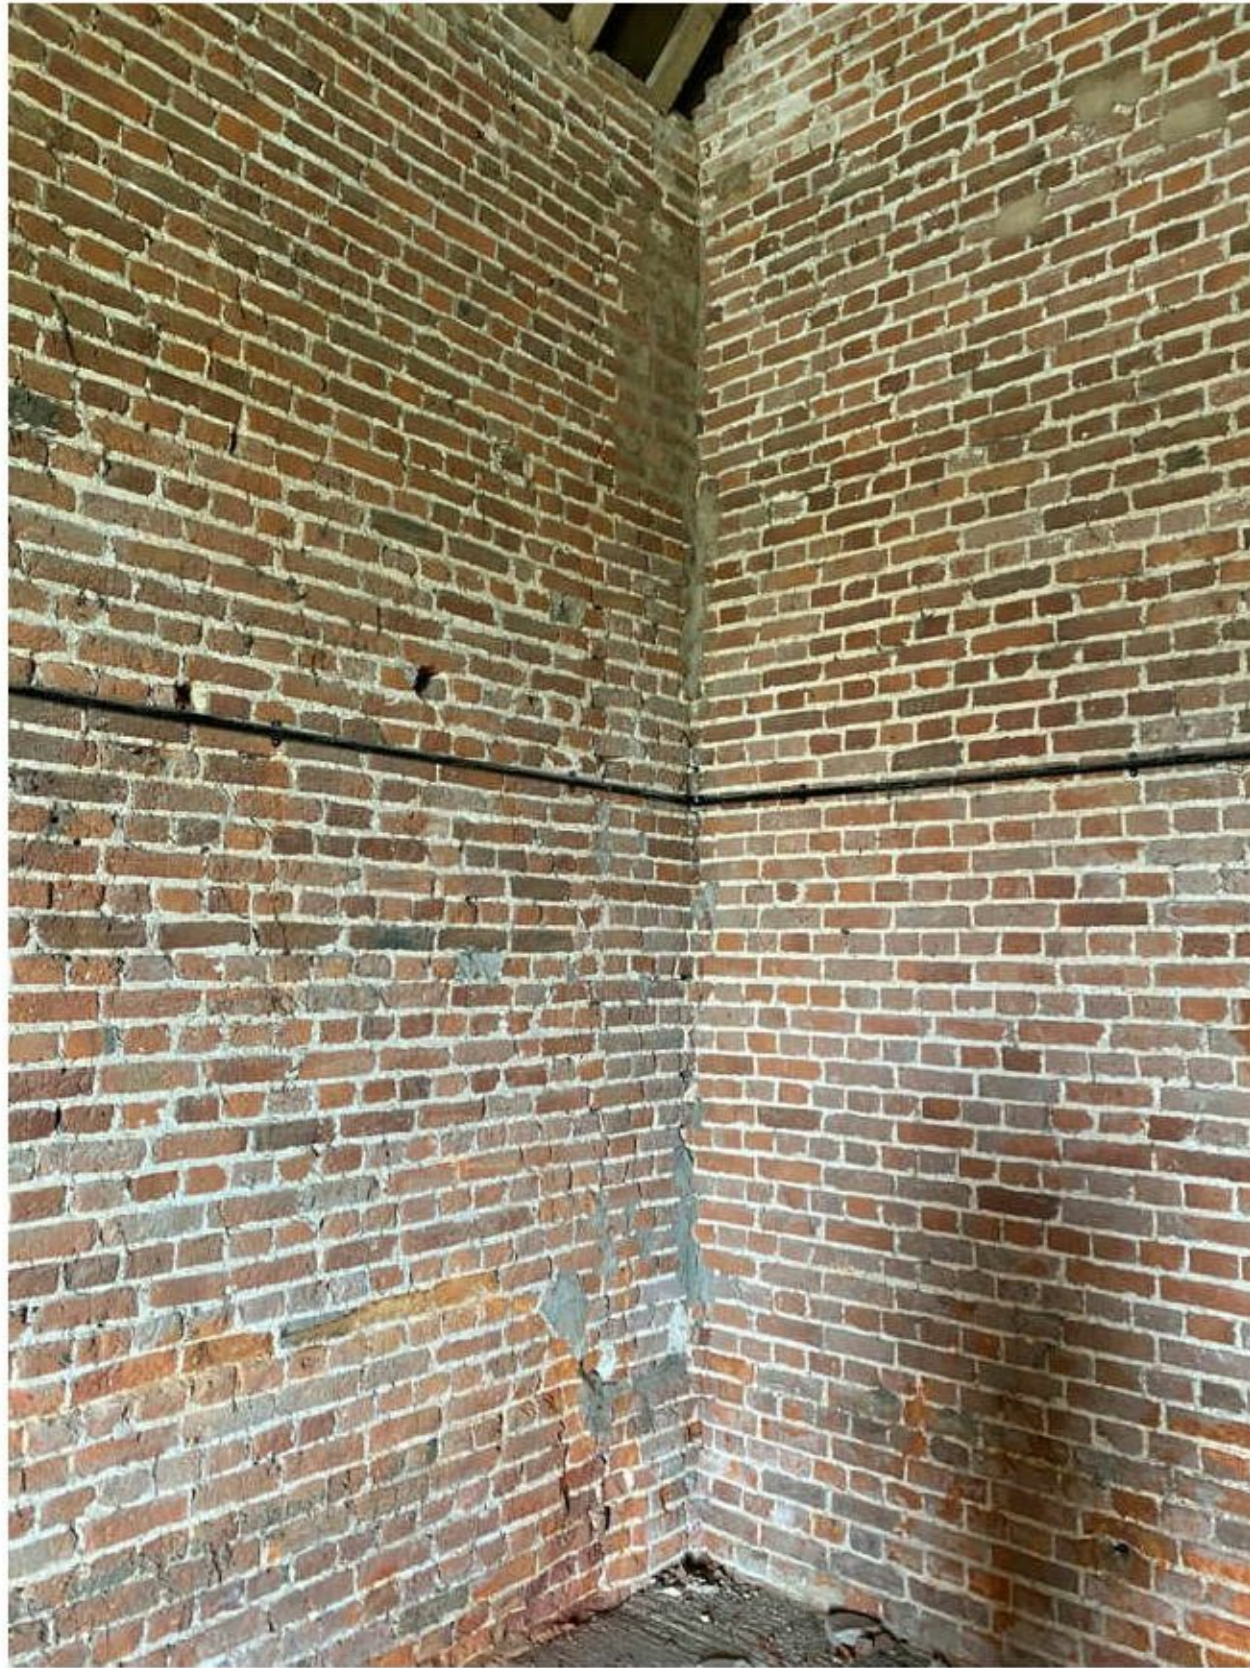
- 2.1.6 The internal walls within the Barn are again, generally true and in good condition, albeit will benefit from some strapping which will assist in tying the internal walls back to the external walls during the course of conversion. (Please refer to Photograph 11 in Appendix 'A').

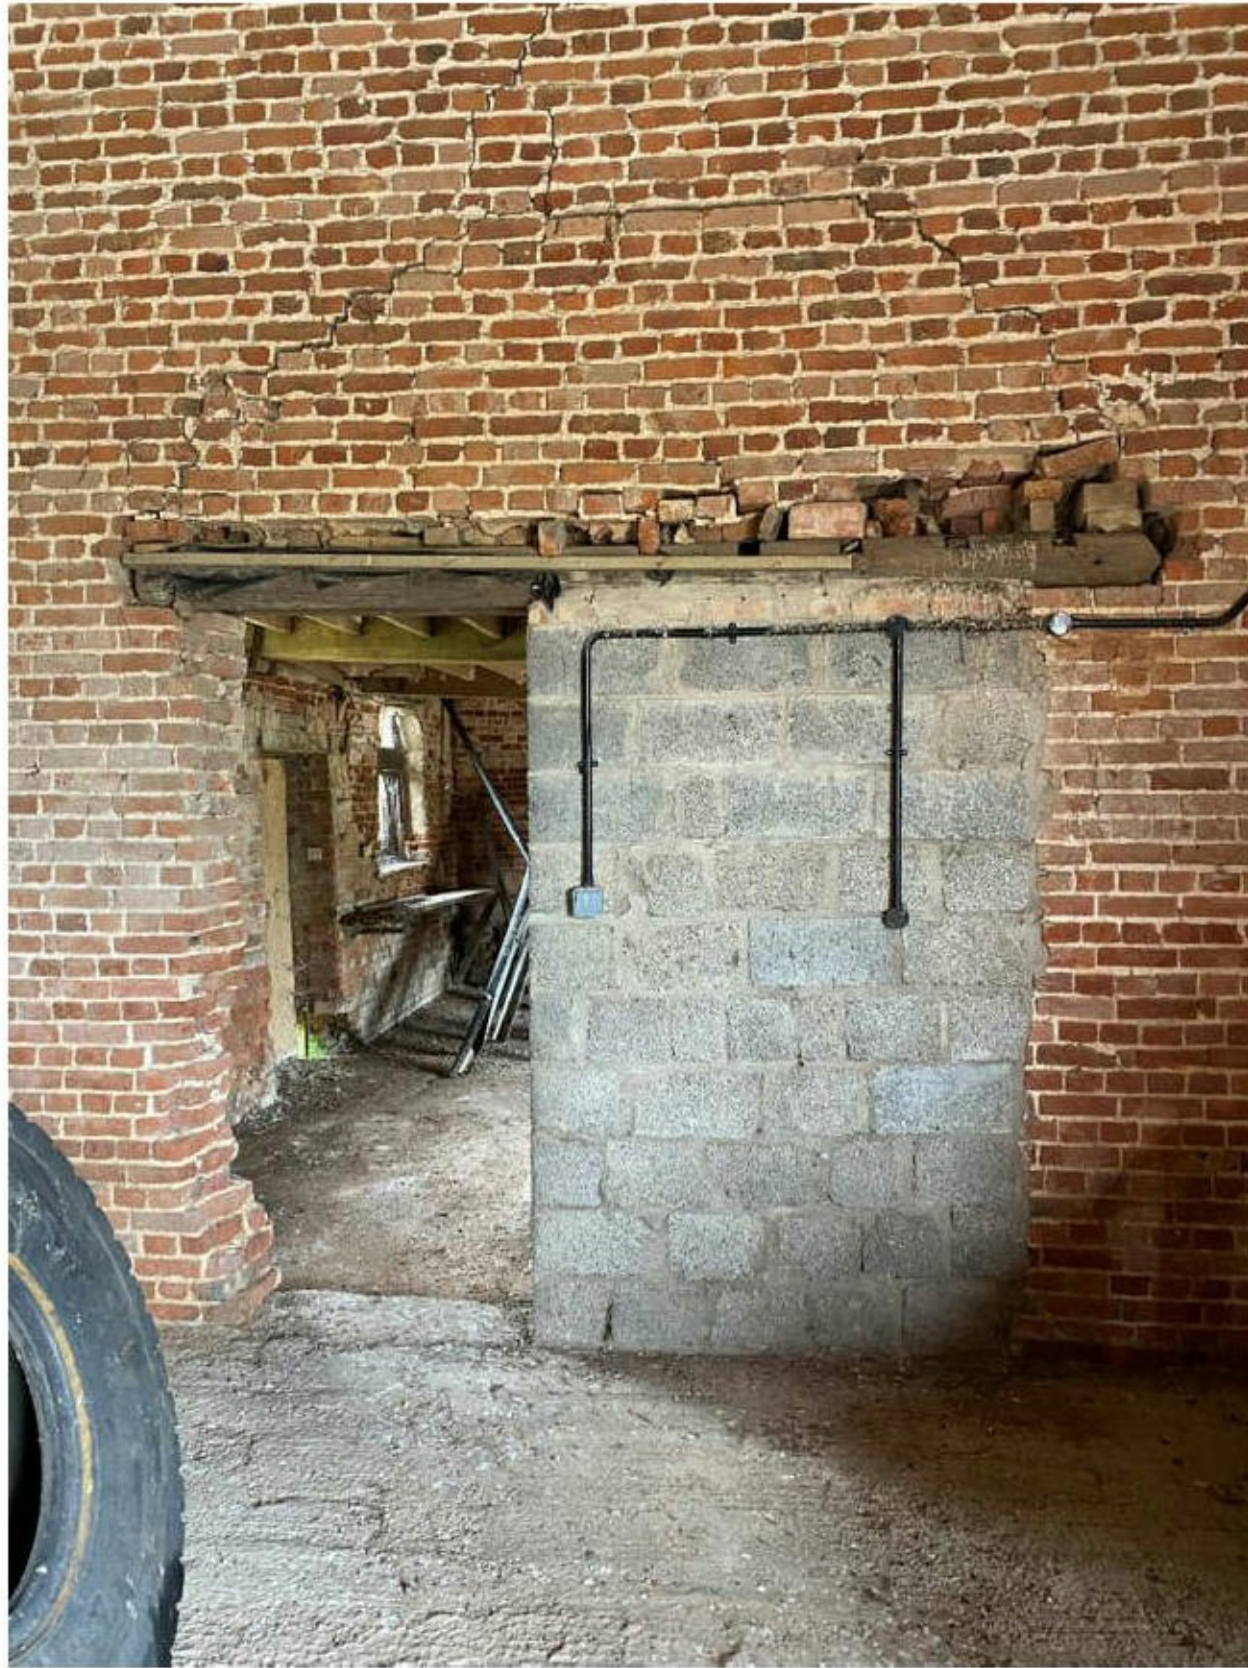
- 2.1.7 Additionally, the timber lintel between the higher ridge and lower ridged portions of the roof requires the brickwork to be rebuilt in order to ensure no further cracking takes place albeit this is likely to be resolved as part of the conversion works. (Please refer to Photograph 12 in Appendix 'A').

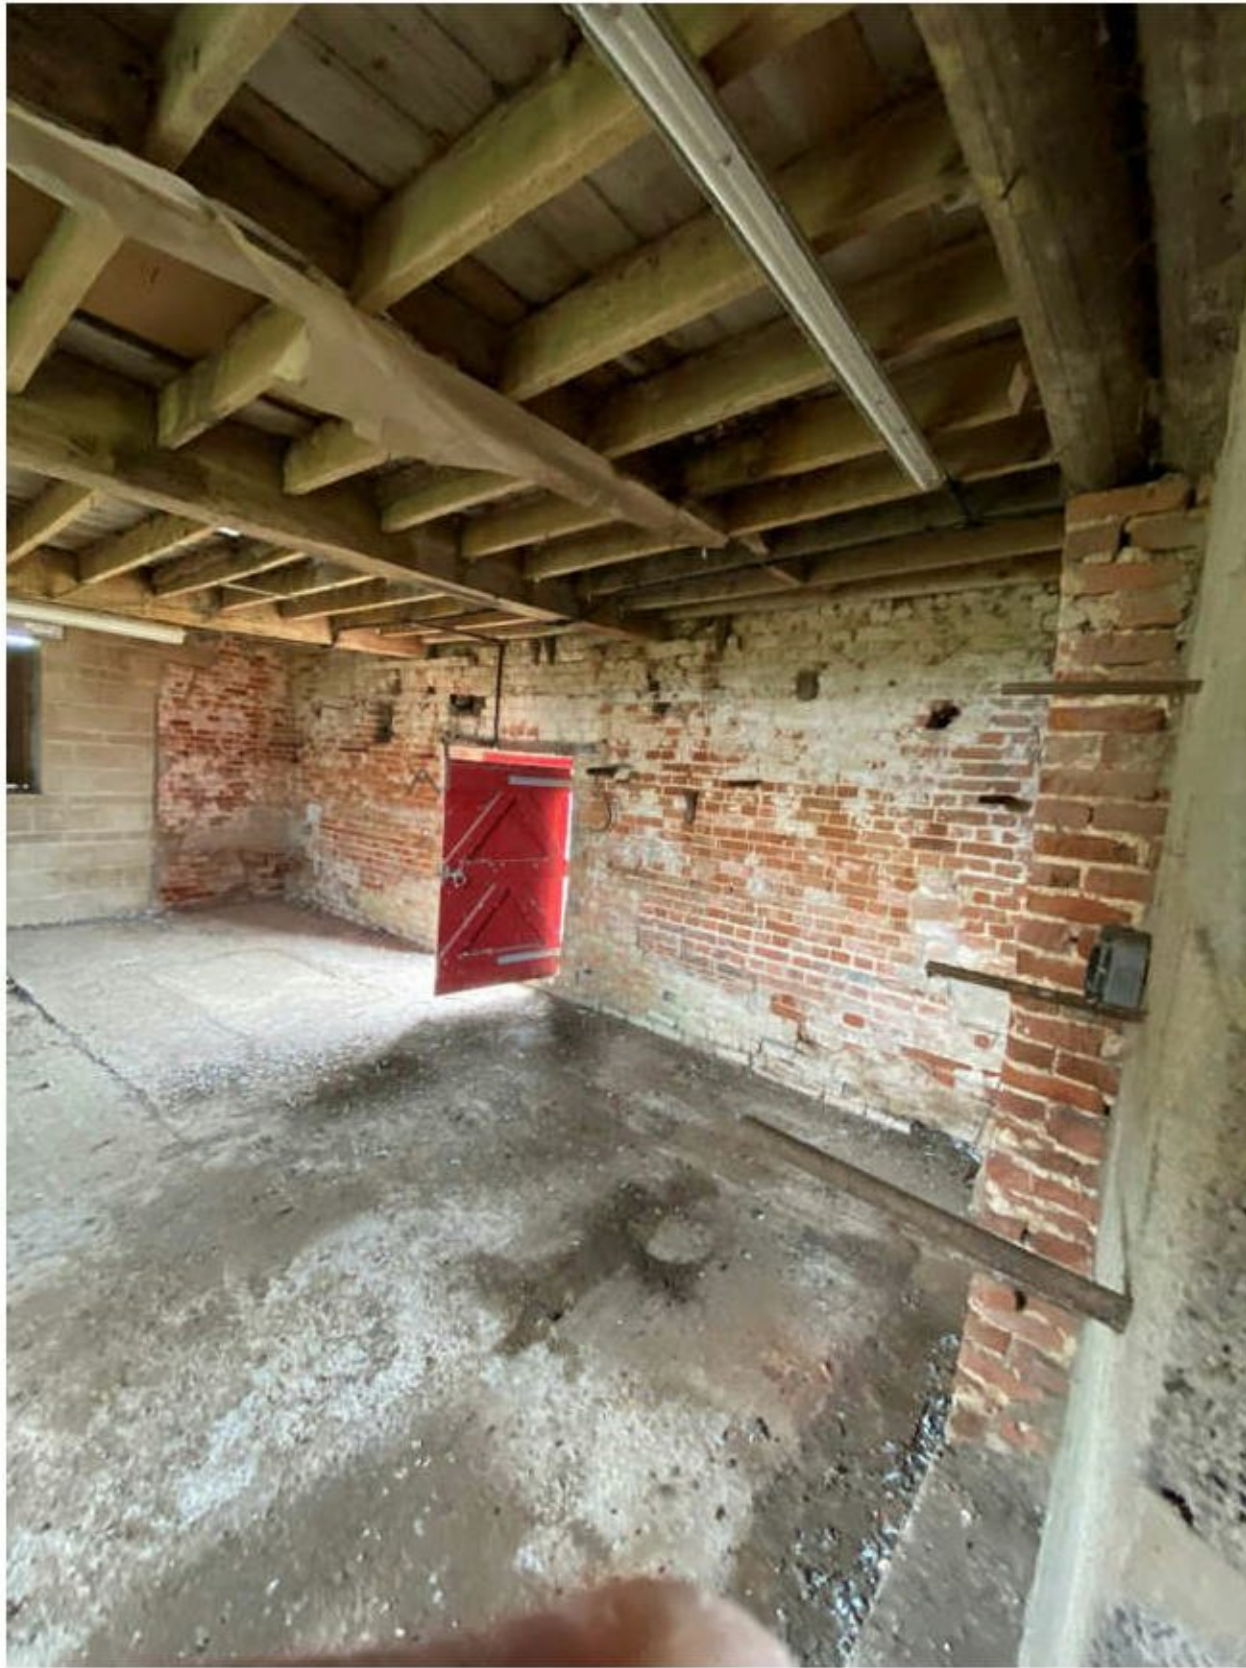
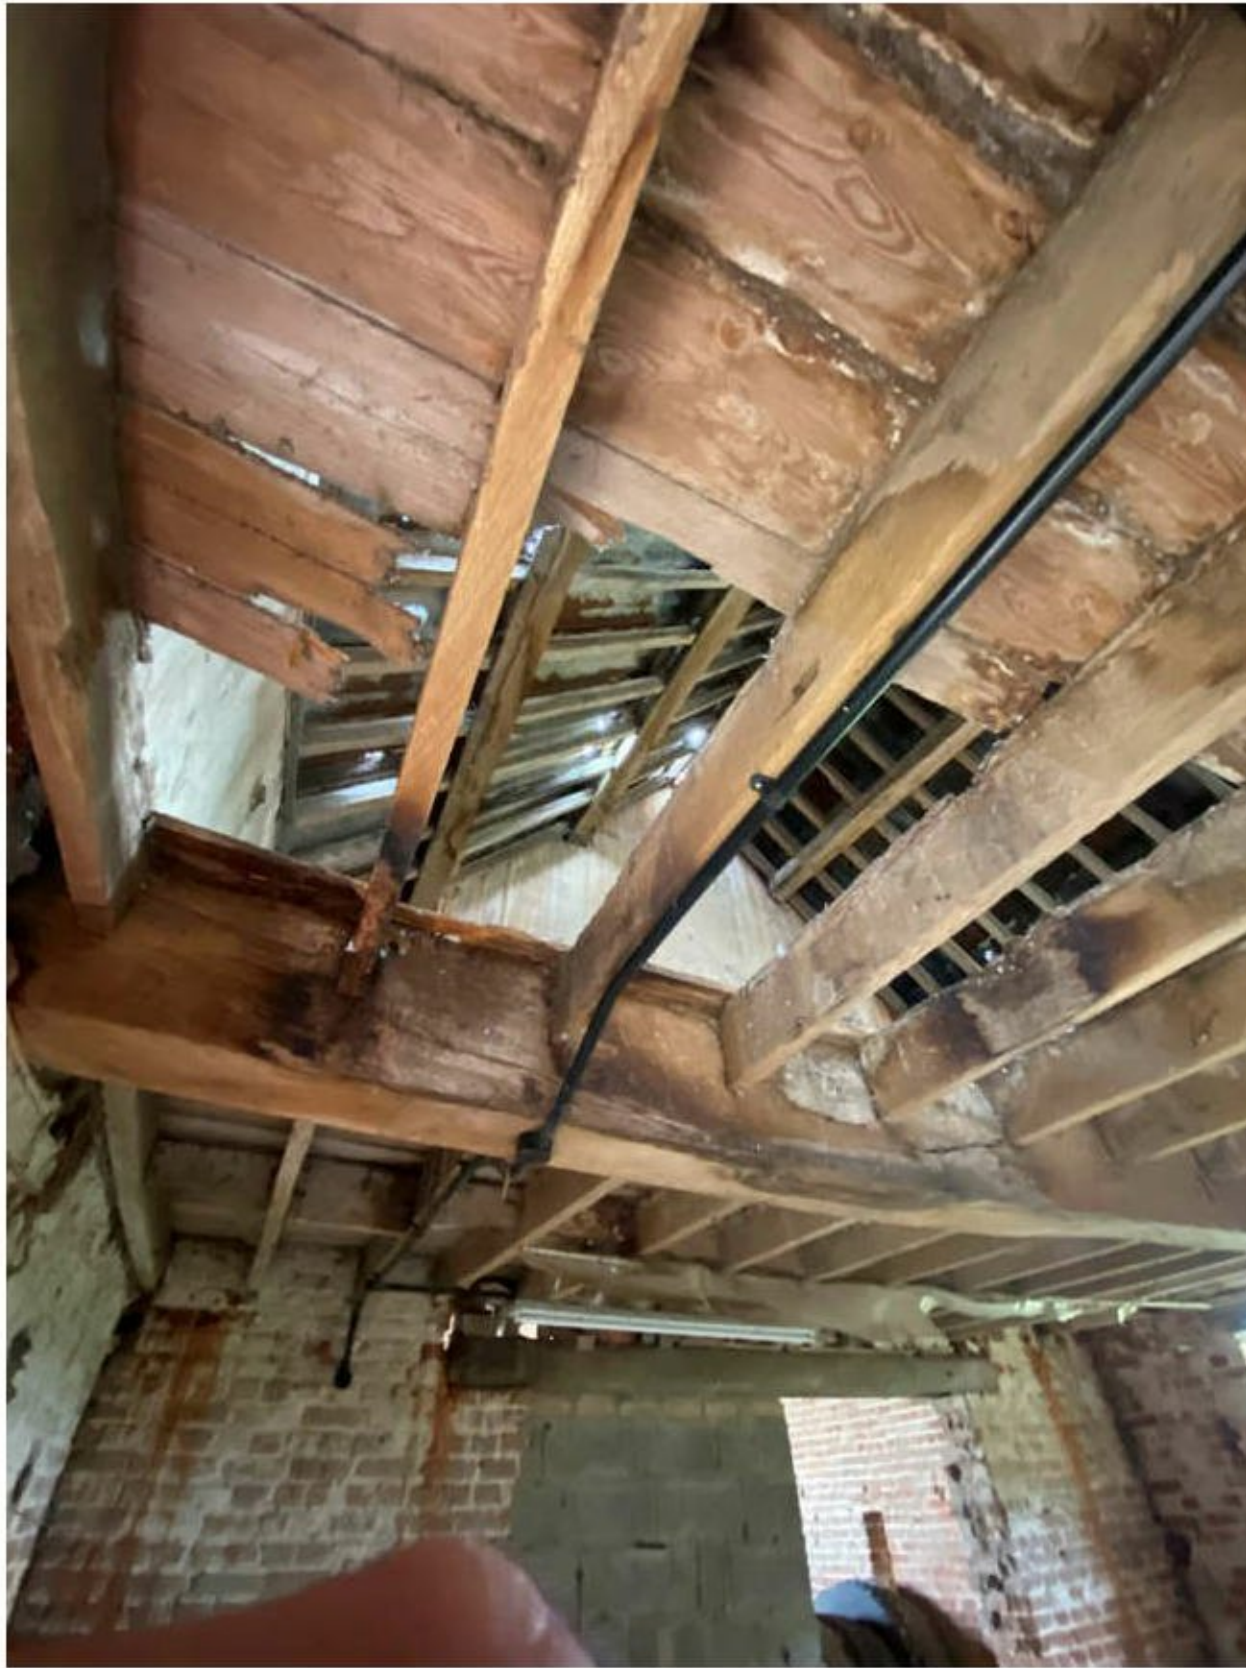
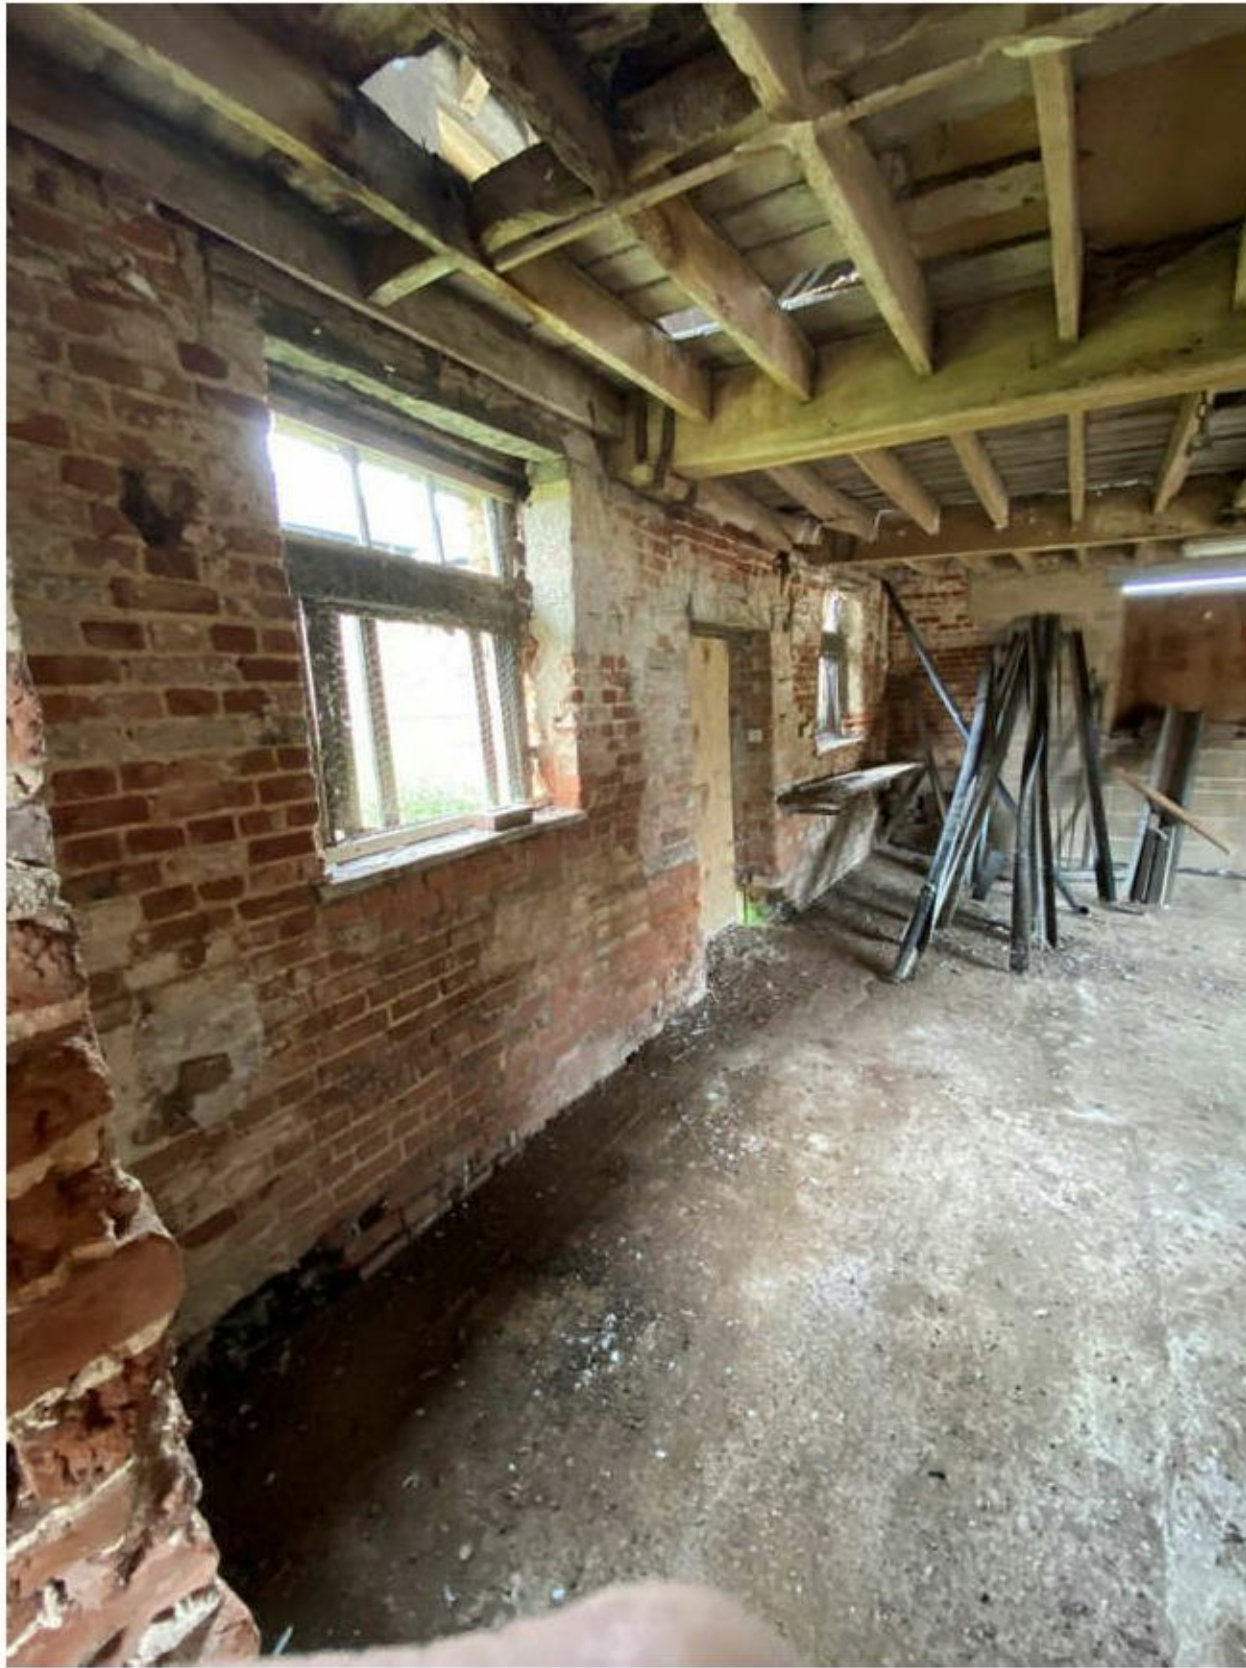
- 2.1.8 The existing timber floor within the lower roof Barn to the South is in need of replacement timbers in certain areas due to water ingress that has caused some of the timbers to rot. In addition to this, the brickwork walls would also benefit from the installation of a new floor within this area in order to provide restraint to the brickwork walls themselves. Again, localised brickwork repairs will be required as part of the conversion, but generally, this is in reasonable condition given its type and age. (Please refer to Photographs 13 – 15 in Appendix 'A').

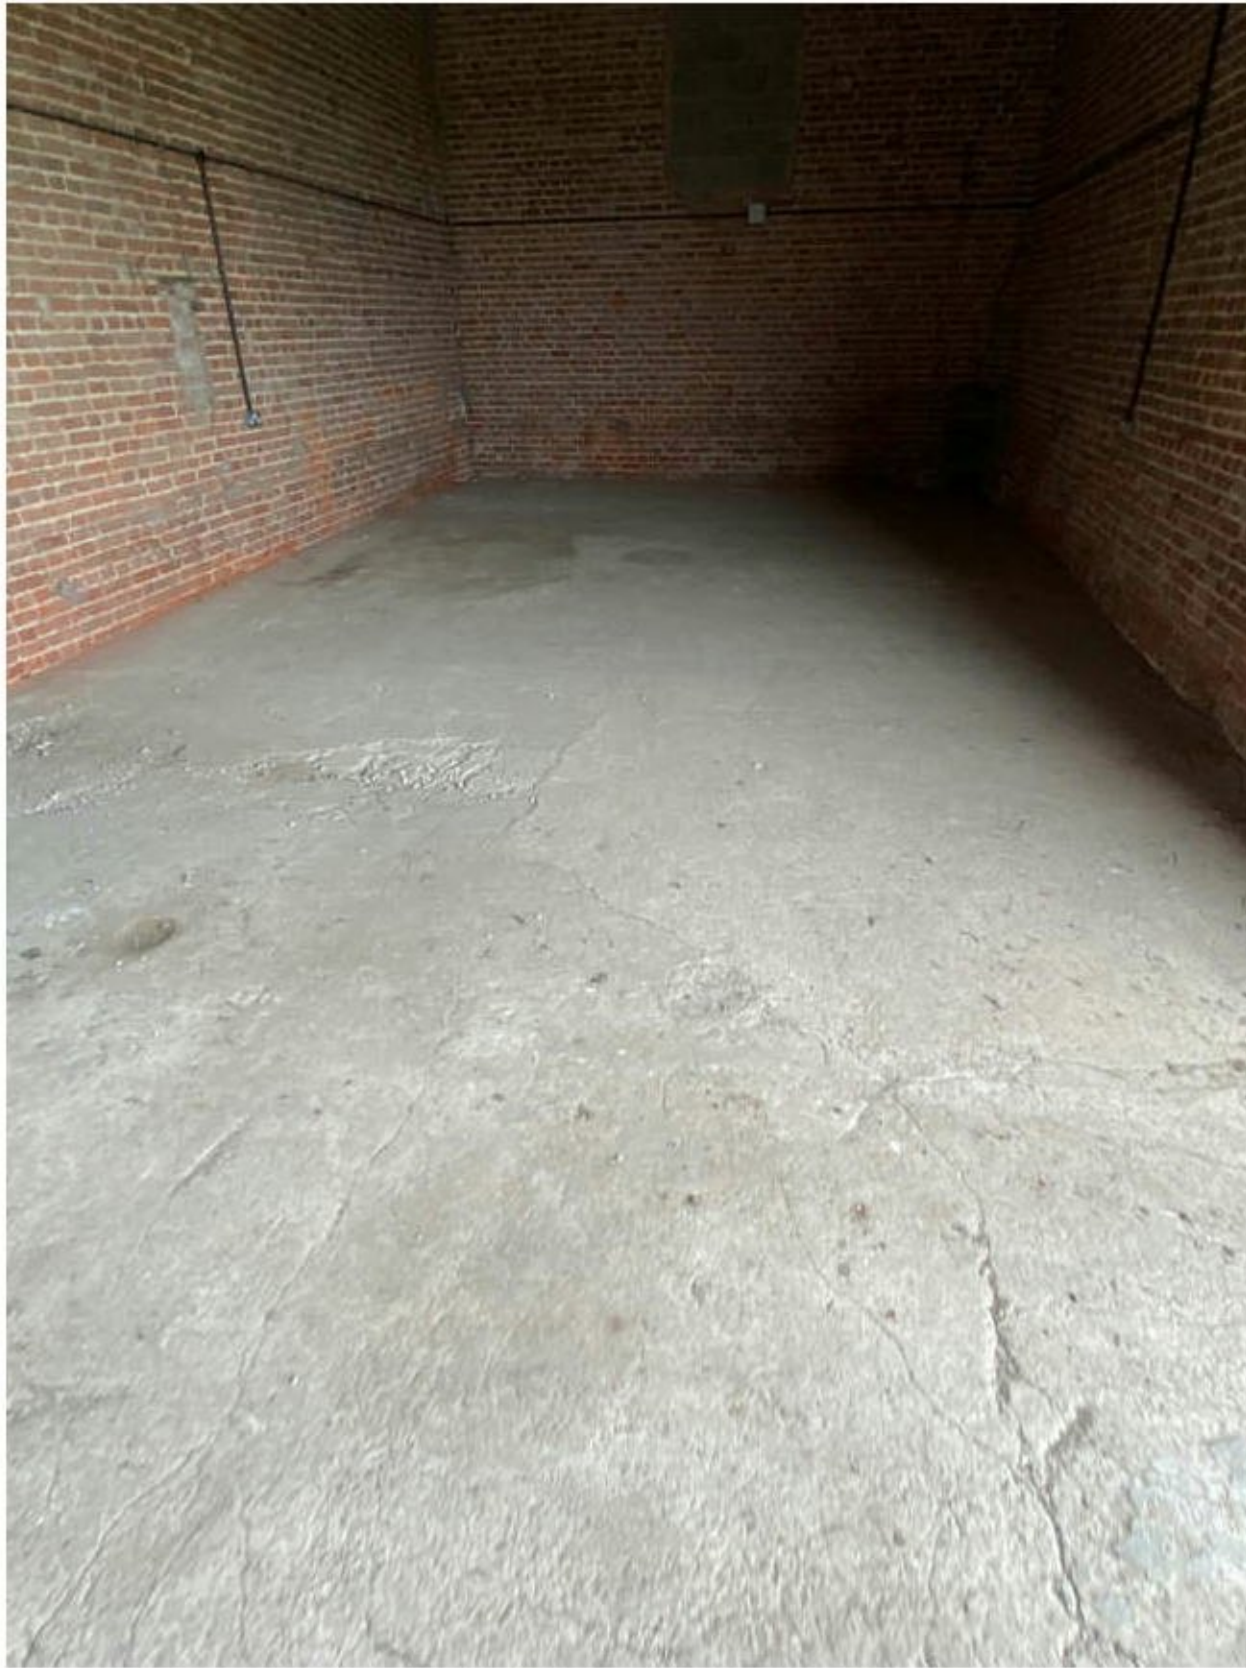
- 2.1.9 The ground floor slab is in good condition for an Agricultural Building and is suitable to be used as a sub-base for a new concrete floor-insulation and screed as desired during conversion works.

The floor has clearly undergone significant loading with various agricultural machinery over the years and therefore, will easily be capable of supporting a domestic floor.

On this basis that the floor remains, there will also be no need to carry out any trial holes in order to confirm the depth of the existing footings as there will be no need to undermine these during the installation of a new floor slab. (Please refer to Photograph 16 in Appendix 'A').

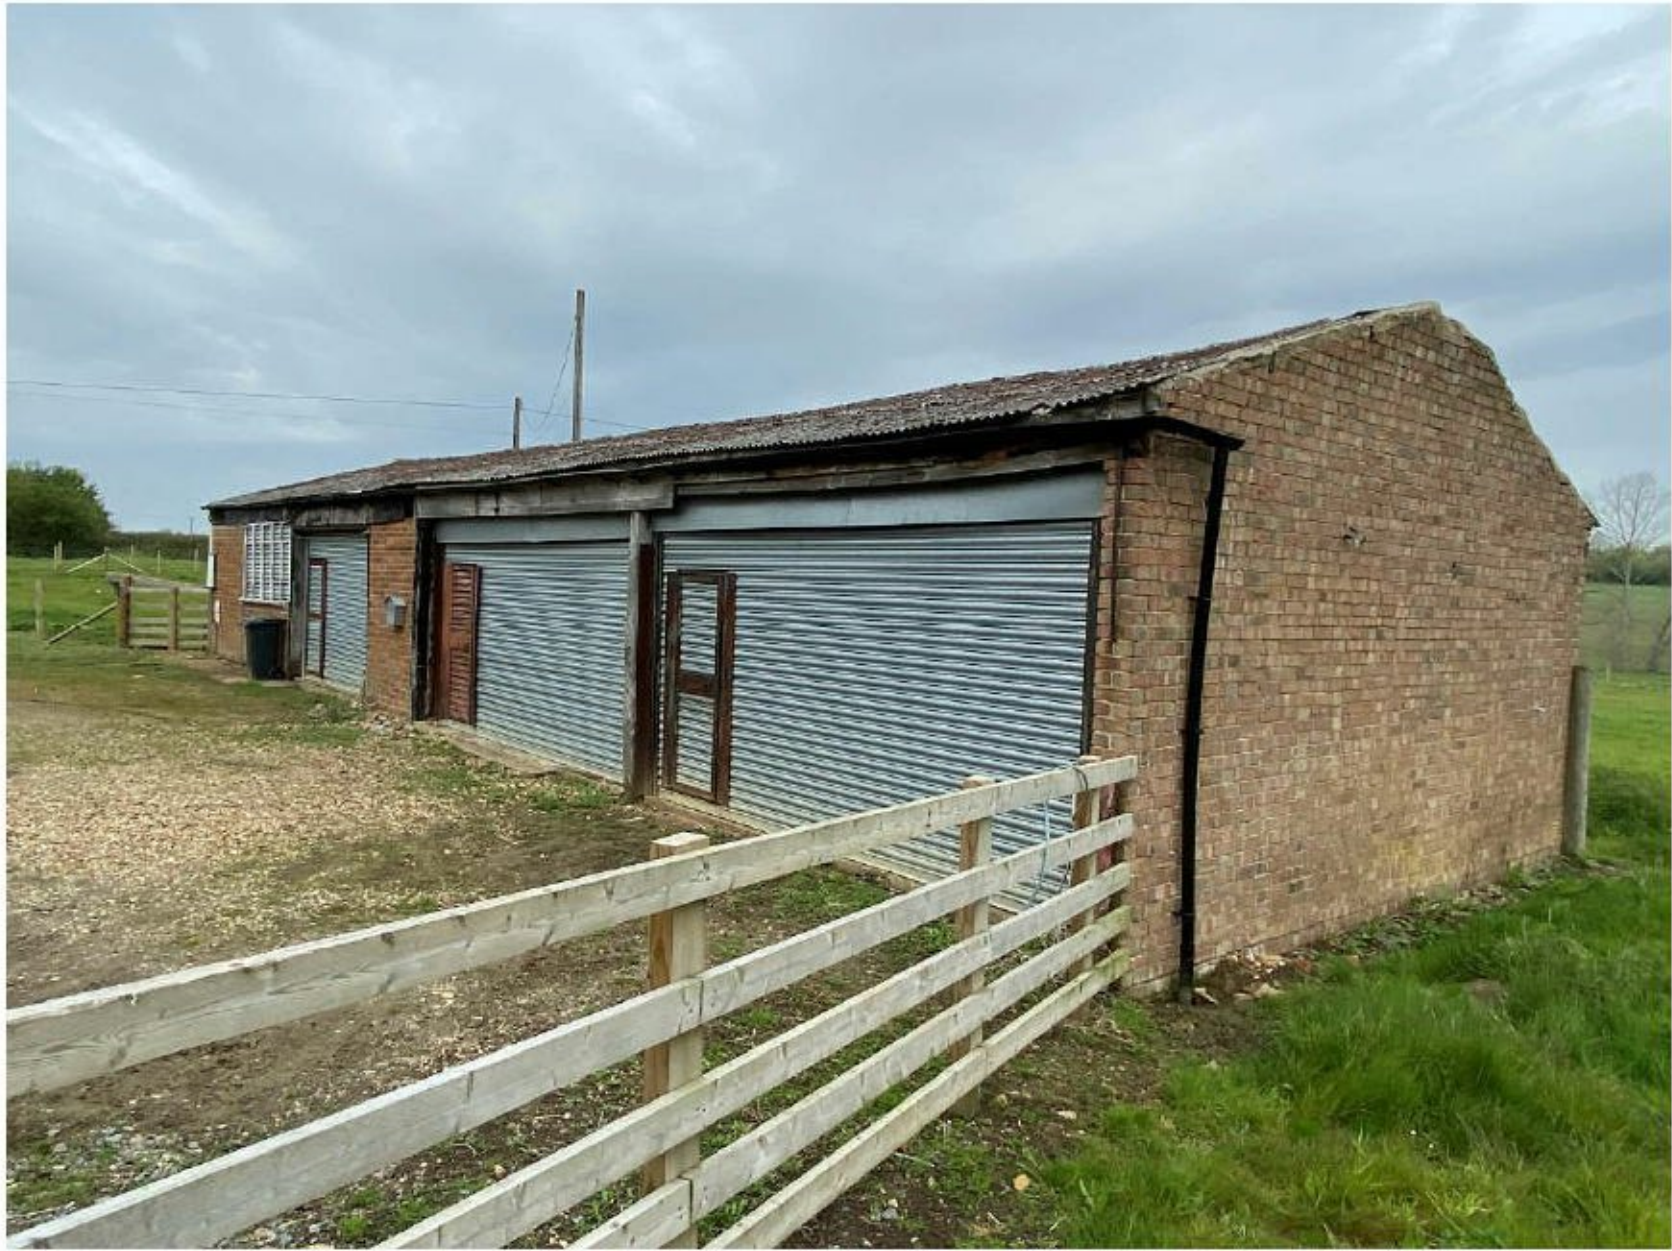
2.2.1 In principle, this is a brick built, relatively smaller Barn in relation to Barns 1 & 3 and has been converted from what is likely to have been an open Barn in the past. (Please refer to Photograph 17 in Appendix 'A').

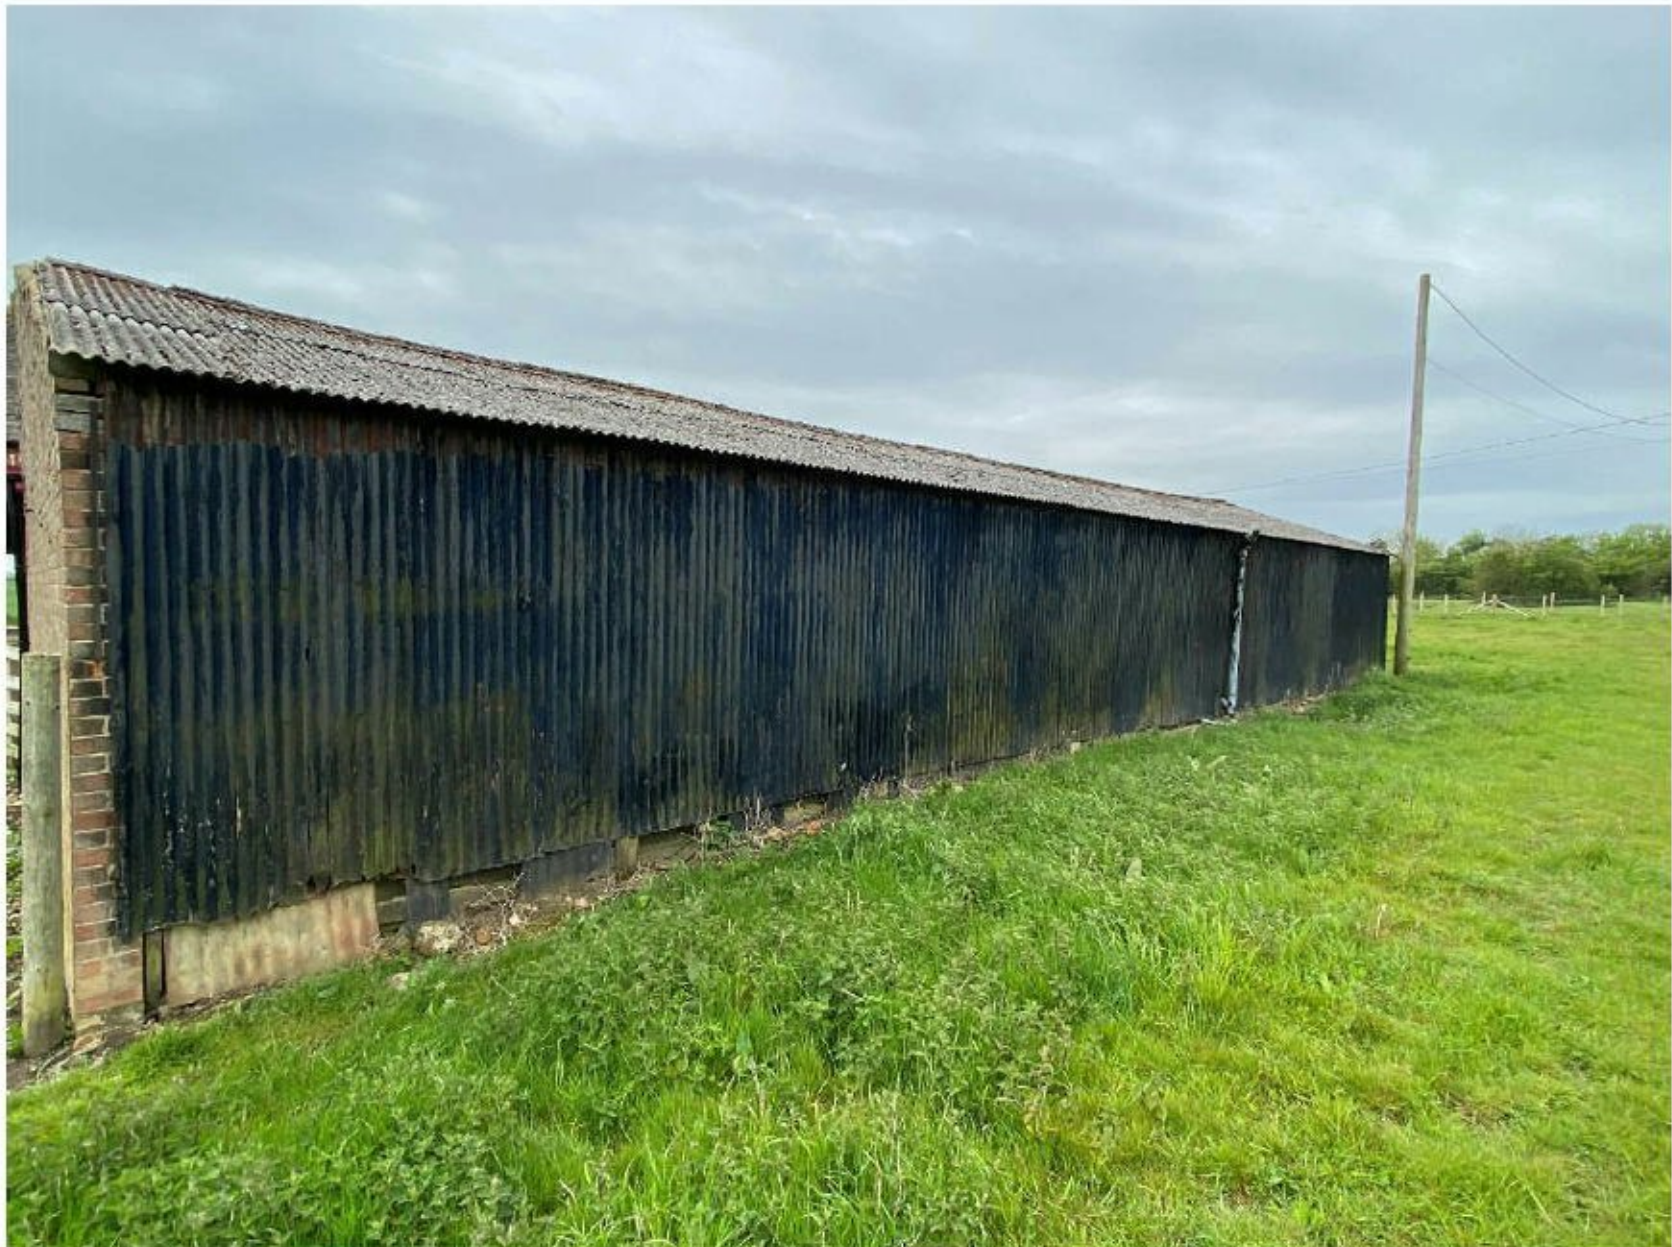
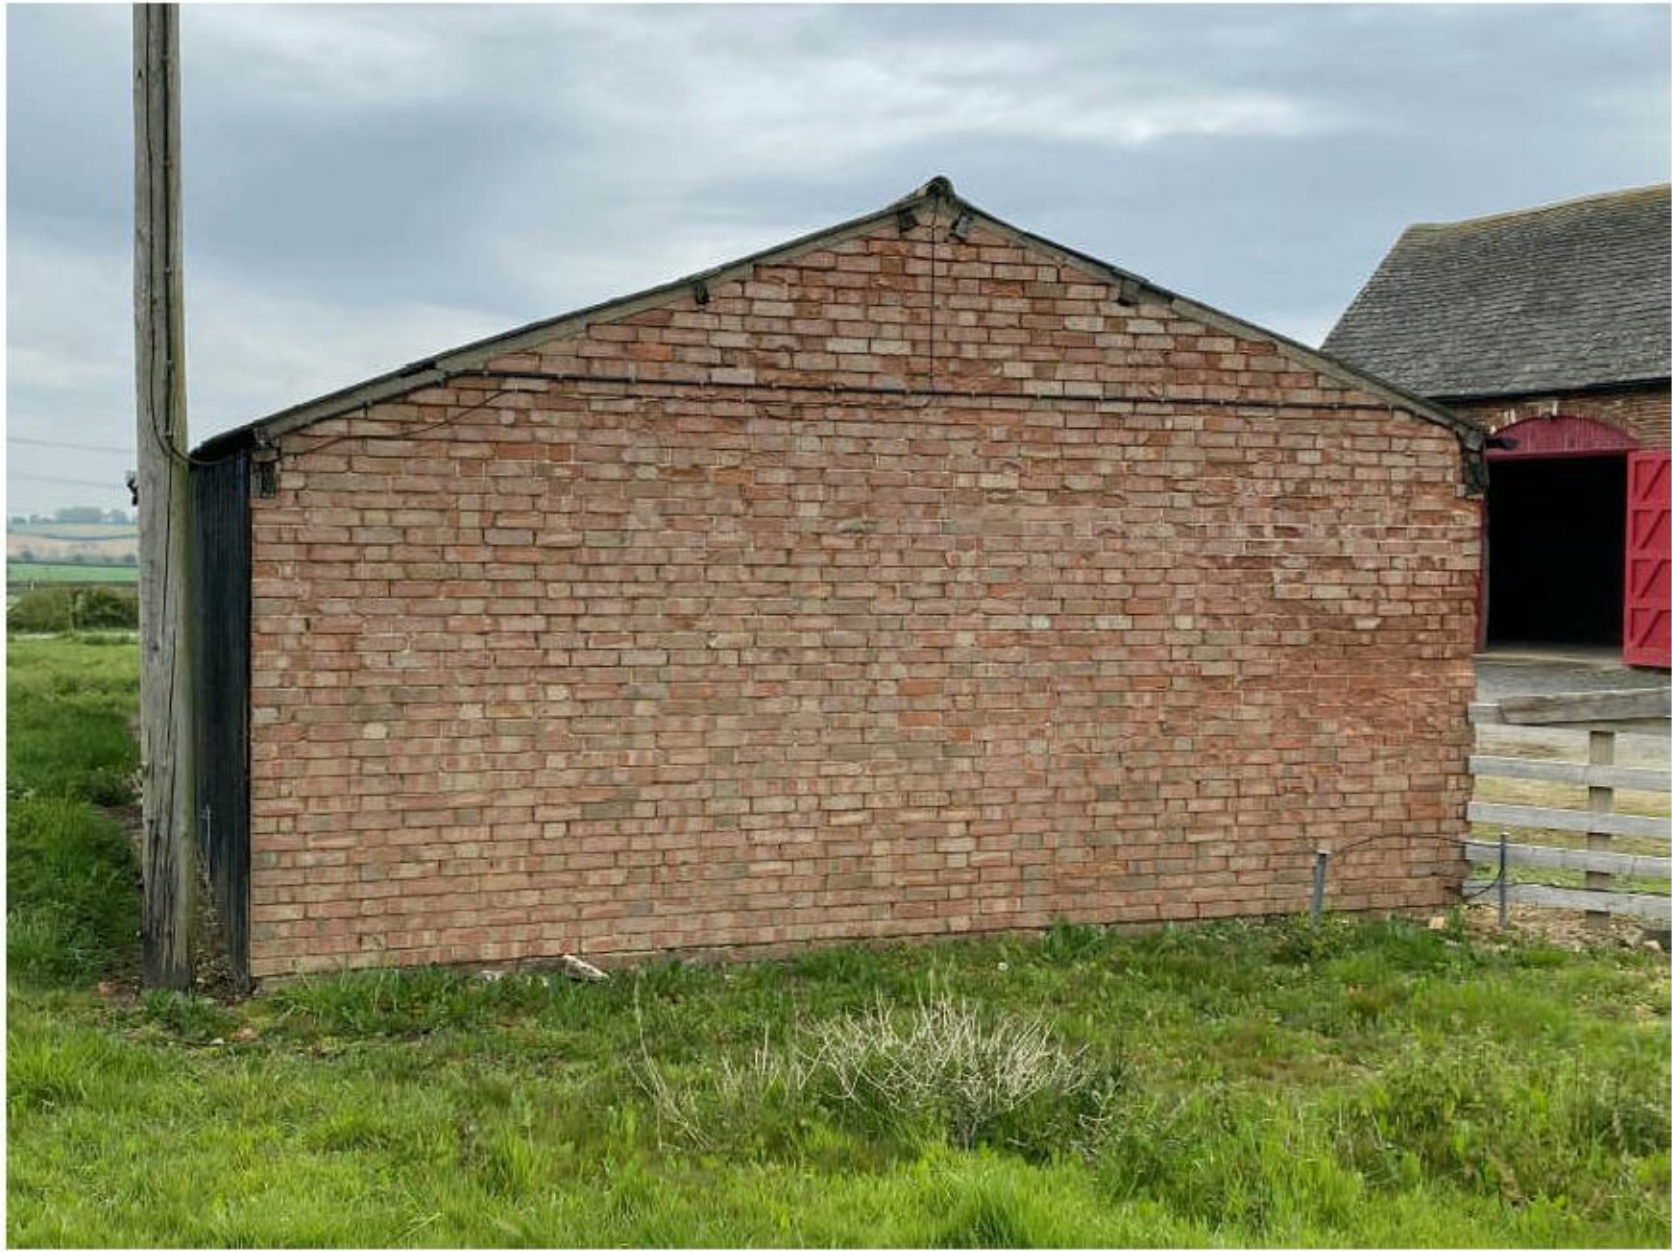
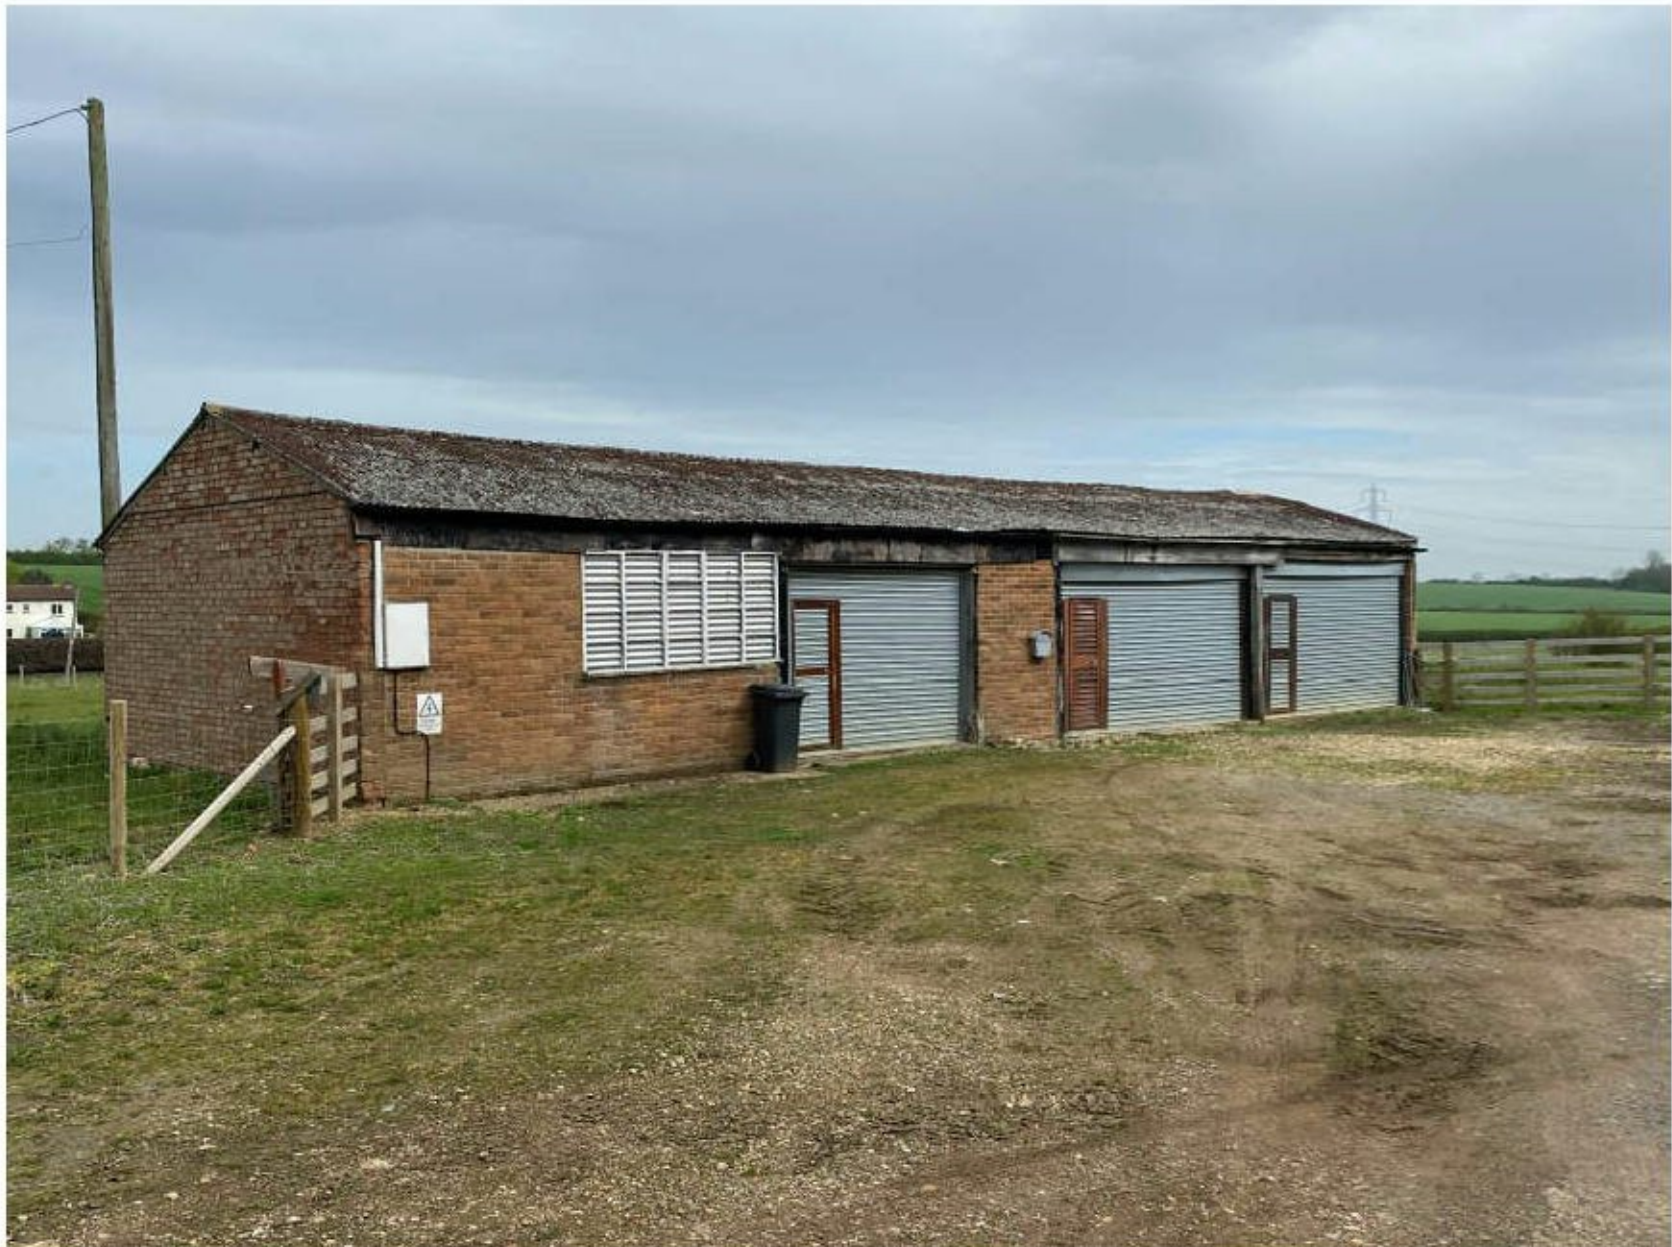
2.2.2 The gable ends are 9" brickwork, and the Western elevation consists of a combination of cladding and blockwork up to dado level. The Eastern elevation looks like it has been infilled in possible the 60's or 70's with new roller shutter doors creating three units. (Please refer to Photographs 18 – 20 in Appendix 'A').
