Ref: 21 / 43971  
Date: May 2021  
Prepared by: Steve Ainge

**CLIENT:  
BLETSOES  
OAKLEIGH HOUSE  
THRAPSTON  
NORTHANTS  
NN14 4LJ**

**VISUAL STRUCTURAL  
INSPECTION OF  
AMERICA FARM,  
WARMINGTON  
PE8 6UP**

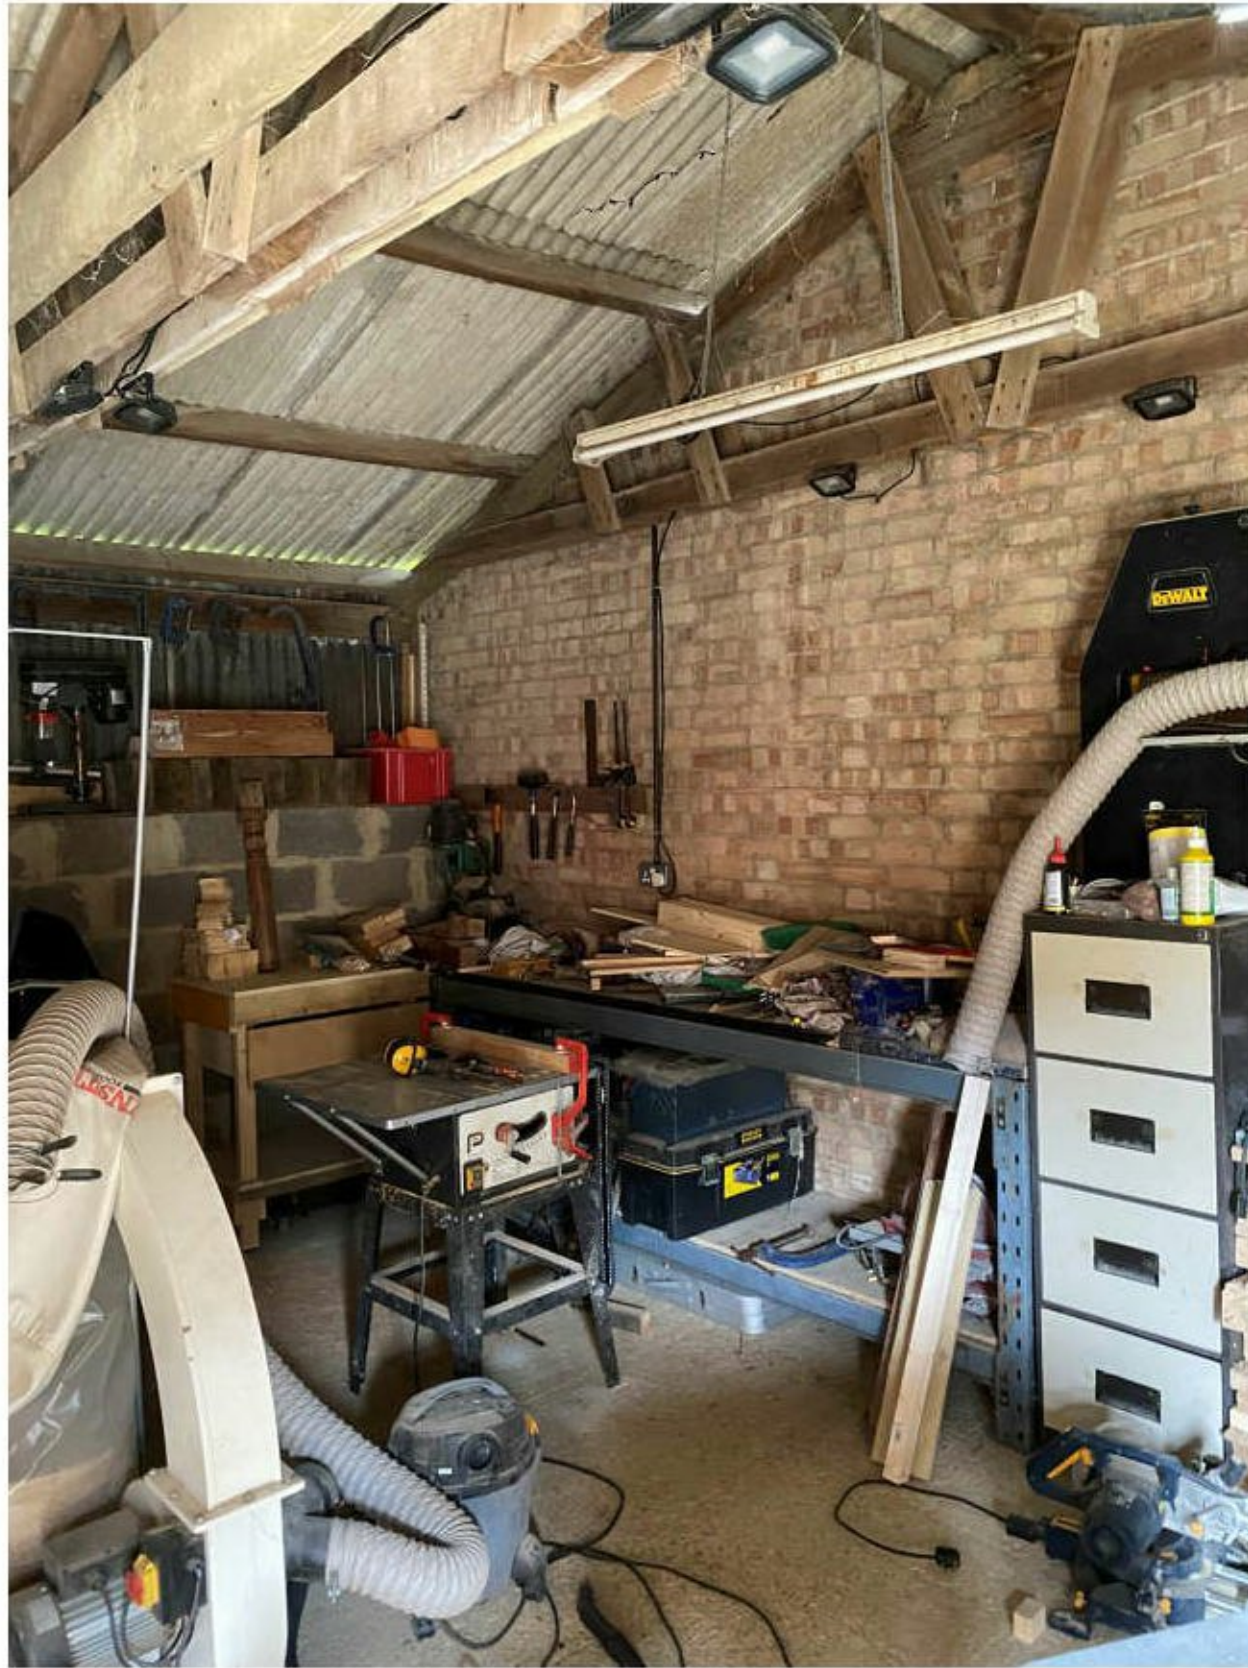
2.2.3 The roof structure is cementitious fibre carried by a cut timber roof with purlins running the full length of the Barn sitting on TRADA style trusses at regular centres. (Please refer to Photograph 21 in Appendix 'A').

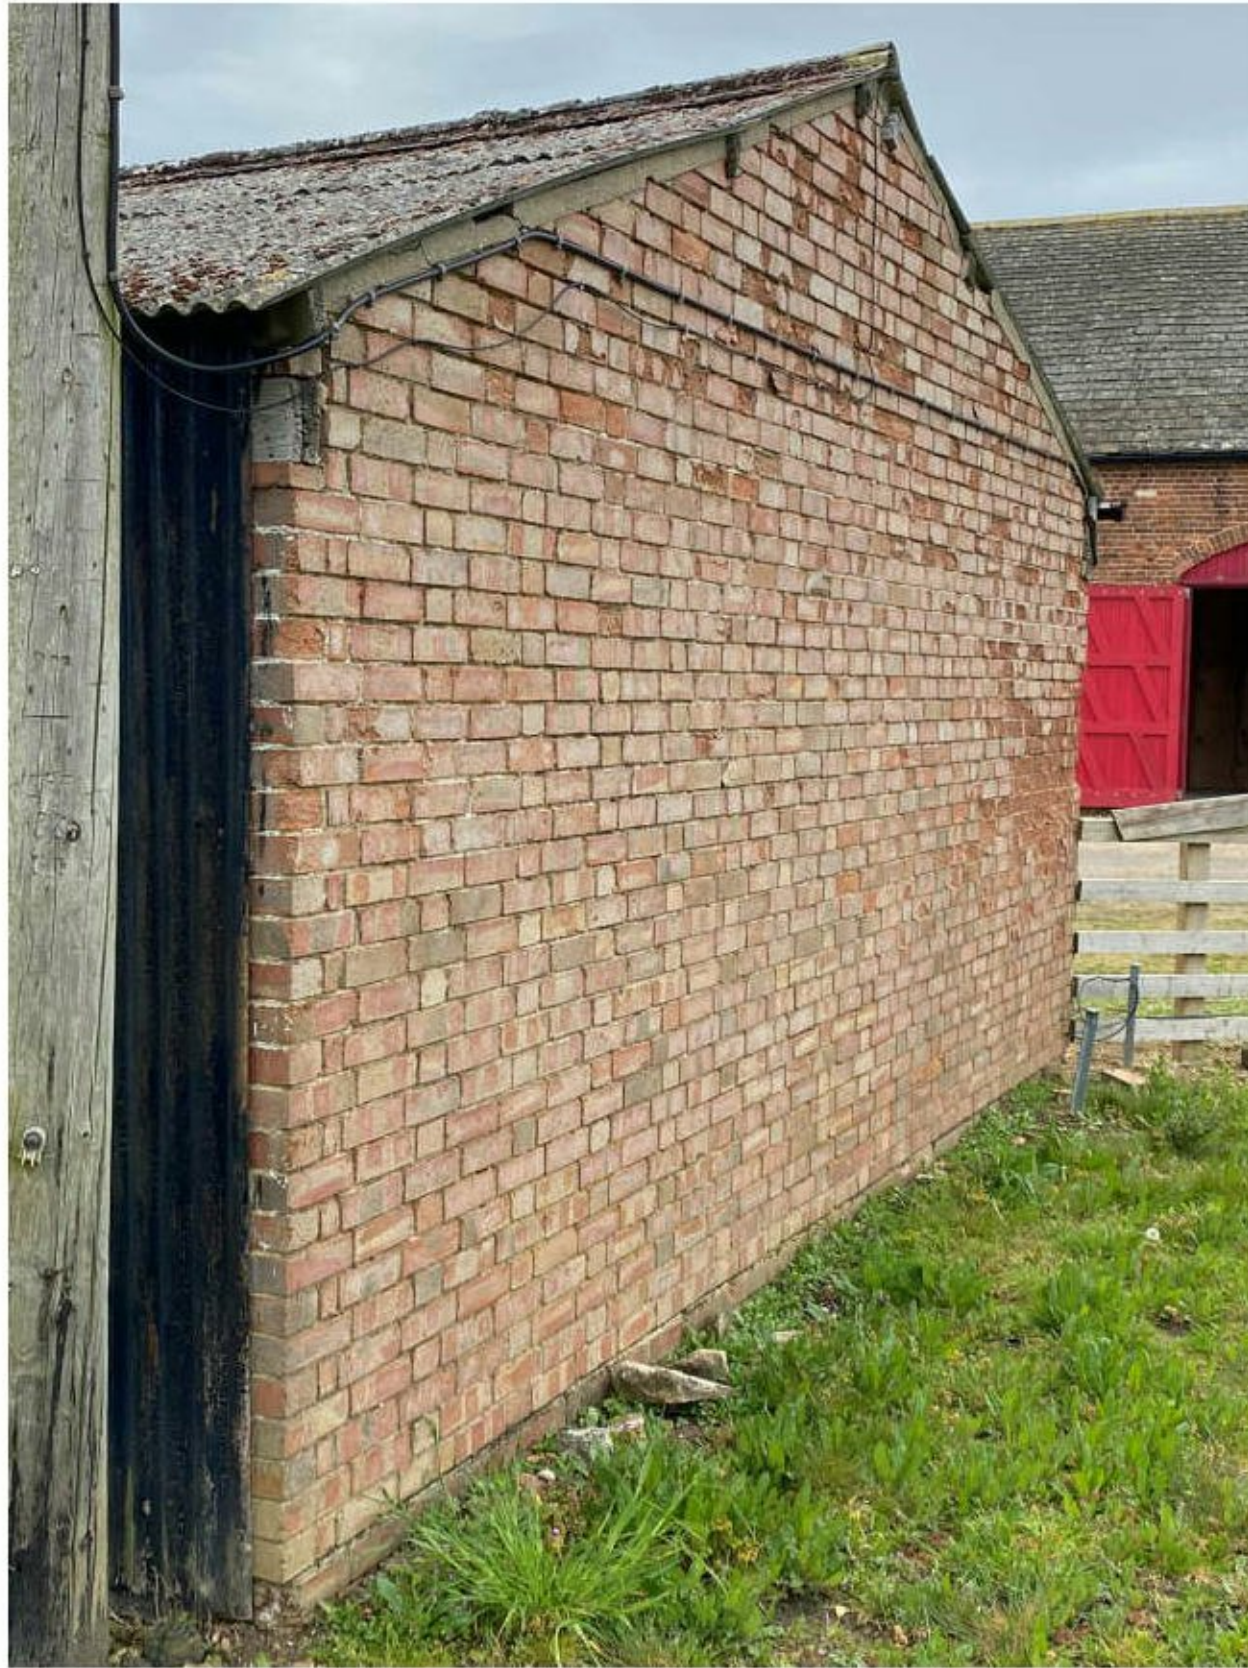
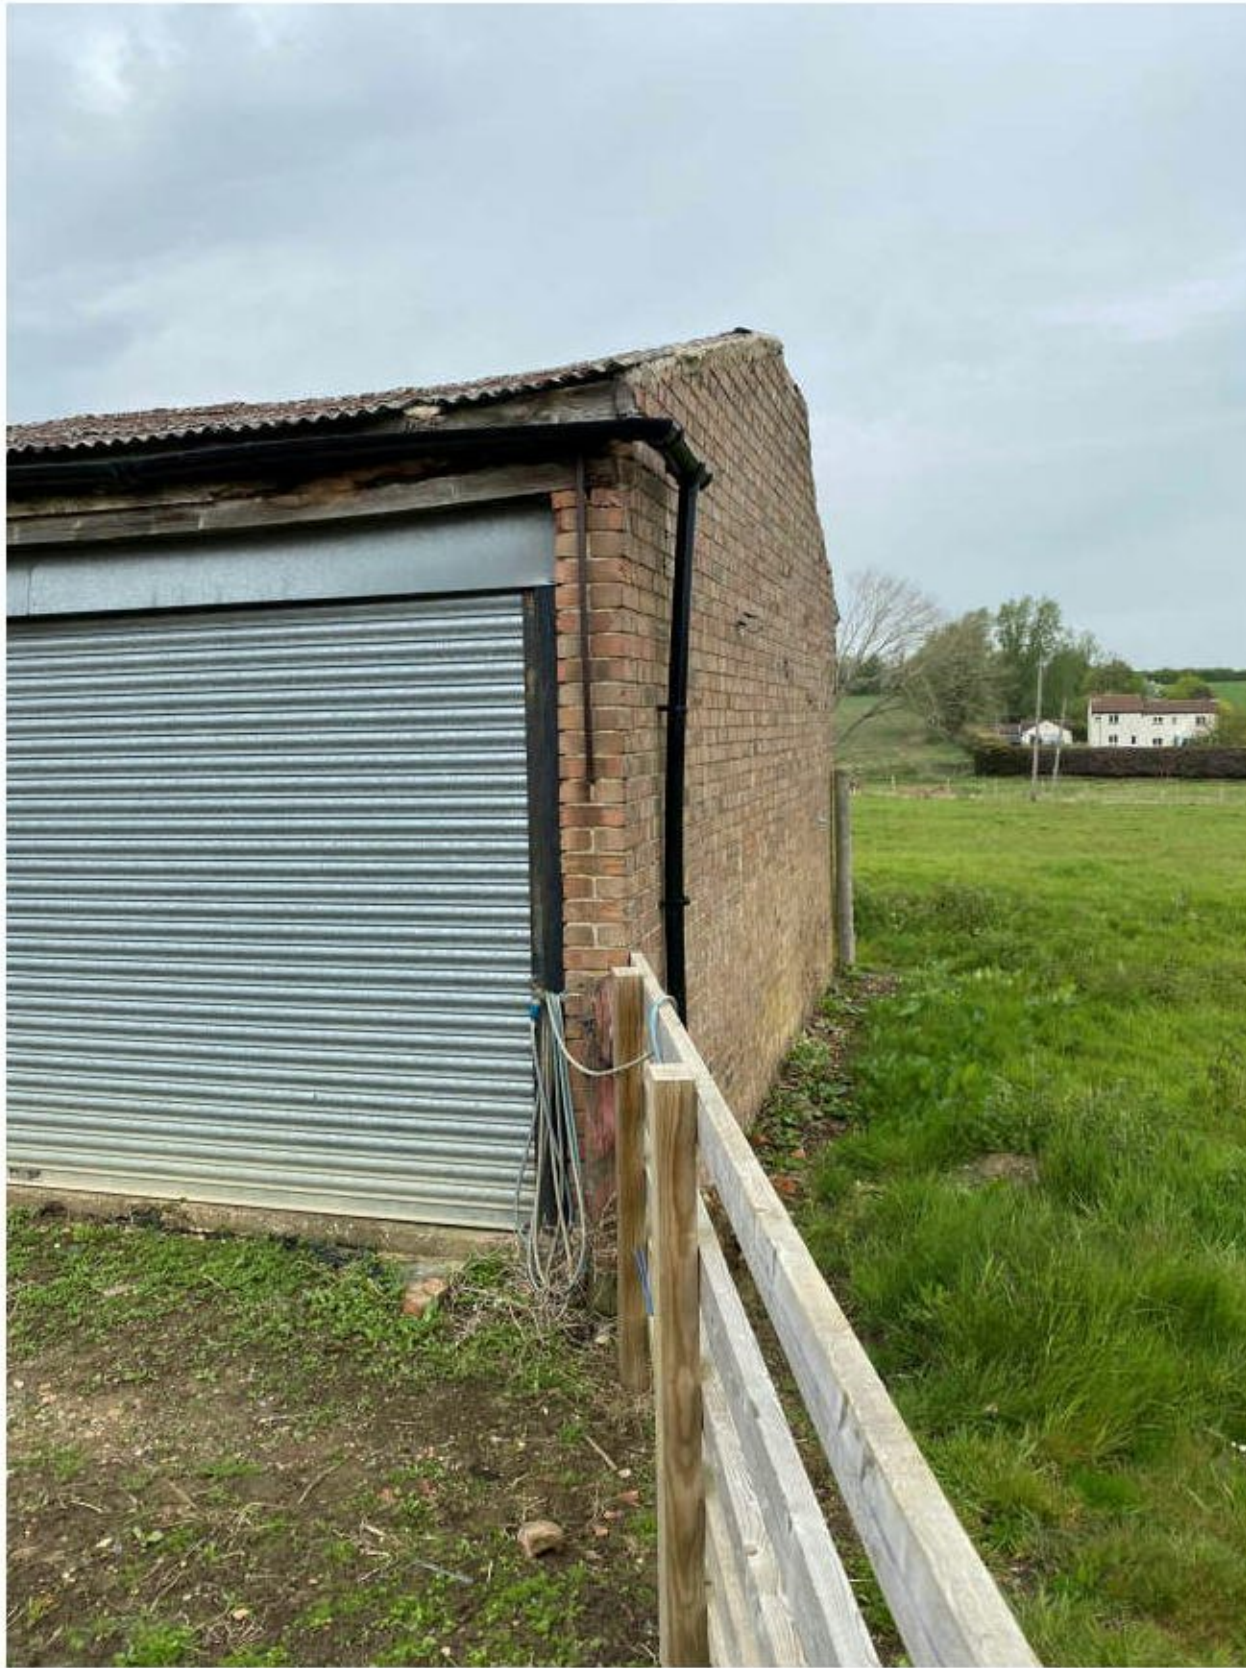
- 2.2.5 The Northern gable does show some minor leaning from eaves level up to ridge and this will benefit from the installation of a new ridged roof structure that can be tied back using galvanised straps in accordance with Building Regulations. (Please refer to Photograph 22 in Appendix 'A').
- 2.2.6 The timber lintels over the roller shutter doors do show some signs of rot and therefore, will need to be replaced as part of the conversion works albeit it is highly likely that these apertures will be partially infilled and therefore, this will negate this issue during conversion. (Please refer to Photograph 23 in Appendix 'A').
