Building Recording - First Floor

Internal Doors

Showing existing photos, noted location, frame condition, leaf condition and proposed refurbishment works

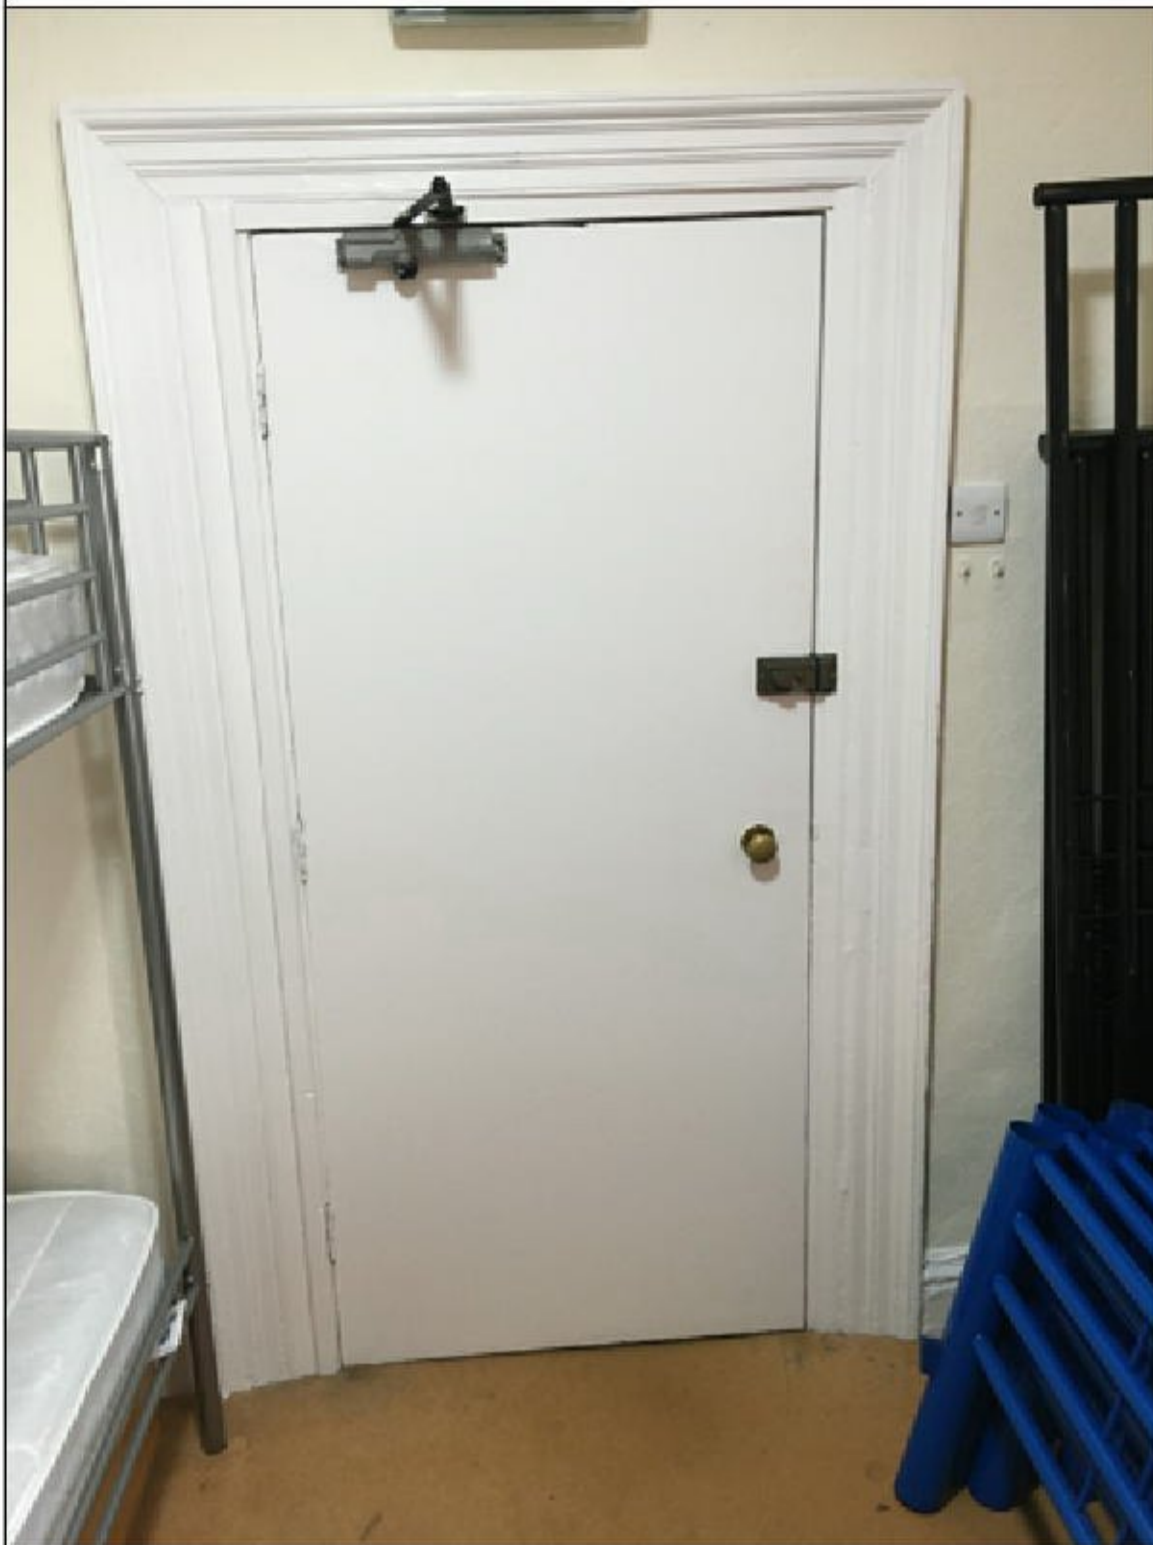
Internal Photo D101i

Photo Location - Brecon Dorm - Door Number **D101** - See floor plans for location

Door leaf - Presumed non original - Good condition

Frame and Architrave - Presumed original - Good condition

Glass - None

- Refurbish and repaint frame

Door leaf replaced

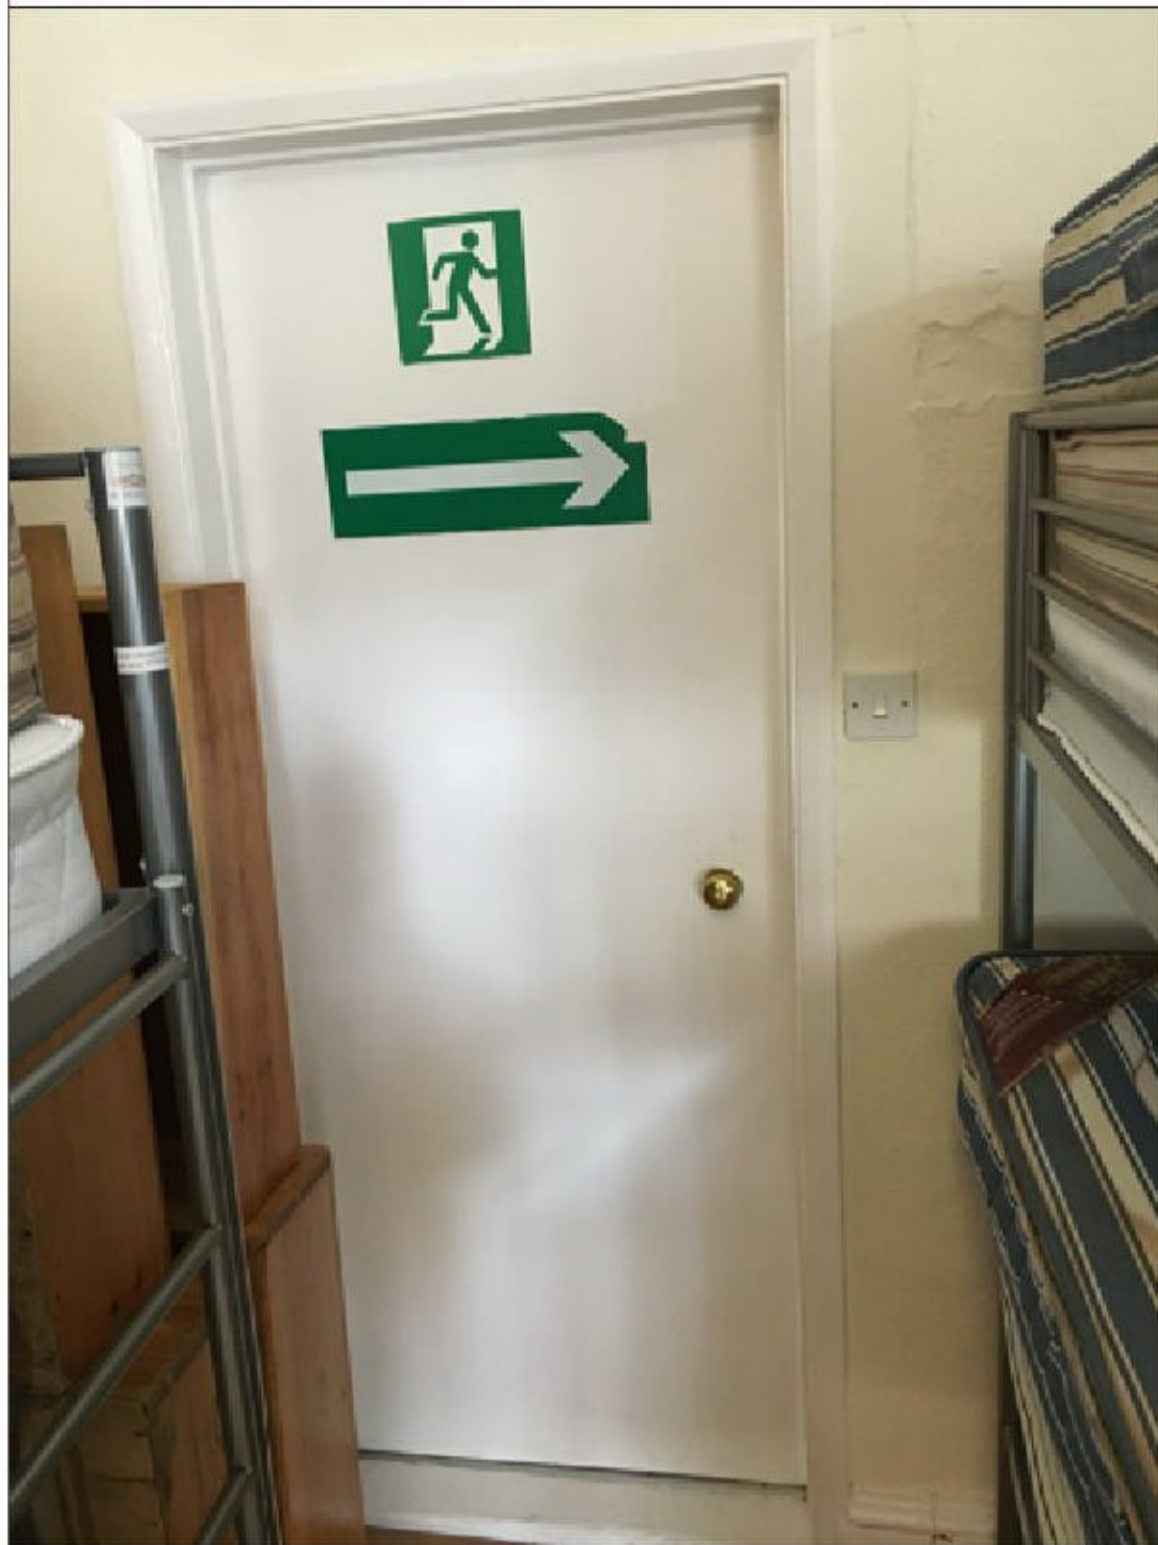
Internal Photo D102i

Photo Location - Brecon Dorm - Door Number **D102** - See floor plans for location

Door leaf - Presumed non original - Good condition

Frame and Architrave - Presumed original - Good condition

- Removed in proposed, see proposed plans 001158 _ **111**

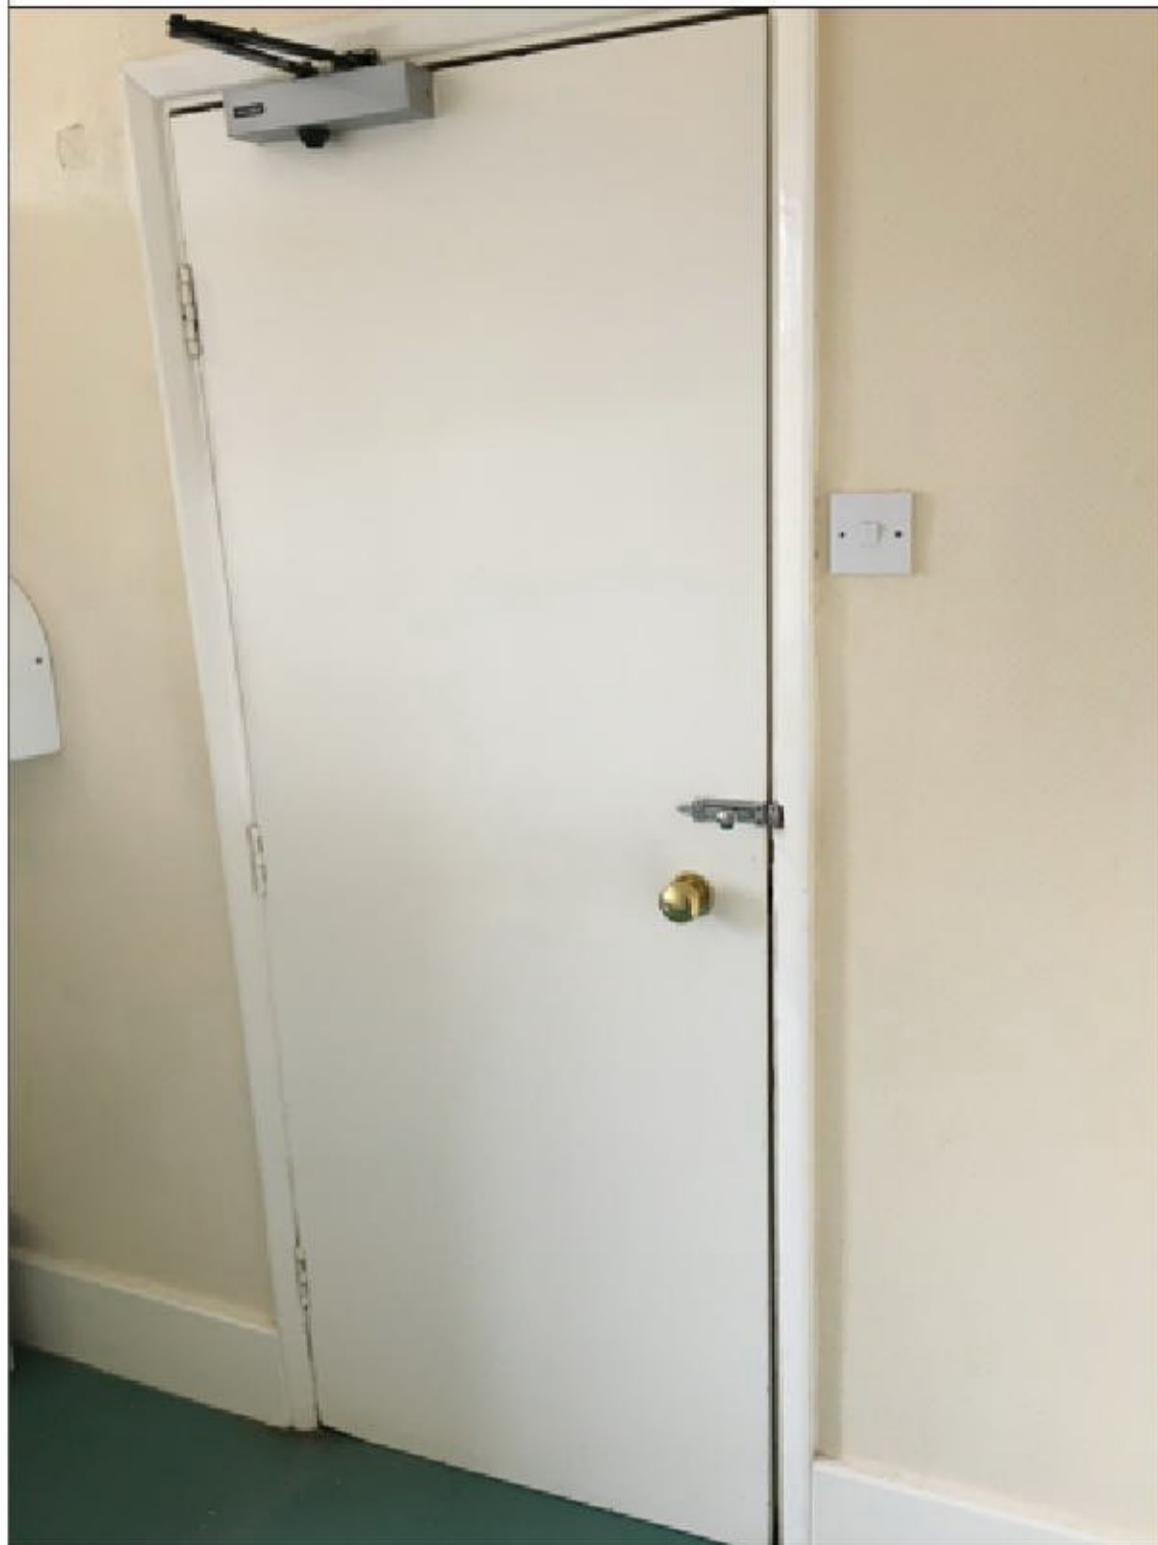
Internal Photo D103i

Photo Location - Brecon Dorm Wc - Door Number **D103** - See floor plans for location

Door leaf - Presumed non original - Good condition

Frame and Architrave - Presumed non original - Good condition

- Removed in proposed, see proposed plans 001158 _ **111**

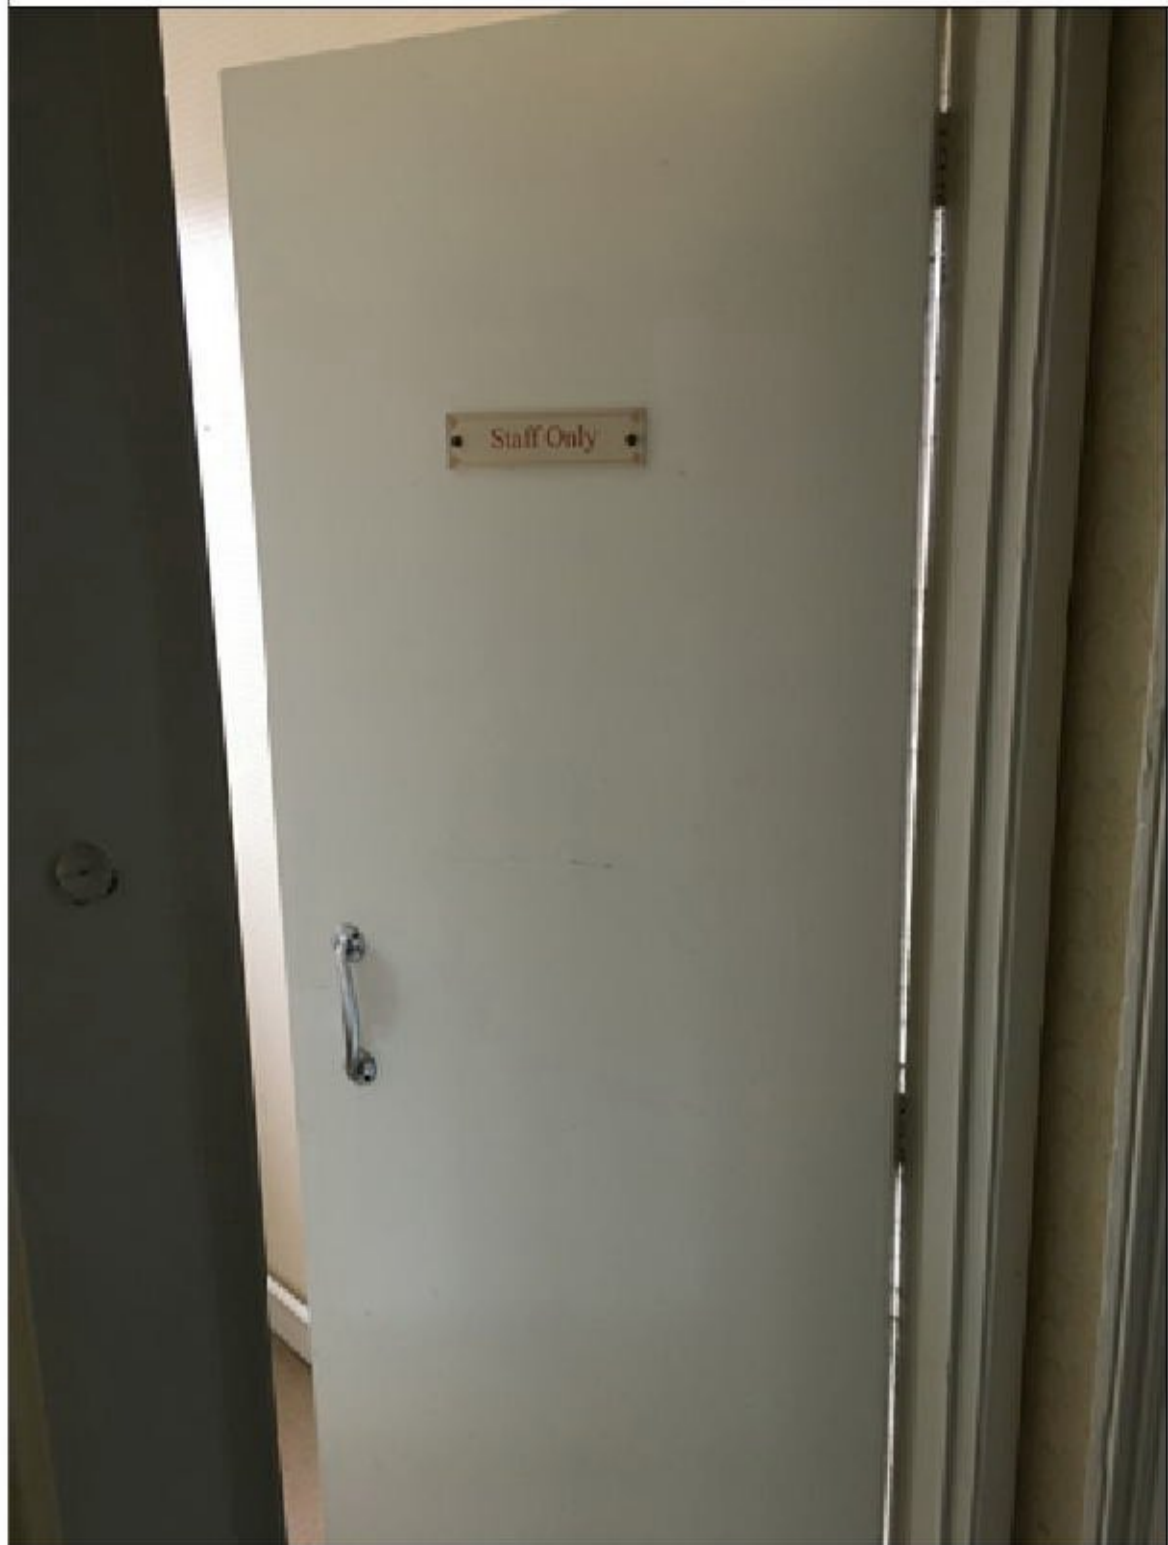
Internal Photo D104i

Photo Location - Wc - Door Number **D104** - See floor plans for location

Door leaf - Presumed non original - Good condition

Frame and Architrave - Presumed original - Good condition

· None

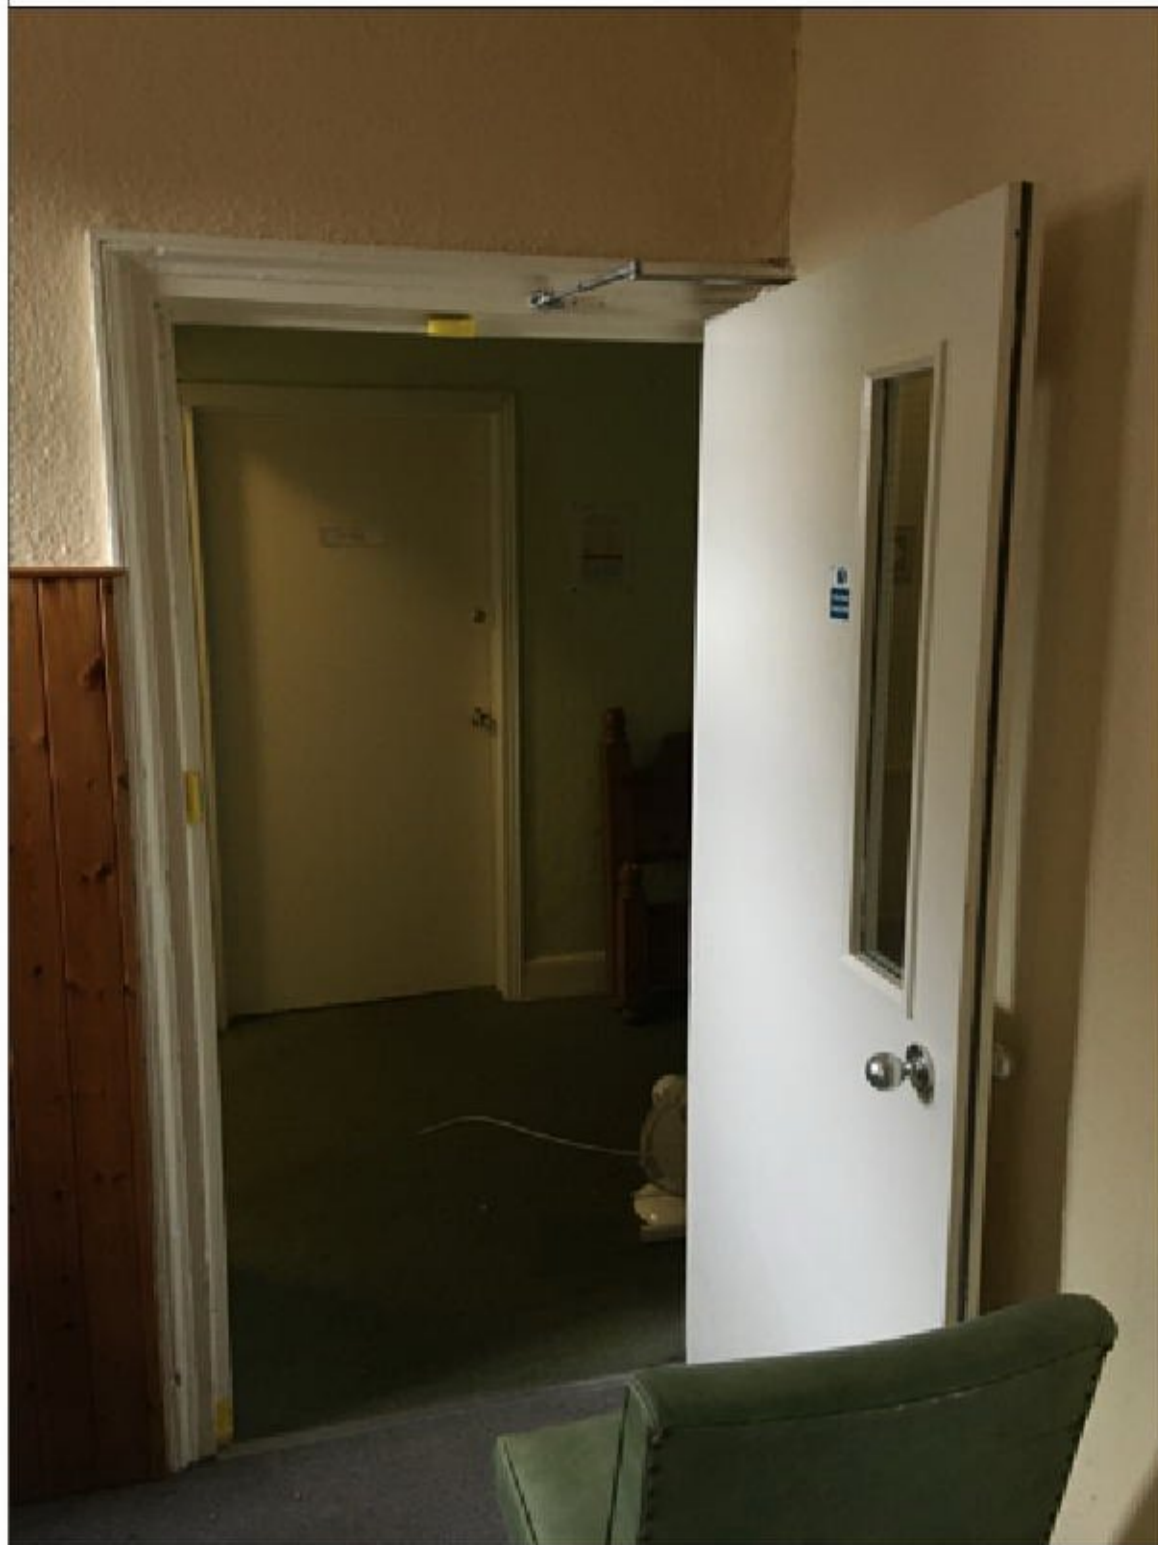
Internal Photo D105i

Photo Location - Back stairs - Door Number **D105** - See floor plans for location

Door leaf - Presumed non original - Good condition

Frame and Architrave - Presumed original - Good condition

Glass - Vision panel

- Removed in proposed, see proposed plans 001158 _ **111**

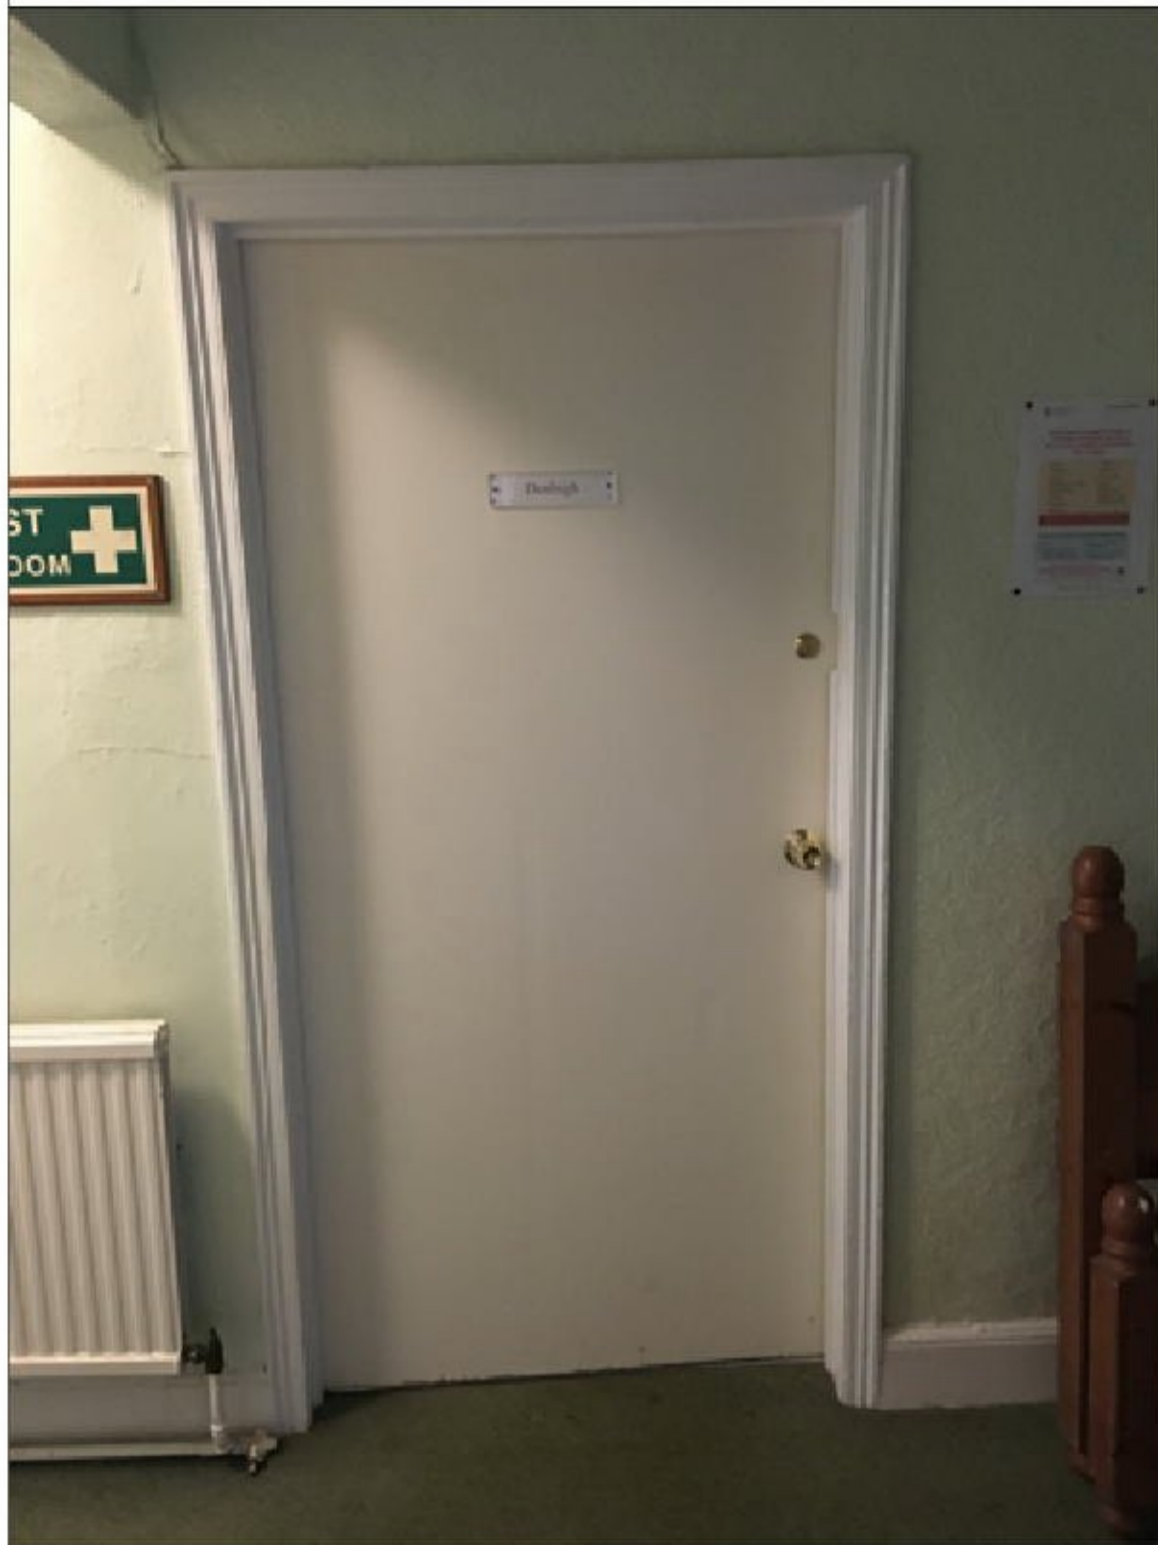
Internal Photo D106i

Photo Location - Landing - Door Number **D106** - See floor plans for location

Door leaf - Presumed non original - Good condition

Frame and Architrave - Presumed original - Good condition

· None

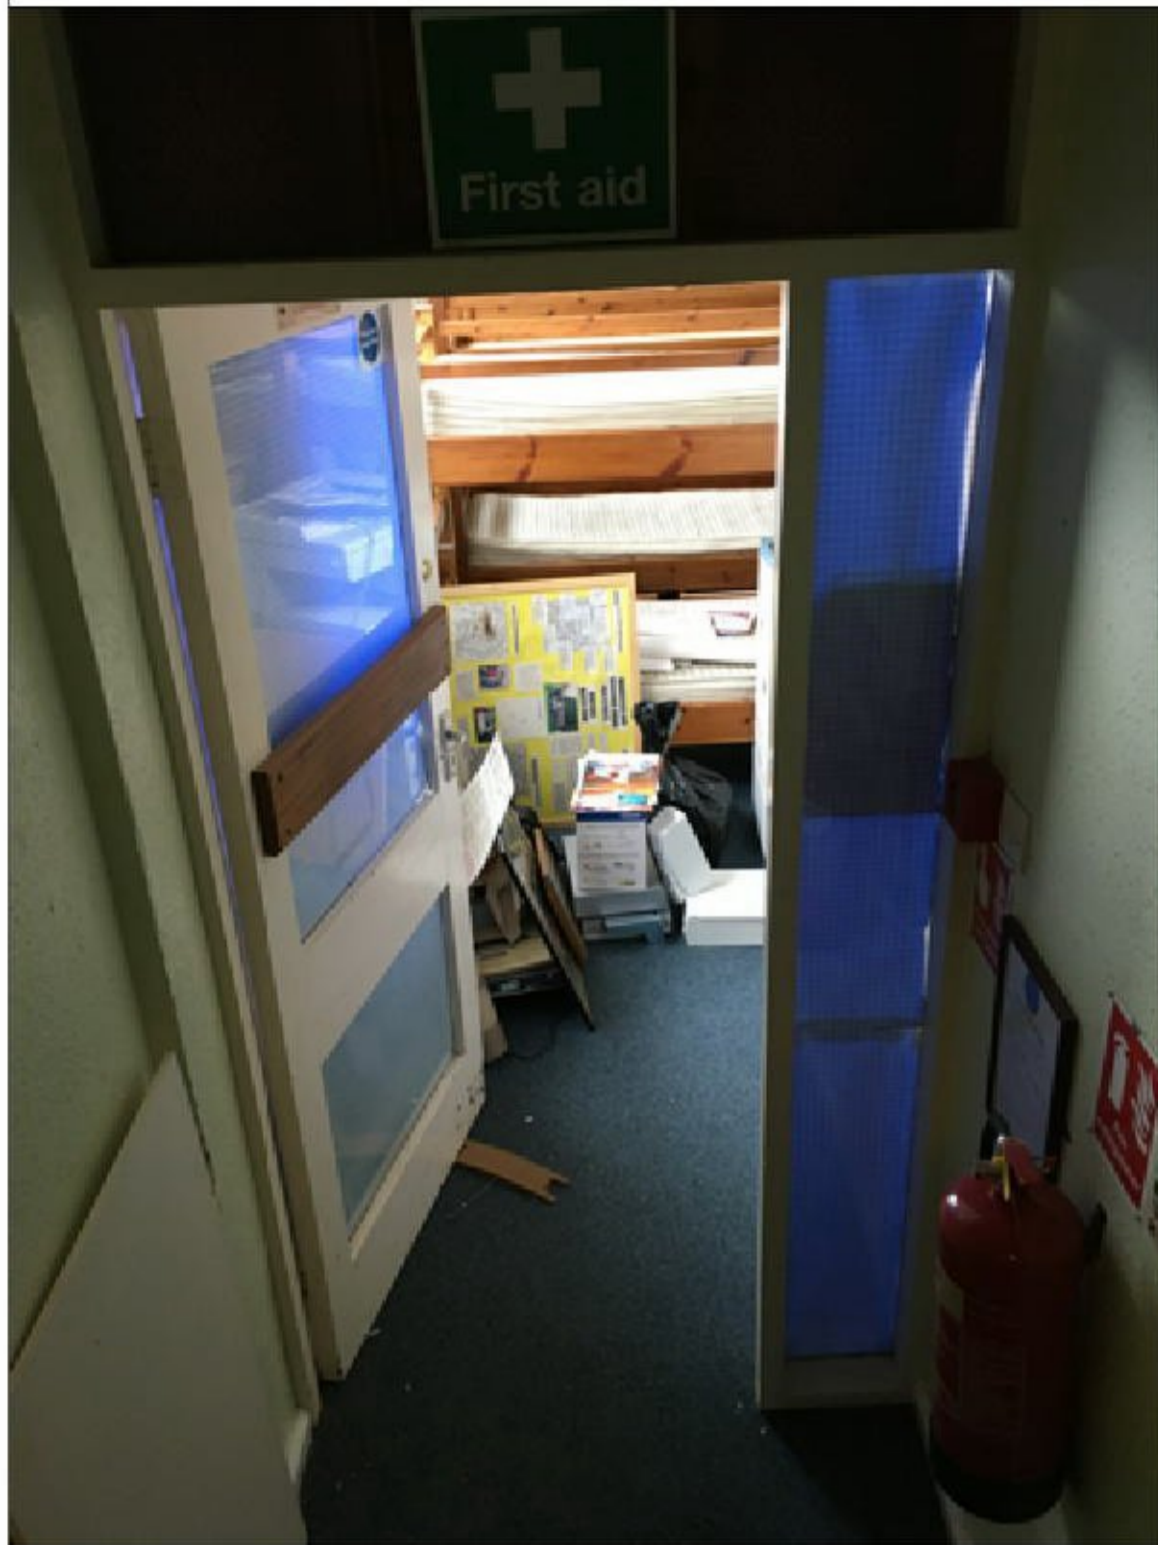
Internal Photo D107i

Photo Location - Lecture room - Door Number **D107** - See floor plans for location

Door leaf - Presumed original - Good condition

Frame and Architrave - Presumed original - Good condition

Glass - Safety Glass

- Removed in proposed, see proposed plans 001158 _ **111**

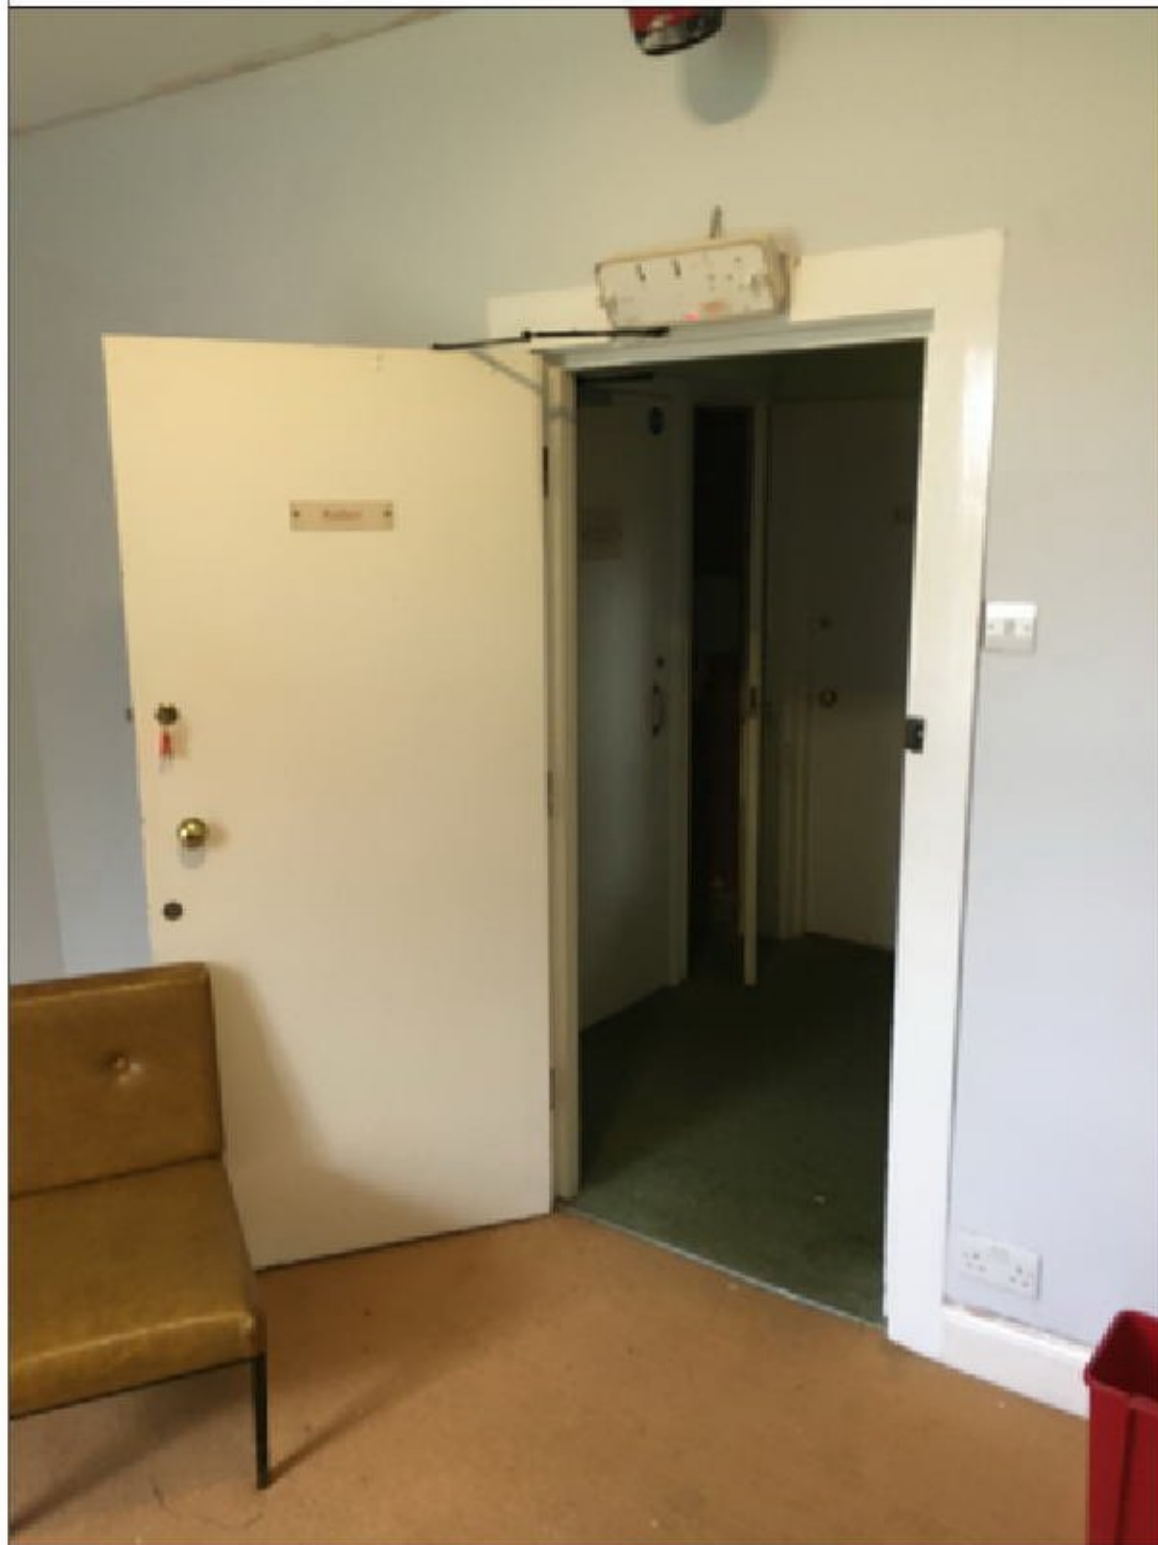
Internal Photo D108i

Photo Location - Nador Dorm - Door Number **D108** - See floor plans for location

Door leaf - Presumed non original - Good condition

Frame and Architrave - Presumed original - Good condition

- Removed in proposed, see proposed plans 001158 _ **111**

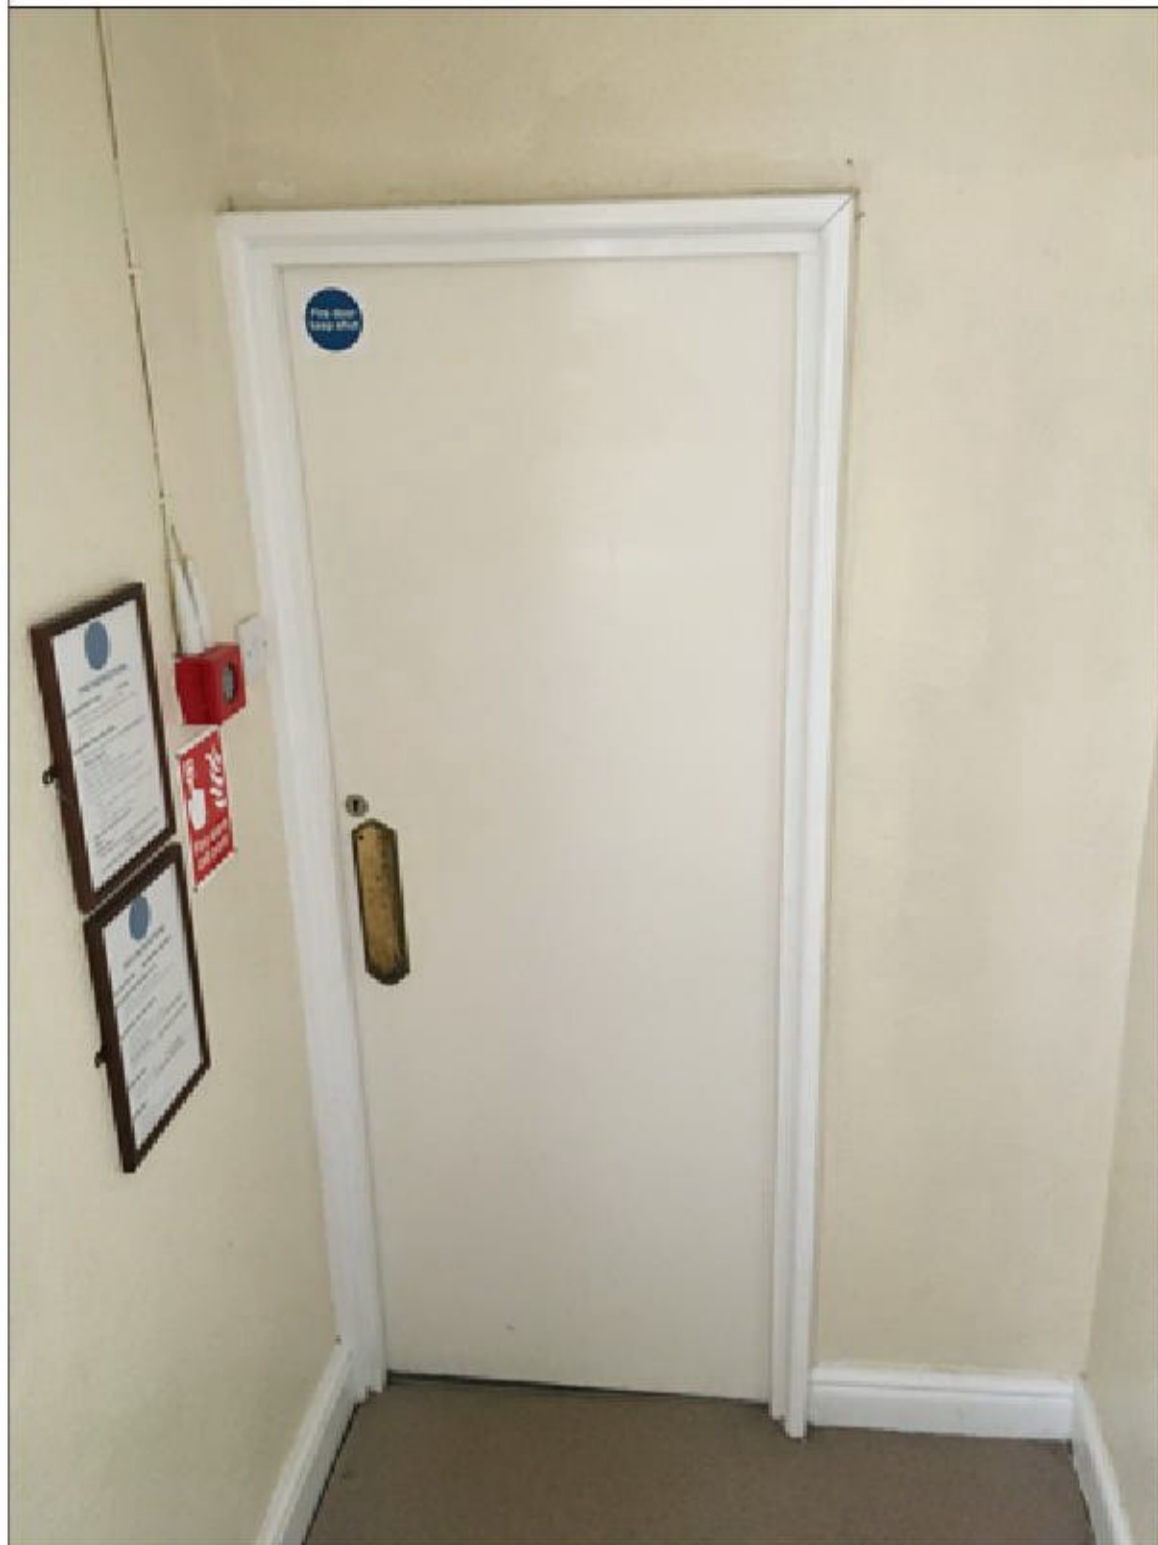
Internal Photo D109i

Photo Location - Wc - Door Number **D109** - See floor plans for location

Door leaf - Presumed non original - Good condition

Frame and Architrave - Presumed non original - Good condition

- Removed in proposed, see proposed plans 001158 _ **111**

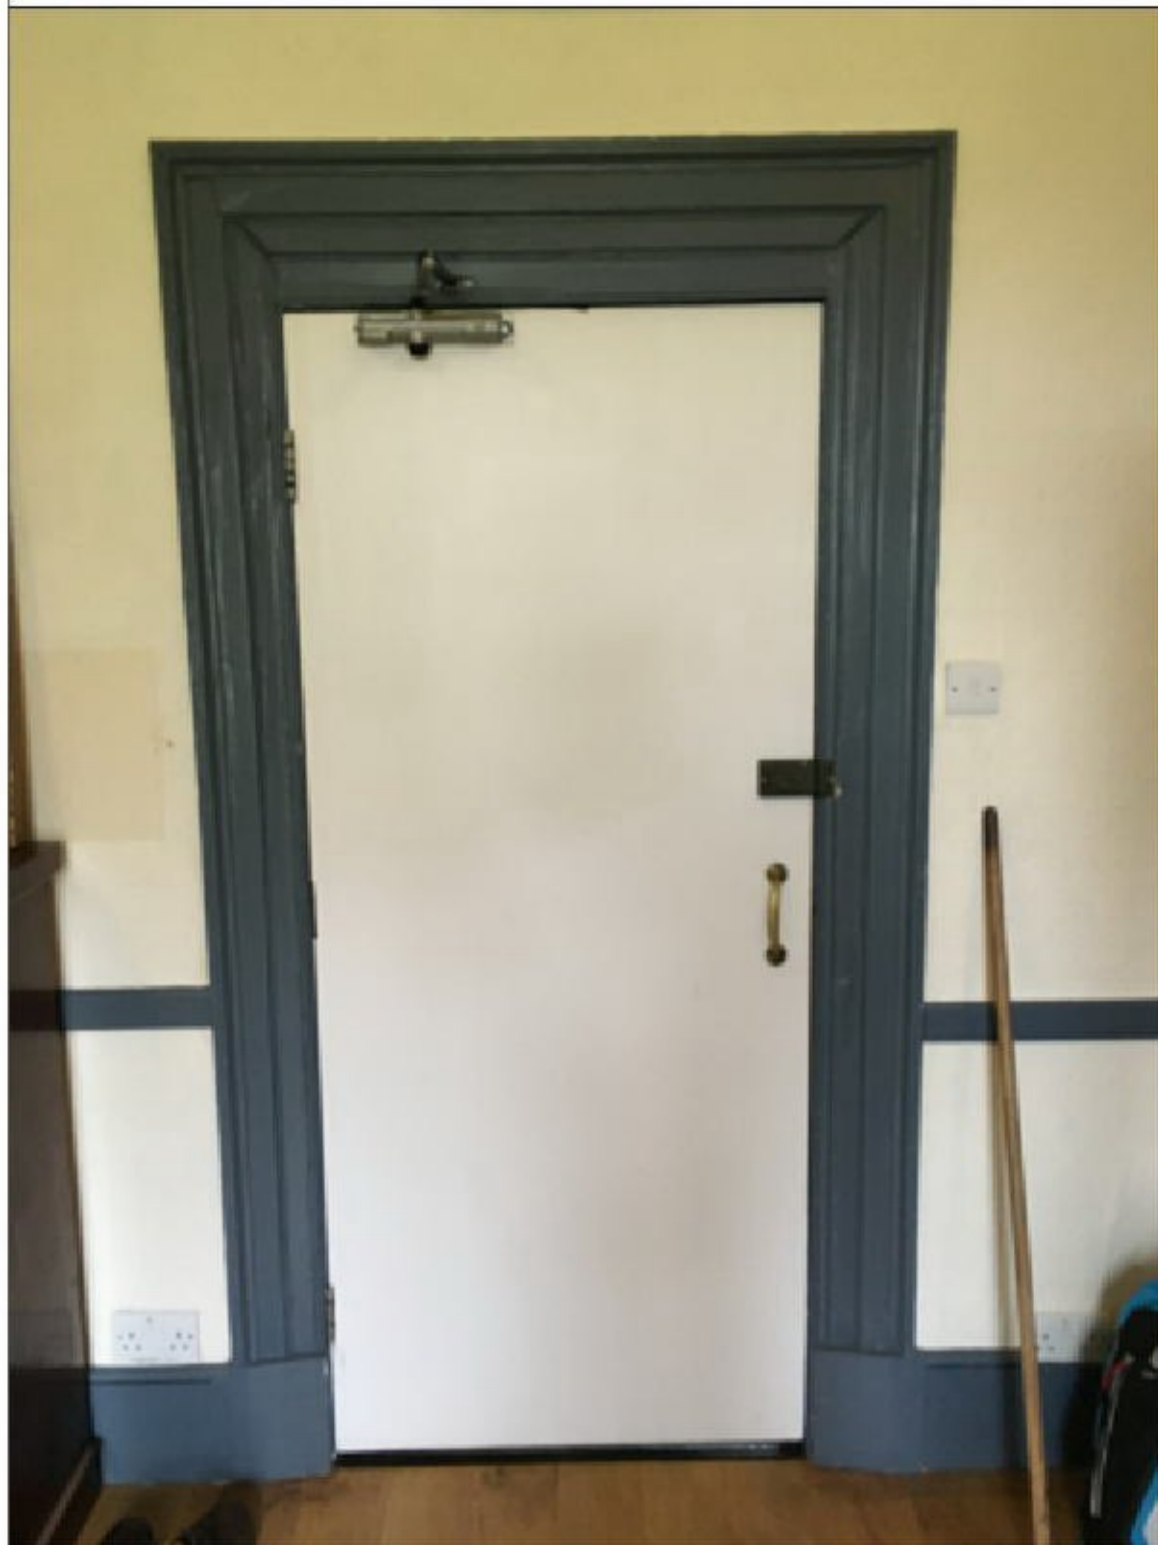
Internal Photo D110i

Photo Location - Wc - Door Number **D110** - See floor plans for location

Door leaf - Presumed non original - Good condition

Frame and Architrave - Presumed original - Good condition

- To enable a new ensuite bathroom and greater amenity for the users the existing opening is to be filled in a reversible manner, retain all existing frame and architrave. See proposed plans 001158 _ **111**

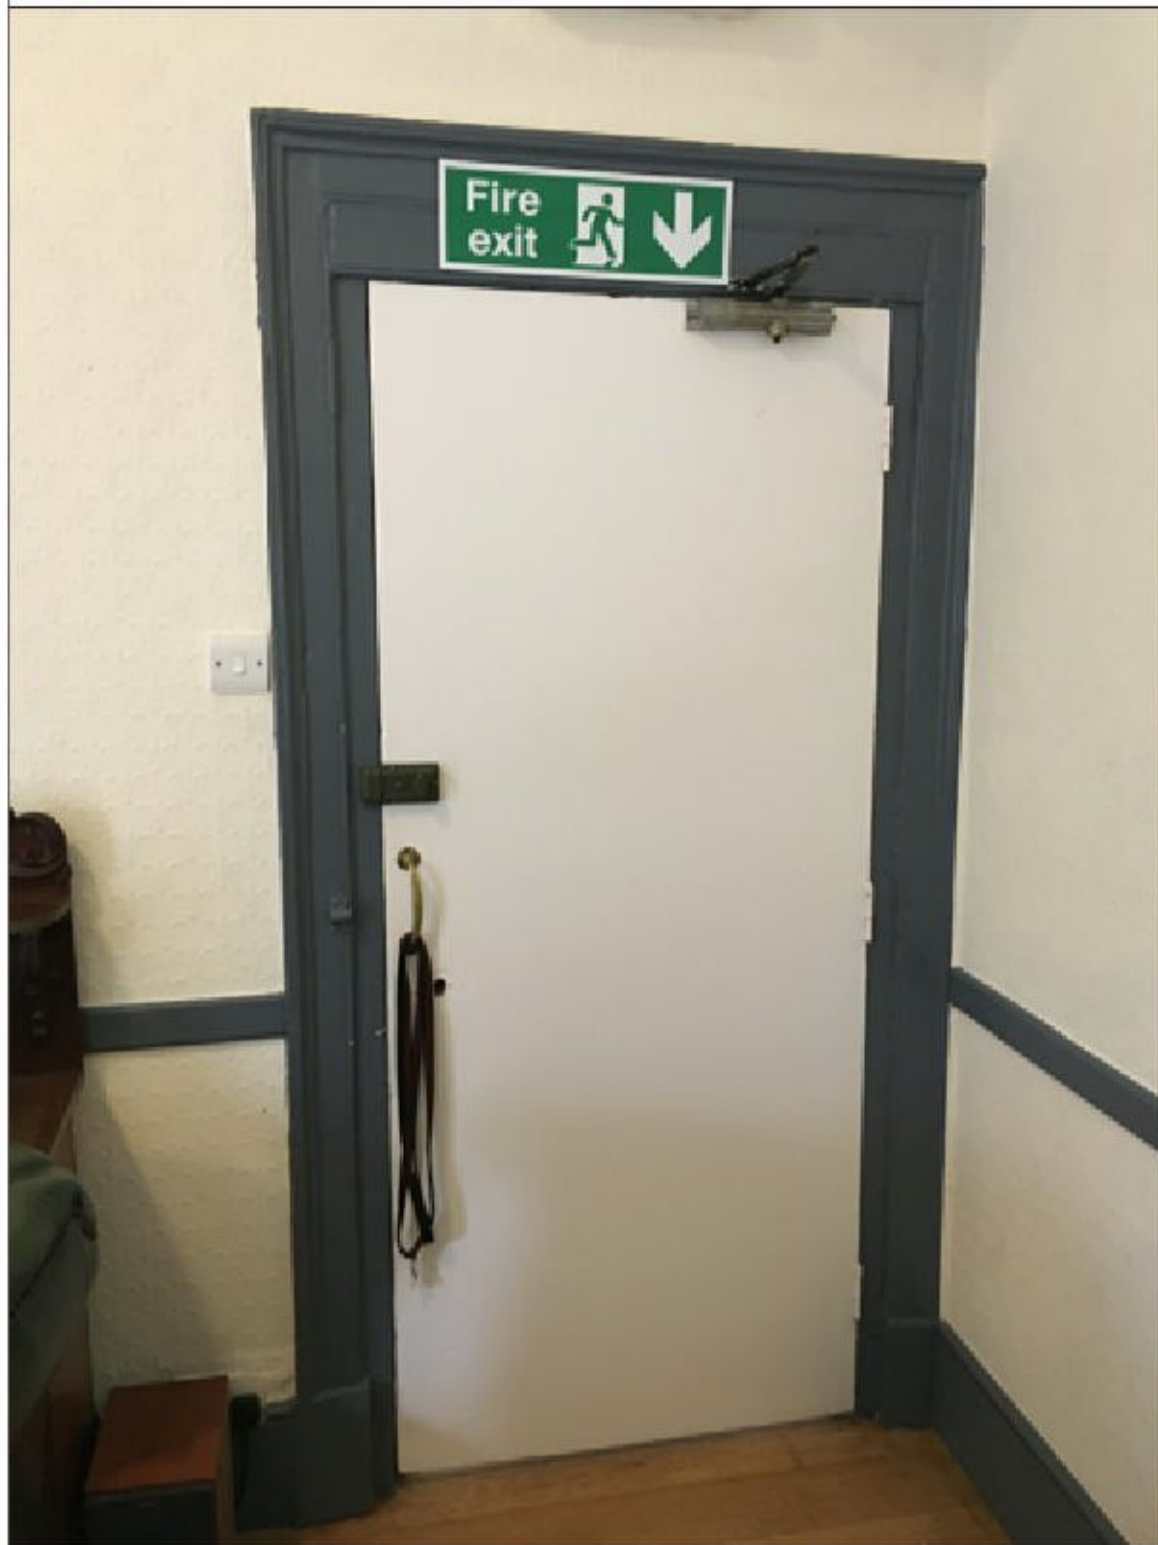
Internal Photo D111i

Photo Location - Landing - Door Number **D111** - See floor plans for location

Door leaf - Presumed non original - Good condition

Frame and Architrave - Presumed original - Good condition

· None

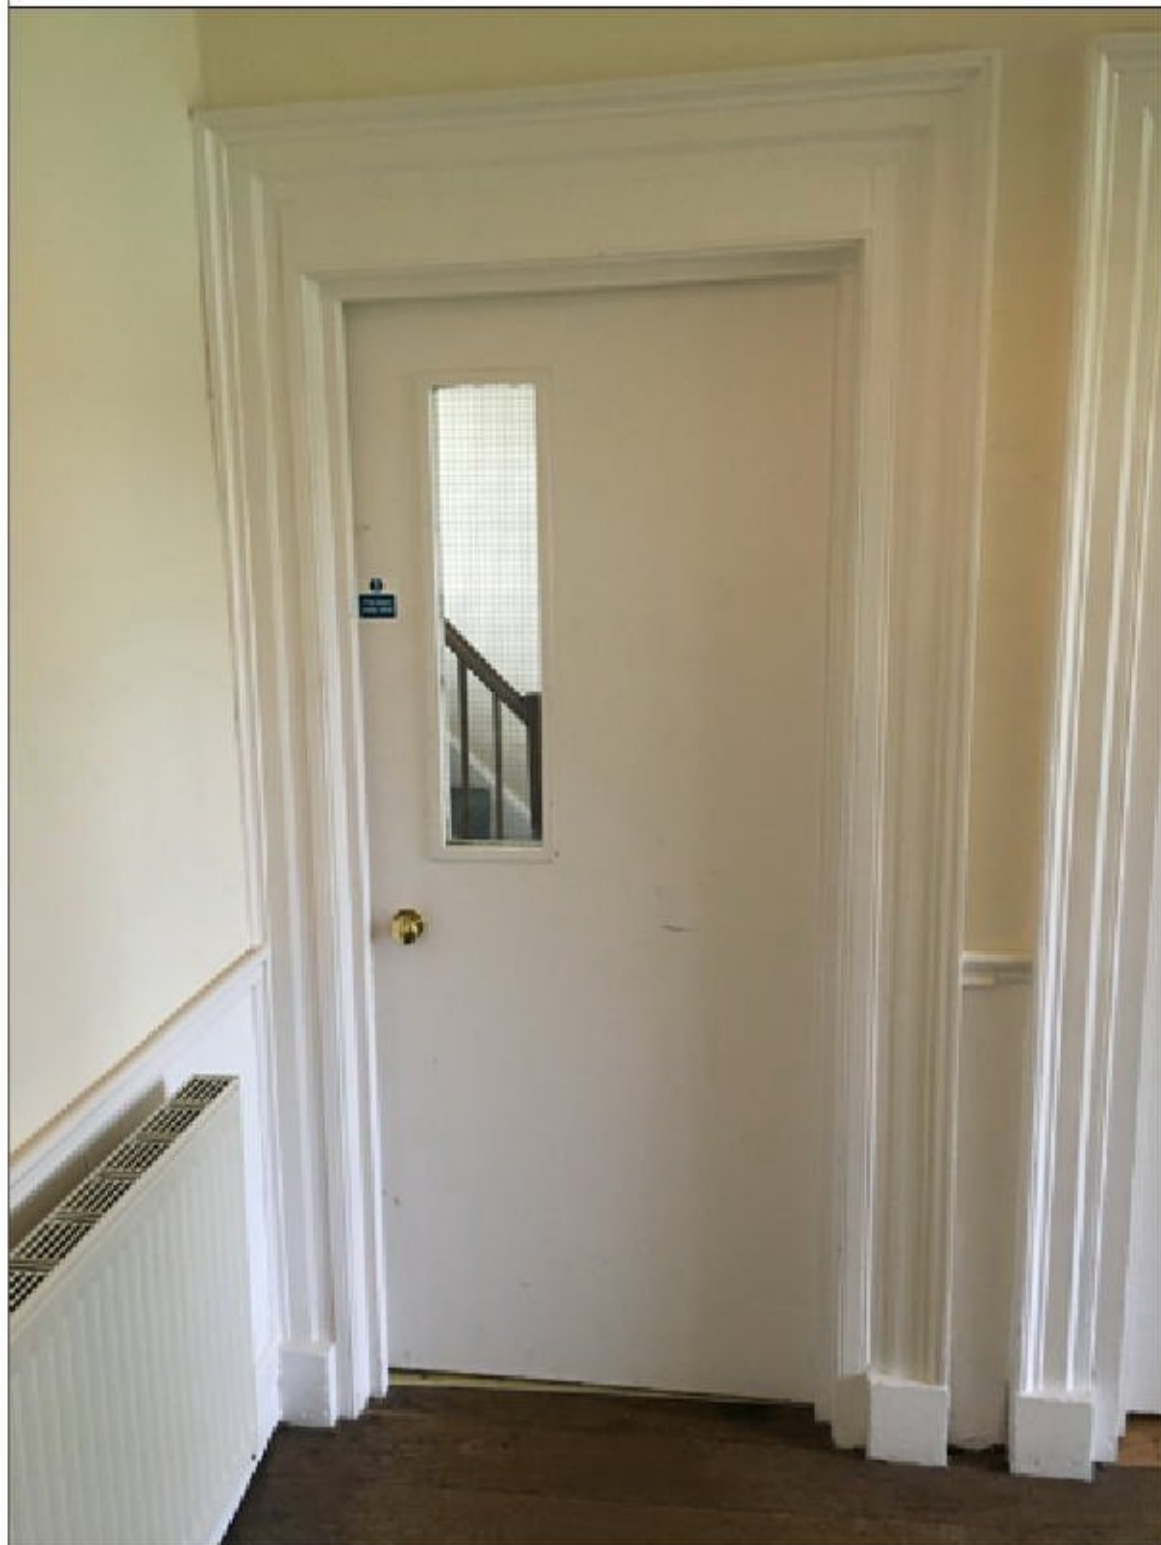
Internal Photo D1112i

Photo Location - Landing - Door Number **D112** - See floor plans for location

Door leaf - Presumed non original - Good condition

Frame and Architrave - Presumed original - Good condition

· None
