Building Recording - First Floor

Internal Doors

Showing existing photos, noted location, frame condition, leaf condition and proposed refurbishment works

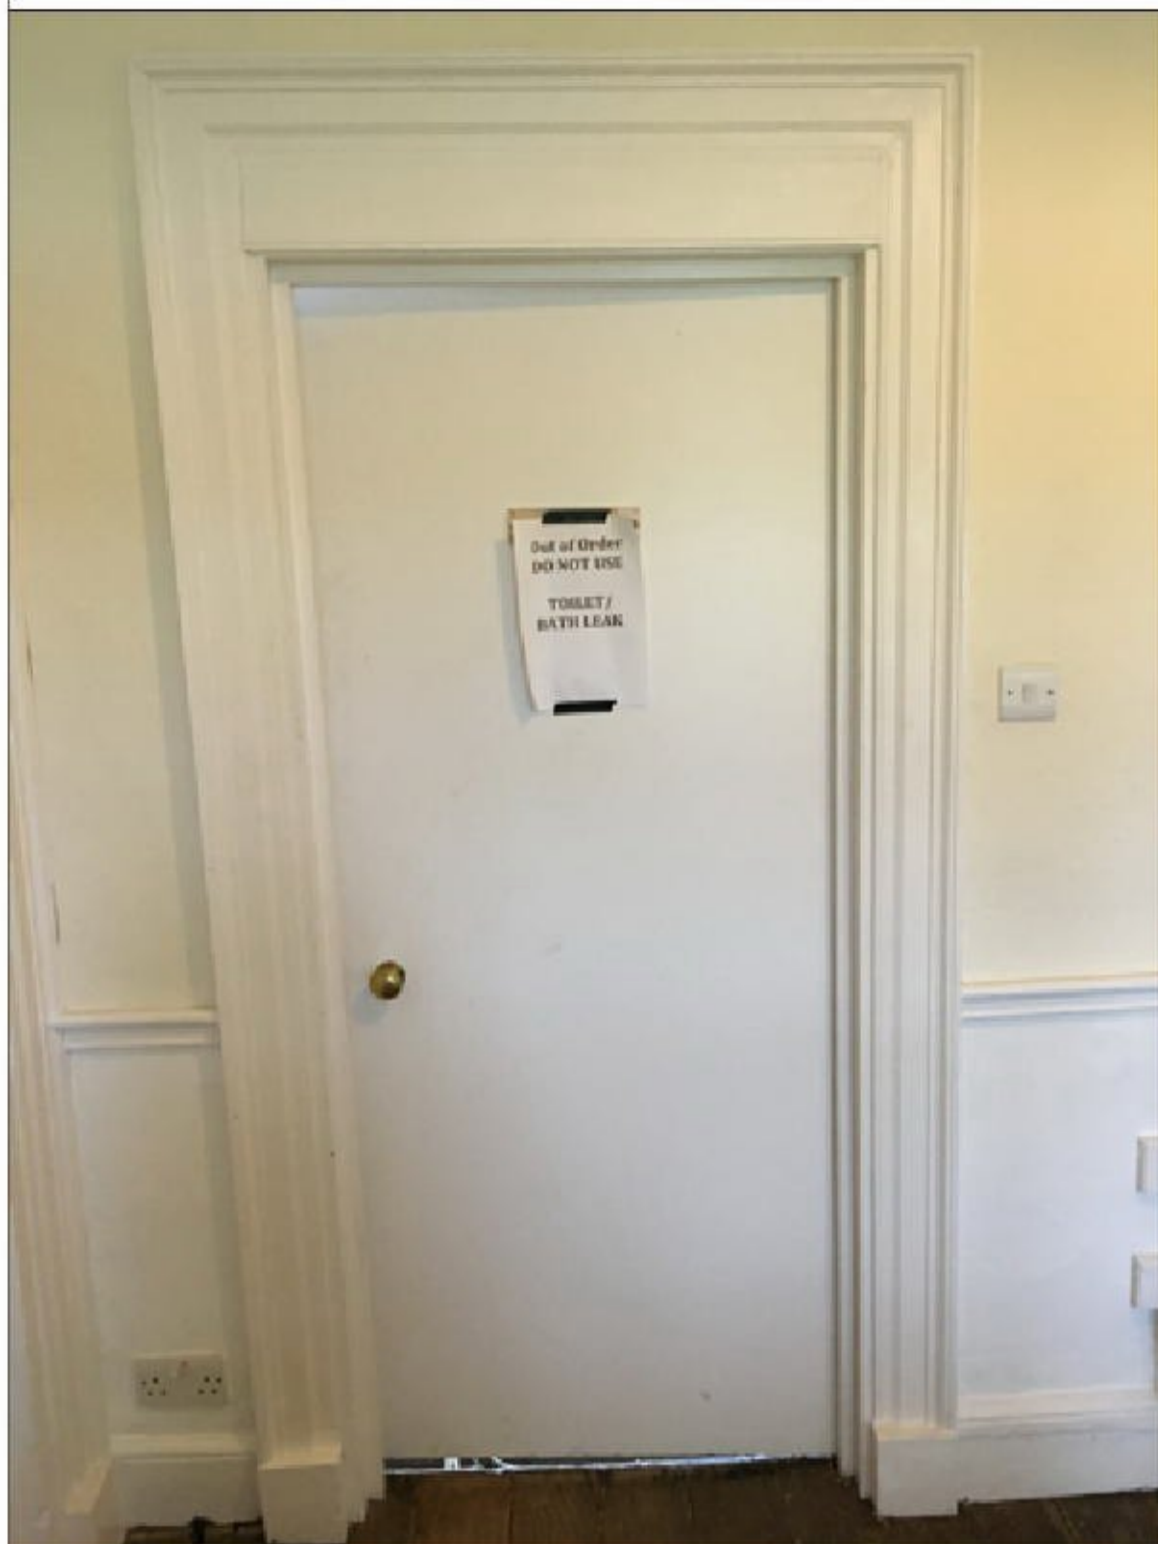
Internal Photo D1113i

Photo Location - Landing - Door Number **D113** - See floor plans for location

Door leaf - Presumed non original - Good condition

Frame and Architrave - Presumed original - Good condition

- To enable a new ensuite bathroom and greater amenity for the users the existing opening is to be filled in a reversible manner, retain all existing frame and architrave. See proposed plans 001158 _ **111**

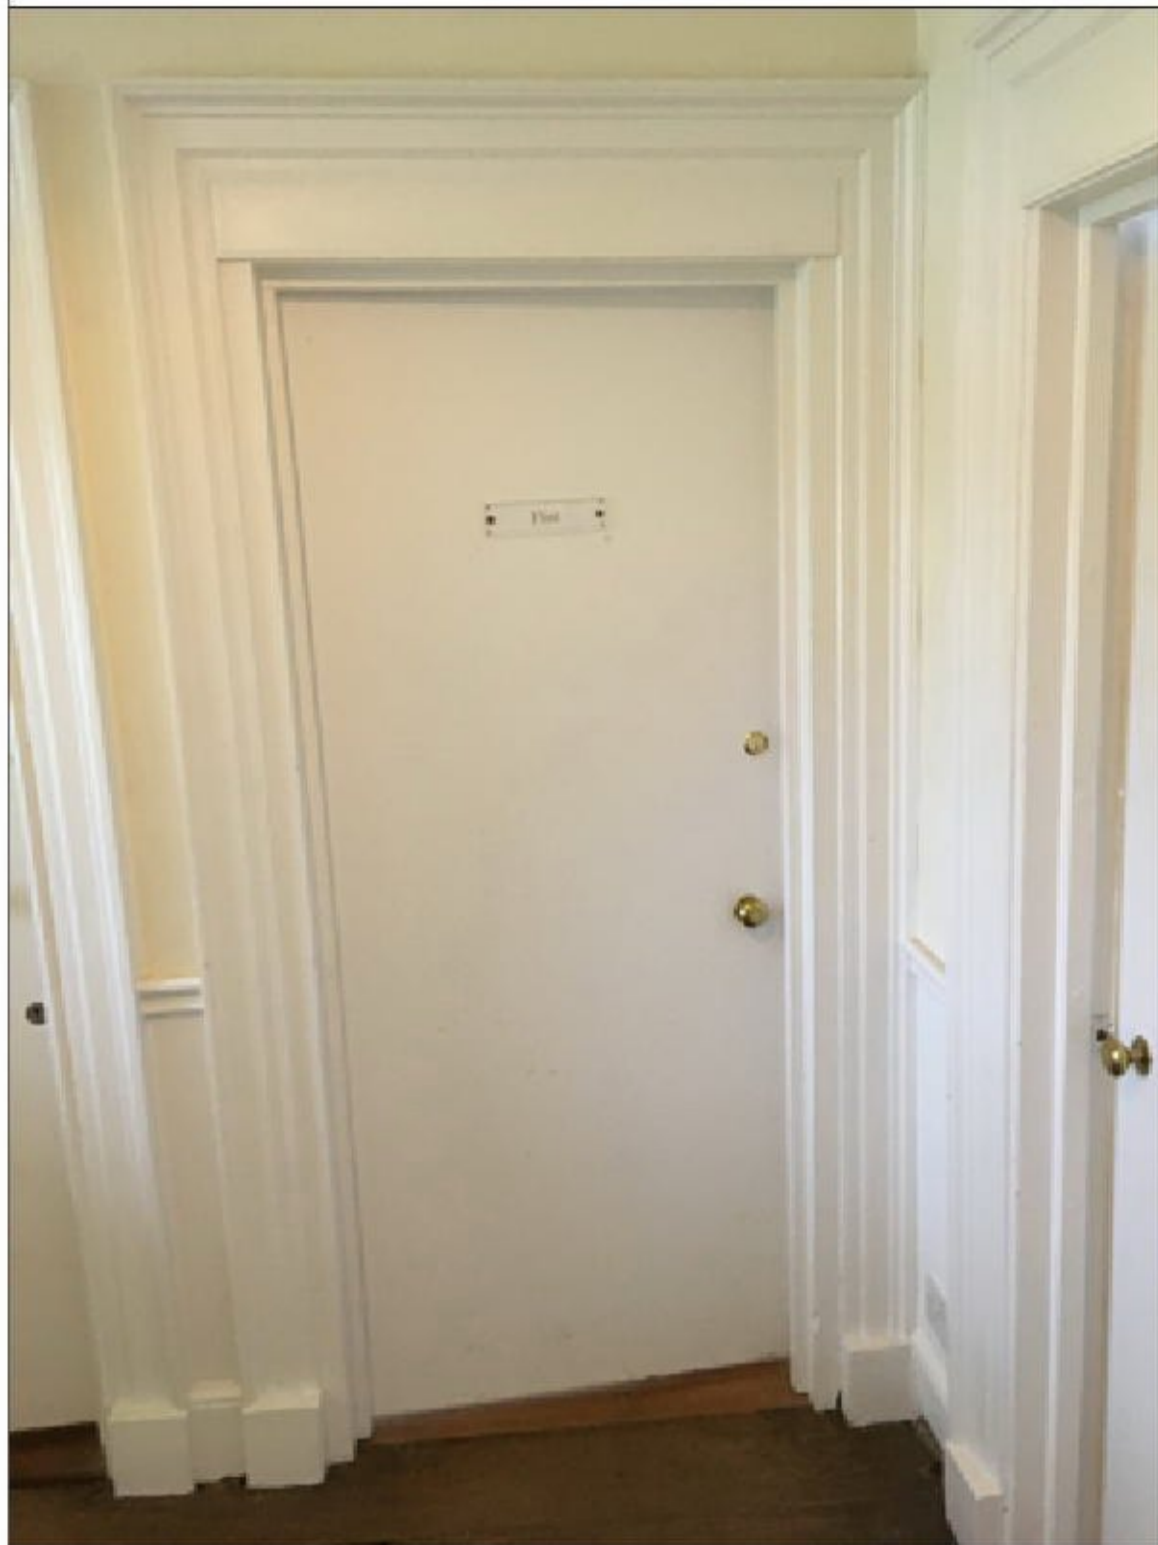
Internal Photo D1114i

Photo Location - Landing - Door Number **D114** - See floor plans for location

Door leaf - Presumed non original - Good condition

Frame and Architrave - Presumed original - Good condition

· None

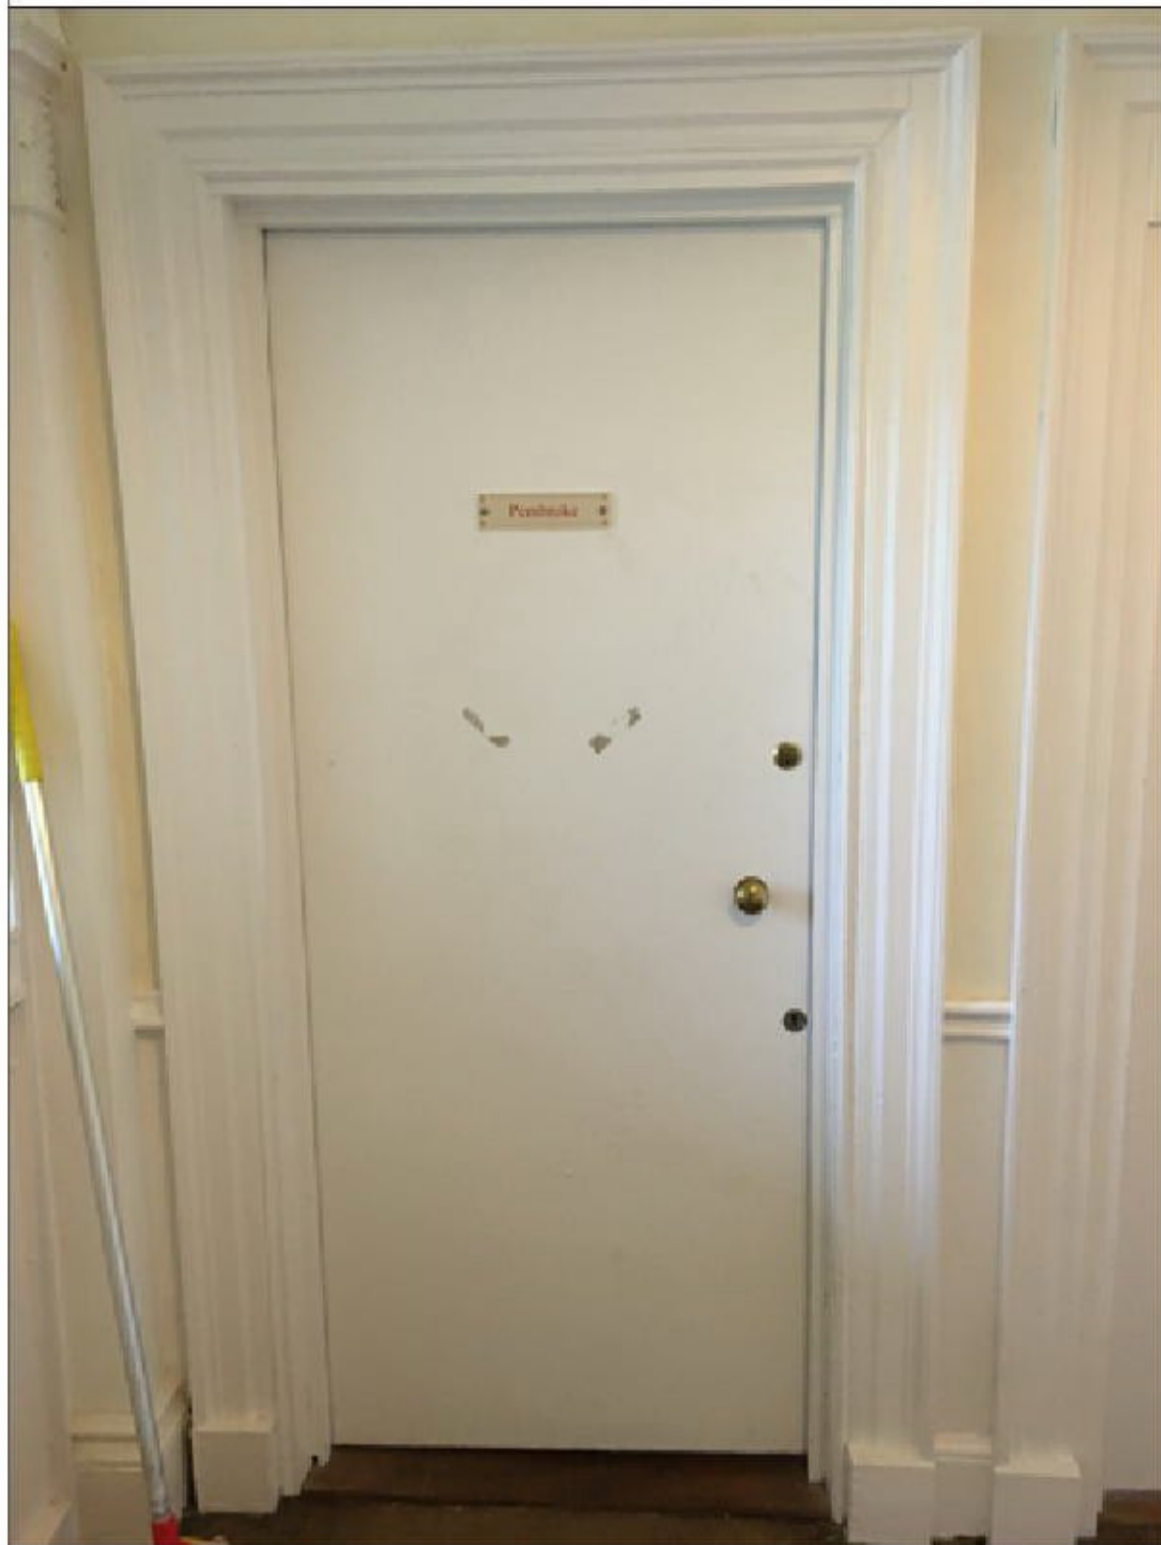
Internal Photo D115i

Photo Location - Landing - Door Number **D115** - See floor plans for location

Door leaf - Presumed non original - Good condition

Frame and Architrave - Presumed original - Good condition

· None

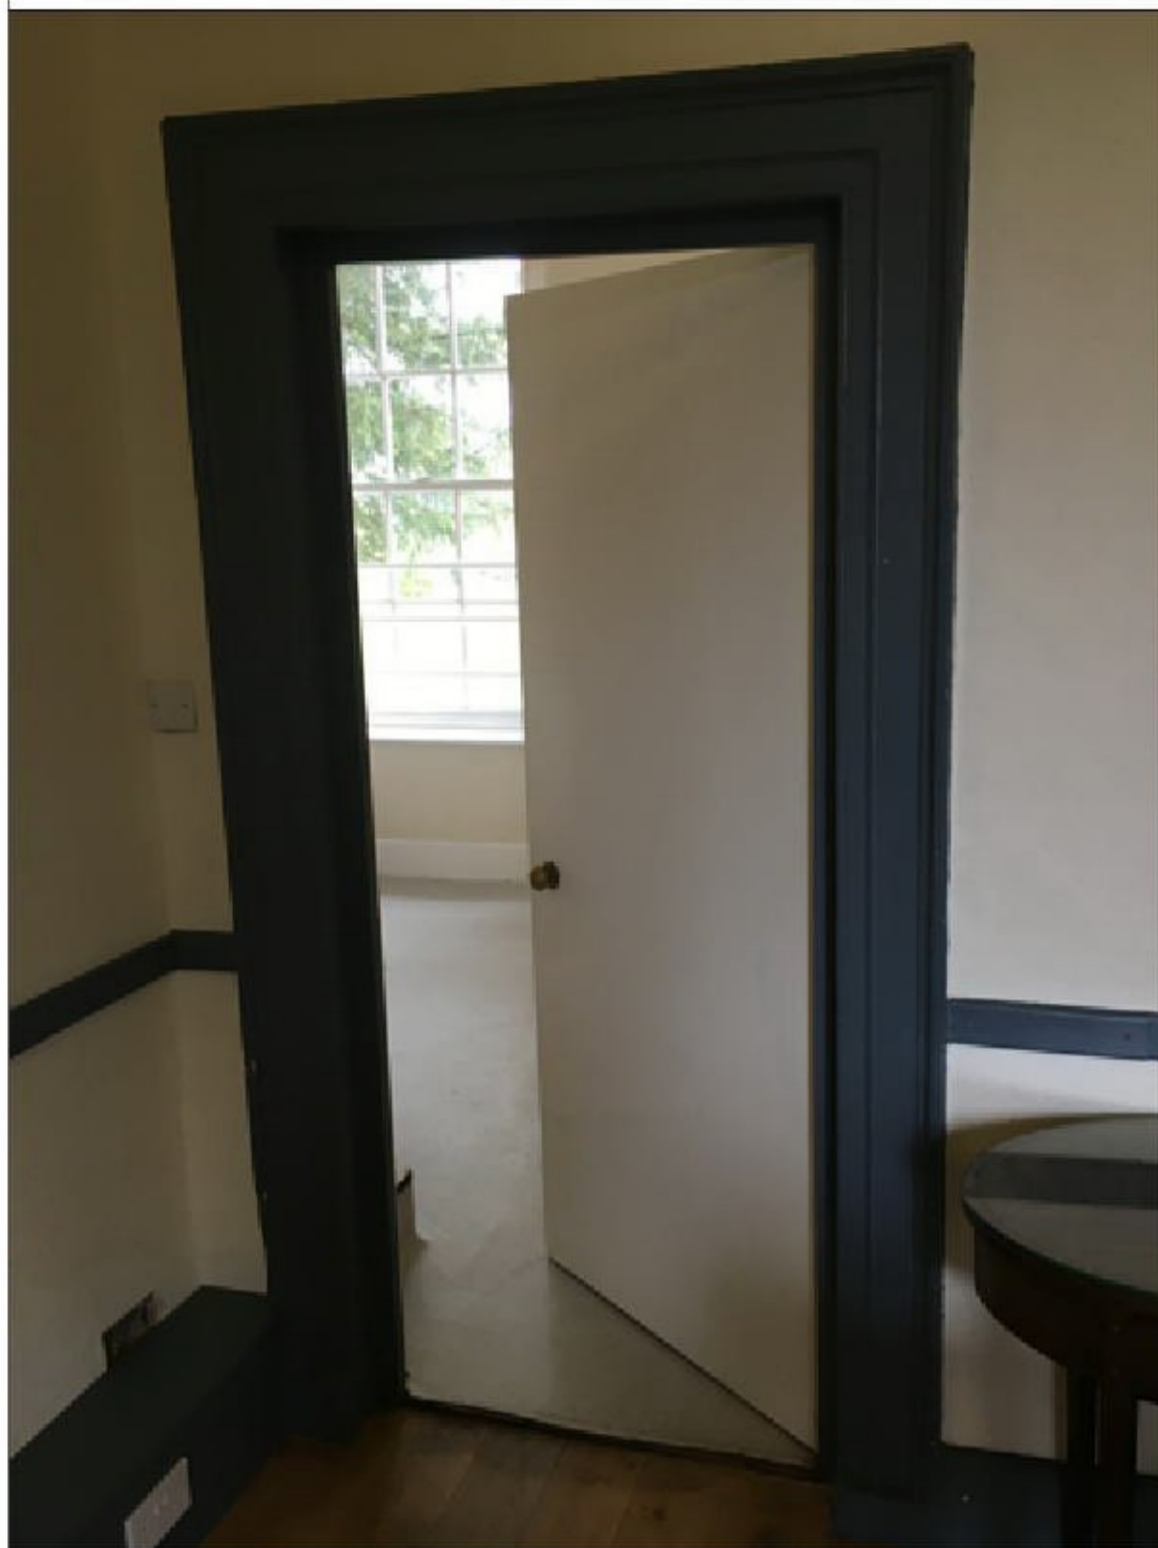
Internal Photo D116i

Photo Location - Bedroom 1 - Door Number **D116** - See floor plans for location

Door leaf - Presumed non original - Good condition

Frame and Architrave - Presumed original - Good condition - removed and reused in building

- To enable a new ensuite bathroom and greater amenity for the users the existing opening is to be filled in a reversible manner, retain all existing frame and architrave. See proposed plans 001158 _ **111**

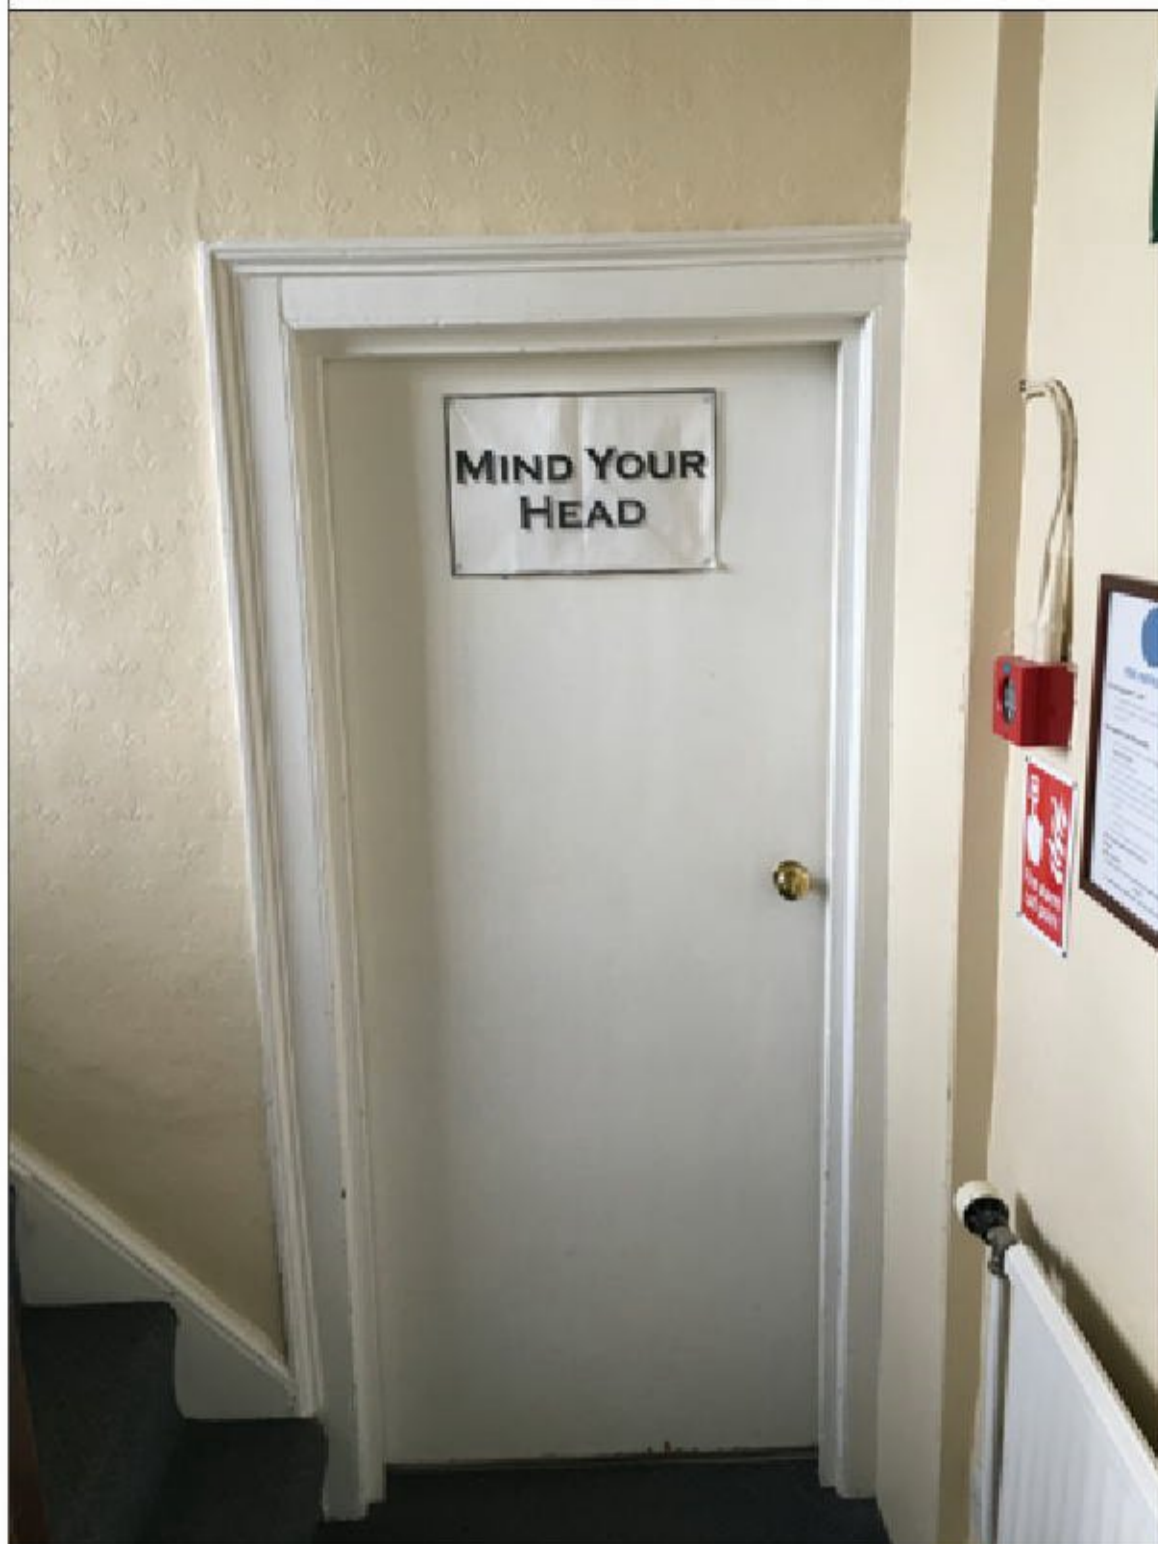
Internal Photo D117i

Photo Location - Stairwell - Door Number **D117**- See floor plans for location

Door leaf - Presumed non original - Good condition

Frame and Architrave - Presumed original - Good condition

- To enable a new ensuite bathroom and greater amenity for the users the existing opening is to be filled in a reversible manner, retain all existing frame and architrave. See proposed plans 001158 _ **111**

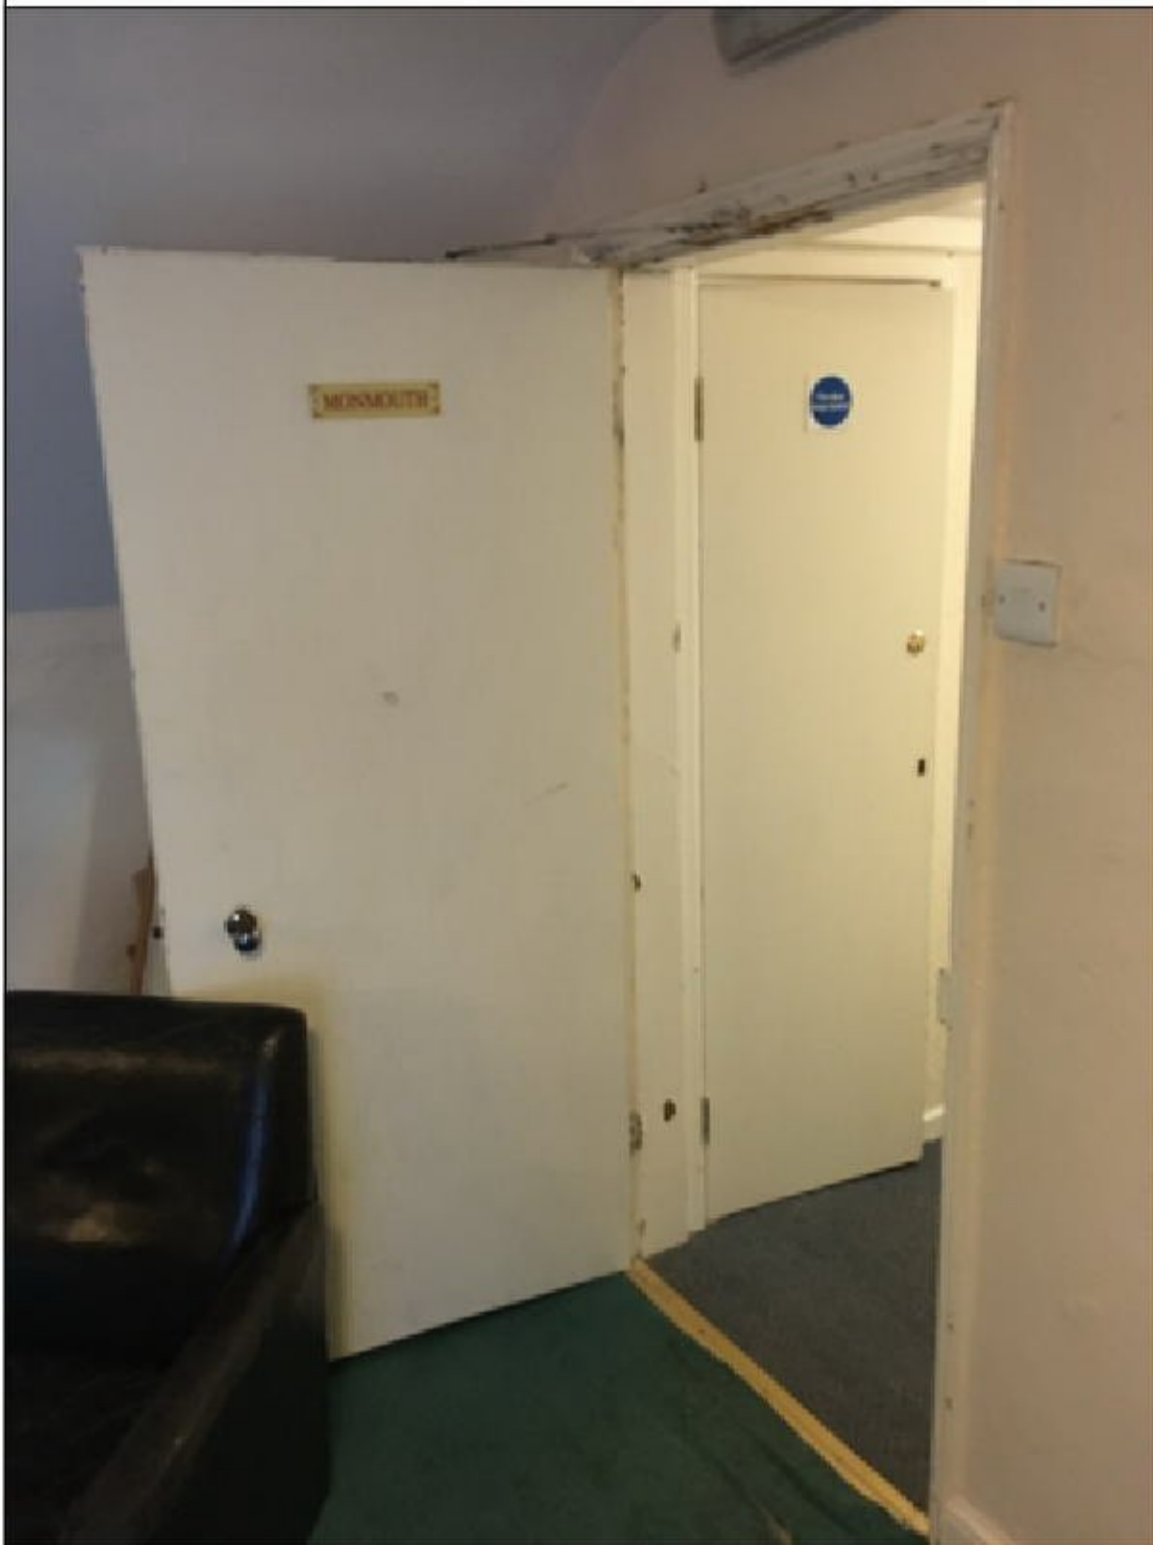
Internal Photo D201i

Photo Location - Bedroom 6 - Door Number **D201**- See floor plans for location

Door leaf - Presumed non original - Average condition

Frame and Architrave - Presumed non original - Average condition

- To enable a new ensuite bathroom and greater amenity for the users the existing opening is to be converted into a sliding leaf pocket door. See proposed plans 001158 _ **112**

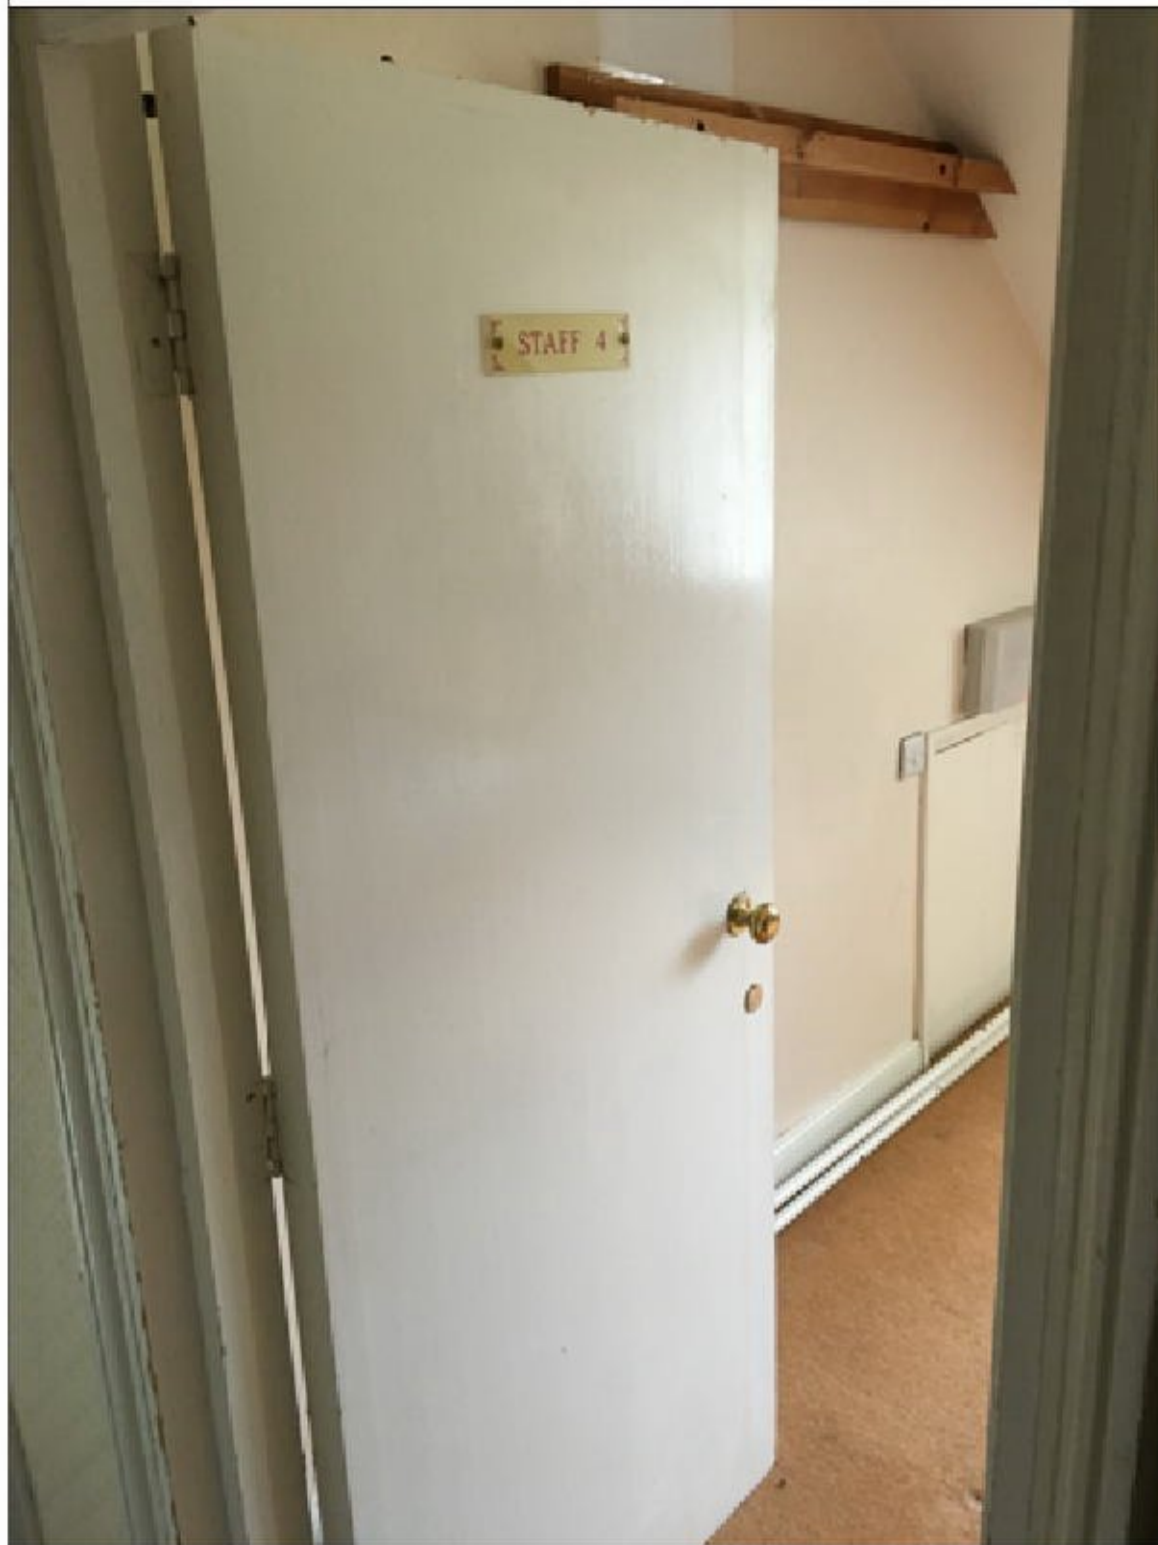
Internal Photo D202i

Photo Location - Landing - Door Number **D202**- See floor plans for location

Door leaf - Presumed non original - Good condition

Frame and Architrave - Presumed original - Good condition

- To enable a new ensuite bathroom and greater amenity for the users the existing opening is to filled. See proposed plans 001 158 _ **112**

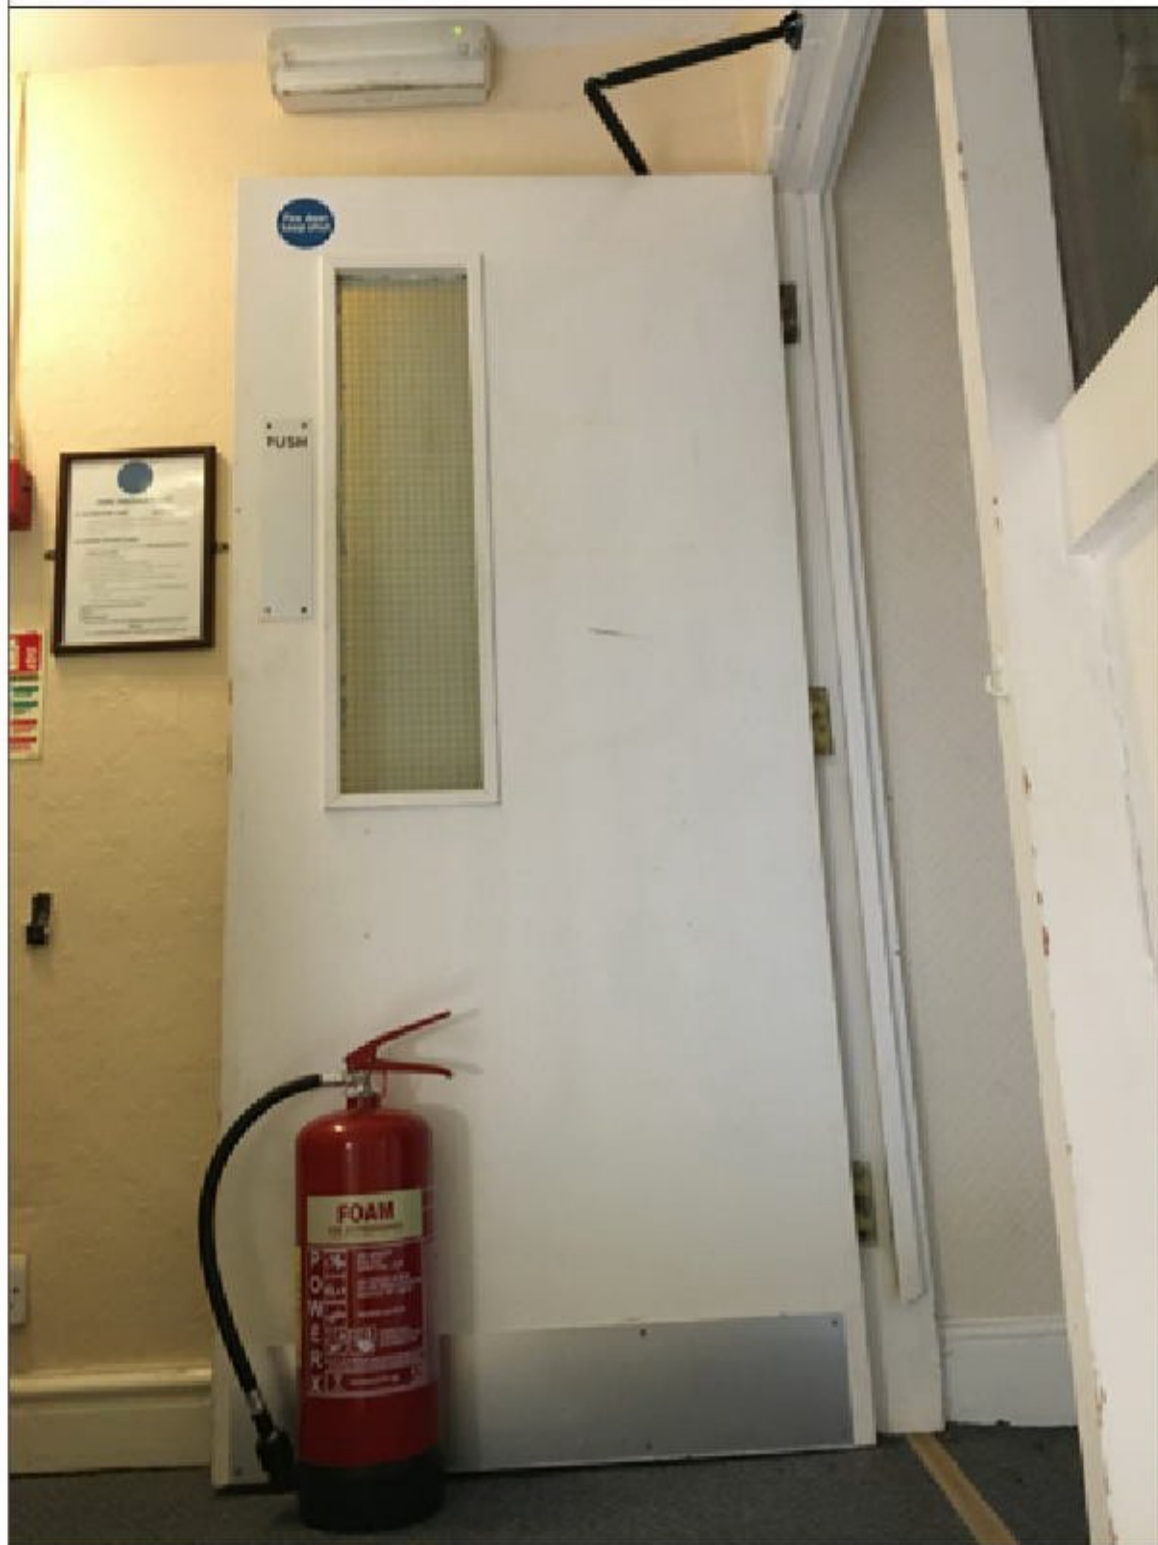
Internal Photo D203i

Photo Location - Landing - Door Number **D203**- See floor plans for location

Door leaf - Presumed non original - Average condition

Frame and Architrave - Presumed non original - Average condition

- To enable a new ensuite bathroom and greater amenity for the users the existing opening is to filled. See proposed plans 001158 _ **112**

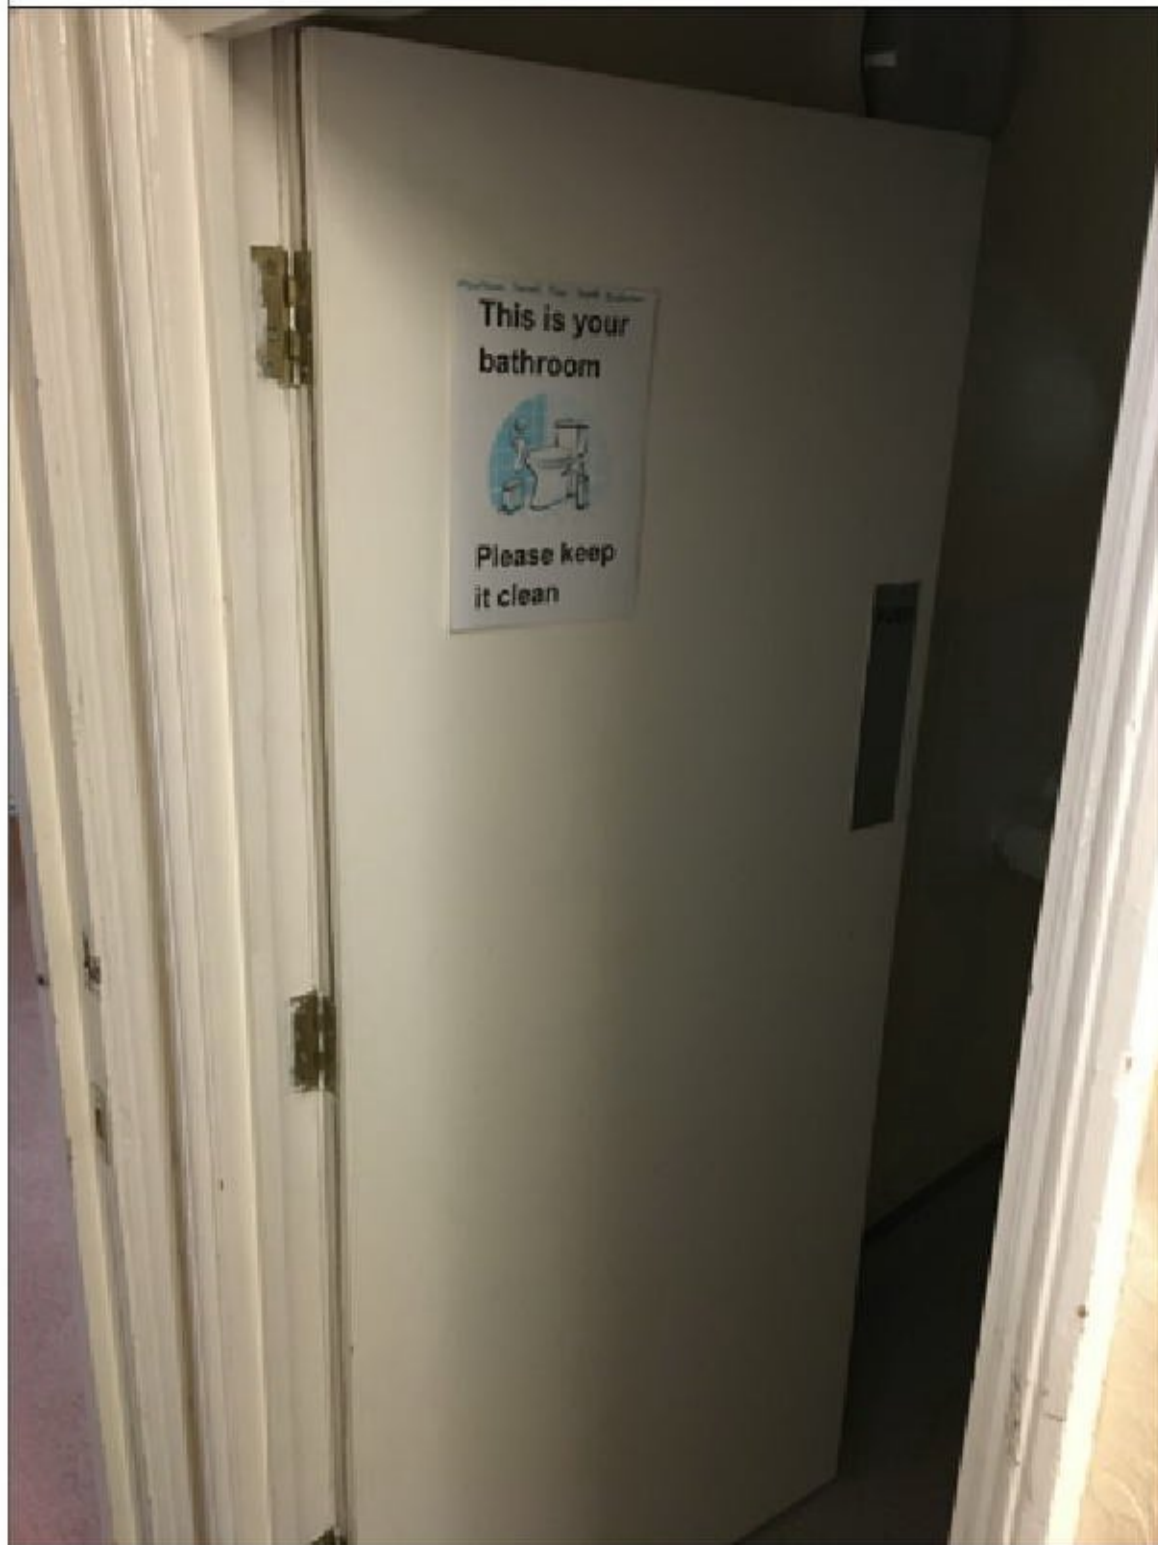
Internal Photo D204i

Photo Location - Landing - Door Number **D204**- See floor plans for location

Door leaf - Presumed non original - Average condition

Frame and Architrave - Presumed non original - Average condition

- To enable a new ensuite bathroom and greater amenity for the users the existing opening is to be filled. See proposed plans 001 158 _ **112**

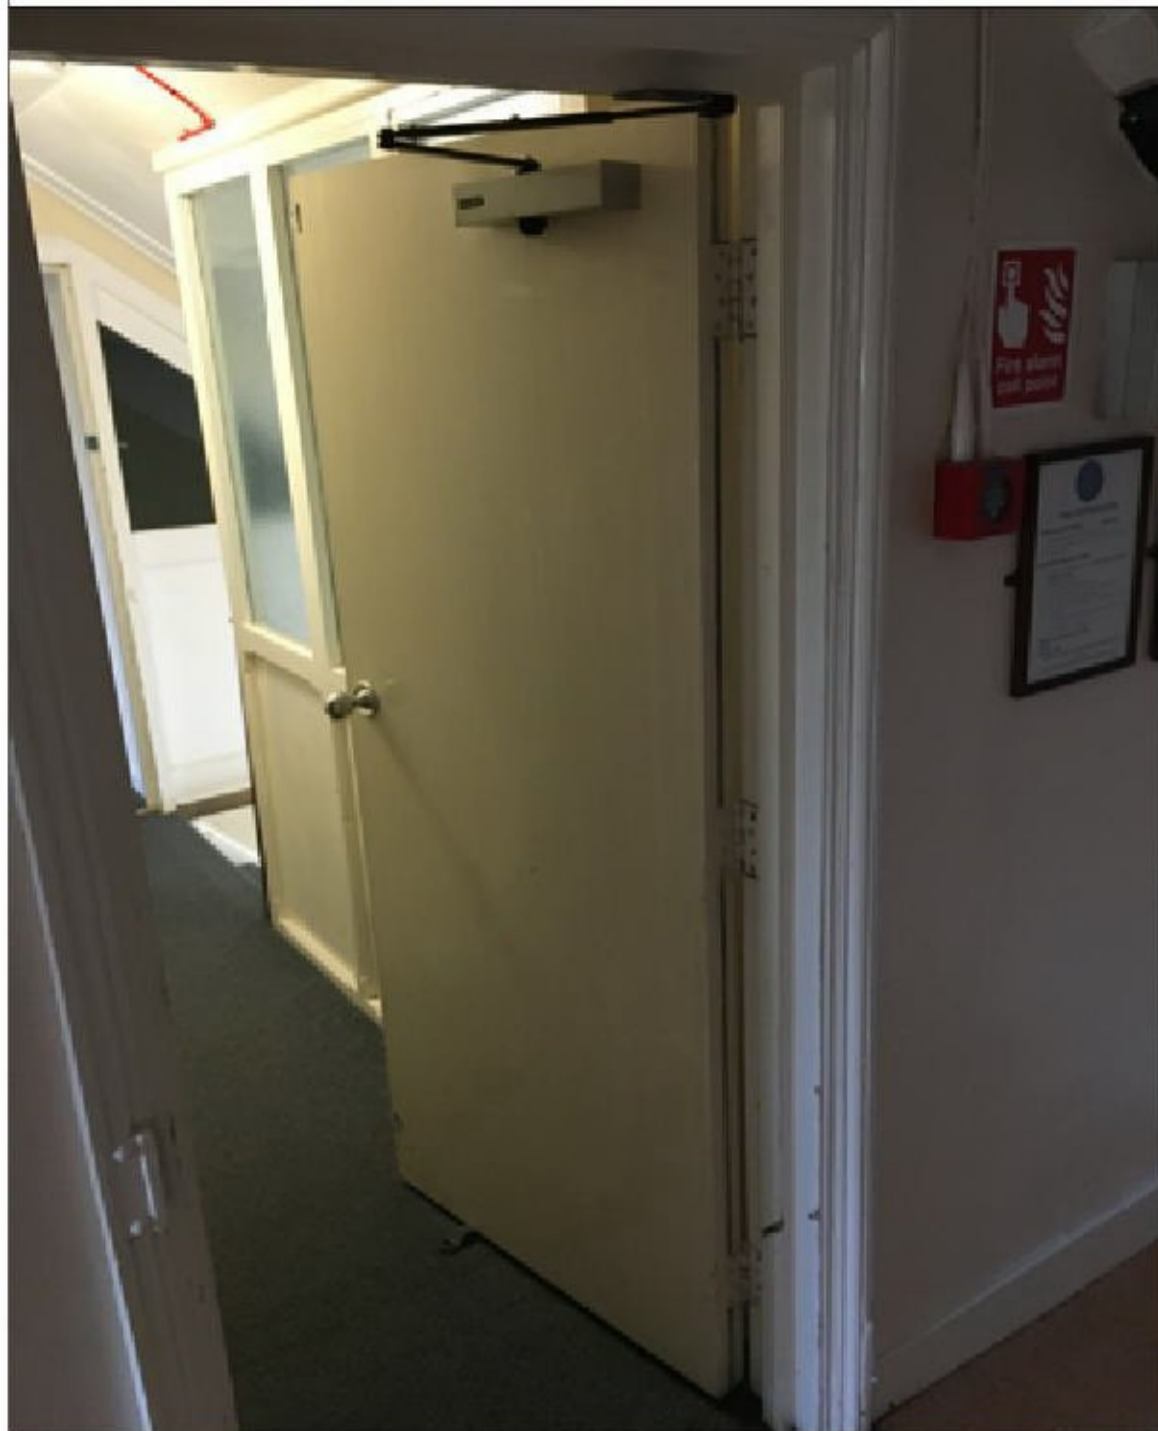
Internal Photo D205i

Photo Location - Landing - Door Number **D205**- See floor plans for location

Door leaf - Presumed non original - Average condition

Frame and Architrave - Presumed non original - Average condition

- To enable a new ensuite bathroom and greater amenity for the users the existing door and frame is to be replaced. See proposed plans 001 158 _ **112**
