Building Recording - Ground Floor

External and Internal Doors

Showing existing photos, noted location, frame condition, leaf condition and proposed refurbishment works

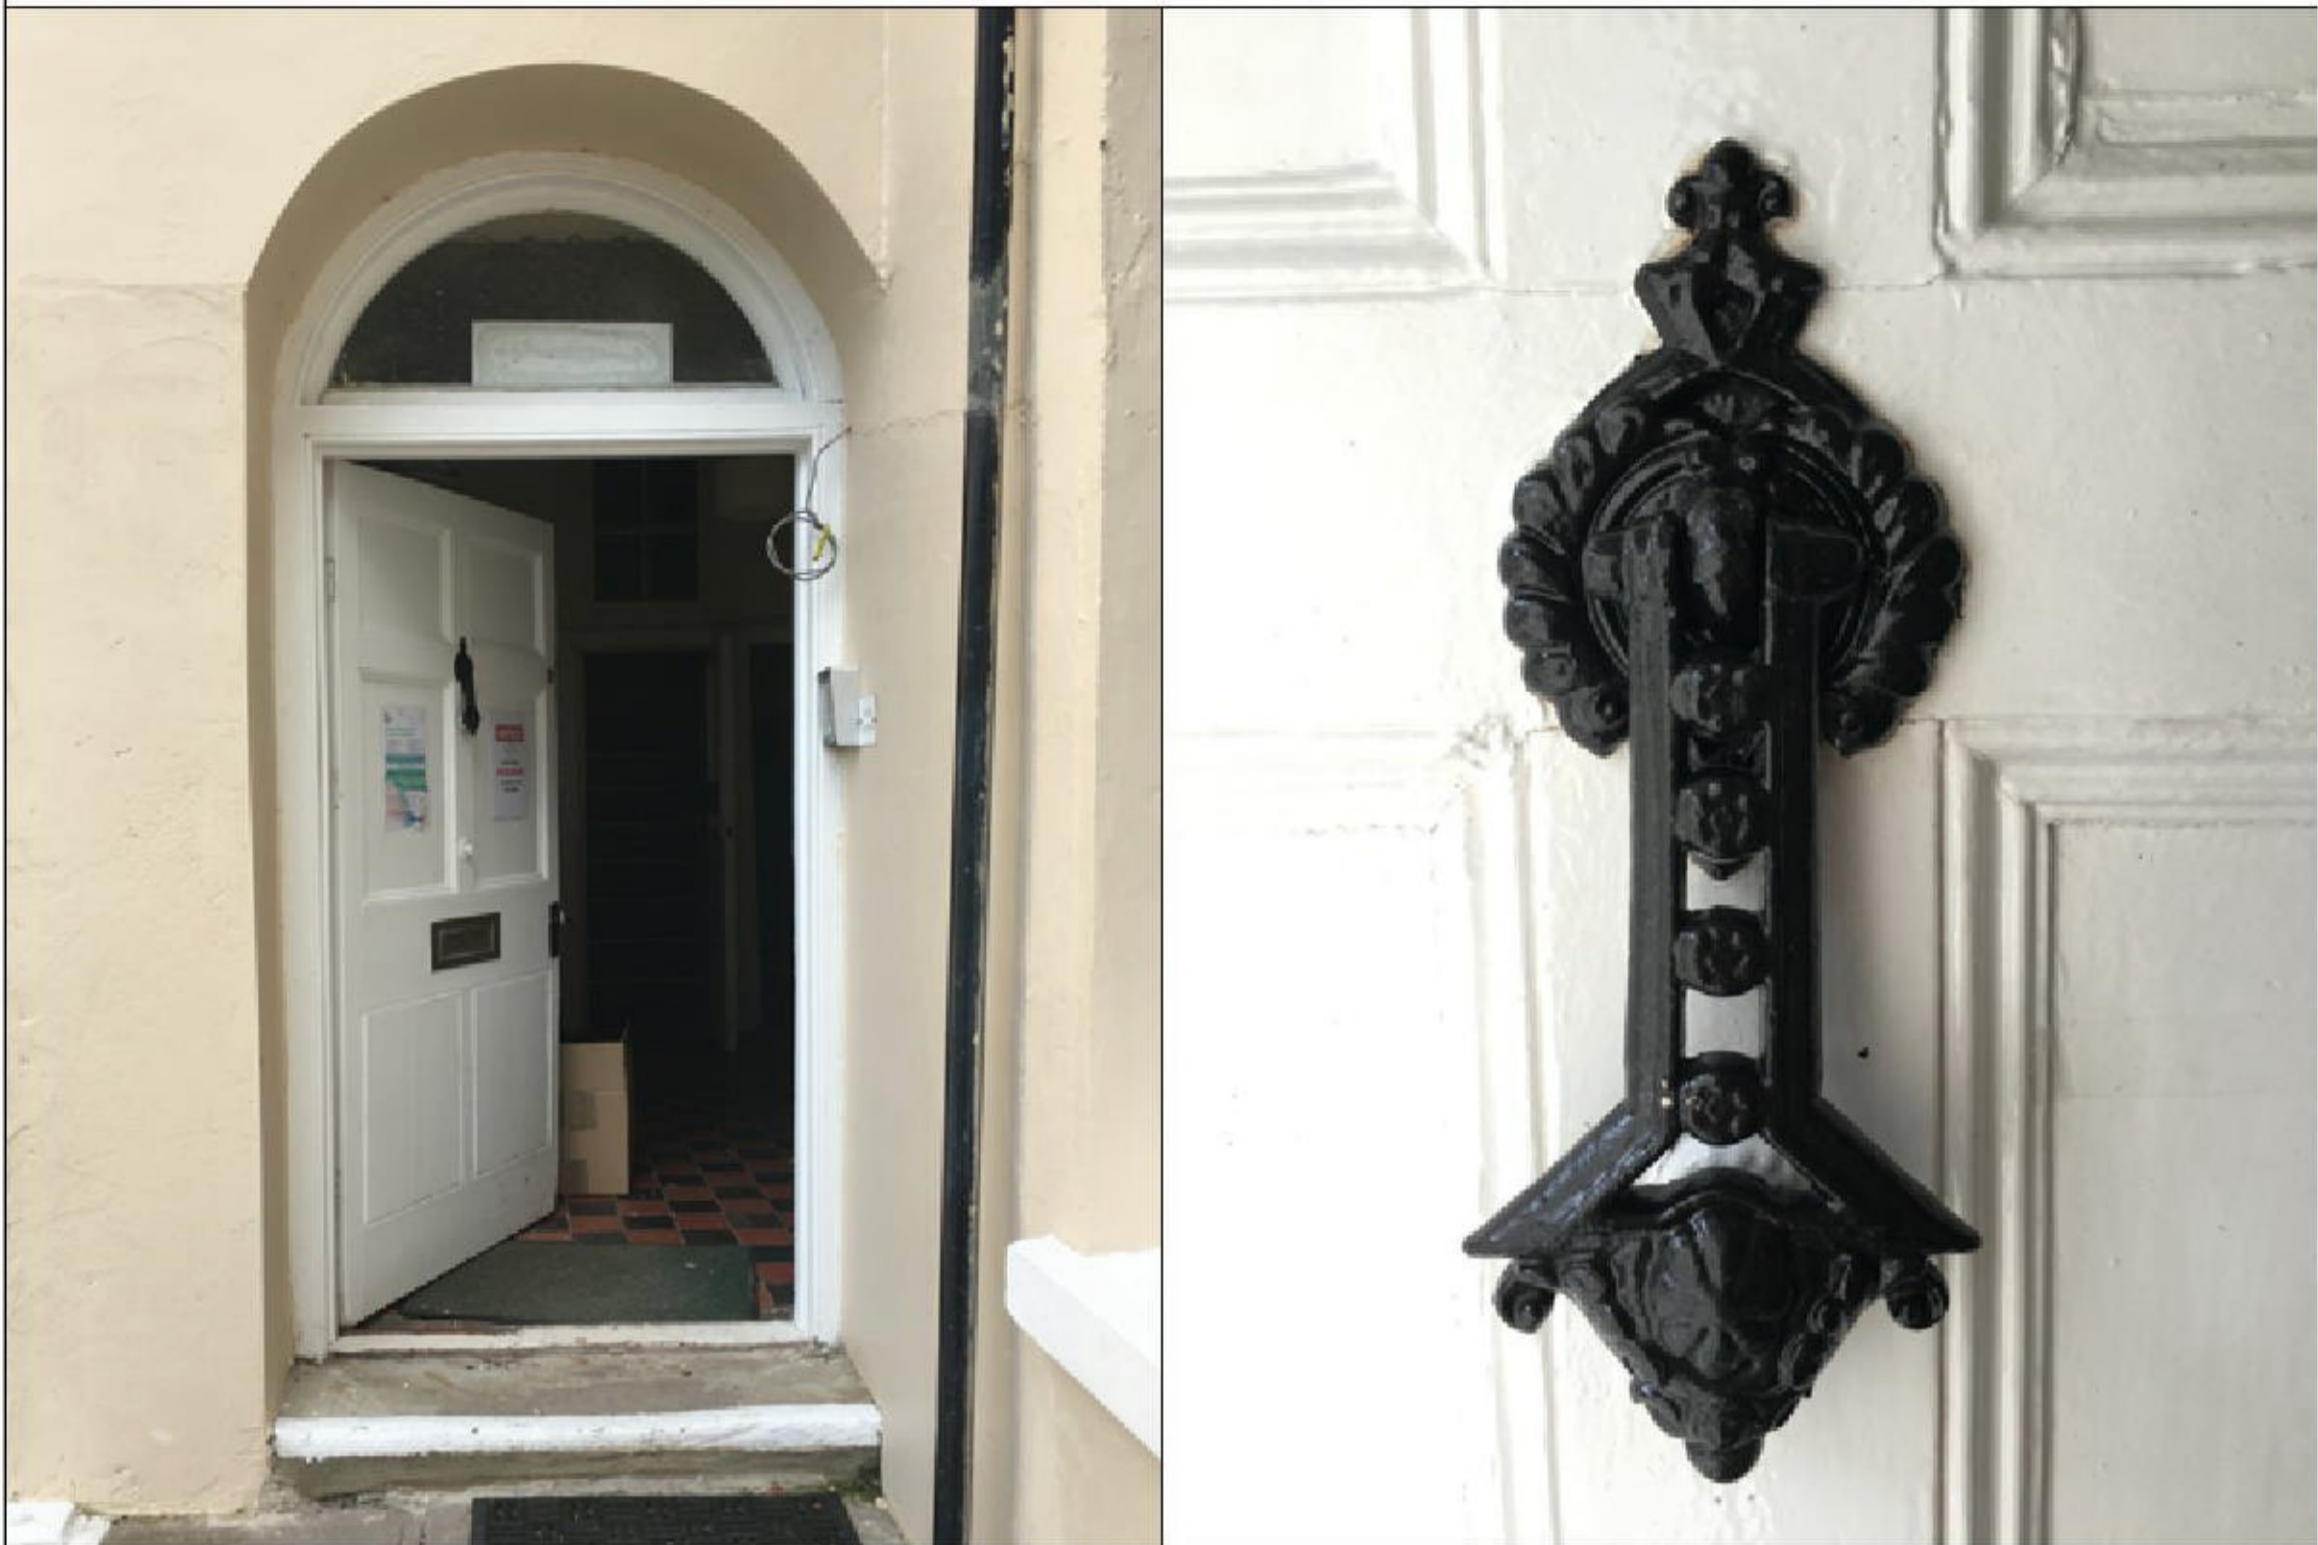
Internal Photo ED001E

Photo Location - External South - Door Number **ED001** - See floor plans for location

Door leaf - Presumed original - Good condition

Frame and Architrave - Presumed original - Good condition

Glass - Arched glass over - Presumed original - Good condition

- Refurbish and repaint, retain original ironmongery
additional security locks to be added

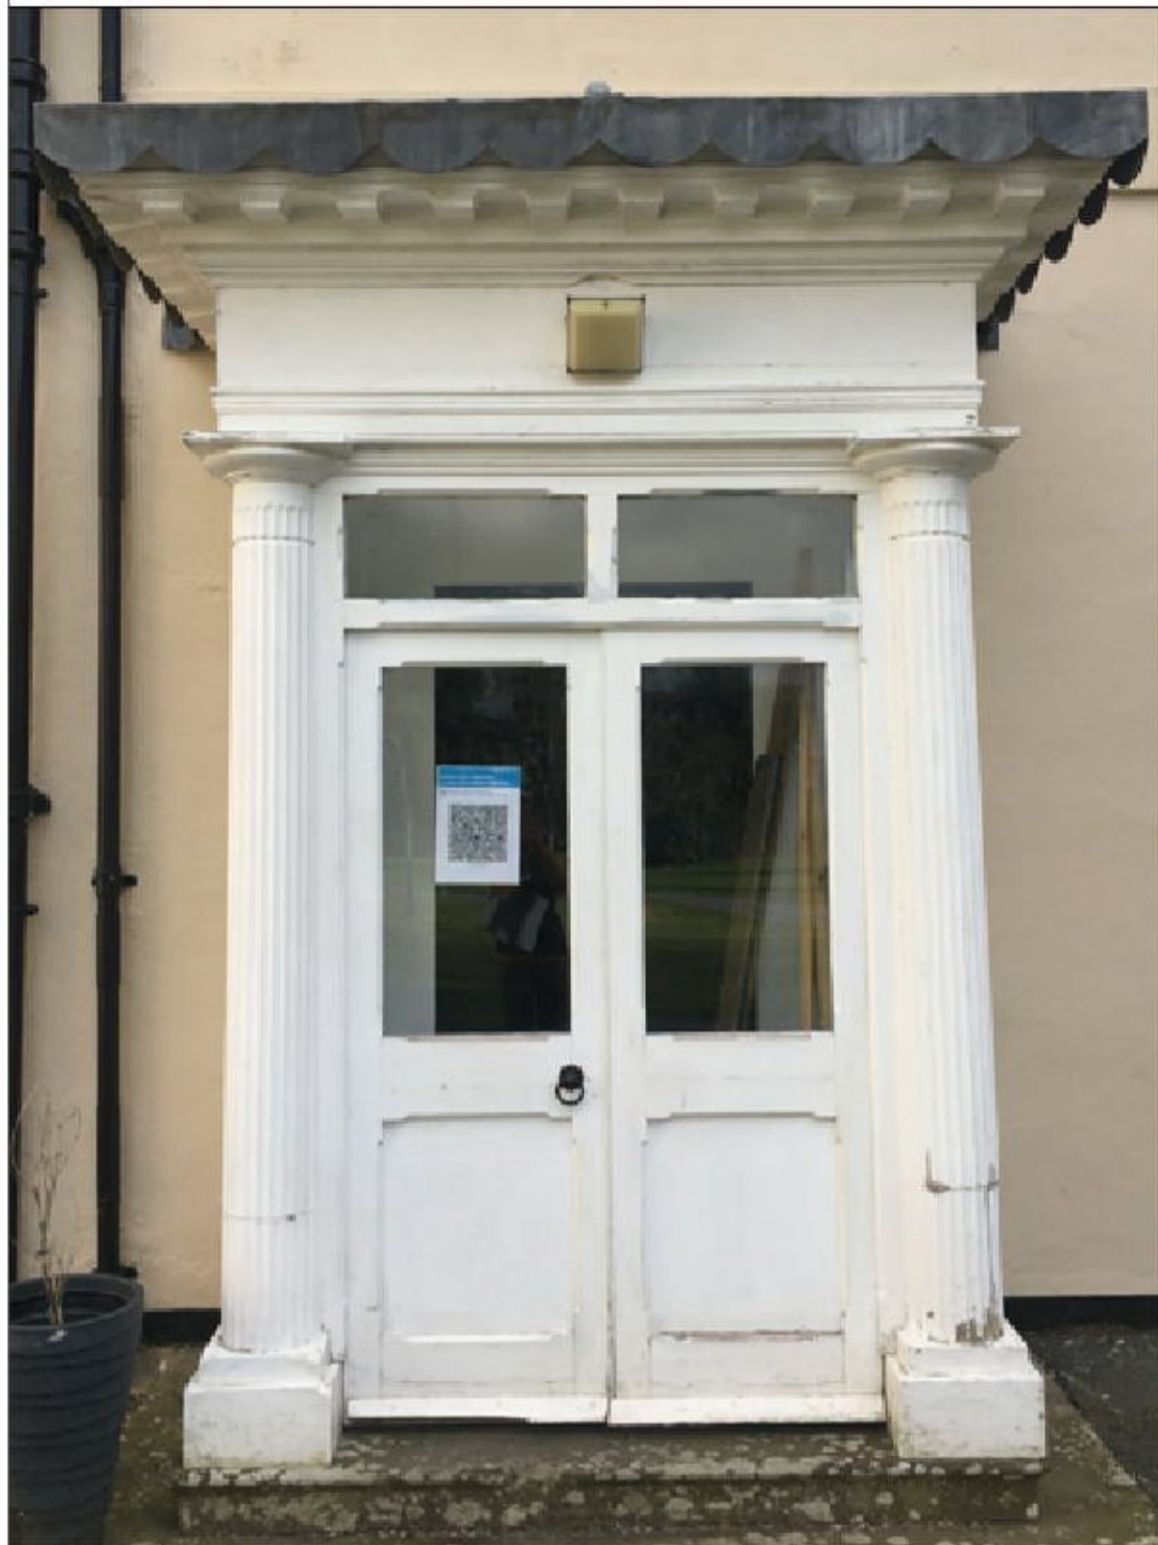
External Photo ED002E

Photo Location - External West - Door Number **ED002** - See floor plans for location

Door leaf - Presumed original - Good condition

Frame and Architrave - Presumed original - Good condition

Glass - Presumed non original

- Refurbish and repaint, retain original ironmongery

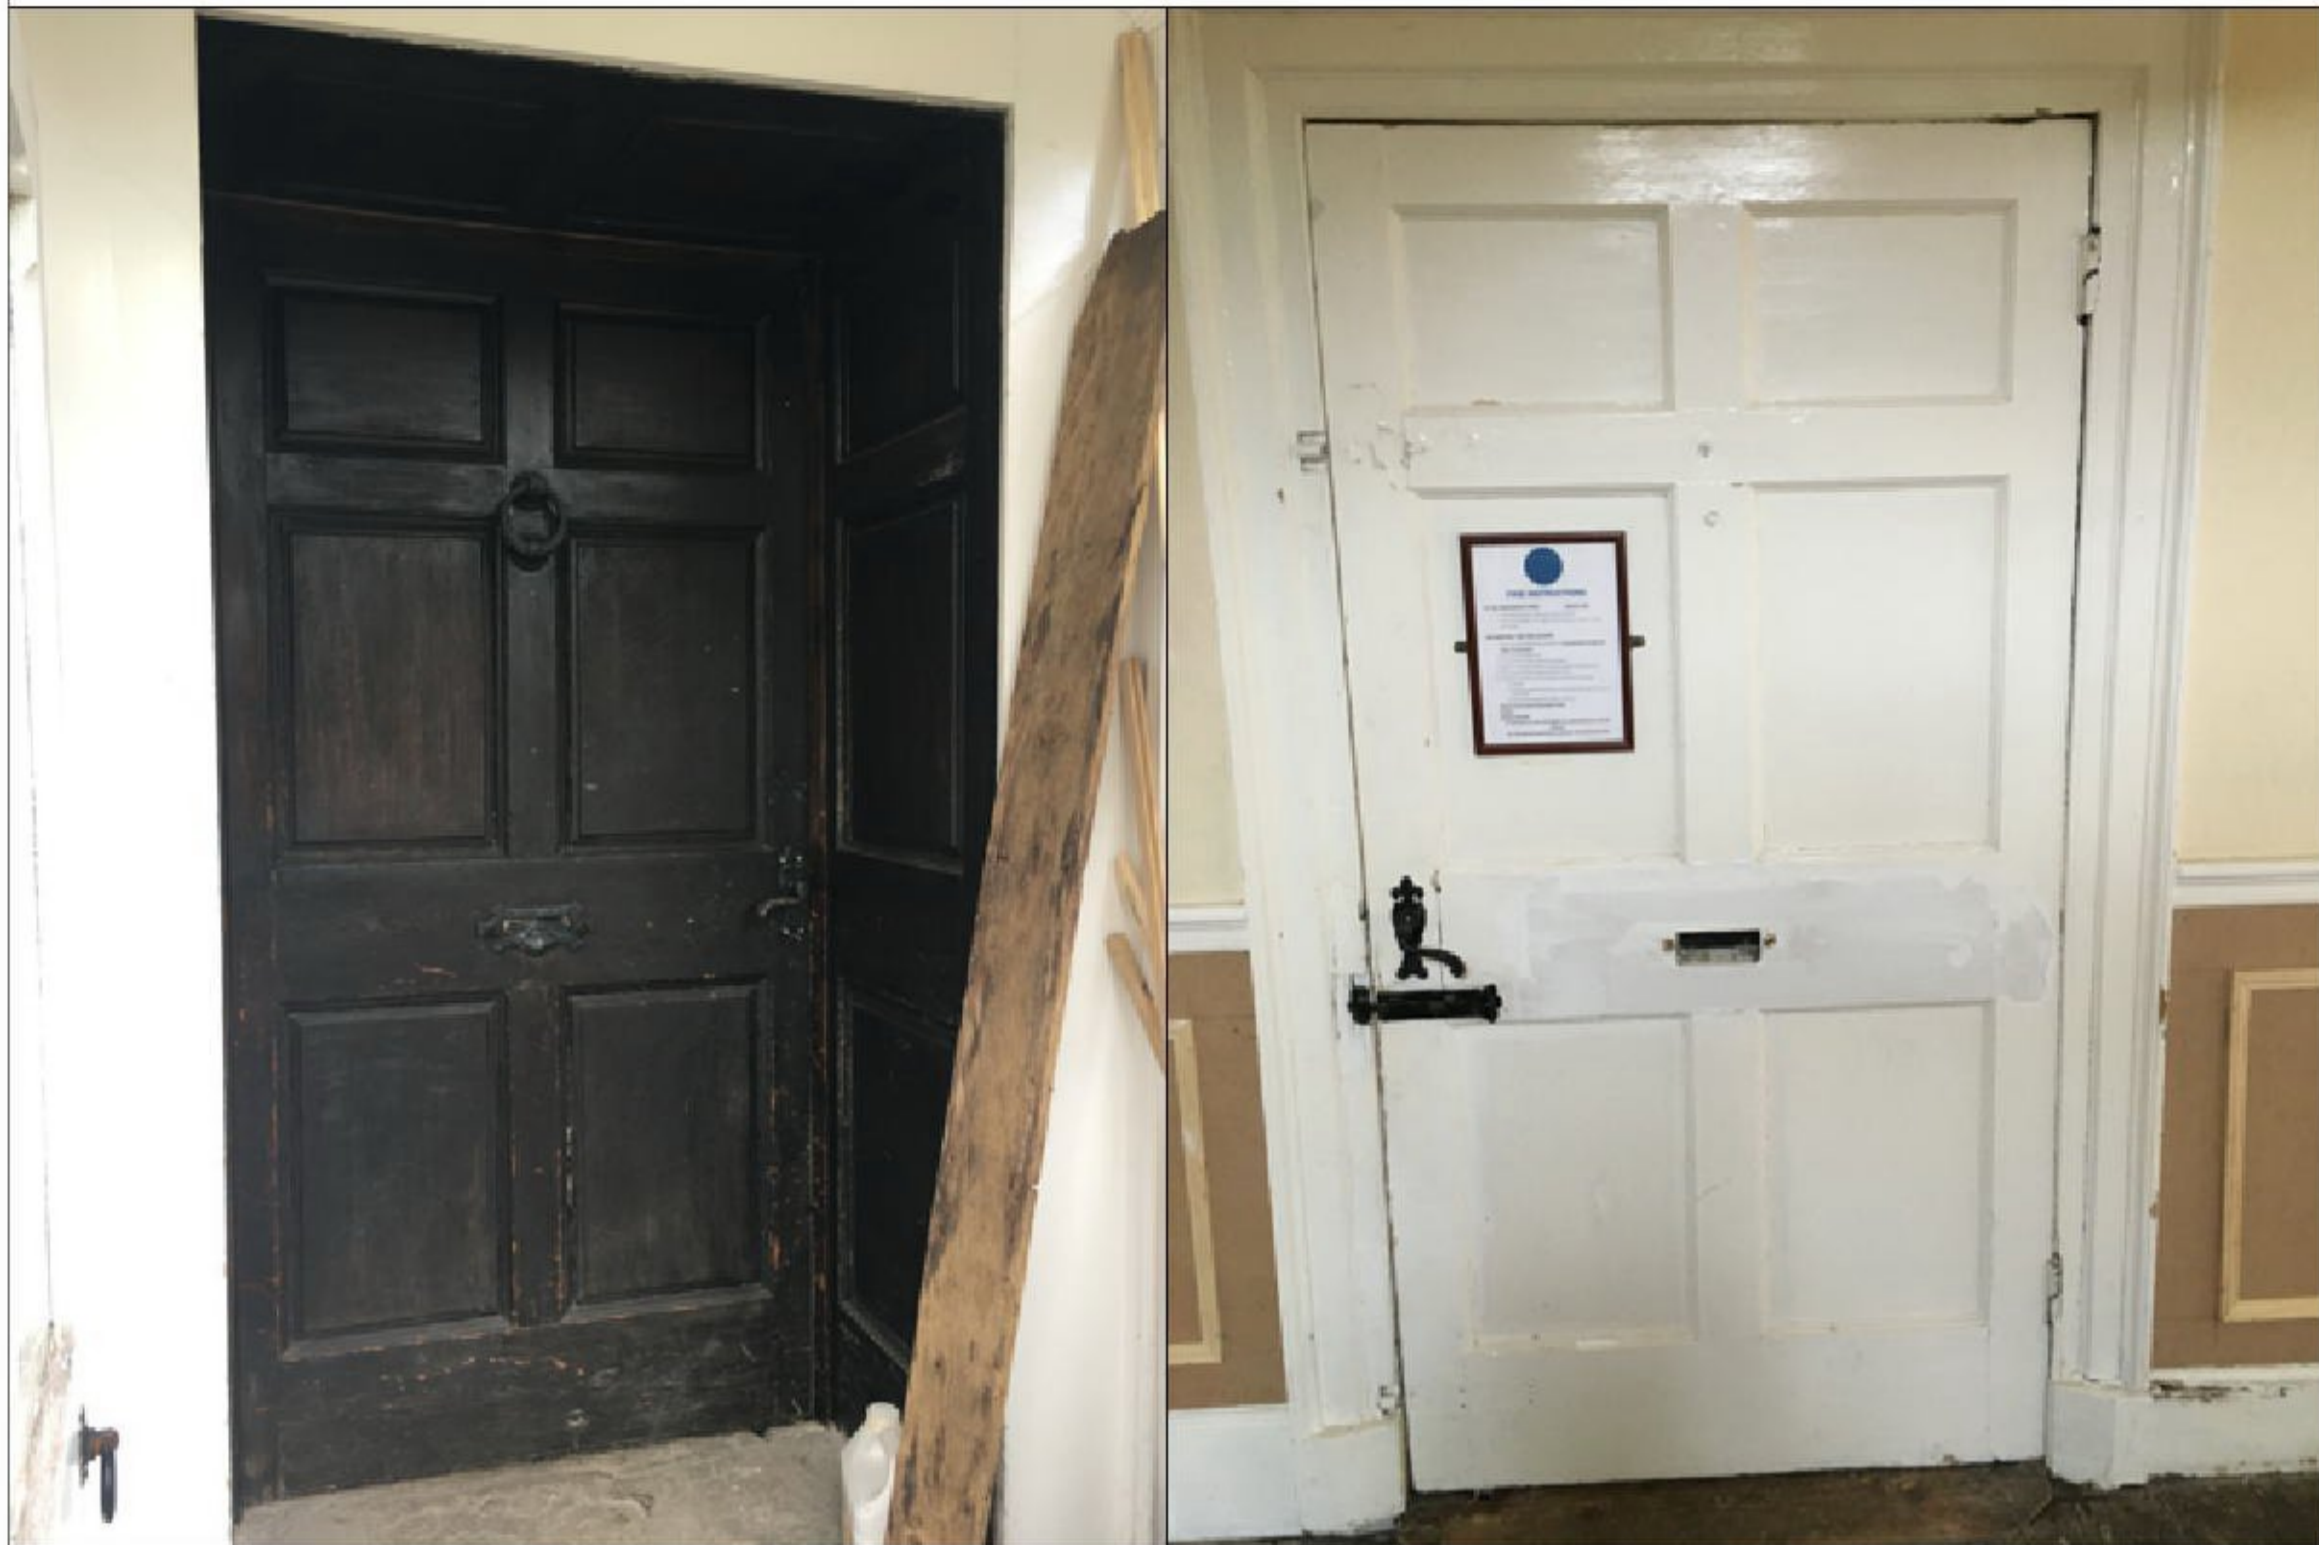
External Photo ED003E

Photo Location - External West - Door Number **ED003** - See floor plans for location

Door leaf - Presumed original - Good condition

Frame and Architrave - Presumed original - Good condition

- Refurbish and repaint, retain original ironmongery
additional security locks to be added

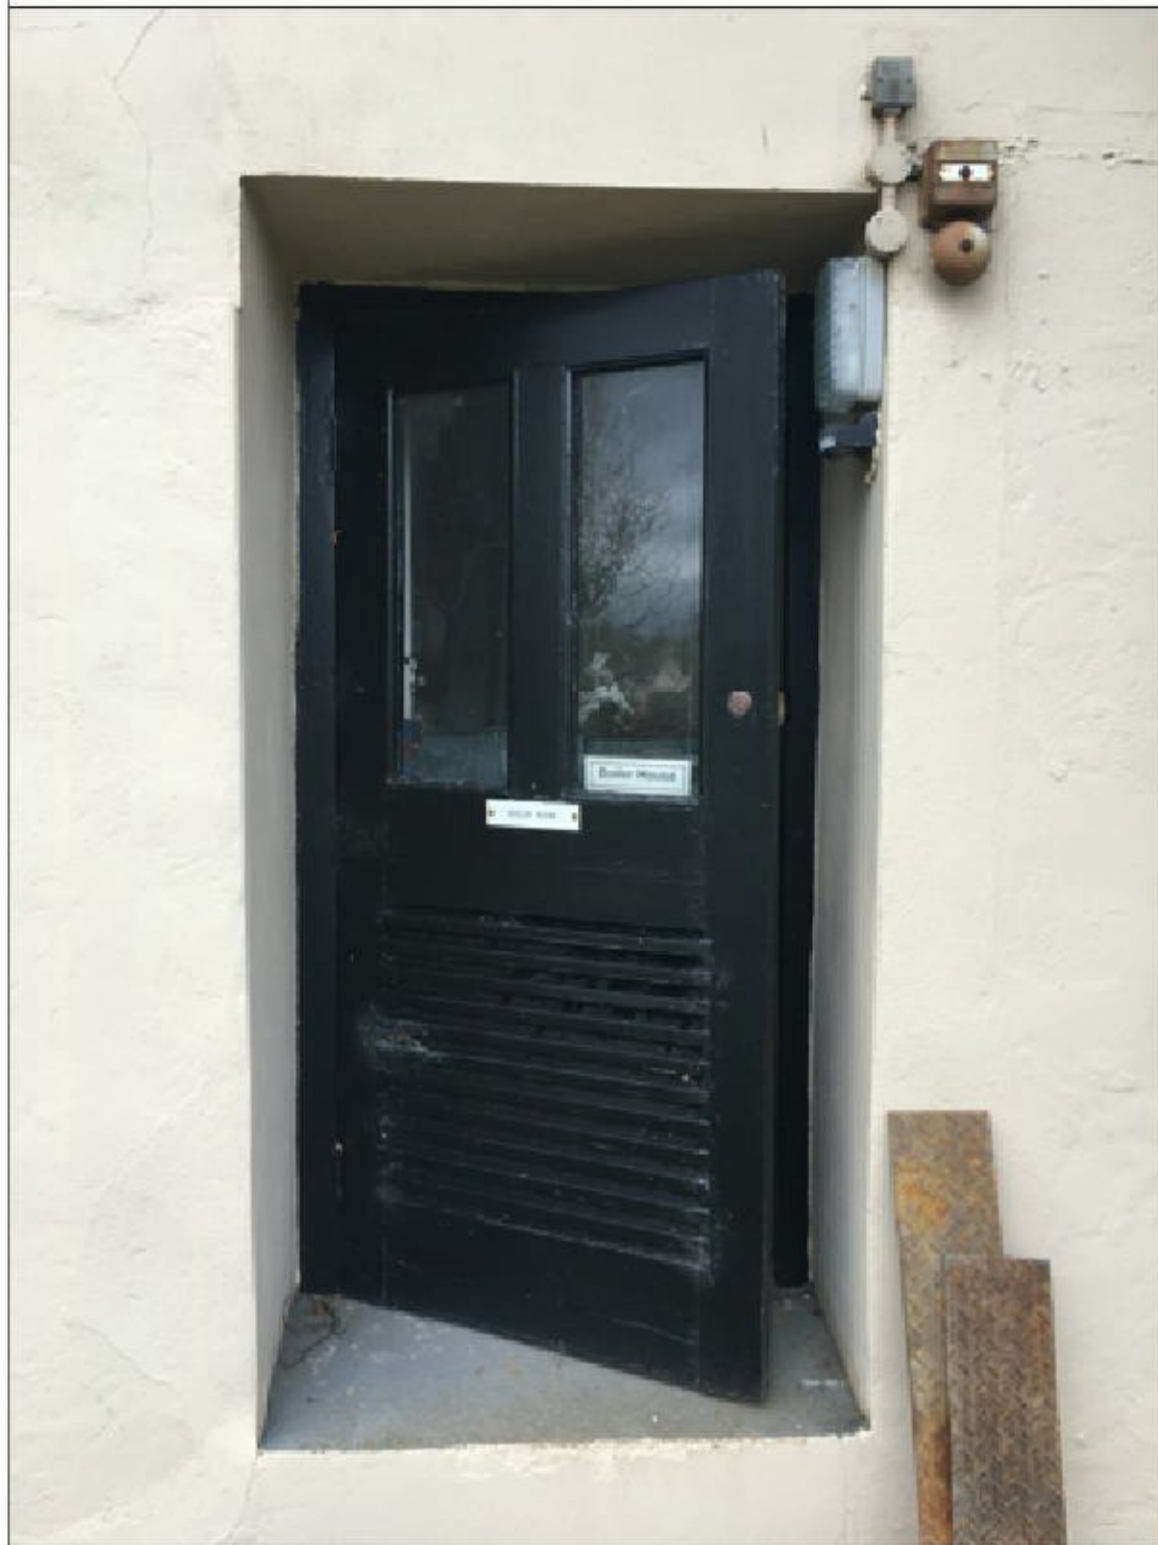
External Photo ED004E

Photo Location - External West - Door Number **ED004** - See floor plans for location

Door leaf - Presumed original - Good condition

Frame and Architrave - Presumed original - Good condition

Glass - Presumed non original

- Refurbish and repaint

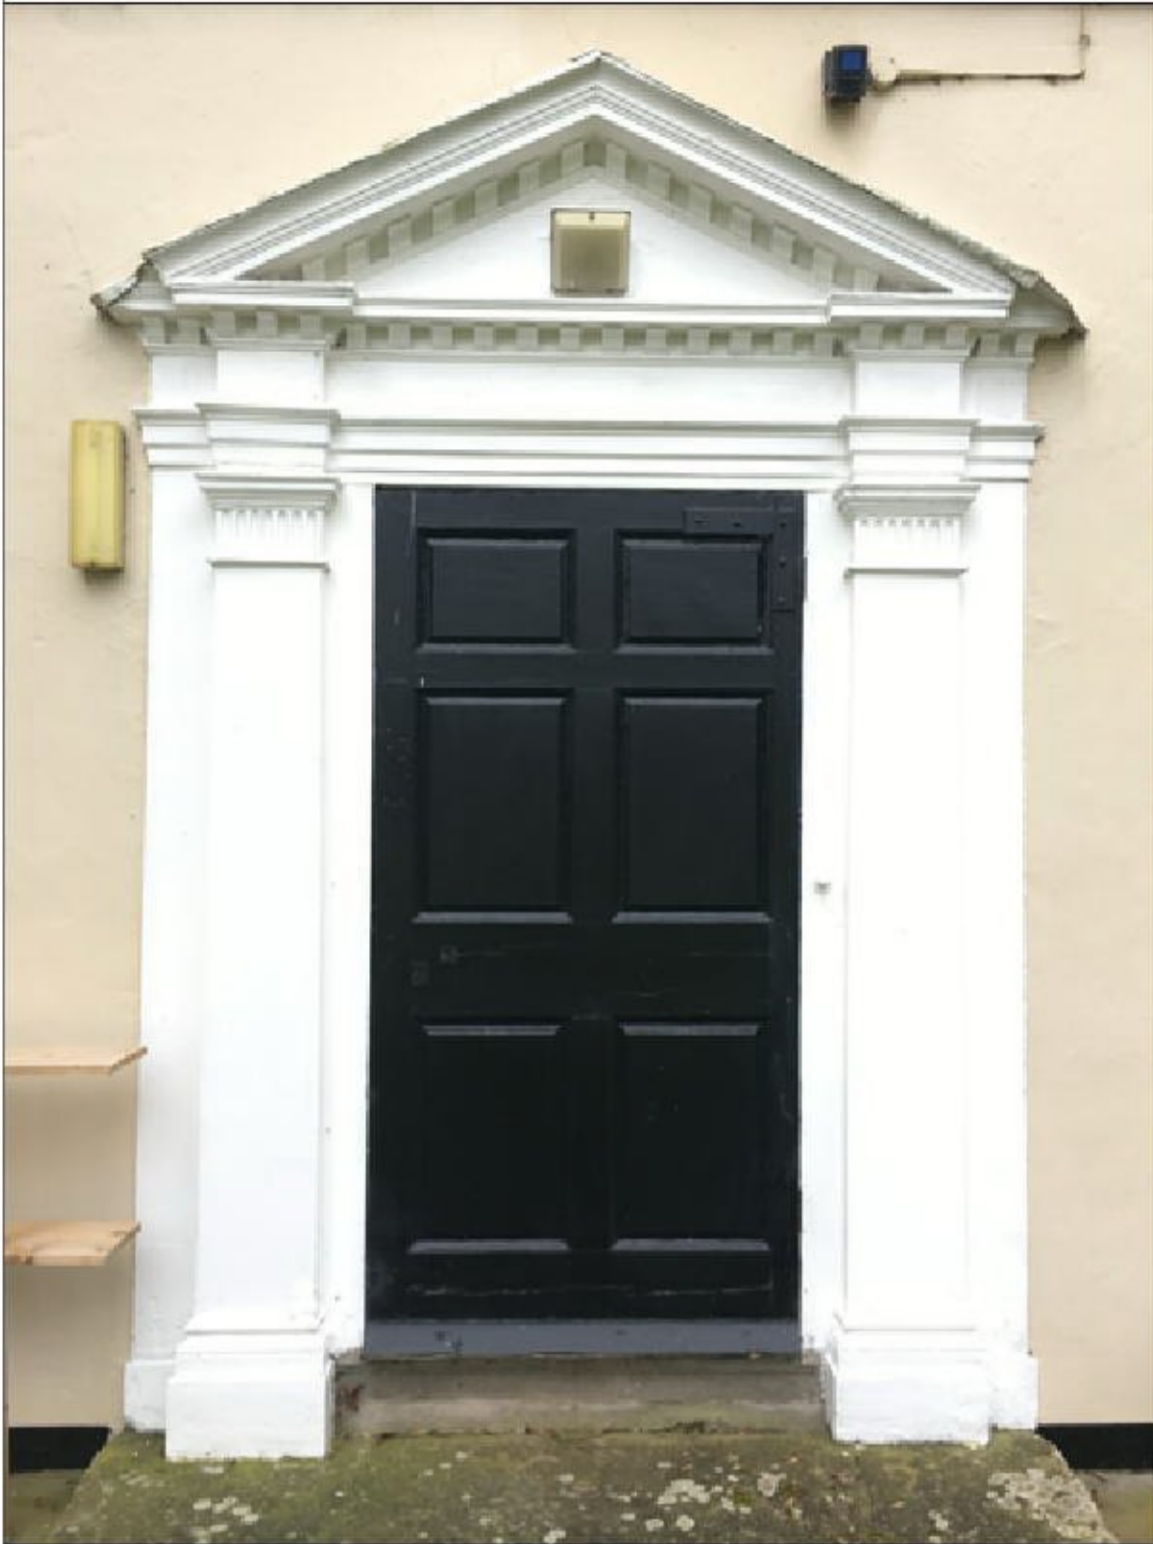
External Photo ED004E

Photo Location - External East - Door Number **ED005** - See floor plans for location

Door leaf - Presumed original - Good condition

Frame and Architrave - Presumed original - Good condition

- Refurbish and repaint

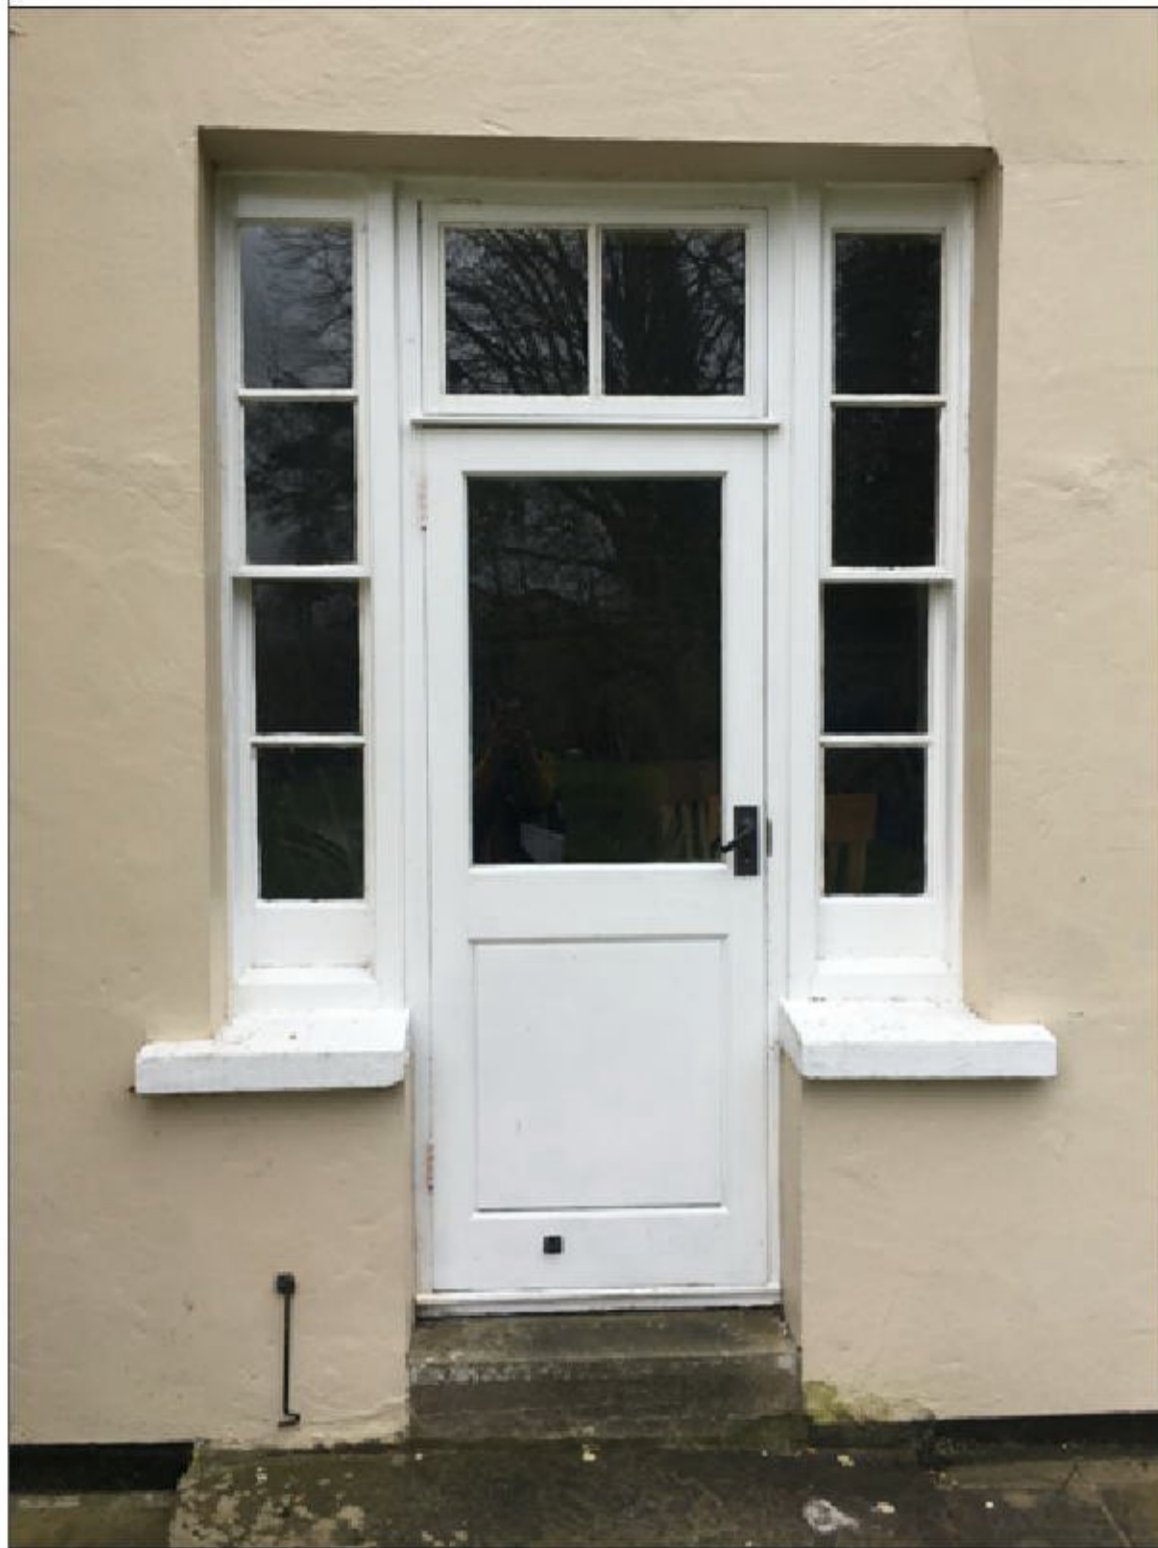
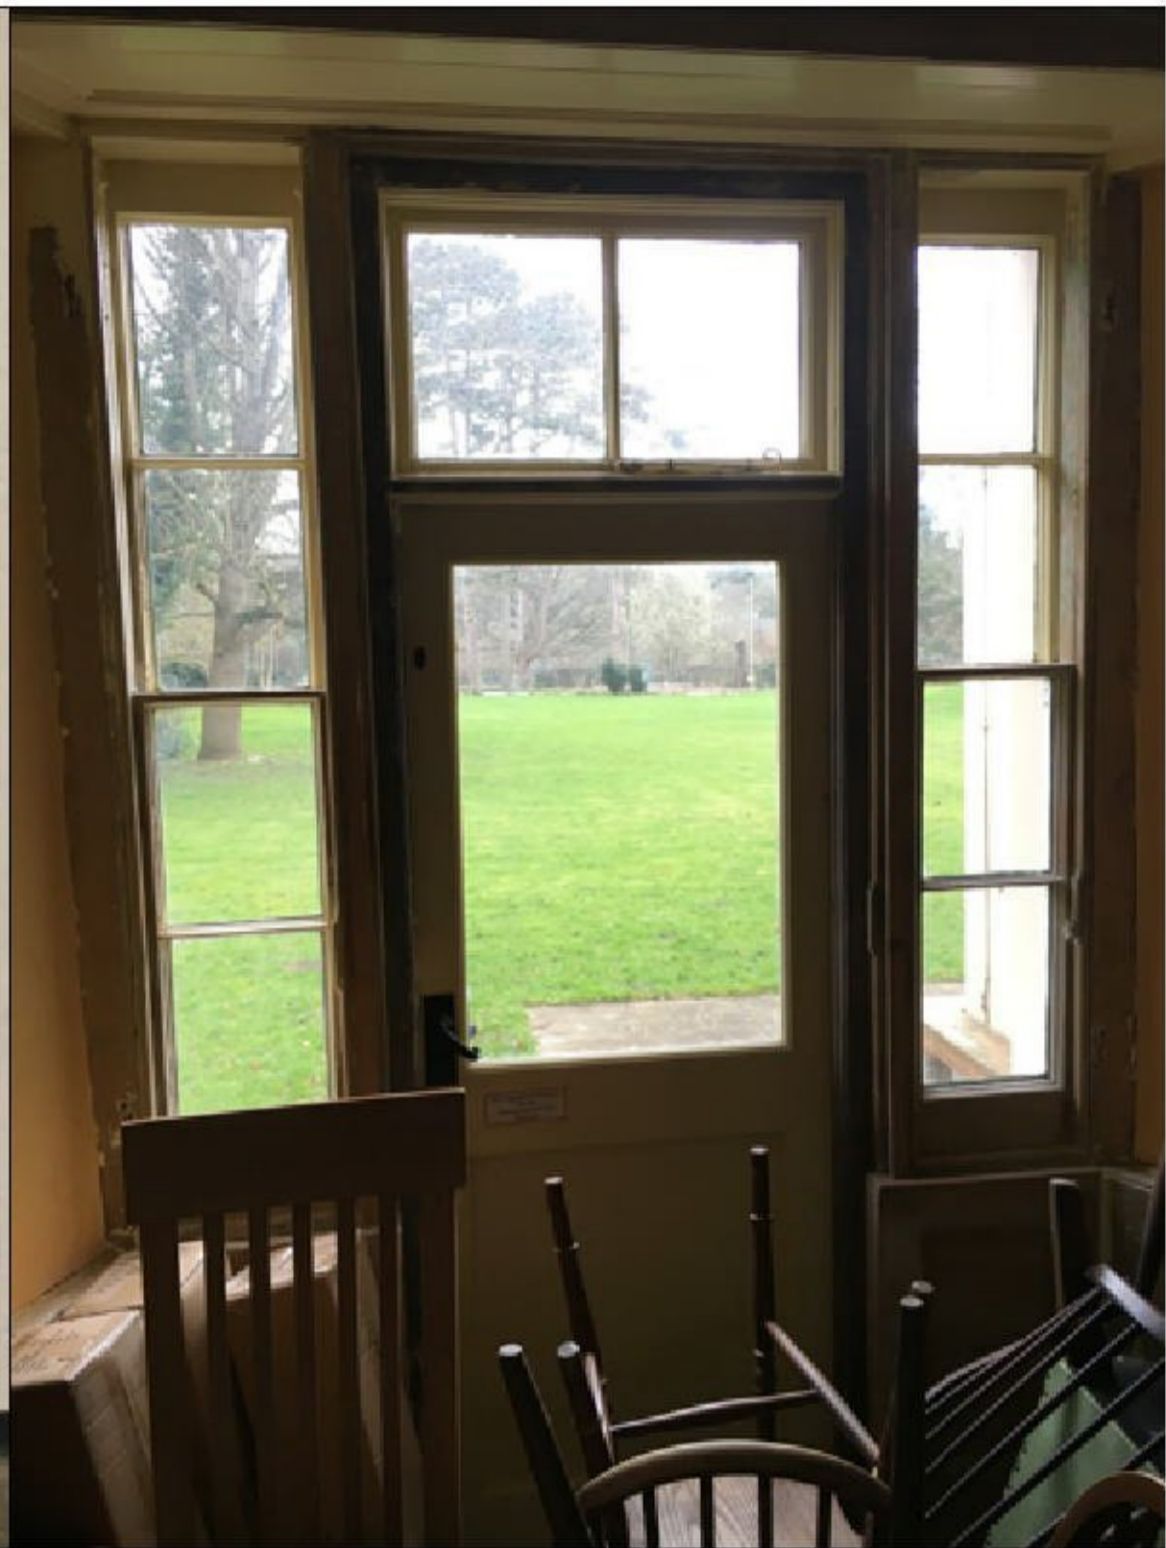
Photo Location - External East - Door Number **ED006** - See floor plans for location

Door leaf - Presumed non original - Good condition

Frame and Architrave - Presumed non original - Good condition

Glass - Central pane presumed non original - Good condition
- Smaller panes presumed non original - Good condition

- Refurbish and repaint

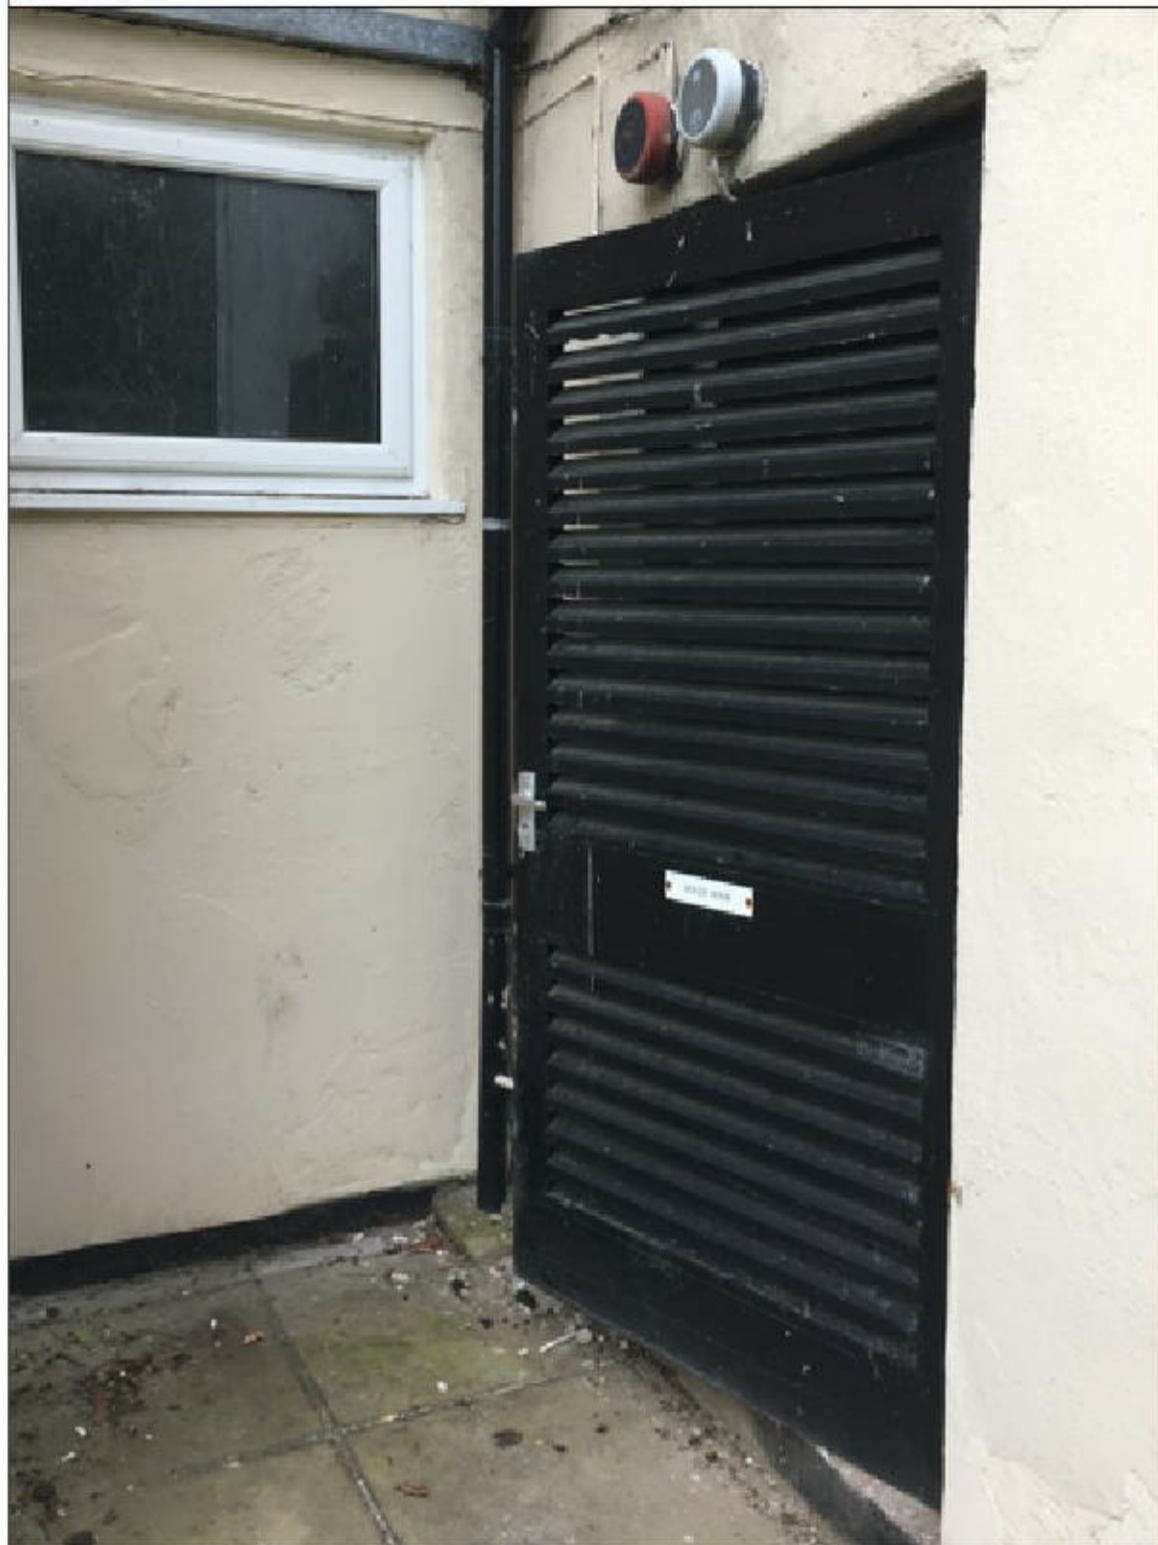
External Photo ED007E

Photo Location - External South - Door Number **ED007** - See floor plans for location

Door leaf - Presumed original - Average condition

Frame and Architrave - Presumed original - Average condition

- Refurbish and repaint

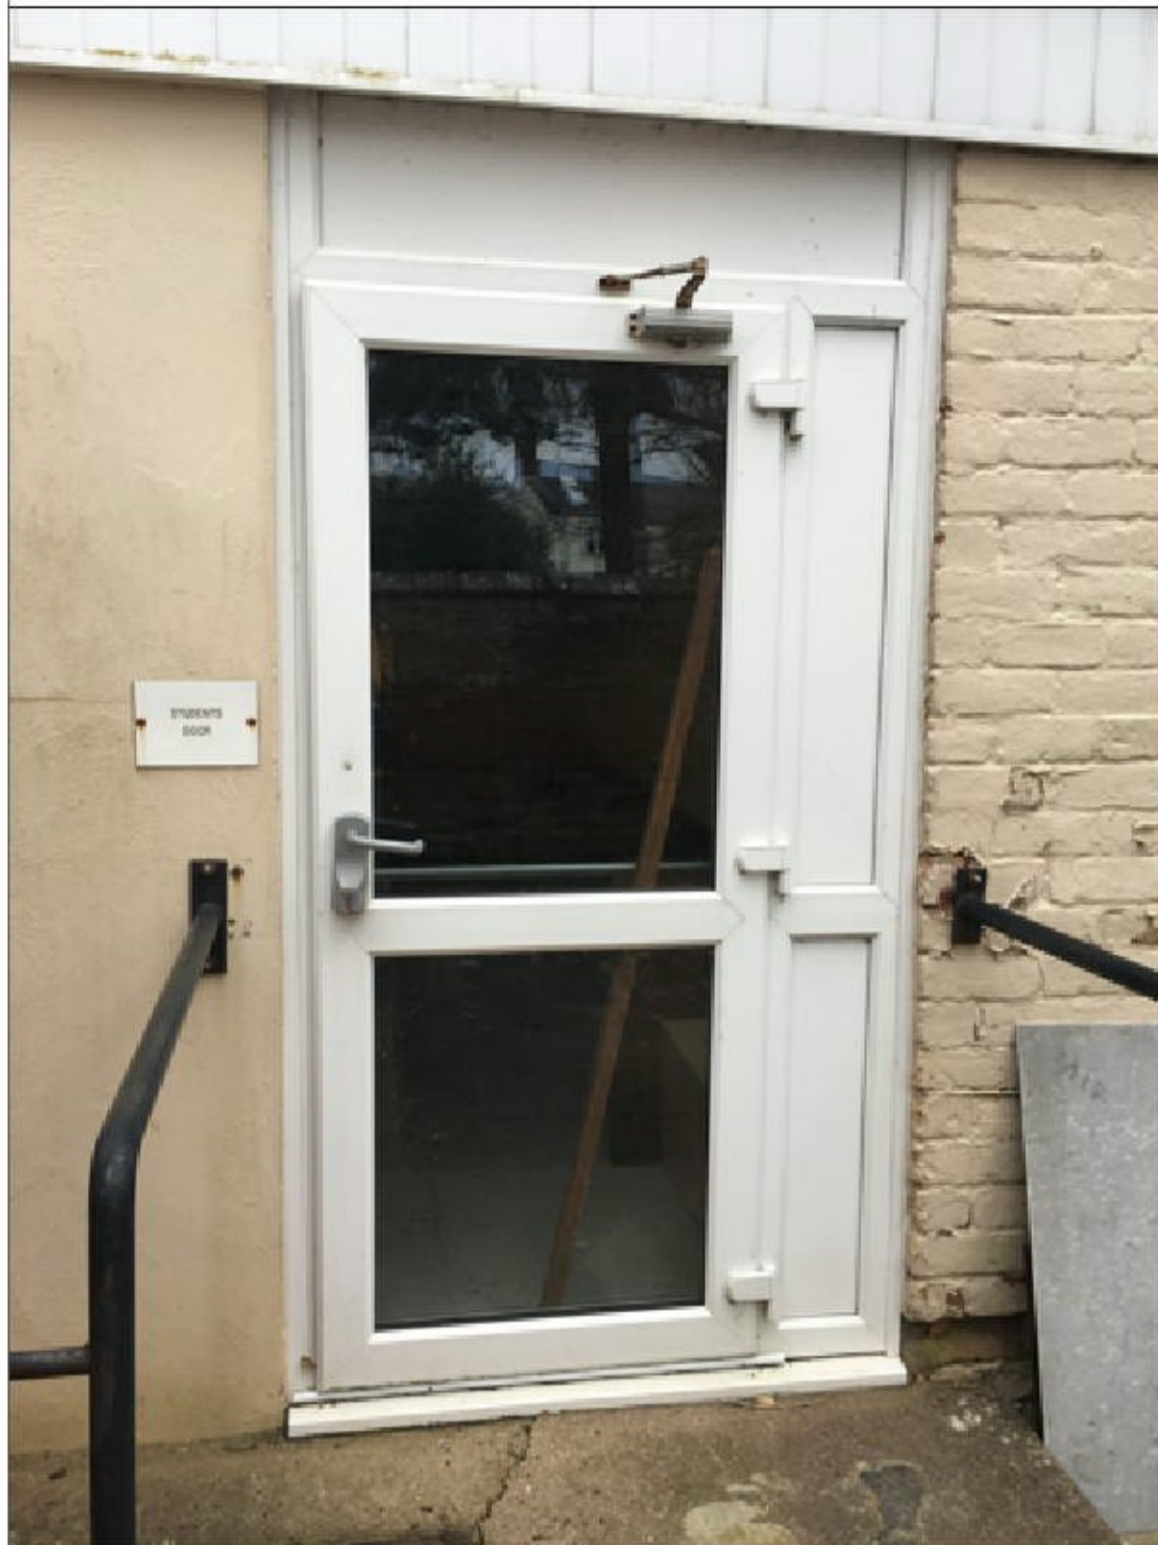
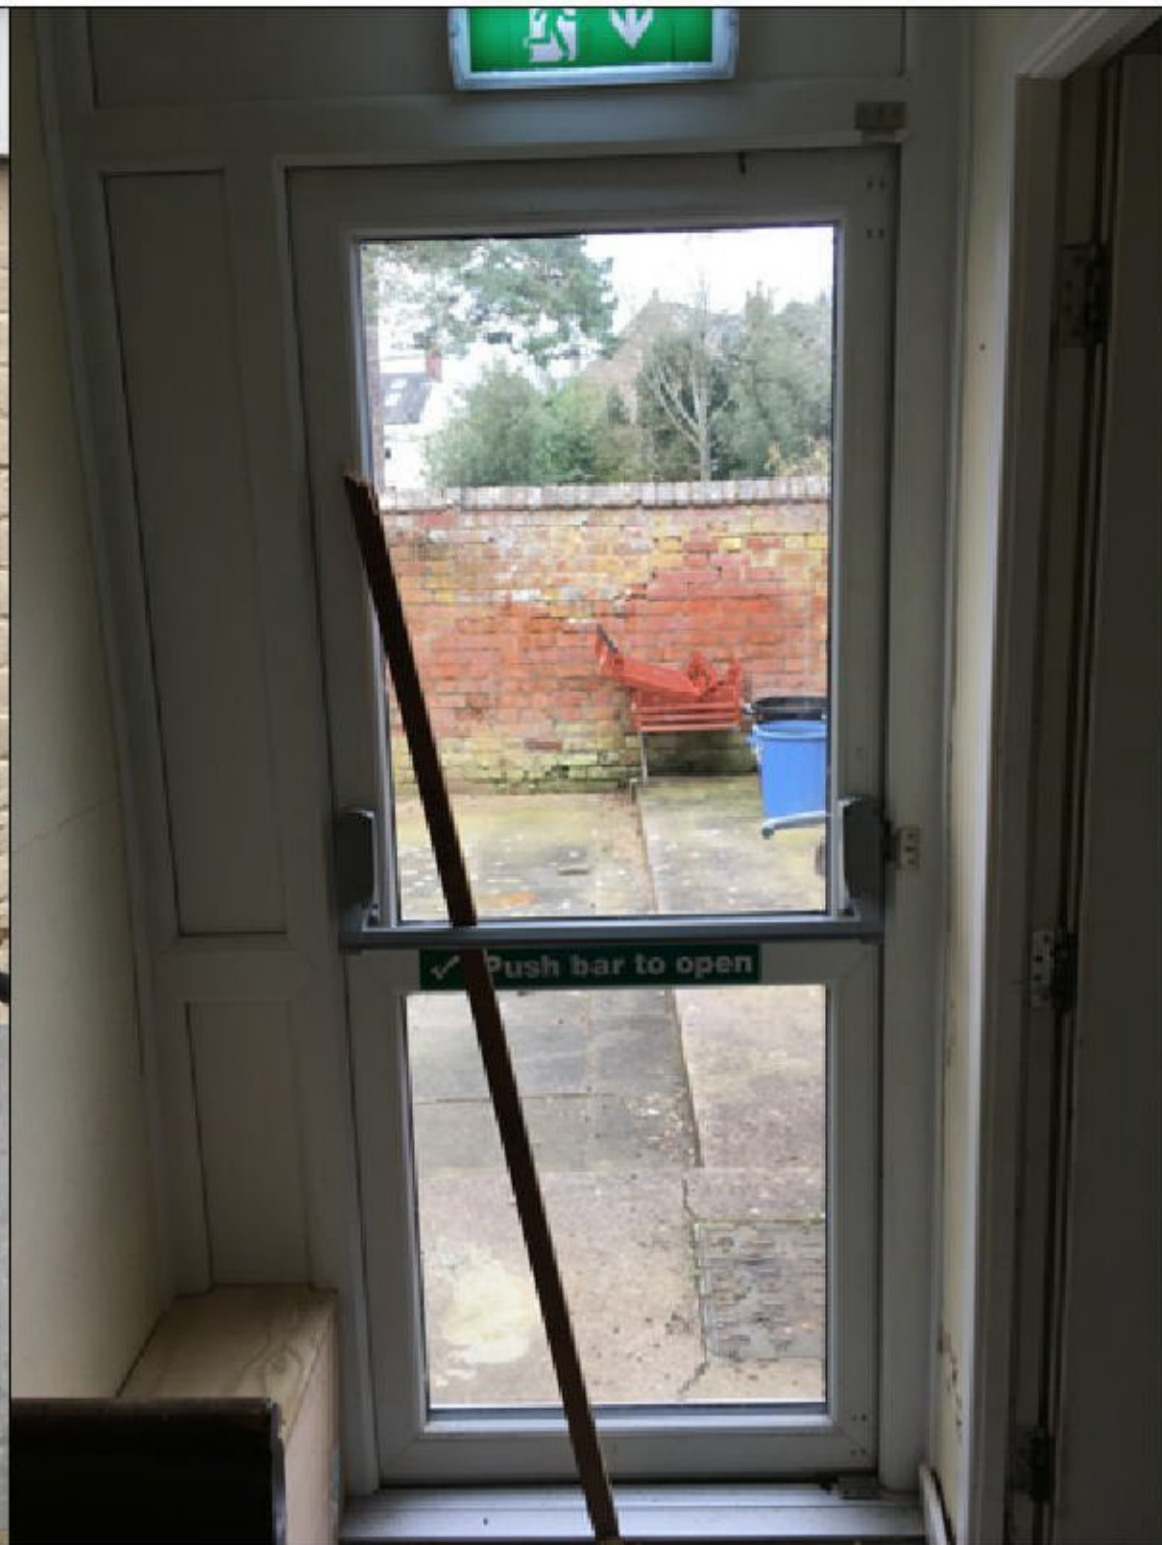
Photo Location - External West - Door Number **ED008** - See floor plans for location

Door leaf - Presumed original - Good condition

Frame and Architrave - Presumed original - Good condition

Glass - Presumed original - Good condition

- Refurbish
