Building Recording - Ground Floor

External and Internal Doors

Showing existing photos, noted location, frame condition, leaf condition and proposed refurbishment works

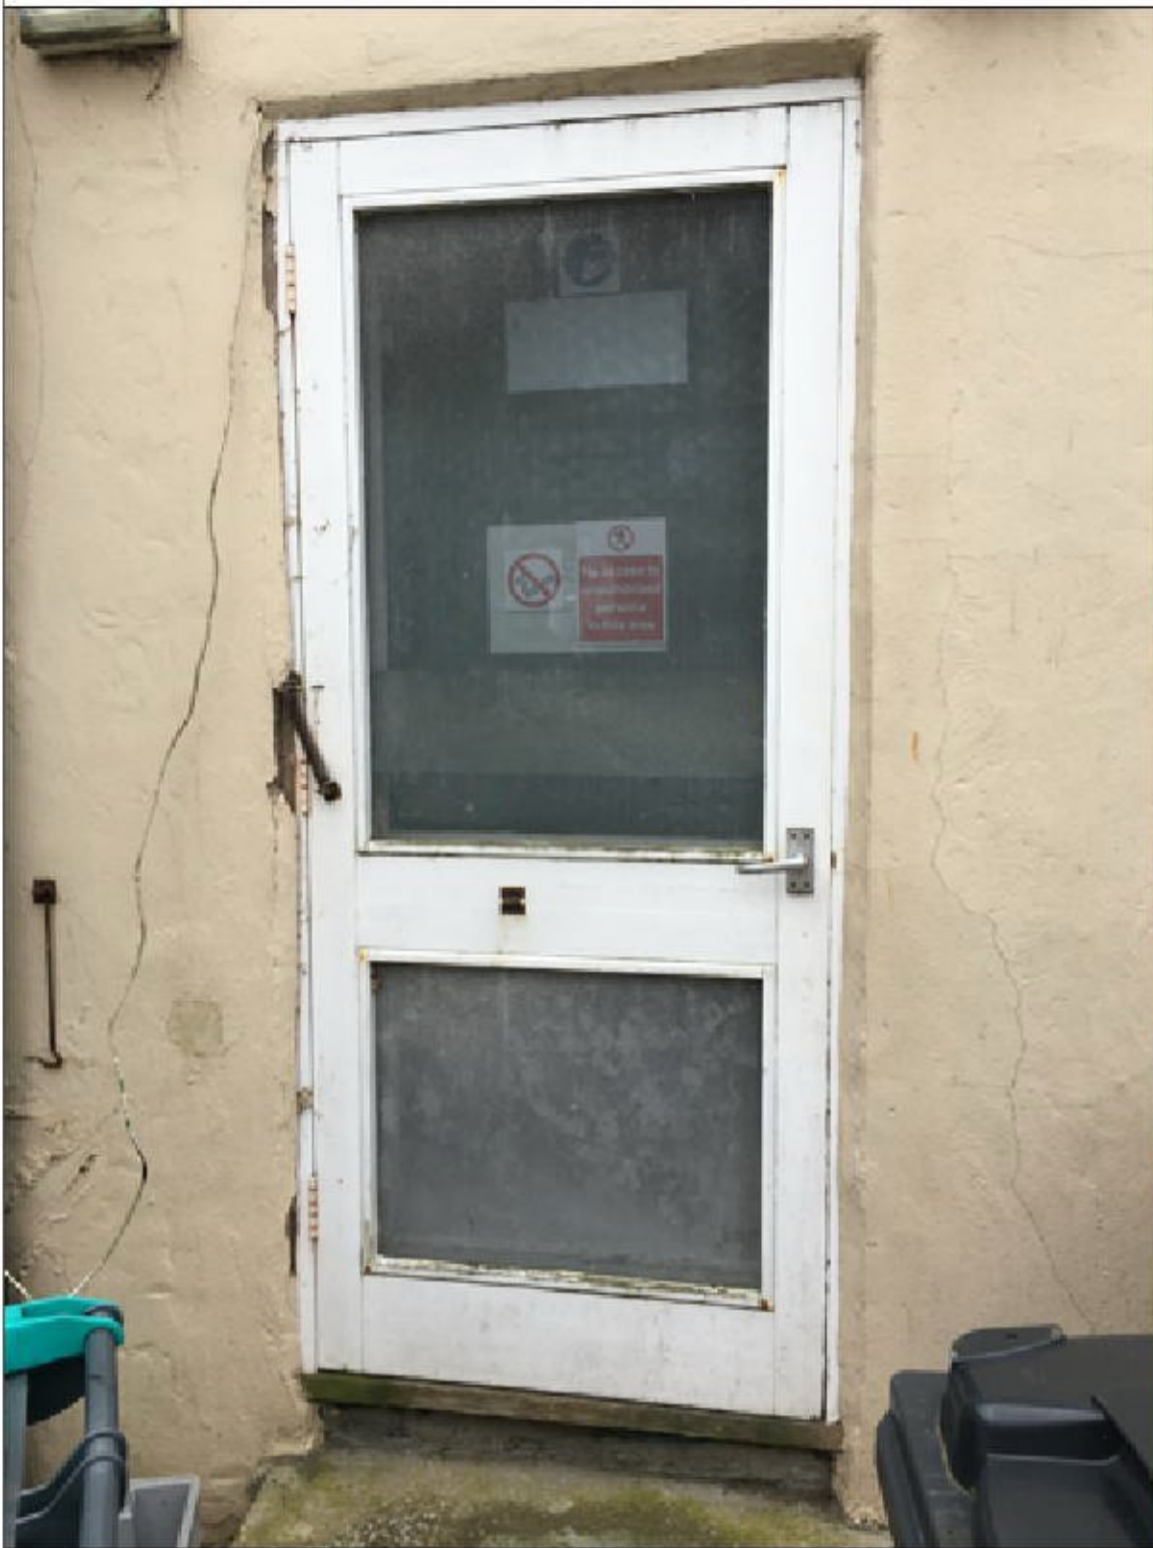
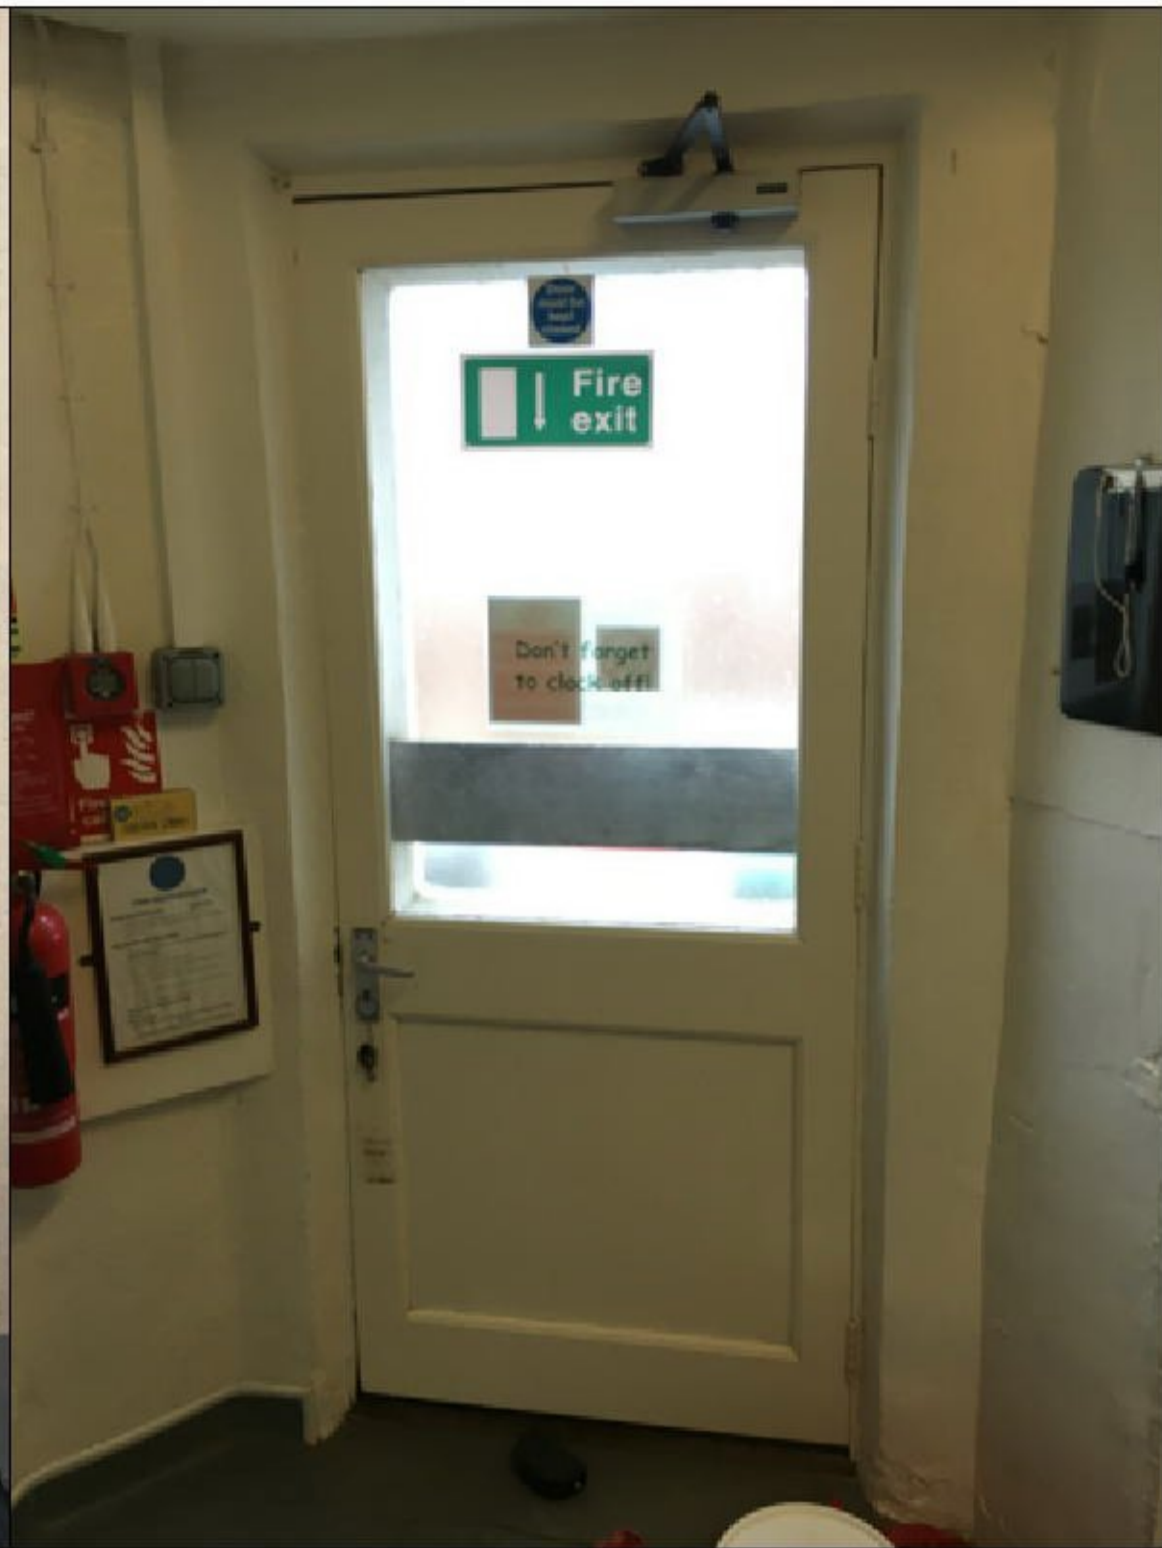
Photo Location - External West - Door Number **ED009** - See floor plans for location

Door leaf - Presumed non original - Poor condition

Frame and Architrave - Presumed non original - Poor condition

Glass - Presumed non original - Poor condition

- Replaced

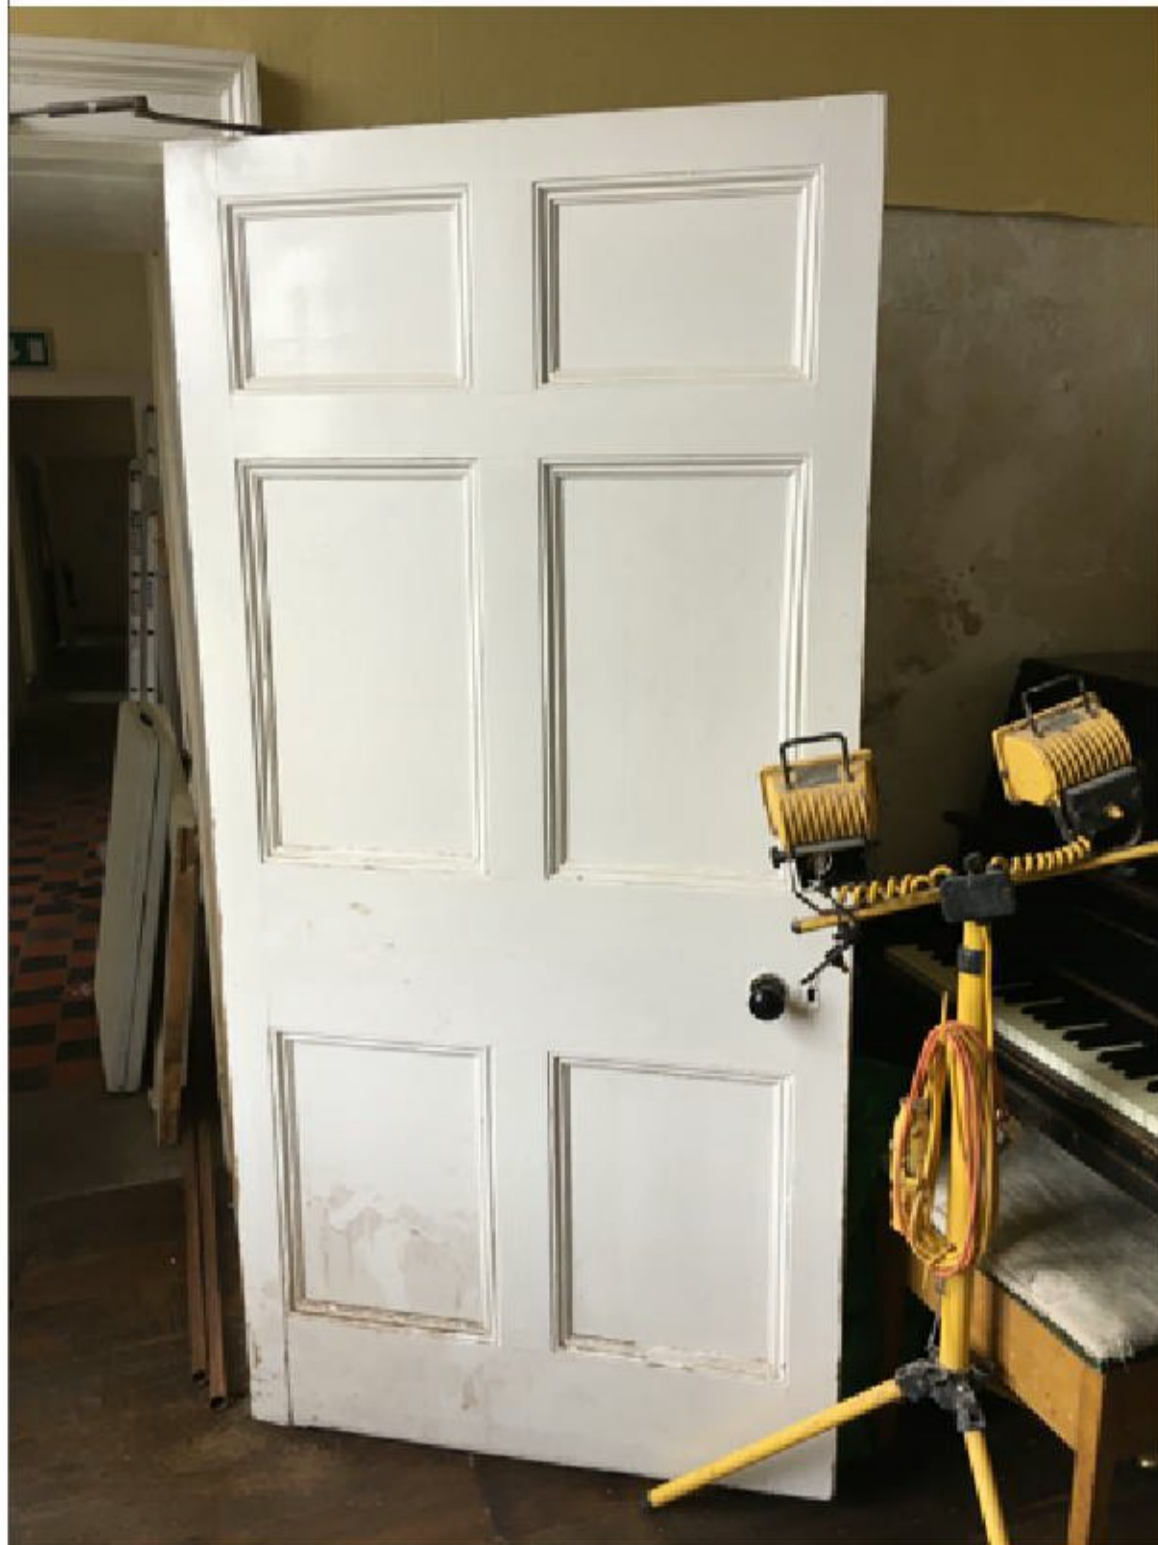
Internal Photo D001i

Photo Location - Hall - Door Number D001 - See floor plans for location

Door leaf - Presumed original - Good condition

Frame and Architrave - Presumed original - Good condition

- Refurbish and repaint.**

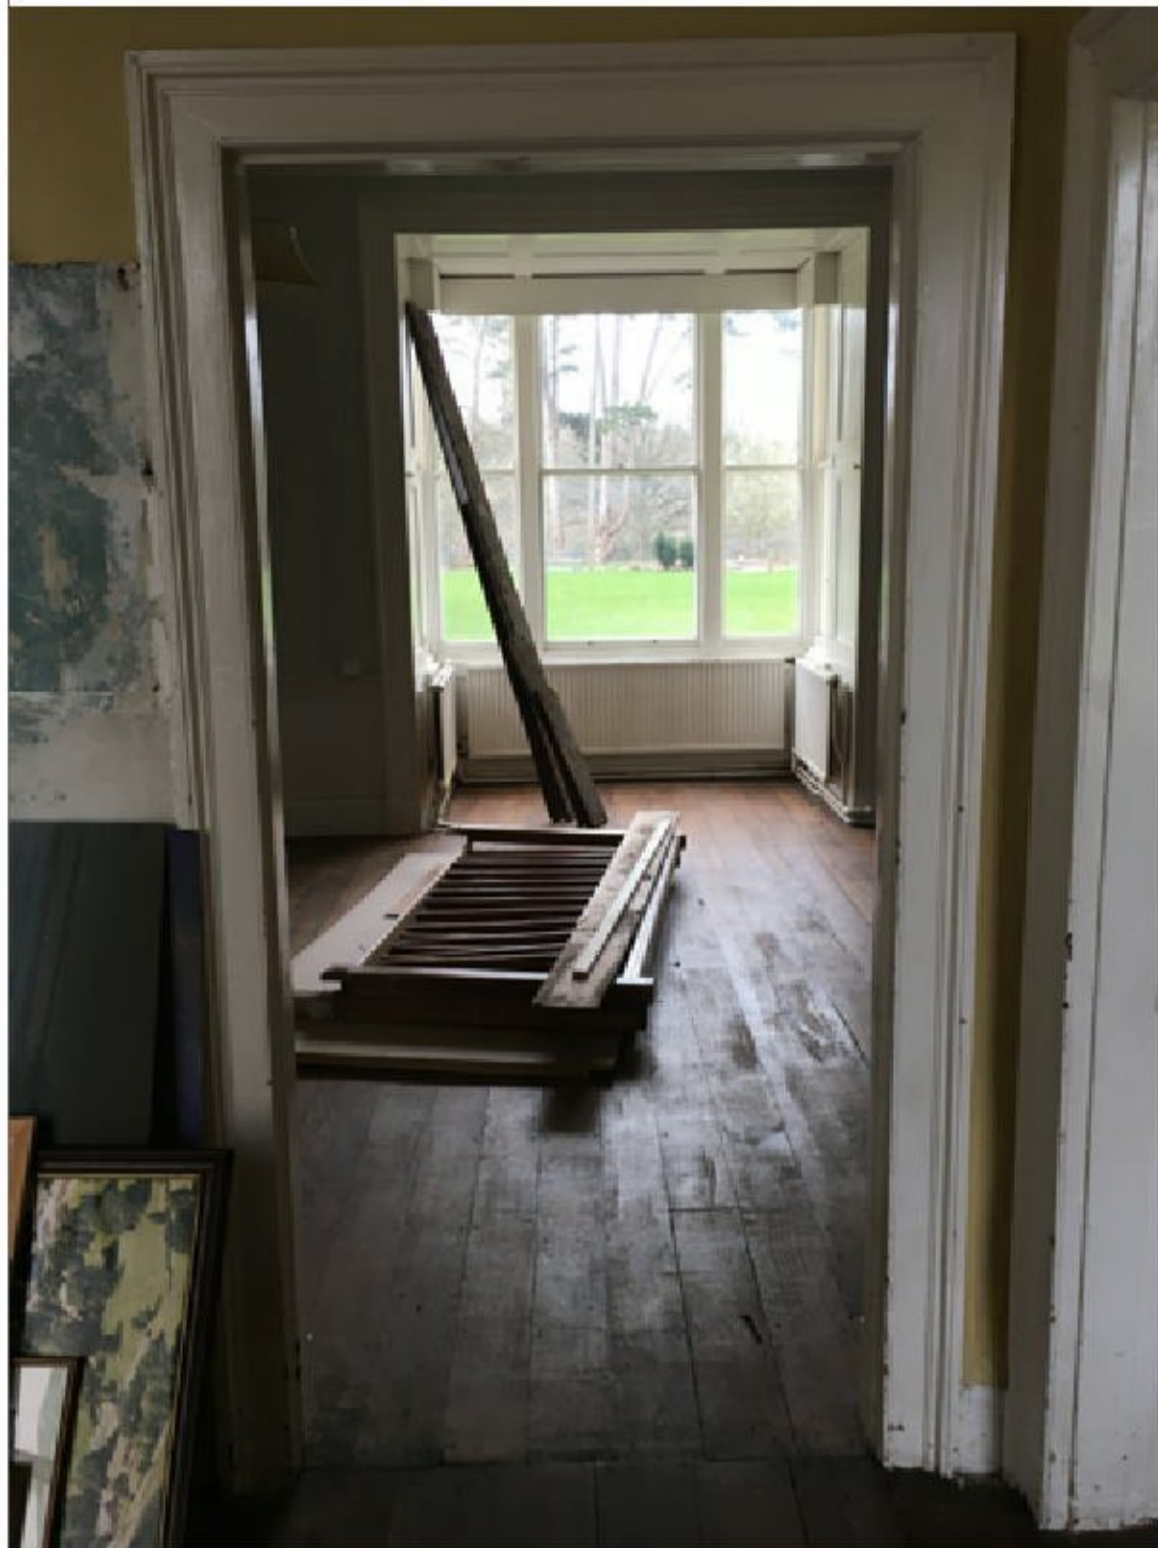
Internal Photo D002i

Photo Location - Lounge - Door Number **D002** - See floor plans for location

Door leaf - Presumed original - Good condition (currently being restored)

Frame and Architrave - Presumed original - Good condition

- Refurbish and repaint.
- Fire officer's comments on the proposed fire strategy is to be taken into account. It is aimed to retain the door and provide the required fire rating with intumescent frame seals.

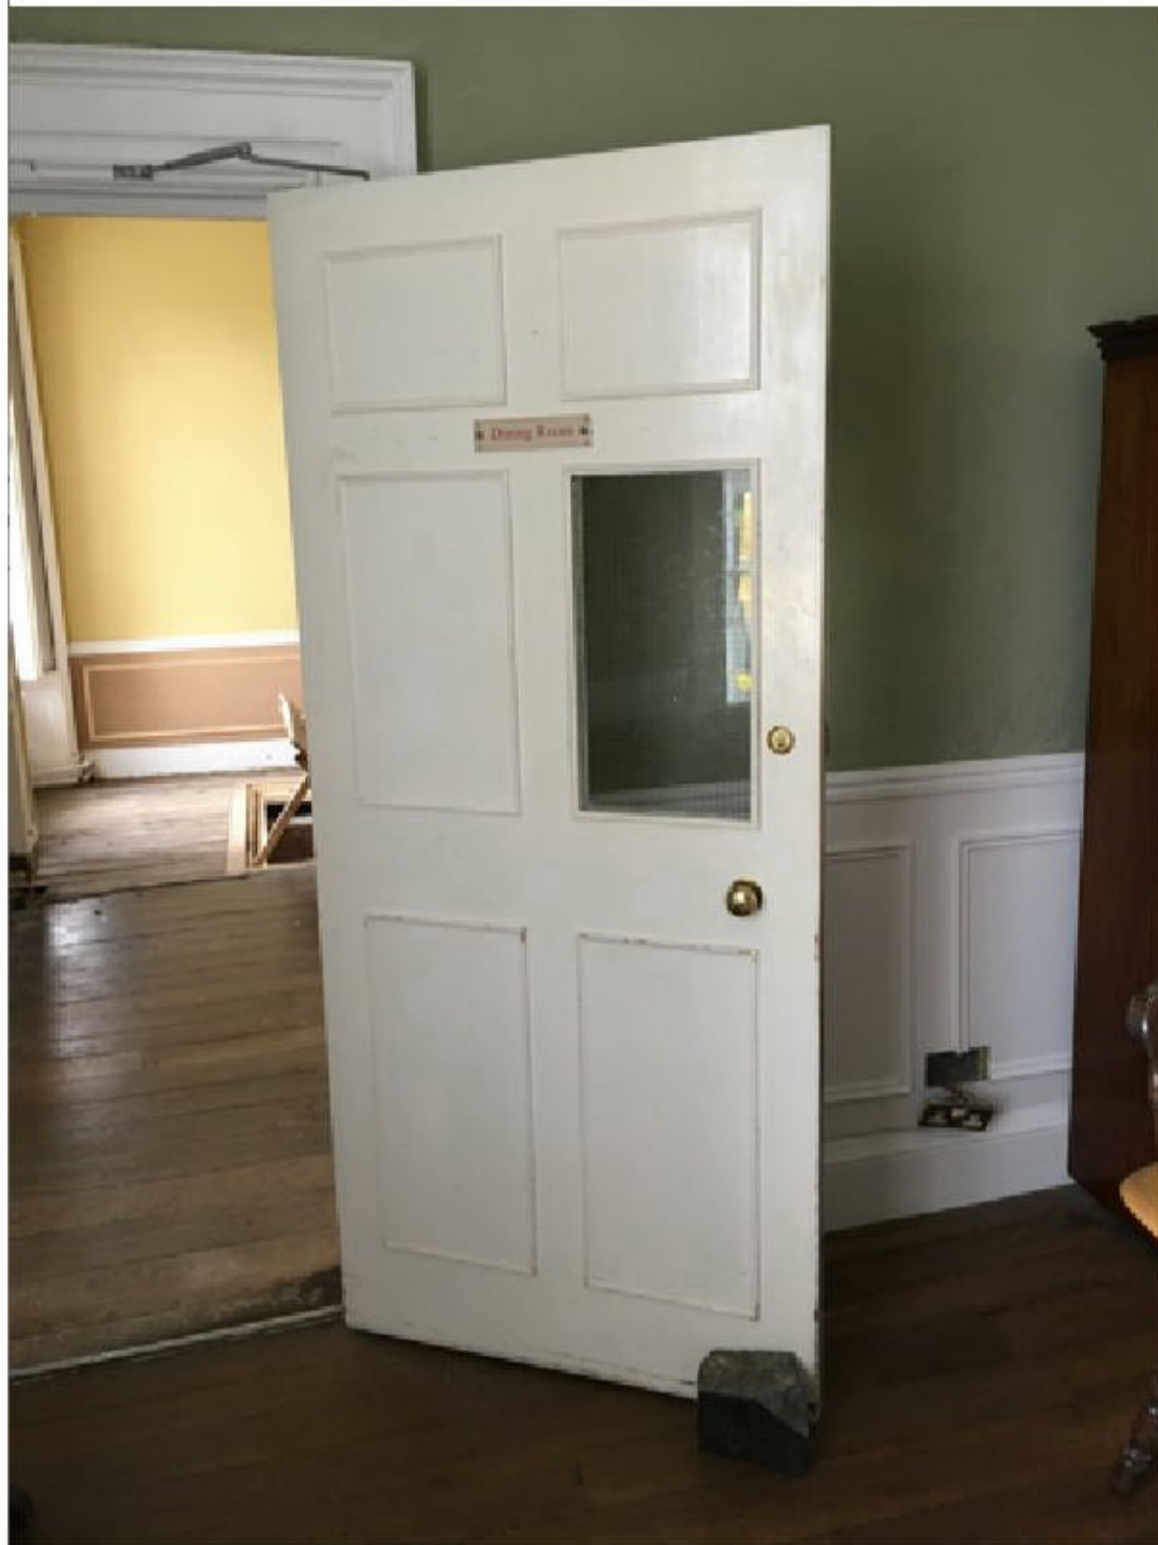
Internal Photo D003i

Photo Location - Dining Room - Door Number **D003** - See floor plans for location

Door leaf - Presumed original - Good condition missing timber pane

Frame and Architrave - Presumed original - Good condition

Glass - Non original to be removed

- Refurbish and repaint, replace timber pane

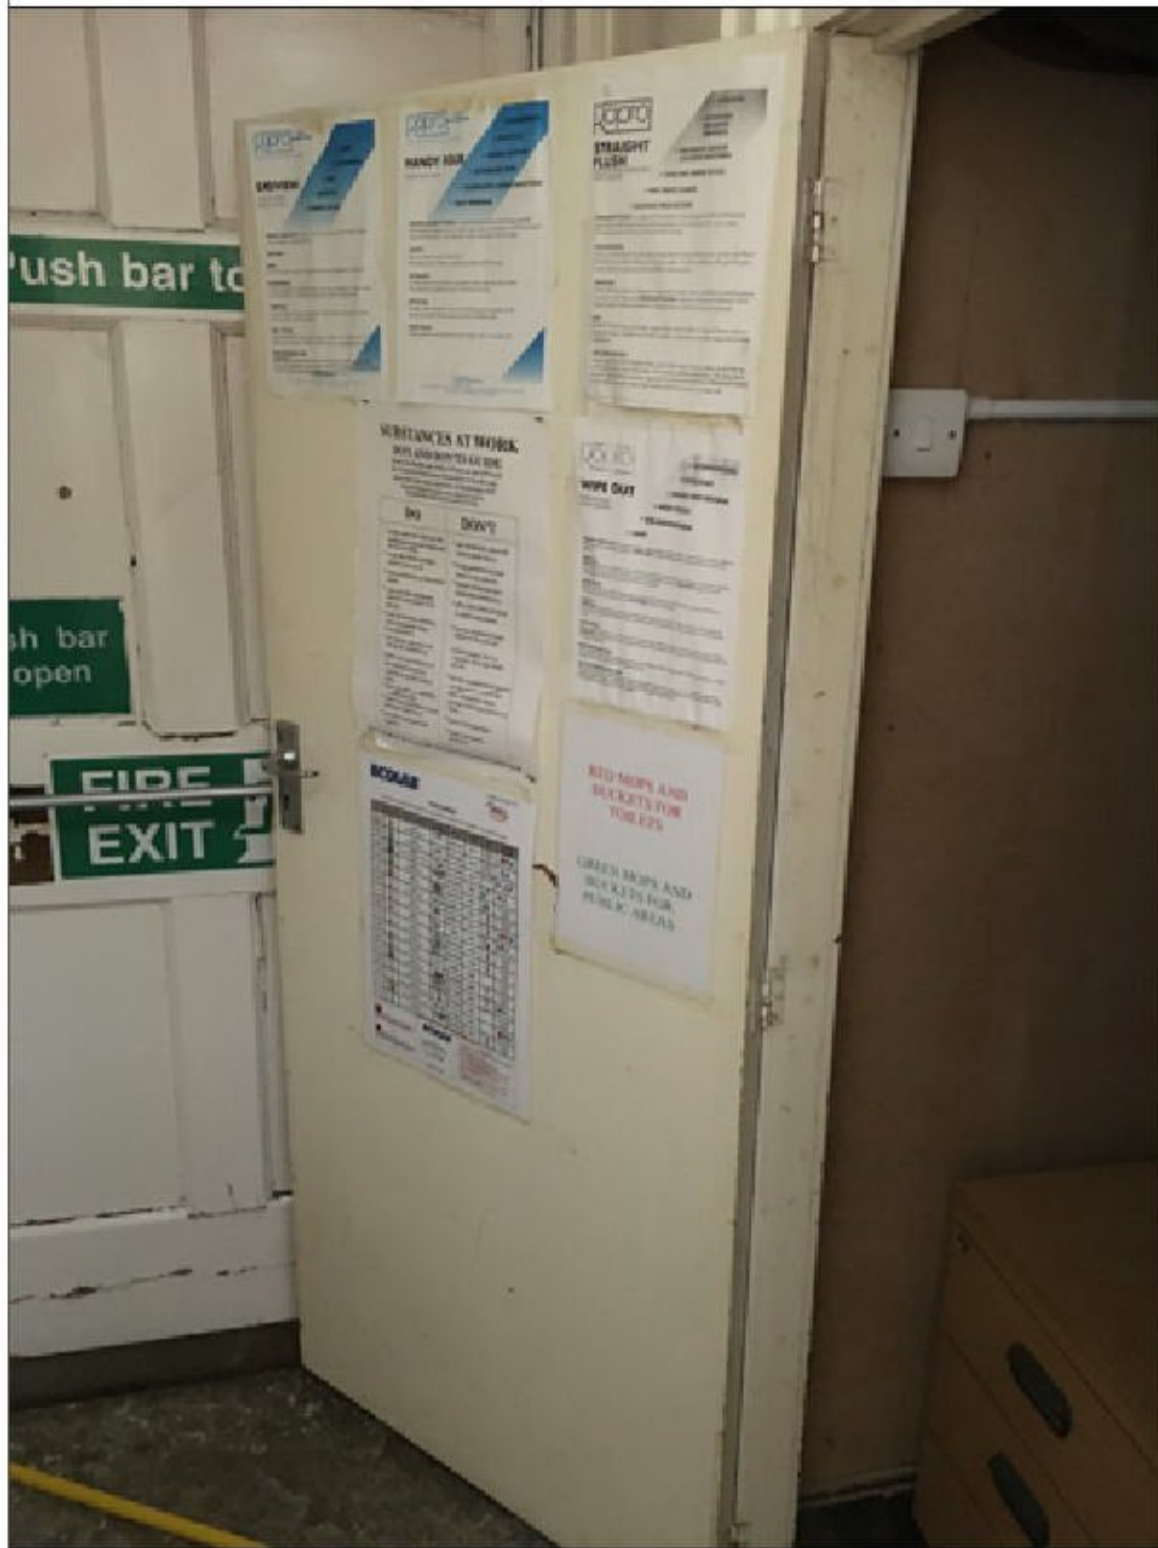
Internal Photo D004i

Photo Location - Cupboard in hall - Door Number **D004** - See floor plans for location

Door leaf - Presumed non original - Average condition

Frame and Architrave - Presumed non original - Average condition

- Refurbish and repaint

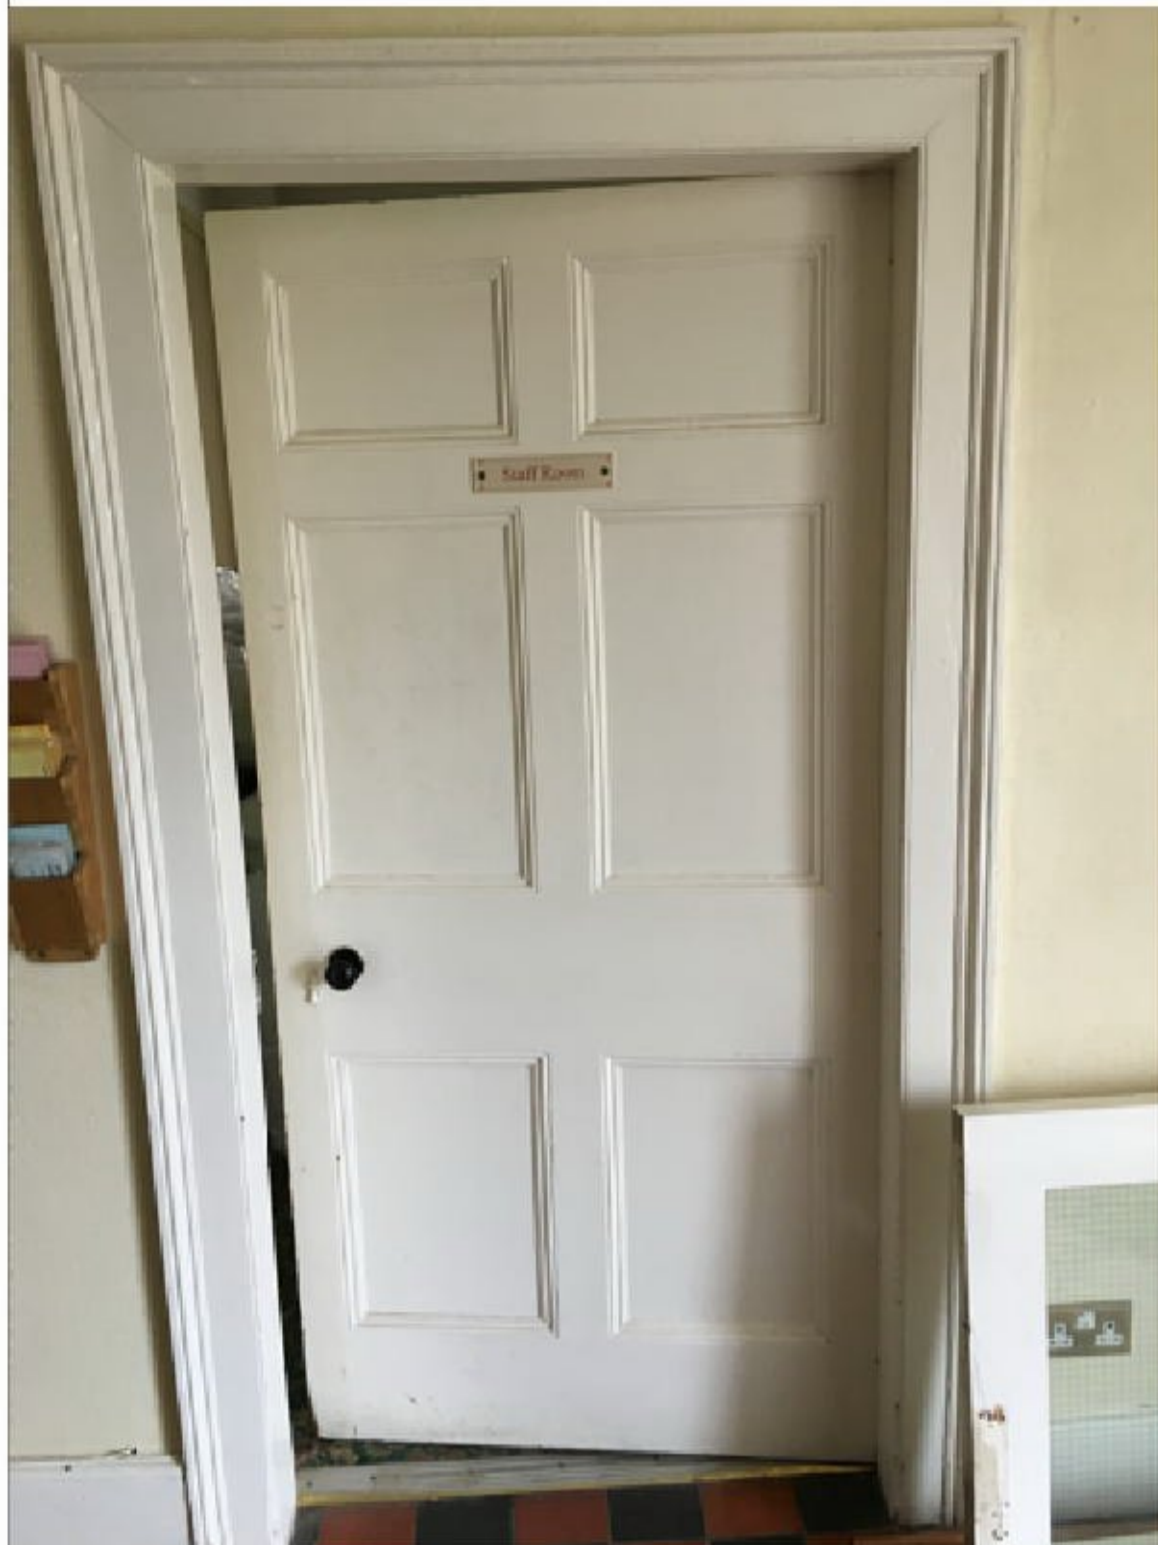
Internal Photo D005i

Photo Location - Staff Room - Door Number **D005** - See floor plans for location

Door leaf - Presumed original - Good condition

Frame and Architrave - Presumed original - Good condition

- Refurbish and repaint

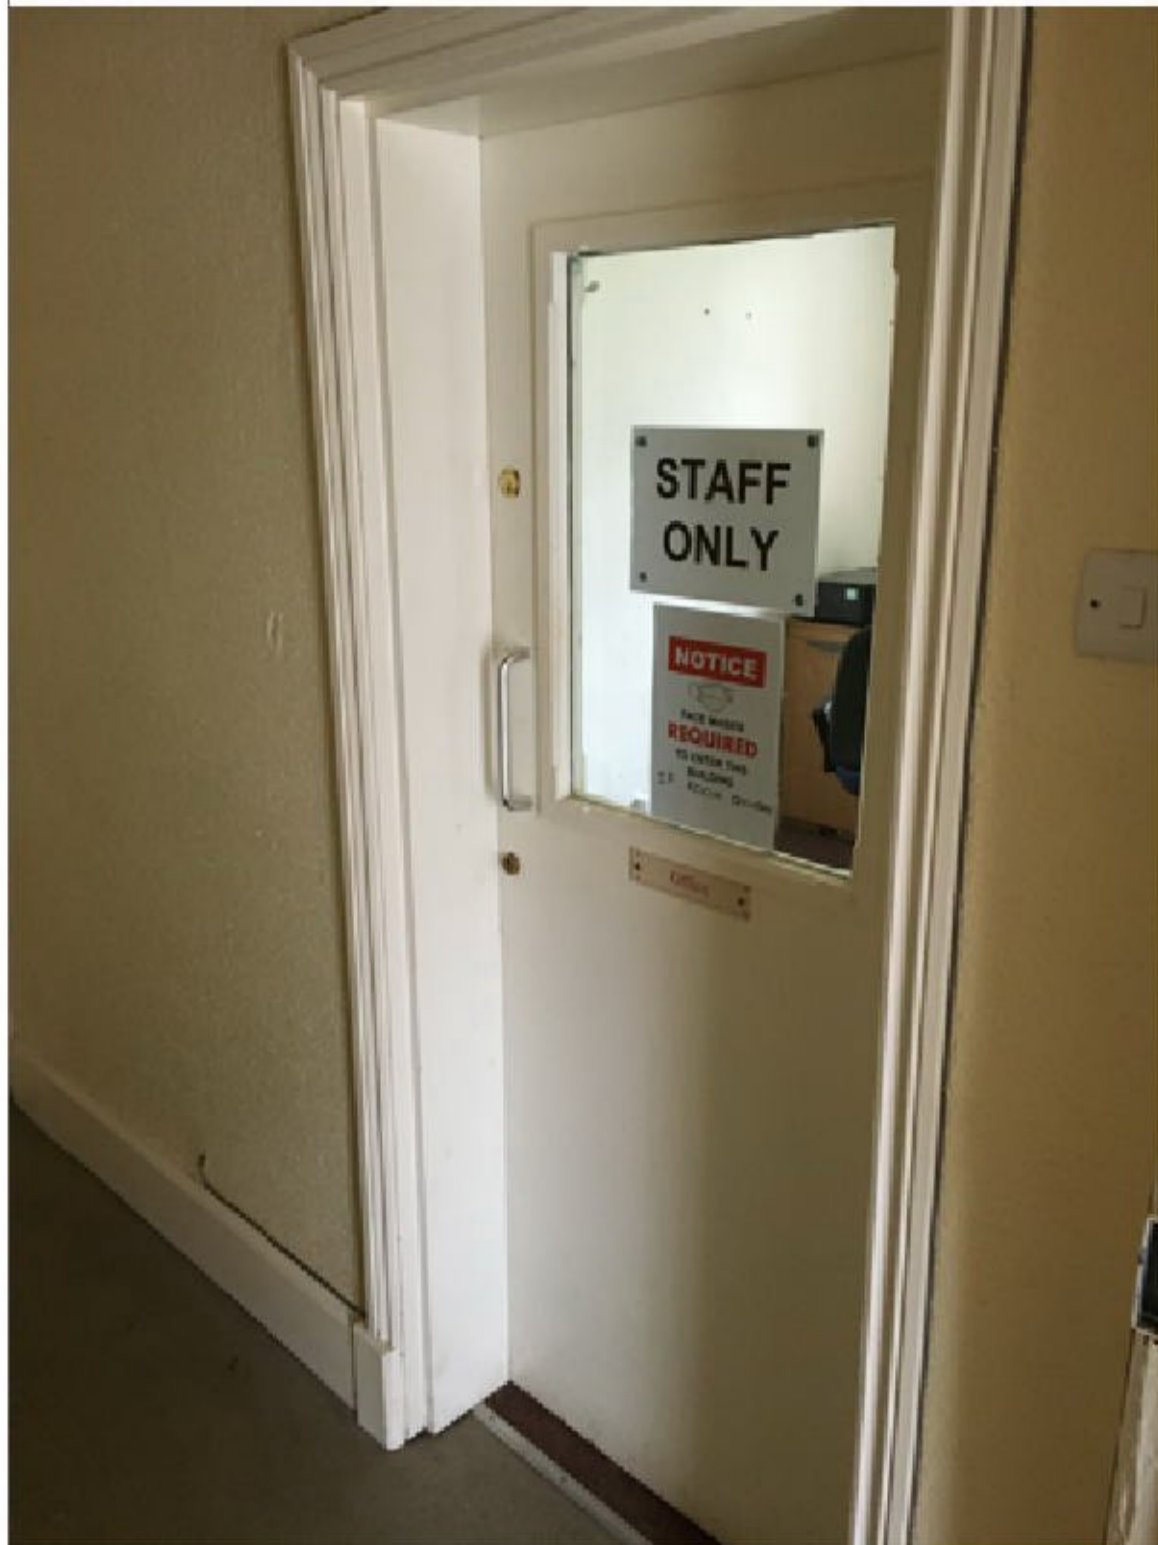
Internal Photo D006i

Photo Location - Office - Door Number **D006** - See floor plans for location

Door leaf - Presumed non original - Good condition

Frame and Architrave - Presumed original - Good condition

- Replace door leaf with new matching original doors, Refurbish and repaint frame

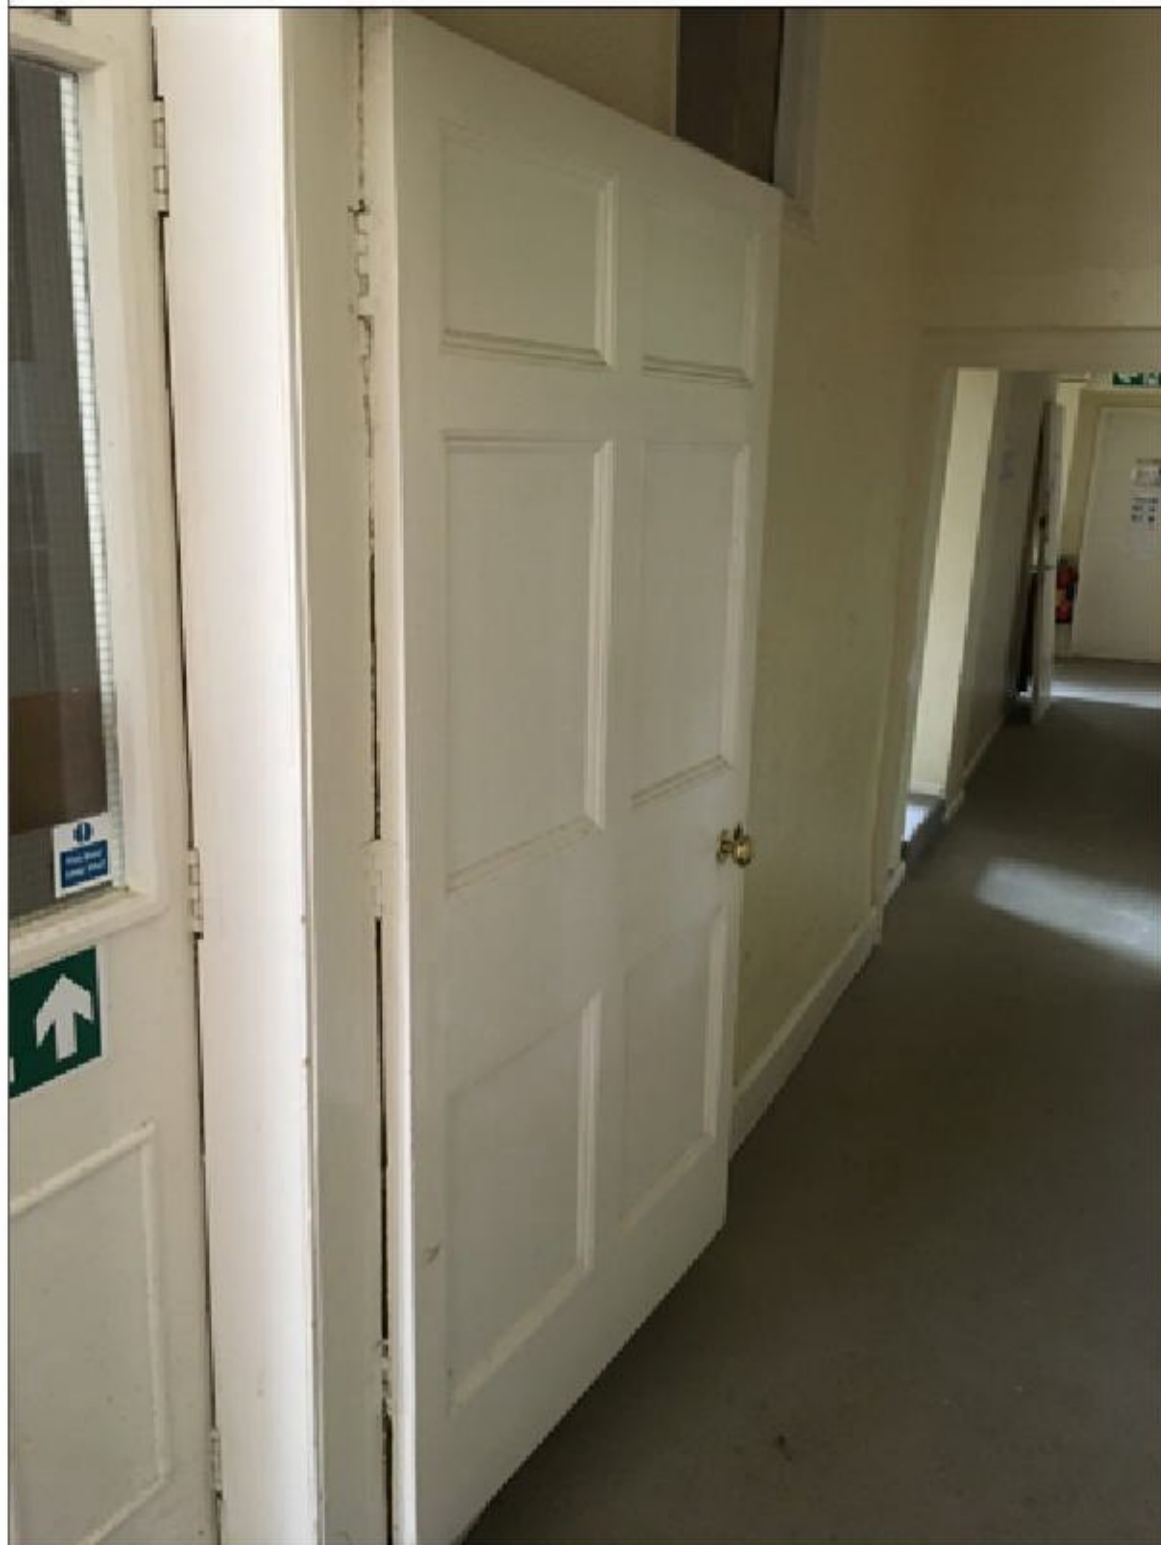
Internal Photo D007i

Photo Location - Entrance Hall - Door Number **D007** - See floor plans for location

Door leaf - Presumed original - Good condition

Frame and Architrave - Presumed original - Good condition

- Refurbish and repaint frame

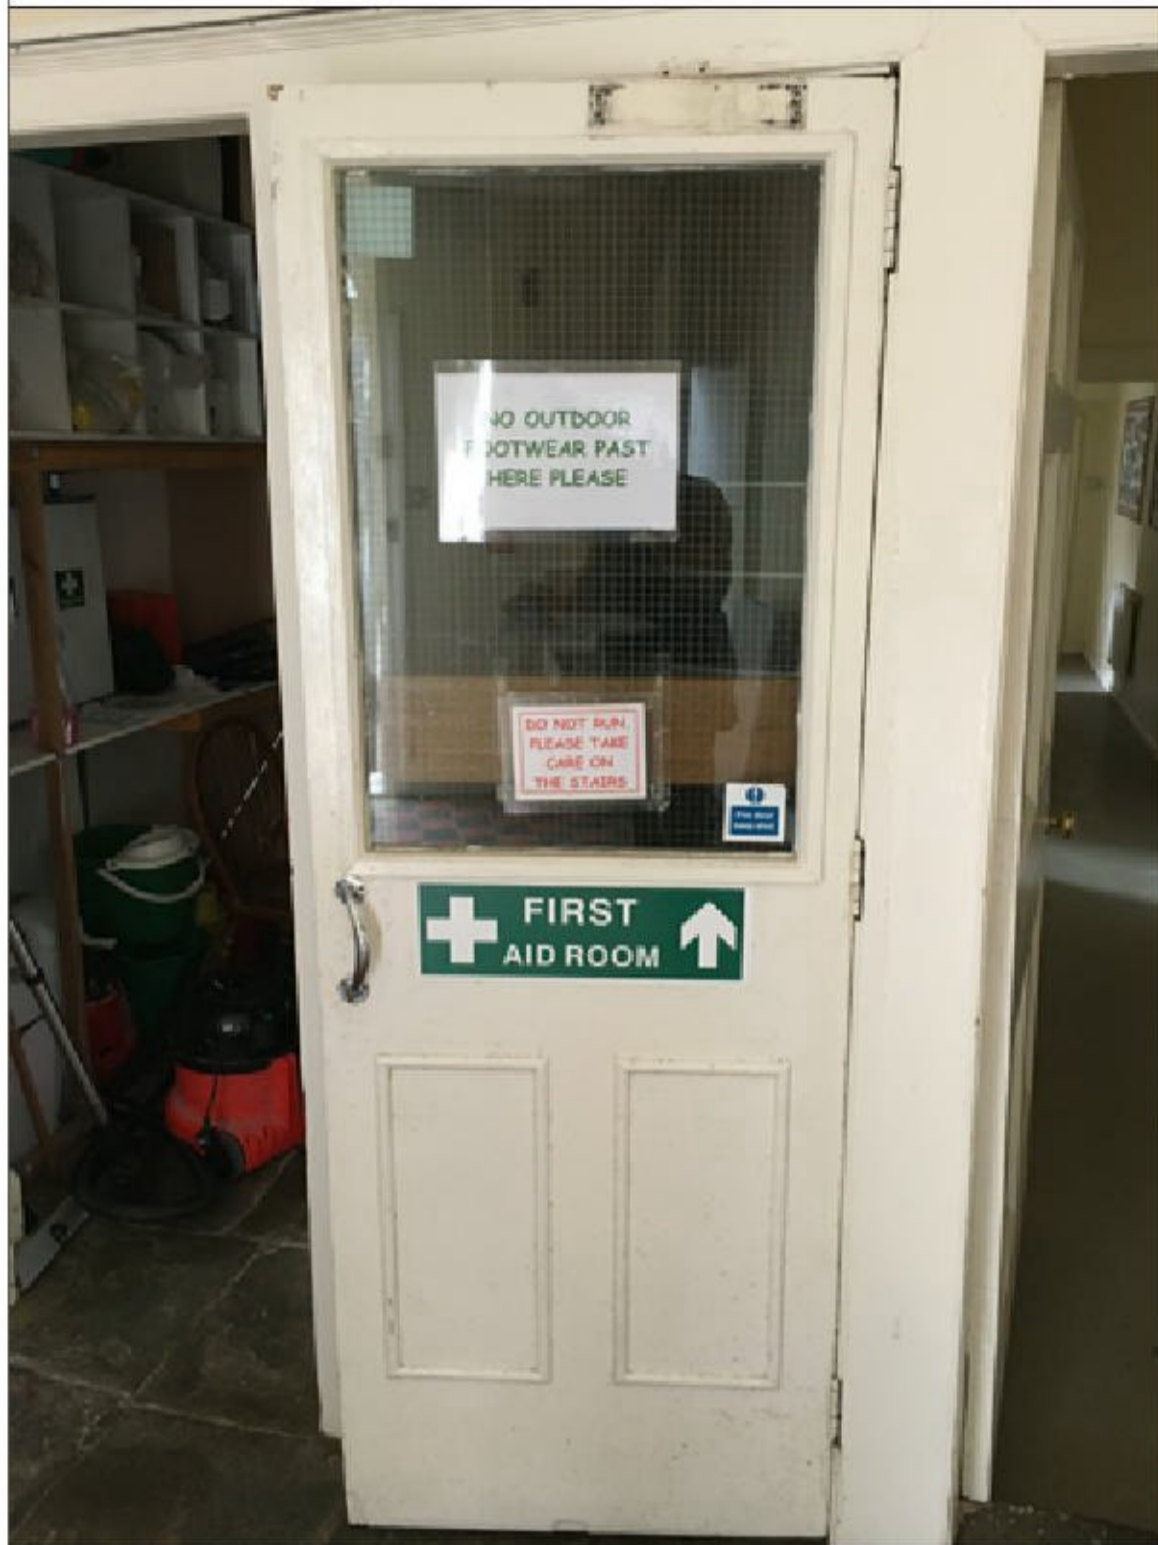
Internal Photo D008i

Photo Location - Entrance Hall - Door Number **D008** - See floor plans for location

Door leaf - Presumed original - Good condition

Frame and Architrave - Presumed original - Good condition

Glass - Non original safety glass

· Refurbish and repaint frame, to be consulted with the fire officer as an alternative first floor external fire escape is to be reinstated, this door can be retained with out replacement.

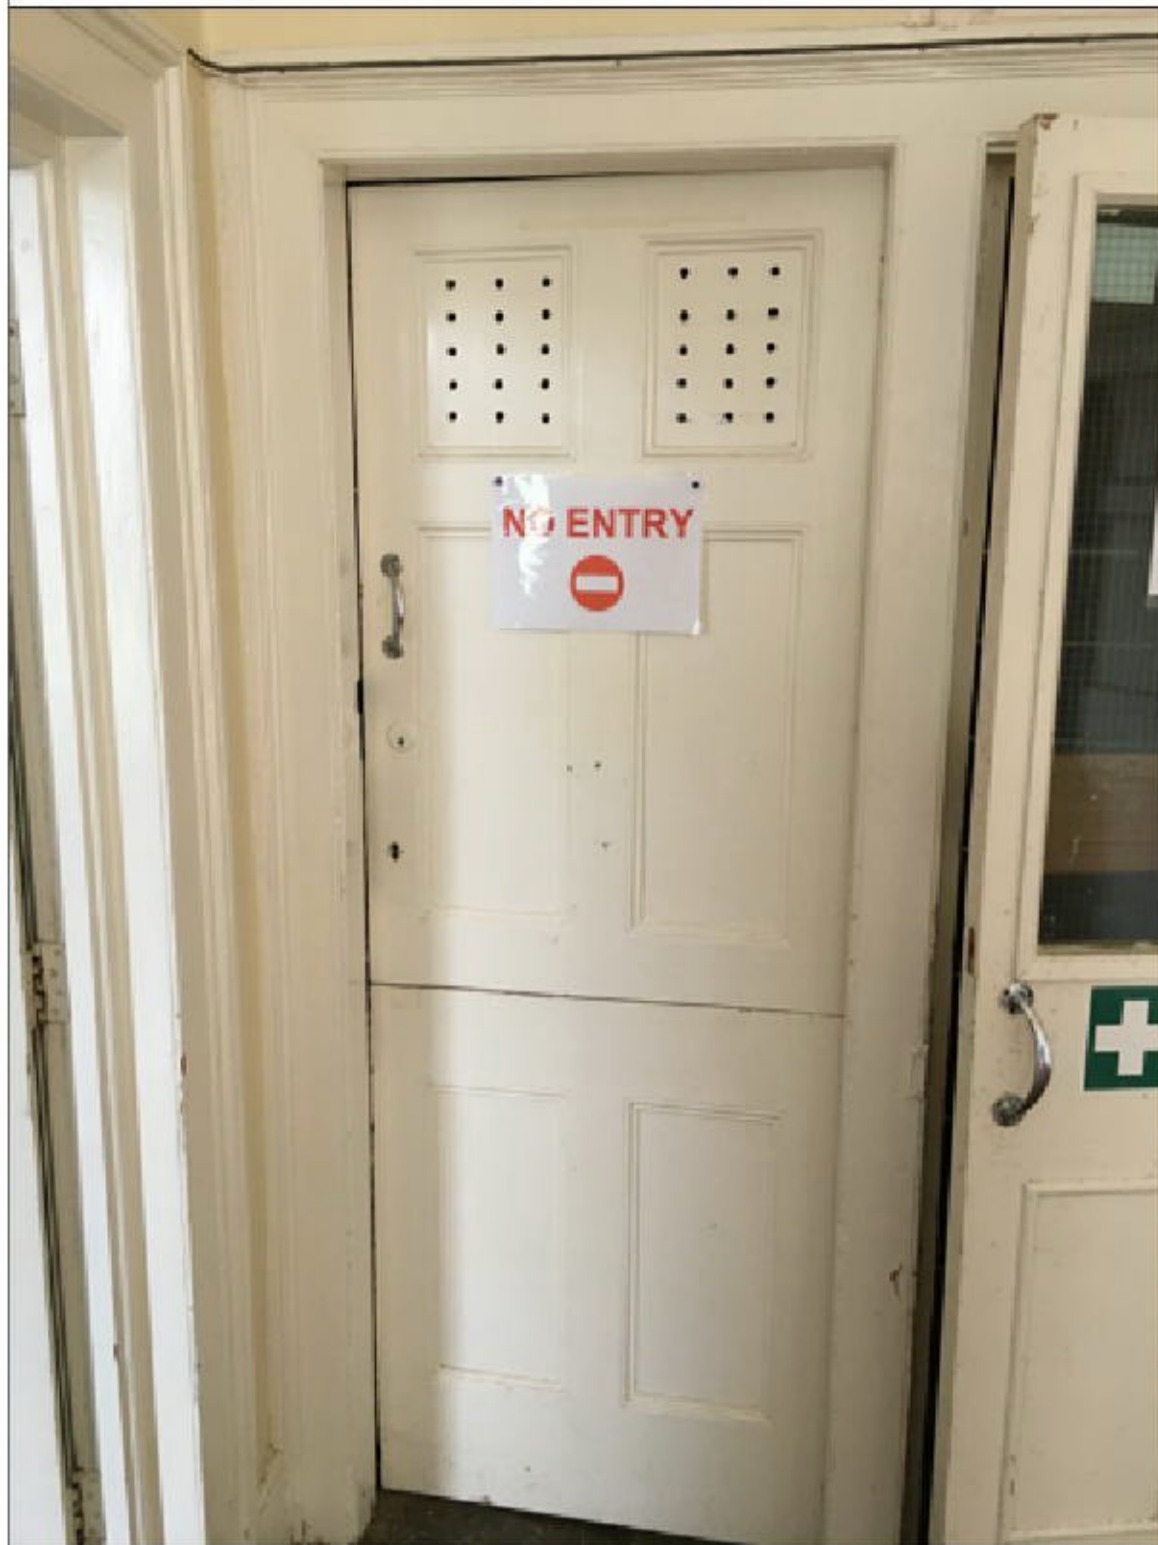
Internal Photo D009i

Photo Location - Store - Door Number **D009** - See floor plans for location

Door leaf - Presumed original - Good condition

Frame and Architrave - Presumed original - Good condition

- Refurbish and repaint frame

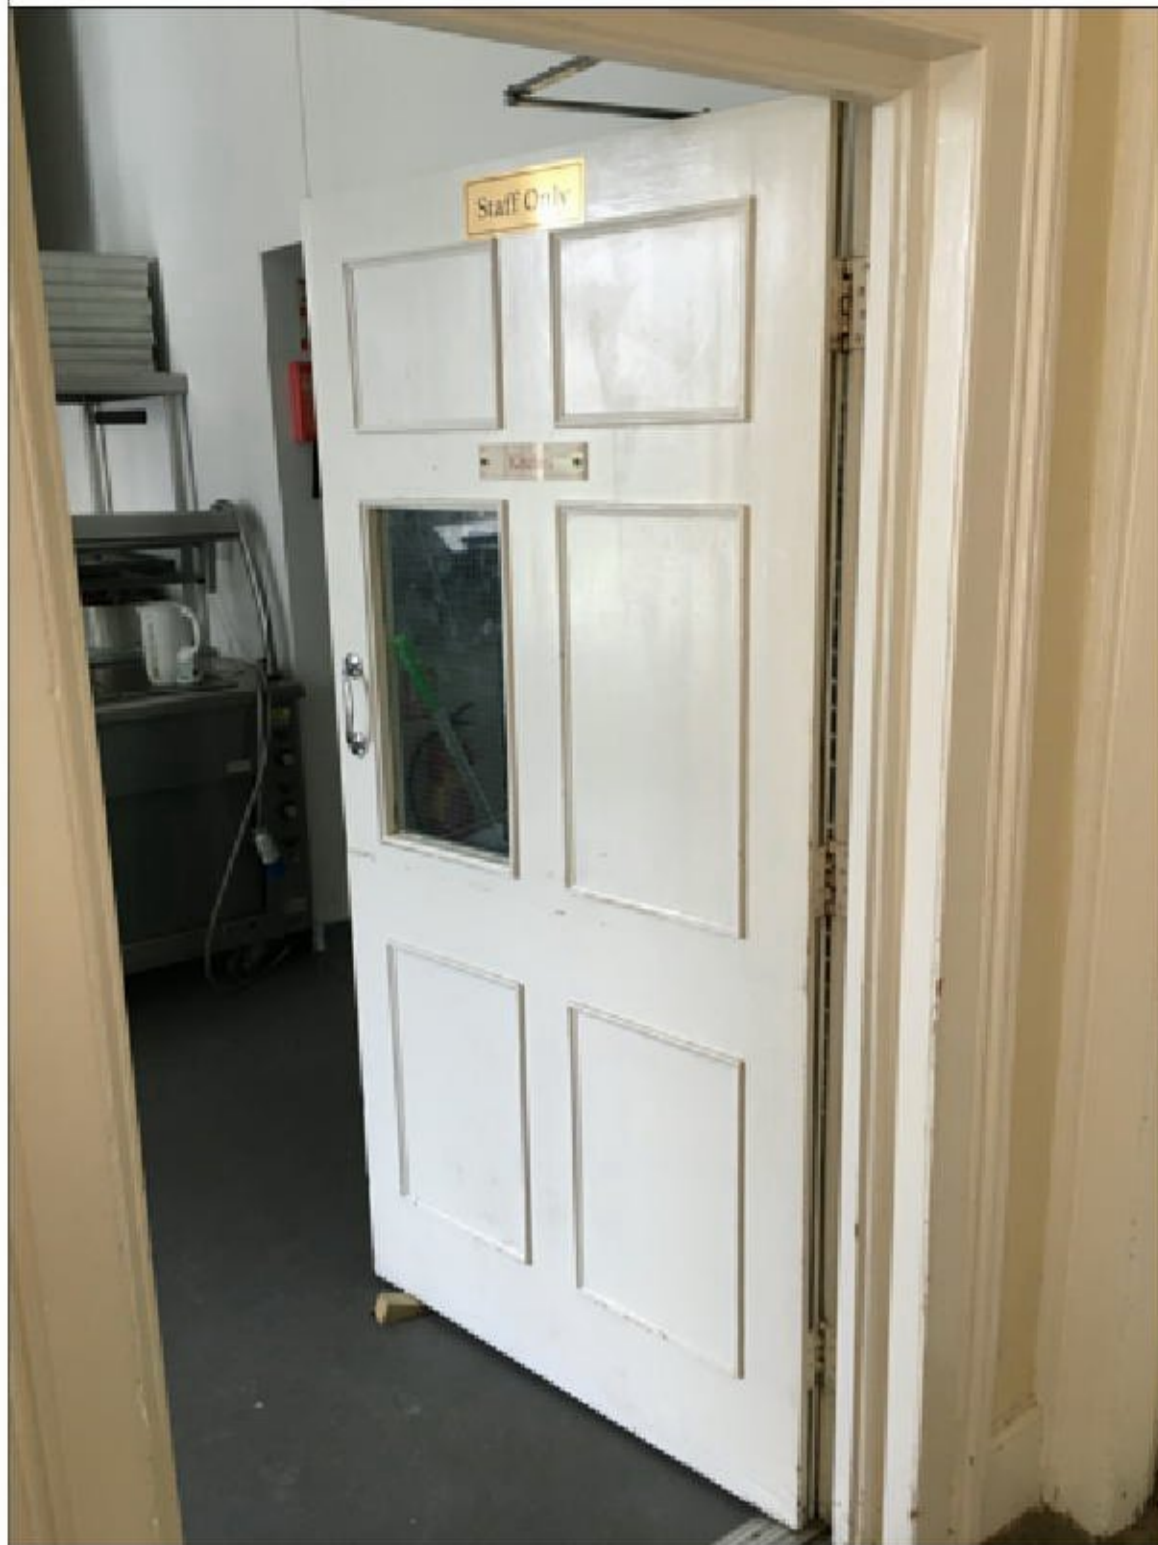
Internal Photo D010i

Photo Location - Kitchen - Door Number **D010** - See floor plans for location

Door leaf - Presumed original - Good condition

Frame and Architrave - Presumed original - Good condition

Glass - Non original safety glass

- Replace glass with new clear pane, Refurbish and repaint frame
